PERIODIC REVIEW REPORT MARCH 2015 – MAY 2020

**HAIGHT FARM SITE
CLARENDON, NEW YORK 14429**

NYSDEC Site No. 837006

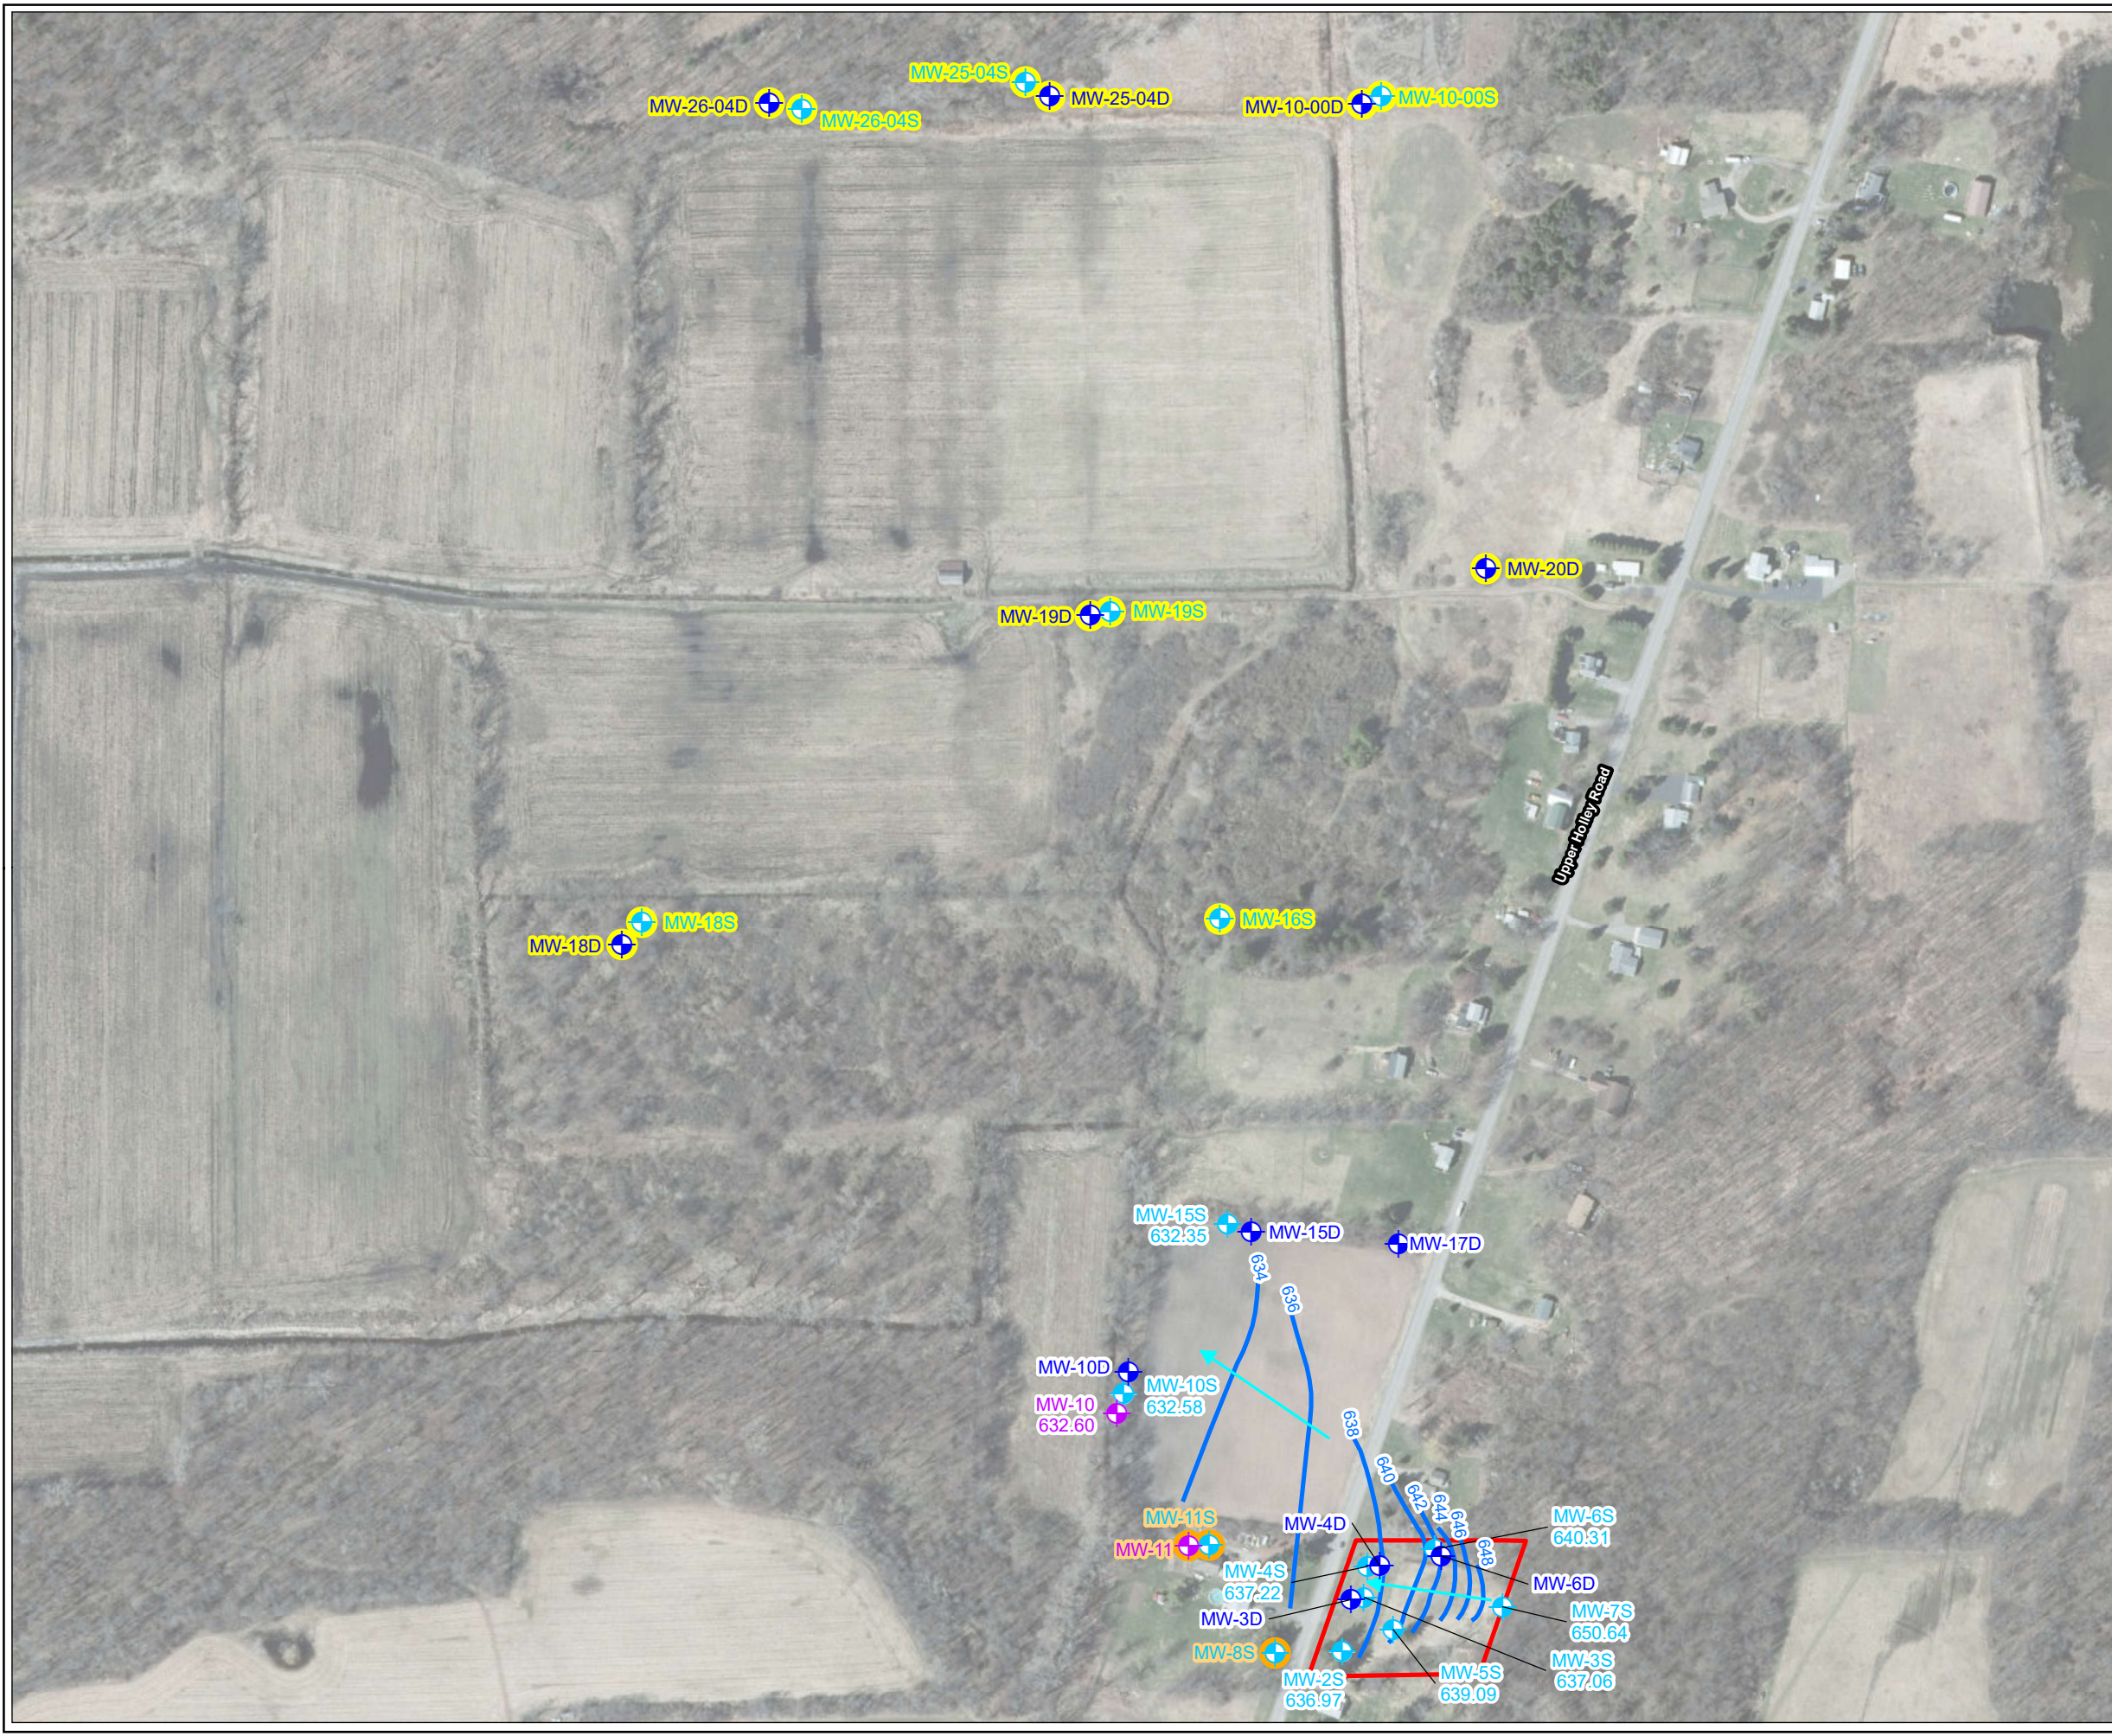
FILE NO.: Fig03_ShallowGW.mxd

Figure 3 – Shallow Groundwater Surface Elevations and Flow Map – May 2, 2019

- Based on groundwater elevations measured during the May 2019 site visit, groundwater flow in upper water bearing shallow zone of fractured and weathered bedrock is to the west from the Site, under Upper Holley Road and towards the stream/irrigation ditch to the northwest of the residences. Groundwater flow in the deeper water bearing zone of highly fossilized and fractured dolostone is also to the west under Upper Holley Road and towards the stream/irrigation ditch. This flow pattern is similar to historical reporting for the Site. Historical groundwater data has shown that the groundwater flow changes directions and flows northward towards the Hanson Aggregate Clarendon Quarry after reaching the stream/irrigation ditch on the northwestern side of the residential properties on Upper Holley Road. Since the downgradient monitoring wells MW-16S, MW-18S, MW-18D, MW-19S, MW-19D, MW-20D were not gauged for water elevations, it is unclear if this flow pattern is still present.

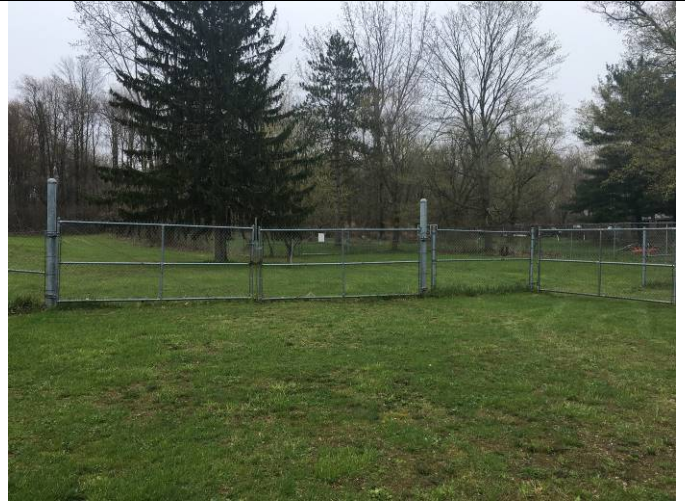
Photo 2: Looking east at the entrance gate to the Haight Farm Site from Upper Holley Road. The gate lock was cut, and replaced with a Master Lock® with key code #2537.

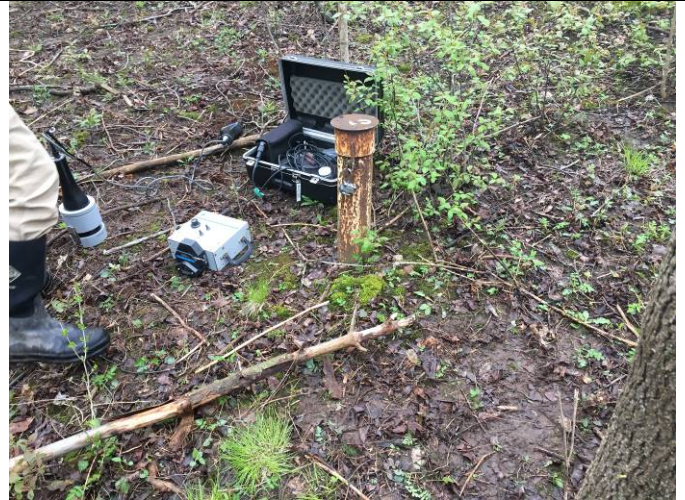
Photo 4: Looking west. Setting up low-flow sampling equipment on MW-7S.

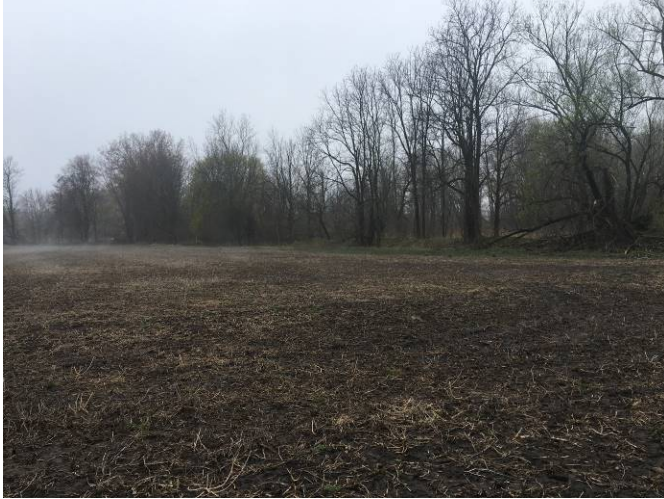
Photo 1: Looking Northwest towards off-site wells MW-15S and MW-15D.

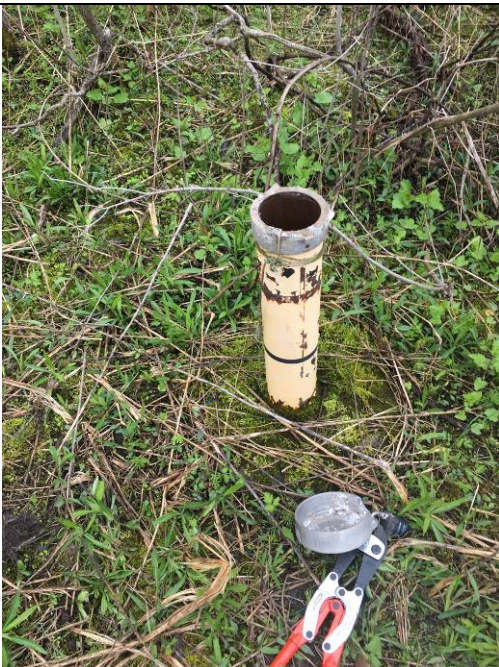
Photo 3: Offsite monitoring well MW-15D. Locks for all site wells sampled as part of this visit were cut and replaced with Master Lock® with key code #2537.

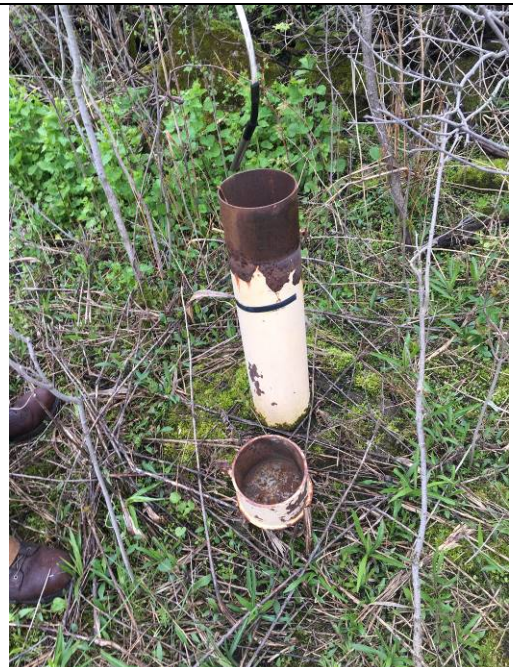
Photo 4: Offsite monitoring well MW-15S.
