Re: 2025 Annual Groundwater Monitoring Report
National Grid Former Albion MGP Site
Albion, NY
Case #837012

2025 Groundwater Monitoring Report

National Grid Albion Former MGP Site
Ingersoll Street
Albion, NY
NYSDEC Site # 837012

National Grid Albion Site
Ingersoll Street
Albion, NY

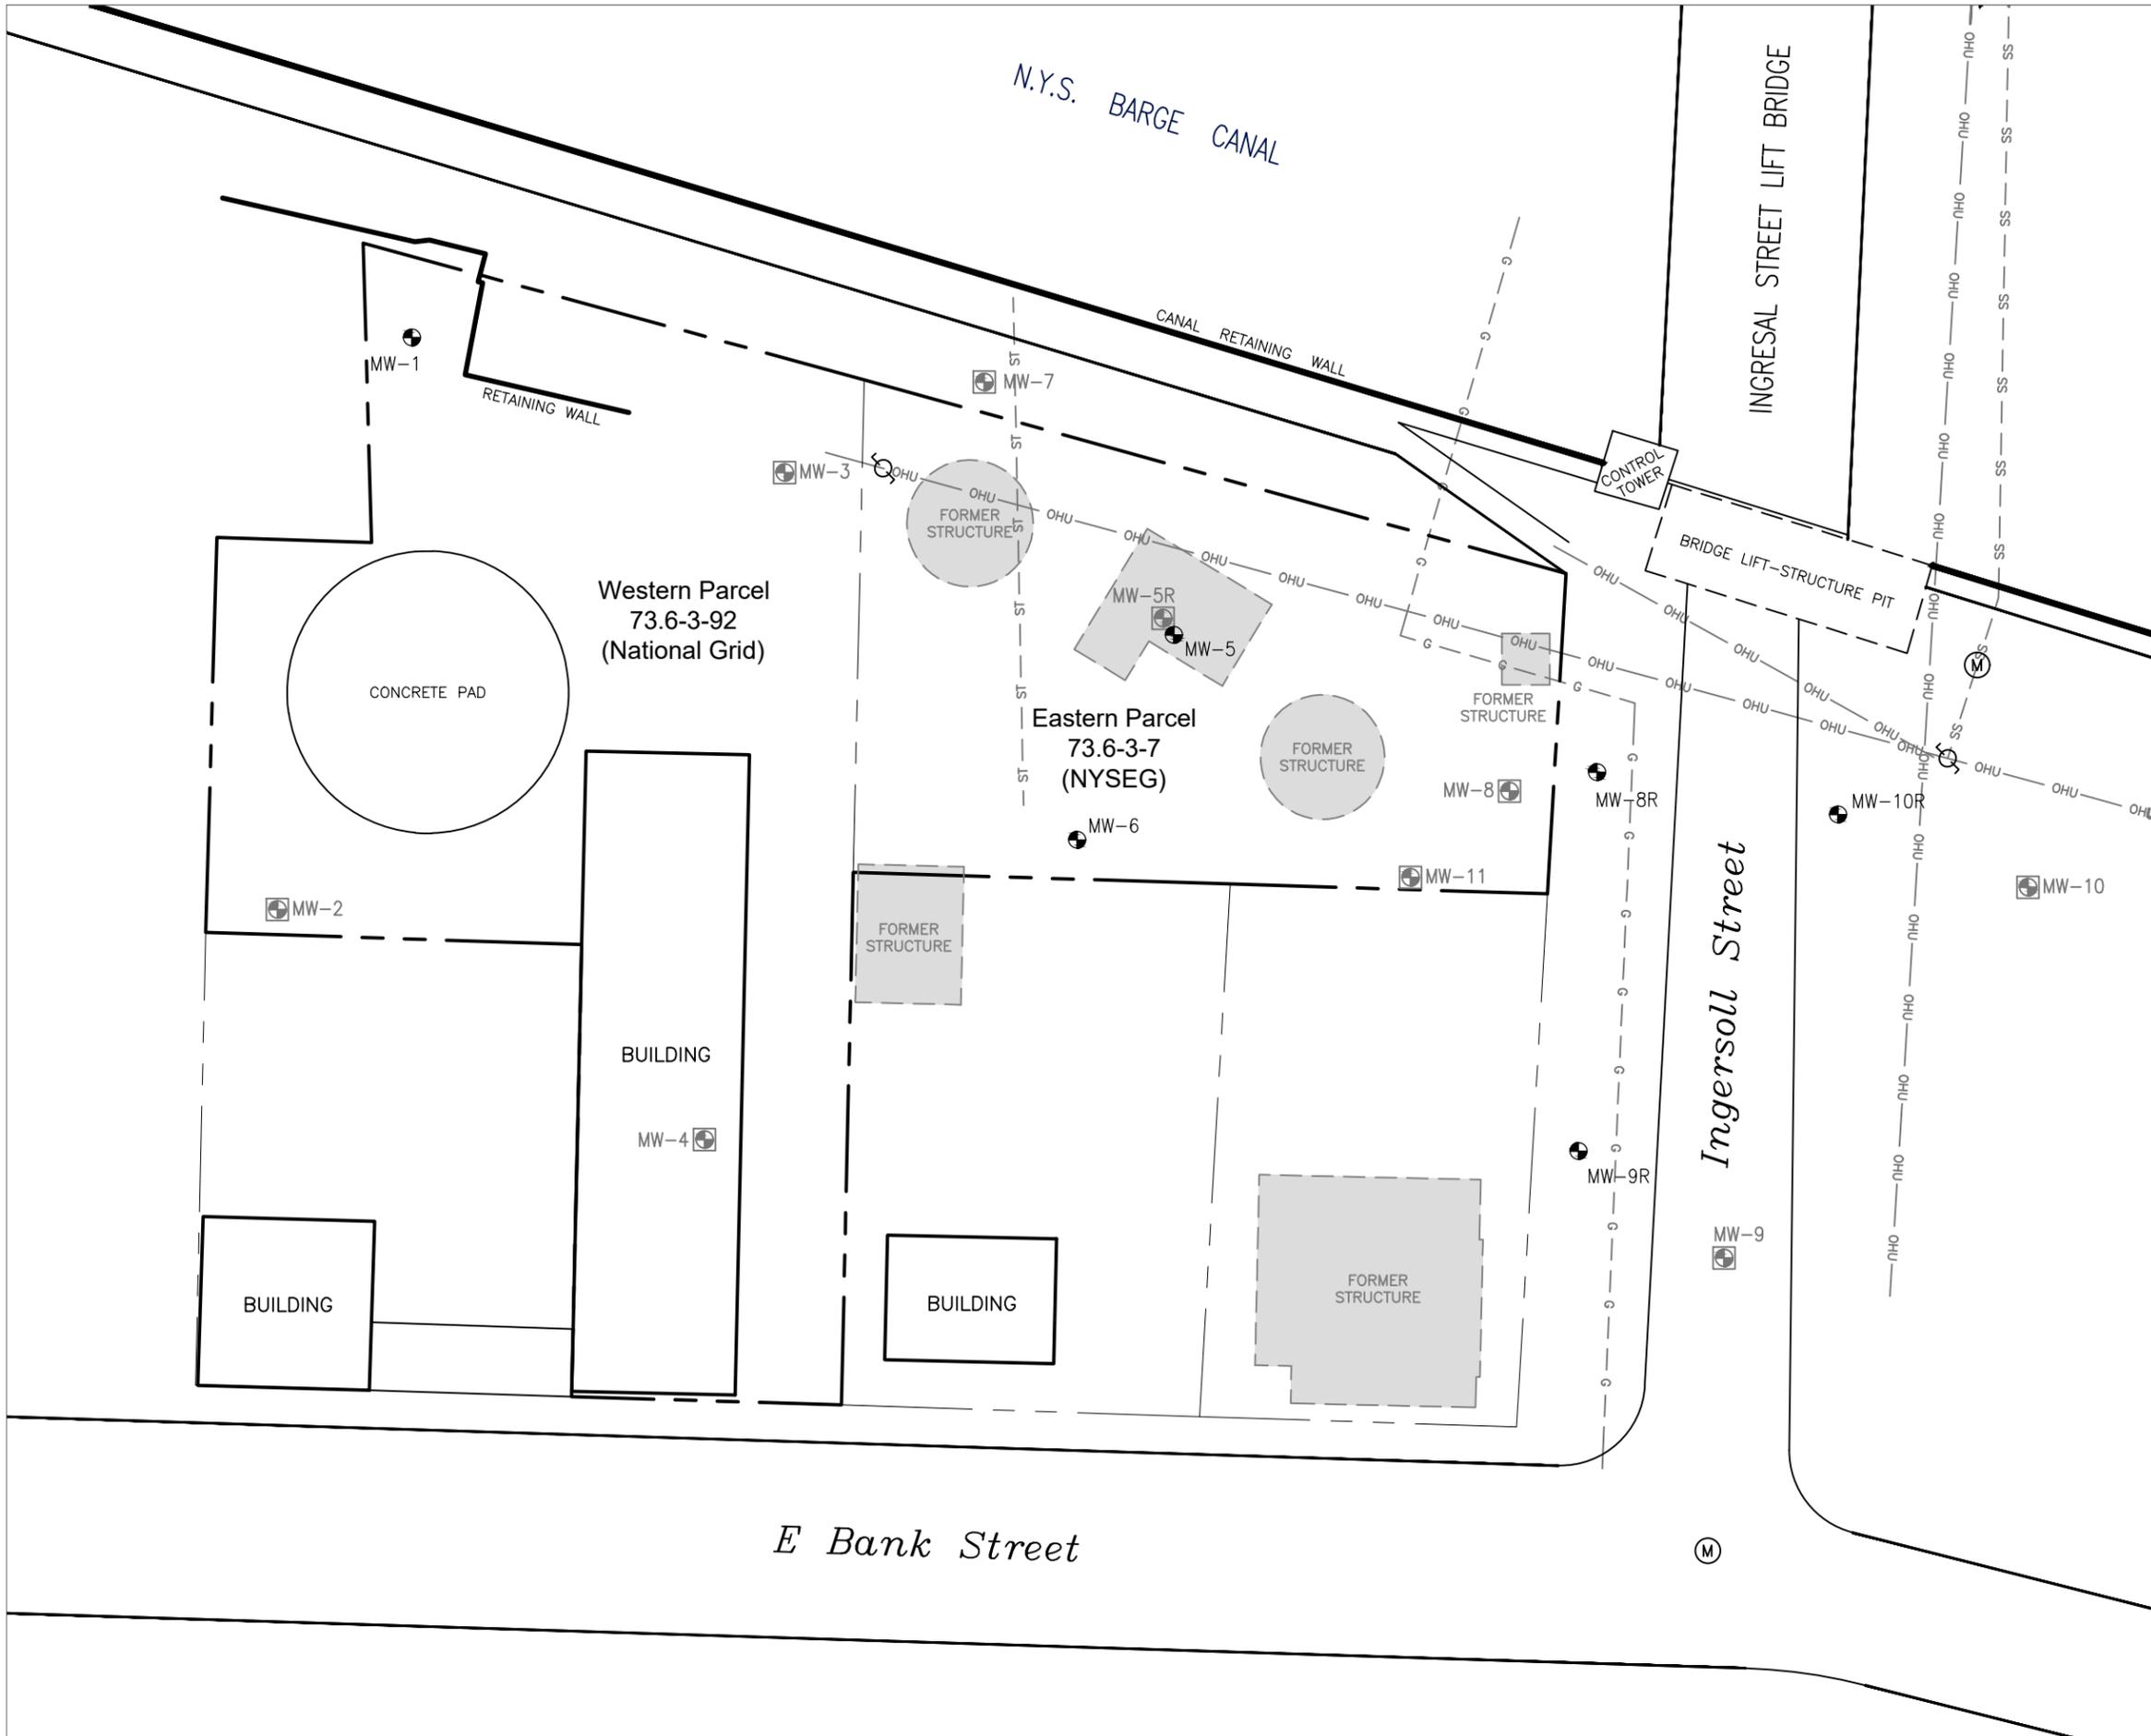
Site Map	
National Grid Former MGP Site Ingersoll Street Albion, New York	
Drawn M.H. Designed R.K. Approved T.B.	Date 11/06/25 Figure 2
Scale In Feet (Approximate)

The Site consists of two (2) adjoining properties is located at 134 Ingersoll Street and 127 East Bank Street in the Town of Albion, Orleans County, New York, **Figure 1** provides a site location map. The approximately 0.5-acre property is identified as the Site. It is bordered by the New York State Erie Barge Canal to the north, Ingersoll Street to the east, Bank Street to the south, and a park and commercial building to the west. Currently, the western parcel contains an active electrical substation on the property (not identified as an environmental concern during previous investigations), while the eastern parcel is vacant and undeveloped. A structure location map showing the location of features at the Site is presented as **Figure 2**.

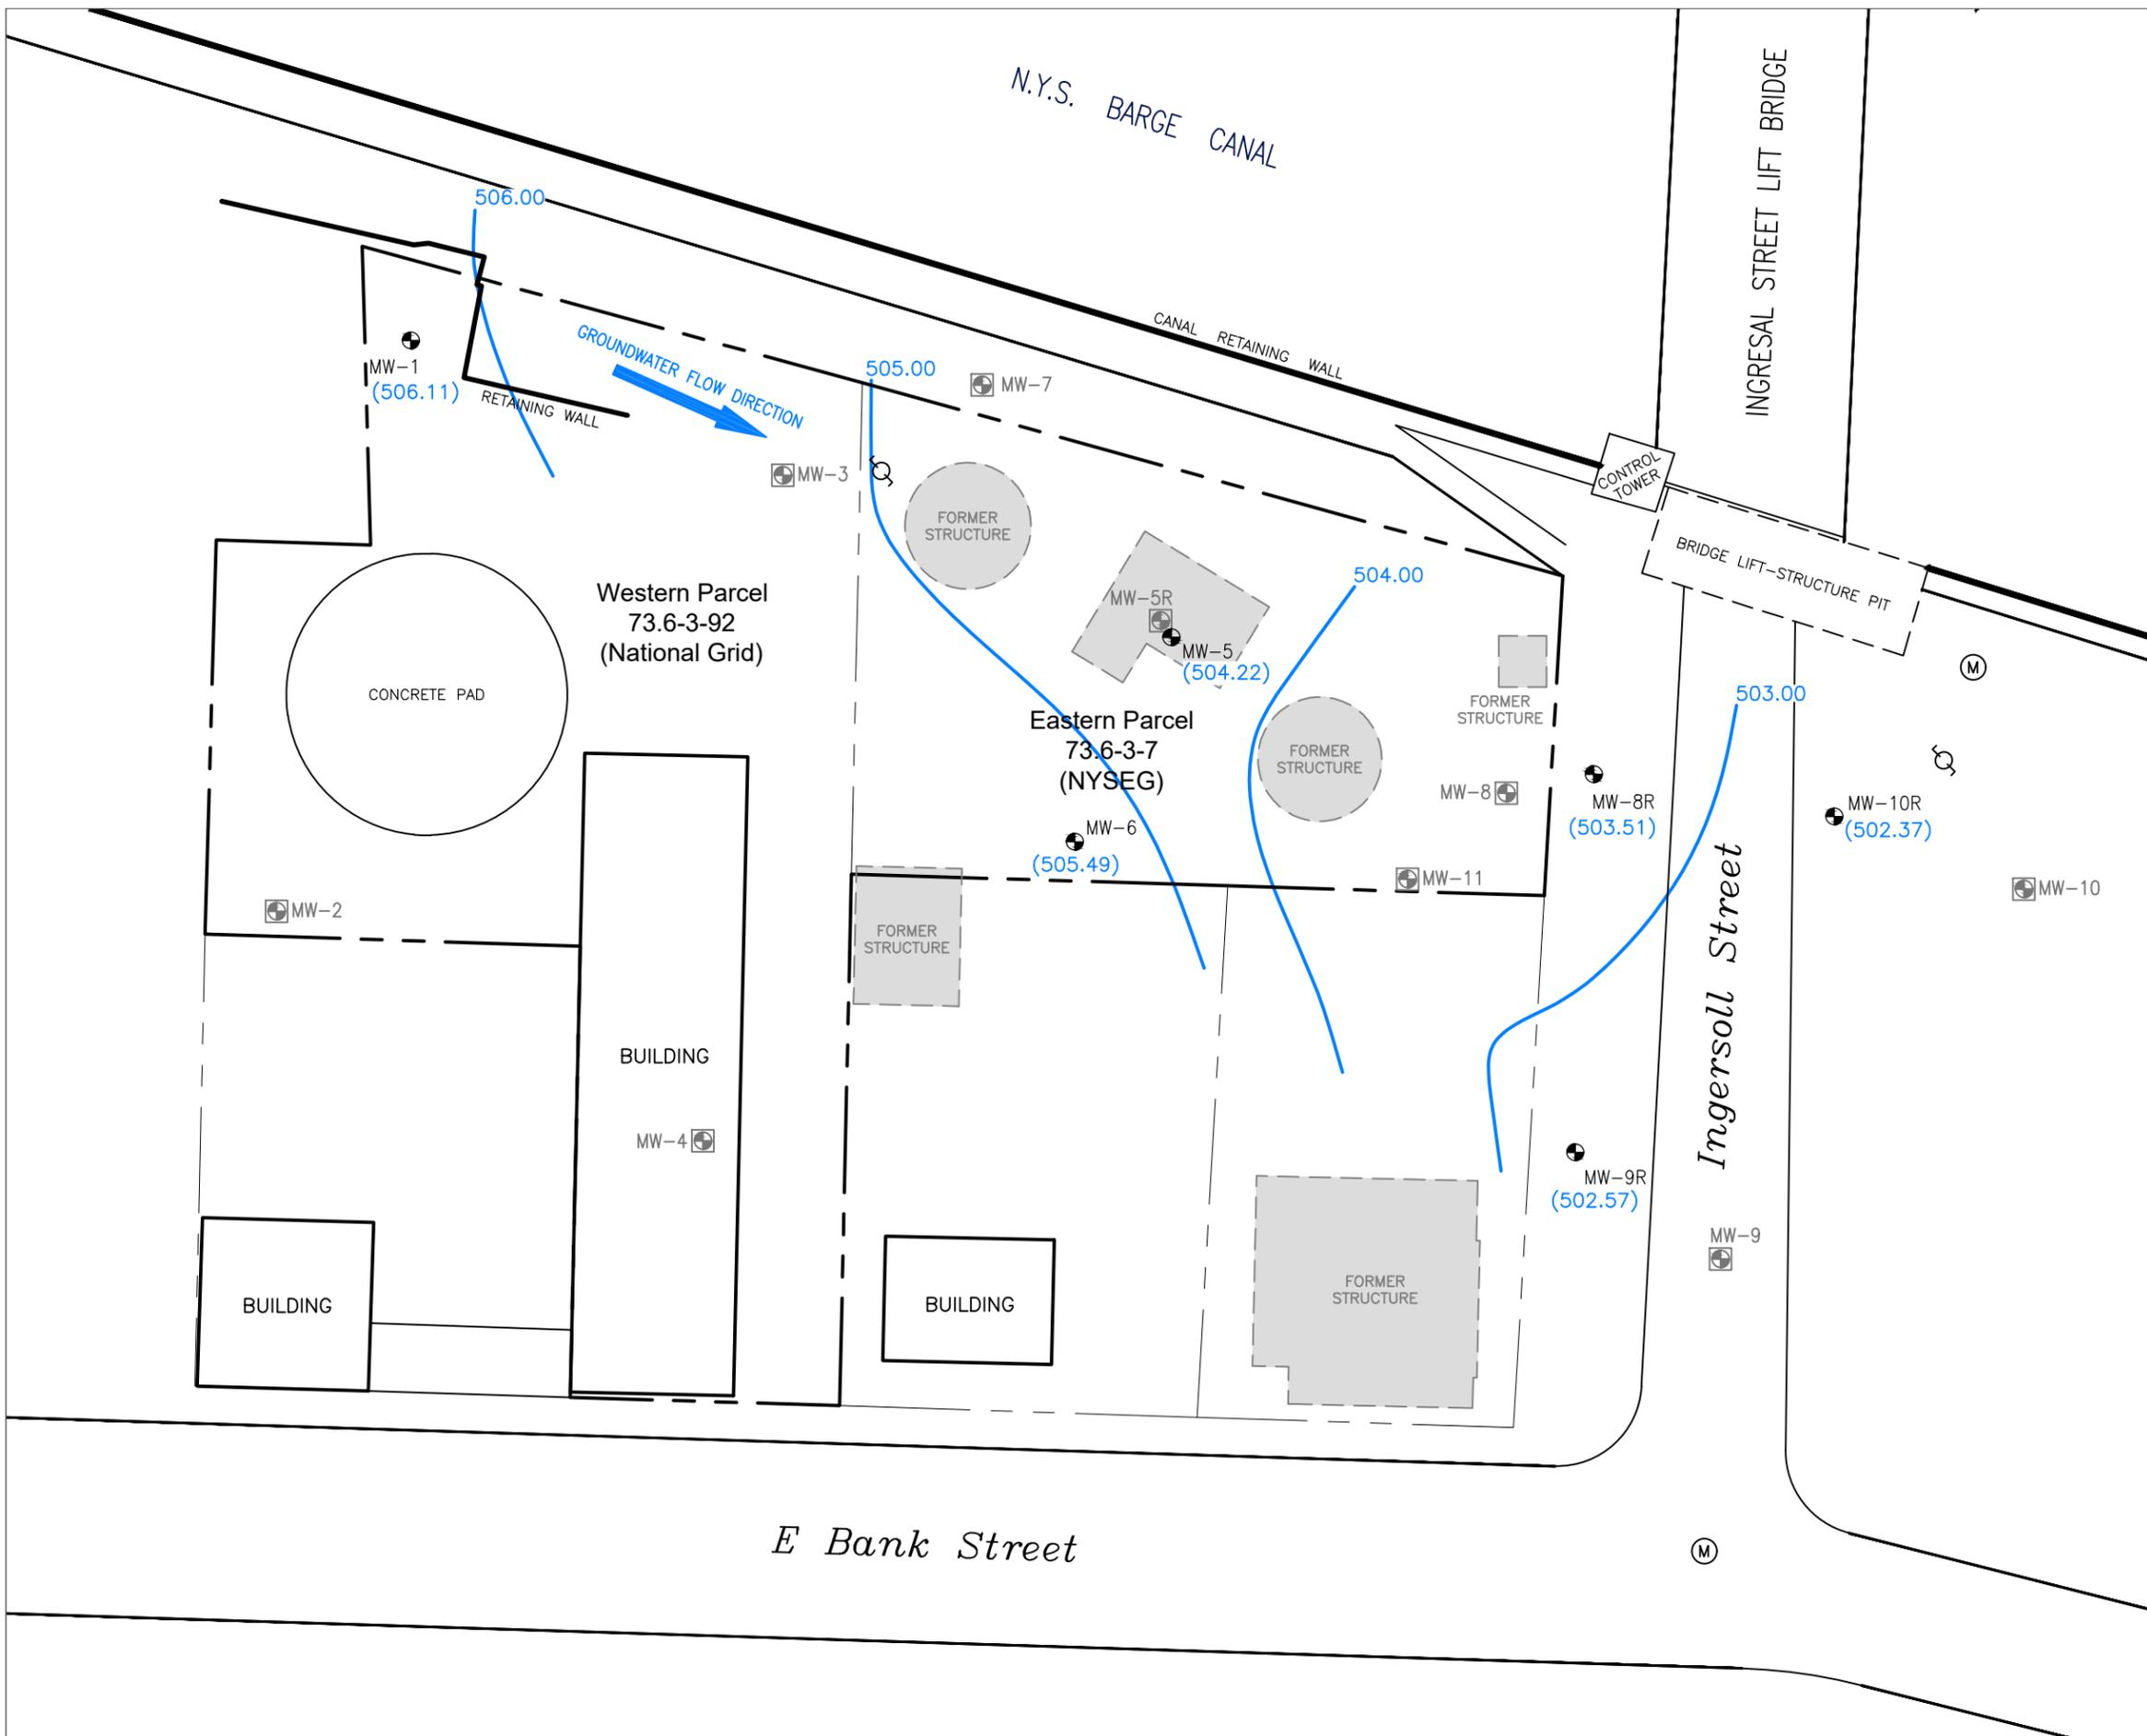
Groundwater Contour Map April 8, 2025	
National Grid Former MGP Site Ingersoll Street Albion, New York	
Drawn M.H. Designed R.K. Approved	Date 11/06/25 Figure 3

Purging data for the wells, field parameters measured during purging, and the chain of custody for the samples are included in **Appendix A**. The groundwater level measurements are provided on **Table 1**. Groundwater contours are shown on **Figure 3** and **Figure 4**.

Groundwater generally flows in an easterly to southeasterly direction, with a slight seasonal influence by seasonal operating levels at the adjacent NYS Barge Canal. Groundwater elevations ranged from 502.37 feet above sea level (asl) (well MW-10R) to 506.11 feet asl (well MW-1) in April 2025; and from 500.65 feet asl (well MW-9R) to 508.59 feet asl (well MW-1) in October 2025.

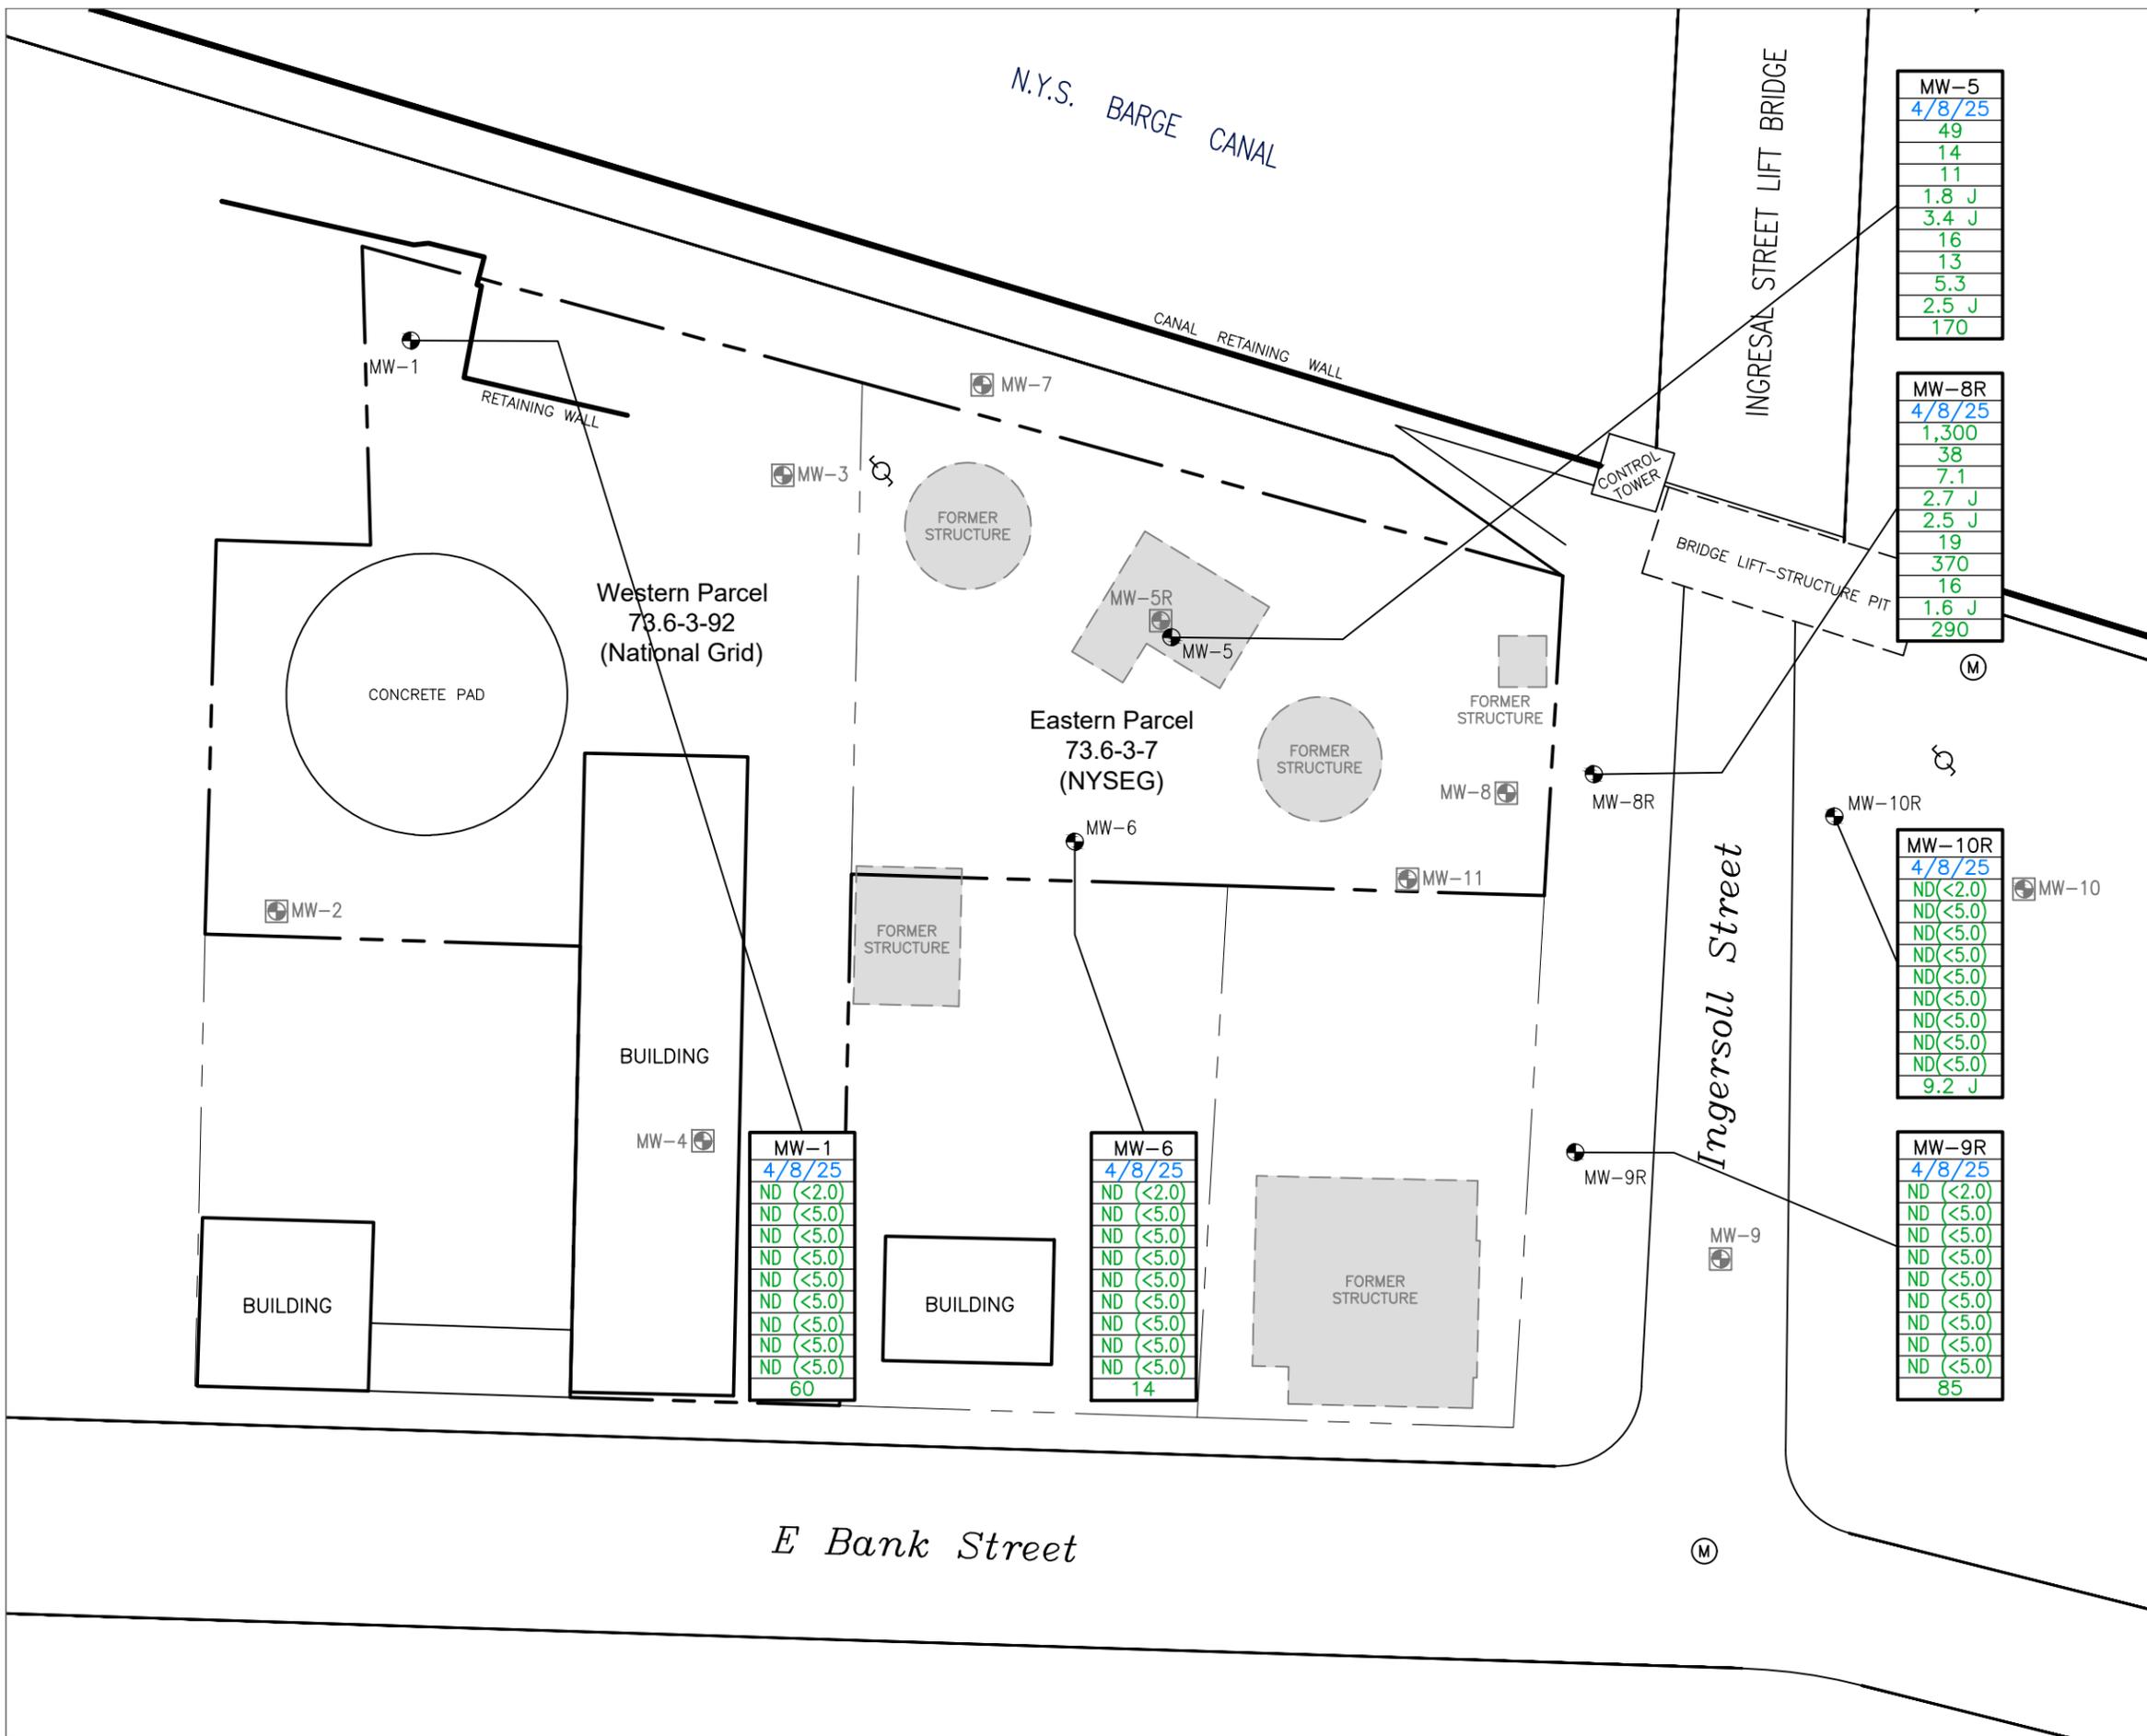
Groundwater Monitoring Map
 April 8, 2025

In April 2025, monitoring wells MW-1, MW-6, MW-9R, and 10R had no detections of any analyzed compound with the exception of cyanide which was observed at concentrations below the applicable criteria. There were BTEX, PAH and/or cyanide detections in monitoring wells MW-5 and MW-8R. Benzene, ethylbenzene, total xylenes, and naphthalene were detected above the regulatory criteria in MW-5. BTEX, acenaphthene, naphthalene, and cyanide were detected above the regulatory criteria in MW-8R.

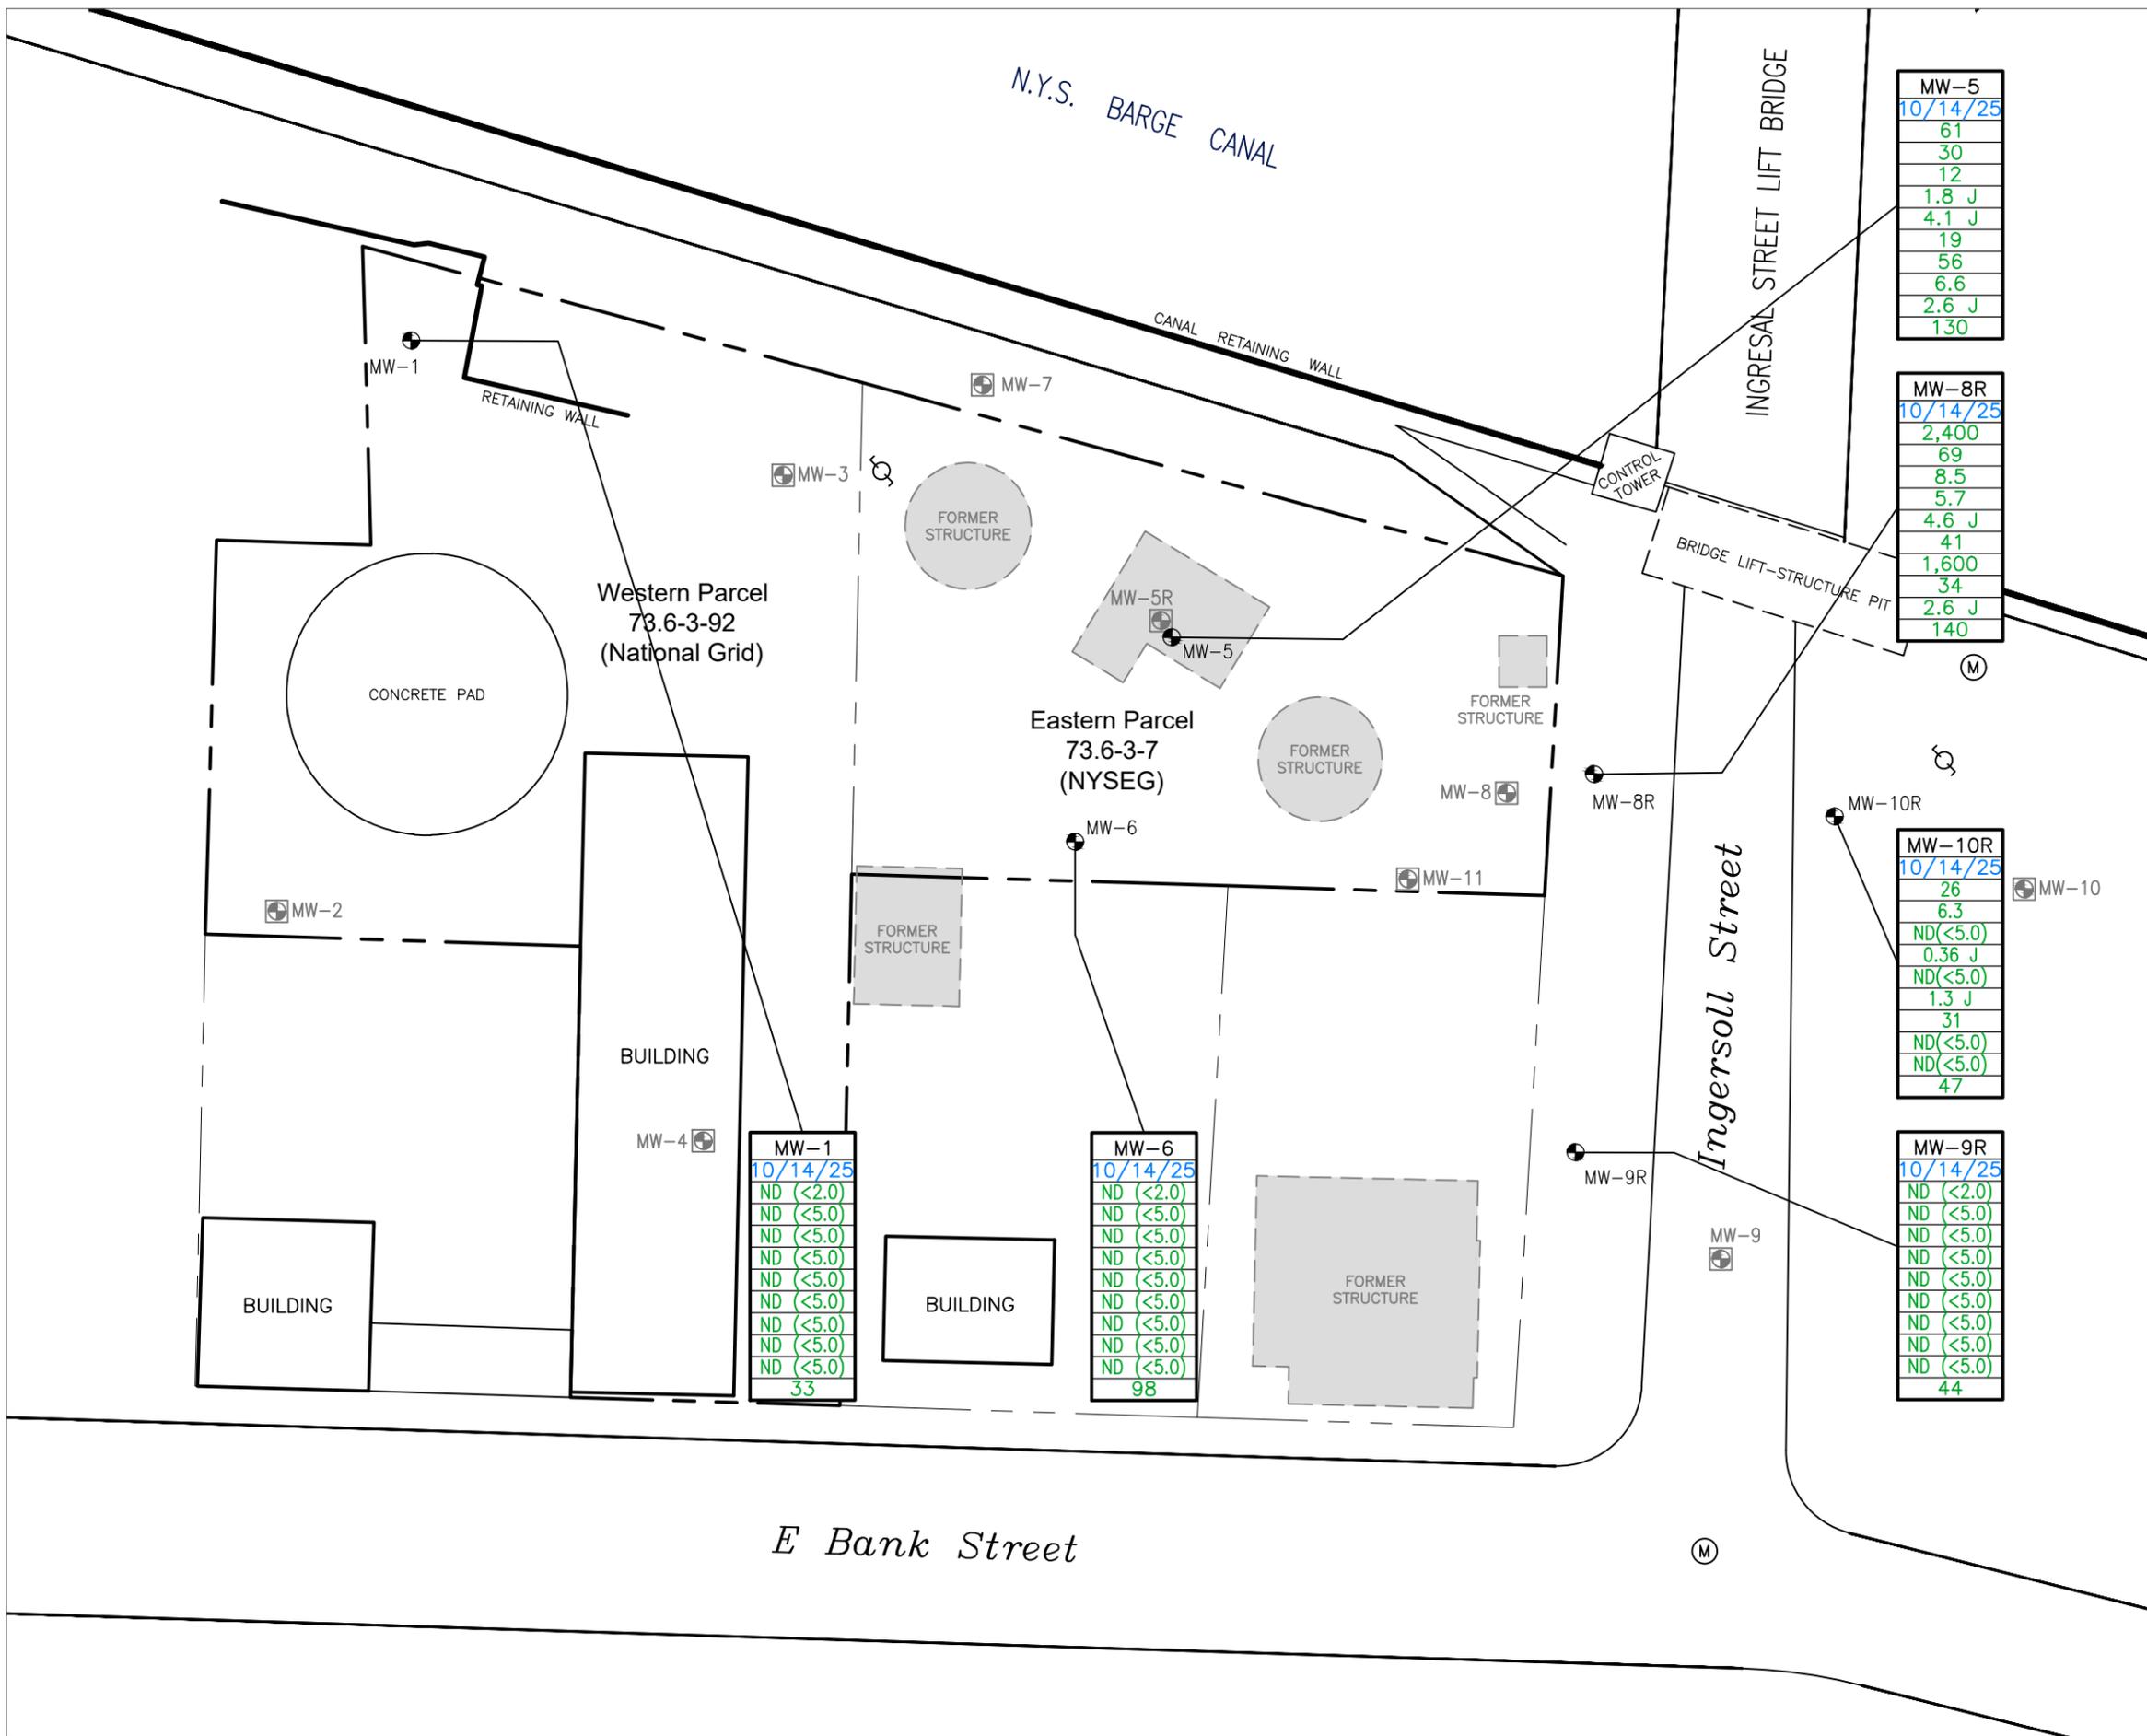
Groundwater Monitoring Map
October 14, 2025

In October 2025, monitoring wells MW-1, MW-6, and MW-9R had no detections of any analyzed compound with the exception of cyanide, which was below the applicable criteria at each location.

BTEX, PAH and/or cyanide were detected in monitoring wells MW-5, MW-8R, and MW-10R. Benzene, ethylbenzene, total xylenes, acenaphthene, and naphthalene were detected above the regulatory criteria in MW-5. BTEX, acenaphthene, and naphthalene were detected above the regulatory criteria in MW-8R. Benzene and naphthalene were detected above the regulatory criteria in MW-10R. Cyanide were detected in these wells at levels below the regulatory criteria.

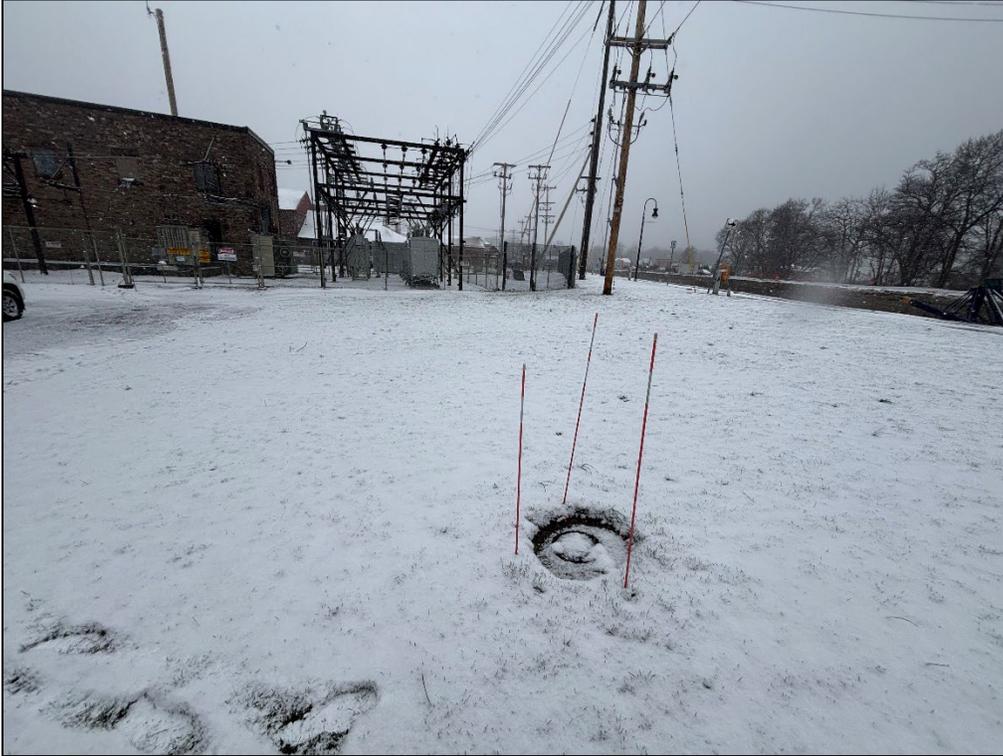
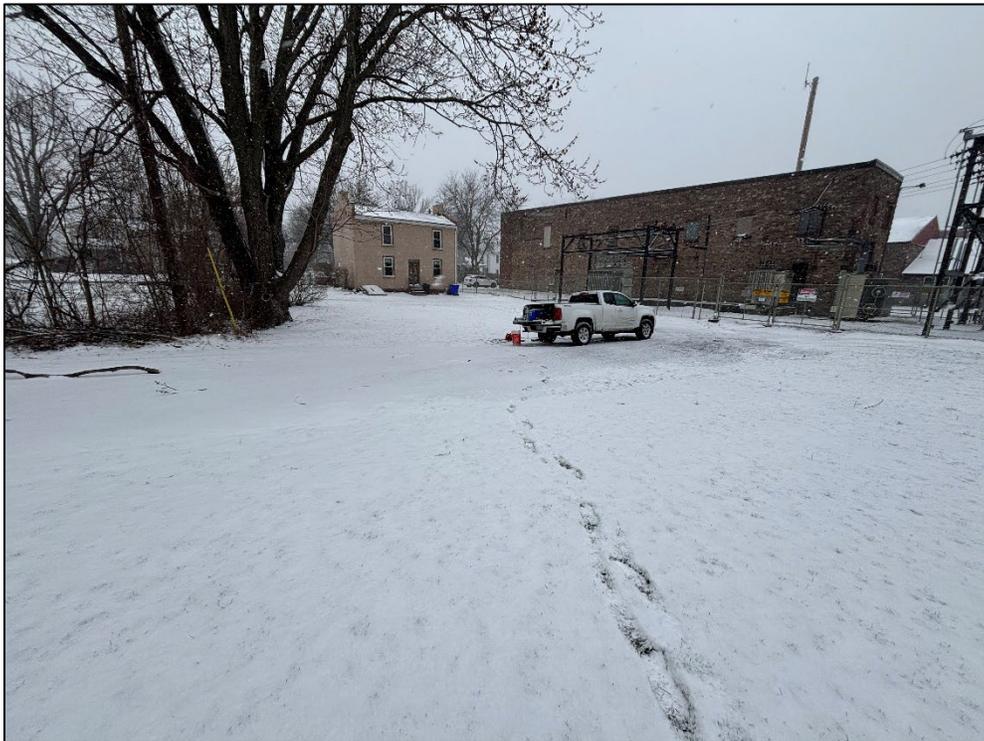
April 8, 2025 – Site Conditions

Quarterly site-wide inspections were conducted by GES on January 28, April 8, July 16, and October 14, 2025. The vegetative cover, fence line, and security gates are inspected as part of site-wide inspection activities. Refer to **Appendix C** for photographs of the current site conditions and for the quarterly Site Inspection Forms. In general, the Site is in compliance with the requirements listed in the SMP.
