**BI-MONTHLY LETTER REPORT
ACTIVE VENTING SYSTEM
OPERATION AND MAINTENANCE
FEBRUARY 2005 SAMPLING EVENT
NORTH FRANKLIN STREET SITE
SITE #8-49-002
VILLAGE OF WATKINS GLEN, NEW YORK**

**RE: NYSDEC Standby Contract
Active Venting System Operation and Maintenance # D003825-09.3
February 2005 Sampling Event
North Franklin Street Site, Site No. 8-49-002
Summary of Operation and Maintenance Activities: Bi-Monthly Letter Report**

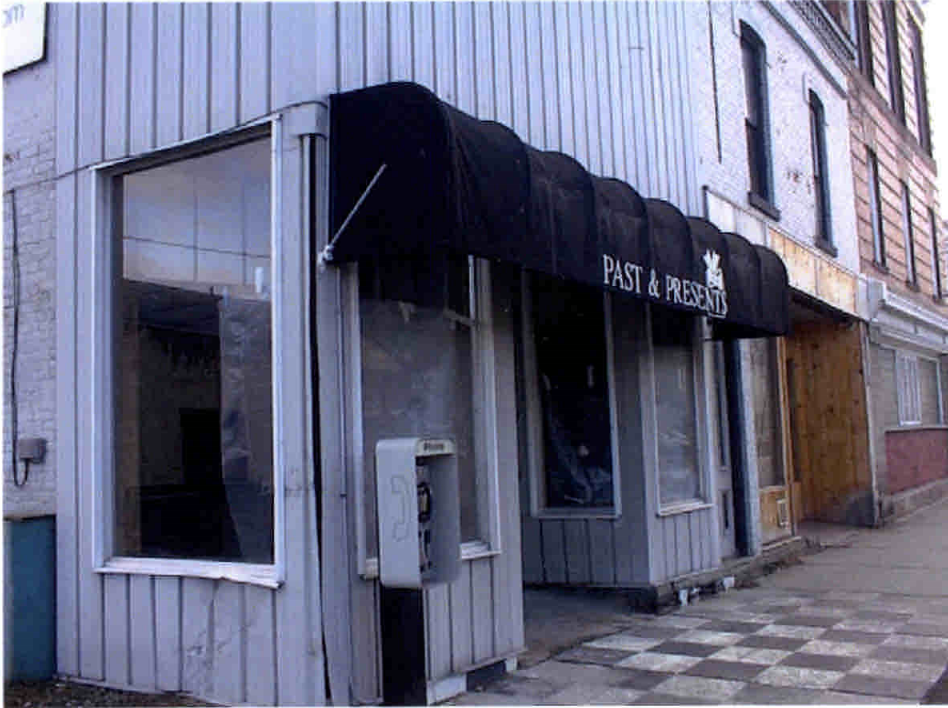
Client Name: New York State Department of Environmental Conservation		Site Location: 20 N. Franklin St., Watkins Glen, New York	Project No. 11173258.61000
Photo No. 1	Date: 2-15-05

Direction Photo Taken: Southeast			
Description: Site Building (20 N. Franklin St.), with new tenant (Past & Presents).

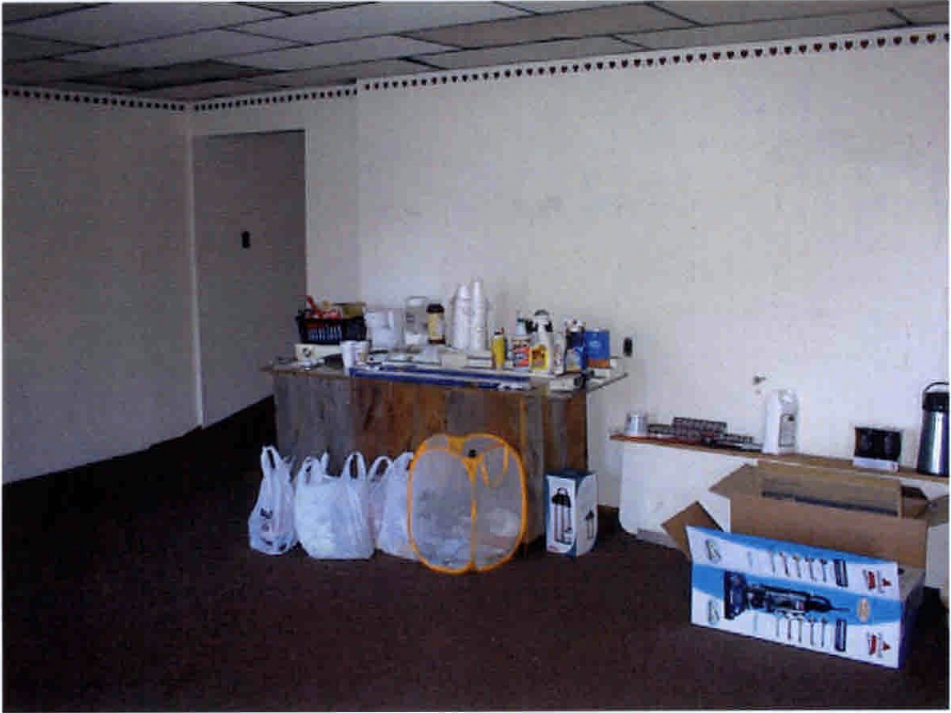
Client Name: New York State Department of Environmental Conservation		Site Location: 20 N. Franklin St., Watkins Glen, New York	Project No. 11173258.61000
Photo No. 3	Date: 2-15-05

It should be noted that the concentration of xylenes and toluene detected in the indoor air sample have increased since the December O&M event. These increases are most likely the result of the above-mentioned paints and solvents staged adjacent to the indoor air sampling location. The remainder of the compounds detected had concentrations at or near their corresponding reporting limits.

Direction Photo Taken: Southeast			
Description: Back room of site building (indoor air sampling location). Paints and other assorted solvents designated for remodeling present.

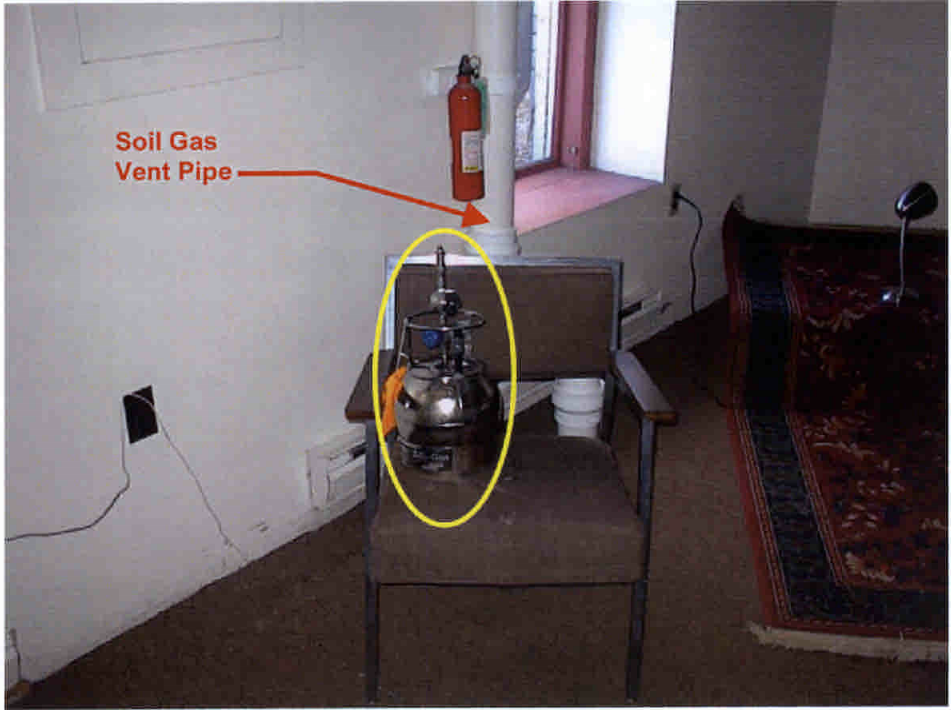
Photo No. 4	Date: 2-15-05

- One (1) 4-hour indoor air sample was collected in the back room of the site building (INDOOR-0205), adjacent to the above-mentioned paints, cleaners, and solvents; and,
- One (1) soil gas grab sample was collected from the venting system's exhaust stack (SOILGAS-0205).

Direction Photo Taken: Northeast		
Description: Back room of site building, with ambient air sample "INDOOR-0205" being collected. Pipe to soil gas venting system in background.

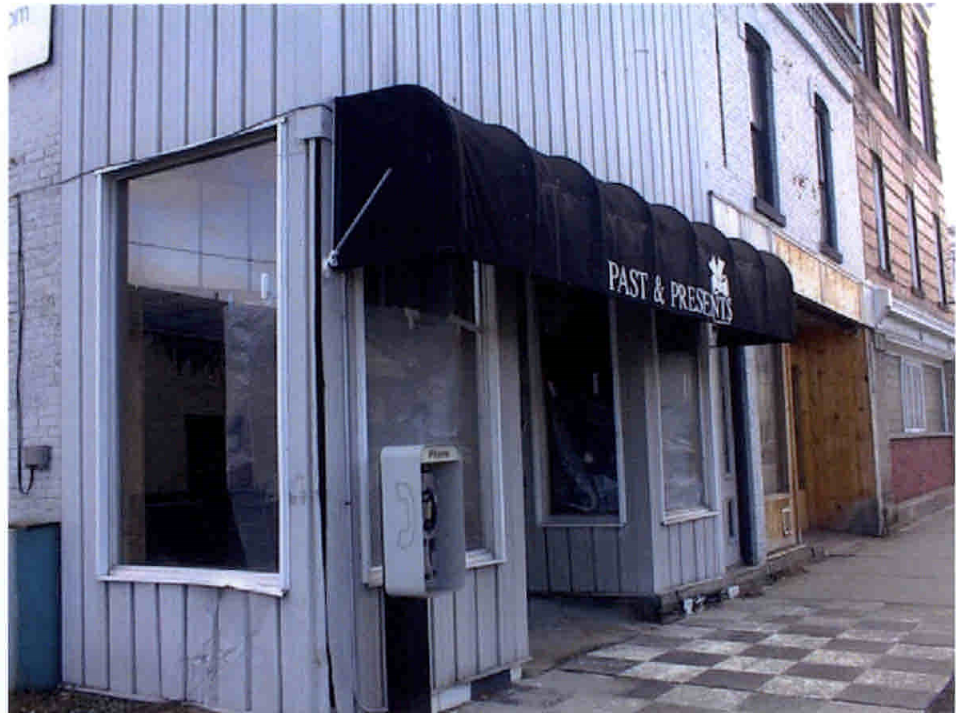
Photo No.

Site Building (20 N.
Franklin St.), with new
tenant (Past & Presents).

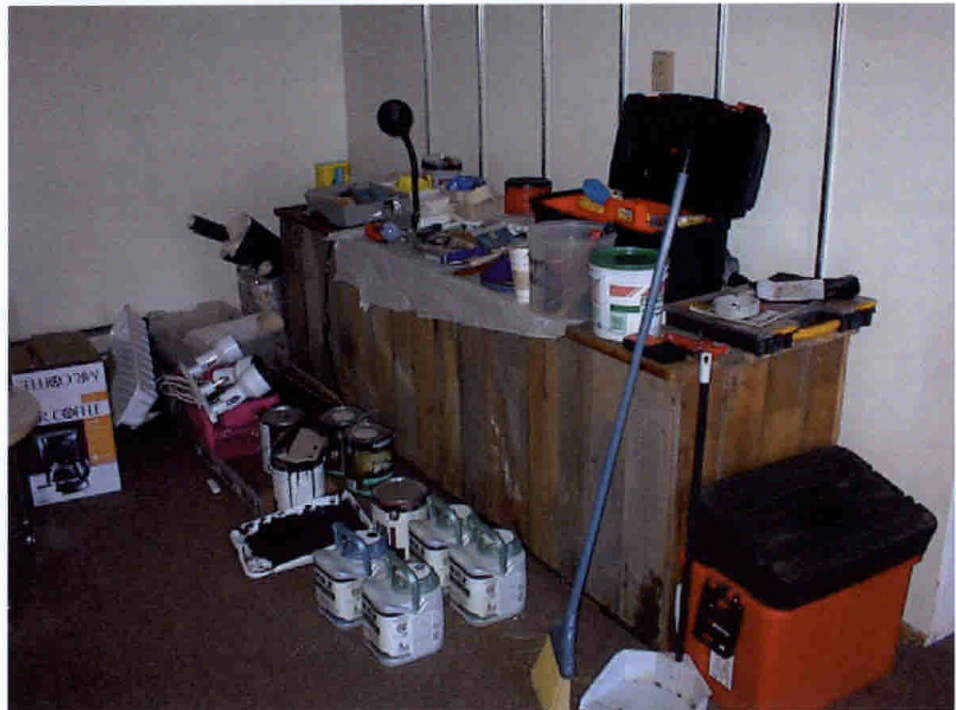
**Photo No.**

It should be noted that the concentration of xylenes and toluene detected in the indoor air sample have increased since the December O&M event. These increases are most likely the result of the above-mentioned paints and solvents staged adjacent to the indoor air sampling location. The remainder of the compounds detected had concentrations at or near their corresponding reporting limits.

Back room of site building
(indoor air sampling
location). Paints and
other assorted solvents
designated for remodeling
present.

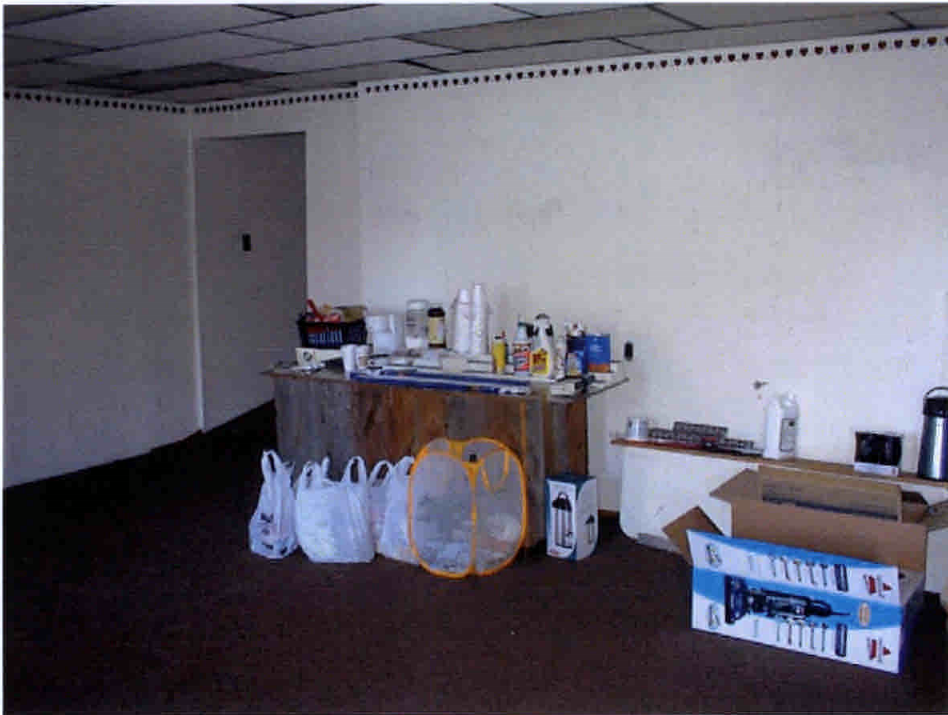
Client Name: New York State Department of Environmental Conservation		Site Location: 20 N. Franklin St., Watkins Glen, New York	Project No. 11173258.61000
Photo No. 3	Date: 2-15-05

Direction Photo Taken: Southeast			
Description: Back room of site building (indoor air sampling location). Paints and other assorted solvents designated for remodeling present.

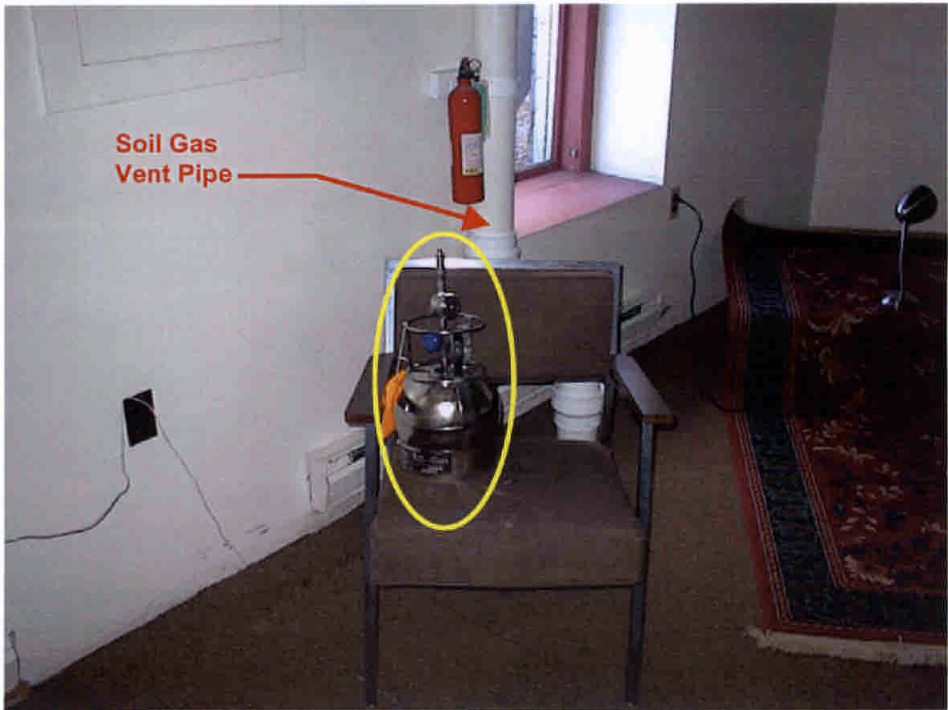
Photo No. 4	Date: 2-15-05

- One (1) 4-hour indoor air sample was collected in the back room of the site building (INDOOR-0205), adjacent to the above-mentioned paints, cleaners, and solvents; and,
- One (1) soil gas grab sample was collected from the venting system's exhaust stack (SOILGAS-0205).

Direction Photo Taken: Northeast		
Description: Back room of site building, with ambient air sample "INDOOR-0205" being collected. Pipe to soil gas venting system in background.
