REMEDIAL LETTER REPORT

SUMMARY OF THE INSTALLATION OF THE SUB-SLAB DEPRESSURIZATION SYSTEM AT THE SENECA MARKET BUILDING NORTH FRANKLIN STREET SITE

**NORTH FRANKLIN STREET SITE
WATKINS GLEN (V)**

**SITE NO. 8-49-002
SCHUYLER (C), NY**

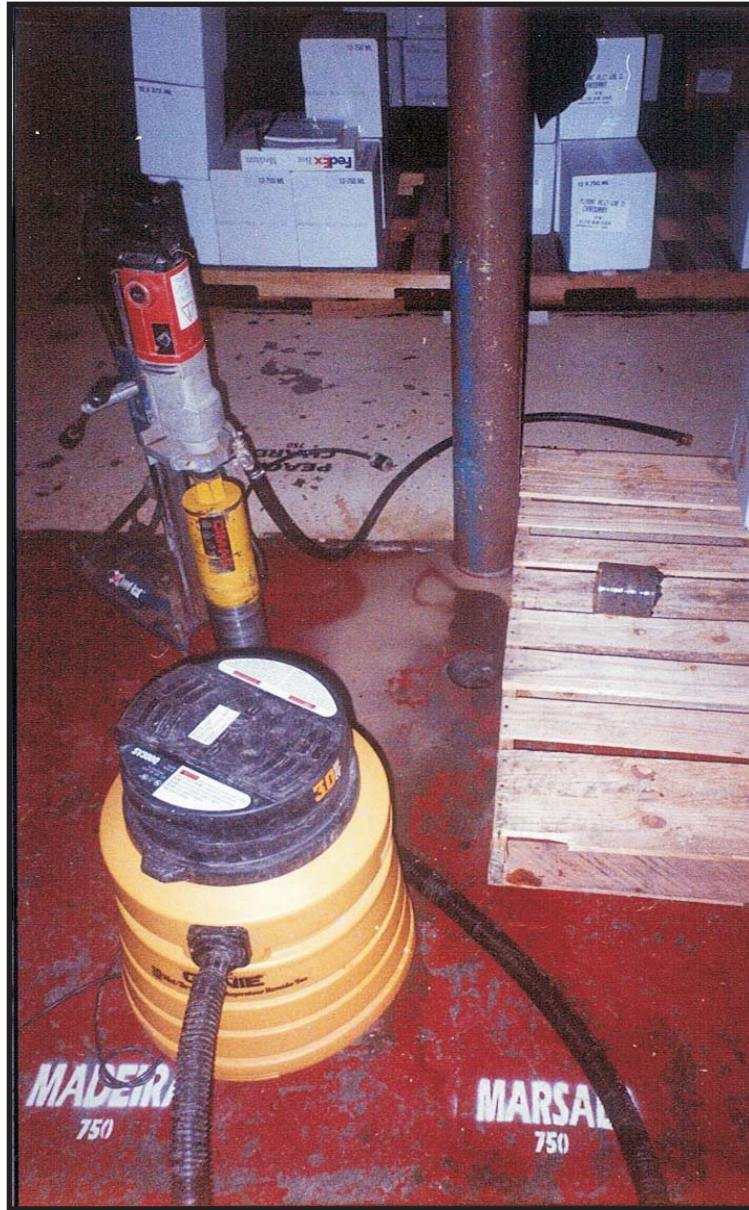
Photograph of coring slab at suction point #1.

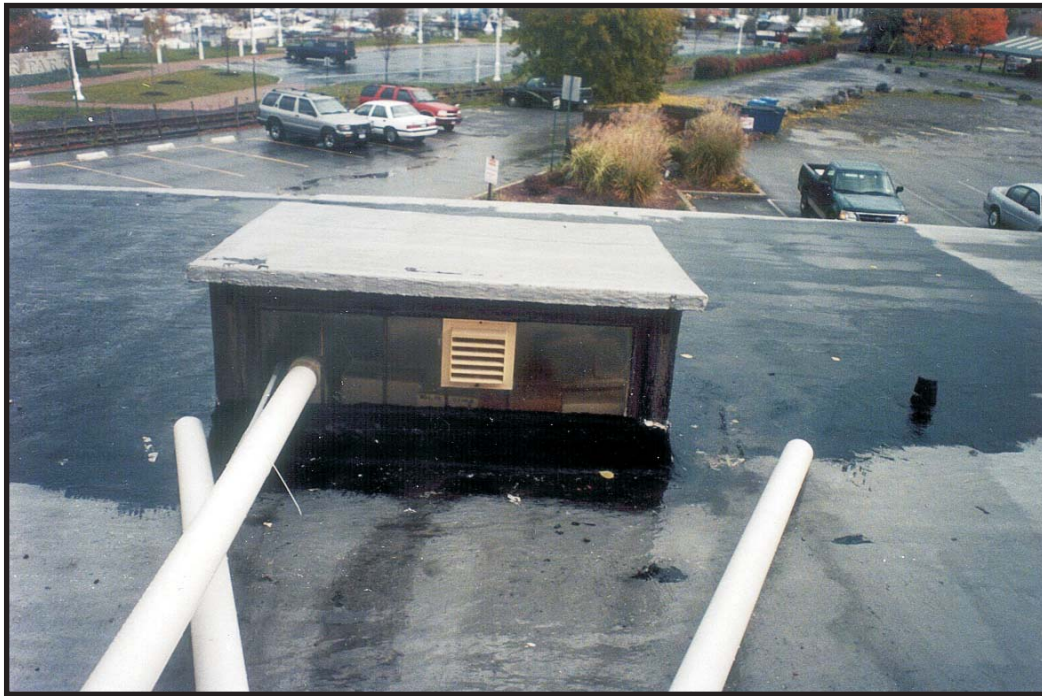
Suction pipe and electrical penetration of dormer.

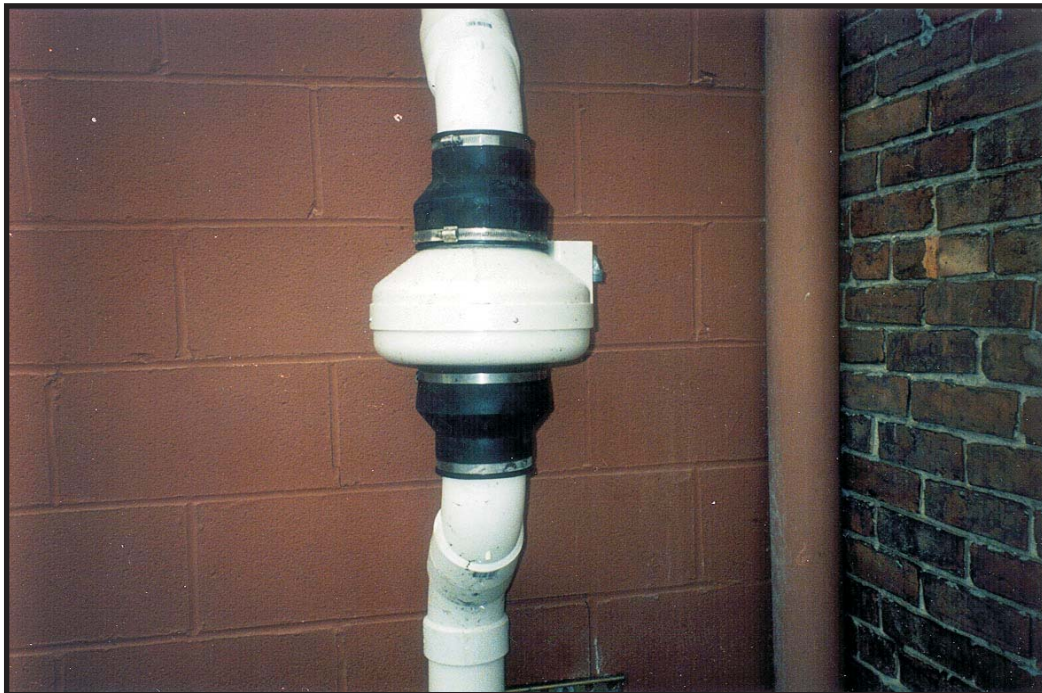
Photography of fan mounted on side of building.

- A Fantech model HP 220 fan was mounted on the side of the three-story portion of the building and the exhaust pipe was greater than 10 feet from any window. The fan and the exhaust piping were secured to the outside of the east side of the three-story portion of the building.

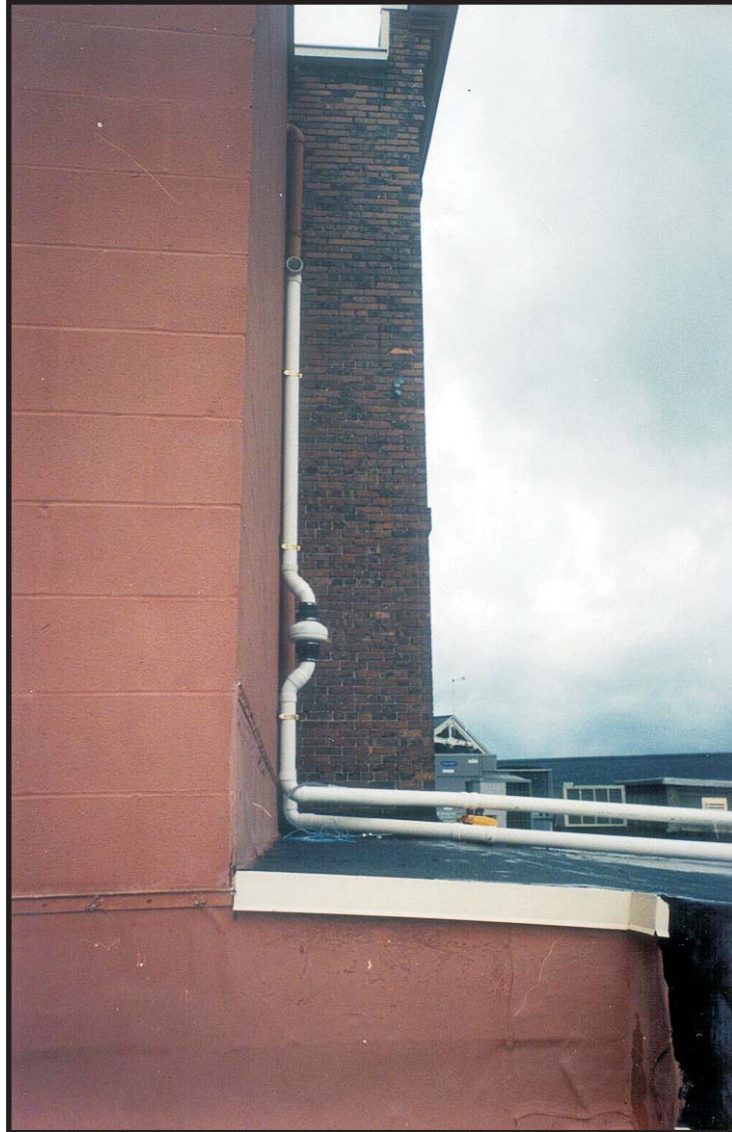
Photograph of fan and discharge.

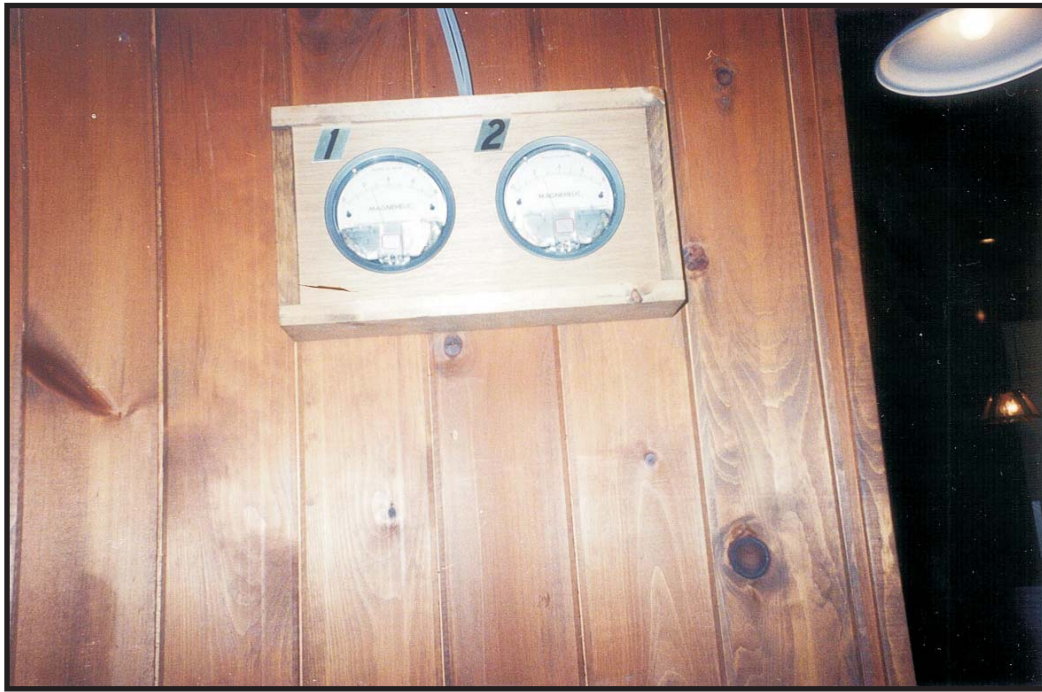
Photograph of Magnehelic gauges indicating suction at both points.

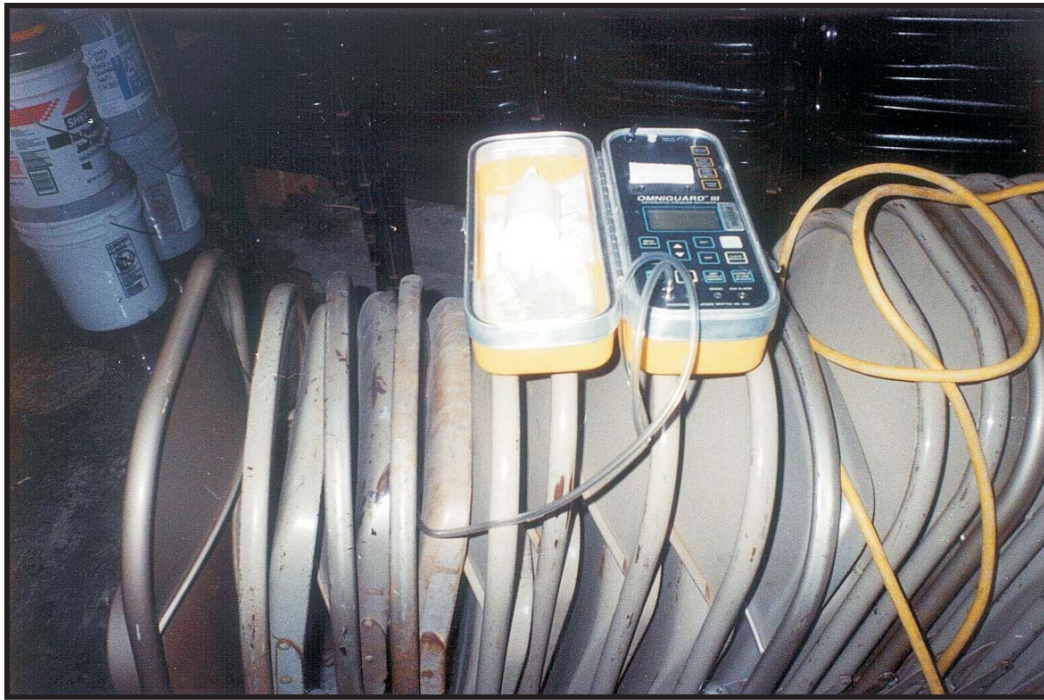
Picture of vacuum pressure gauge used to vacuum test.

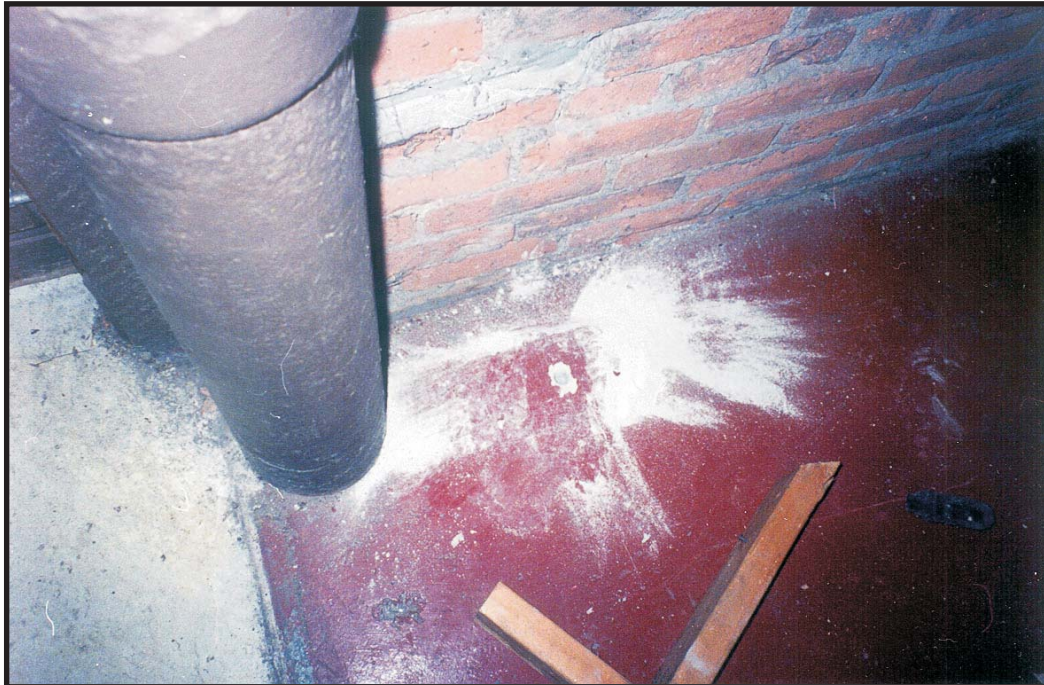
Vacuum test hole #1.

- drill $\frac{3}{8}$ " TEST hole & insert pressure recorder
- TEST HOLE 1 \pm - 0.010 inch of H_2O
- TEST HOLE 2 \pm - 0.012 inch of H_2O
- see backfills holes w/ concrete patch
- close up split boxes
- Give owner of Service Windows the instruction to system operation,
 - pressure gauges
 - Red light on if Fan OFF
 - where safety breaker is
 - call URS if system is down

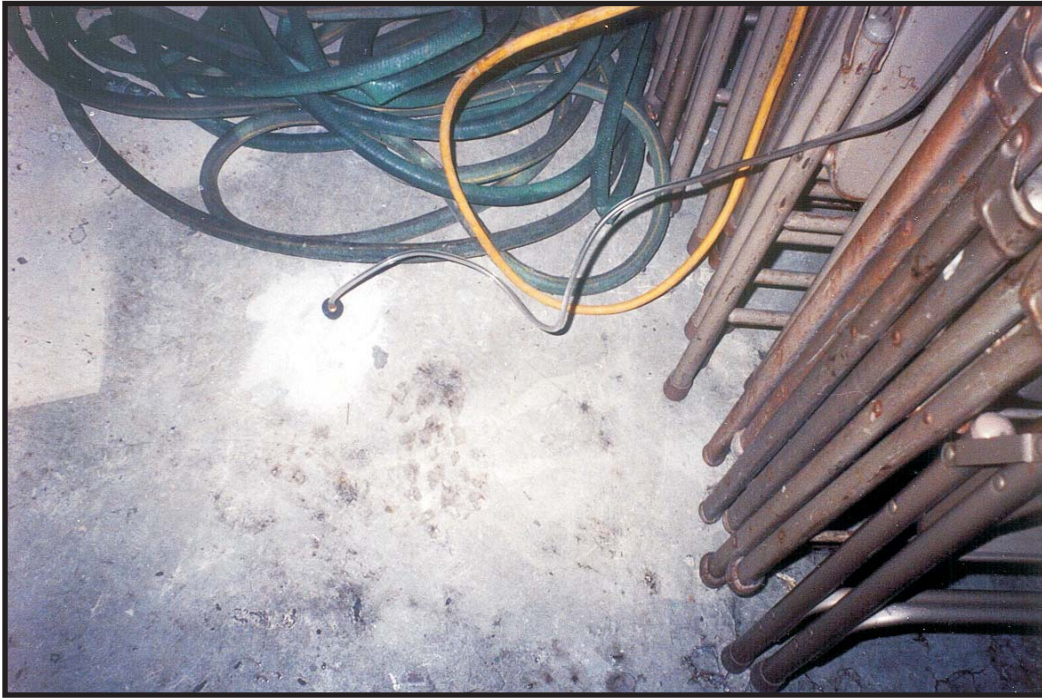
Vacuum test hole #2.

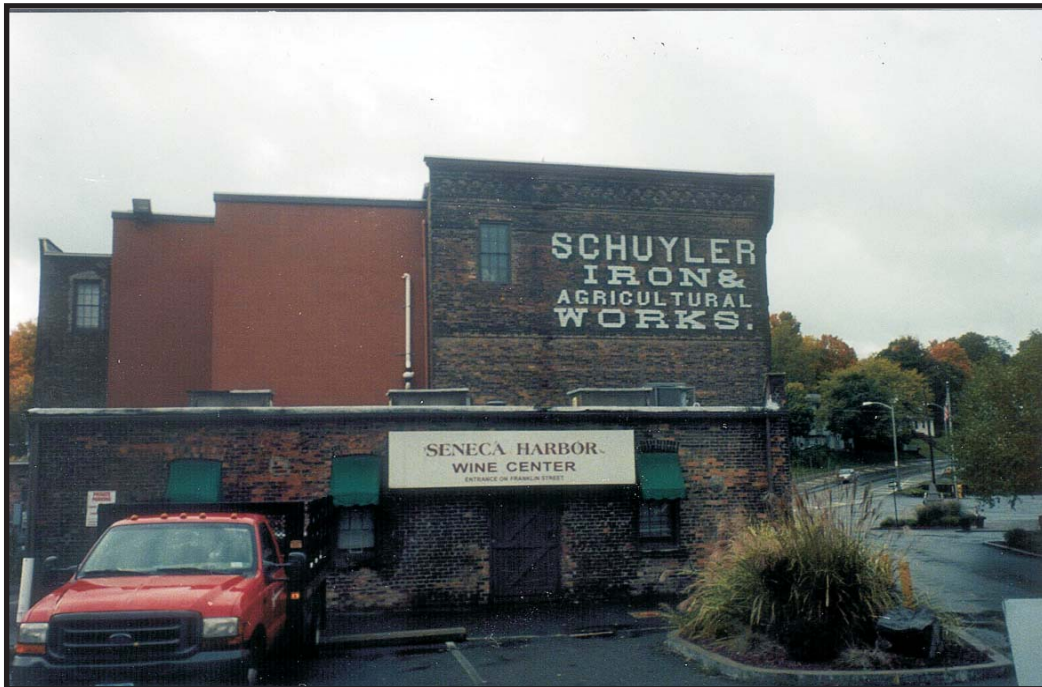
Photograph of back of building showing SSD System.

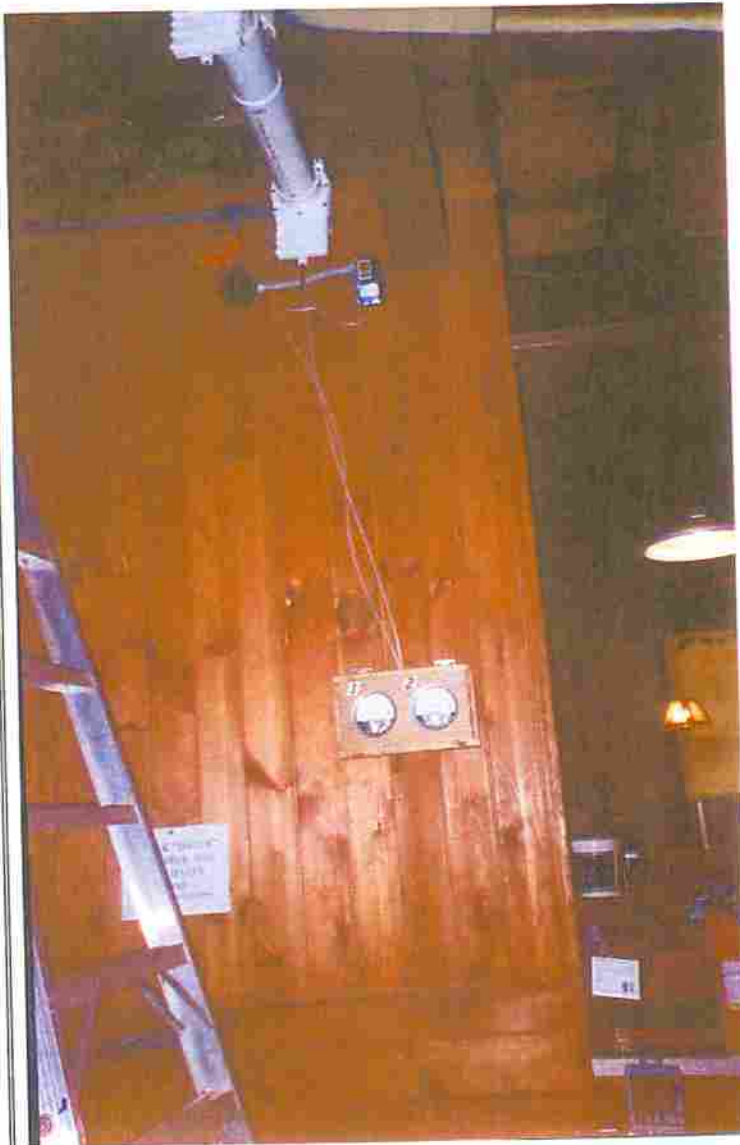
Photo No. 1 – Magnehelic Gauges, Vacuum Switch, Red Indicating Light and Inline Valves

The ventilation pipe was installed into the hole. The bottom of the pipe is recessed into the floor slab. System piping is constructed of 4-inch diameter schedule 40 PVC pipe. The pipe is sealed to the concrete floor with silicone sealant, runs vertically to the ceiling and then across the ceiling. The horizontal runs are connected to a manifold where each exaction point has a vacuum control valve (see Photo #1).

The system has visual references to indicate proper operation (see photo #1). A magnehelic gauge, vacuum switch and a red indicating light are connected to the system piping. The magnehelic gauge reads 2 inches of water at proper operation. The vacuum switch will activate a red indicating light if there is a system failure. These system interlocks were tested and operate properly.

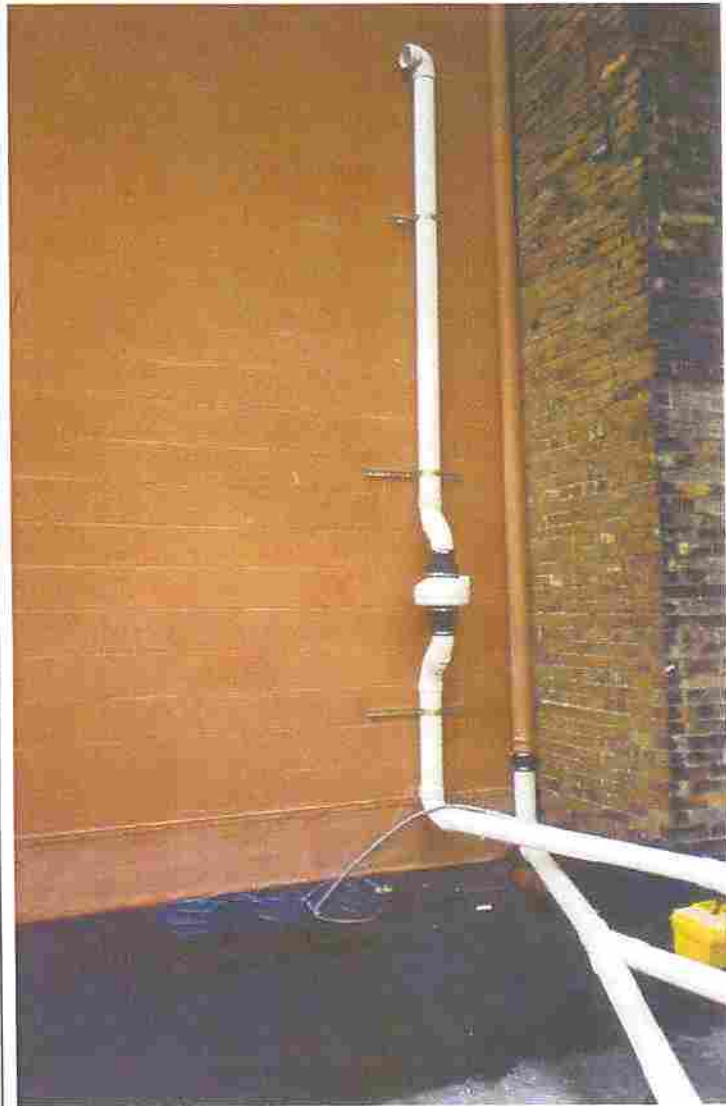
Photo No. 2 – "FANTECH" BLOWER

The ventilation pipe exits the roof through a dormer window. The pipe runs parallel with the roof where it is connected to a "Fantech" blower model number HP220, which is mounted vertically (see Photo #2). The discharge point is above all windows and greater than ten (10) feet away from any windows. The piping is pitched to allow condensation to drain to the extraction point.
