Evans Chemetics Facility
228 East Main Street
Waterloo, New York 13165

Radian International
304 West Wackerly Street
Midland, MI 48640-4700

November 1999

***Building 4 Pit Cleaning
Summary Report***

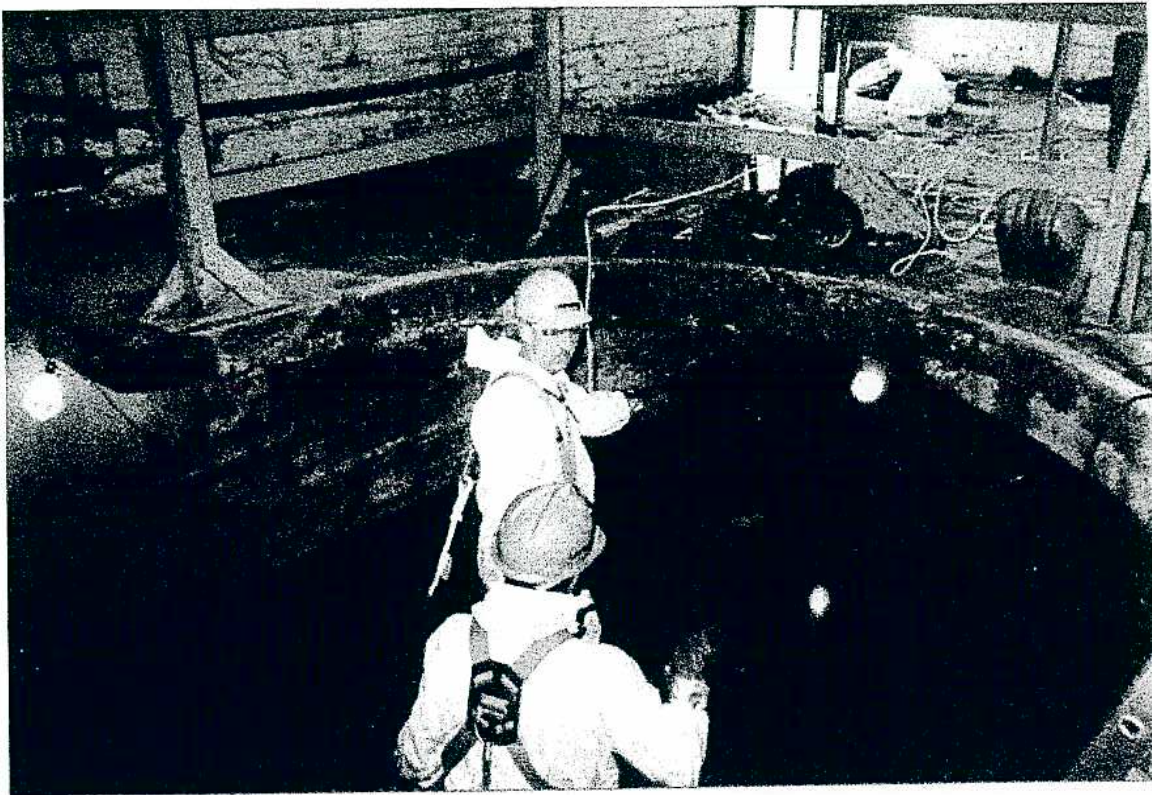
Photo 1: View to west, into opening of Building 4 Pit.

Once these tasks were completed, Radian International began removing debris and sediment, and began to power wash the walls and floor of the pit (Photo 1 and 2 in Appendix C). Debris and sediment that had accumulated in the sump was collected with shovels, and loaded into a roll-off box pending characterization and disposal. Material that could not be removed by scraping was removed by pressure washing. Pressure washing was done from west to east to direct the water and sediment toward the sump located at the eastern end of the pit. Water from the pressure washing operation was pumped from this sump into the Evans Chemetics wastewater treatment plant.

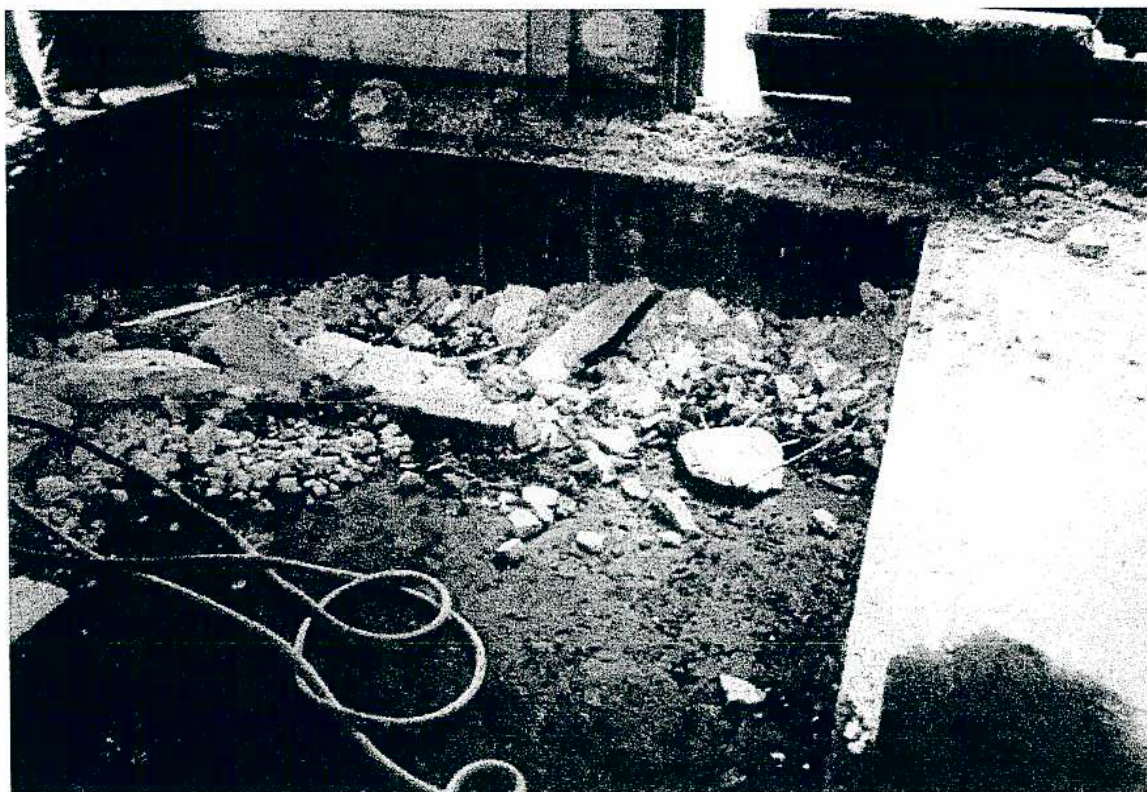
Photo 6: View to West of partially cemented pit, and debris from former roof.

A new, 4-inch diameter by 10 foot long PVC well was installed in the pit sump, and the sump was backfilled with 14 tons of gravel. The top of the sump was covered with sheet plastic, and the entire pit was then filled with flowable cement to within approximately 1-2 feet of the floor level of Building 4. After the cement had cured, the remaining roof of the pit was removed using a jackhammer (Photo 6 in Appendix C). The concrete debris was removed for disposal and a fiberglass reinforced plastic collection trench was purchased, placed along the north end of the former pit, and connected to the floor drain collection system for the area (Photos 7 & 8 in Appendix C). The flow from this trench was connected to an existing sump on the north side of Building 4 that was installed when the previous work in this area had been done in 1994. Additional flowable cement was then added to the pit to bring the level up to approximately 6 inches from the existing floor grade of Building 4 (Photo 9 in Appendix C).

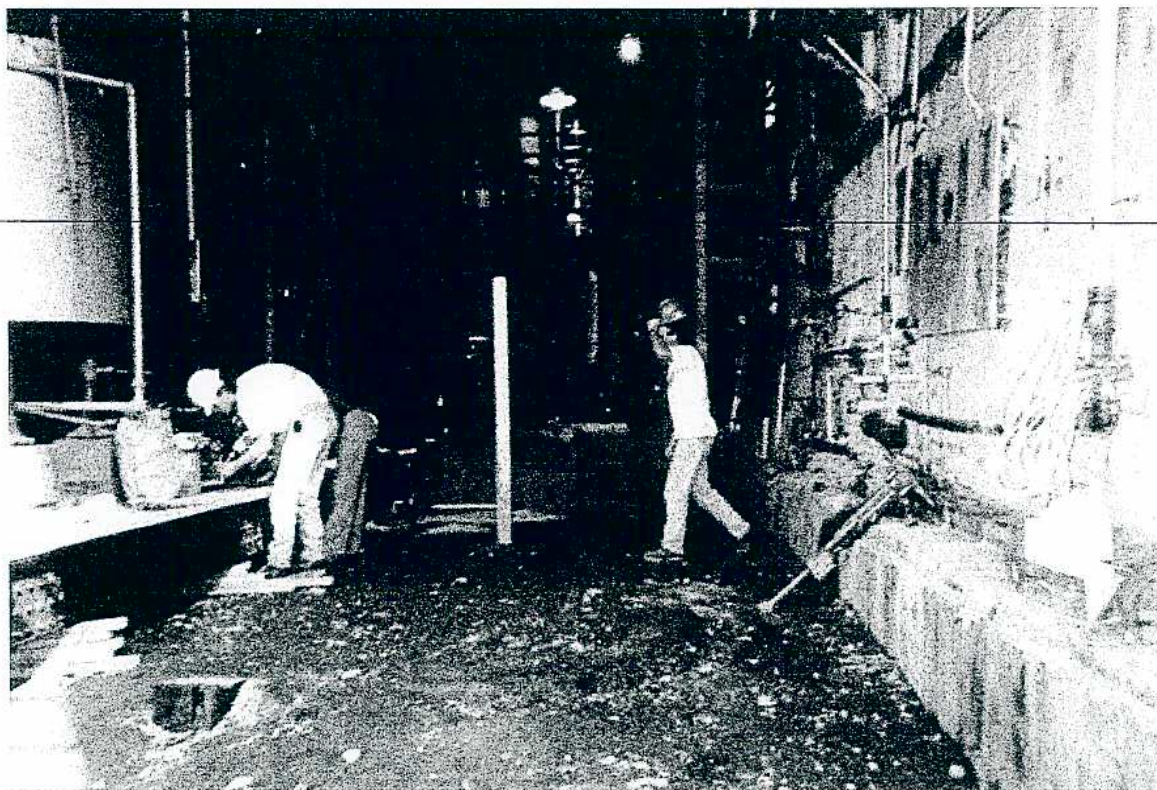
Photo 8: View to East of partially cemented pit, floor trench, and new sump well.
