Subject: Results of the Sediment Post-Removal Verification Sample Core Collection,
Former Hampshire Chemical Corp. Facility Area of Concern A - Sediment
Removal Project, Waterloo, New York

Sediment Post-removal Verification Sample Core Collection, Former Hampshire Chemical Corp. Facility, Area of Concern A — Sediment Removal Project, Waterloo, New York

DATE: May 1, 2015

PROJECT NUMBER: 482750

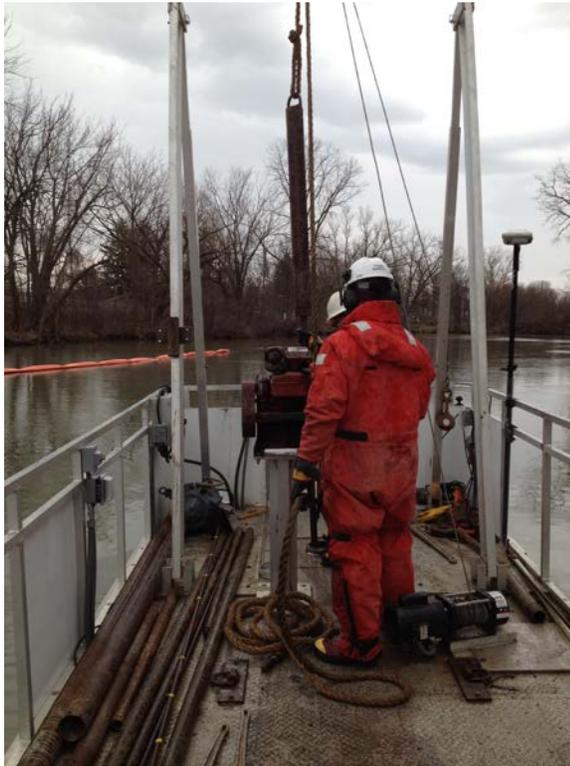
Sediment Coring and Sampling. Nine sediment cores were collected from the Gorham Street and Downstream Deposits at locations presented on Figure 1. The coring was performed using a vessel-mounted tri-pod rig and a 140-pound cathead hammer that was used to advance a split spoon sampler. A 3-inch diameter by 2.5-foot long Lexan-lined split spoon sampler was used to collect the samples. The split spoon was fitted with a nose cone and a core retainer to improve core retention and sample retrieval. This method utilizes a modified split spoon sampler (different length and diameter of split spoon than specified for Standard Penetration Tests [SPT]) designed to enhance sample volume recovery, thus SPT numbers could not be obtained. However, the blow counts from the modified method do represent the relative hardness encountered. The blow count number, geotechnical results, and visual lithologic descriptions provide the information needed to adequately assess the material encountered in the Gorham Street and Downstream Deposits.

Refusal was defined as a penetration rate of less than 3 inches of penetration at 50 blow counts. The number of cat head hammer blows (blow counts) were recorded and this blow count number was used to interpret the relative hardness of the material encountered. Core penetration depths ranged from 0.8 foot to 4.3 feet in length; however, the core recovery lengths ranged from 0.5 foot to 3.1 feet. The maximum penetration depth (4.3 feet) and recovery lengths (3.1 feet) were recorded in the “Finger area” of the Gorham Street Deposit.

Typical Cat Head Split Spoon Sampler – Safety Method

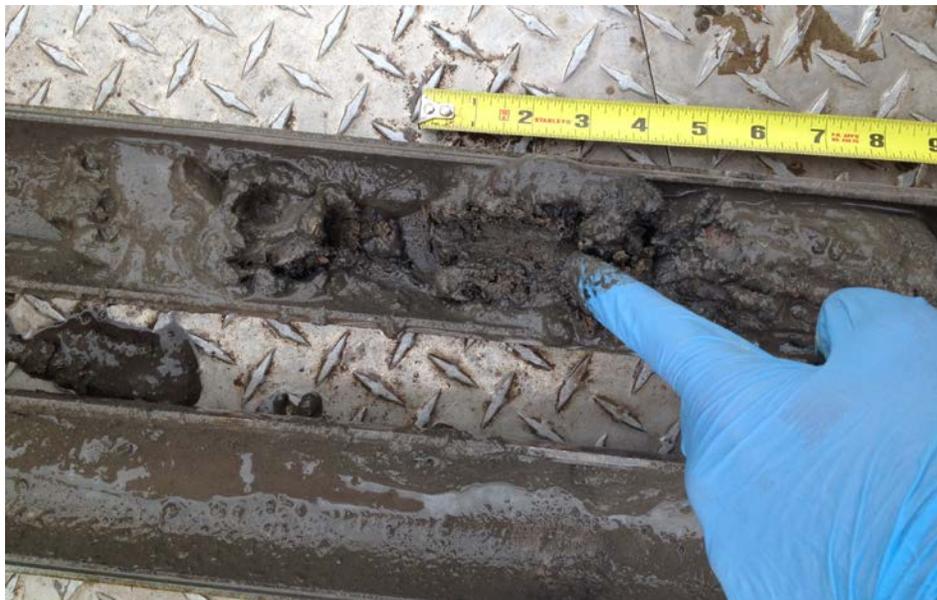
Soft Sediment Evaluation. Gorham Street Deposit. The distribution of soft sediment is discussed in terms of the DMU segments within the Gorham Street and Downstream areas, which are presented on Figure 1. In general, the soft sediment thickness ranged from 0.1 to 1.66 feet, with the maximum of 1.66 feet encountered in the “finger area” of the Gorham Street Deposit-1 (GSD-1) – the “finger area” is defined as the thin, elongated portion of the Gorham Street area that runs along the north bank of the canal. The thinnest remnant sediment thickness within the Gorham Street area was observed in the Gorham Street Deposit-2 (GSD-2) area with thicknesses ranging from no soft sediment to 0.6 feet of soft sediment at location CSC-4. Most of the soft sediment found in the GSD-2 area was soft, brownish black sandy silt with trace gravel. Significant soft sediment thicknesses were observed in the GSD-1 deposit (finger area), ranging from 1.0 to 1.66 feet and the material encountered was very soft, black, silt or fine sand, with natural organic odor and some produced gas.

Typical Soft Sediment found in the Finger Area of Gorham Street Deposit (GSD-1)

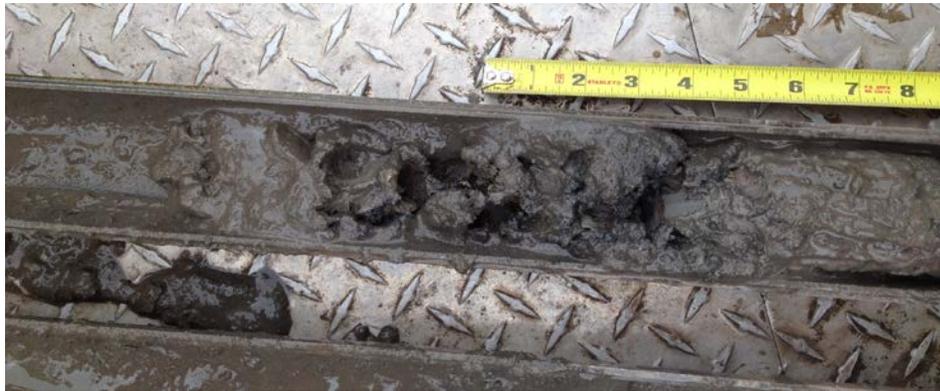
Brownish black Soft Sediment found in the Finger Area of Gorham Street Deposit (GSD-1)

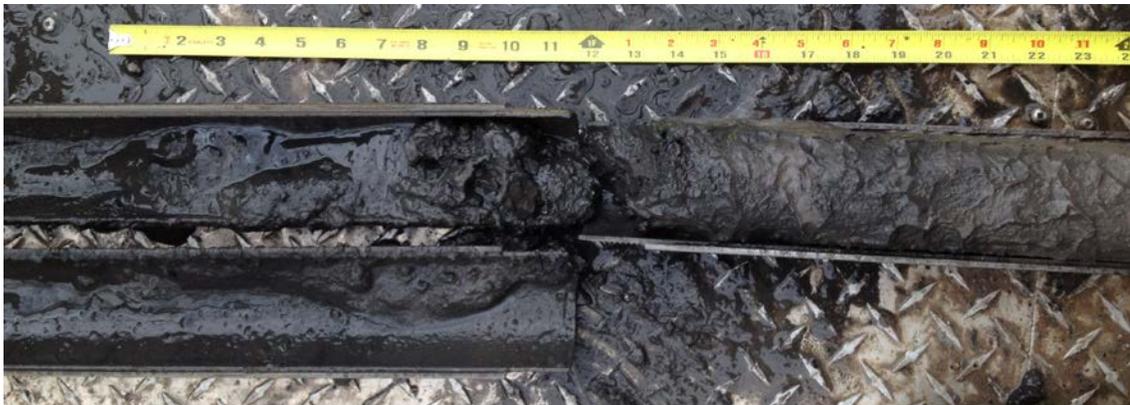
Typical Black, Very Soft Sediment observed in the Finger Area of the Gorham Street Deposit (GSD-1)

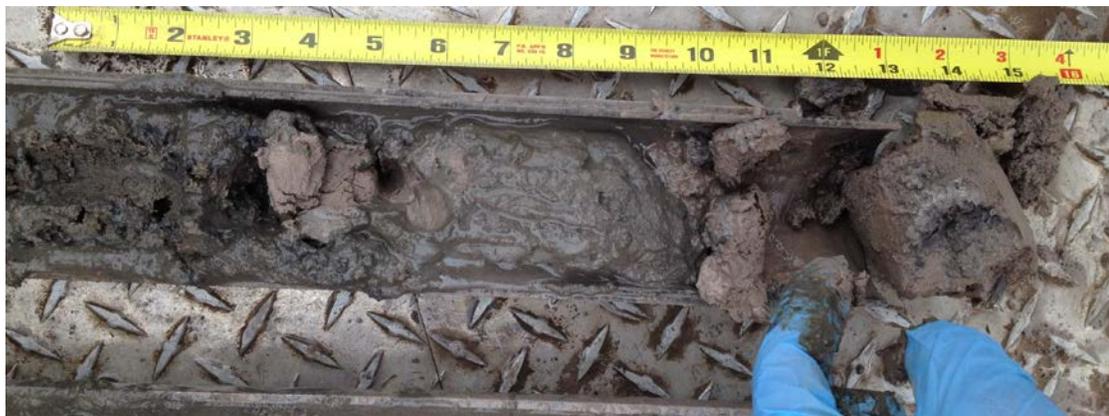
Soft Sediment / Compacted fine sand layer above the till material observed in Gorham Street Deposit (GSD-2)

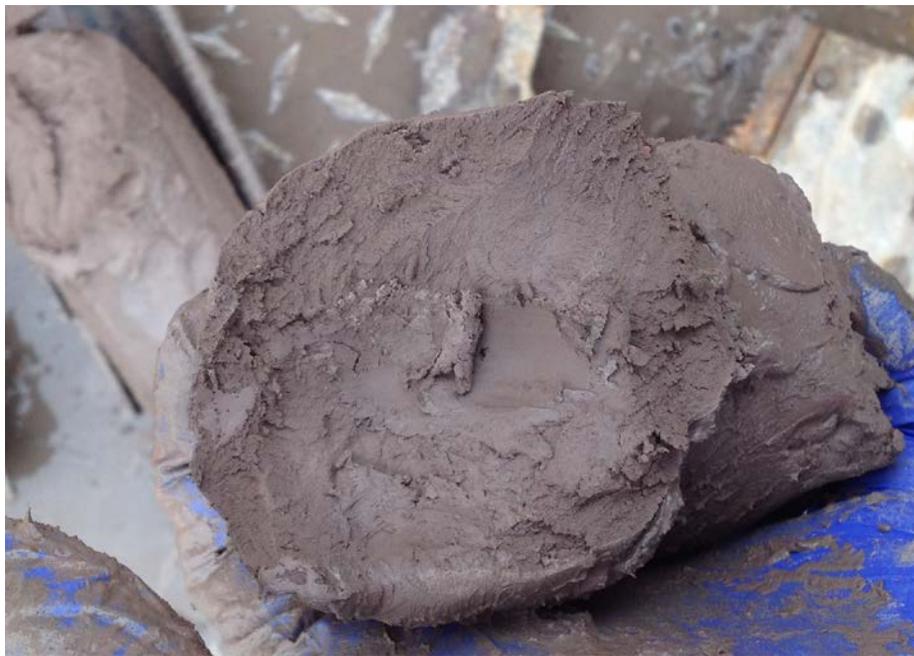
The till material encountered in both Gorham Street Deposits was moist within the top intervals and with depth, the moisture content dropped and was dry, conforming to the typical till description. The moisture content in the till material ranged from 9 to 15%, whereas the soft sediment's moisture content ranged from 38 to 56% (see Attachment 2).

Dry – Typical Pale reddish brown Till material observed in Gorham Street and Downstream Deposit

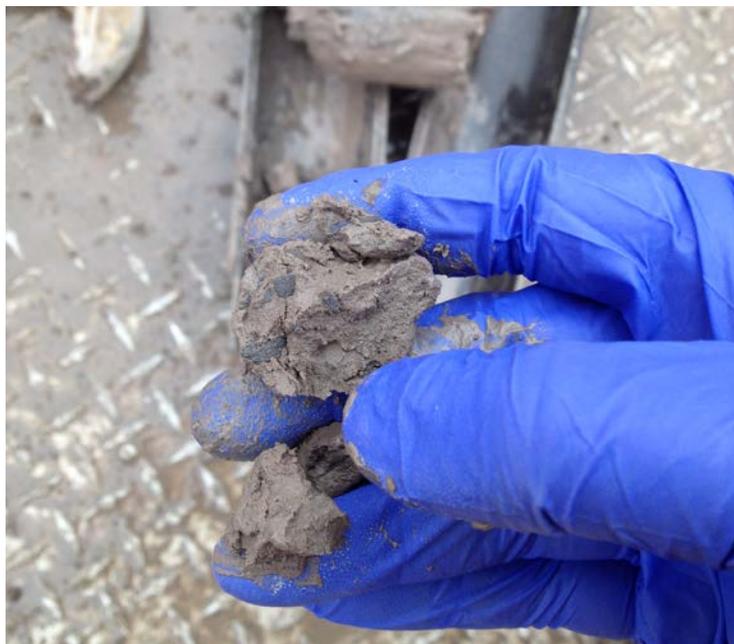
Typical Till material – with sub-angular clast ingrained throughout the interval

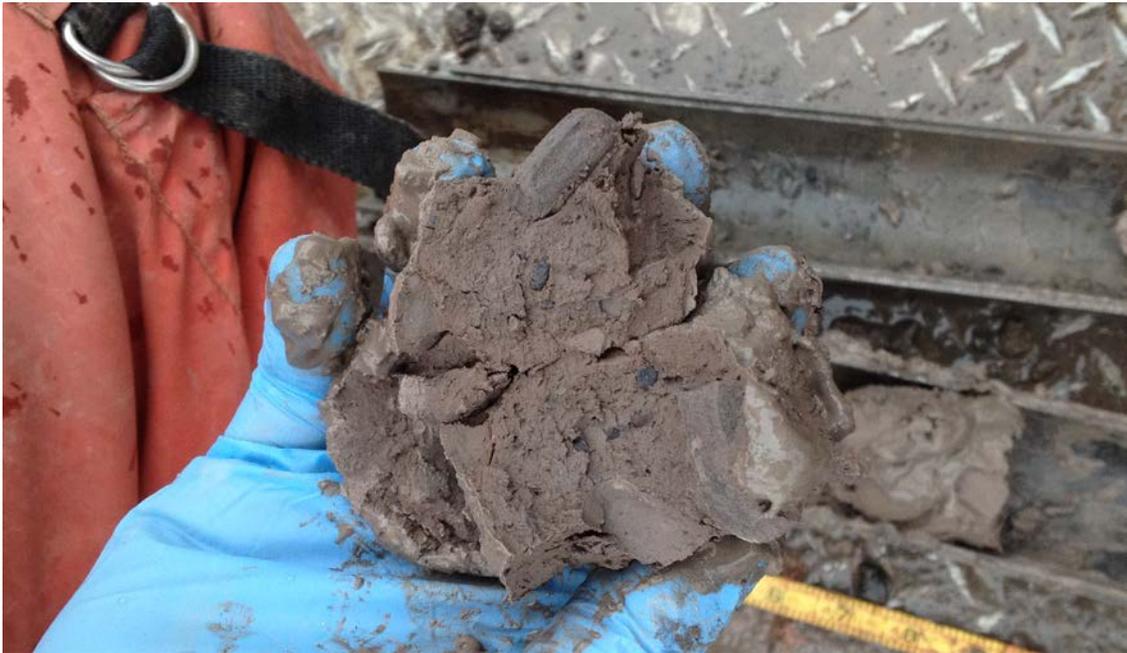
Typical Till material – with rounded and sub-angular clast ingrained throughout the interval

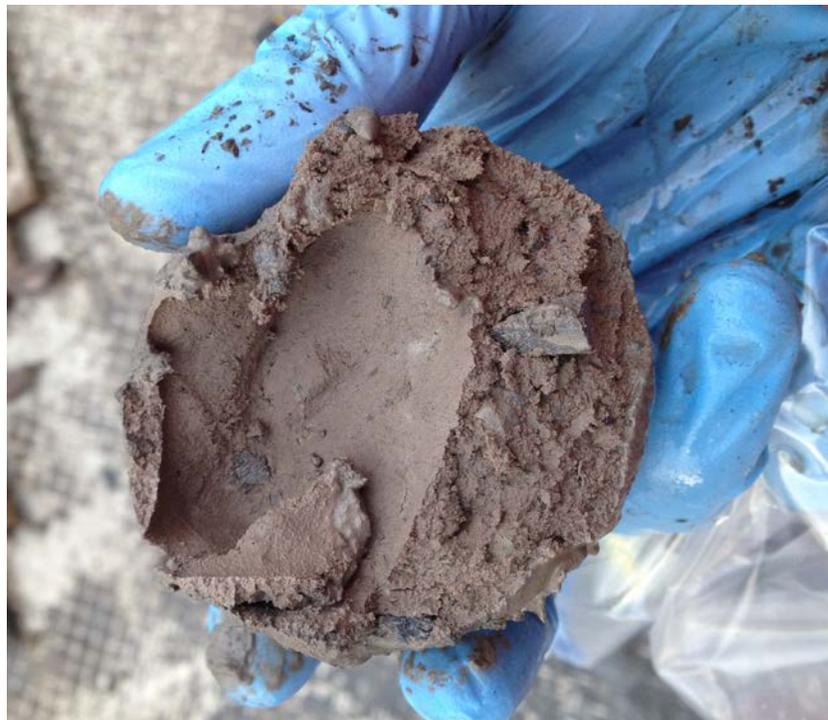
Typical Pale Reddish Brown Till material with Clast (Angular / Sub-angular) observed in the Gorham Street and Downstream Deposits

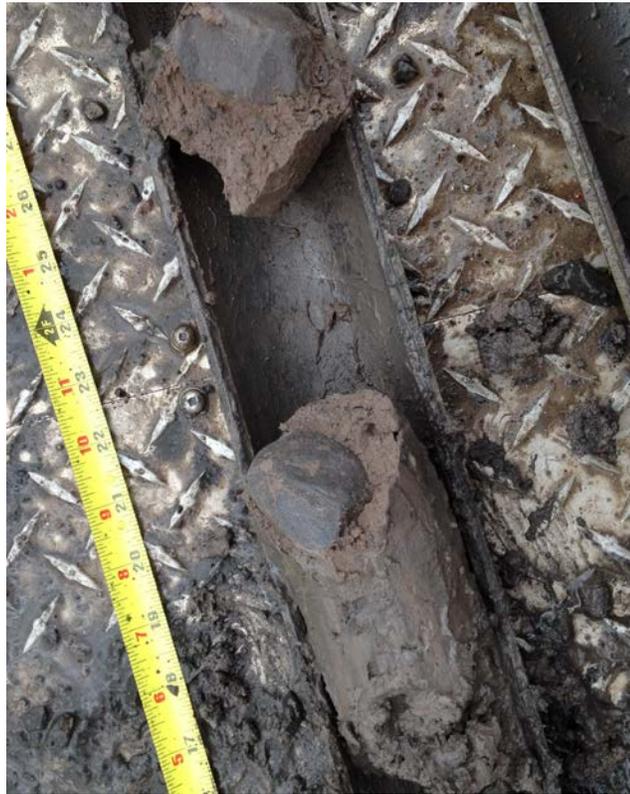
Typical Pale Reddish Brown Till material with large Clast / gravel (Rounded / Sub-angular) observed in the Gorham Street and Downstream Deposits.

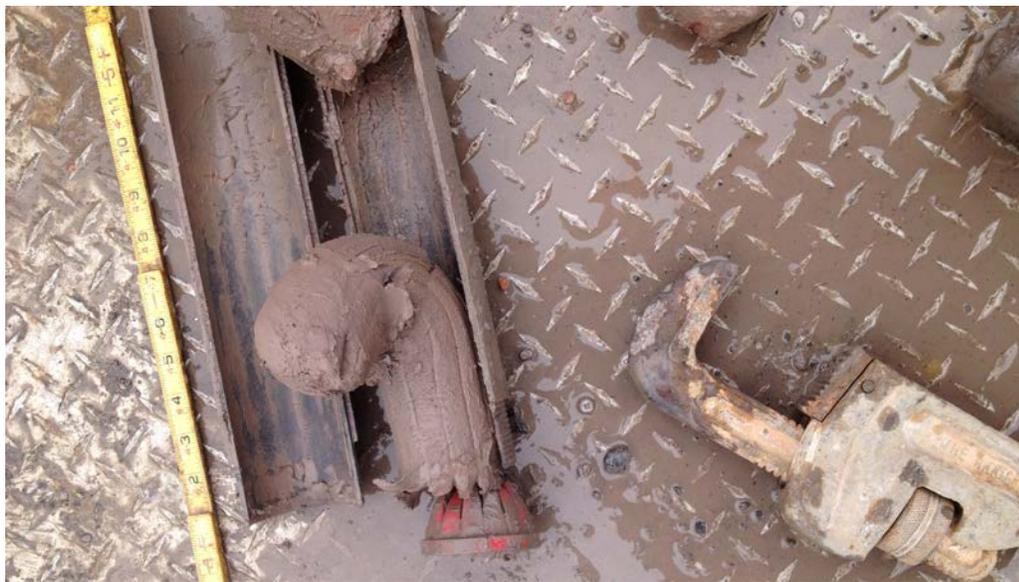
Till Evaluation. Gorham Street Deposit. In the four locations (CSC-01 through -04) sampled in the GSD-2 area, glacial till/till moraine was encountered. At the GSD-2 deposit locations, the till layer started at approximately 0.2 feet beneath the soft sediment surface and extended down to the refusal depth. Most of the till material observed in the GSD-2 area consisted of low permeability, pale reddish brown, very high plasticity, hard and dense silt and clay that contained clasts throughout the core. Photographs of these samples are presented in Attachment 3.

Highly Plastic / stiff fat clay at Gorham Street Deposit GSD-2

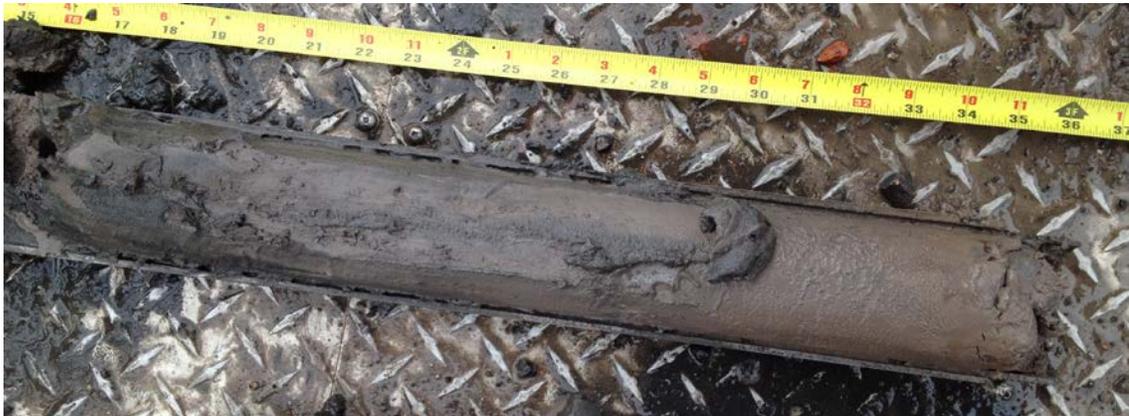
Undisturbed core sample from Gorham Street Finger area – GSD-2 DMU – Note Clast/gravel at bottom

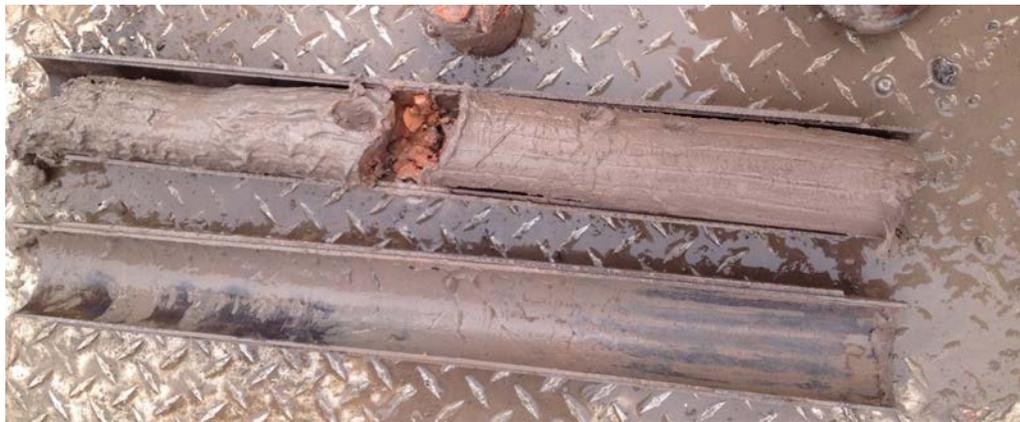
Fat Clay observed in Gorham Street Deposit (GSD-2) at CSC-03 with Red Brick in between
