Subject: 2018 Supplemental Building 4 Vapor Investigation at the Former Hampshire Chemical Corp. Facility, Waterloo, New York
Site No. 850001A

RE: 2018 Supplemental Building 4 Vapor Investigation at the Former Hampshire Chemical Corp.
Facility, Waterloo, New York
Site No. 850001A

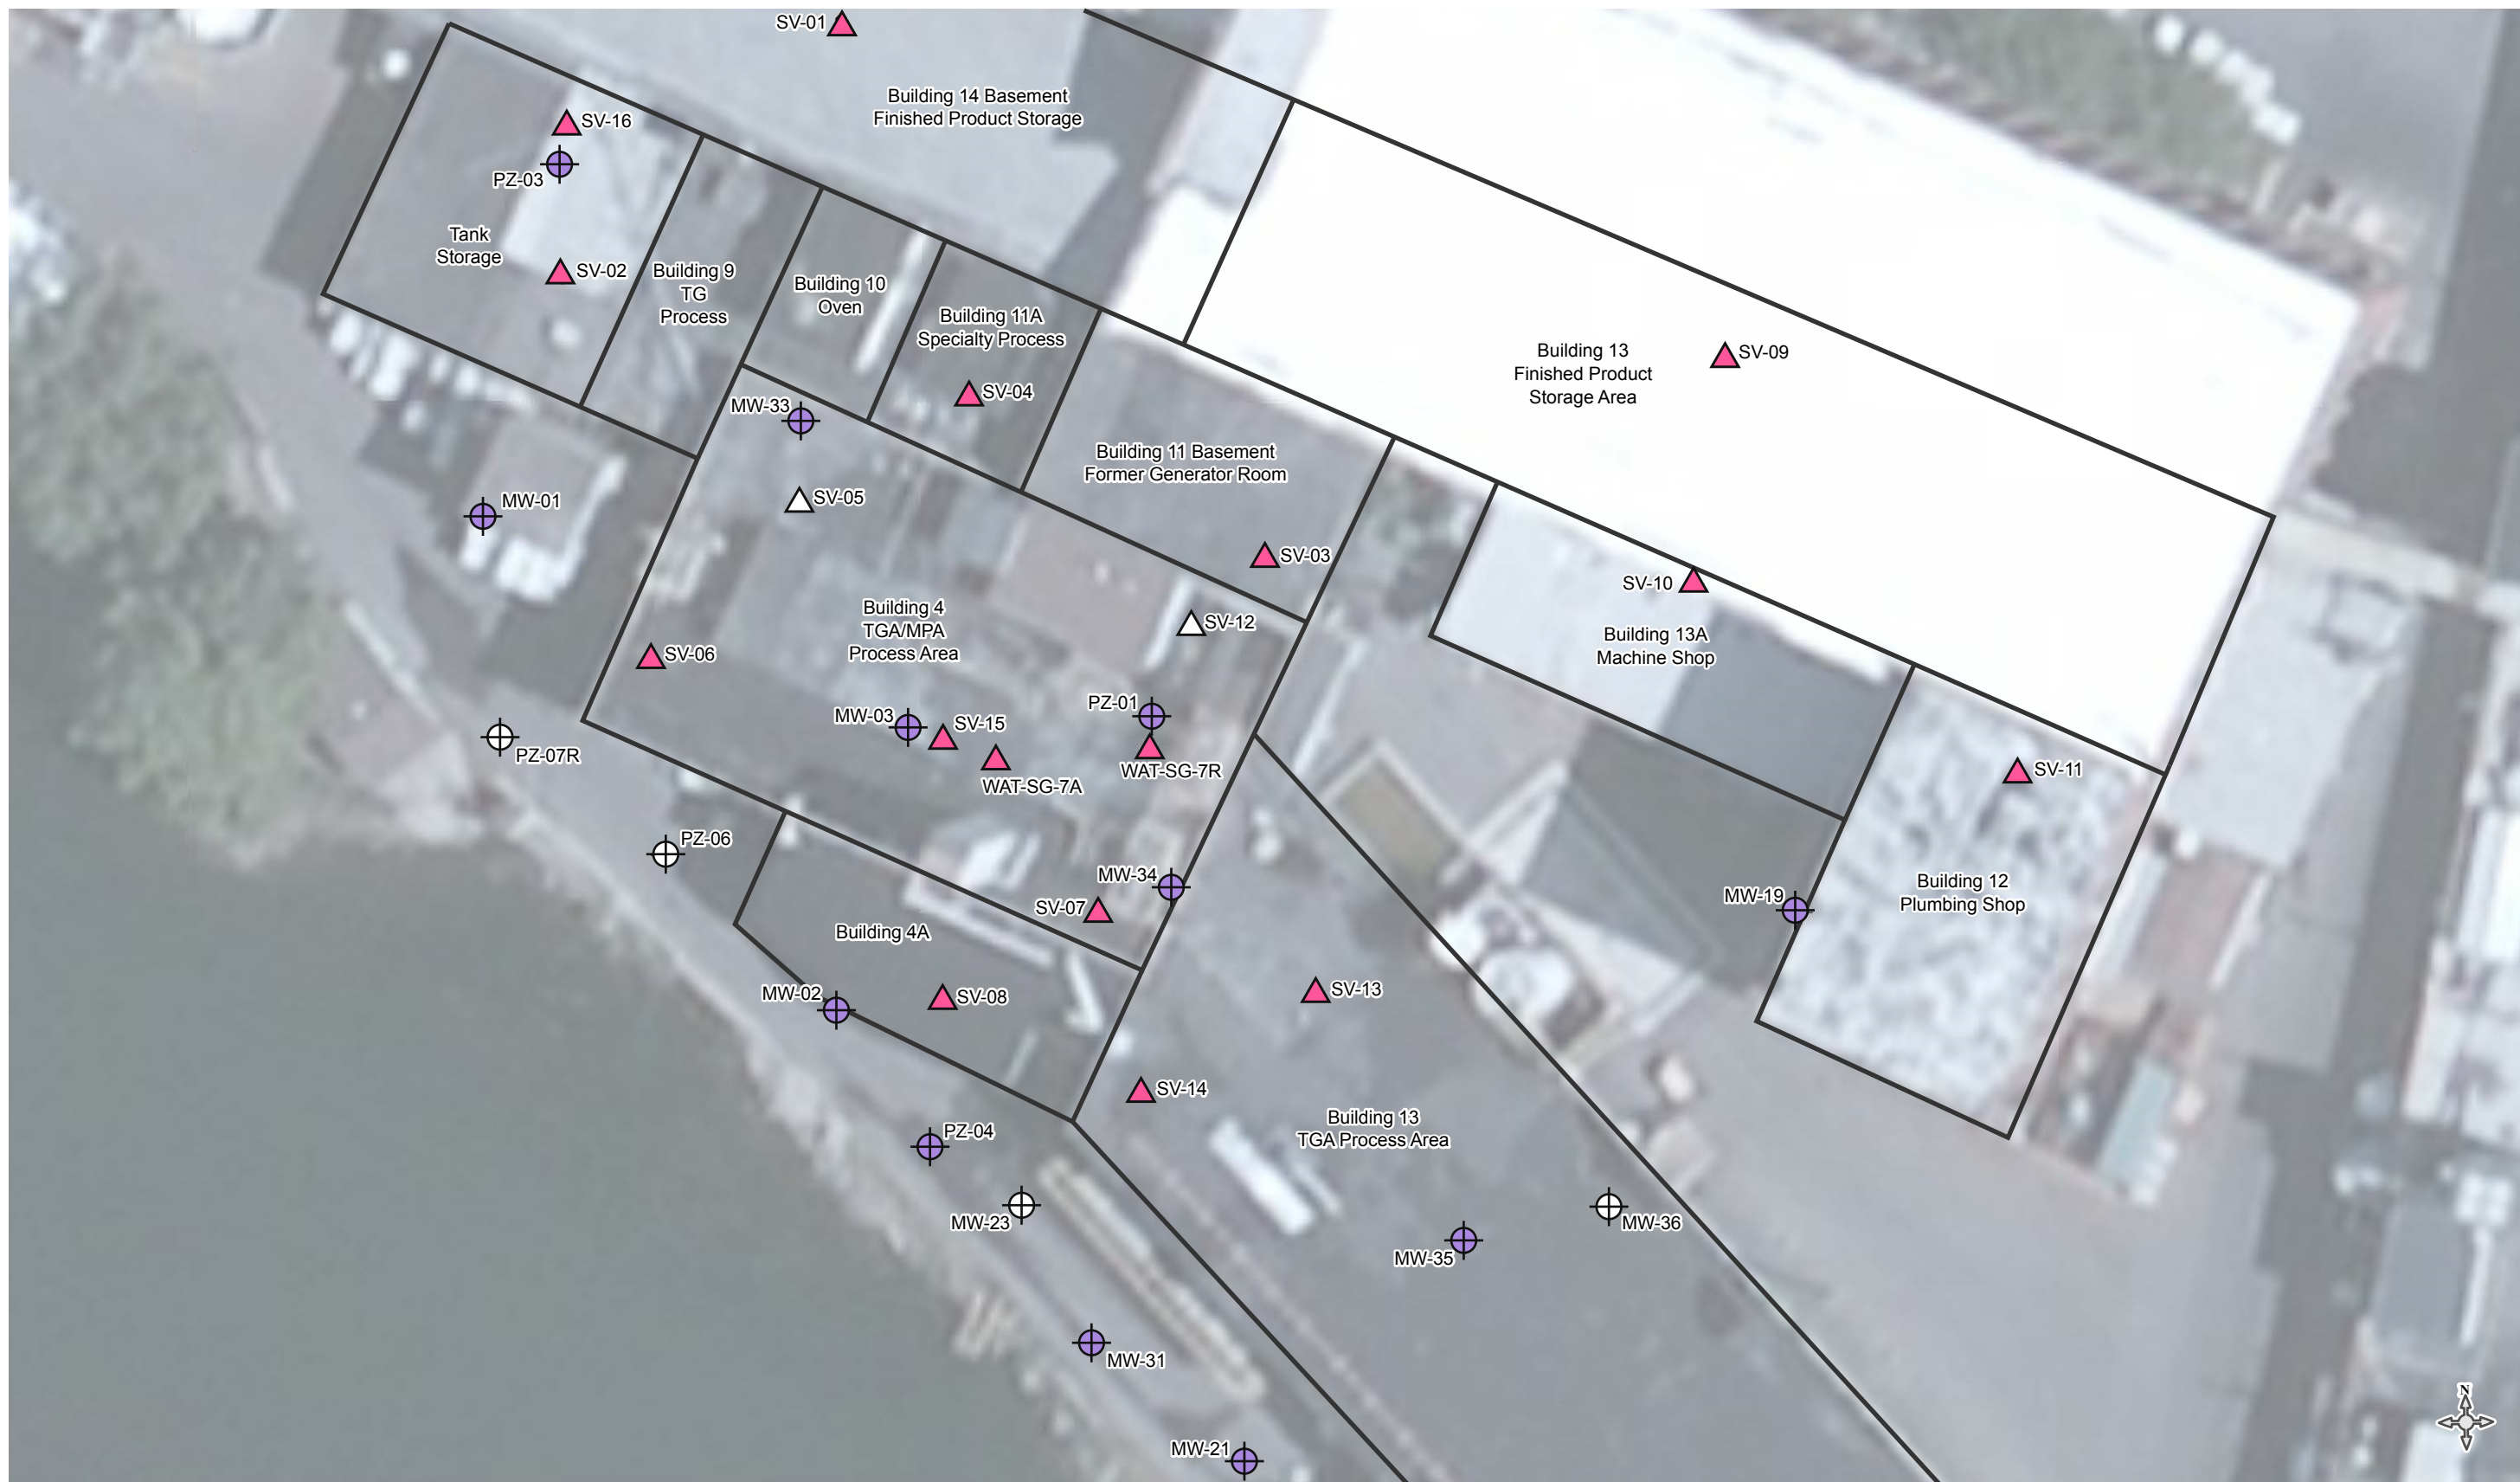
Figure 2-2
 2018 Subslab and Headspace Vapor Sampling Locations
 2018 Supplemental Building 4 Vapor Investigation
 Former Hampshire Chemical
 Waterloo, New York

- ▲ 2018 Subslab Vapor Sampling Locations
- ⊕ 2018 Monitoring Well Headspace Vapor Sampling Locations
- ⊕ Monitoring Wells

On June 6, 2018, one new subslab port (SV-16) was installed in Building 7 (tank storage room) using standard installation procedures adapted to the need for ventilating potentially hazardous gases and suppressing sparks. SV-16 was placed with respect to known historical and geophysical features, and at least 5 feet away from exterior walls and penetrations in the slab (e.g., large cracks, sumps, drains, and utilities) to avoid short-circuiting of ambient air. Figure 2-2 shows the locations of the subslab ports.

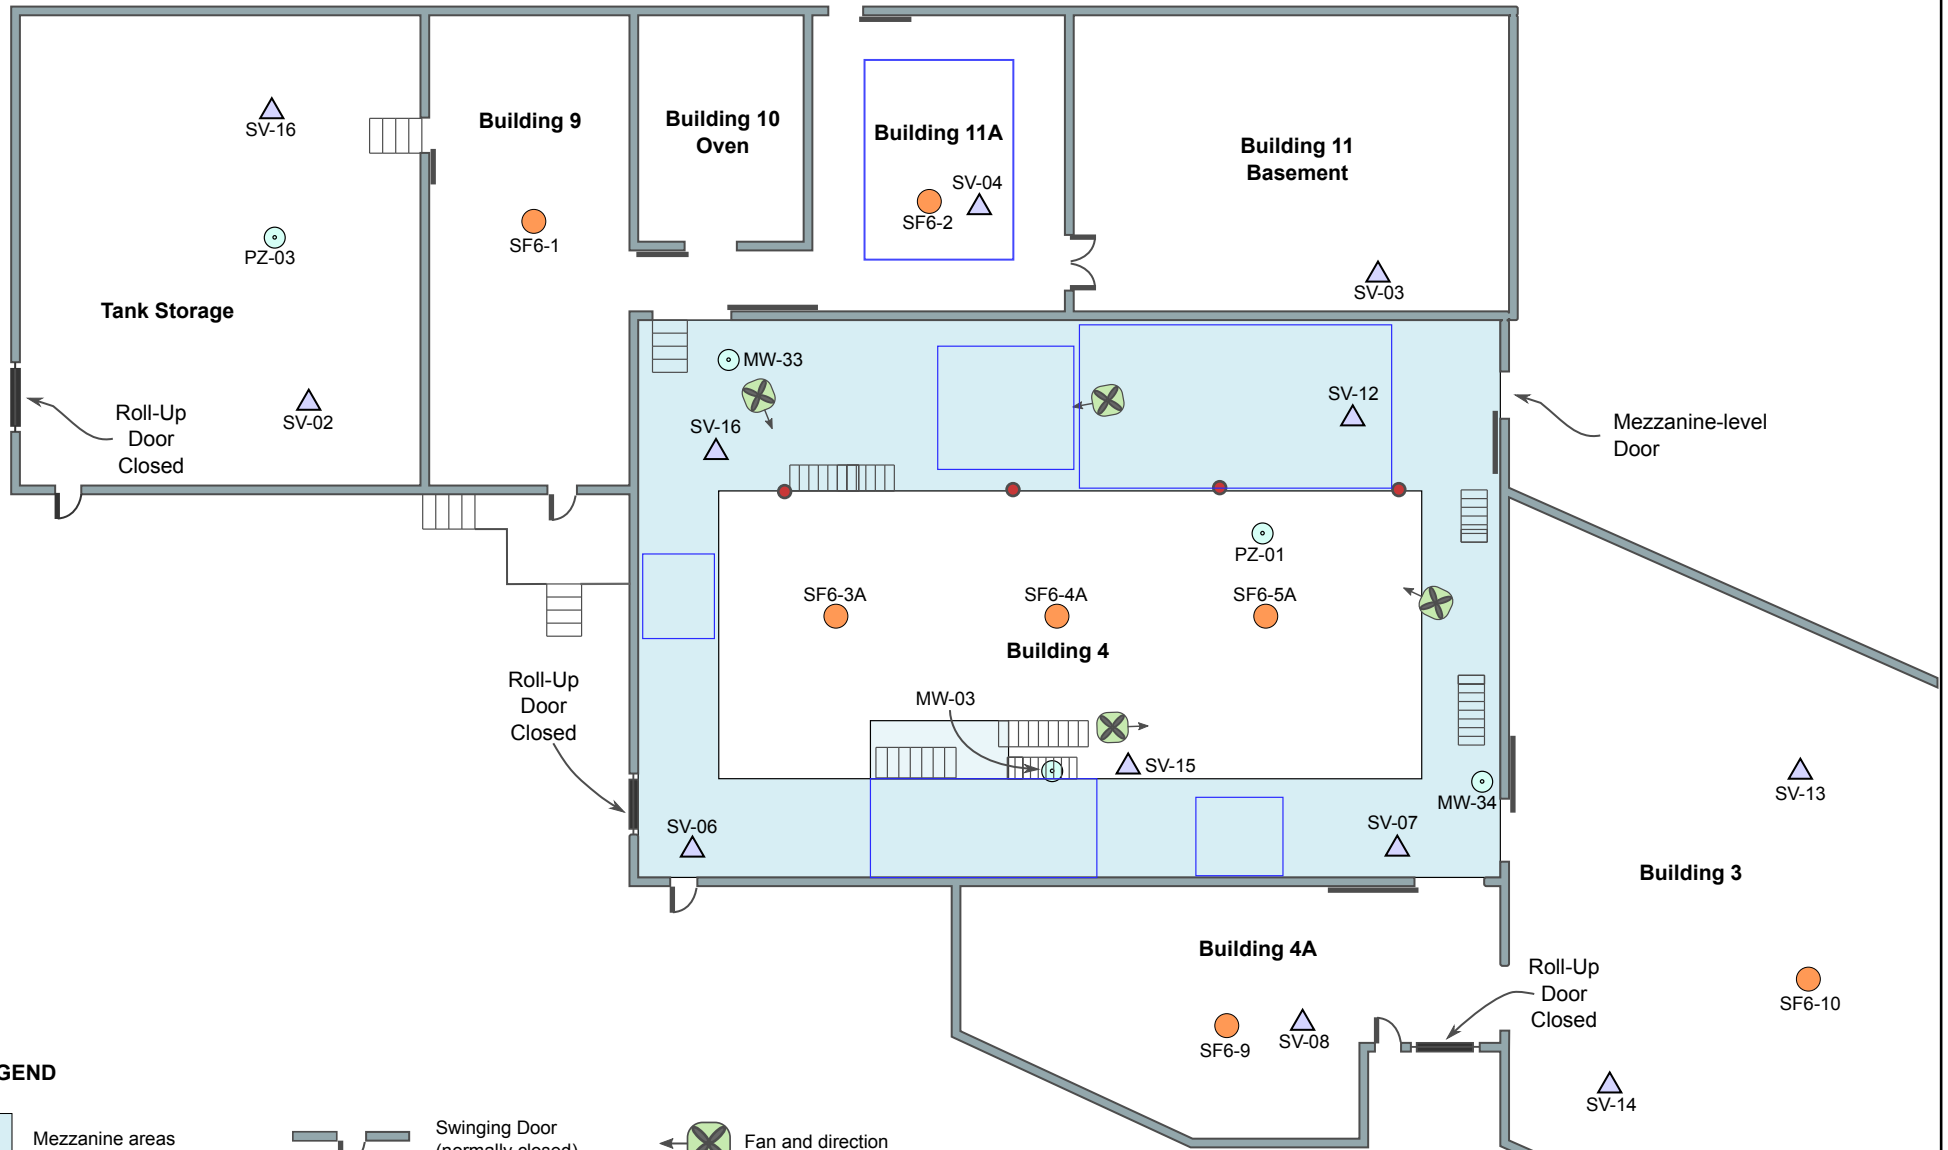
Figure 6-3
 Sulfur Hexafluoride Tracer Test Configuration
 Sixth Test Run
 2018 Supplemental Building 4 Vapor Investigation
 Former Hampshire Chemical Corp.
 Waterloo, NY

- Mezzanine areas
- Roof extensions
- Monitoring well
- △ Subslab probe
- SF6 sampling station at ground level
- Swinging Door (normally closed)
- Roll-Up Door (open/up)
- Roll-Up Door (closed/down)
- Fire Door (normally open)

Test 6 was conducted with the largest exterior doors of Building 4 in a closed condition (Figure 10-3), which was intended to more closely simulate winter operations.¹ Because one of two SF₆ instruments had become inoperable, a smaller number of monitoring locations were used than in Tests 3 and 4. In contrast to the observations in the previous tests, the initial tracer dose did not rapidly spread to Buildings 9 and 11A under the influence of the mixing fans. Concentrations gradually rose in Buildings 3,

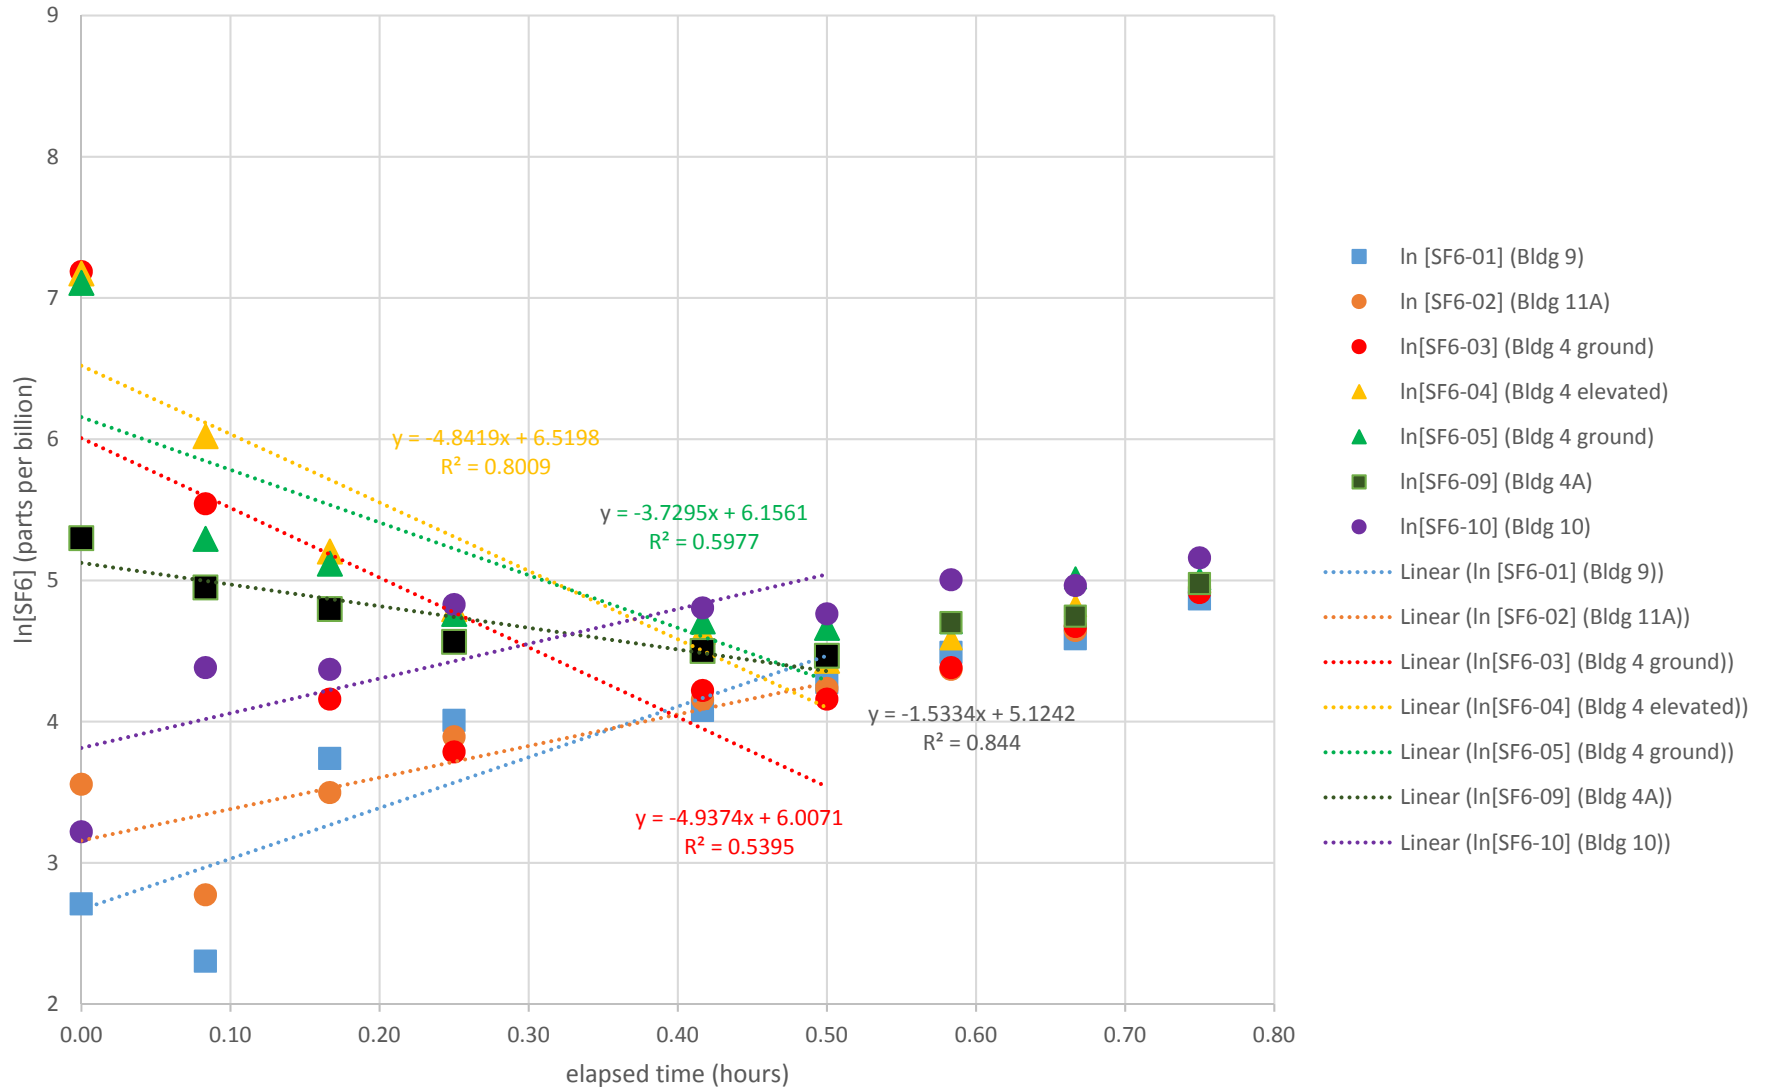
Figure 10-3. Sulfur Hexafluoride Tracer Test #6 Decay
 2018 Supplemental Building 4 Vapor Investigation
 Former Hampshire Chemical Corp.
 Waterloo, New York

Sulfur Hexafluoride Trace Test #6 analysis

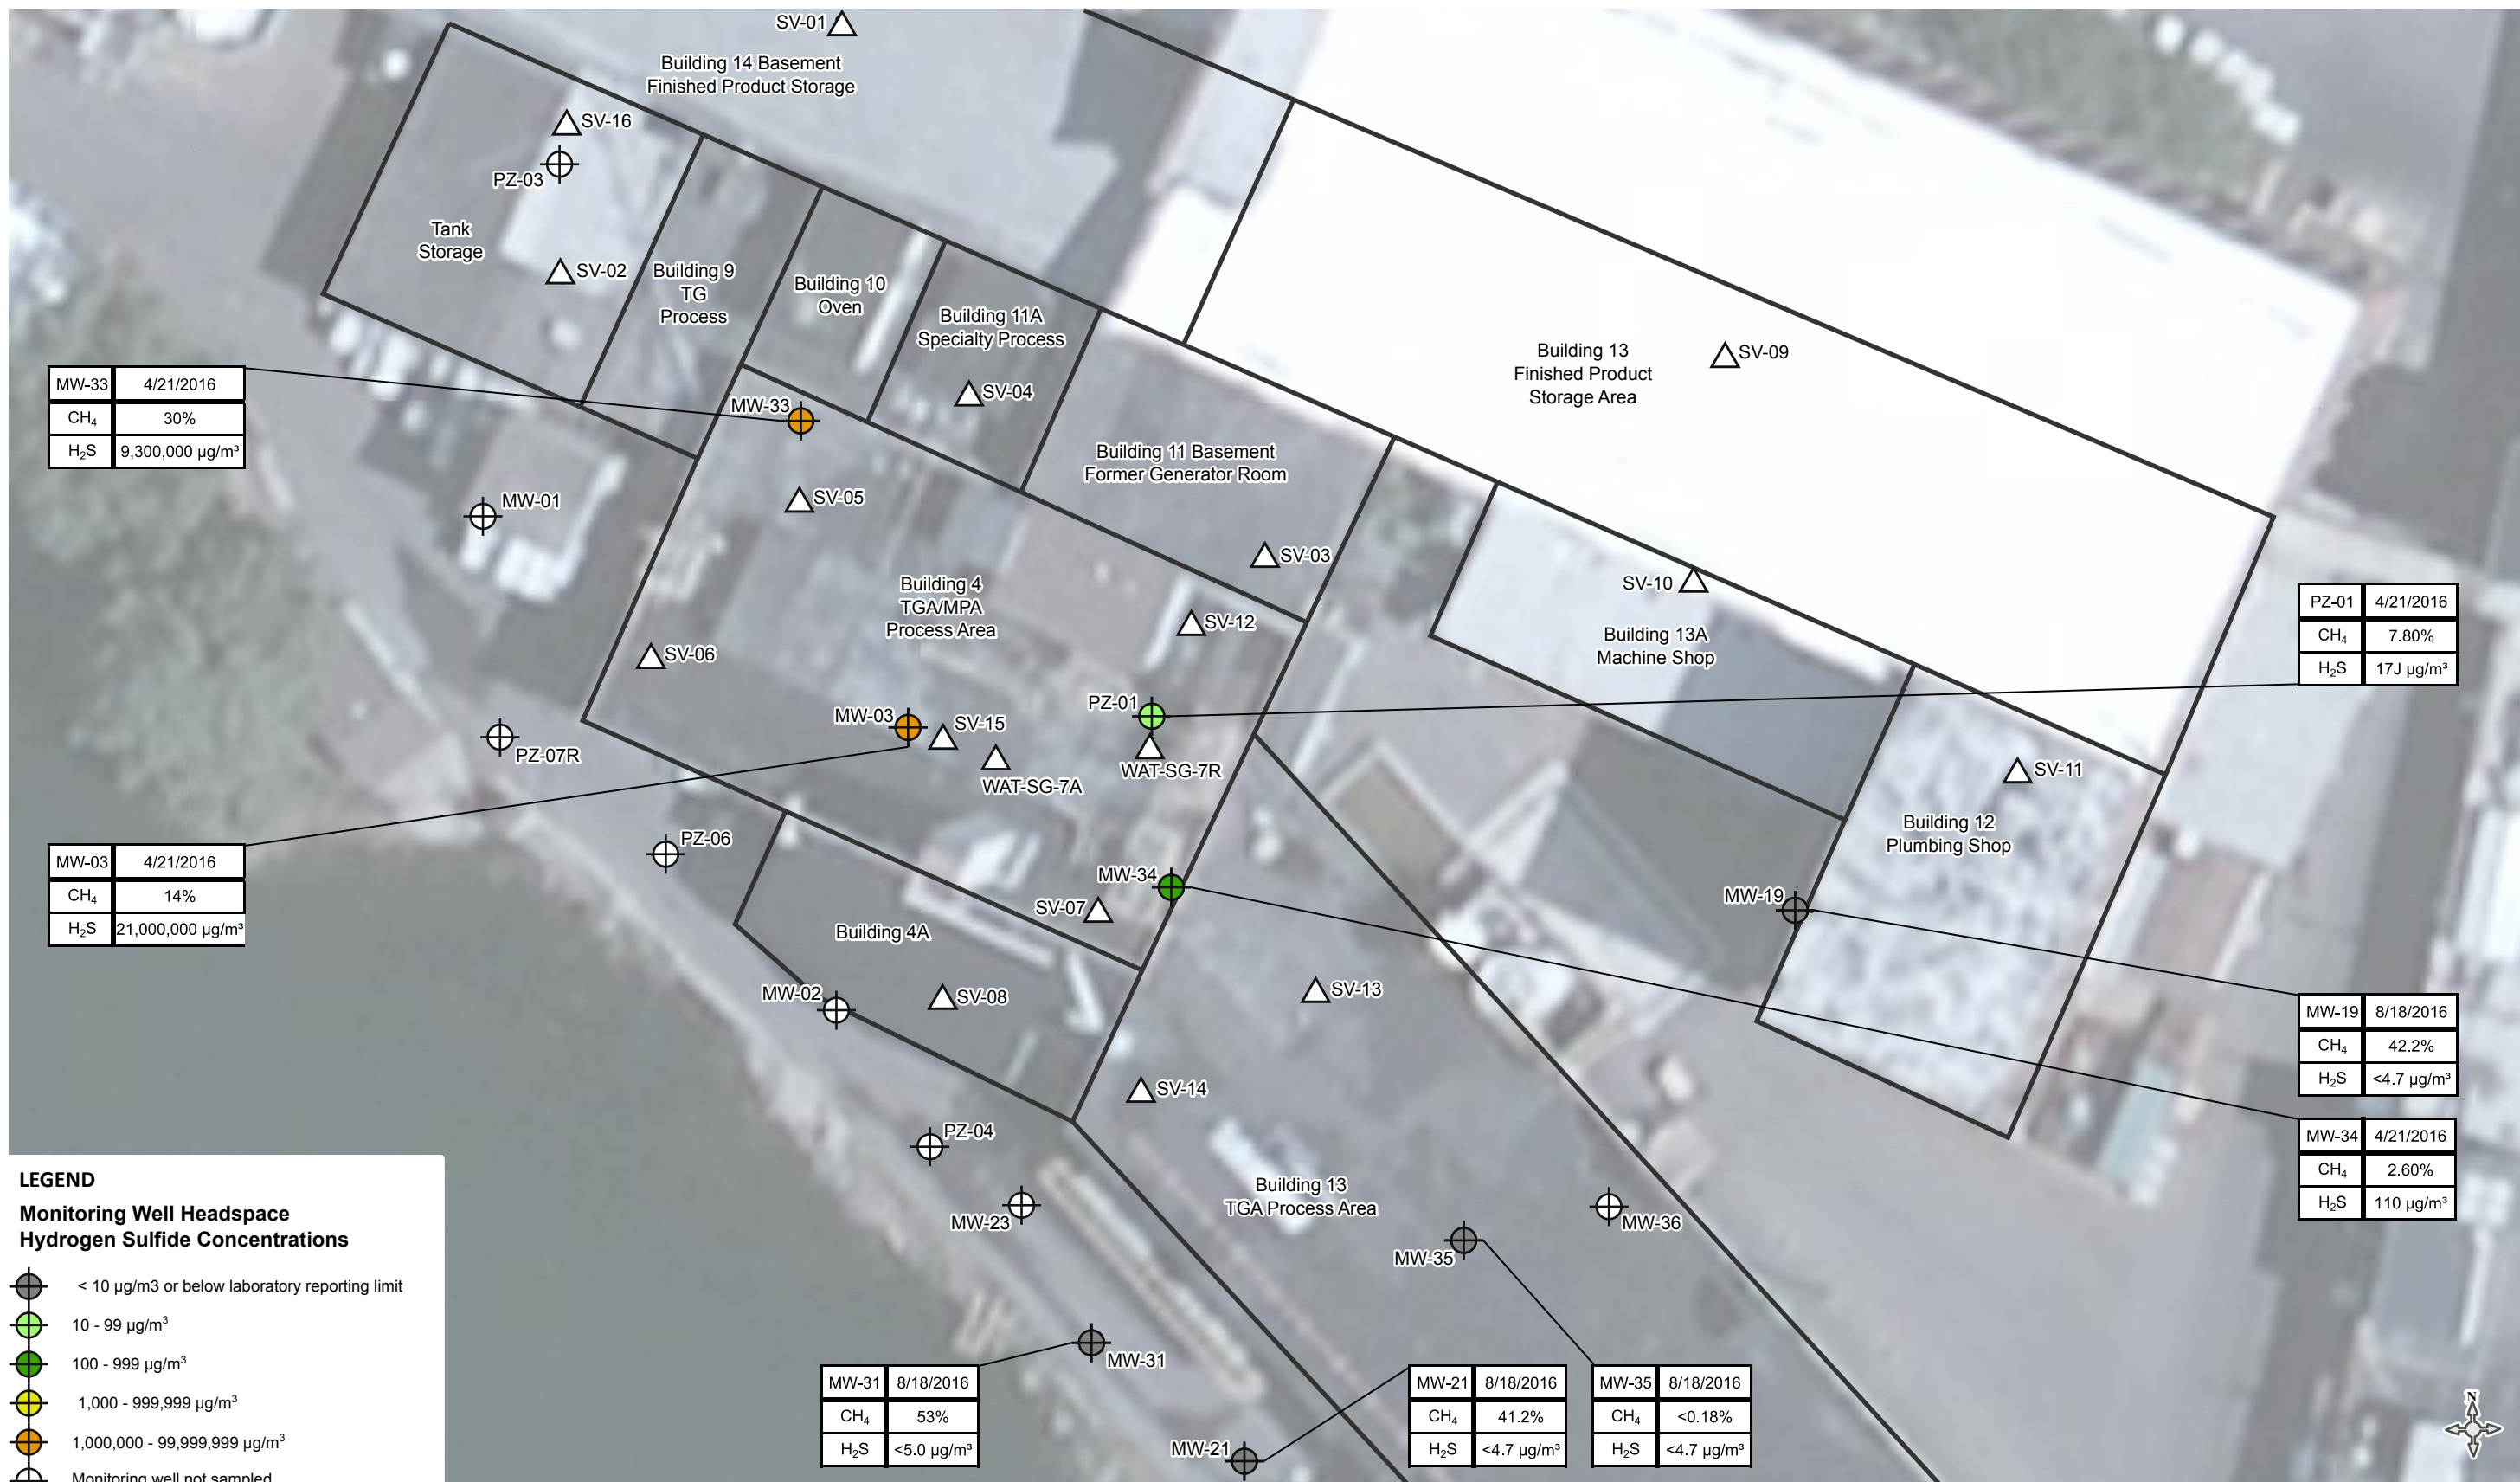
FIGURE 11-6
Monitoring Well Headspace Hydrogen Sulfide Results, April & August 2016
 2018 Supplemental Building 4 Vapor Investigation
 Former Hampshire Chemical
 Waterloo, New York

MW-33	4/21/2016
CH ₄	30%
H ₂ S	9,300,000 µg/m ³

MW-03	4/21/2016
CH ₄	14%
H ₂ S	21,000,000 µg/m ³
