Former Hampshire Chemical Corp. Facility, Waterloo, New York, Site No. 850001A

Sitewide Corrective Measures Study

Final February 2020 Hampshire Chemical Corporation

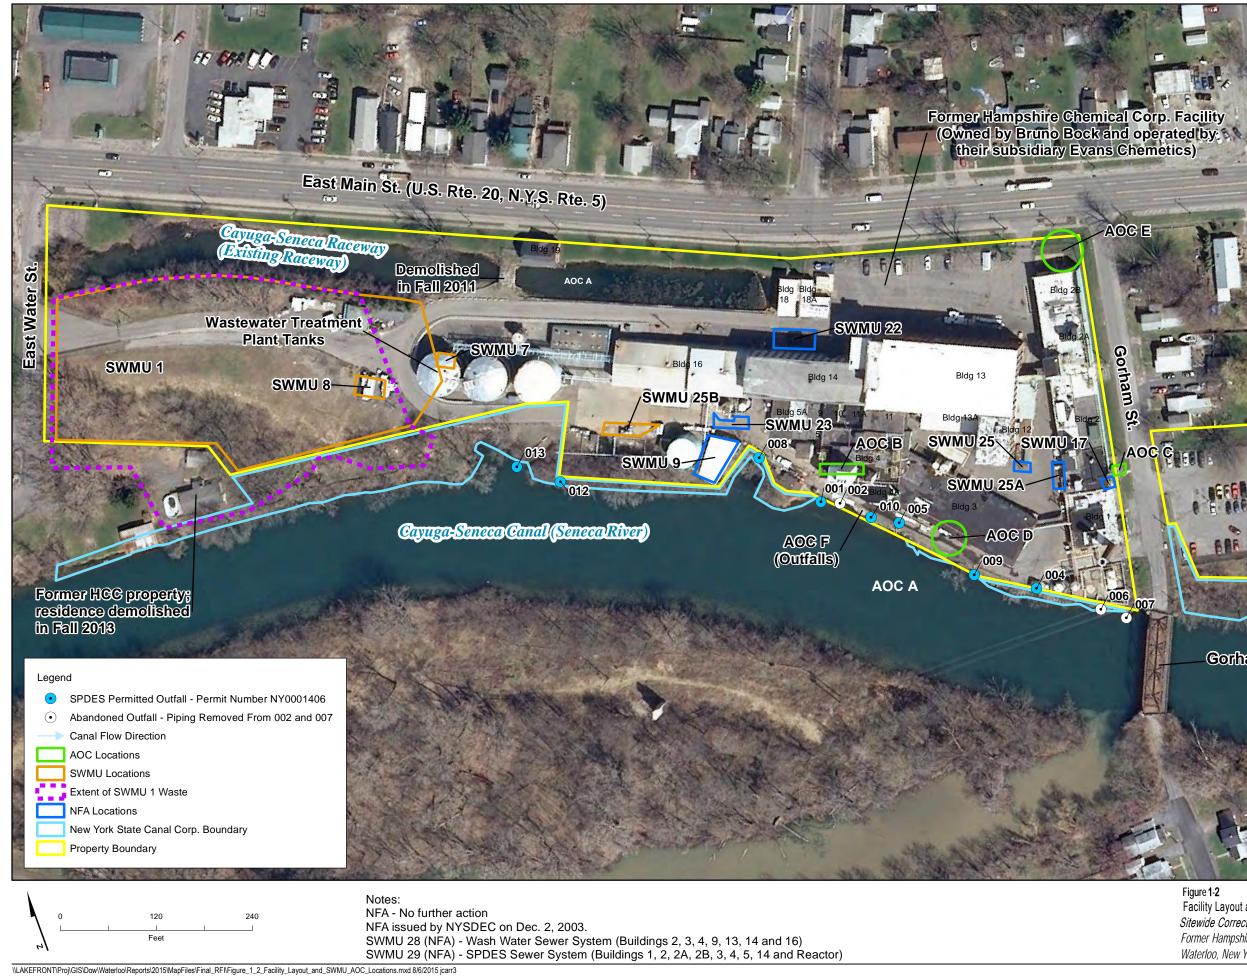
Figure 1-2 Facility Layout and SWMU/AOC Locations Sitewide Corrective Measures Study Former Hampshire Chemical Corp. Facility Waterloo, New York

The facility is located at 228 East Main Street, Waterloo, New York, which is within Seneca County, New York. As shown on Figure 1-2, the main portion of the facility is bordered to the north by East Main Street, to the east by Gorham Street, to the west by East Water Street, and to the south by the Cayuga-Seneca Canal (canal). The facility also includes a property currently owned by Evans Chemetics on the eastern side of Gorham Street, which is used as a parking lot. The facility is surrounded by residential properties (north, east, and southwest) and commercial businesses (west).

The facility has undergone significant changes over time. Several buildings were constructed in the 1800s at the facility, some of which are still standing, while others were demolished. The canal and raceway system was much more extensive in the 1800s and early 1900s than it is today. By 1948, most of the canals and raceways were filled and covered (O'Brien & Gere Engineers, Inc. [OB&G] 2003). Figure 1-2 depicts the current facility configuration.

Several RFI work plans (OB&G 2001a; CH2M 2004a, 2007a, 2007b, 2008a, 2010a, 2010b, 2010c, 2011a) have been submitted to NYSDEC for approval to perform facility investigations at the SWMUs and AOCs (Figure 1-2) to understand the nature and extent of impacted media at the facility. The investigations were performed in accordance with standard operating procedures outlined in the associated quality assurance project plan (QAPP) (OB&G 2001b, as amended; CH2M 2004a), the soil vapor investigation QAPP (CH2M 2007b, Appendix A), and the RFI QAPP (CH2M 2009a, amended 2010). The RFI QAPP was conditionally approved by NYSDEC (2009), and the amended RFI QAPP was accepted by NYSDEC (2017a). The waste materials generated were managed in accordance with the materials management plan (CH2M 2007c, 2008b [revised]).

The hazardous waste container storage area identified as SWMU 7 (Figure 1-2) was a RCRA-regulated storage shed that measured approximately 16 feet by 10 feet and was approximately 200 feet west of Building 16. At present, the area that originally constituted SWMU 7 is within a concrete-paved and diked area that has an engineered foundation to support the WWTP bioreactors. No documented releases exist for this area.

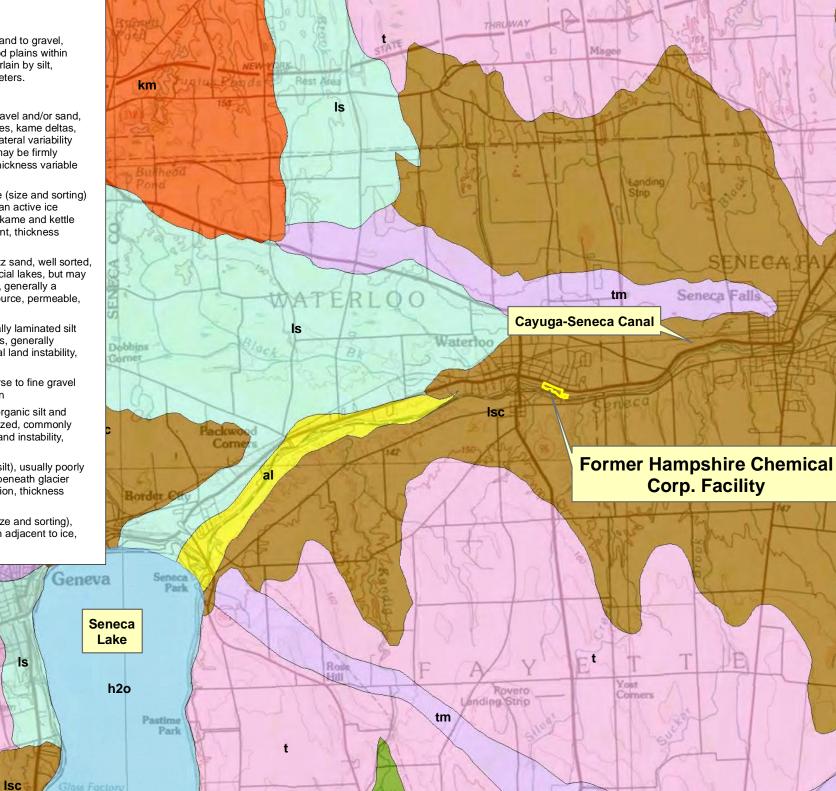
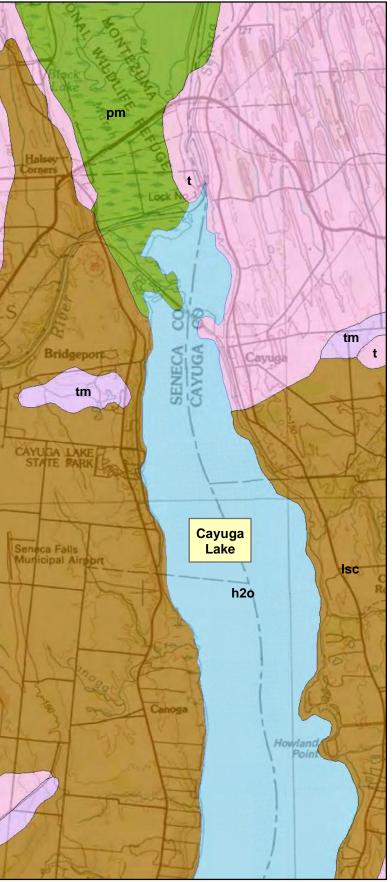
Figure **2-2** Regional Surficial Geology Map *Sitewide Corrective MeasuresStudy Former Hampshire Chemical Corp. Facility Waterloo, New York*

t - Till - Variable texture (boulders to silt), usually poorly sorted sand-rich diamict, deposition beneath glacier ice, permeability varies with compaction, thickness variable (1-50 meters)

tm - Till moraine - Variable texture (size and sorting), generally low permeability, deposition adjacent to ice, thickness variable (10-30 meters).

Source: Surficial Geologic Map of New York, Finger Lakes Sheet, 1:250,000 scale, New York State Museum - Geological Survey, Map and Chart Series No. 40, Compiled and Edited by Ernest H. Muller and Donald H. Cadwell, 1986.

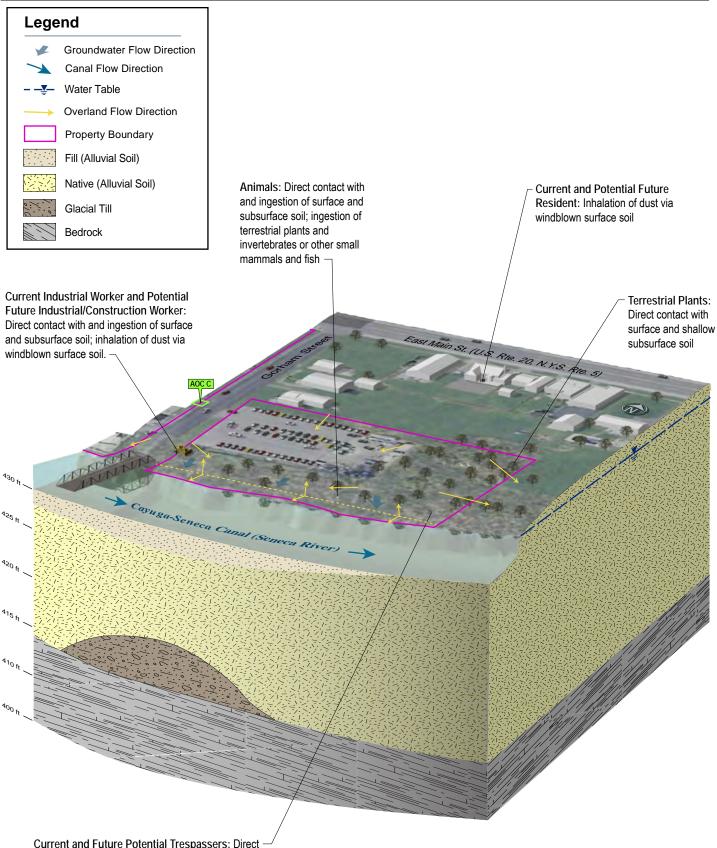
Figure 2-5 AOC C/Gorham Street Conceptual Site Model Sitewide Corrective Measures Study Former Hampshire Chemical Corp. Facility Waterloo, New York

Current and Future Potential Trespassers: Direct – contact with and ingestion of surface and subsurface soil; inhalation of dust via windblown surface soil

Corrective measures were required for AOC C/Gorham Street (for PCBs). Soil excavation corrective measures were performed and documented in the *Construction Completion Report for Gorham Street PCB Remediation* (CH2M 2010g). Additional Gorham Street soil investigation was performed, and the results were summarized in the Gorham Street soil investigation reports (CH2M 2010h, 2012d, 2012e). Based on these investigations, a CSM was developed for AOC C (Figure 2-5) to describe the relevant facility features, and the surface and subsurface conditions to understand the extent of identified COCs and the potential risk to receptors.

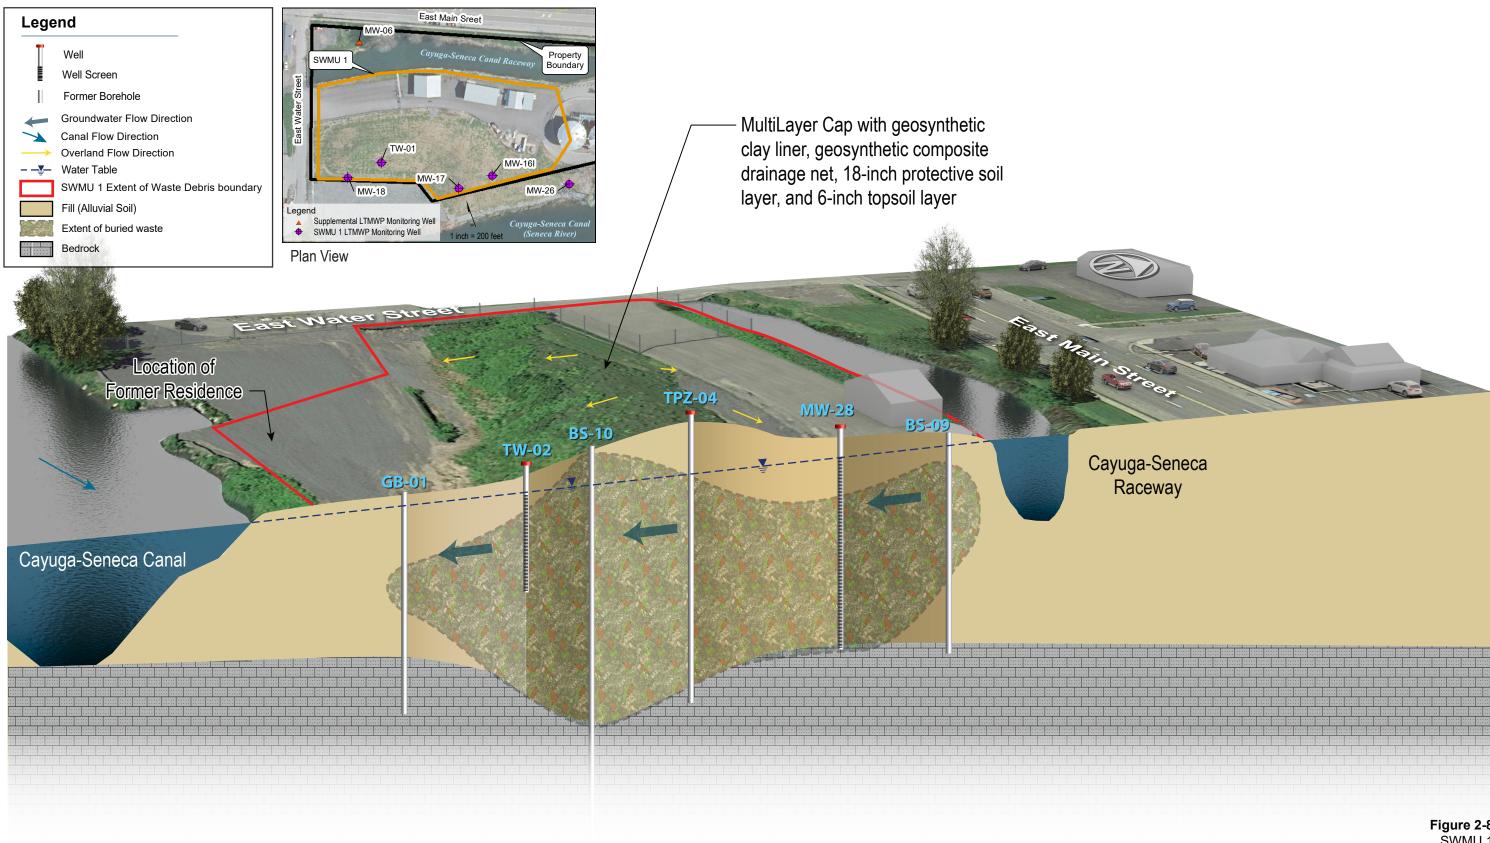
Figure 2-8 SWMU 1 **Conceptual Site Model** Sitewide Corrective Measures Study Former Hampshire Chemical Corp. Facility Waterloo, New York

Note: TW-02 well screen: 5.5 ft to 10.5 ft bgs MW-28 well screen: 6 ft to 16 ft bgs

Further investigation was required for SWMU 1. These investigations included groundwater, soil vapor, and methane surveys and were summarized in several reports (CH2M 2008c, 2010e, 2011b, 2011d, 2012a, 2012g, 2013c, 2013d, 2014a, 2015f). Based on these investigations, a CSM was developed for SWMU 1 (Figure 2-8) to describe the relevant facility features, and the surface and subsurface conditions to understand the extent of identified COCs and the potential risk to receptors. The results of these investigations and the CSM understanding were sufficient to evaluating potential interim corrective action alternatives for the RTA at SWMU 1.
