**PHILIPS DISPLAY COMPONENTS COMPANY  
SENECA FALLS, NEW YORK**

**RCRA FACILITY ASSESSMENT  
SAMPLING VISIT WORK PLAN**

**VOLUME I  
MANAGEMENT PLAN**

**PROJECT NO. 288788-11**

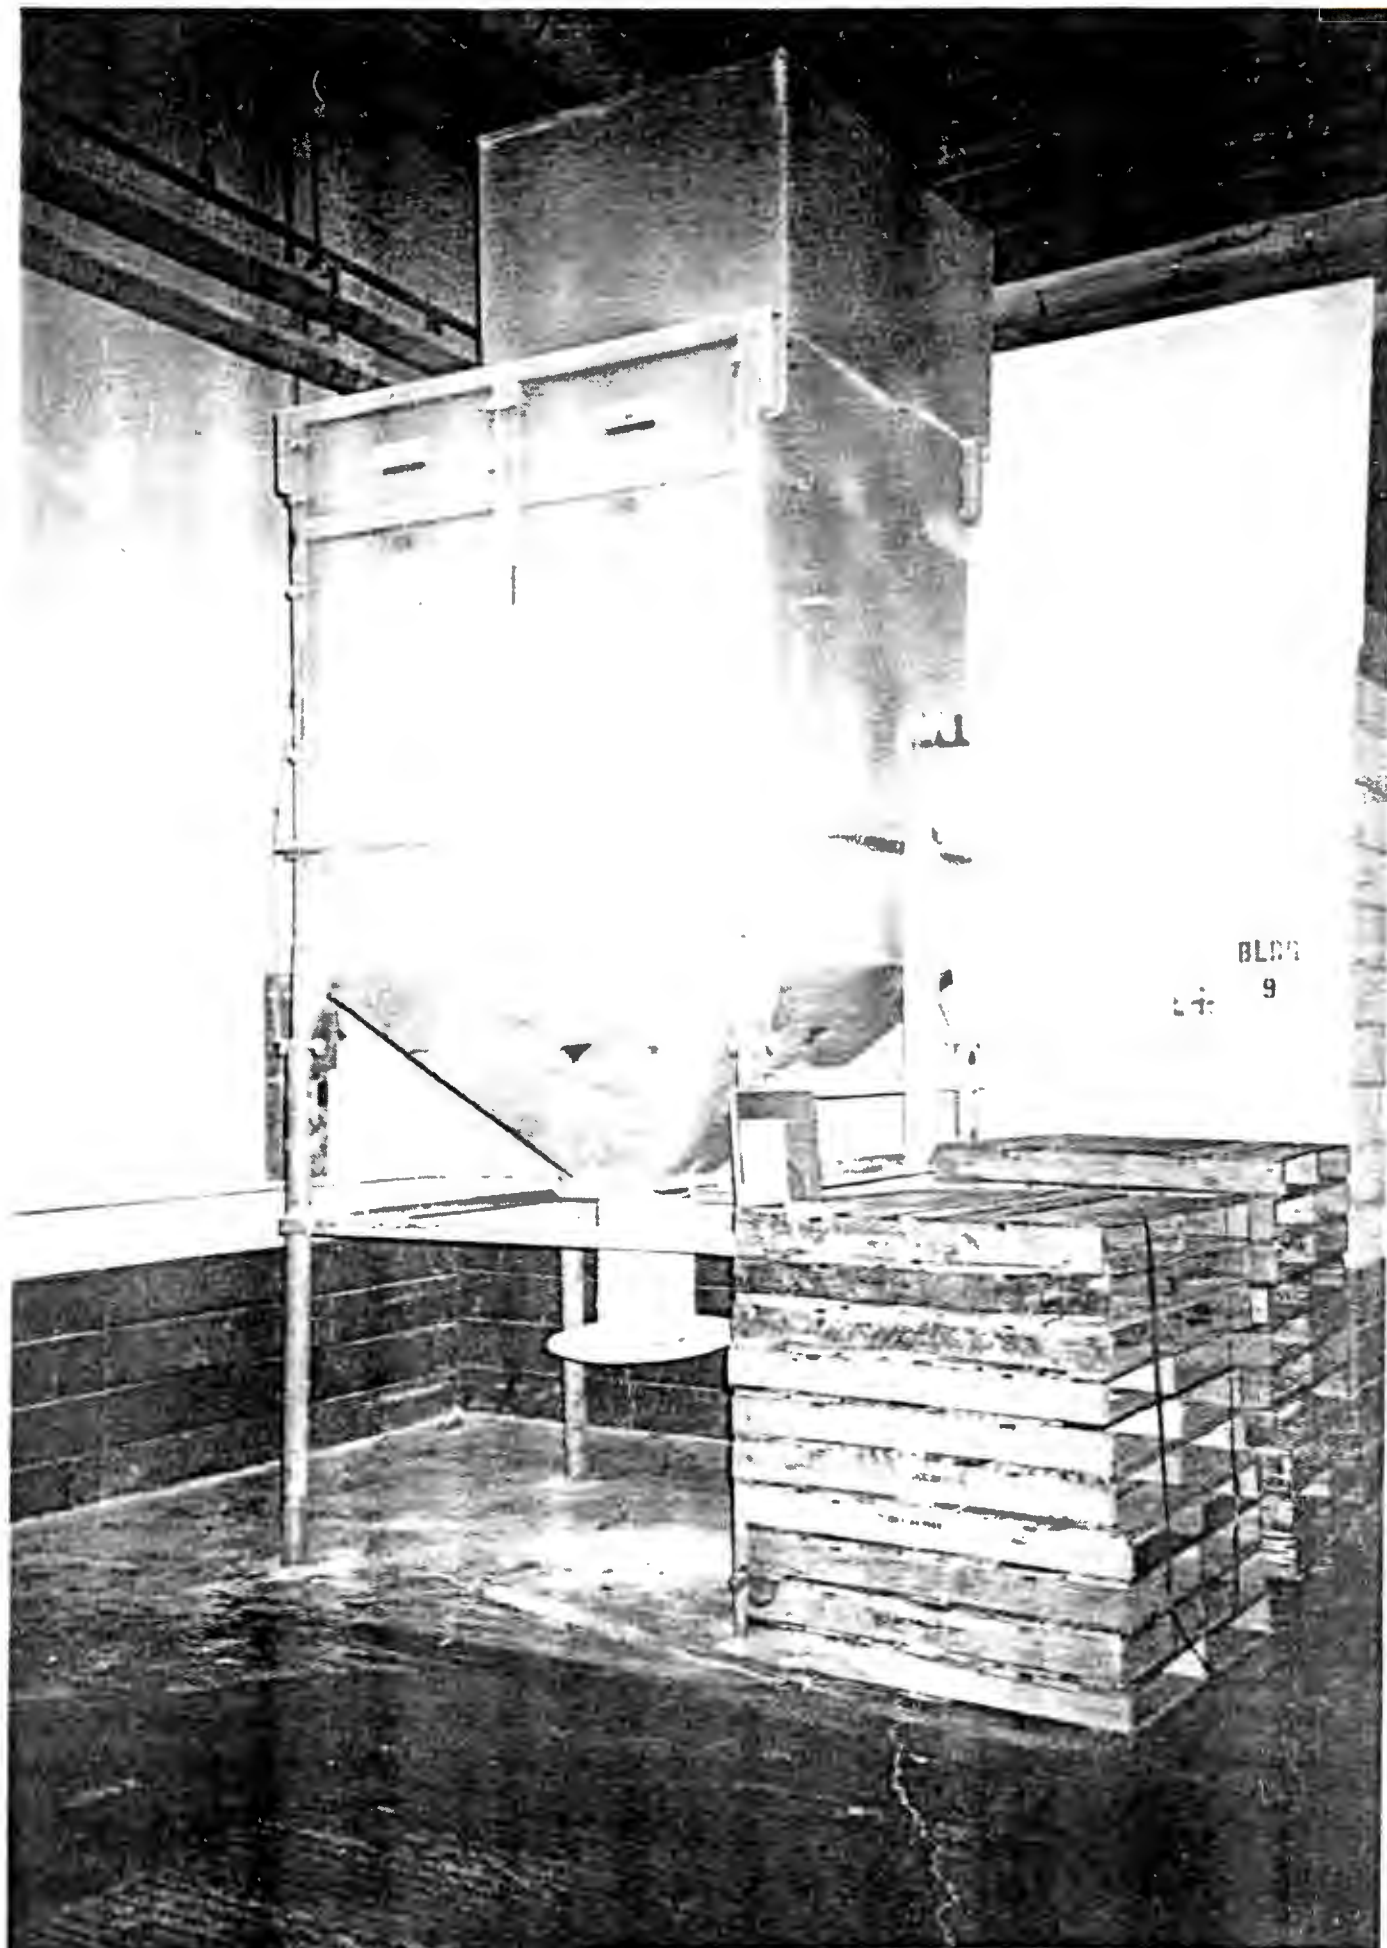
Figure 4 Glass Buffing Dust Collector Building No. 9

This area in the east-central part of Building #9 (designated as SS 3 in Figure 1; see also Figure 4) was used to collect high lead glass from the glass buffing dust collector. All material was collected in drums. No cracks in the concrete floor or other evidence of pathways for migration of the material into the environment are evident. No sampling will be performed at this location.

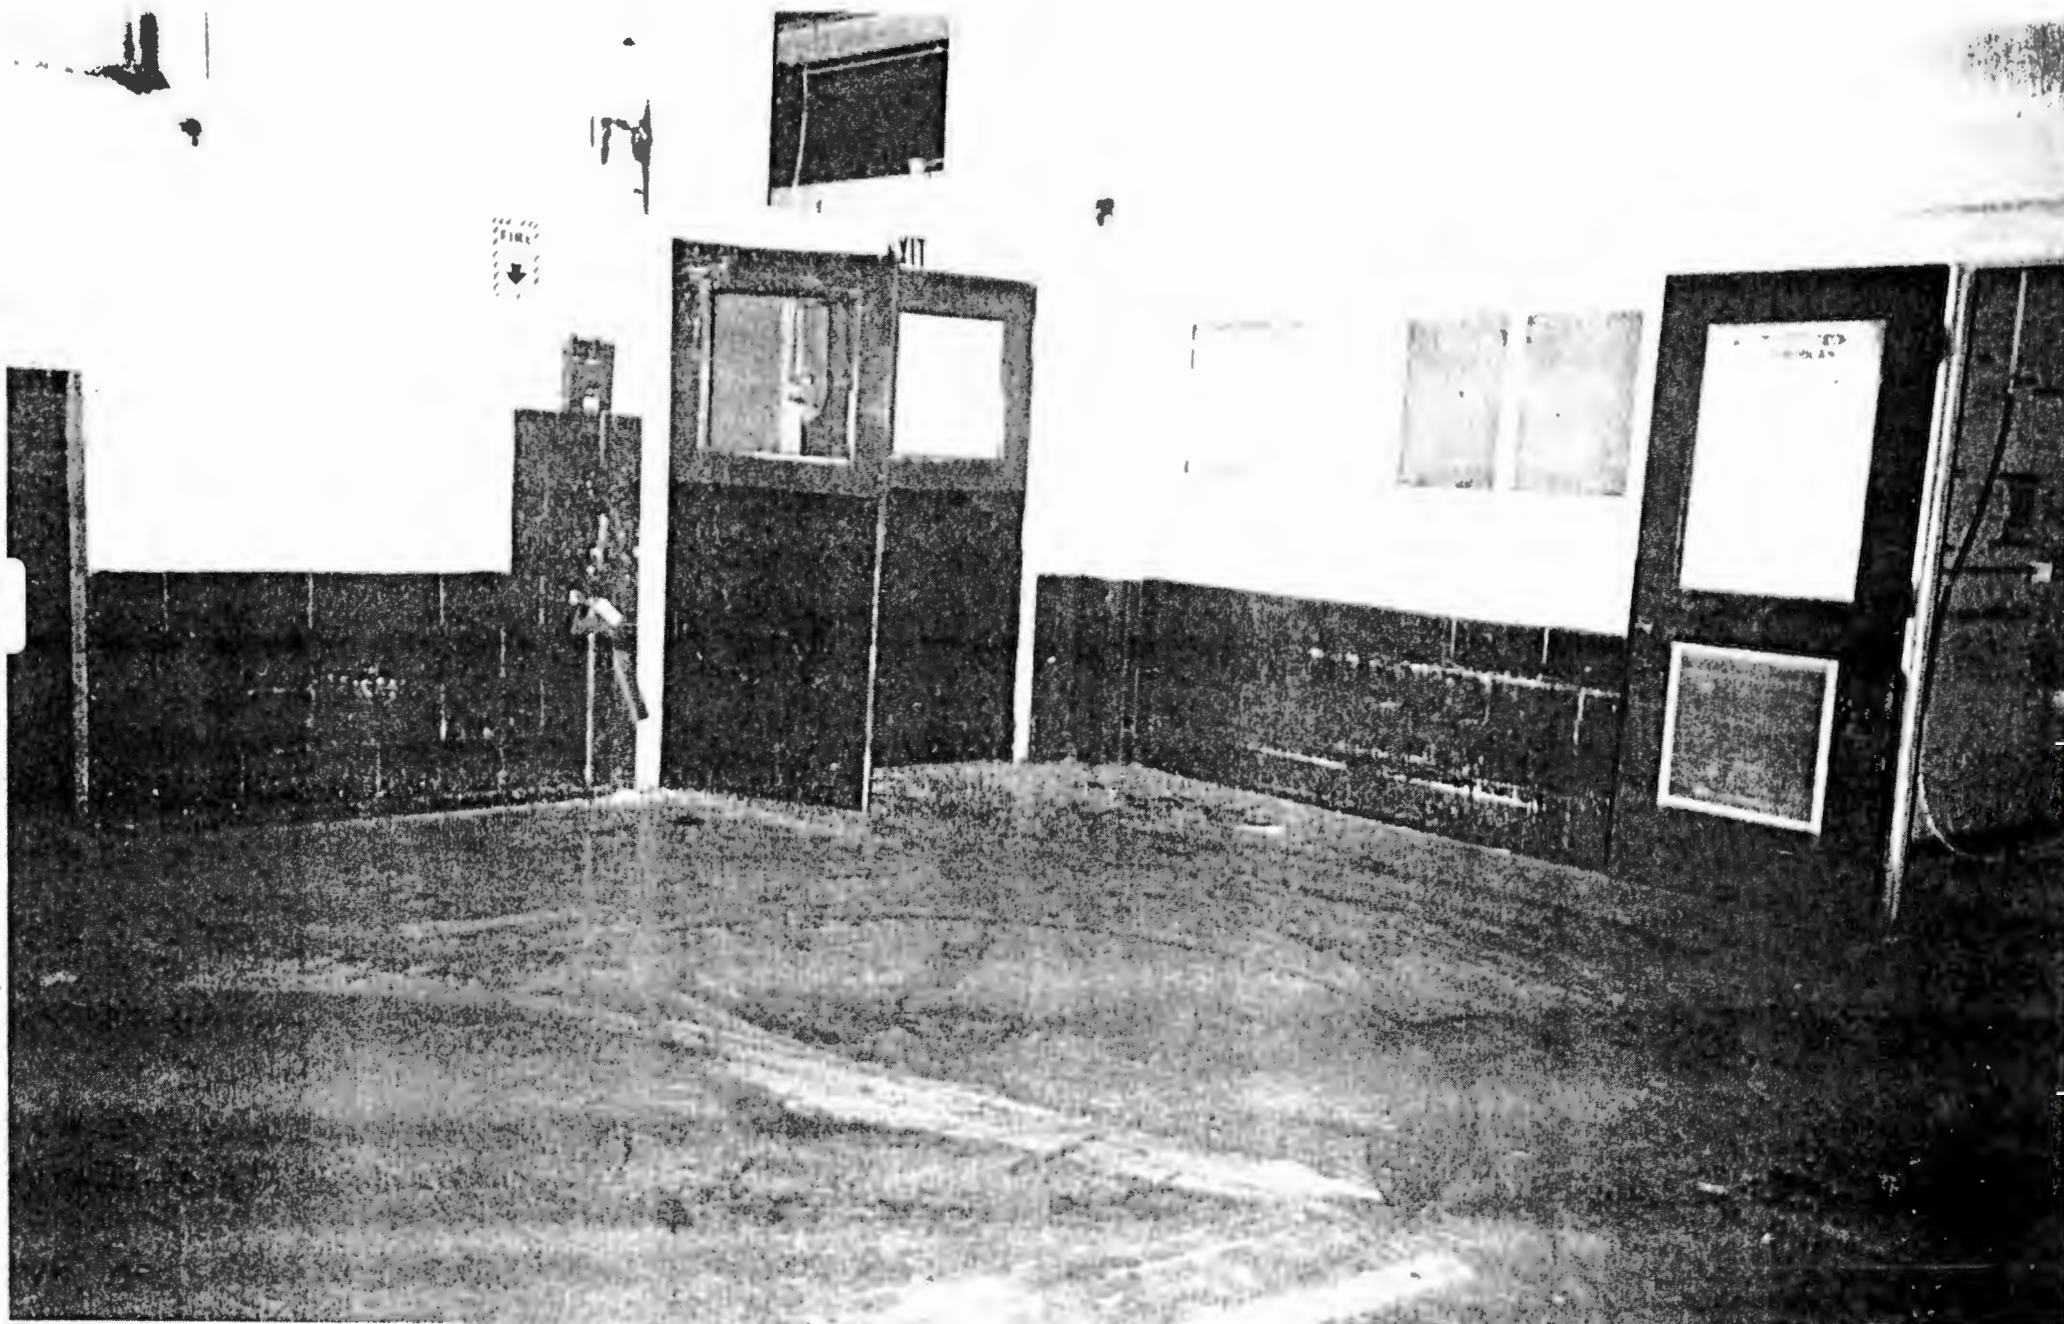
Figure 5 Frit Room Building No. 10

This area in the south-central part of Building #10 (designated as SS 4 in Figure 1; see also Figure 5) was used to collect high lead glass frit waste. This material was collected in drums. No cracks in the concrete floor or other evidence of pathways for migration of the material into the environment are evident. No sampling will be performed at this location.
