RE: Building 2 Underground Storage Tank Closure Report
Philips Display Components Company
Seneca Falls, New York
EPA I.D. No.NYD002246015

PHILIPS DISPLAY COMPONENTS COMPANY
SENECA FALLS FACILITY
SENECA FALLS, NEW YORK

BUILDING 2
UNDERGROUND STORAGE TANK
CLOSURE REPORT

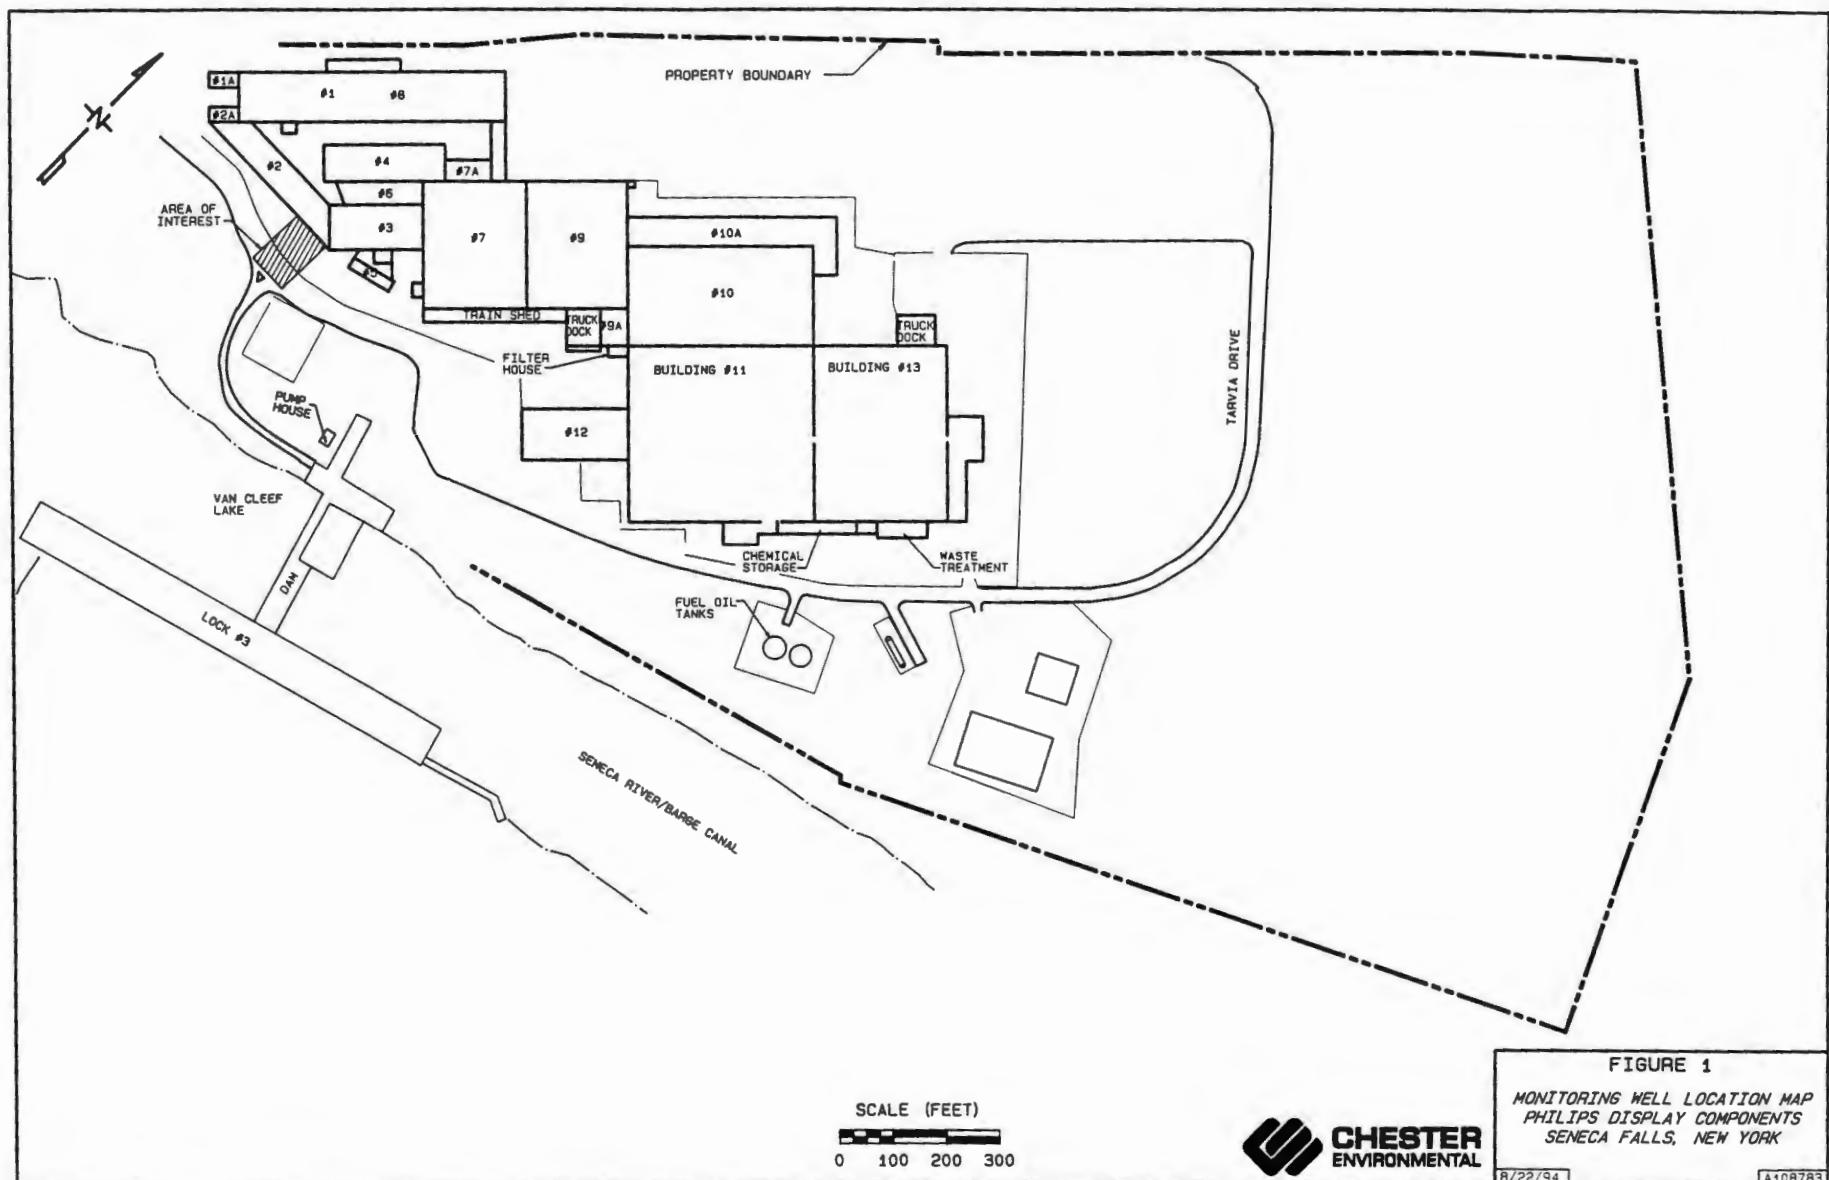
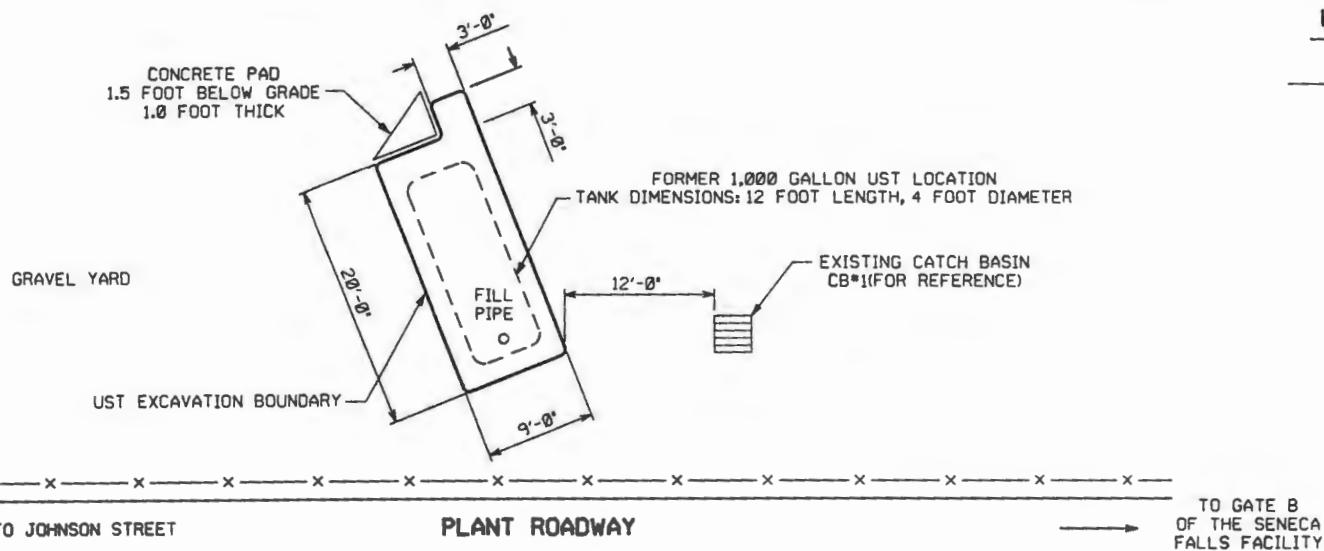
FIGURE 2
 UNDERGROUND STORAGE TANK LAYOUT & LOCATION
 PHILIPS DISPLAY COMPONENTS COMPANY
 SENECA FALLS, NY

SAMPLE I.D. *		SAMPLE LOCATION AND COMPOSITION
NW		COMPOSITE OF NORTHERN SIDEWALL, 6' DEPTH, CLAY
SW		COMPOSITE OF SOUTHERN SIDEWALL, 6' DEPTH, CLAY & FILL
WW		COMPOSITE OF WESTERN END WALL, 6' DEPTH, CLAY
EW		COMPOSITE OF EASTERN END WALL, 6' DEPTH, CLAY
EB		COMPOSITE OF EXCAVATION BOTTOM, 8' DEPTH, FILL

To characterize the tank excavation, Chester's engineer collected five composite soil samples from the excavation floor and sidewalls in accordance with the NYSDEC's Spill Technology and Remediation Series (STARS) Memo #1. Samples NW, SW, WW, and EW were collected from the northern, southern, western and eastern sidewalls, respectively at a depth of six feet below grade. Sample EB was collected from the excavation bottom. Sample location and composition information is provided on Figure 2.

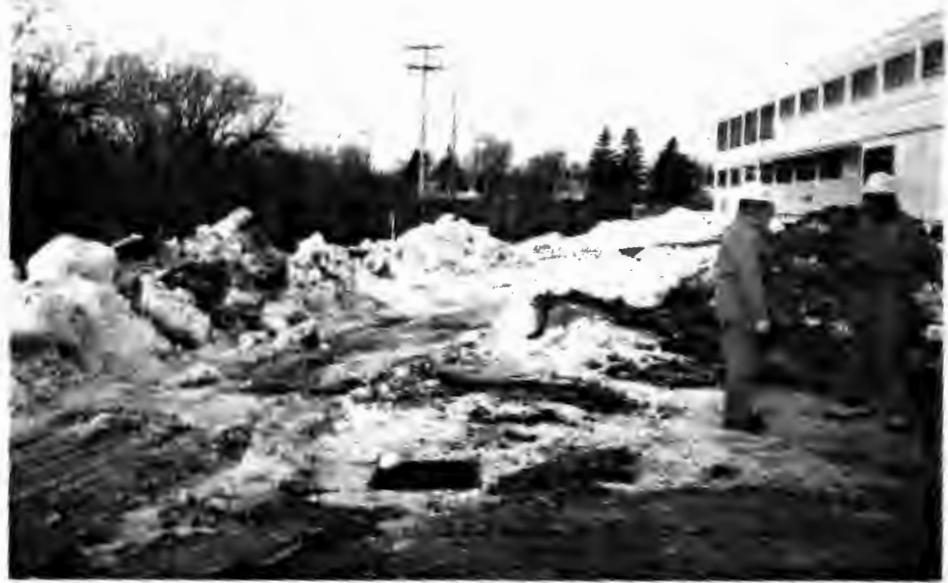
Photo #1: LOCATION OF UNDERGROUND STORAGE TANK (UST). TANK FILL PIPE IS MARKED BY SAFETY CONE. (LOOKING SOUTH)

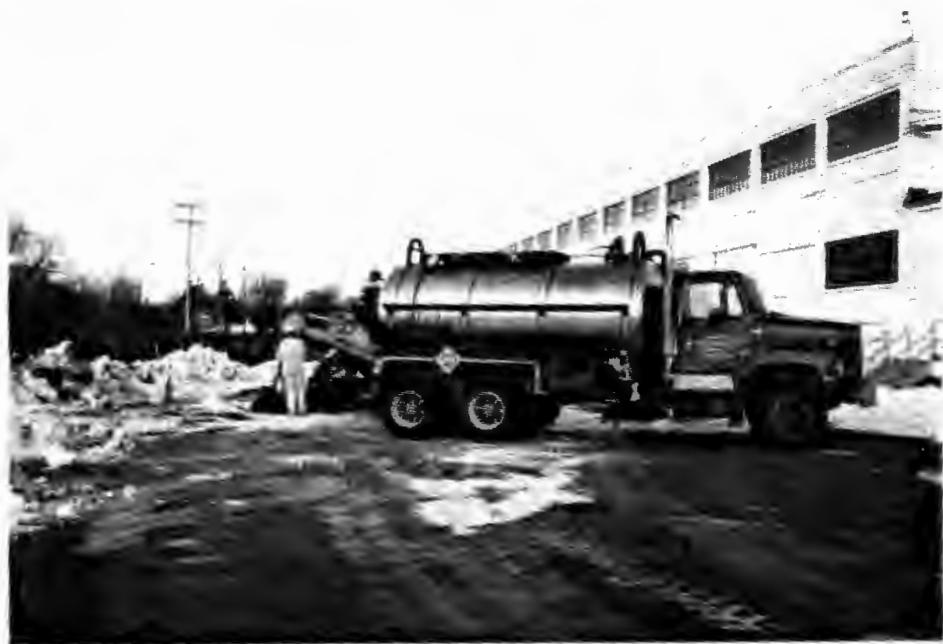
Photo #2: EMPTYING UST OF REMAINING CONTENTS. (LOOKING SOUTH)

To initiate permanent UST closure, the residual product/water was removed from the tank and subsequently recycled by Industrial Oil Tank Service Corporation. Because information concerning the confirmed historical usage of the UST was not available, the tank contents were transported under hazardous waste and land disposal notification protocol. The disposal documentation is provided in Appendix A.

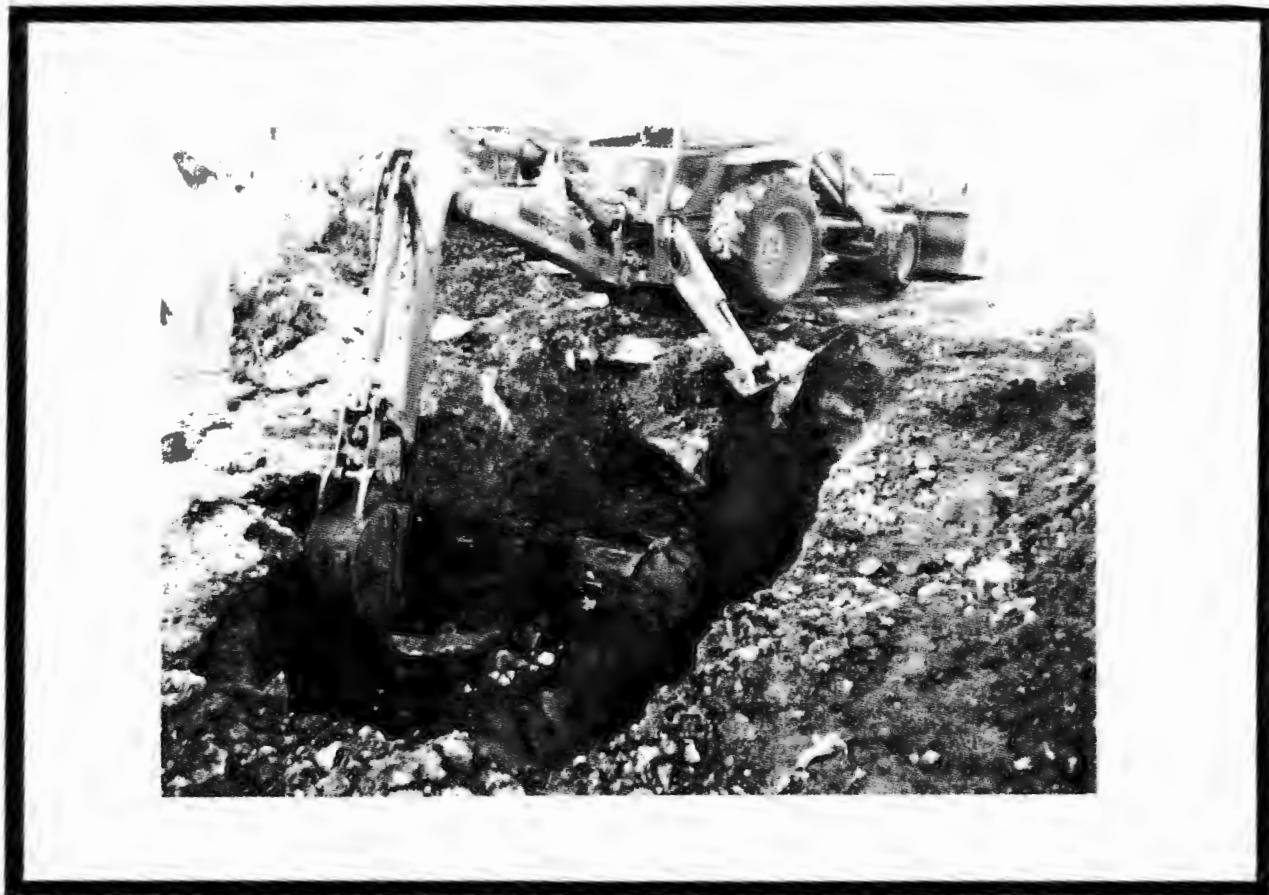
Photo #3: EXCAVATION OF SOIL FROM ATOP UST. (LOOKING WEST)

Following the removal of the residual product/water from the UST and the inerting of the tank atmosphere, the soil was excavated from atop the UST, staged temporarily adjacent to the tank area, and subsequently transported to the designated soil staging area. The field inspection of the excavated soil indicated minor staining. Due to inclement weather conditions (extreme cold), a photoionization detector was not effective in monitoring soil for volatile organic compounds. The soil atop the UST consisted mainly of sandy fill material.

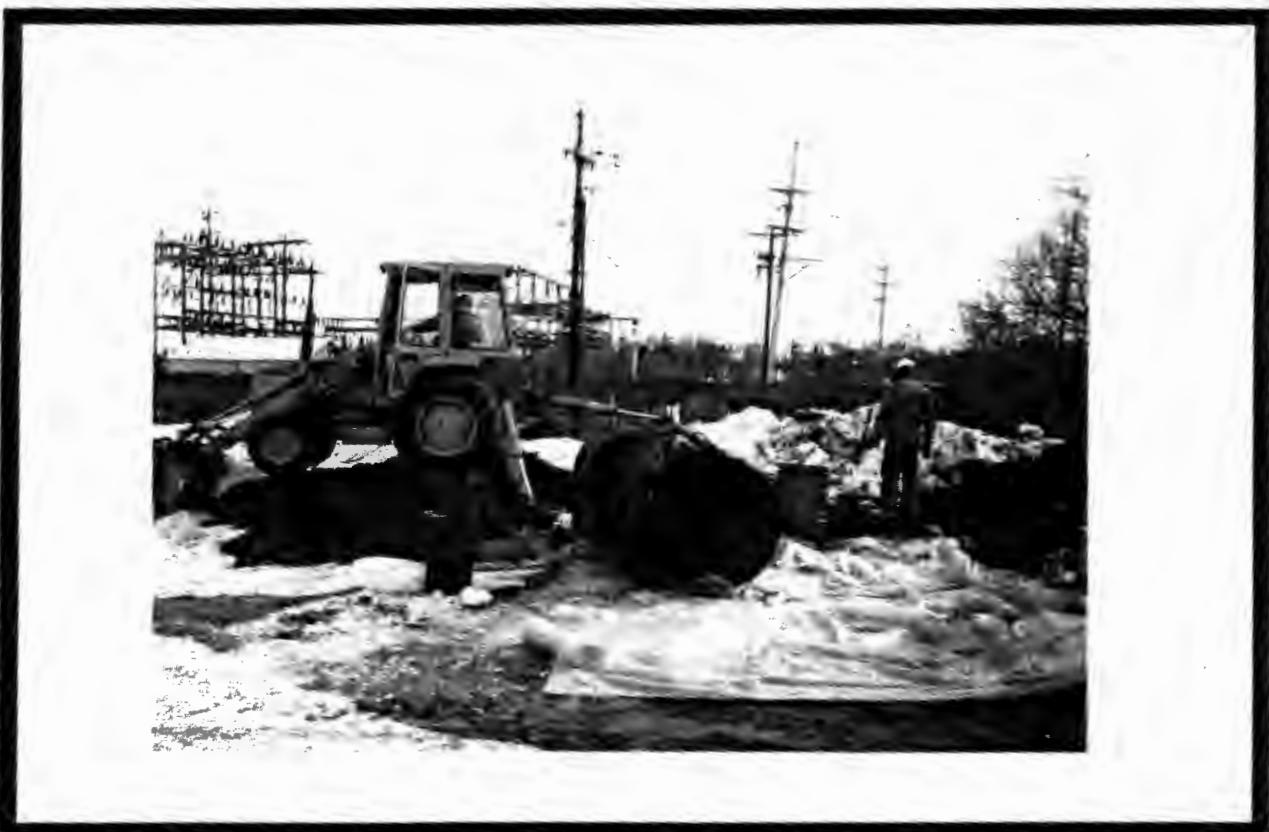
The visual inspection of the UST revealed general surface corrosion and numerous "dime-sized" corrosion holes.

Photo #4: TEMPORARY STAGING OF UST FOLLOWING REMOVAL. (LOOKING SOUTHEAST)

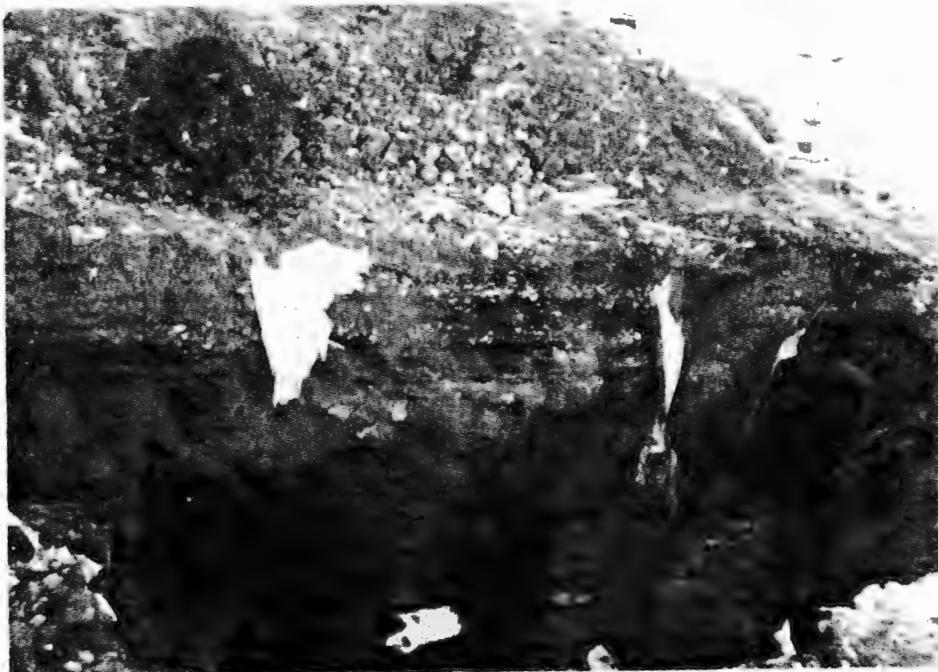
Following removal of the tank, approximately six inches of visually impacted soil was removed from the southern excavation sidewall. The inspection of the excavation sidewalls revealed mainly red clay exhibiting no field evidence of remaining petroleum impacts. The excavation bottom consisted mainly of black and gray sandy fill material exhibiting minor discoloration.

**Photo #5: SOUTHERN EXCAVATION SIDEWALL FOLLOWING UST REMOVAL.
(LOOKING SOUTH)**

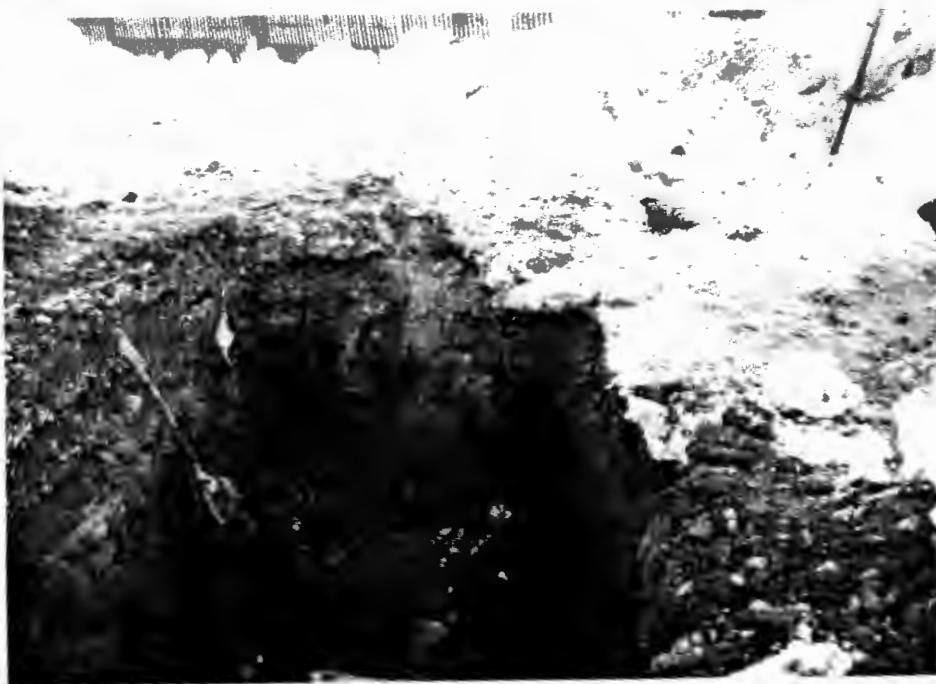
**Photo #6: EASTERN END OF EXCAVATION FOLLOWING UST REMOVAL.
(LOOKING EAST)**

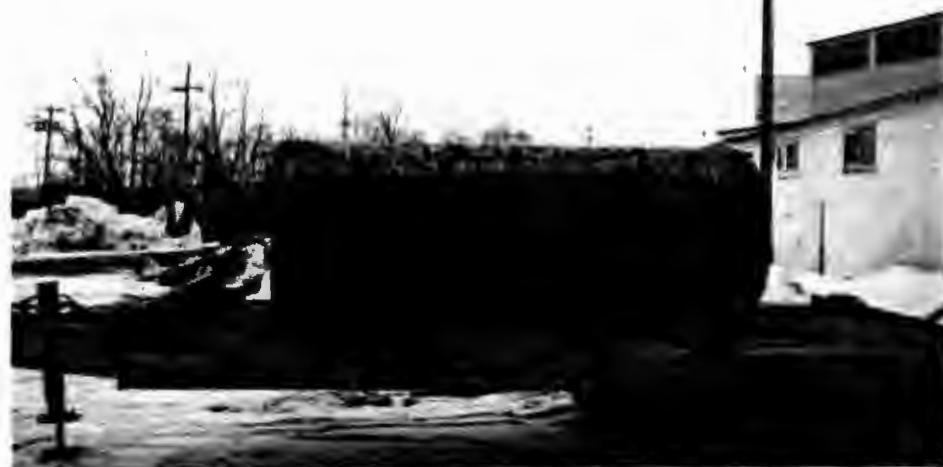
**Photo #7: LABELLED UST PRIOR TO TRANSPORTATION FOR DISPOSAL.
(LOOKING SOUTH)**

The tank was subsequently transported to Consolidated Scrap Processing in Auburn, New York for ultimate disposal as scrap metal. A certificate of disposal is provided in Appendix B.

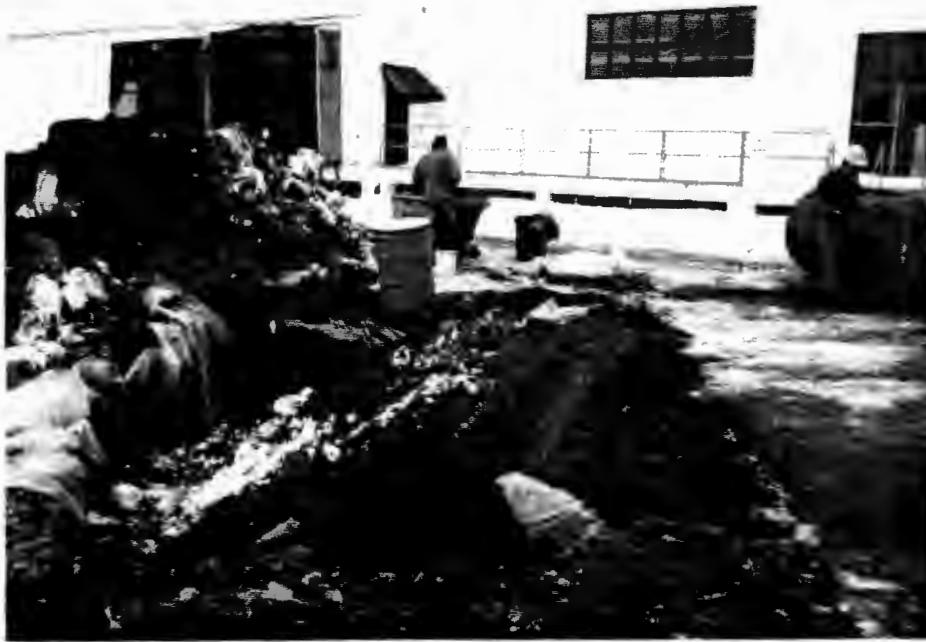
**Photo #8: BACKFILLING UST EXCAVATION WITH IMPORTED CLEAN FILL.
(LOOKING WEST)**

Following site characterization sampling, polyethylene sheeting was placed in the excavated area to delineate the limits of excavation. Imported clean fill was then placed on top of the polyethylene sheeting.
