ENGINEERING INVESTIGATIONS AT INACTIVE HAZARDOUS WASTE SITES

PHASE I INVESTIGATION

Conrail
Town Of Hornellsville

Site No. 851002
Steuben County

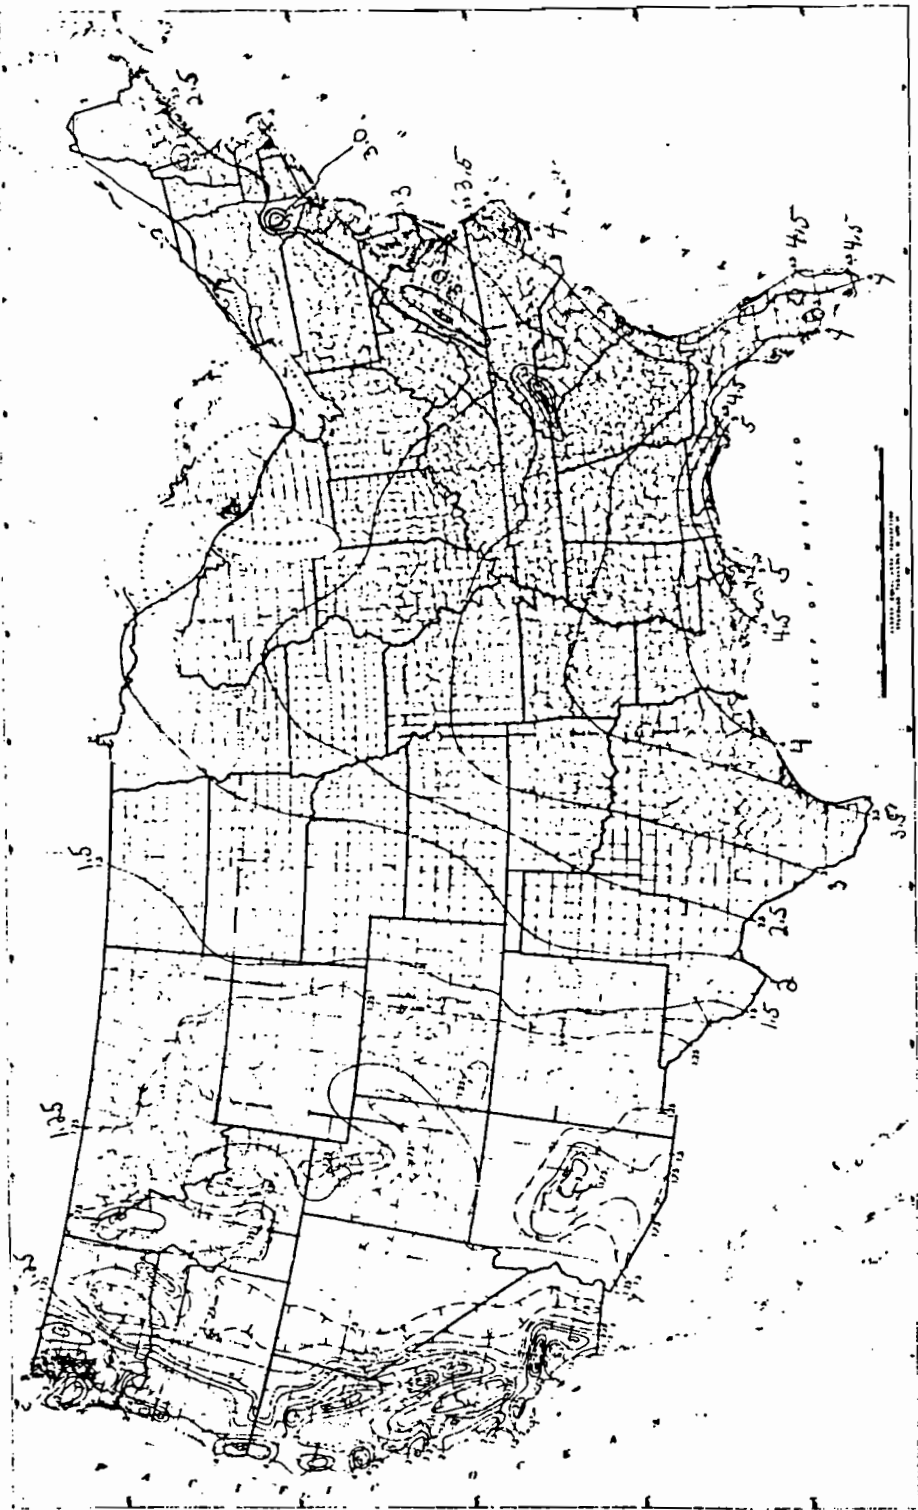
Figure 8
1-Year 24-Hour Rainfall (Inches)

Source: Rainfall Frequency Atlas of the United States, Technical Paper No. 40, U.S. Department of Commerce, U.S. Government Printing Office, Washington, D.C., 1963.
