ENGINEERING INVESTIGATIONS AT
INACTIVE HAZARDOUS WASTE SITES
IN THE STATE OF NEW YORK
PHASE I INVESTIGATION

Erwin Town Landfill
Village of Painted Post, Steuben County
NYSDEC I.D. No. 851003

August 1989

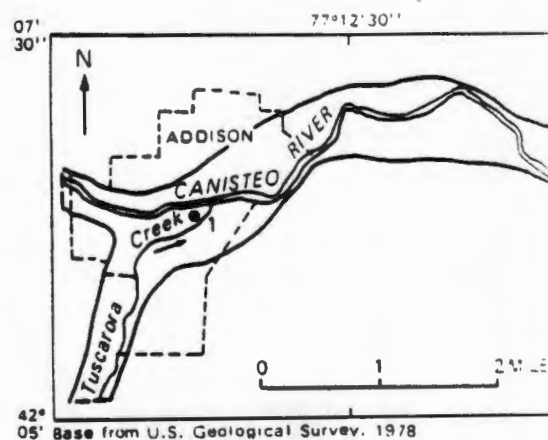
FIGURE 9A CORNING AREA
Location and major geographic features

Corning is the area's major industrial center. Several small communities are scattered along the main valleys. On the east, this aquifer is continuous with the aquifer of the Elmira-Horseheads-Big Flats area, discussed in chapter 7.

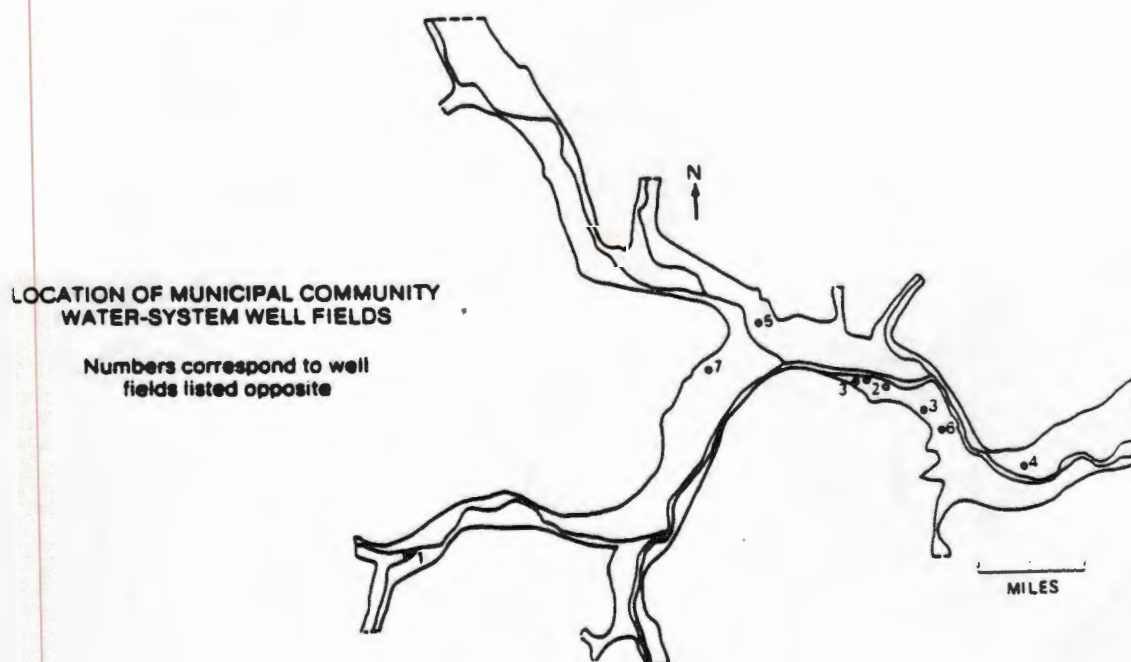
FIGURE 9B CORNING AREA
Population and Pumpage

The table opposite lists 1980 pumpage by the various water suppliers. Locations of municipal systems are shown on the map below and in figure 9A.

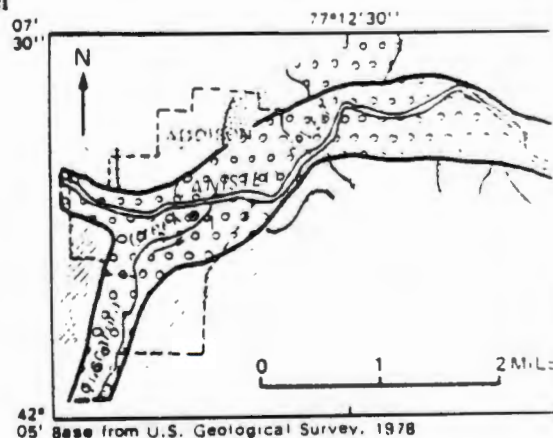
FIGURE 9C CORNING AREA
Geologic setting

The Corning area lies within the northern, glaciated part of the Allegheny Plateau. Bedrock consists of nearly flat-lying shale, siltstone, and sandstone. During periods of glacial advance, ice scoured the preglacial topography and widened and deepened the valleys, oversteepened hillside slopes, and rounded off hilltops. During glacial recession, the melting ice deposited drift within the valleys, partly filling them, and mantled bedrock hills with 5 to 25 feet of till. Figure 9C is a generalized surficial geology map of the Corning area.

The valleys now contain several kinds of drift. Kame terraces flank the west valley walls of Meads and Post Creeks, the north valley wall of Canisteo River, and the east valley wall of Tioga River. Lateral or end-moraine till covers the lower slopes of hillsides and is in places buried beneath or interbedded with lake deposits and surficial outwash. Layers of lacustrine sand, silt, and clay occur irregularly throughout the drift, and outwash sand and gravel form most of the valley flat. Since the retreat of ice, streams have reworked the sediments and deposited fine sand and silt 5 to 15 feet thick in low areas adjacent to streams and as alluvial fans of sand and gravel where upland streams meet the valley flat.

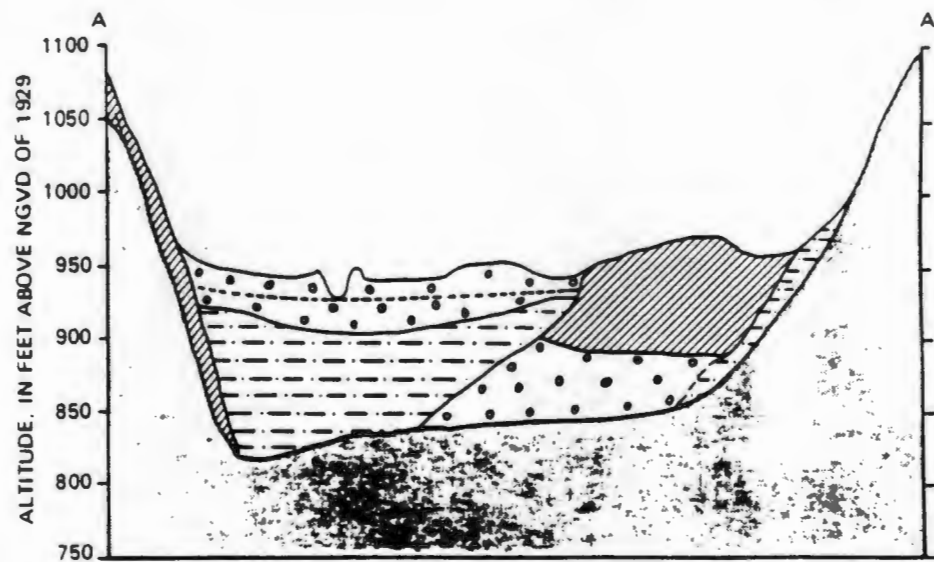
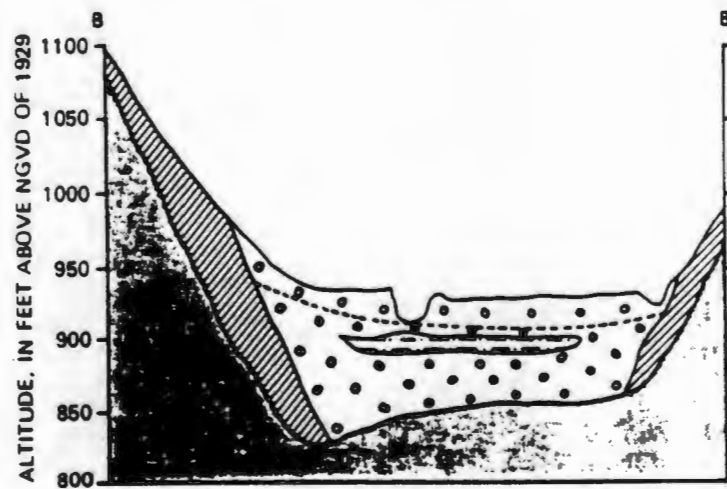
FIGURE 9D CORNING AREA
Geology

In the Corning-Painted Post-Gang Mills area, borings and well logs near the south wall of the valley penetrate mostly sand and gravel (70 to 90 feet thick), some of it silty and containing some till (MacNish, Randall, and Ku, 1969). In Painted Post is a thick section of lake beds along the west and north sides of the valleys, underlain by more gravel, possibly kames (sec. A-A', fig. 9D). Here depth to bedrock ranges from 63 to 90 feet.

In the southern part of the Corning-Painted Post area, borings and well logs penetrate a thick (85 to 95 feet) section of mostly sand and gravel. On the north side of Painted Post, a till deposit (probably a lateral moraine) on the inside bend of the valley overlies a buried sand and gravel aquifer 75 feet thick (sec. A-A', fig. 9D).

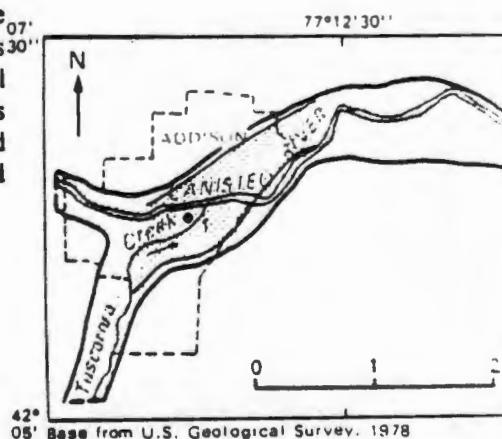
FIGURE 9E CORNING AREA
Aquifer thickness

In the Chemung River valley from South Corning to the Chemung-Steuben County border, lake silt and clay lenses^{07'} and till that are interbedded within the sand and gravel are included in the saturated thickness. In the Gang Mills and Erwin area, the Tioga valley contains a sand and gravel aquifer 40 to 100 feet thick that also has interlayered lake sediments and till.

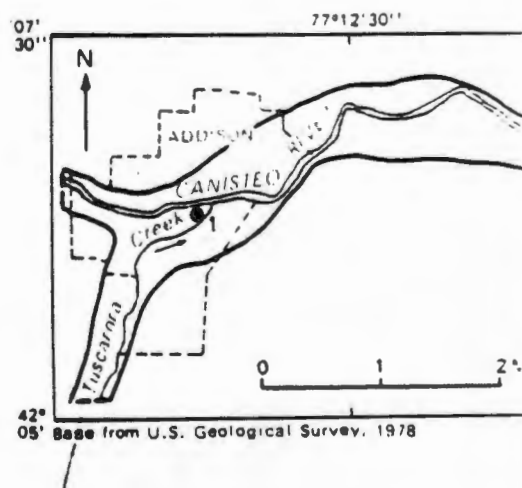
FIGURE 9F CORNING AREA
Ground-water movement

Ground water moves generally downvalley and discharges into the streams, except where tributary streams enter the main valley. At such intersections, ground water is recharged by the streams and forms fan-shaped ground-water mounds in which movement is generally transverse to the valley. Ground water also leaves the valley as underflow toward the Elmira area.

Recharge results from rainfall over most of the valley floor, from seepage along some stream reaches, from the underlying bedrock, and through streambanks during periods of high runoff. Where streambeds are above the ground-water level, stream water may recharge the aquifer; this is common where small streams draining uplands flow onto the permeable sand and gravel valley floor.

¹ The map was compiled from water-level measurements made by U.S. Geological Survey, well drillers, and engineering consultants from 1932-68; most measurements were made in the later 1950's and early 1960's.

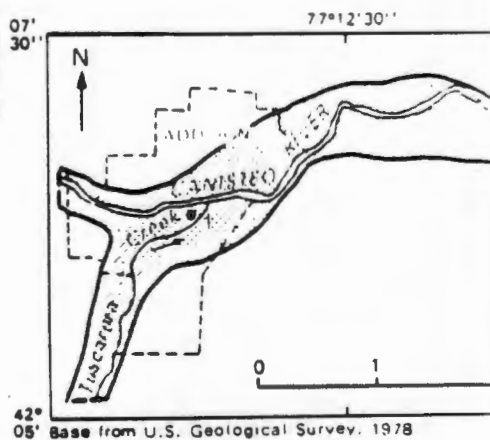
FIGURE 9G CORNING AREA
Well yields

Large water yields to wells (500 to more than 1,000 gal/min) are common where the saturated thickness of permeable sand and gravel exceeds 40 feet and also near streams, where water can be induced to move from the streambed into the aquifer toward the pumping well. Large yields can generally be obtained in most parts of the Cohocton and Chemung River valleys except in the reach between Coopers Plain and Painted Post, where the aquifer is thin. In Corning, large yields are available from the thick deposits (greater than 60 feet) of saturated permeable sand and gravel.

Little information is available on the Canisteo River valley, except that a municipal well in the Village of Addison is reported to yield 350 gal/min. No well-yield information was available on the Tioga River valley south of Erwin.
