**Final Site Characterization Report  
Band Box Cleaners  
Site Number 8-51-025  
Steuben County, New York**

**November 2006**

**NEW YORK STATE DEPARTMENT OF ENVIRONMENTAL CONSERVATION**  
625 Broadway  
Albany, New York 12233

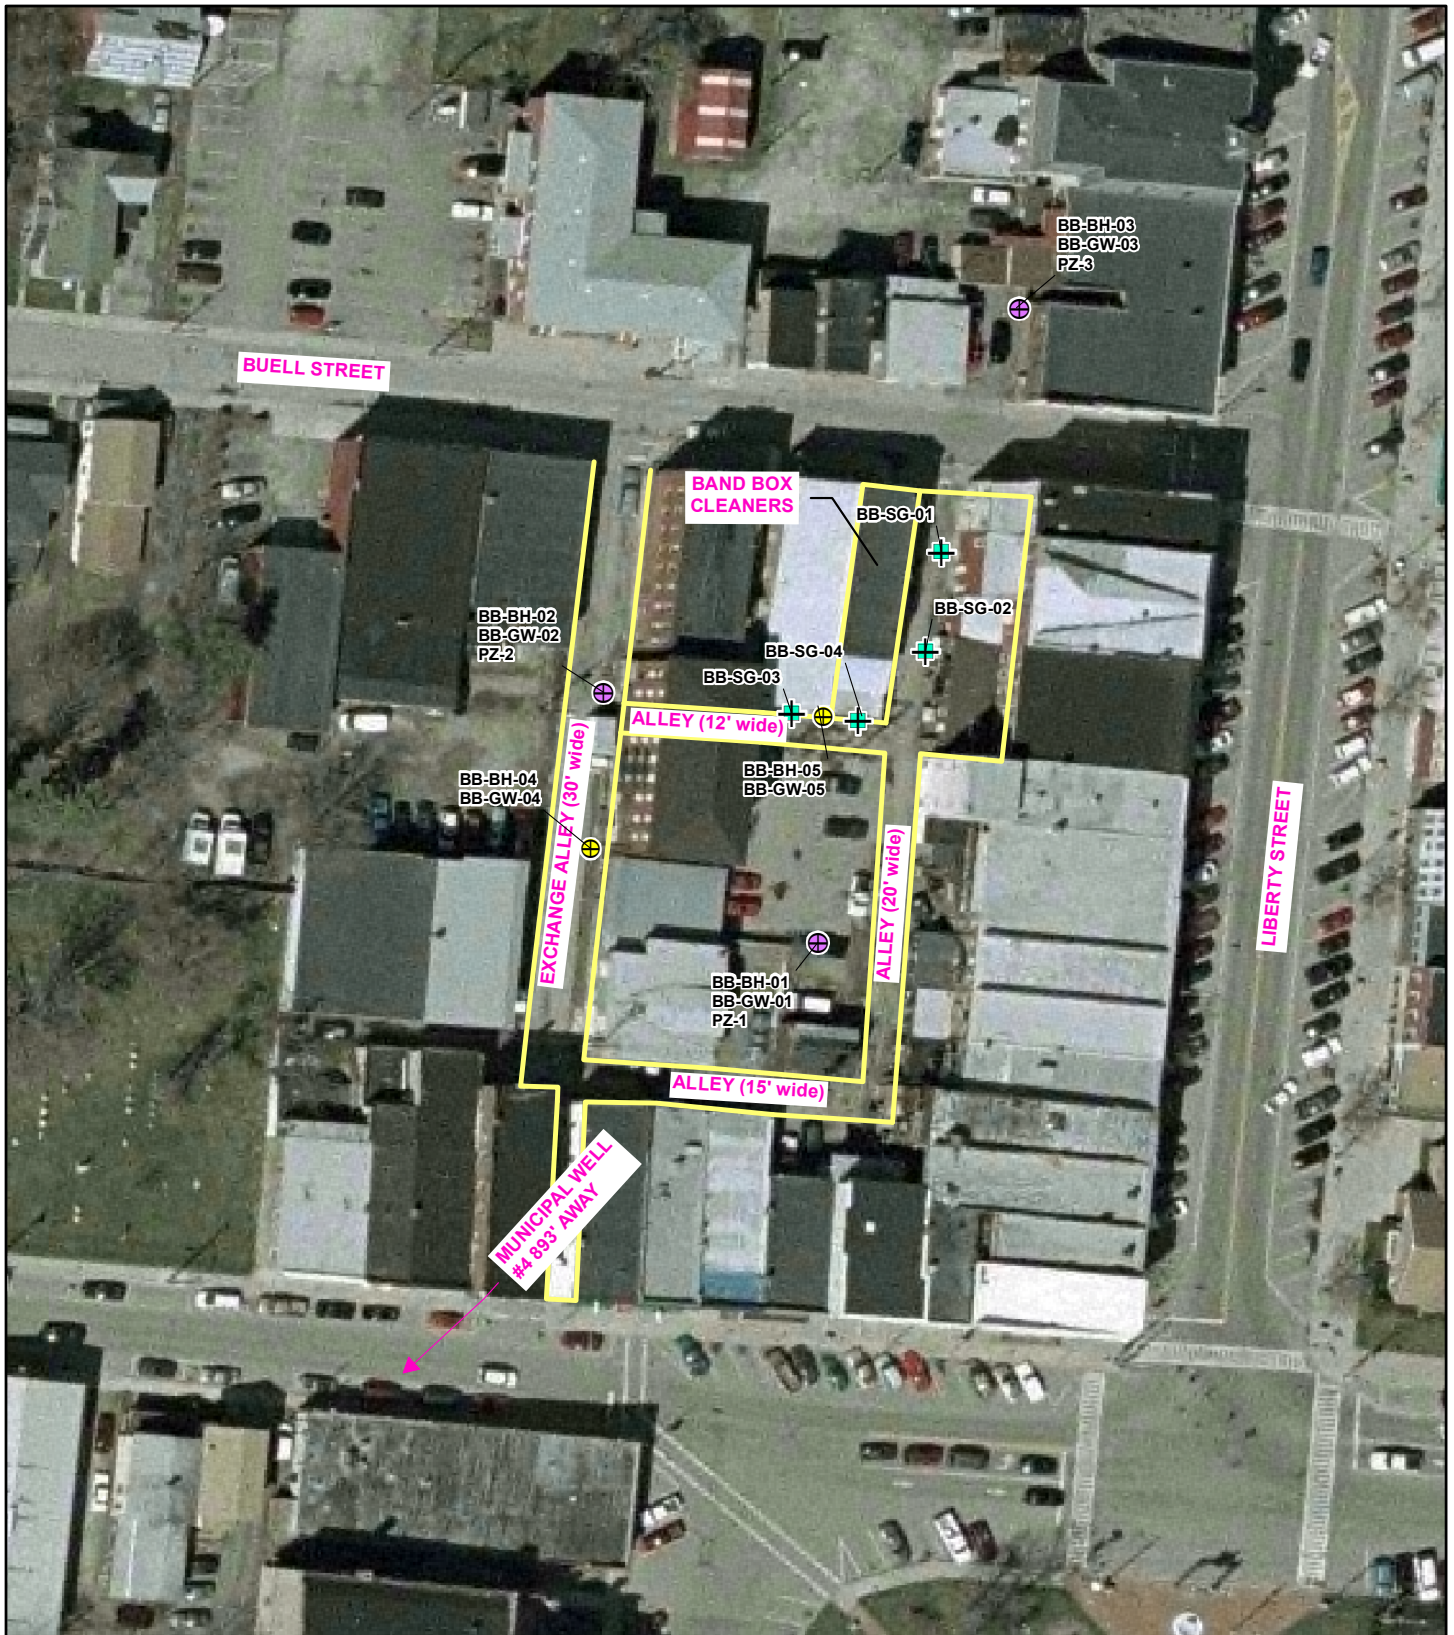
A total of five boreholes were drilled at the Band Box Cleaners site (see Figure 3-1). A copy of the boring logs is provided as Appendix A to this report. Borings were installed via DPT using Geoprobe Model 66DT driving a 5-foot macro-core sampler with dedicated acetate sleeves. Continuous soil cores were collected at each location from ground surface to depths ranging from 25 to 40 feet bgs. Borings at each location were completed to a depth of 40 feet bgs. Groundwater was generally encountered between 13 and 15 feet bgs.

Four soil gas samples (see Table 3-1) were collected (at the locations shown on Figure 3-1) with a Geoprobe rig using the post-run tubing (PRT) system. The PRT system consisted of using a Geoprobe to drive a clean drive-point adaptor and new expendable point approximately 8 feet bgs (or 2 feet above the water table, whichever was shallower) and pulling the rods back 6 inches to create a void, allowing soil gas to migrate into the bottom of the drive-point adaptor. A clean, dedicated, and unused piece of 0.25-inch ID food-grade polyethylene tubing was attached to the stainless-steel adaptor. The tubing was inserted into the probe rod and extended to the bottom of the rod. Using a counter-clockwise circular motion, the tubing was threaded to the drive-point adaptor and tightened to compress the “O-ring” seal. To ensure the integrity of the connections, a vacuum check was performed on the system prior to purging and collecting a sample. After connecting the tubing to the down-hole drive-point adaptor, the line was purged by drawing a measured volume (at least one tubing volume) of soil gas/vapor through the tubing using the vacuum system mounted on the Geoprobe unit. A tubing pinch valve was used to seal the end of the tube while the connection to the sample canister was made.

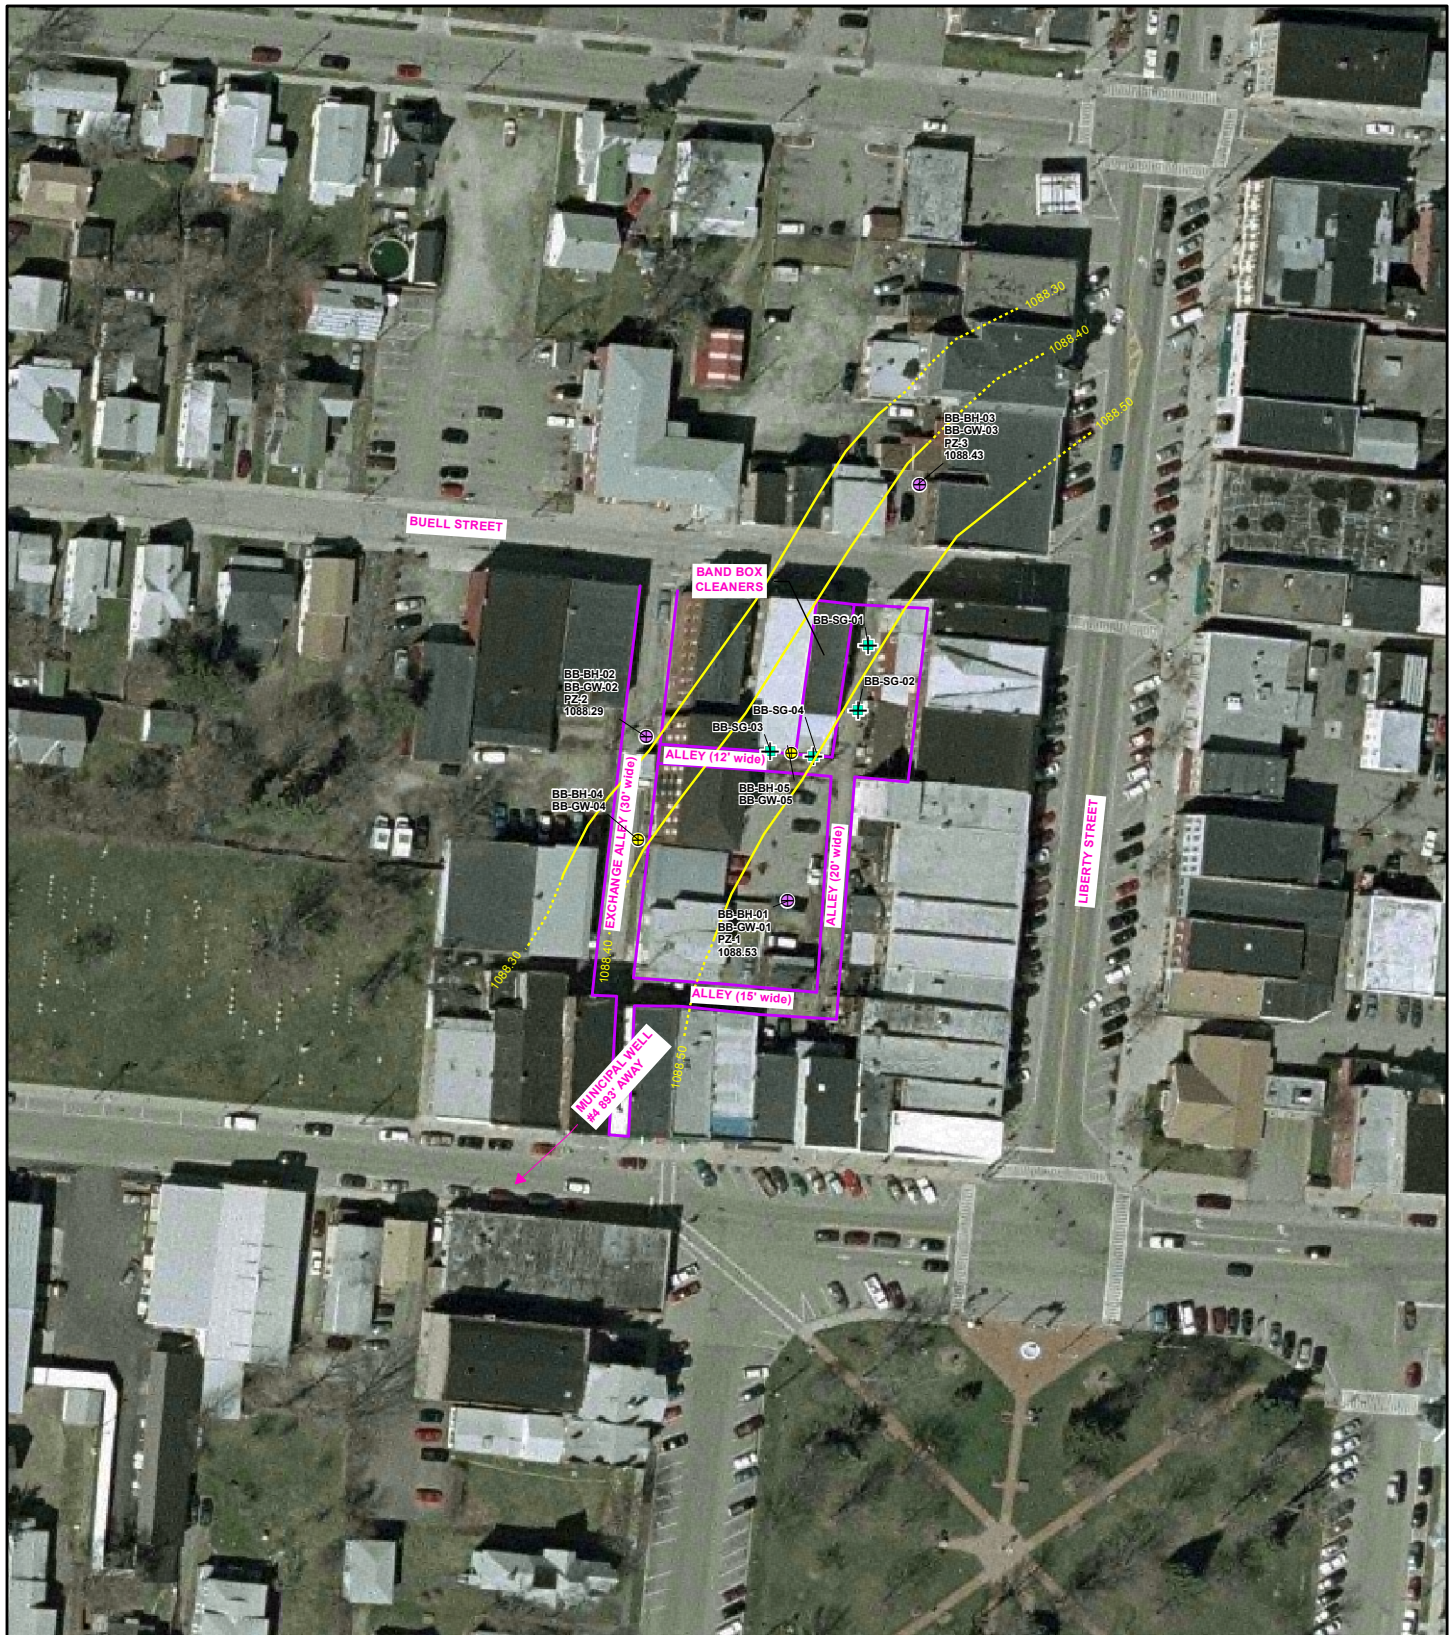
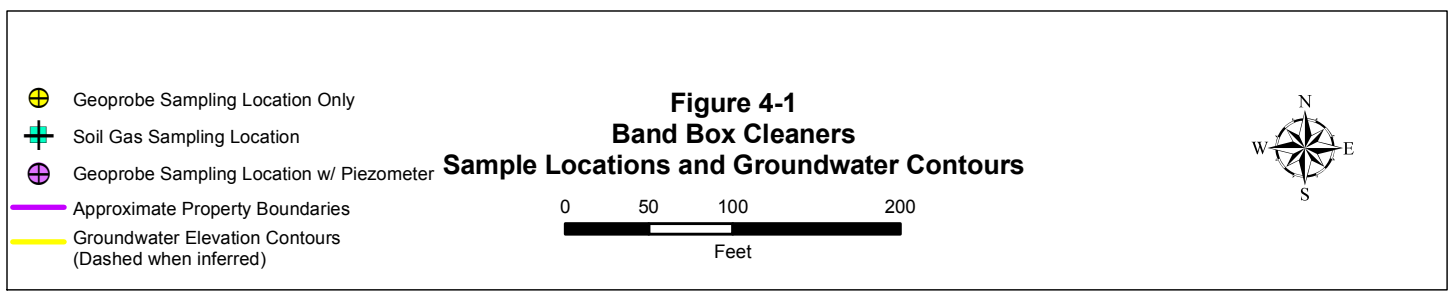
Although groundwater samples collected from the Band Box Cleaners site did not contain detectable concentrations of TCE, trace concentrations (< 5 ppb) of contaminants typically associated with petroleum products were detected in groundwater collected from BB-GW-01, BB-GW-03, BB-GW-4, and BB-GW-05 (see Table 4-1b). Only groundwater collected from BB-GW-05 exhibited an exceedance of NYSDEC screening criteria (see Table 4-1b). Groundwater collected from BB-GW-05 (40 ft bgs) contained benzene at 1.2 ppb, which exceeded the NYSDEC screening criteria of 1 ppb for the compound, but the 1.2 ppb value flagged J+, estimated with a positive bias. BB-GW-05 is adjacent to the southern wall of the Band Box Cleaners building (see Figure 4-1).

Groundwater levels were measured in the three installed piezometers and existing well MW-1, as noted on Figure 4-1. Groundwater flow at the site is toward the northwest at a horizontal gradient of 0.003 feet per foot. Regional groundwater flow is probably toward the Cohocton River, which is toward the south-southwest. The low magnitude of the groundwater gradient indicates that localized variation in groundwater flow direction would be easily affected. Factors that could influence the localized direction of groundwater flow include buildings, building foundations, and pavement. These man-made structures could have a large impact on local infiltration rates and flow directions.

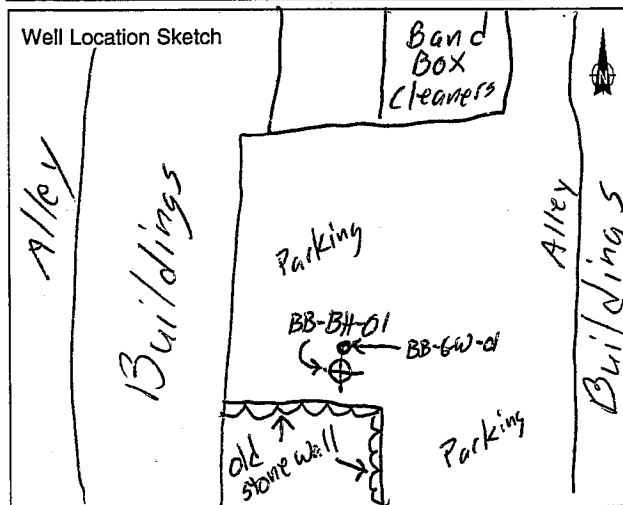
**PZ-1** Lock Number NA

Depth (Feet)	Sample Number	Blows on Sampler	Soil Components Rock Profile CL SL S GR	Penetration Times	Run Number	Core Recovery	RQD	Fracture Sketch	PID HNU/OVA (ppm)	Comments
1				1143						
2					1	1.5'			Oppm	
3										
4				1145						
5				1147						
6										
7					2	2.3'			Oppm	
8										
9										
10				1148						
11				1134						
12										
13					3	3.3'			Oppm	
14										
15				1156

Depth-ft.	NARRATIVE LITHOLOGIC DESCRIPTION	Moisture Content		
		Dry	Moist	Wet
1	0'-0.9, Blacktop & Gravel base (Dry)	⊗	○	○
2	0.9'-1.5' Med. brown/Gray Angular to Rounded gravel with some silt & sand, trace clay. (moist to wet)	○	⊗	⊗
3		○	○	○
4		○	○	○
5	5'-7.3', Broken Coarse Gravel & sm. Cobbles with few silt & VF-Coarse sand.	⊗	⊗	○
6		⊗	⊗	○
7		○	⊗	○
8		○	⊗	○
9		○	⊗	○
10		○	⊗	○
11	10'-13.3' Dry Fine to Coarse gravel (rounded) with little (25%) silt and VF-C sand	⊗	○	○
12		⊗	○	○
13		⊗	○	○
14		⊗	○	○
15		⊗	○	○

Depth(feet).	NARRATIVE LITHOLOGIC DESCRIPTION	Moisture Content		
		Dry	Moist	Wet
16	15'-17.9' Gravel as above, Water @ 15.9' <sup>BGS</sup>	<input type="radio"/>	<input checked="" type="radio"/>	<input type="radio"/>
17		<input type="radio"/>	<input type="radio"/>	<input checked="" type="radio"/>
18		<input type="radio"/>	<input type="radio"/>	<input checked="" type="radio"/>
19		<input type="radio"/>	<input type="radio"/>	<input checked="" type="radio"/>
20		<input type="radio"/>	<input type="radio"/>	<input checked="" type="radio"/>
21	20'-24.1' Gravel as above	<input type="radio"/>	<input type="radio"/>	<input checked="" type="radio"/>
22		<input type="radio"/>	<input type="radio"/>	<input checked="" type="radio"/>
23		<input type="radio"/>	<input type="radio"/>	<input checked="" type="radio"/>
24		<input type="radio"/>	<input type="radio"/>	<input checked="" type="radio"/>
25		<input type="radio"/>	<input type="radio"/>	<input checked="" type="radio"/>

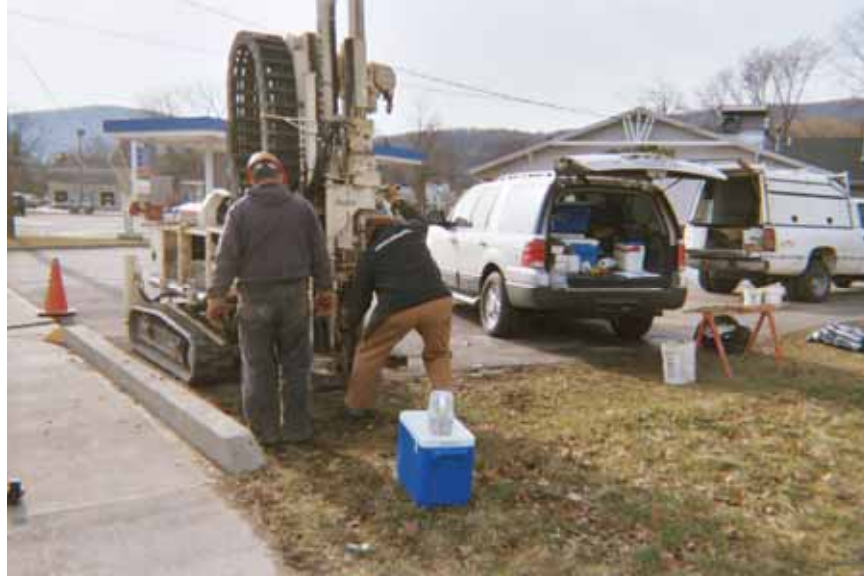
Date: 1/26/06	Subject: Direct-Push activities at the Former Depot Street Dry Cleaner Site boring DS-BH-02
Photographer: Stephanie Reynolds Smith

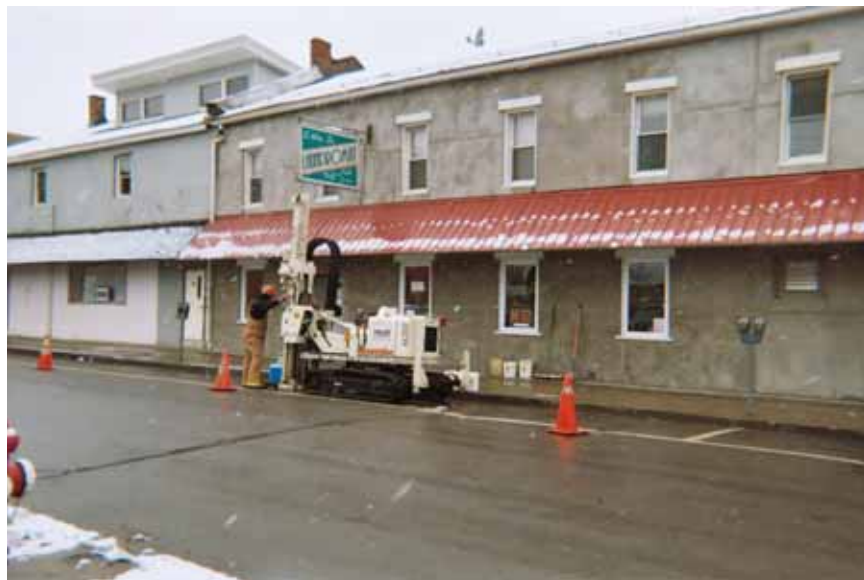
Date: 1/23/06	Subject: Direct-Push activities at the Former Liberty Street Dry Cleaners Site boring LS-BH-06
Photographer: Robert Meyers

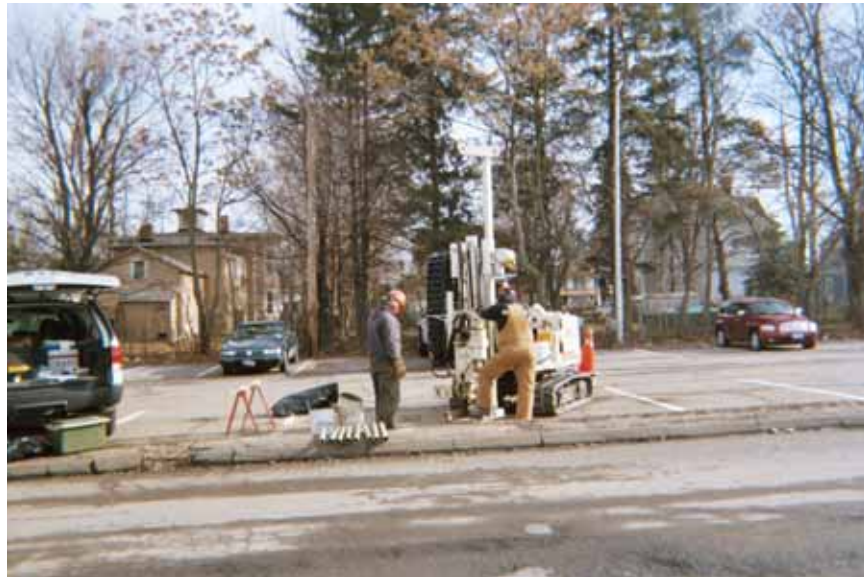
Date: 1/23/06	Subject: Direct-Push activities at the Former Liberty Street Dry Cleaners Site boring LS-BH-01
Photographer: Robert Meyers

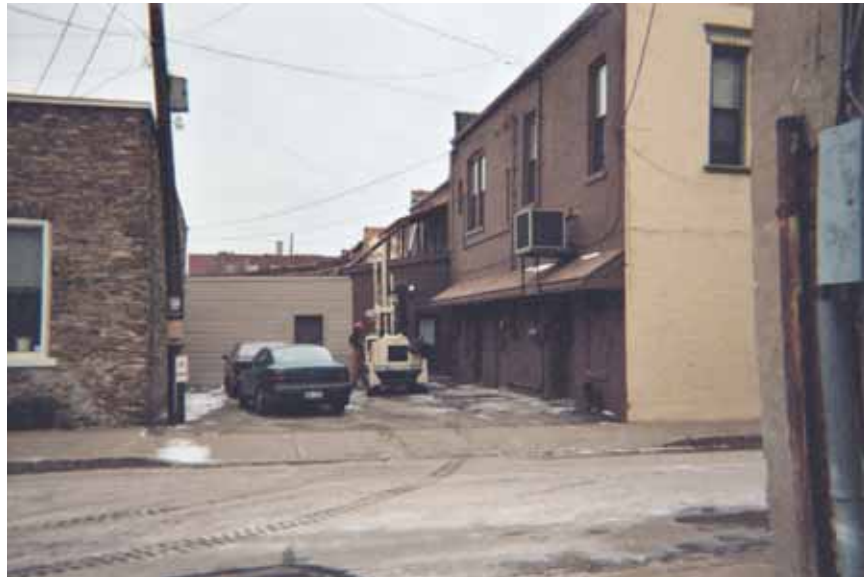
Date: 1/17/06	Subject: Direct-Push activities at the Band Box Cleaners Site boring BB-BH-03
Photographer: Jim Mays

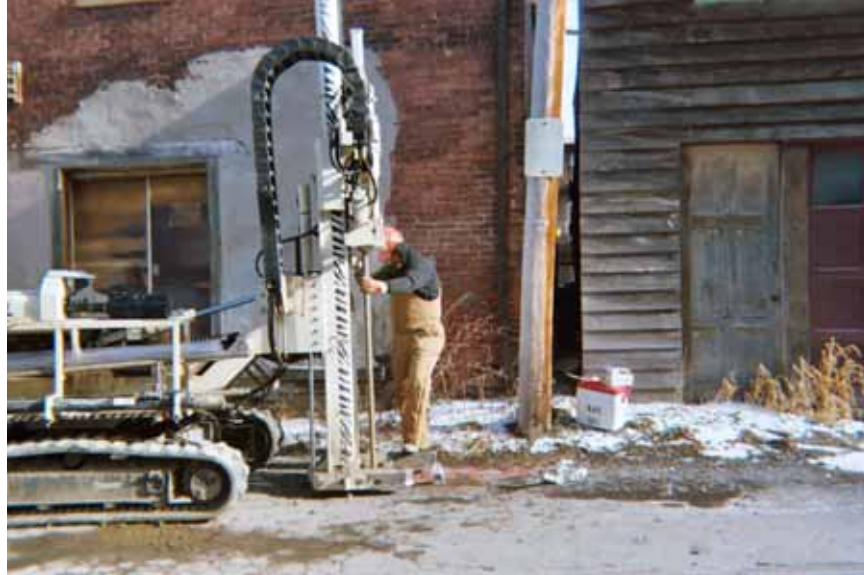
Date: 1/16/06	Subject: Direct-Push activities at the Band Box Cleaners
Photographer: Jim Mays	Site boring BB-BH-04

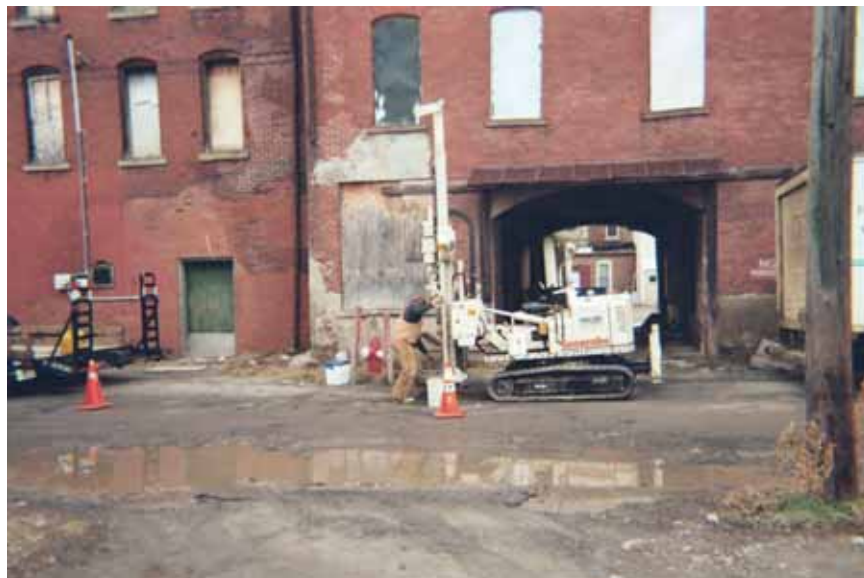
Date: 1/13/06	Subject: Direct-Push activities at the Band Box Cleaners
Photographer: Jim Mays	Site boring BB-BH-02

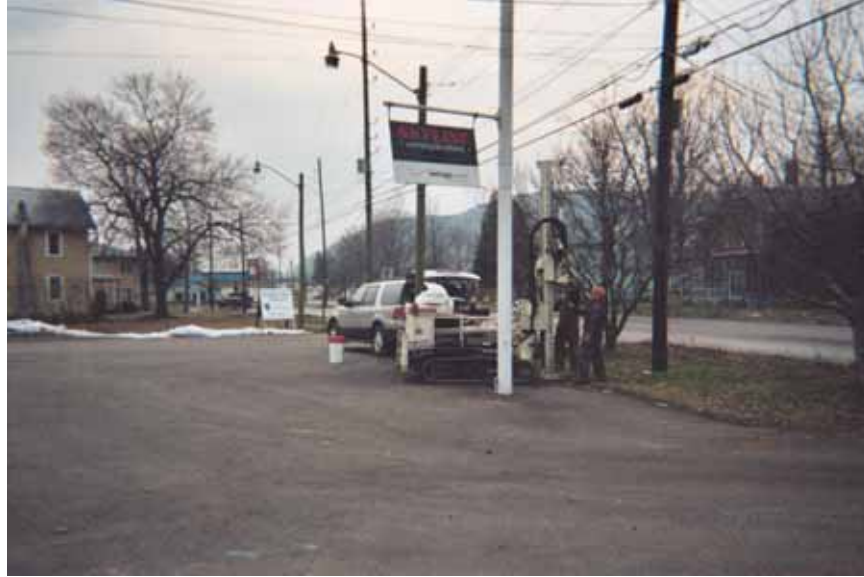
Date: 1/11/06	Subject: Direct-Push activities at the Former Loohns Cleaners Site boring FL-BH-03
Photographer: Jim Mays

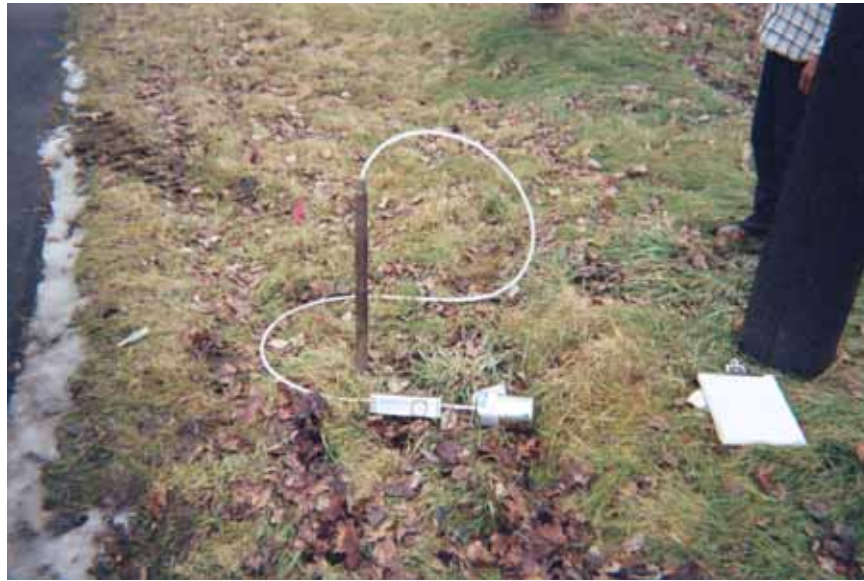
Date: 1/4/06	Subject: Typical soil gas sample collection set-up
Photographer: Stephanie Reynolds Smith
