**Loohns Corning Site  
Steuben County  
Corning, New York**

**SITE MANAGEMENT PLAN**

**NYSDEC Site Number: 851028**

**SEPTEMBER 2017**

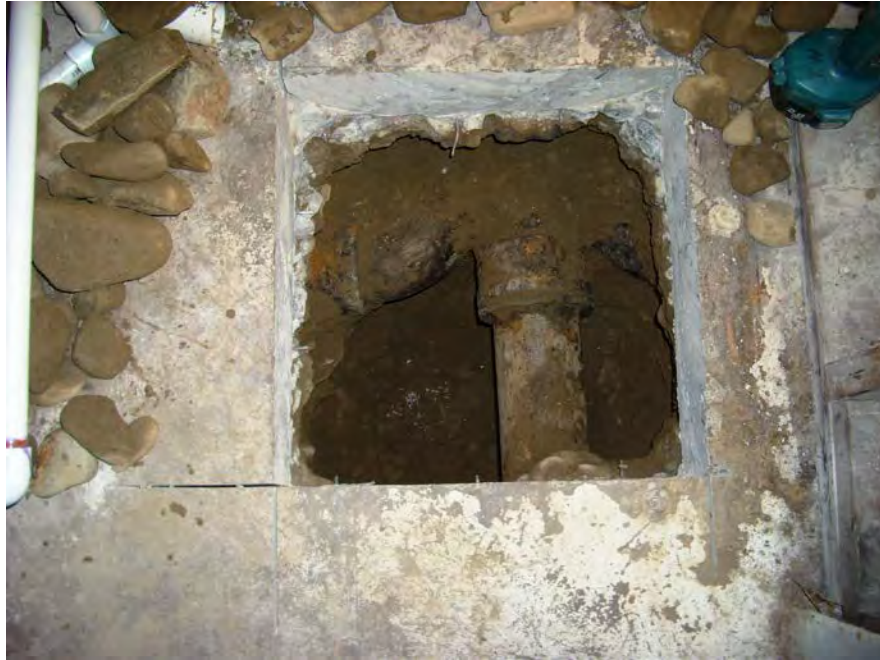
SVE Floor Cut Opening

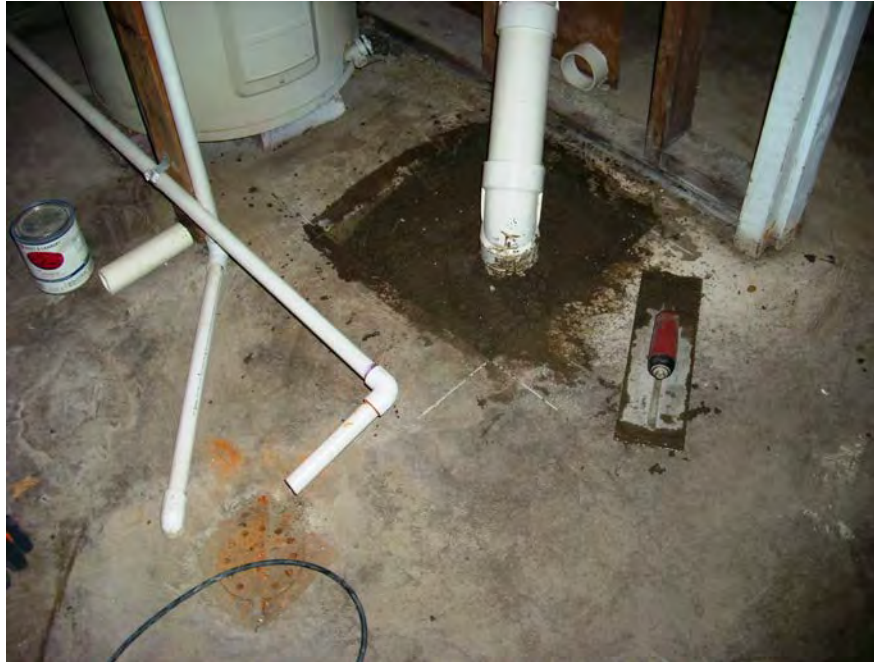
### SVE Riser with Grout Seal

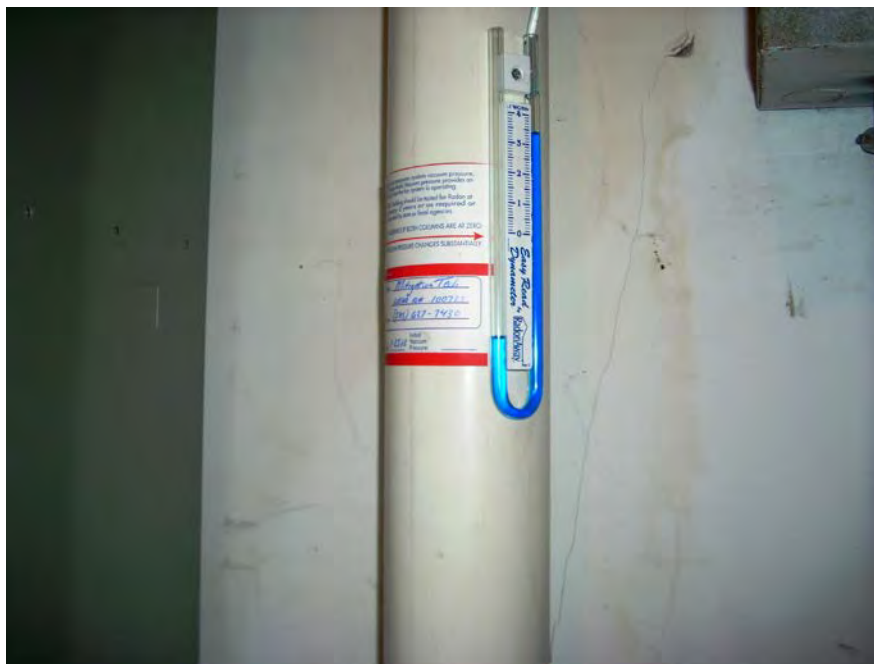
### Installed Manometer

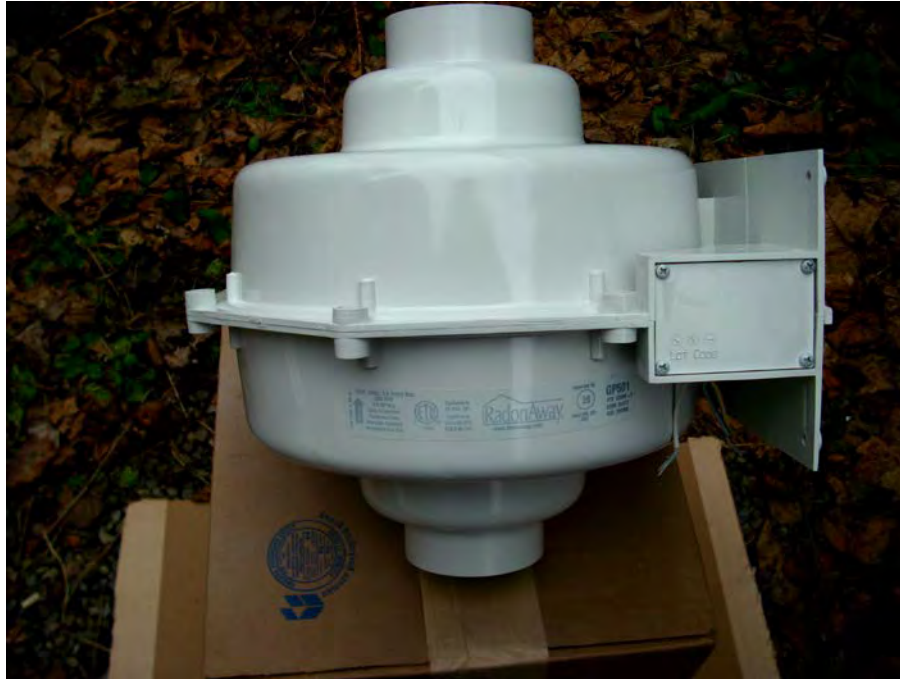
Radonaway GP501 Fan

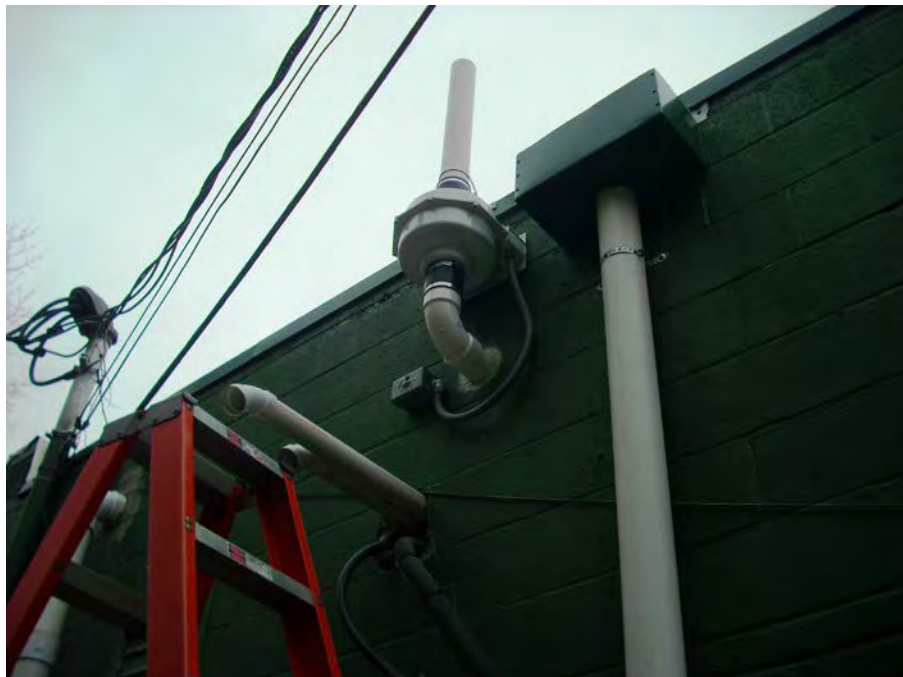
Installed Fan Exterior

2. Leave fan in continuous operation, except for emergency conditions. Fans restart automatically in event of power loss.
3. The fan has an on/off switch mounted near the fan on the exterior of the building. In the event of unusual fan noise, failure to start, or repeated circuit breaker trip, turn fan off and call a certified technician for service.

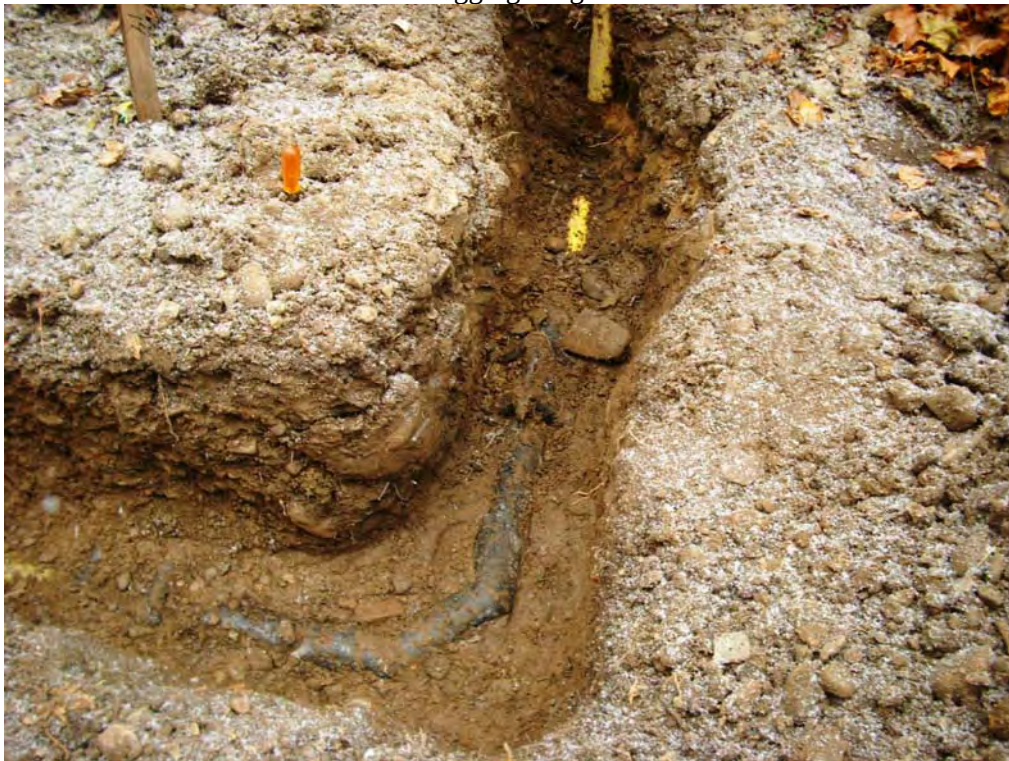
2" gas line

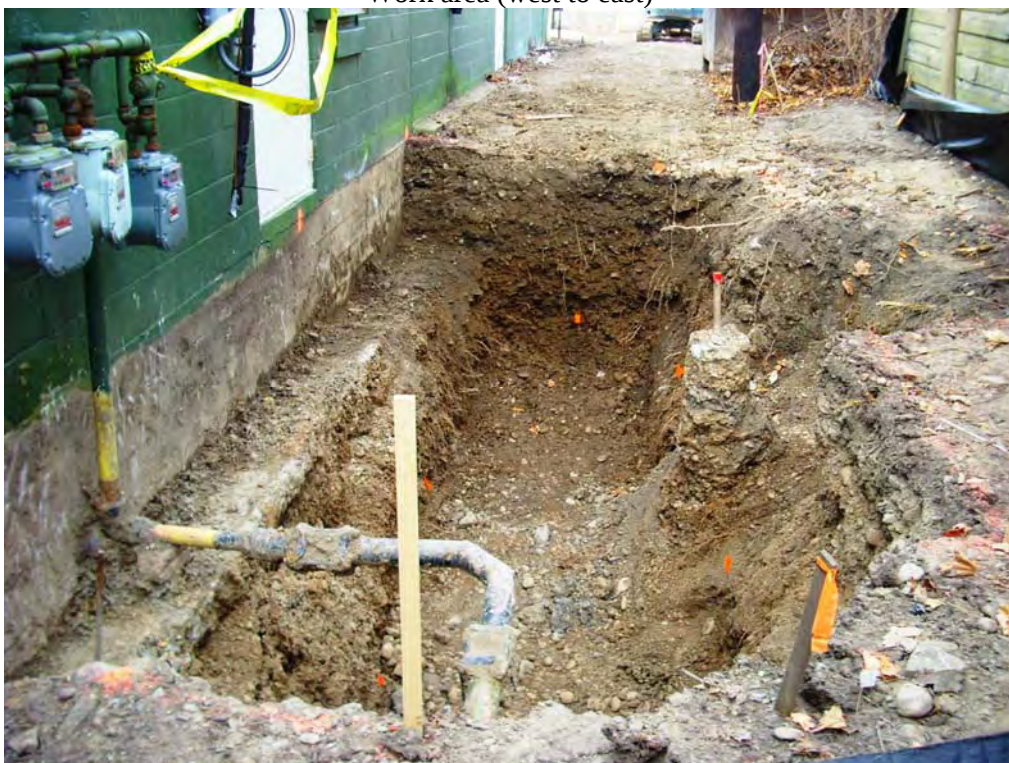
Exposed Gas line and view of west end of excavation

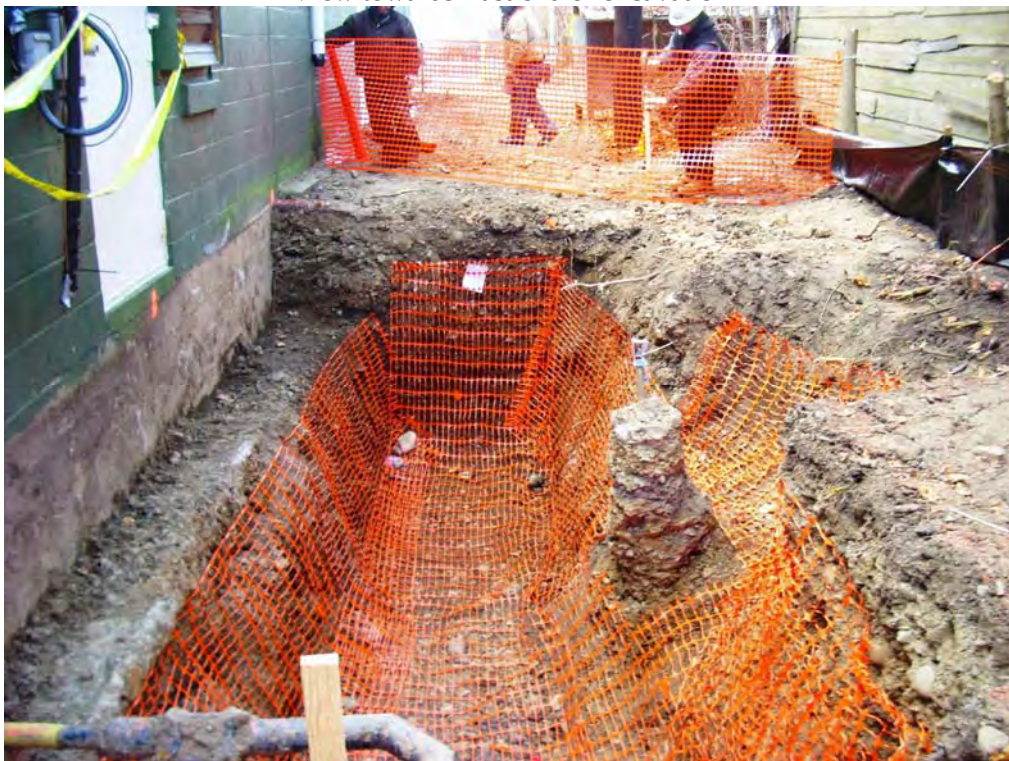
Demarcation layer (view to west)

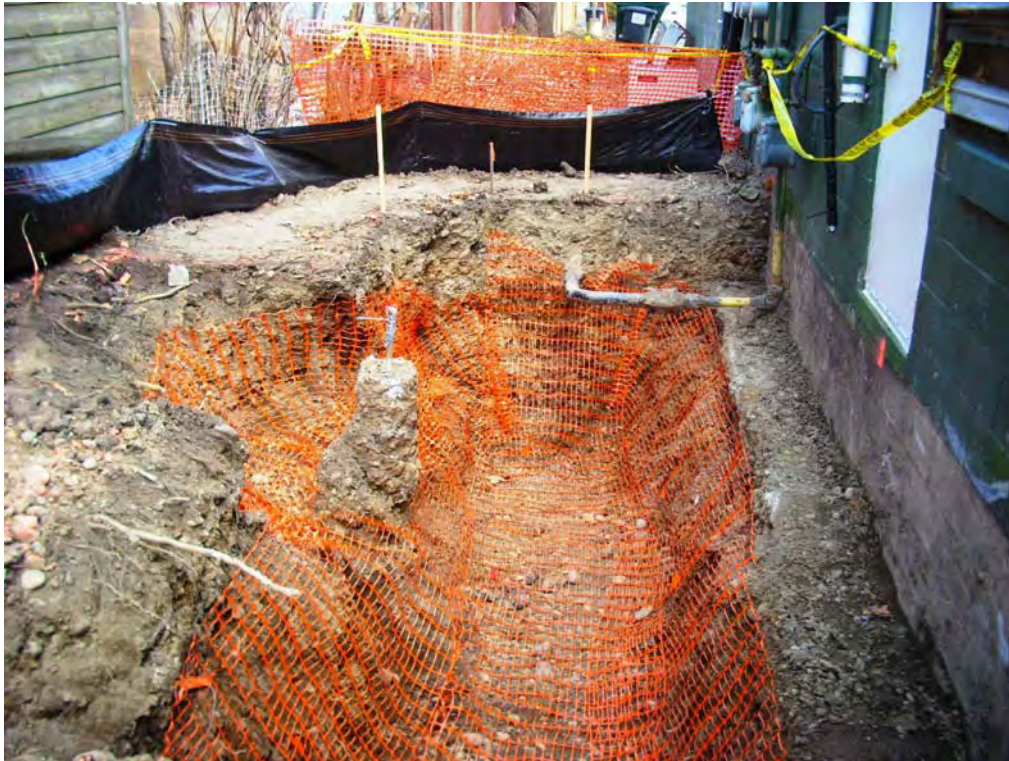
Demarcation layer (view to east)

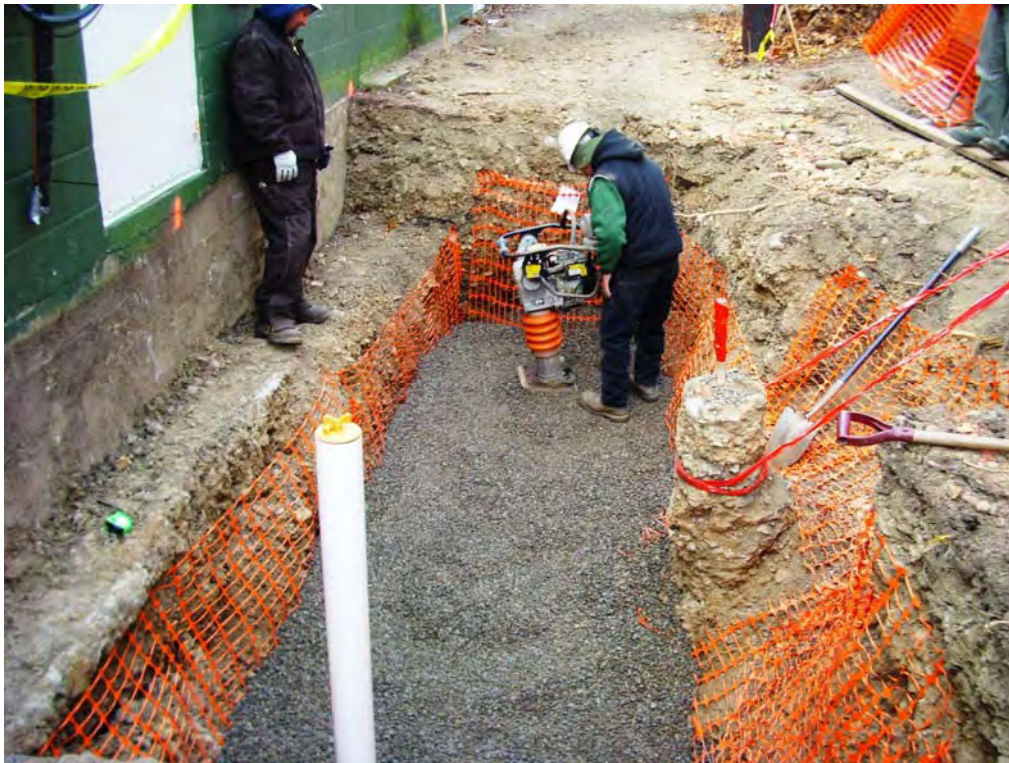
Stone compaction

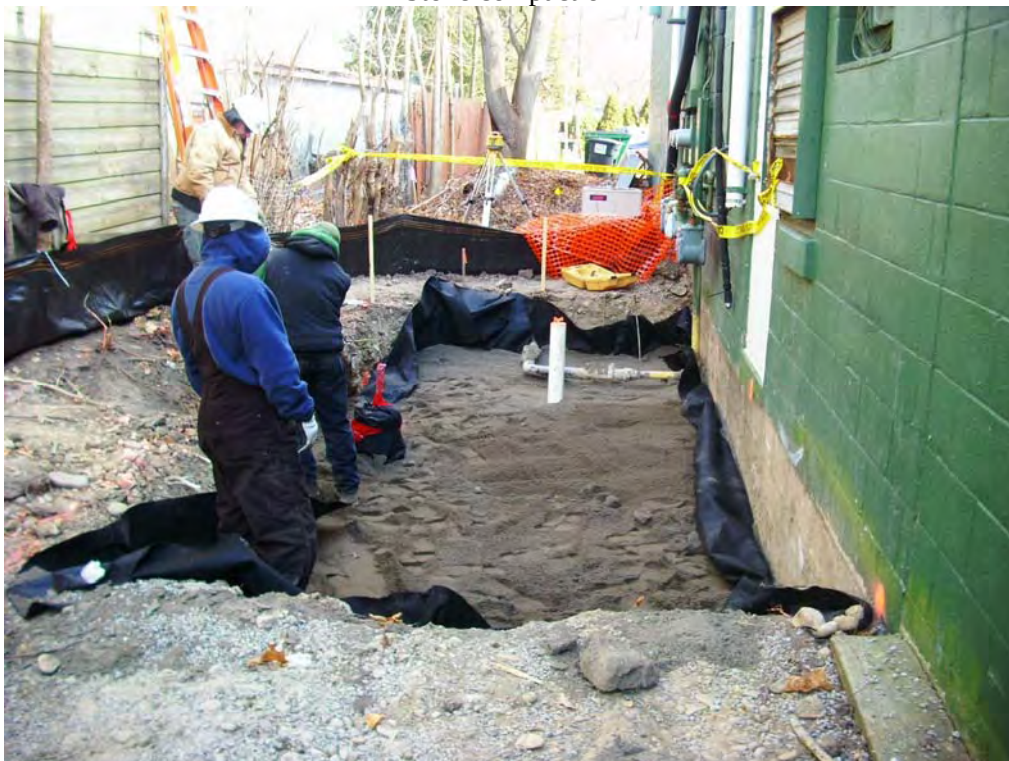
Sand installation (sand layer placed on geotextile)

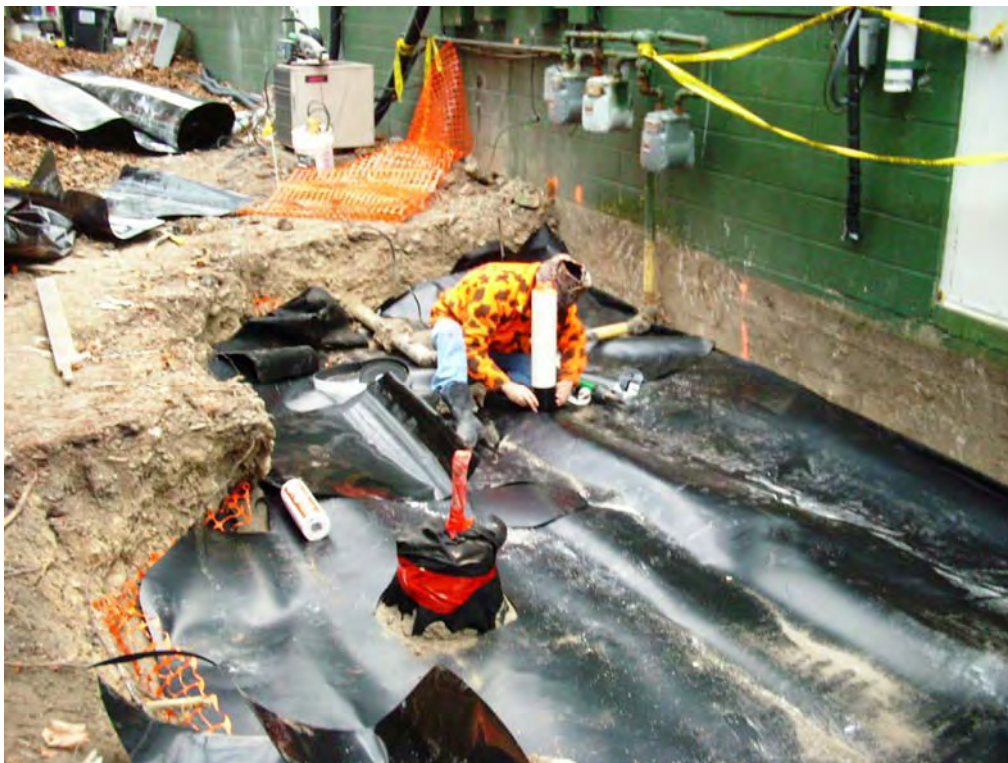
Liner installation (1)

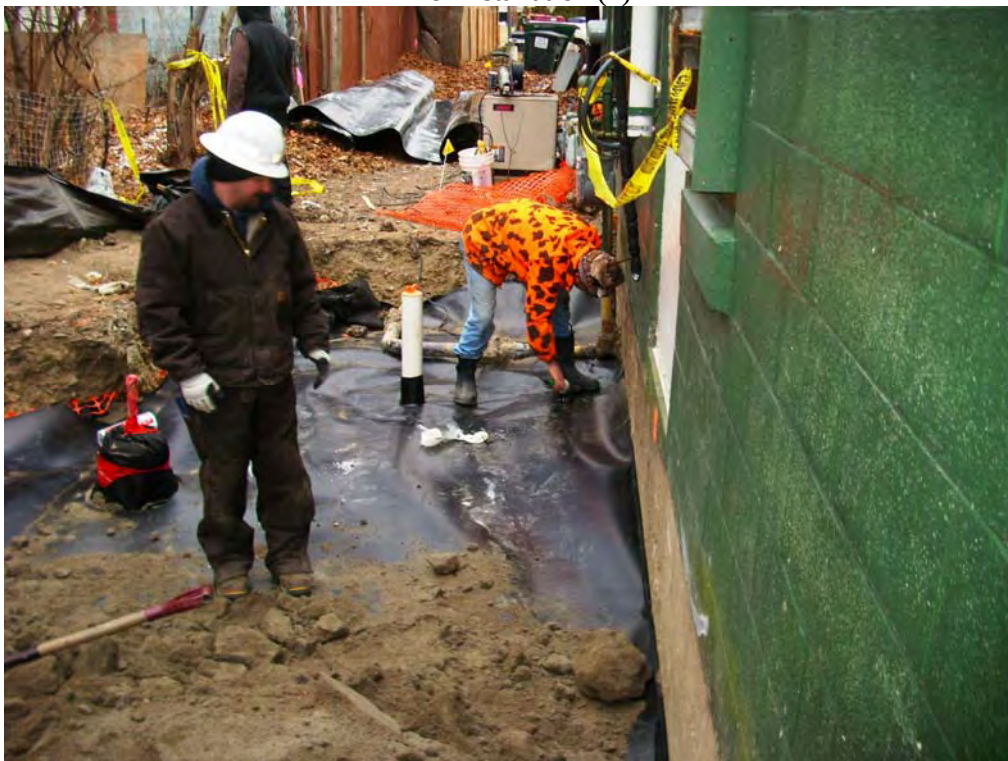
Liner installation (2)

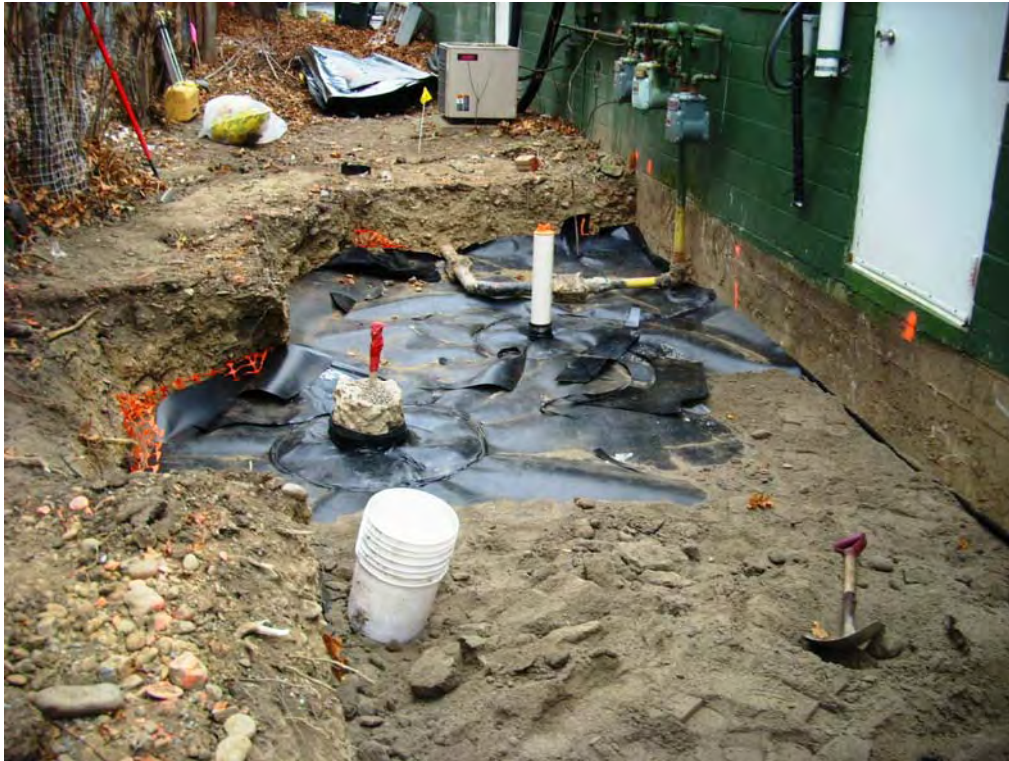
Liner installation (3)

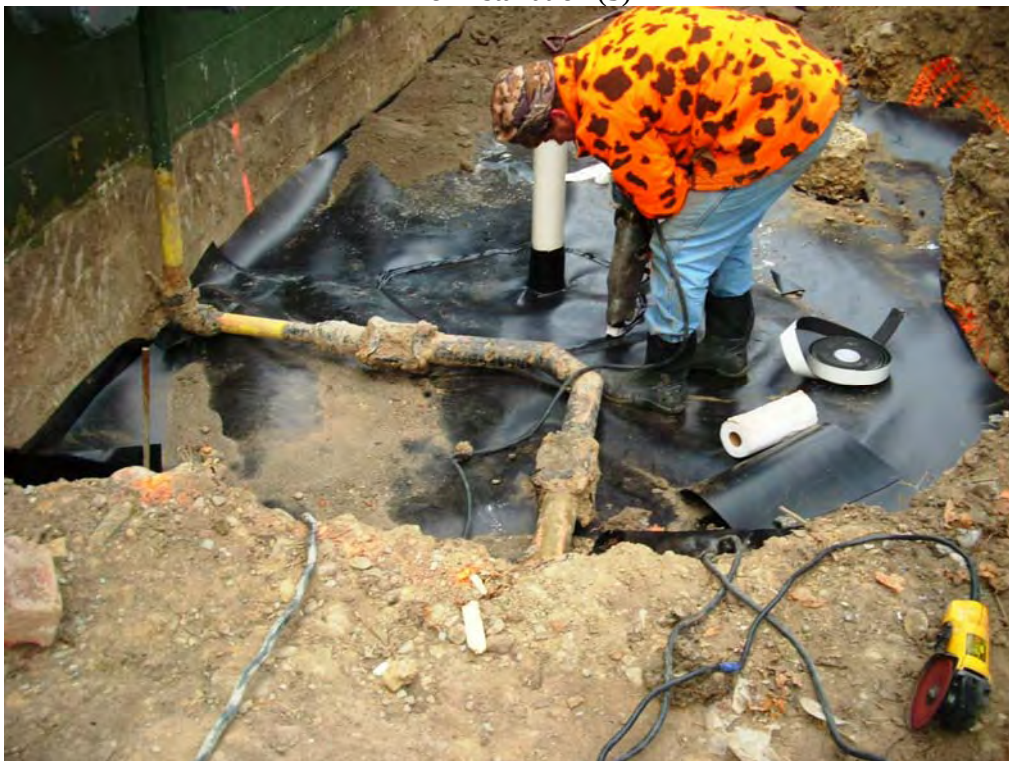
Welding seam around vapor well

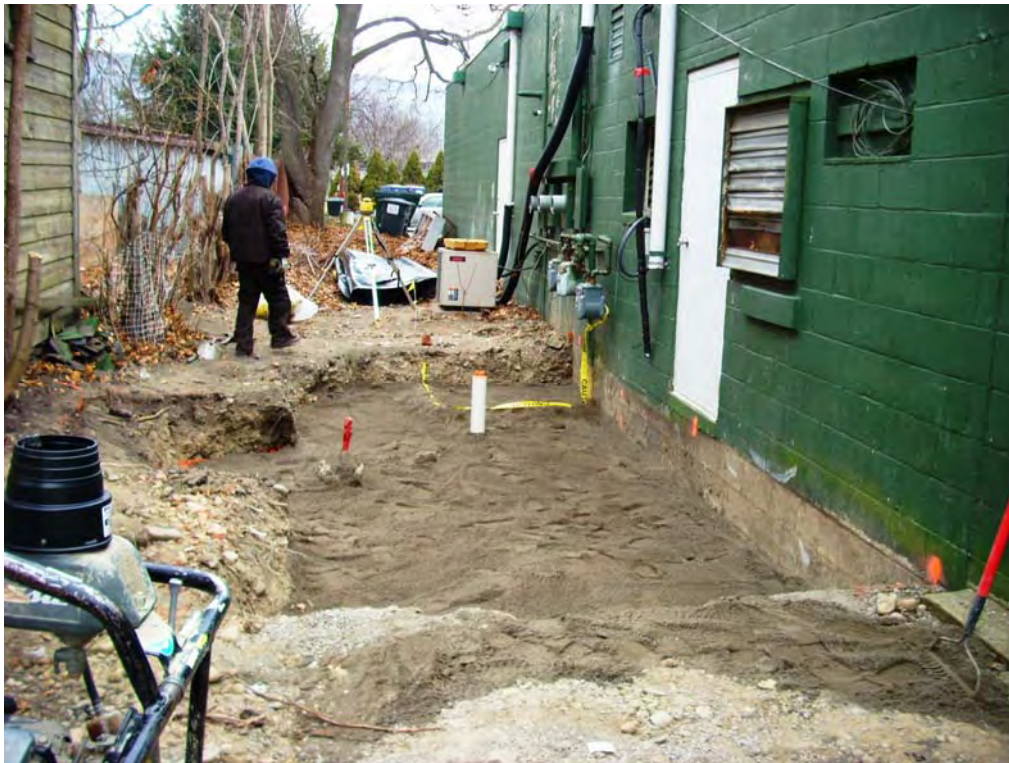
Top sand layer placed on liner

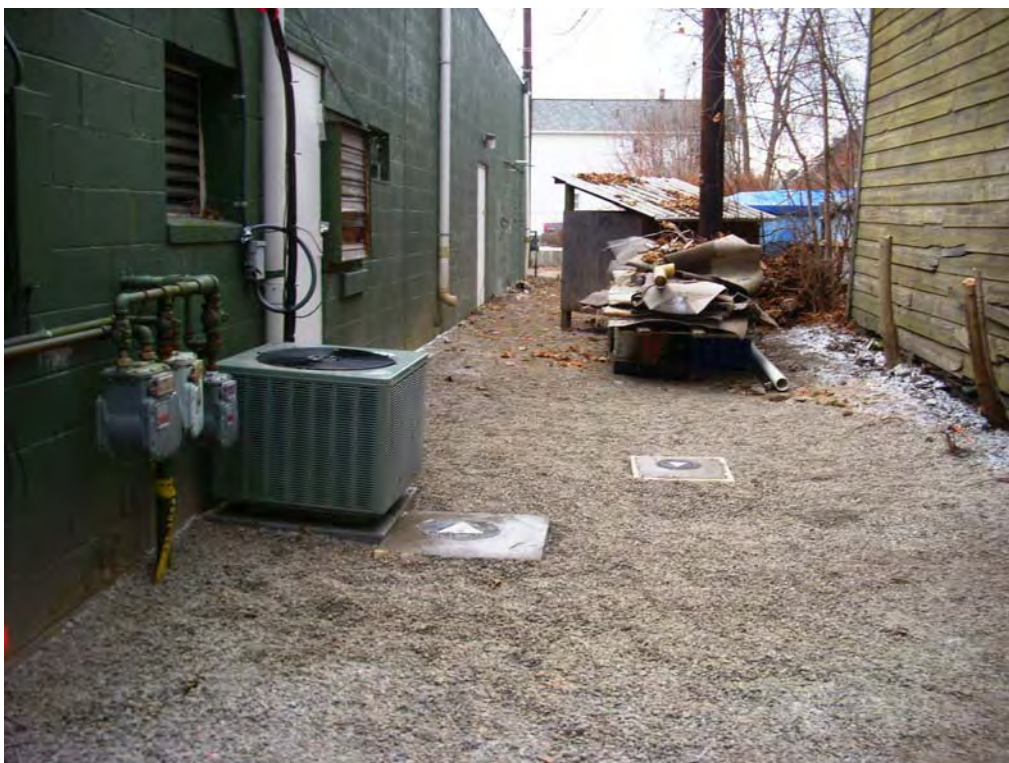
Final grade stone (before trash removal)

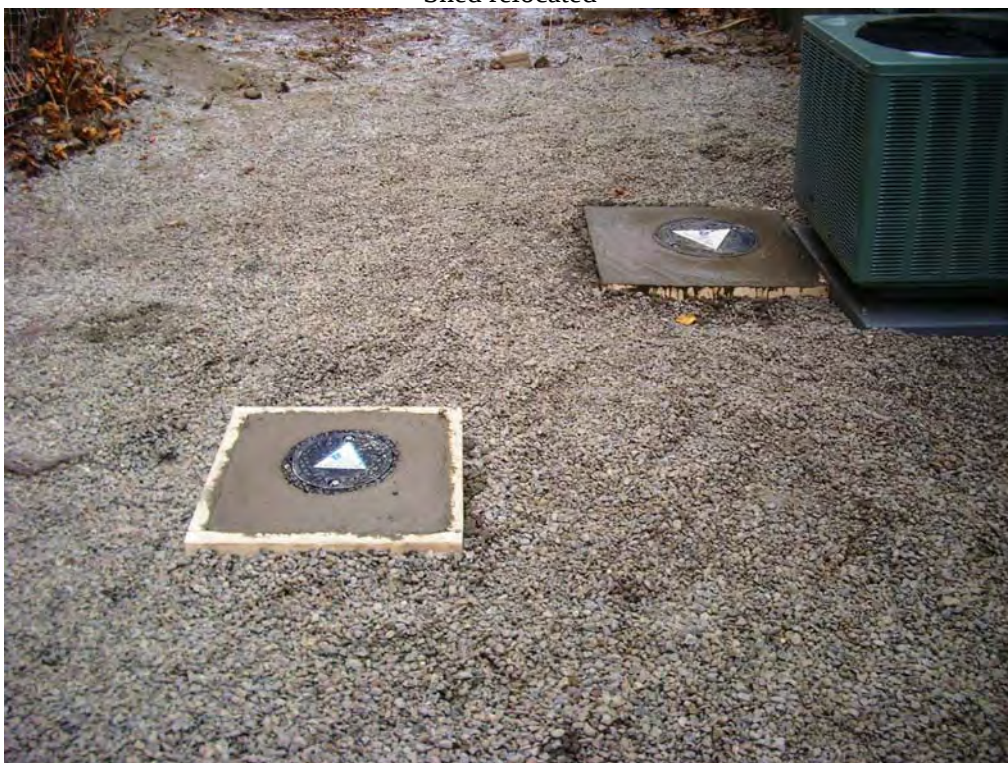
Road boxes (forms still present)
