Reference: EPA Contract No. 68-01-7038; Work Assignment No. R02-01-64;
Corning Glass Works, Main Plant; EPA I.D. No. NYD004971503;
CAPT LOIS Inspection

FINAL REPORT
CORRECTIVE ACTION PRIOR TO LOSS OF
INTERIM STATUS INSPECTION
CORNING GLASS WORKS, MAIN PLANT
CORNING, NEW YORK
EPA I.D. No. NYD004971503

TABLE OF CONTENTS
CORNING GLASS WORKS
CORNING, NEW YORK

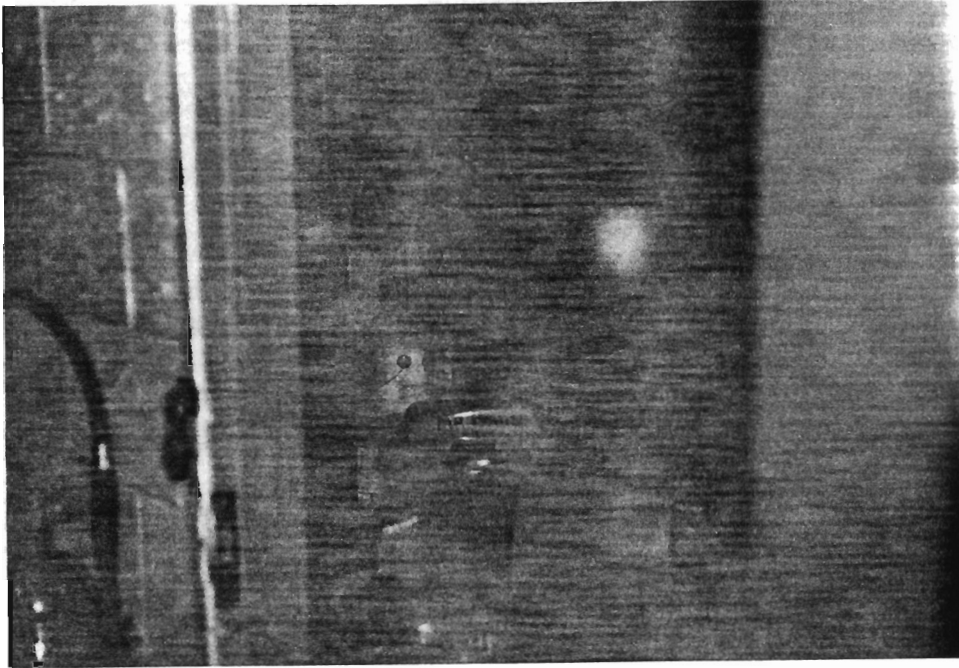
The Waste Oil Accumulation Drum is used to store non-hazardous waste oils and the Solvent Accumulation Drum is used to store spent solvents (D001).

During the inspection, facility personnel stated that no spills have occurred in either of these areas to the best of their knowledge. No evidence of release was observed during the inspection.

Photograph 1. View of the Solvent Accumulation Drum (SWMU 3). The unit is located in a flammable storage room and therefore the camera flash could not be operated in the room.

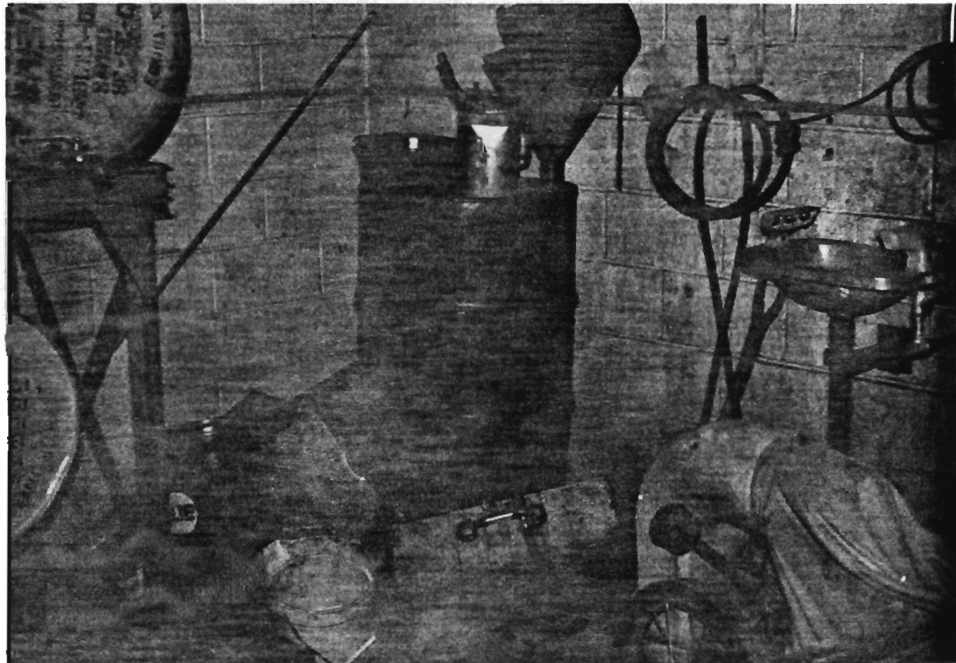
Photograph 2. View of the Solvent Accumulation Drum (SWMU 3) located in the Trade Shop.

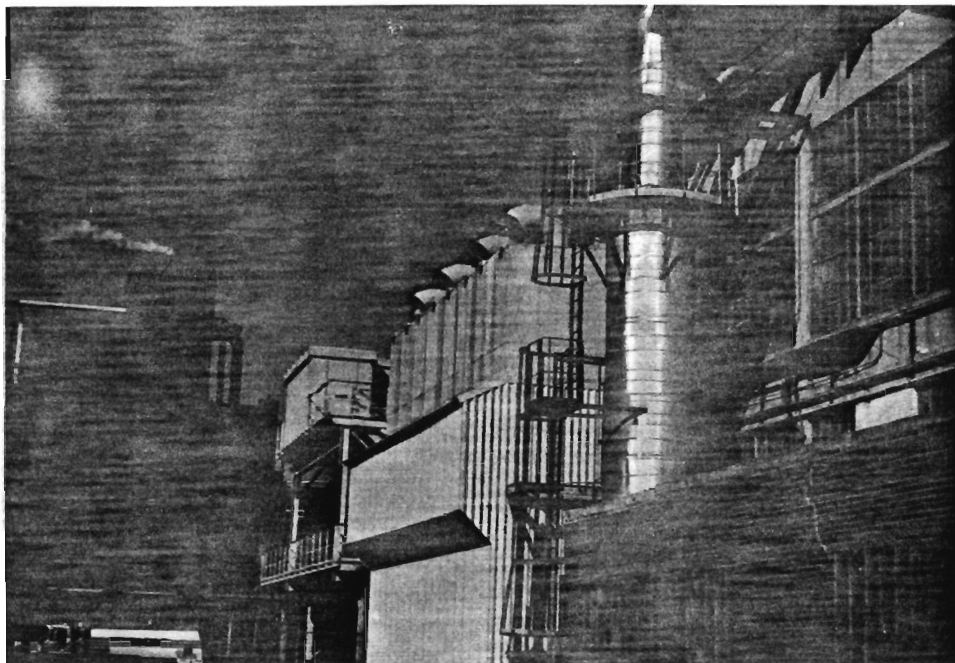
The West Baghouse is located on the west side of Building 36 in Factory C. The baghouse is designed to collect particulates from the active 2A tank and dust from the mixhouse. The baghouse was built in 1974 (Ref. 32), and consists of four chambers and a cooling chamber. The cooling chamber is presently used as a settling chamber for large particulates prior to entering the baghouse. The particulates can be emptied from the cooling chamber to an open polyflex bag located below the unit. Dust from the baghouse

chambers is collected in polyflex bags which are located below the elevated chambers. Both the cooling chamber and baghouse chambers are steel and elevated above-ground.

This unit is used to manage air emissions from tank 2A and the mixhouse. The waste is considered EP toxic for lead and arsenic. The waste is manifested as D008 (Ref. 32).

During the inspection, facility personnel stated that no spills have occurred in the area to the best of their knowledge. No evidence of release was observed during the inspection.

Photograph 3. Photograph of the West Baghouse (SWMU 1) looking northeast. The cylindrical tower in the foreground is the cooling chamber.

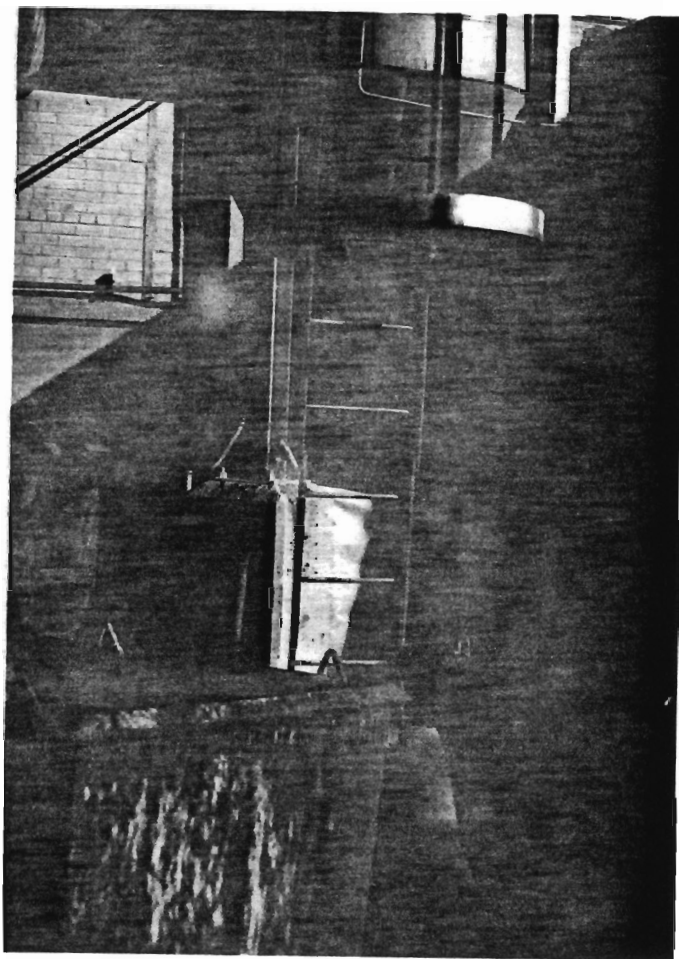
Hazardous dusts from this unit are accumulated in polyflex bags prior to shipment off-site. The bags are approximately three feet on a side and four feet high and are stored on wooden pallets in an enclosed room with a concrete floor. The bags from the baghouse chambers are completely sealed so that dust cannot escape to the environment (Photograph 12). The polyflex bag from the cooling chamber is located outdoors and is not sealed (Photograph 4). The bags are stored either in the enclosed room below the baghouse or in the less than 90-day hazardous storage area prior to disposal off-site.

Photograph 4/5. Photograph of the polyflex bag located below the cooling chamber of the West Baghouse (SWMU 1). (Note: photograph shot twice due to suspected problem with photograph 4.)

P-4 hyper prior to
bay house - 2 55 gallon drums
found in bay house

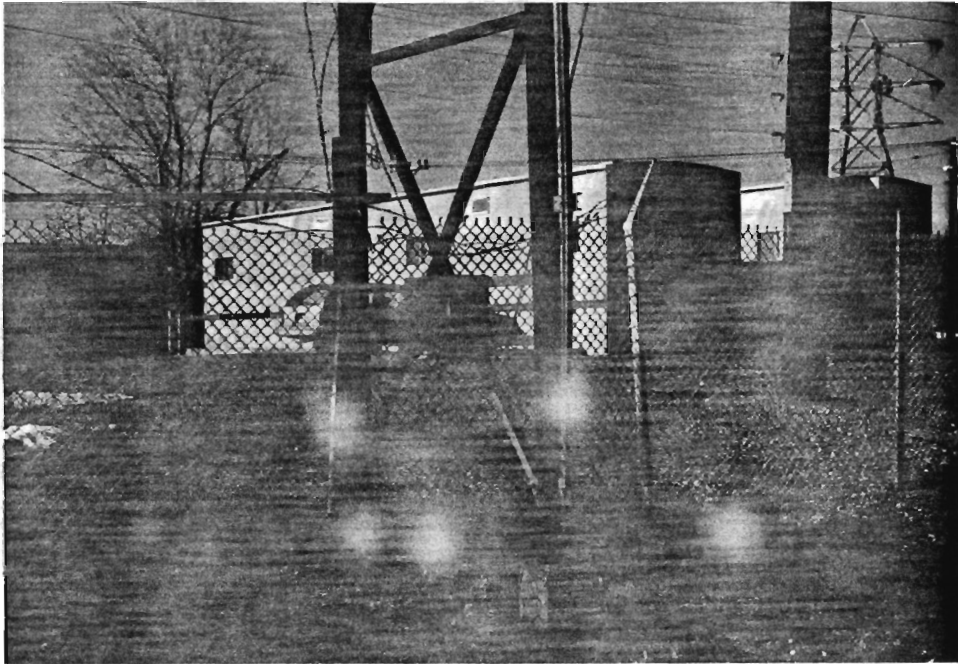
The Main Plant Incinerator was formerly located just north of the present Main Plant property boundary. The incinerator was permitted by NYSDEC and burned only non-hazardous wastes. The unit was installed to generate steam in 1982 (Refs. 13 and 32).

The unit was used to burn solid wastes such as pallets, paper, and cardboard. The unit also received solid waste shredded and compacted into bales from Monroe County, New York (Ref. 13).

This unit was cited on numerous occasions when opacity was observed to be in excess of 20% (Ref. 13). Prior to the site visit this unit was removed and could not be observed.

Photograph 6. Former location of the Incinerator (SWMU 18) looking northwest.

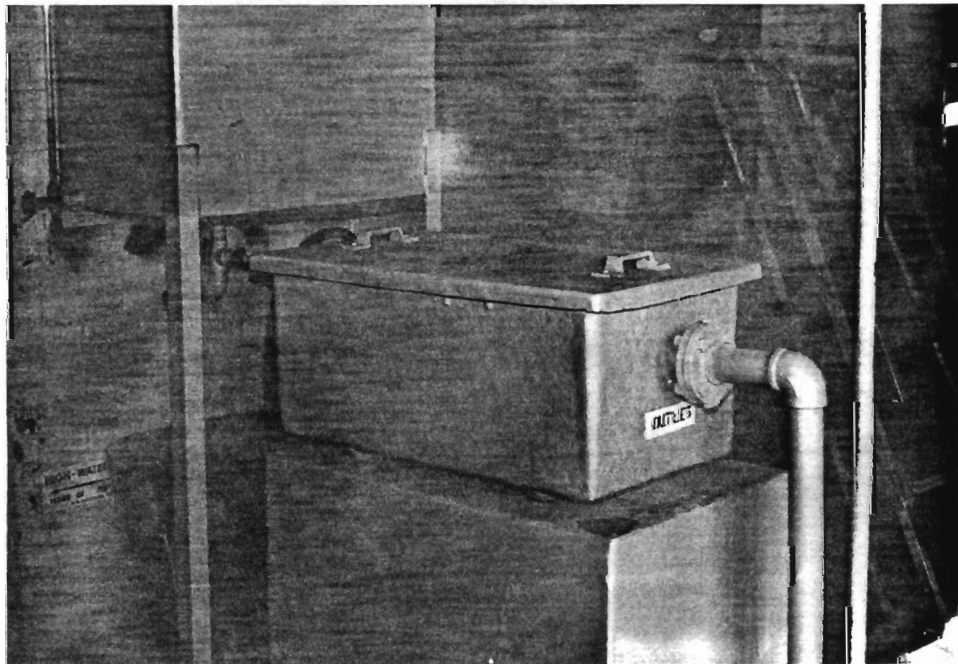
This unit is designed to gravity separate oil from water discharged to a SPDES outfall. The unit treats steam condensate generated in the power plant which is mixed with oil for lubrication purposes. The oil accumulates in a closed above-ground accumulation tank which is drummed when full and shipped off-site as non-hazardous waste oil. Facility personnel estimated that approximately two drums are shipped off-site per year from this unit (Ref. 32).

During the inspection, facility personnel stated that no spills have occurred in the area to the best of their knowledge. No evidence of release was observed during the inspection.

Photograph 7. Photograph of the Powerhouse Oil/Water Separator (SWMU 4). The upper tank is used for settling and the lower tank is used for accumulation.

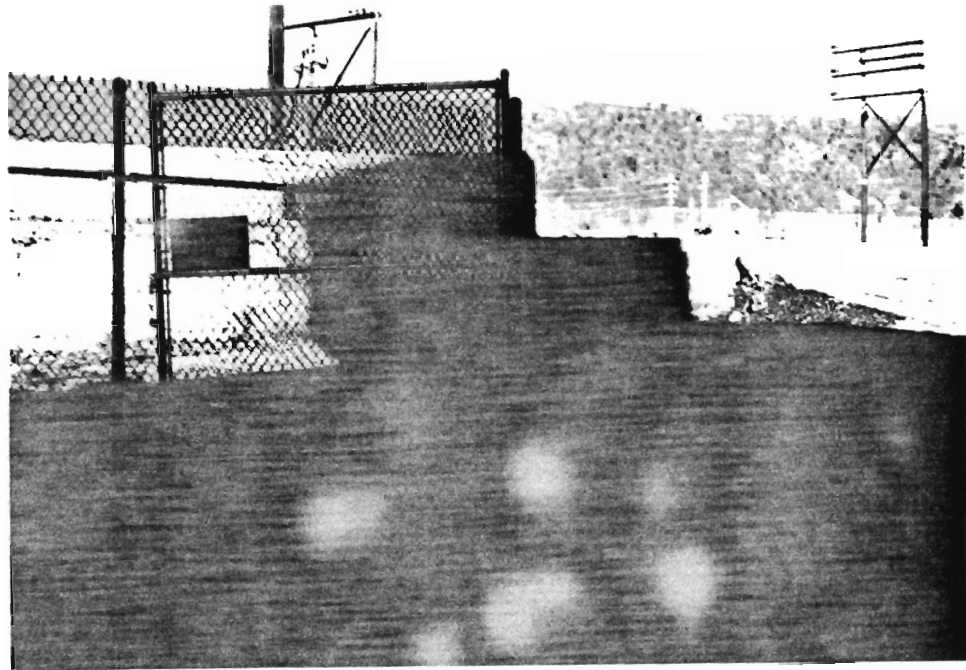
The Old Powerhouse Oil/Water Separator was used to treat steam condensate prior to discharge out the SPDES outfall 005. The unit was installed in the mid-1970s and was replaced by a smaller unit, Powerhouse Oil/Water Separator (SWMU 4), in 1988 due to decreased power demands at the plant (Ref. 32). The unit was approximately 8 feet in diameter and 10 feet high, and was completely above-ground.

All of the Inactive Oil/Water Separators were demolished. The 2A and 5A Separators have been inactive since 1984, and the Powerhouse Separator was replaced in 1988 (Ref 32).

Photograph 8. Former location of the Old Powerhouse Separator (SWMU 16) looking north-east.

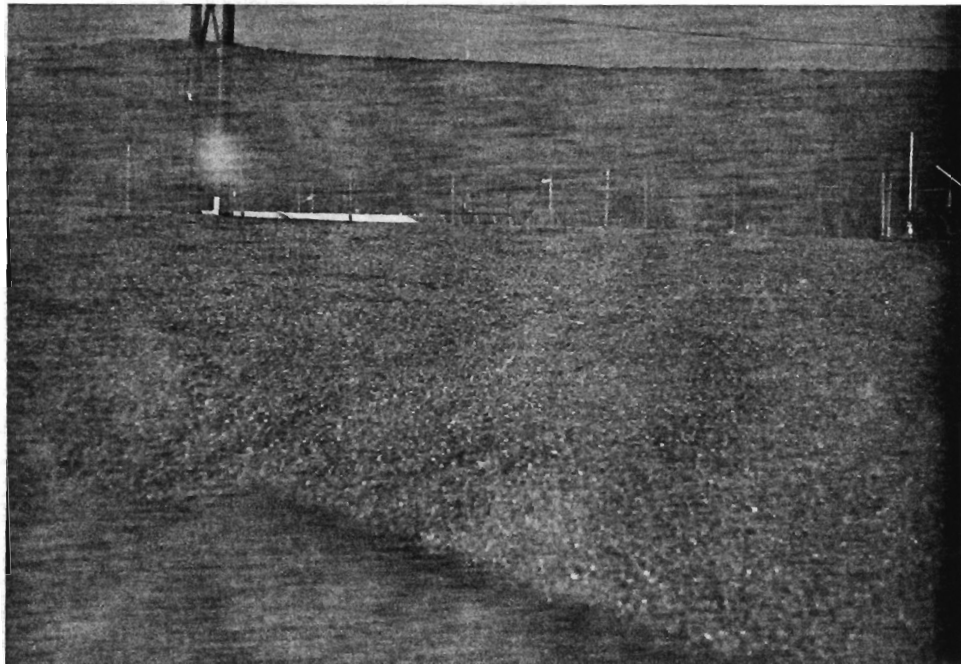
The Hazardous Waste Hopper Storage Area was an outdoor unit located north of Factory B. The unit was a 20 to 30 cubic yard steel roll-off bin for storage of dust generated at the West and North Baghouses and the West Mixhouse Dust Collector (SWMUs 1, 6, and 7). The unit was placed partially over a concrete pad and partially over bare soil (Ref. 32) This unit was used for approximately three years prior to closure under NYSDEC in 1988 (Refs. 31 and 32).

The North Baghouse was used to collect dust generated in Factory C. The West Mix House Dust Collector was used to collect dust from the mixhouse formerly located in Building 38. The Hazardous Waste Hopper Storage Area (SWMU 8) collected D008 dust from various locations at the plant prior to shipment off-site for disposal (unit stored dust for greater than 90-days). The bin has been removed from the site, the surface soils were removed, and soil samples were taken as part of closure under NYSDEC. All soils tested before and after excavation as part of closure were non-toxic as defined by EP toxicity limits (Refs. 29 and 31).

During the inspection, facility personnel stated that no spills have occurred from the North Baghouse and West Mix House. No evidence of release from either of these units was observed in the area where the units were formerly located. The Hazardous Waste Hopper Storage Area has been closed under NYSDEC (Ref. 29).

Photograph 9. Former location of the Hazardous Waste Hopper Storage Area (SWMU 8).

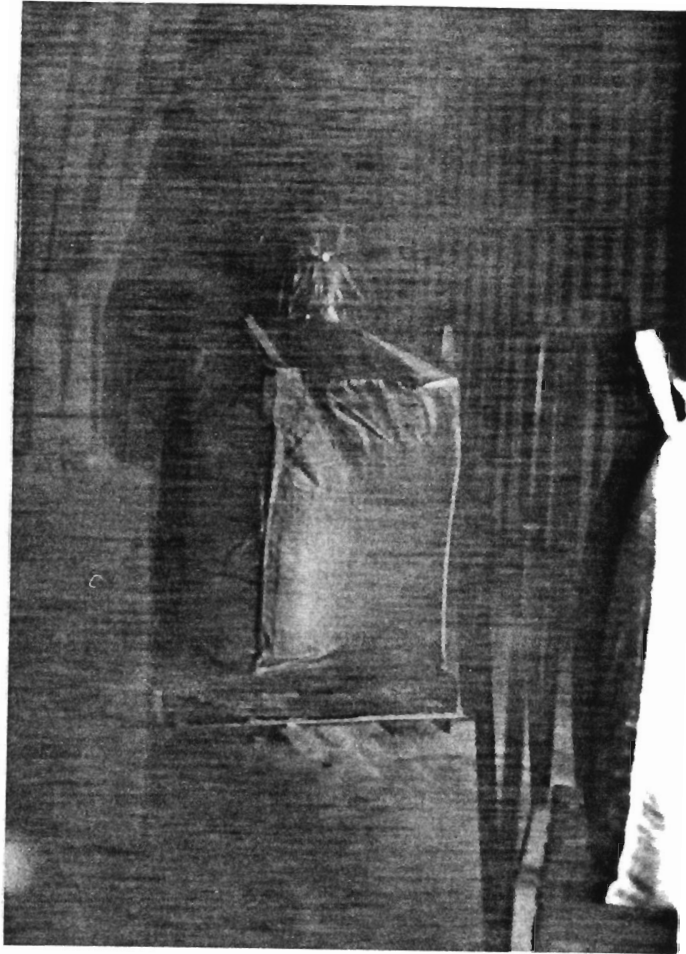
Photograph 12. Photograph of polyflex bag located in the West Baghouse (SWMU 1) accumulating D008 wastes.

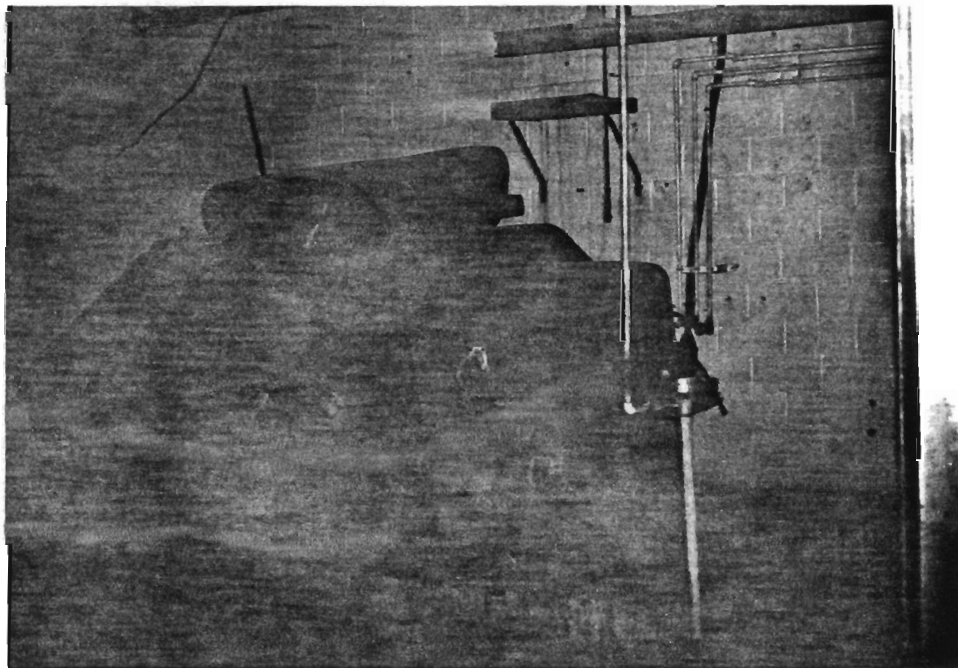
The area is contained completely indoors over a concrete floor. At the time of the VSI, only decontaminated waste hoppers were being stored in the room. All hazardous wastes stored in this room are stored for a period of less than 90 days.

concrete floor and cinder block walls. The room also stored spent filters, which were also corrosive, in open plastic bins lined with bags. The bins were approximately two feet wide, four feet long, and three feet deep (See Photograph 13). The filters were drummed in this room prior to off-site shipment. The bins were stored over an acid-resistant curbed pad.

Photograph 13. Decontaminated plastic bins located in the Less Than 90-day Storage Area (SWMU 5).

P-13 - 50 filter storage
hoppers. Were stored
in this room when
in use. Room also
used for any hazardous
waste generated on-site.
Room has been de-
contaminated.
