SITE CHARACTERIZATION REPORT

Corning Study Area – Offsite OU5

NYSDEC Site No. 851046

March 2017

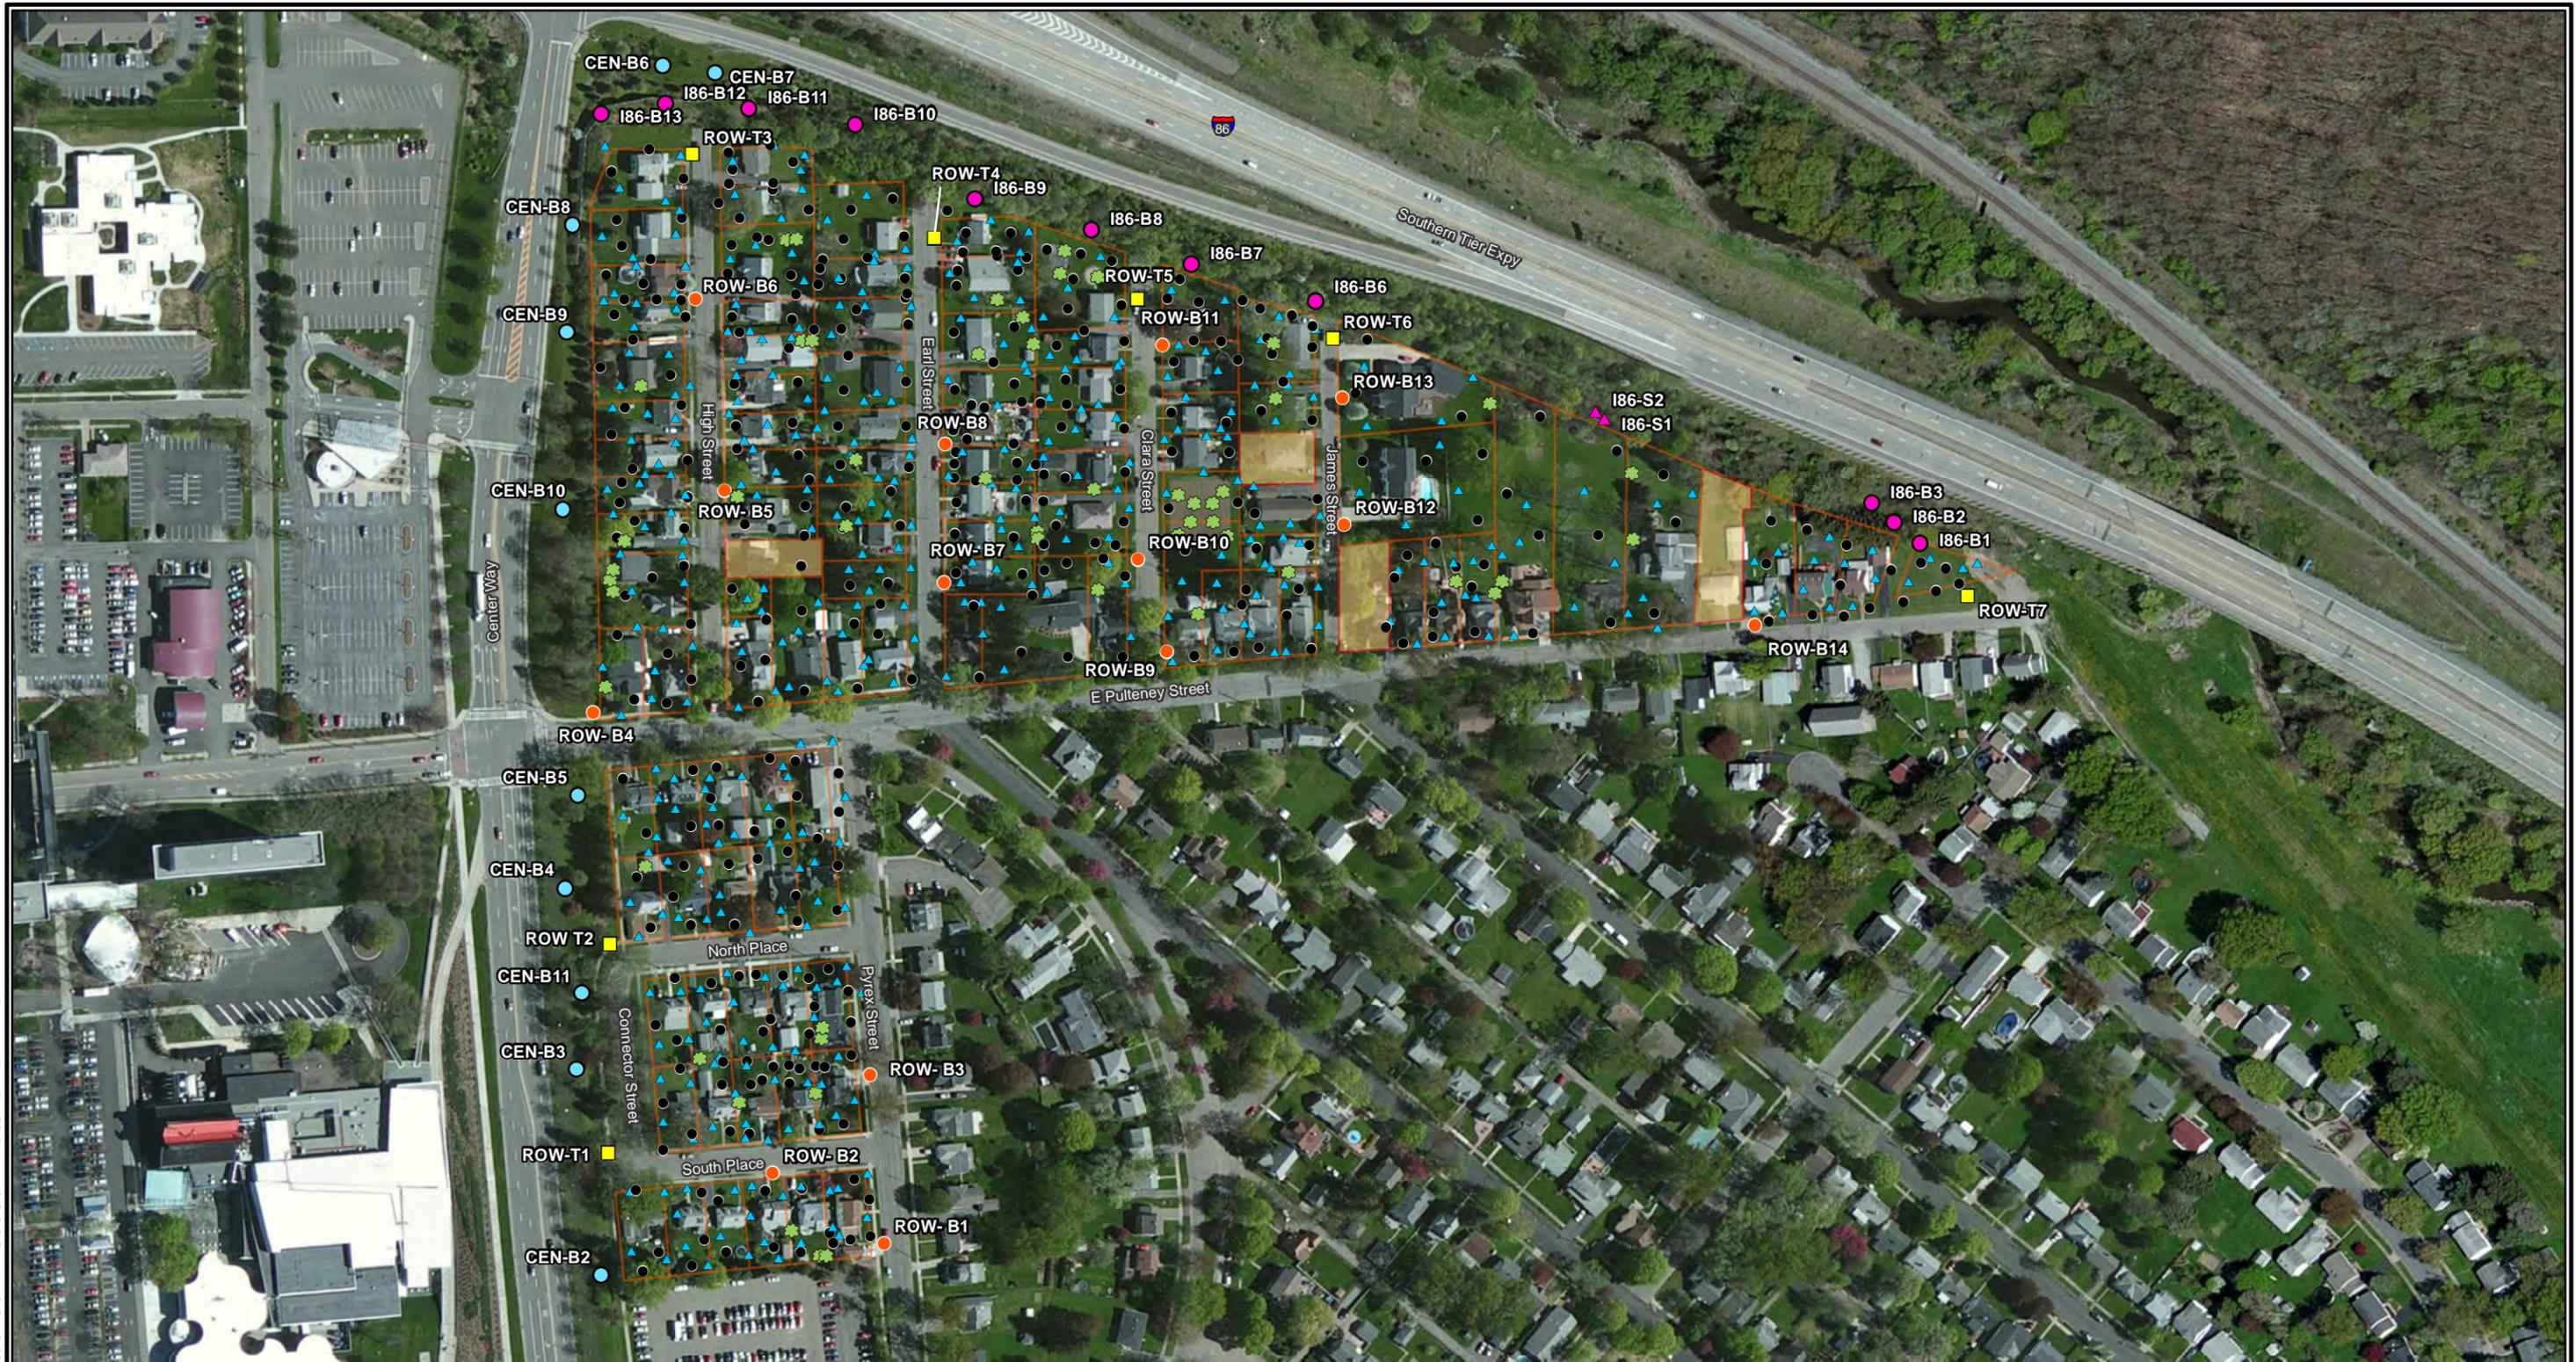
FIGURE
4

Up to four surface soil samples were collected from just below sod or mulch at each residential parcel (Figure 4). The approximate depth of the surface samples was two to four inches below ground surface. Locations of the surface samples collected from each parcel were selected based on areas of potential for human exposure to target fill, spatial distribution within the individual parcel, any worn areas of grass where significant soil was exposed, and after review of sample locations from adjacent parcels.

SAMPLING LOCATIONS

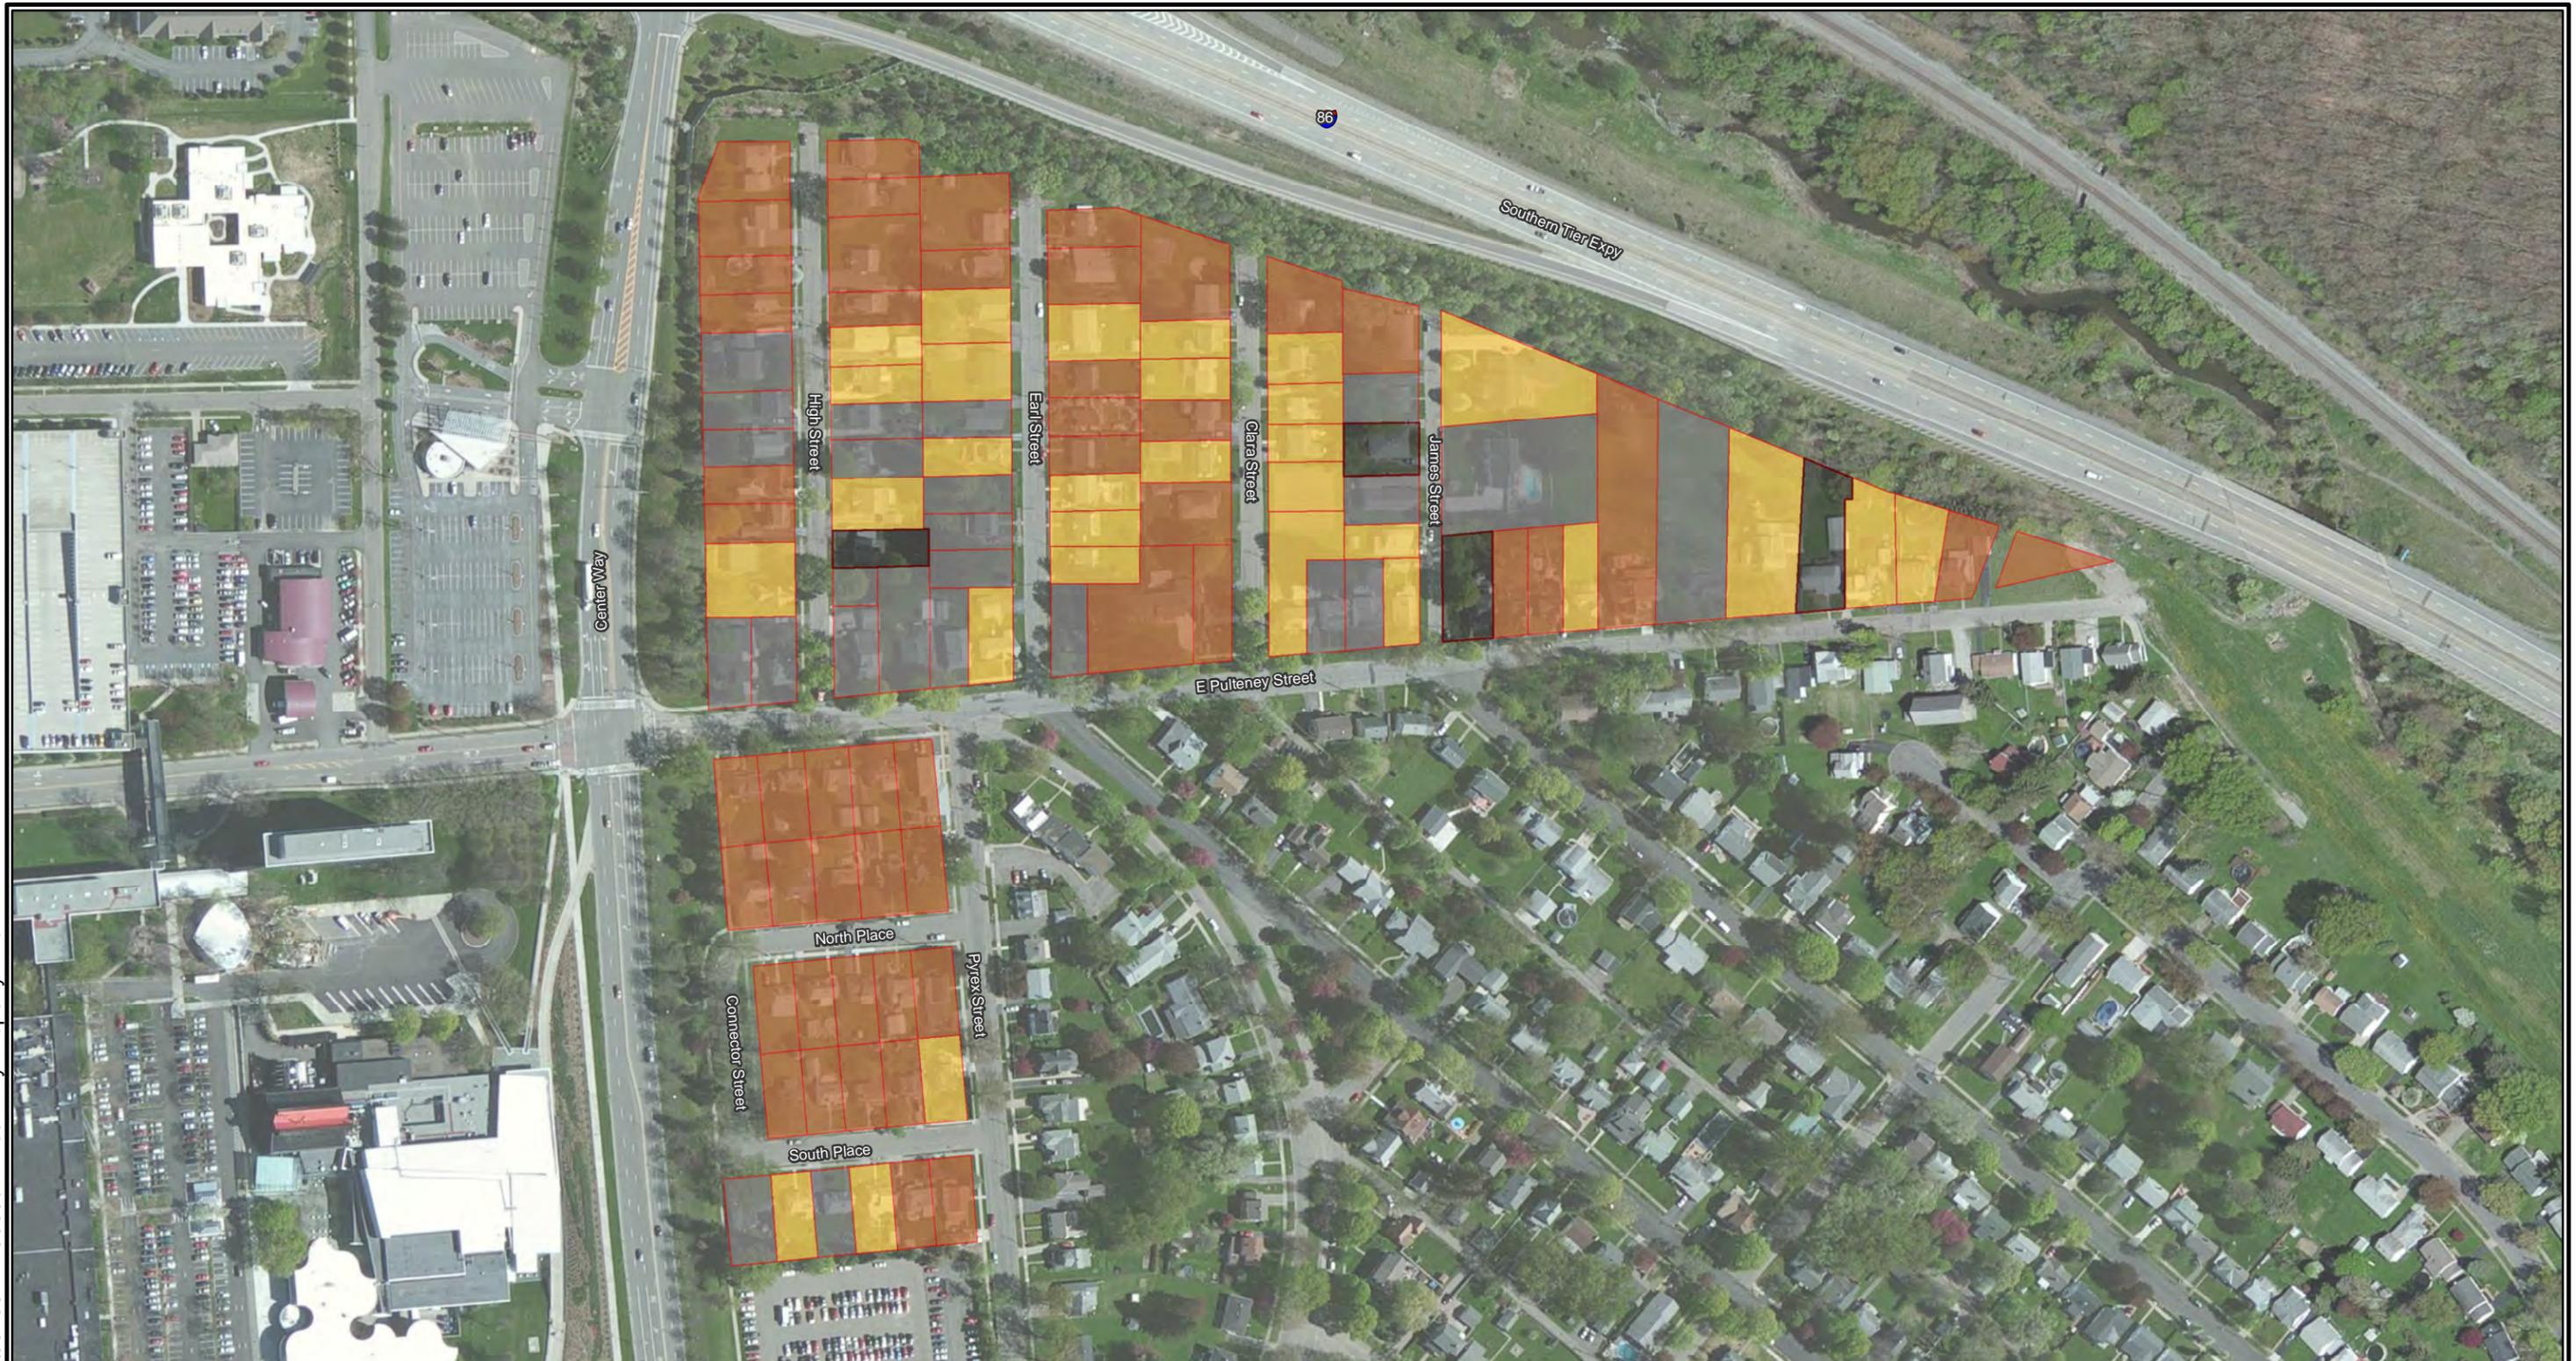
PRESENCE OF FILL BY PROPERTY

Six cross sections were prepared to aid in assessing the vertical and horizontal extent of target fill across OU5. The cross-sections and overview map are included in Appendix E. Areas of target fill are shown on Figure 5. There were 50 parcels observed to contain layers of target fill greater than one inch, while there were 30 additional parcels with trace amounts of target fill observed. Target fill was not observed at 24 parcels. Property owners of four parcels did not provide access for investigation activities.

There were two areas where layers of target fill up to 7 feet thick were observed. The first area, containing 20 parcels, is bounded by Pyrex Street, South Place, Center Way, and East Pulteney Street. Layers were thickest around the East Pulteney and Pyrex Street intersection and tapered out to the south toward the Guthrie Medical Center. Target fill was observed at all twenty parcels. All but one of these parcels had target fill layers greater than one inch. The second area is located at the north end of OU5 adjacent to the I-86 corridor between Center Way and James Street. Layers of target fill were observed to be the thickest and most prevalent in the four to six parcels closest to the I-86 corridor. Target fill layers greater than one inch thick were observed at approximately half of the parcels between Center Way and James Street. Target fill was sporadically observed at the remaining parcels in OU5 outside of the two areas described above.

- No Fill Identified
- Trace Fill
- Target Fill layer >1"
- No Response/No Access to Property

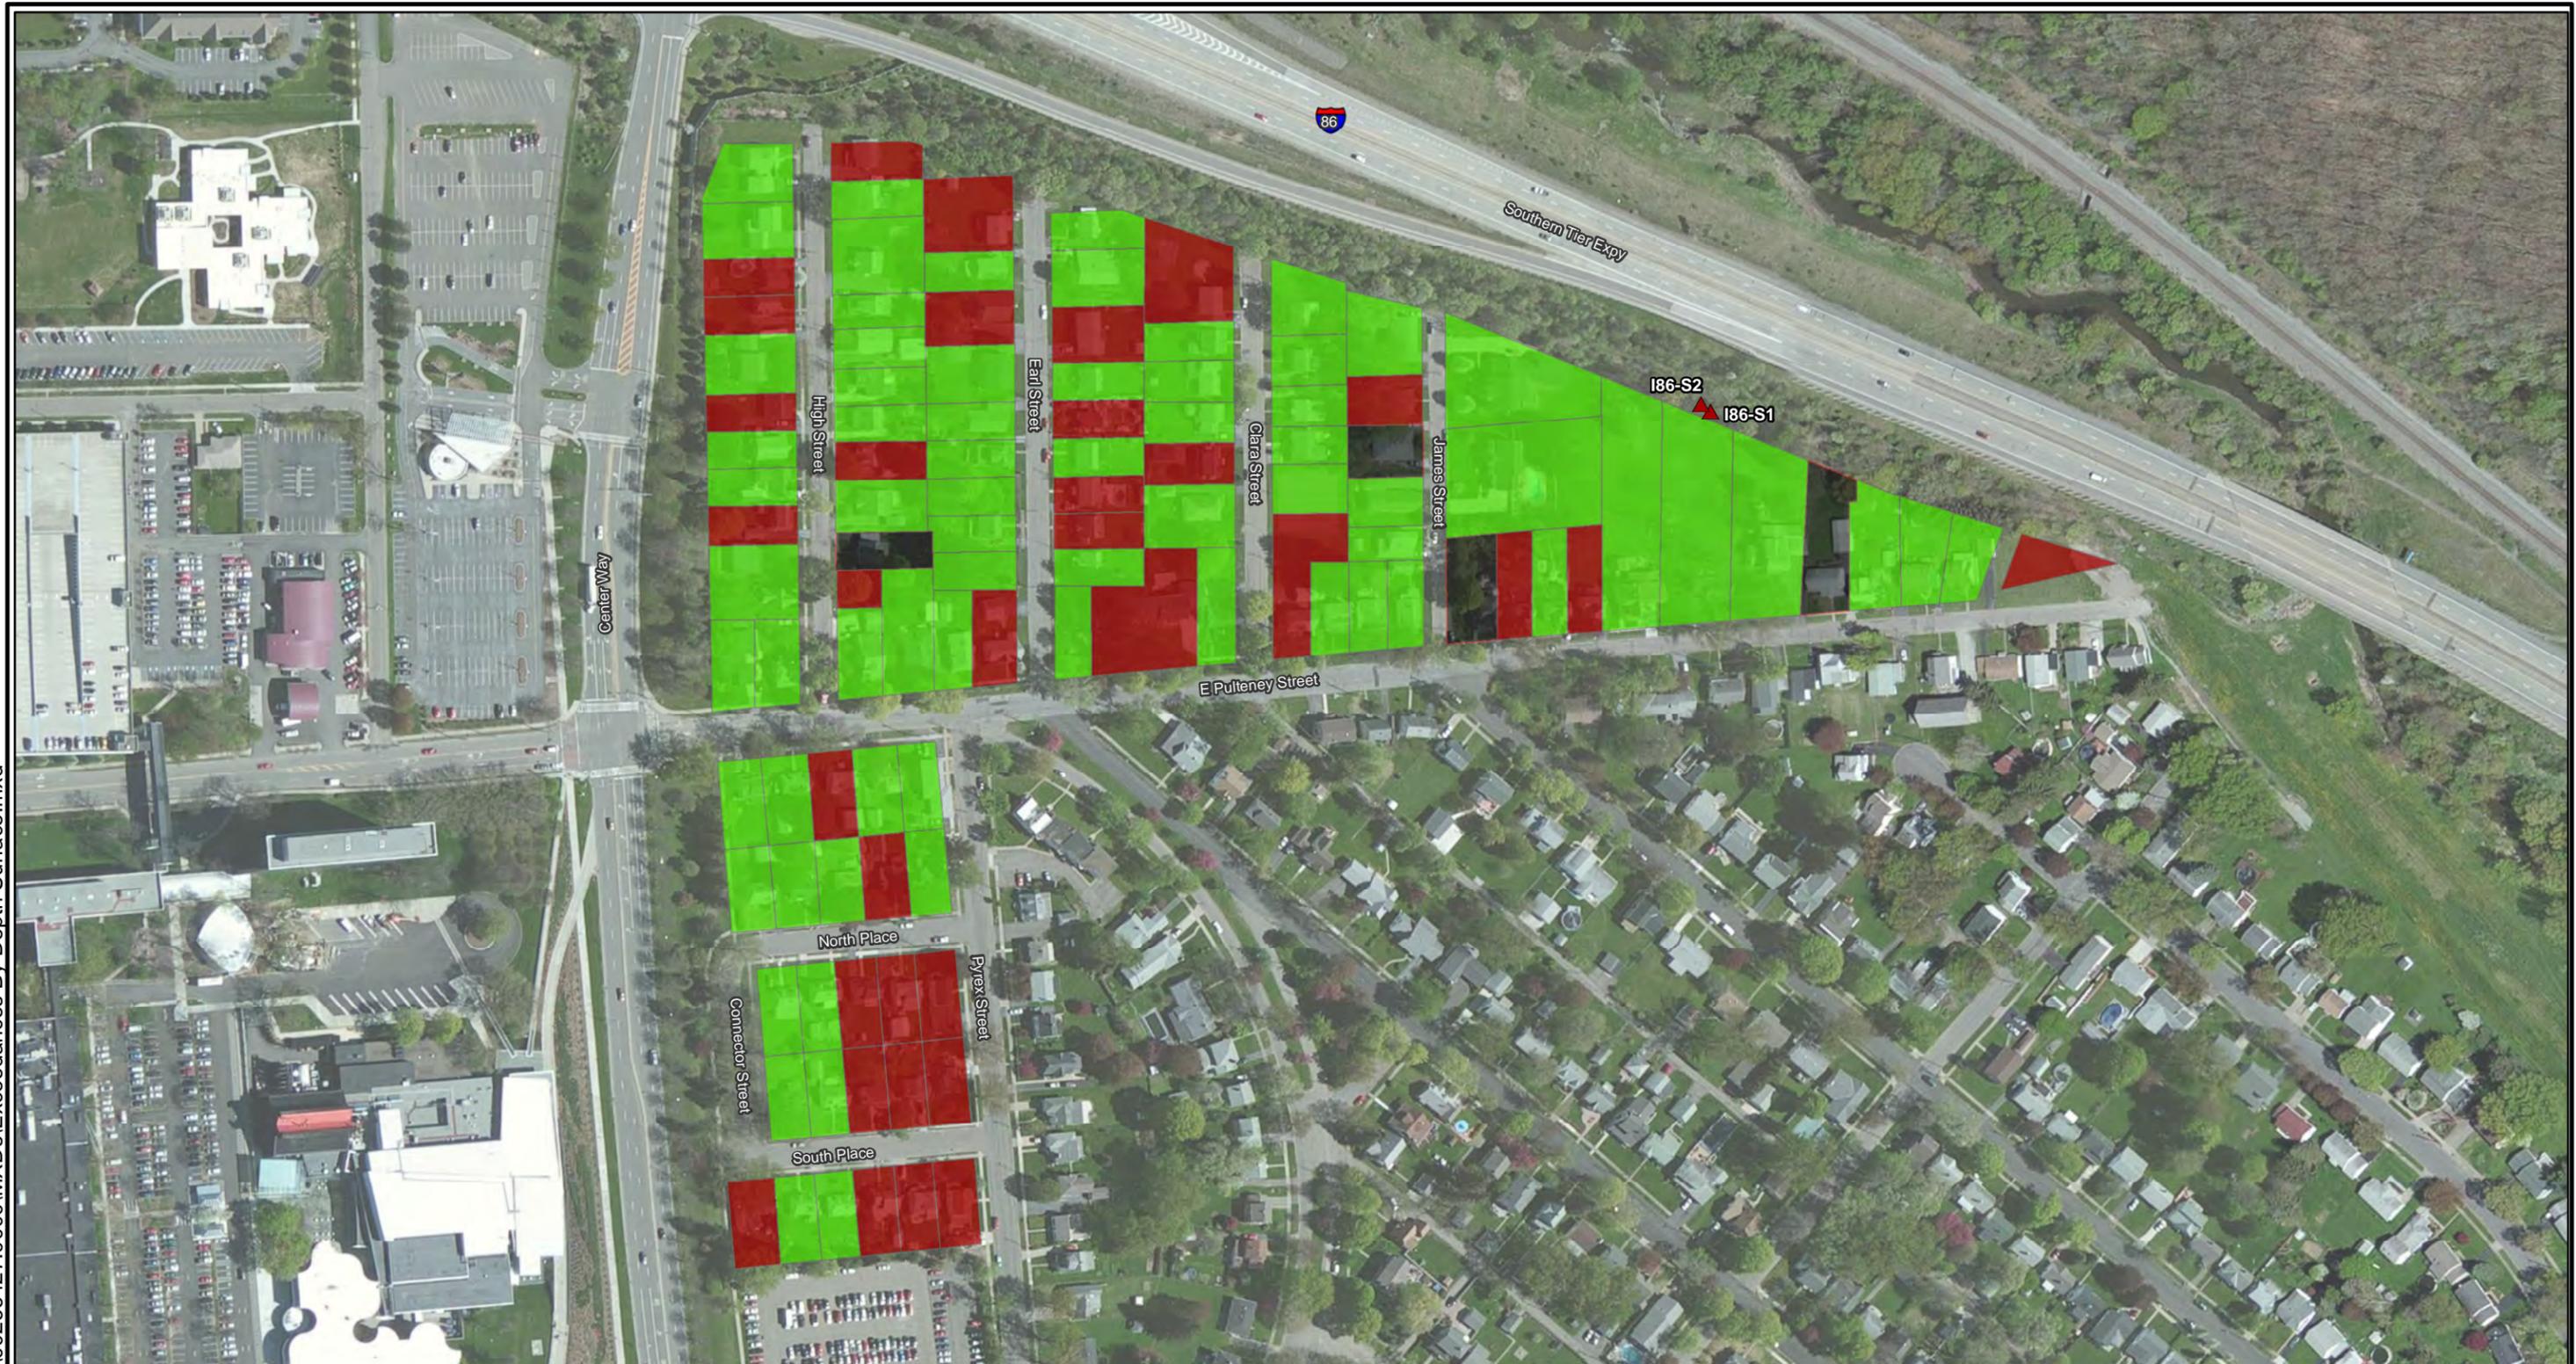
FIGURE

- Legend**
Exceedances of RSCOs in Surface Soil and/or Garden Soil Sample
- Yes
 - No
 - No Access to Property
- Surface Soil Sample**
- ▲ Yes

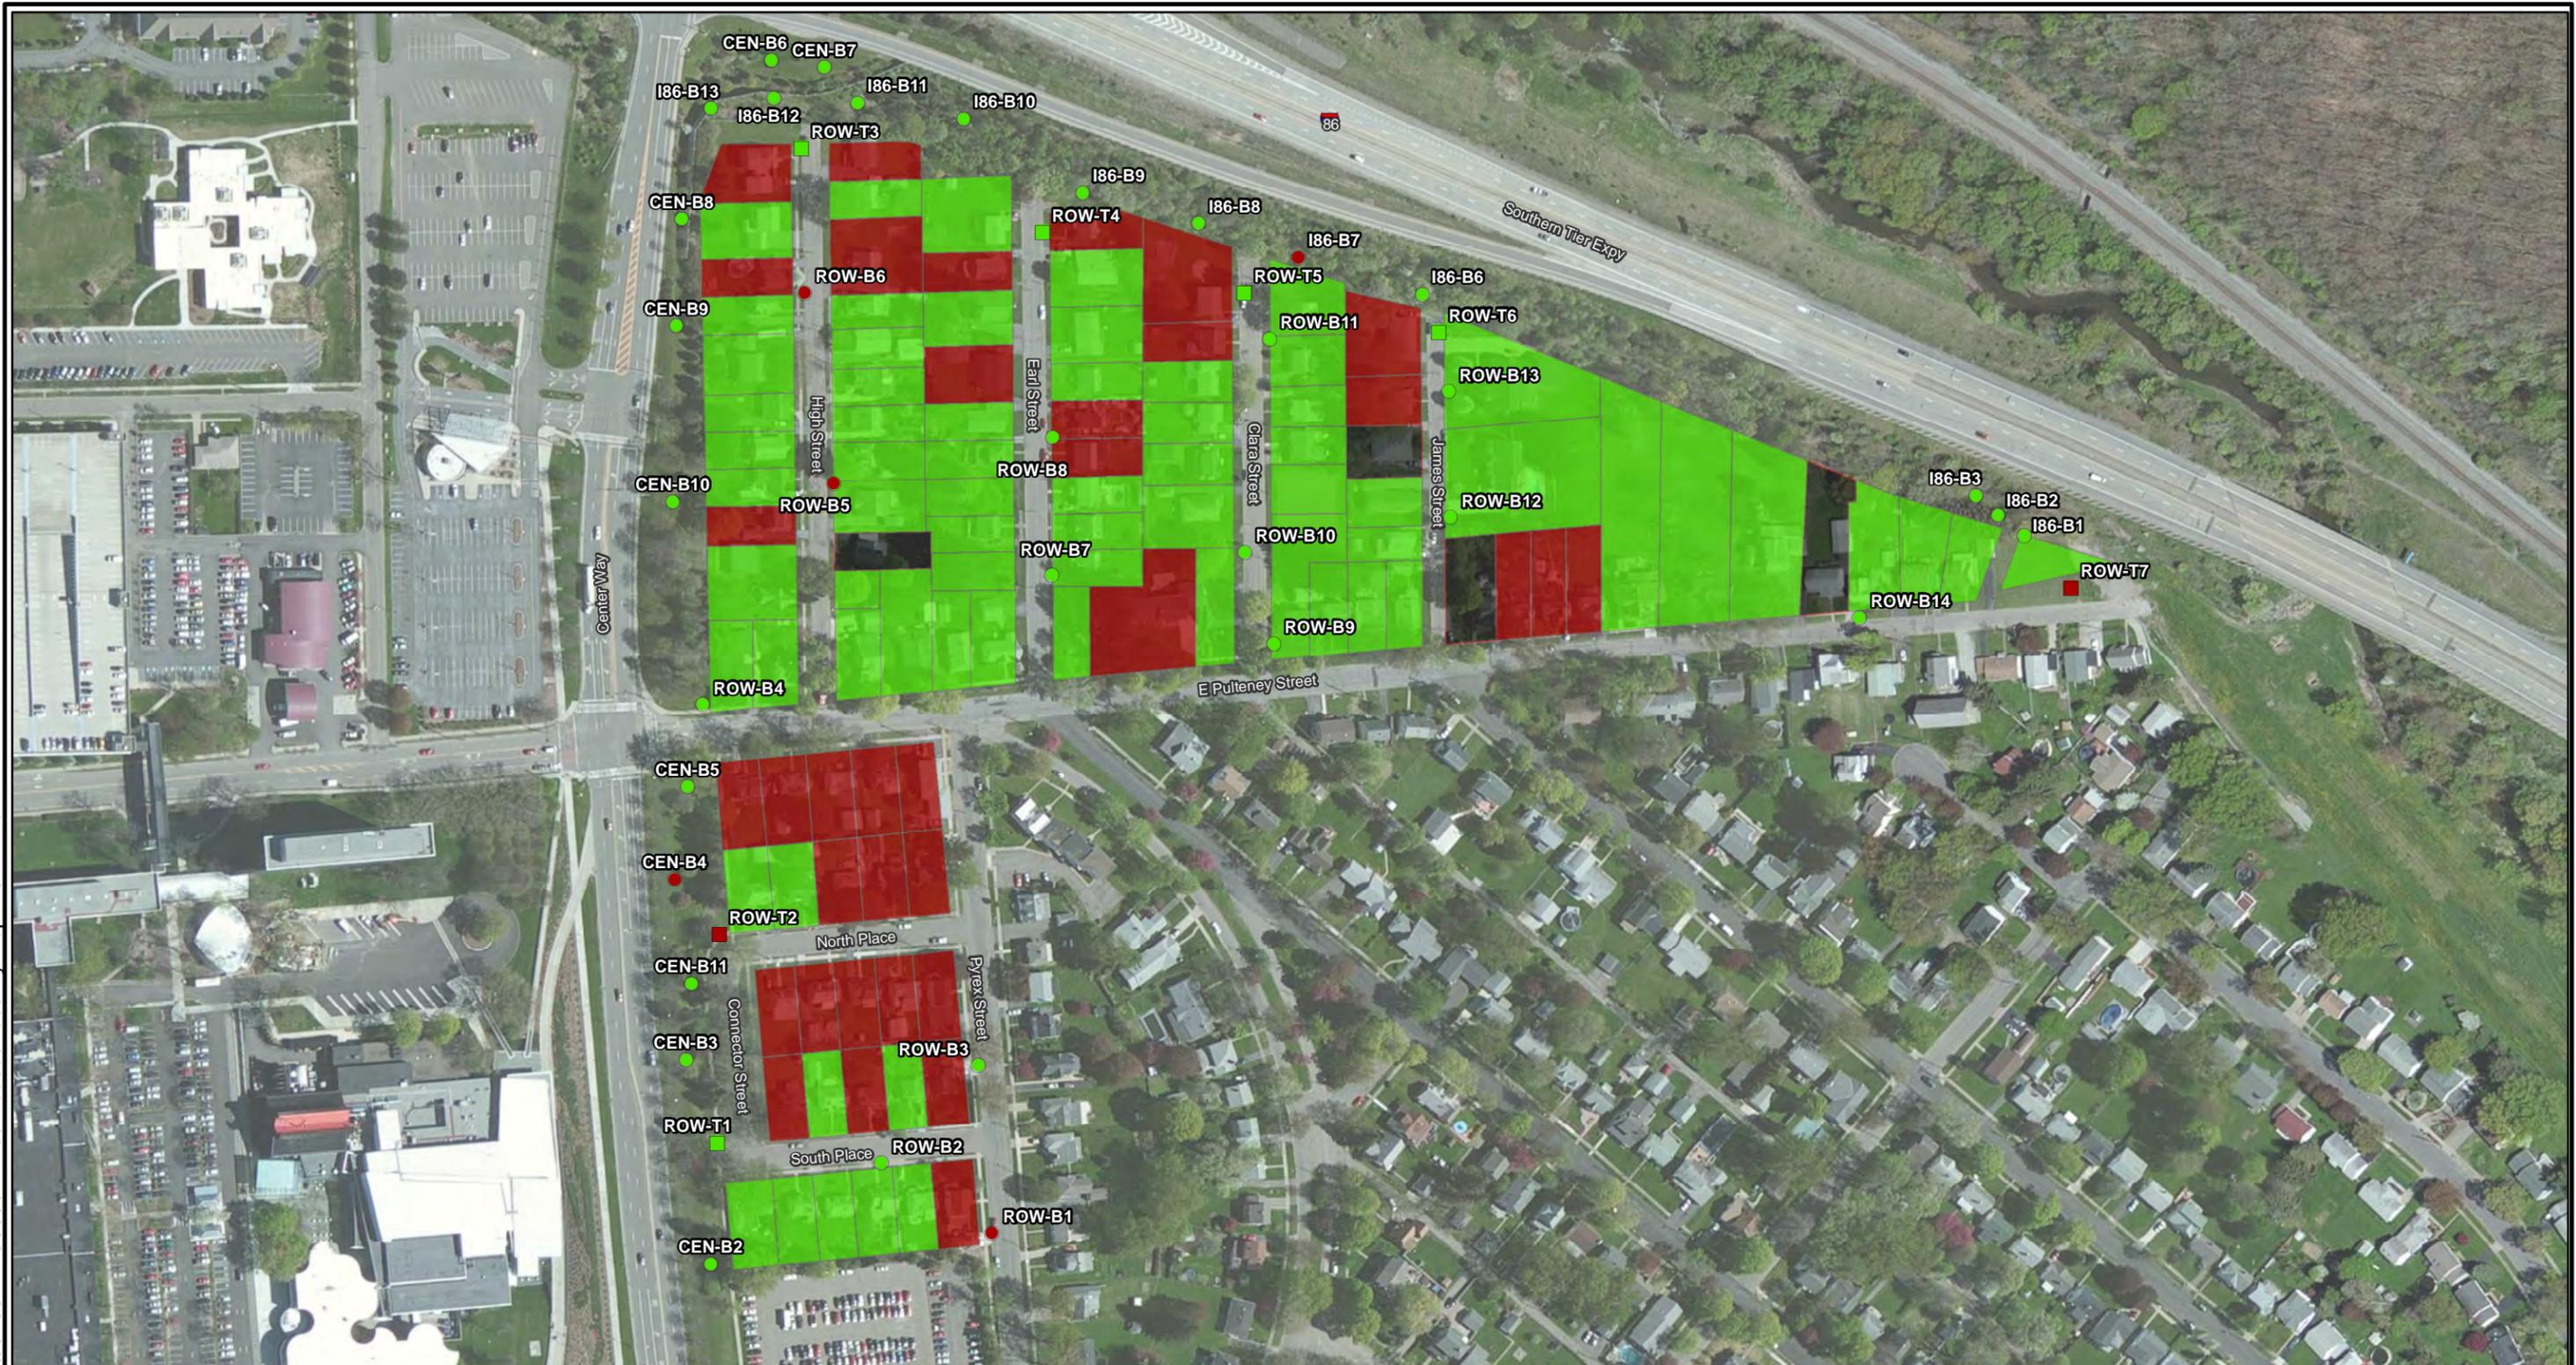
EXCEEDANCES OF RSCOs IN 0-2 FEET BGS SOIL SAMPLES

Legend
Exceedances of RSCOs in 0-2 Feet Interval Below Ground Surface (BGS) Soil Sample

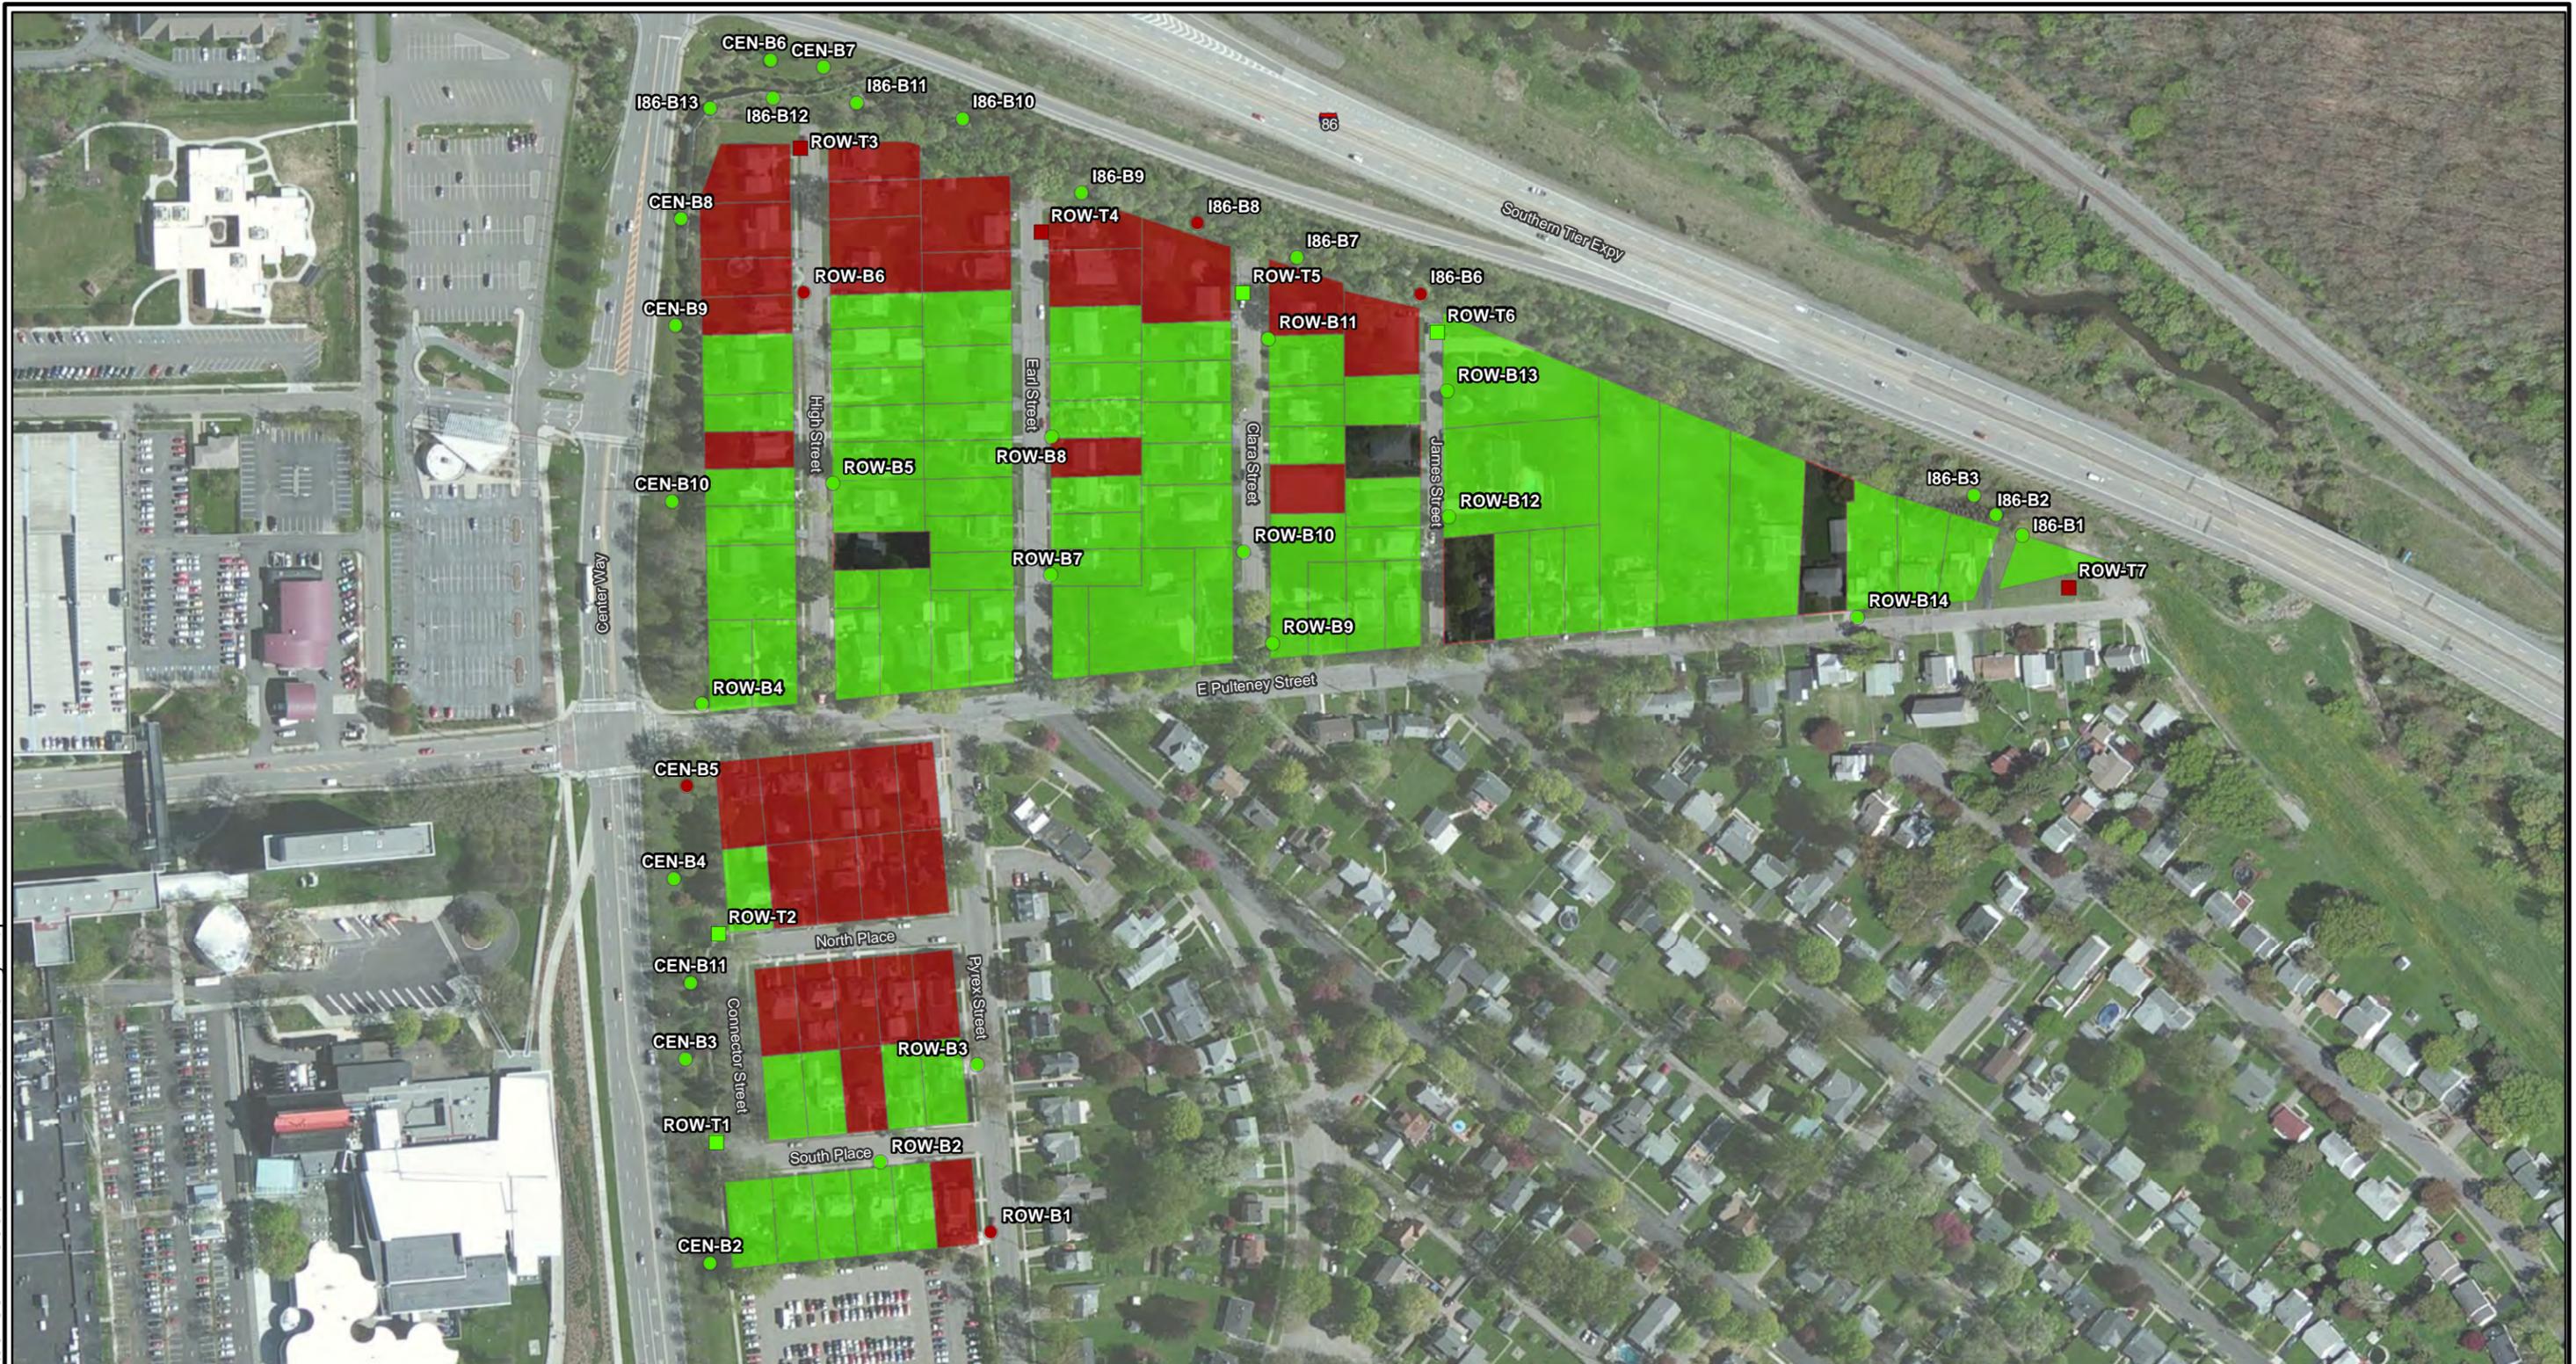
EXCEEDANCES OF RSCOs IN 2-4 FEET BGS SOIL SAMPLES

Legend
Exceedances of RSCOs in 2-4 Feet Below Ground Surface (BGS) Soil Sample

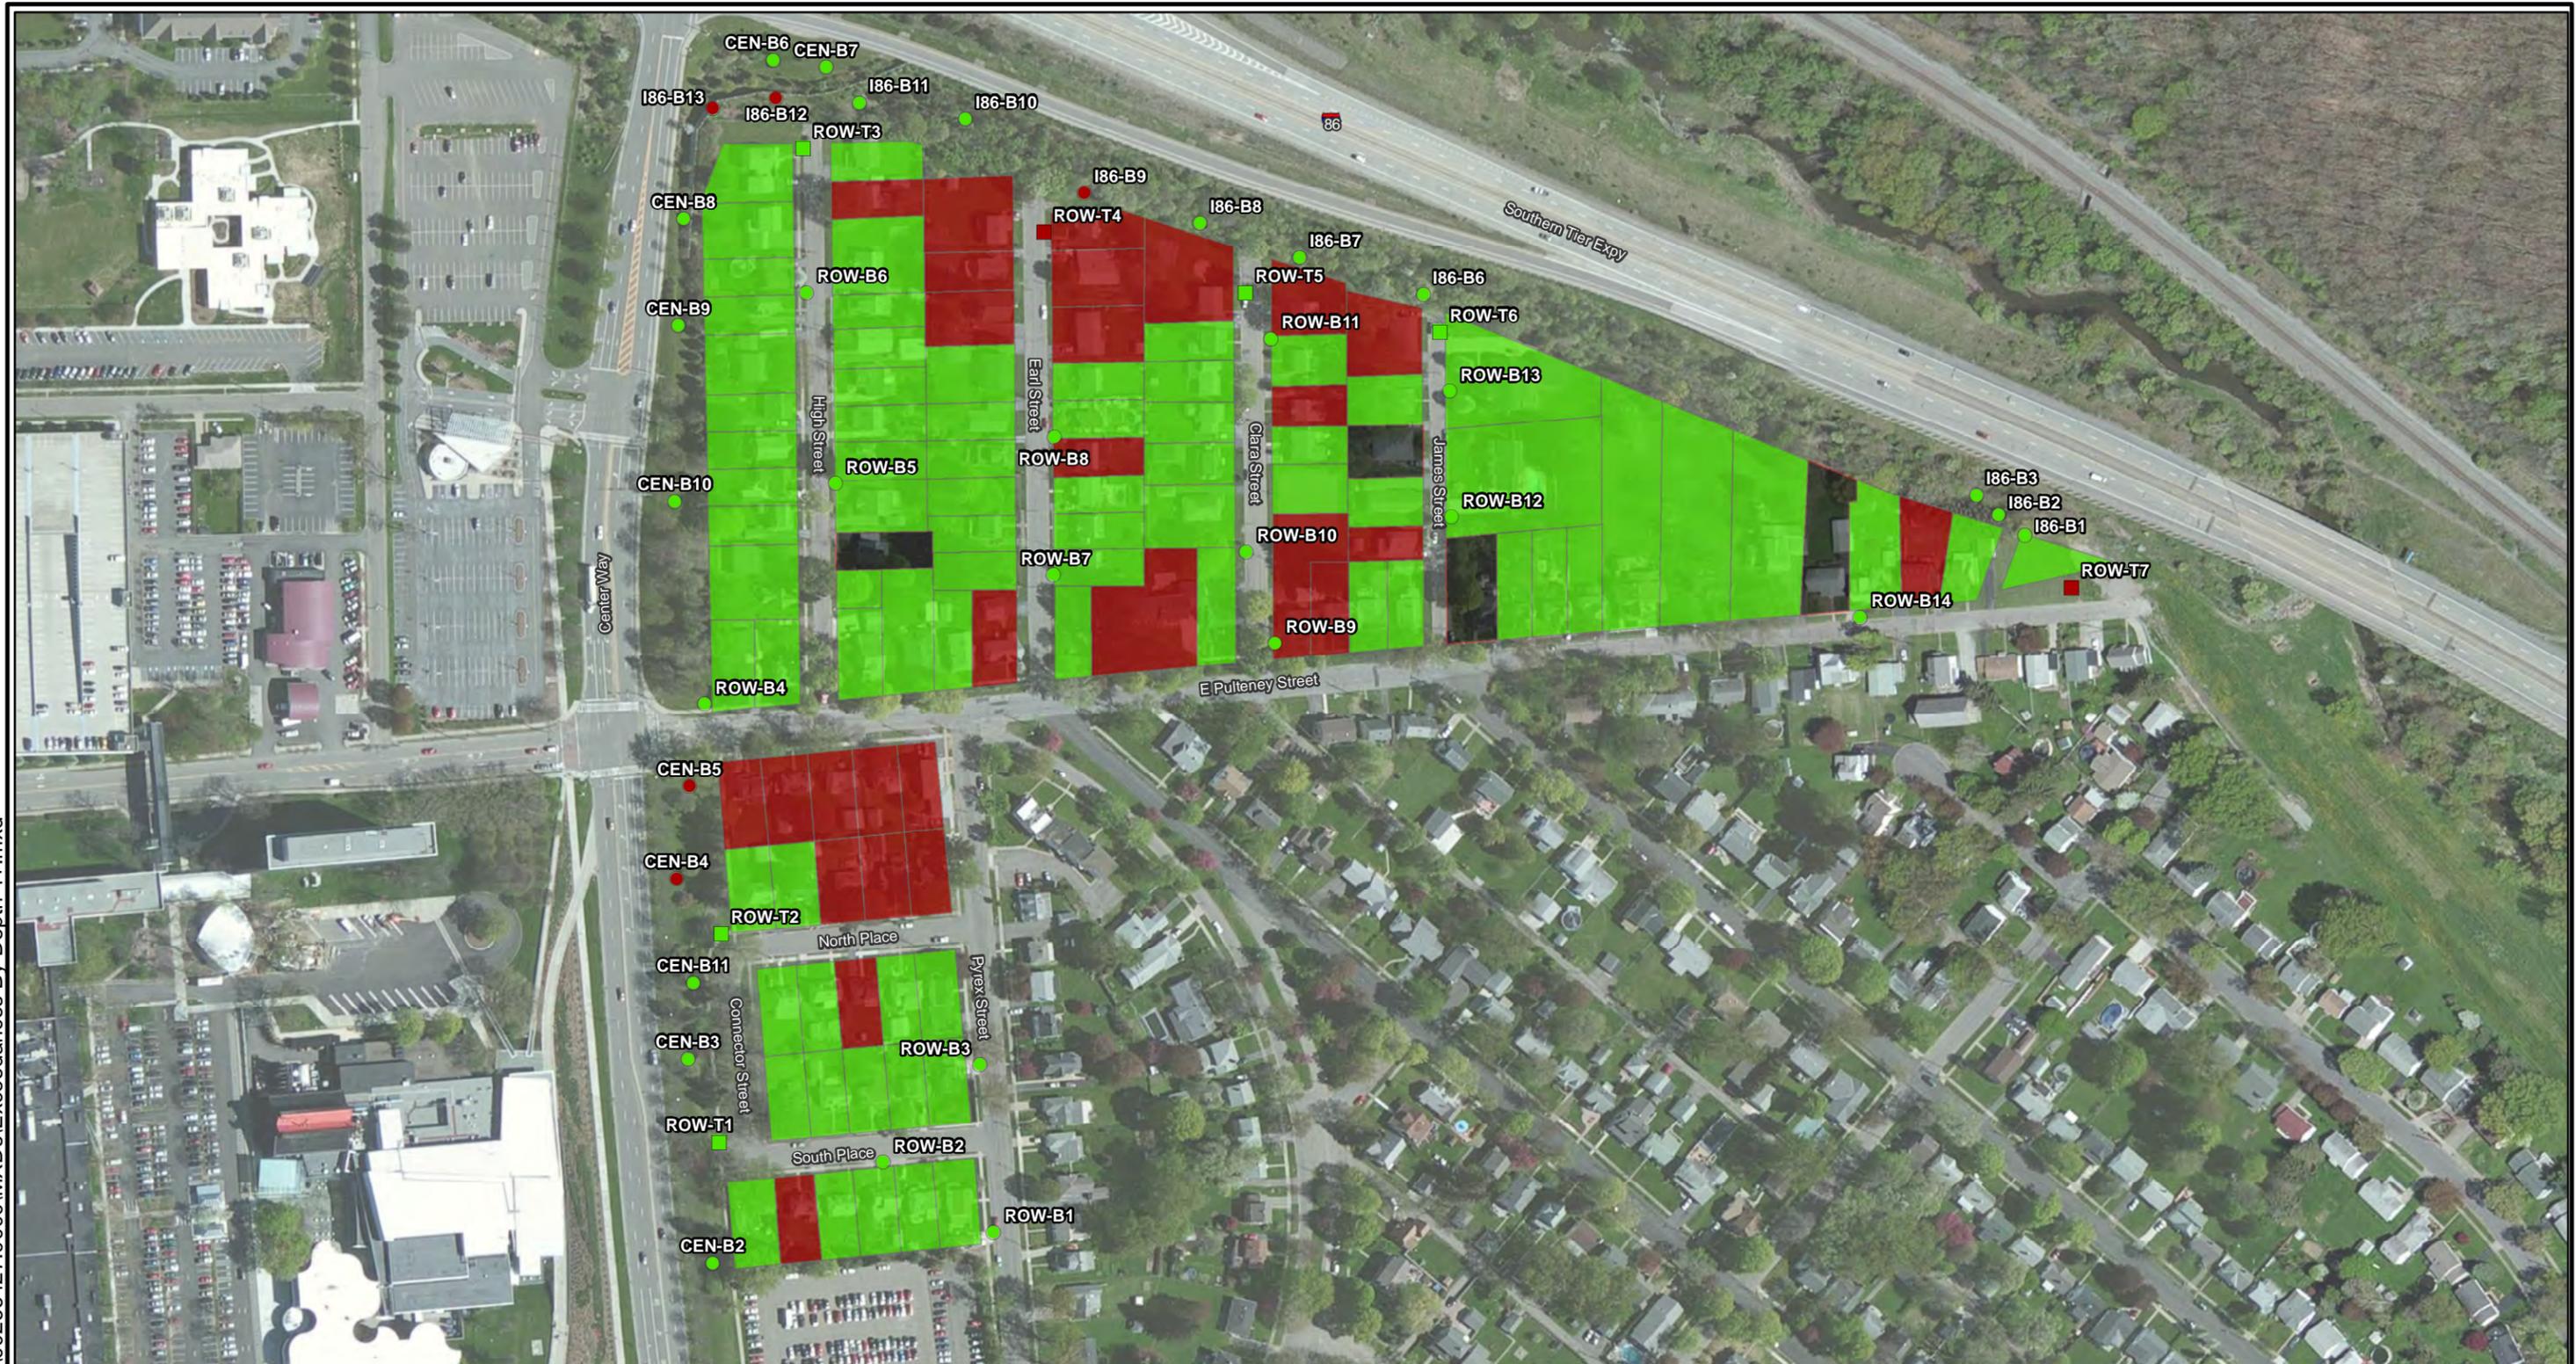
FIGURE
9

- Legend**
Exceedances of RSCOs in 4+ Feet Below Ground Surface (BGS) Soil Sample
- Yes
 - No
 - No Access to Property
- Soil Boring Test Pit**
- No
 - Yes
 - No
 - Yes

Notes:
 For Boring Locations: A "No" symbol is returned for locations with either "no exceedance" or "no sample collected" at that particular depth. Exceedances represent data greater than the Residential Soil Cleanup Objectives (RSCOs)
