Period Review Report

Former Days Inn Site
NYSDEC No. 851054
23 Riverside Drive
Corning, New York

December 11, 2024

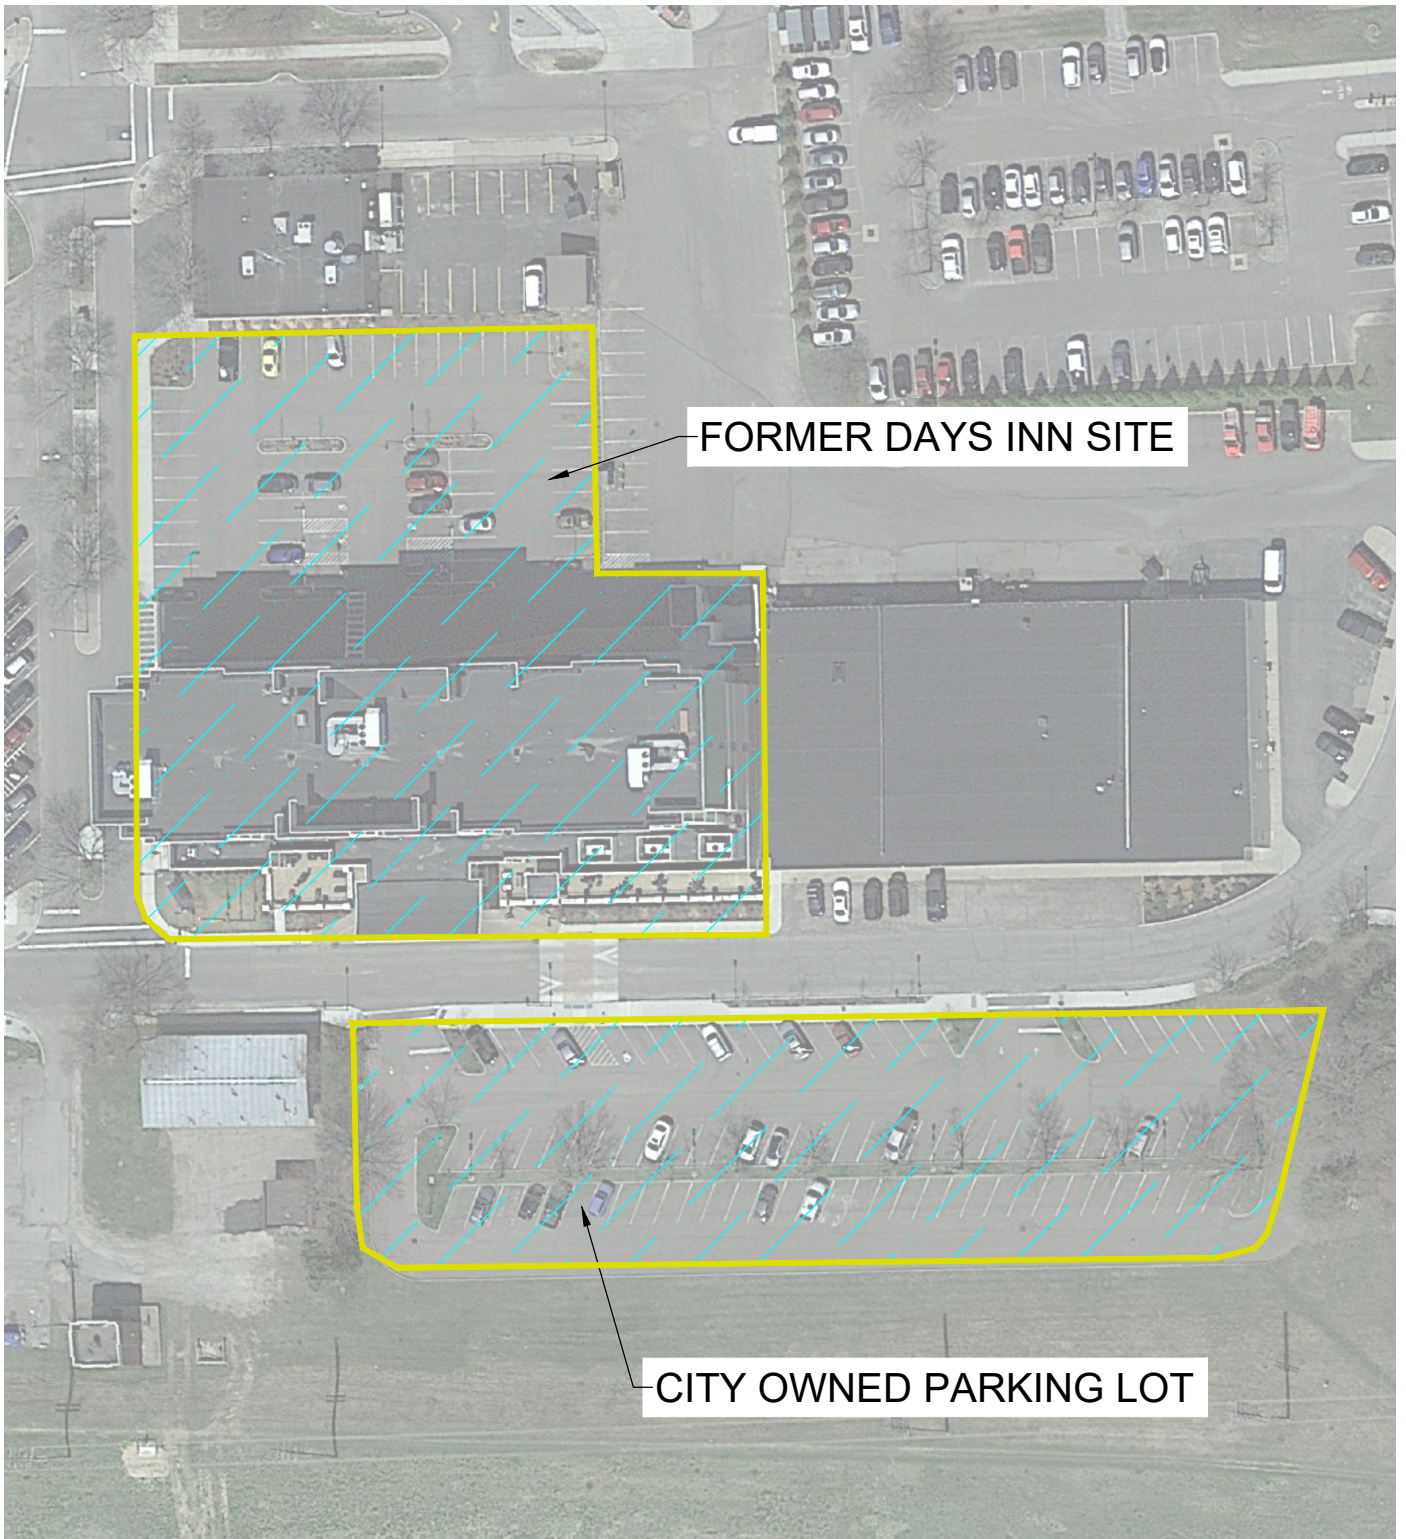
Compiled by: CNK	Date: DECEMBER 2024	FIGURE 2
	Prepared by: CNK	Scale: AS SHOWN	
	Project Mgr: CZB	Project: 4504.0001B000	
	File: FIGURE 2: SITE AND CITY OWNED PARKING LOT PLAN (AERIAL).DWG

Figure 2 is an aerial view of the Site following redevelopment and improvements to the City-Owned Parking Lot.

Title: **SITE AND CITY OWNED PARKING LOT PLAN (AERIAL) PERIODIC REVIEW REPORT**

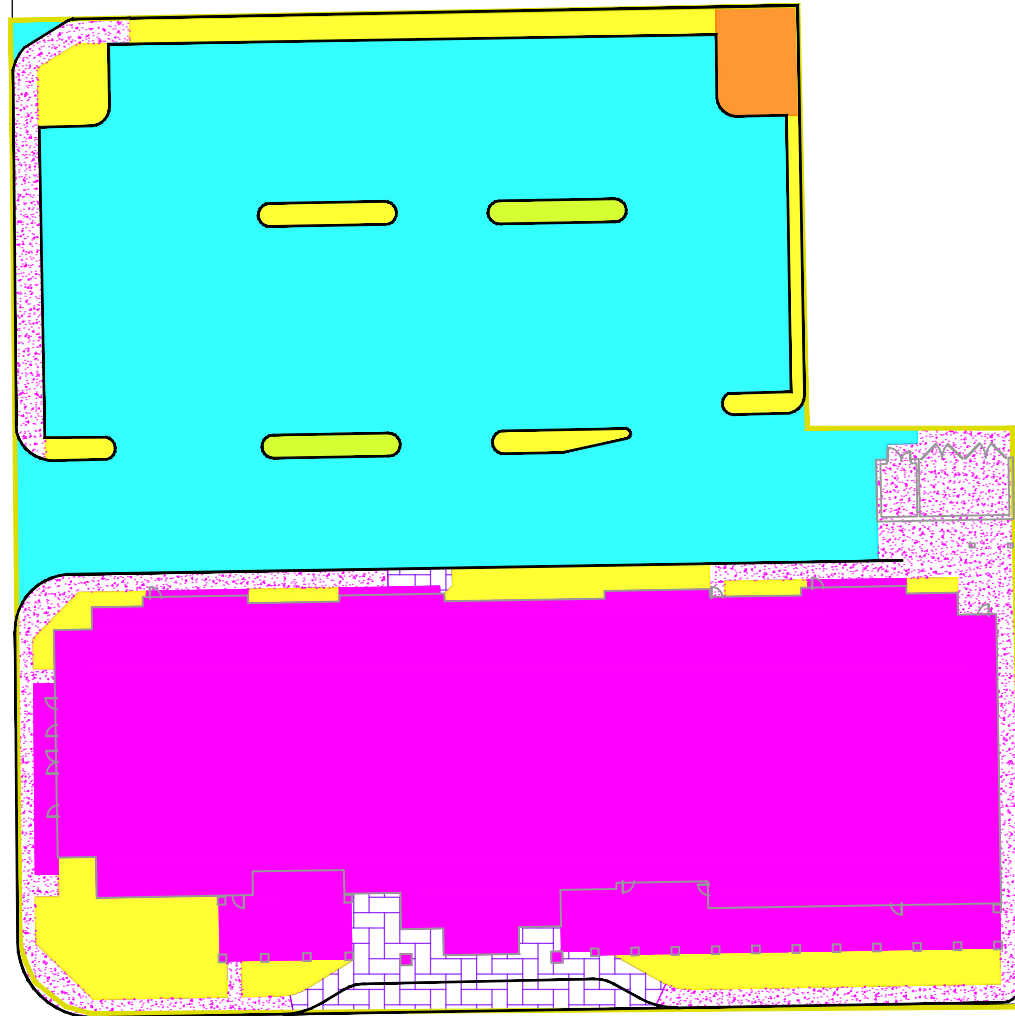
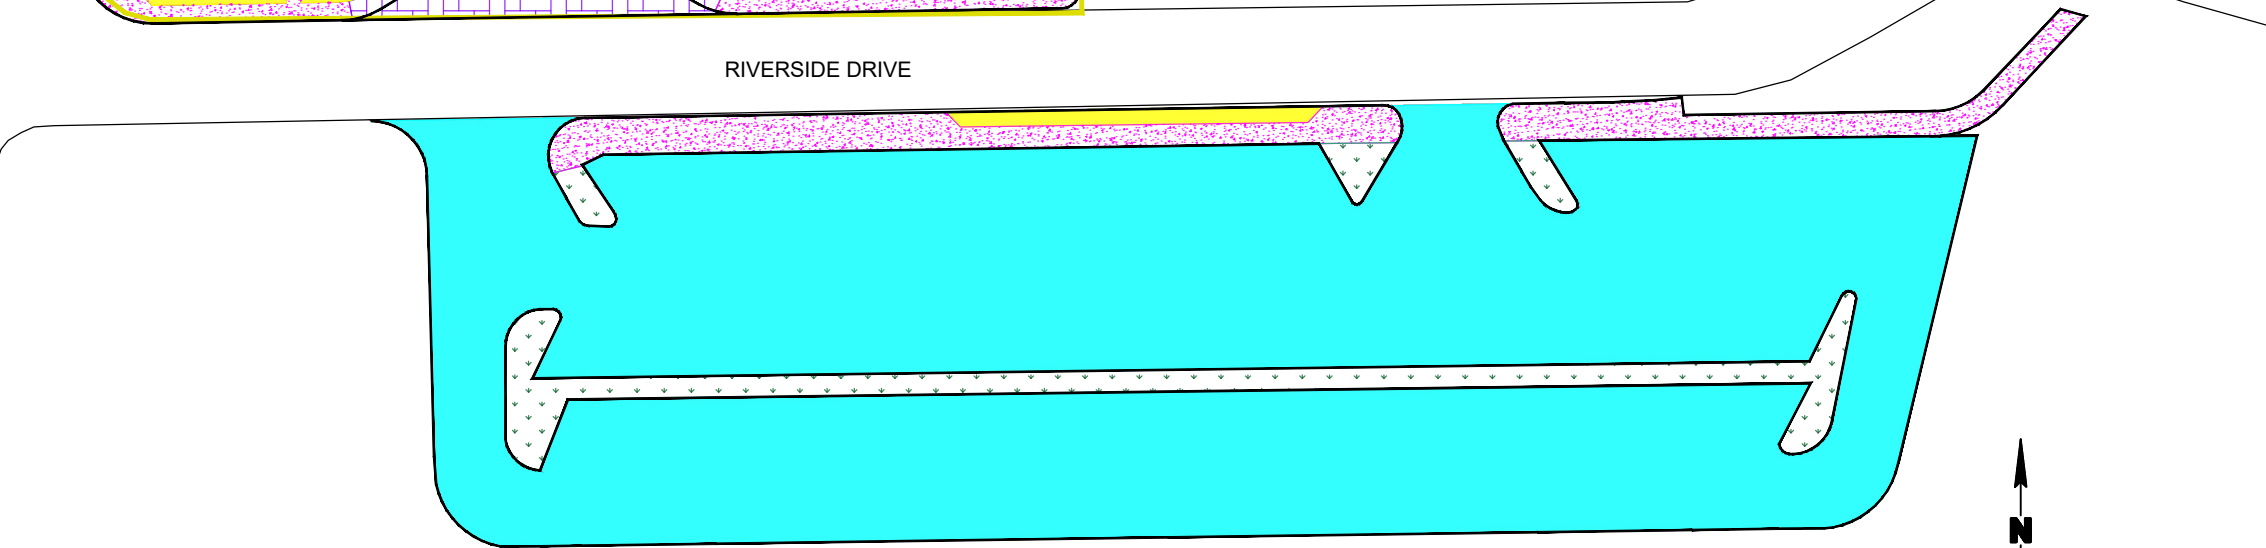
Compiled by: CNK	Date: DECEMBER 2024	FIGURE 3
	Prepared by: CNK	Scale: AS SHOWN	
	Project Mgr: CZB	Project: 4504.0001B000	
	File: FIGURE 3: COVER SYSTEM.DWG

Since remaining contaminated soil/fill exists beneath the Site, Institutional Controls and Engineering Controls (IC/ECs) are required to protect human health and the environment. The Engineering and Institutional Control Plan describes the procedures for the implementation and management of all IC/ECs at the Site. At the time of the site inspection, the Site is compliant with all engineering and institutional control requirements as shown in Figure 3 – Existing Cover System.

At the time of the Site visit and assessment, the existing cover systems (see Figure 3) are performing as intended and found to be compliant with the IC/EC requirements. No observable indication of intrusive activities, cover failure, or use of groundwater were noted.

Title: ENGINEERING CONTROLS AND INSTITUTIONAL CONTROL BOUNDARY PERIODIC REVIEW REPORT 23 RIVERSIDE DRIVE (SITE) AND CITY-OWNED PARKING LOT CORNING, NEW YORK			
Prepared for: FITZPATRICK HOLDINGS, INC.

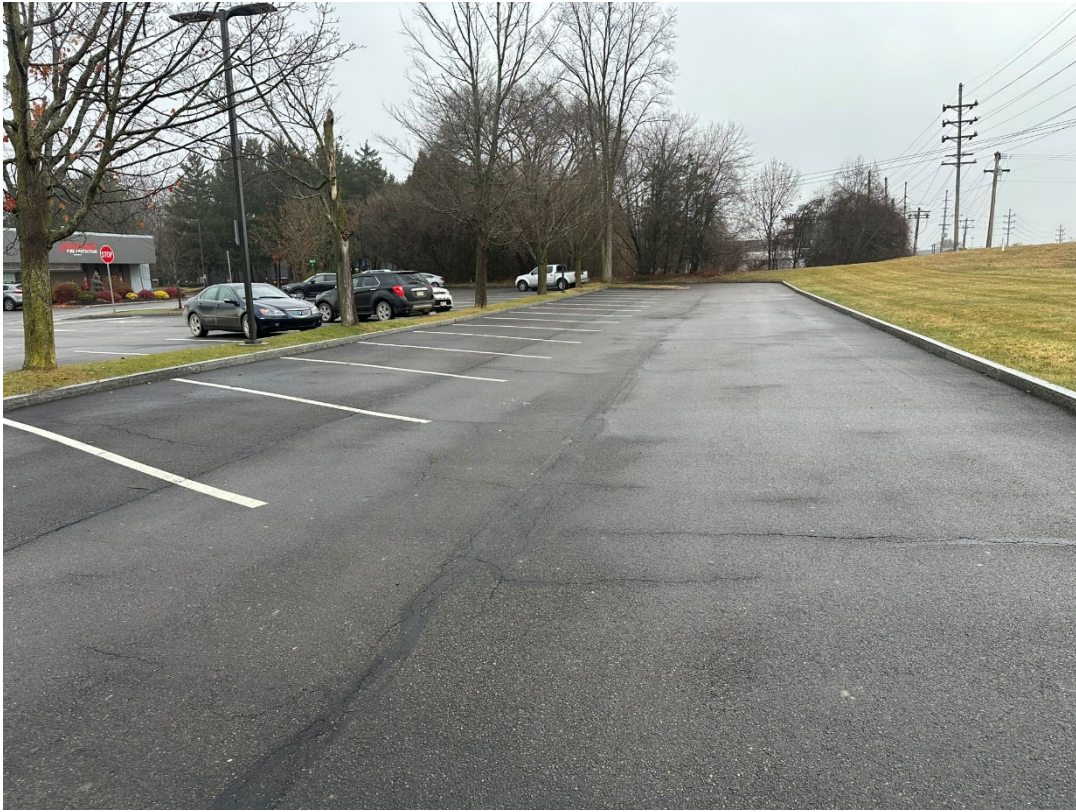
Photograph 1: City-Owned Parking Lot during November 2024 inspection (looking east).

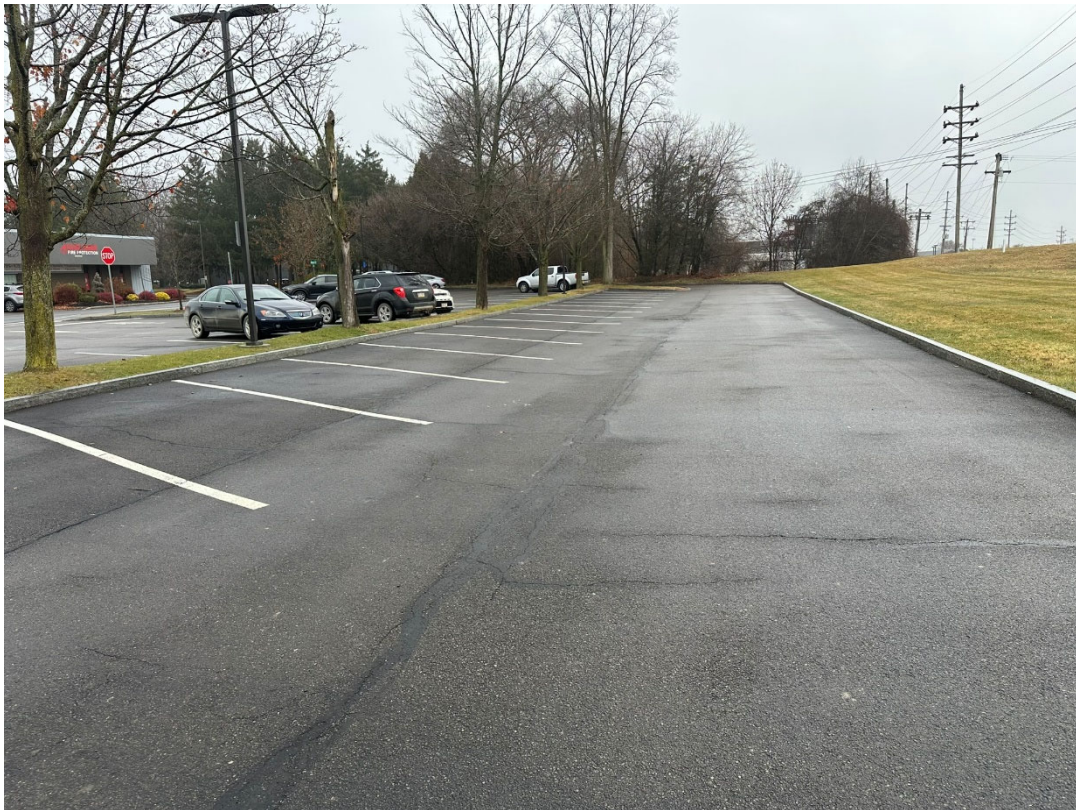
Photograph 2: City-Owned Parking Lot during November 2024 inspection (looking west).

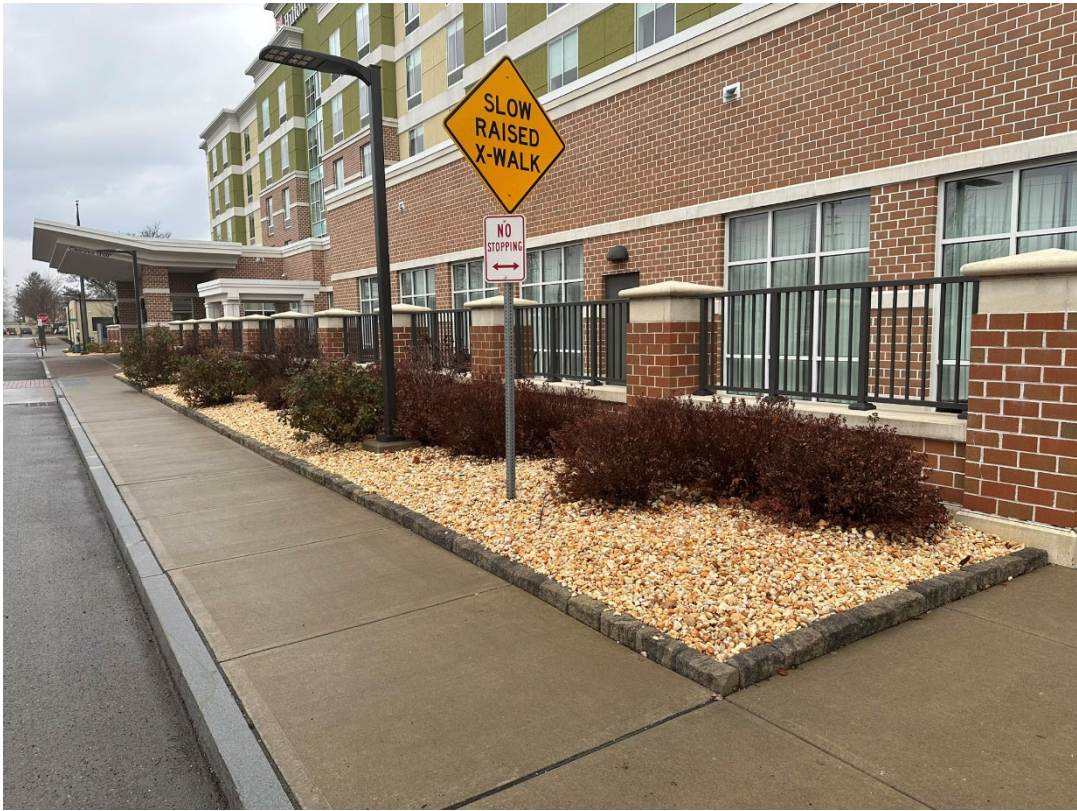
It should be noted that the mulch formerly present in the landscape beds around the building was replaced with riverstone in August 2024, similar to the north parking lots islands in 2019. According to Ms. Pamela Ray, HGI General Manager, Kizis Landscaping removed remaining the mulch to the top of the underlying black landscaping weed control fabric and replaced with riverstone. The black landscaping weed control fabric was confirmed to be present in beds on the north and south of the Site building. See Photography 4 and 10, in Appendix B. The riverstone is not a component of the cover system. The 1-foot of NYSDEC-acceptable soil imported to the Site under lying the black fabric is the cover system underlain by orange demarcation.

Photograph 3: : Landscaped bed in the southeast corner of the building along Riverside Drive. Mulch replaced with river stone in August 2024. (looking west).

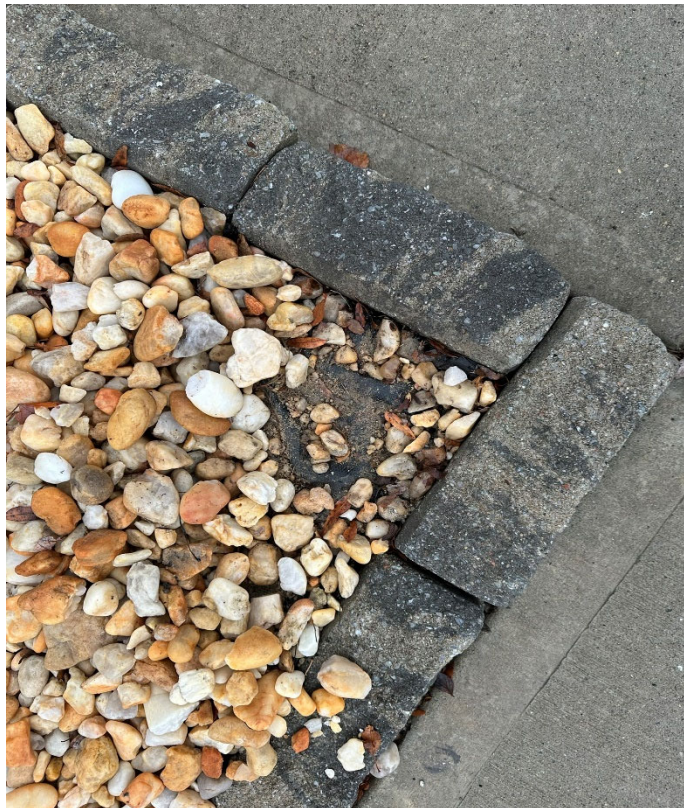
Photograph 4: Black landscape bed fabric beneath river stone in the southeast corner of the building was left in place after removing mulch in August 2024.

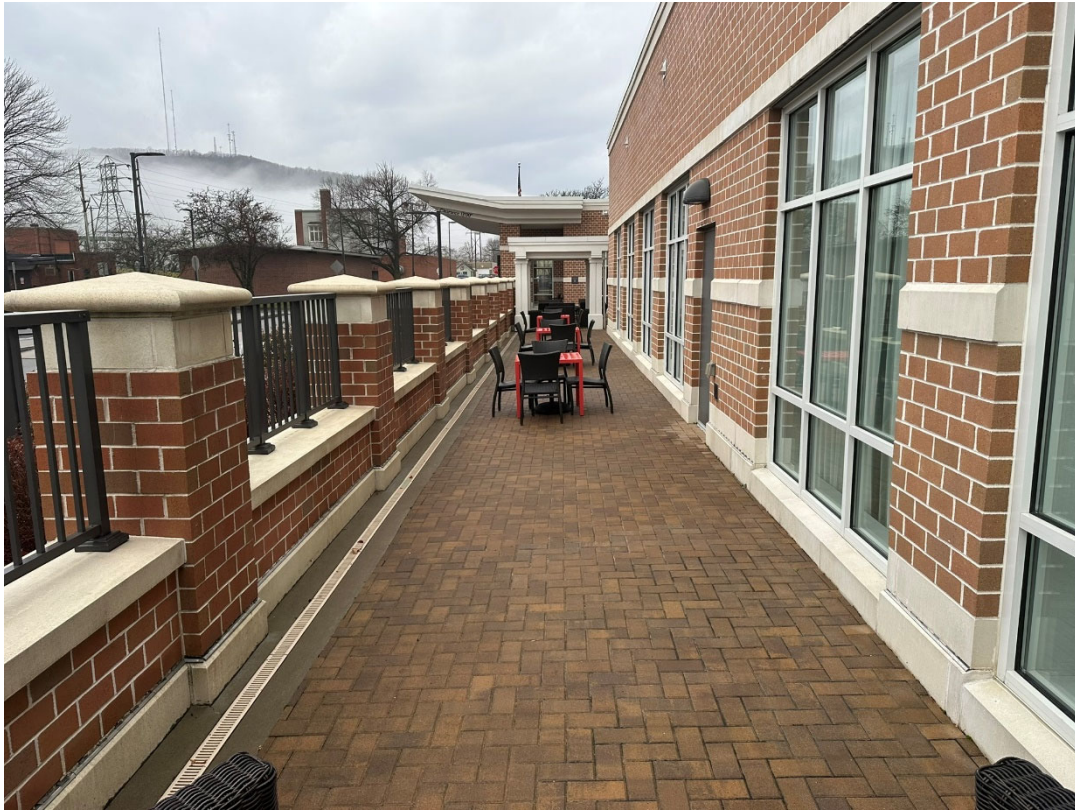
Photograph 5: Patio and stamped concrete cover system in the southeast corner of the building along Riverside Drive (looking west).

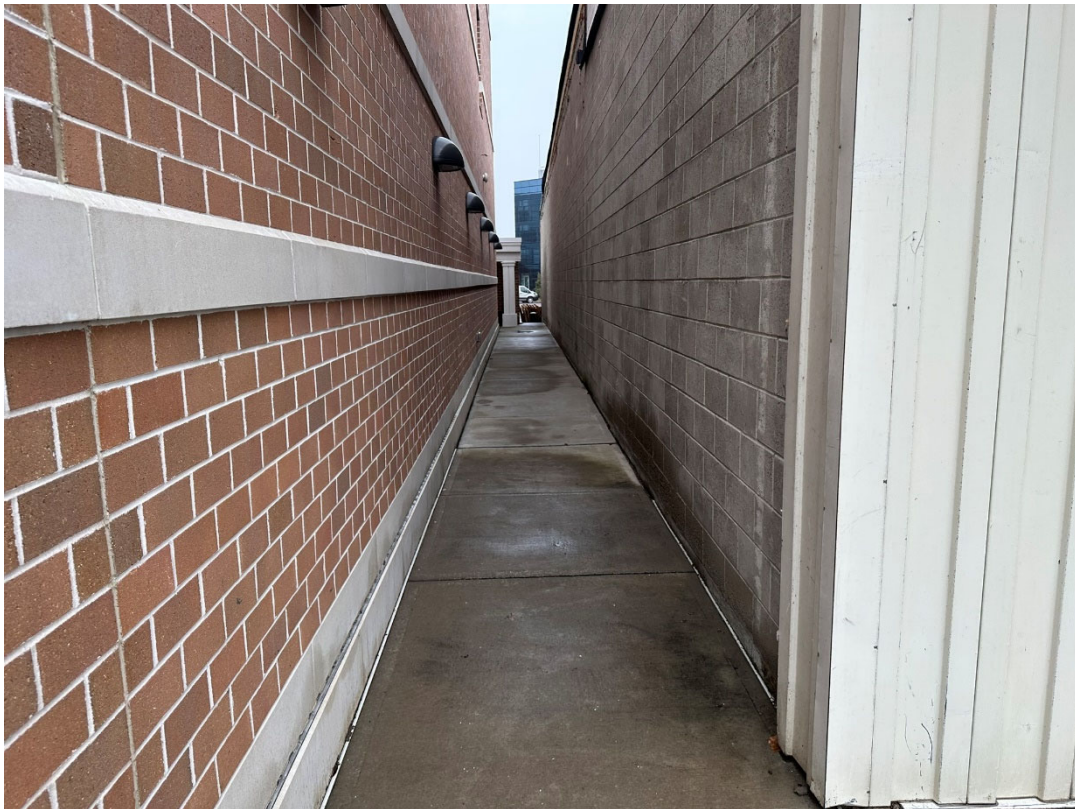
Photograph 6: Concrete cover system along east side of building (looking north).

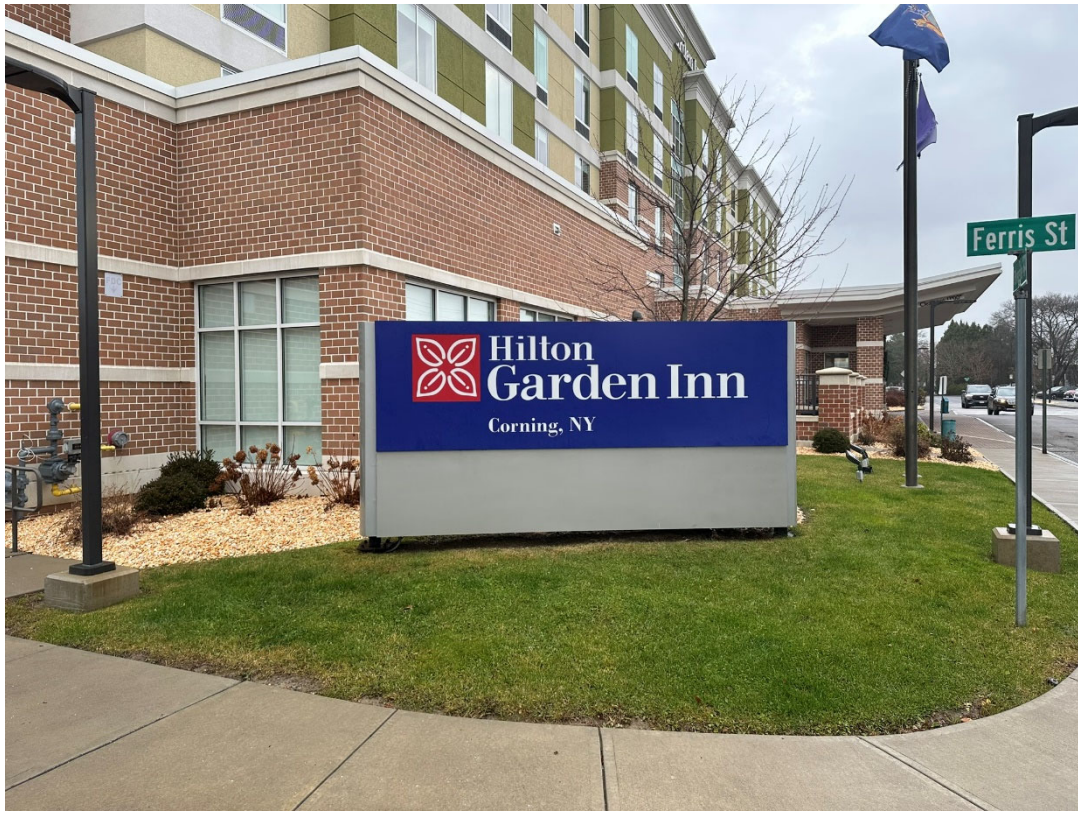
Photograph 7: Greenspace on the southwest corner of the Site (looking east).

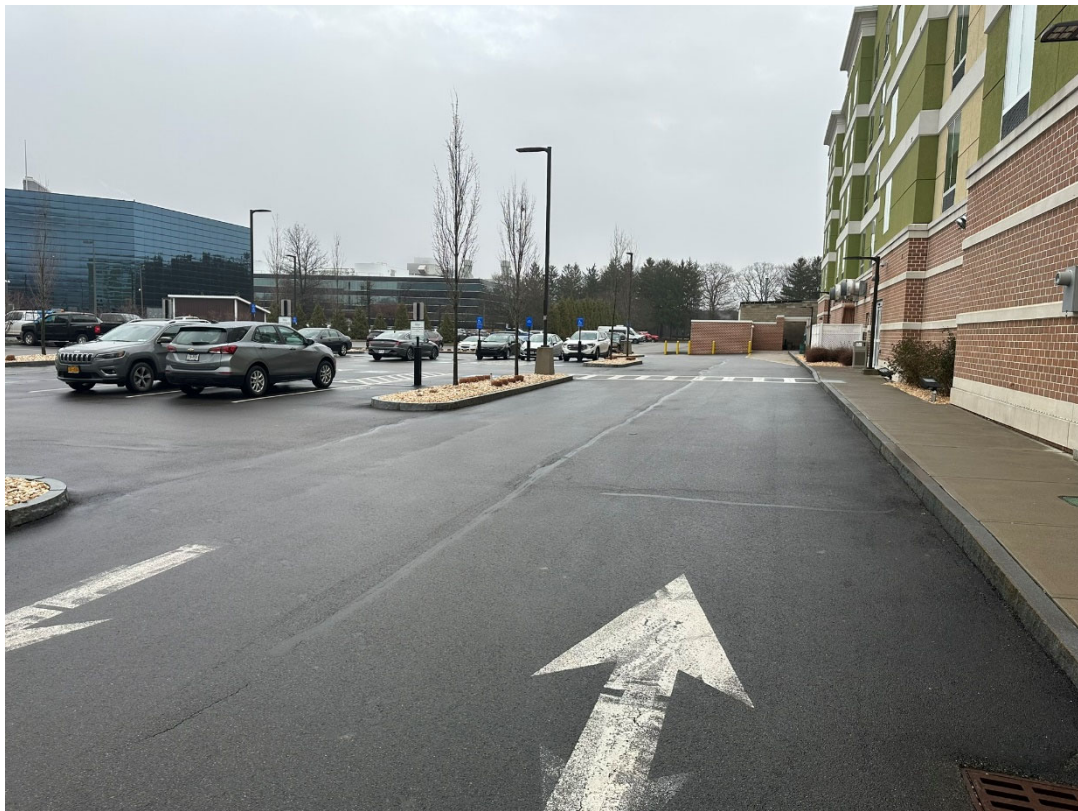
Photograph 8: Parking lot and landscaped islands on the north side of the building (looking east).

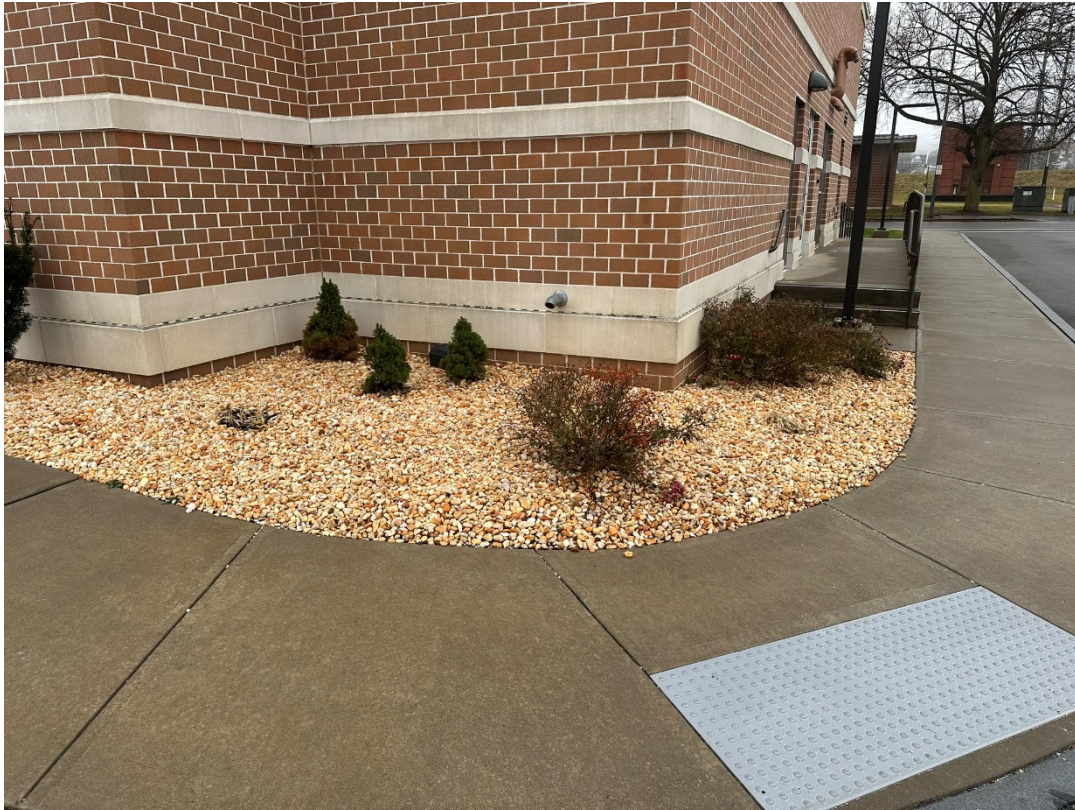
Photograph 9: Landscaped bed (riverstone used to replace mulch in August 2024) on the northwest corner of the building (looking south).

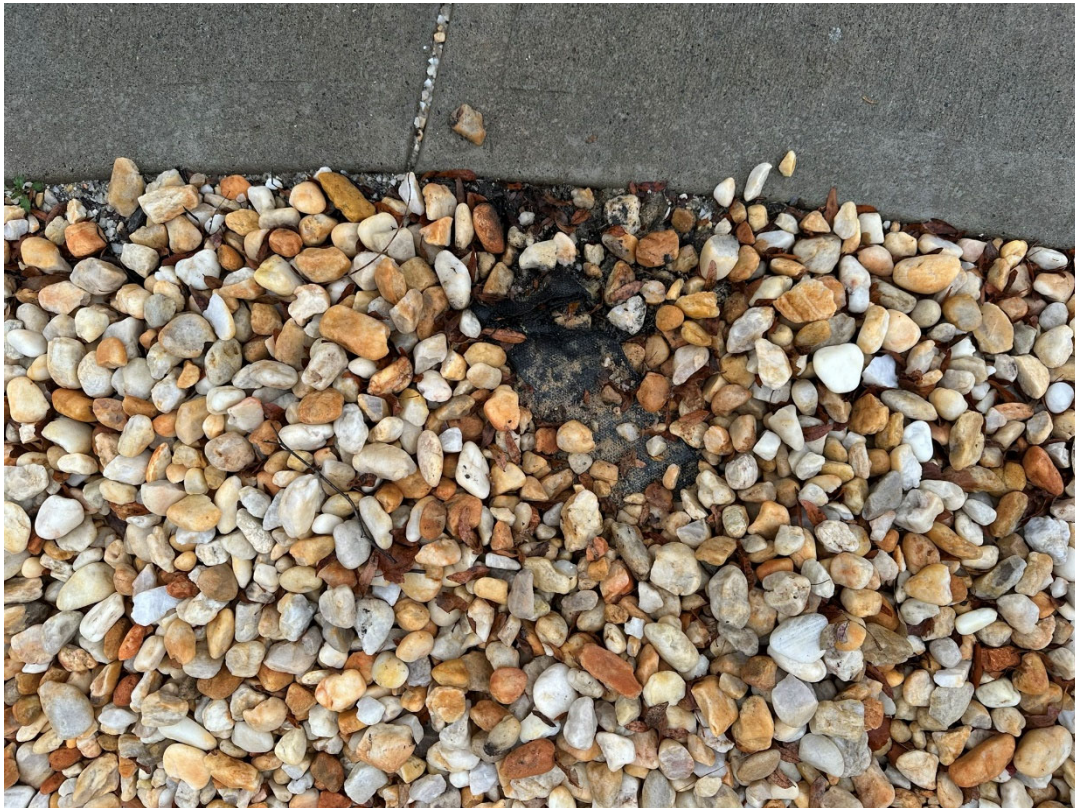
Photograph 10: Black landscape bed fabric beneath riverstone in the northwest corner of the building was left in place after removing mulch in August 2024.

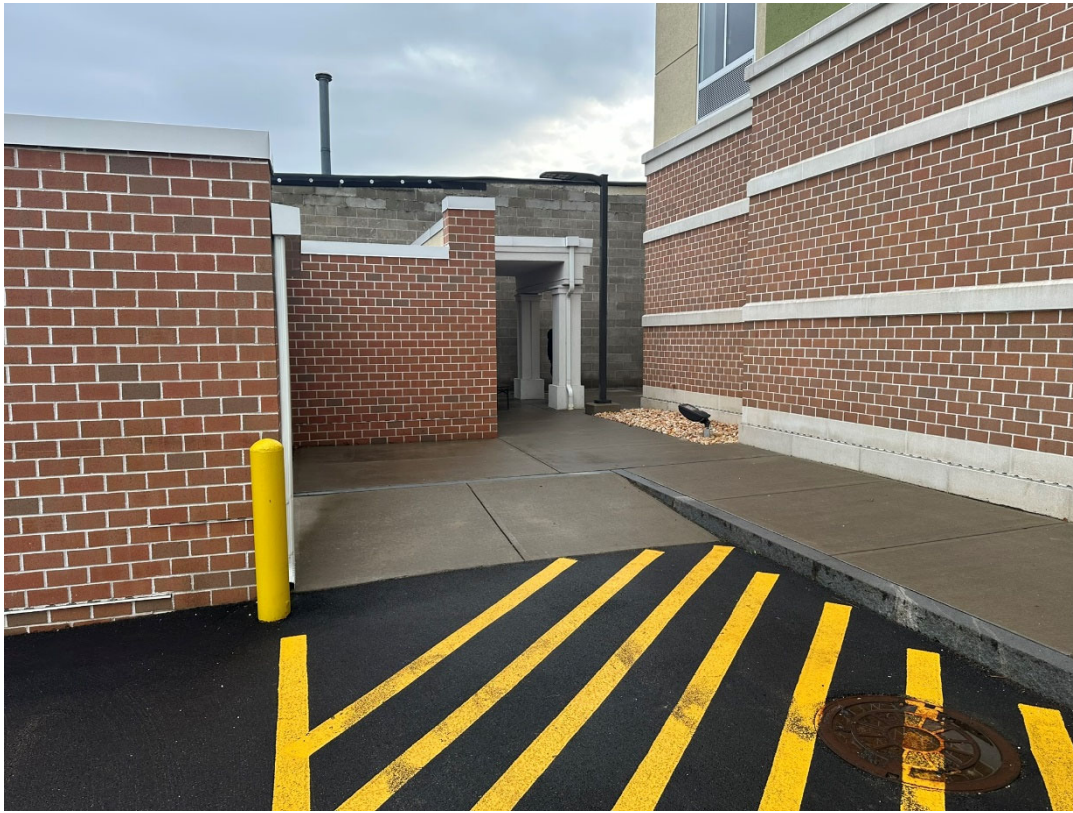
Photograph 11: Concrete sidewalks and back side of exterior storage areas along the northeast corner of the building (looking east).

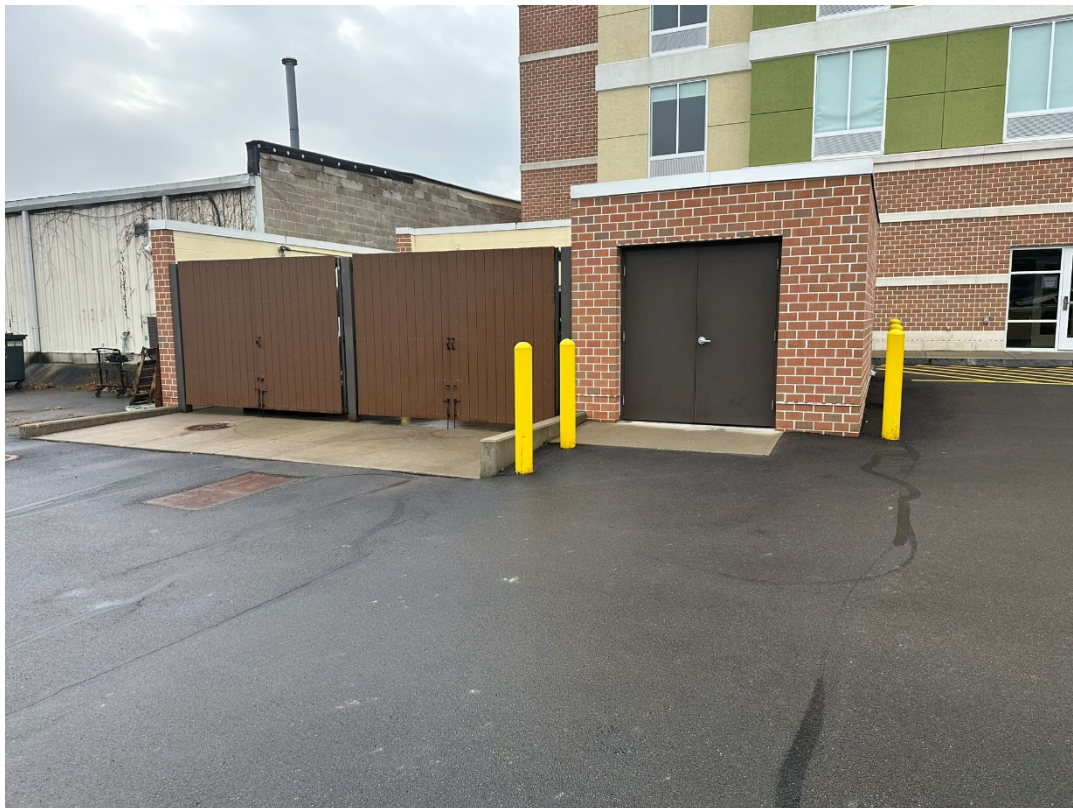
Photograph 12: Dumpster areas and exterior storage area at the northeast corner of the building (looking south).

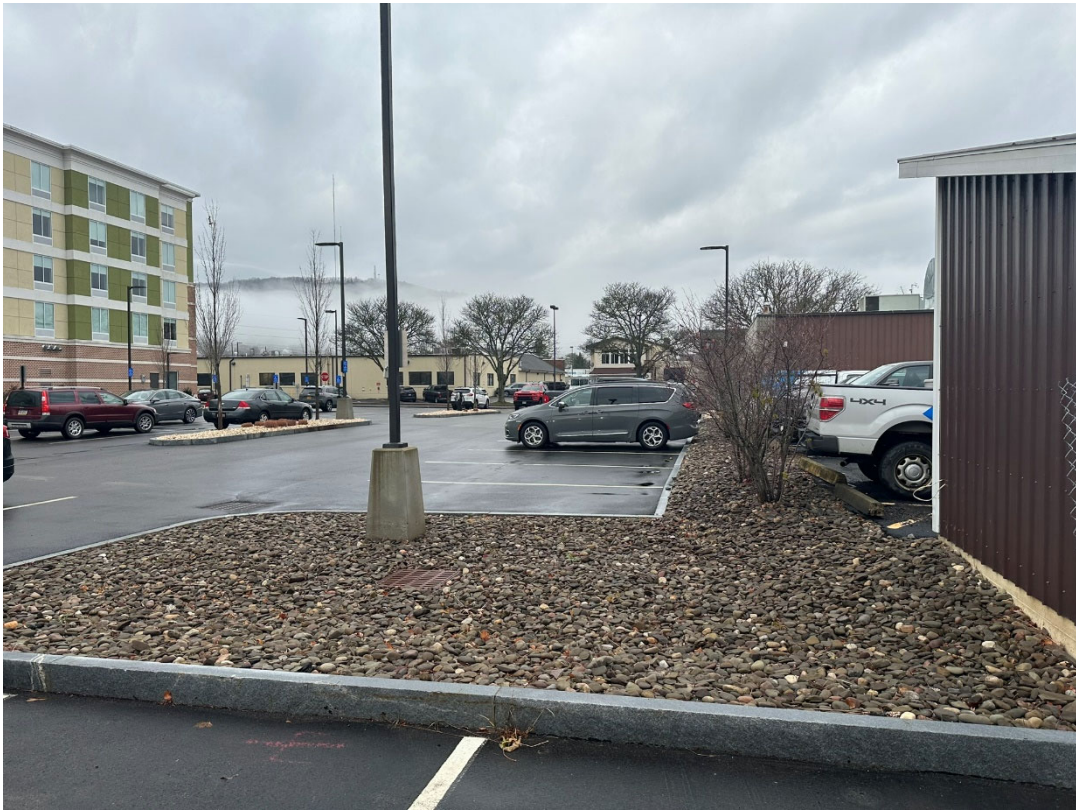
Photograph 13: Rip rap cover system in northwest corner of Site (looking east).

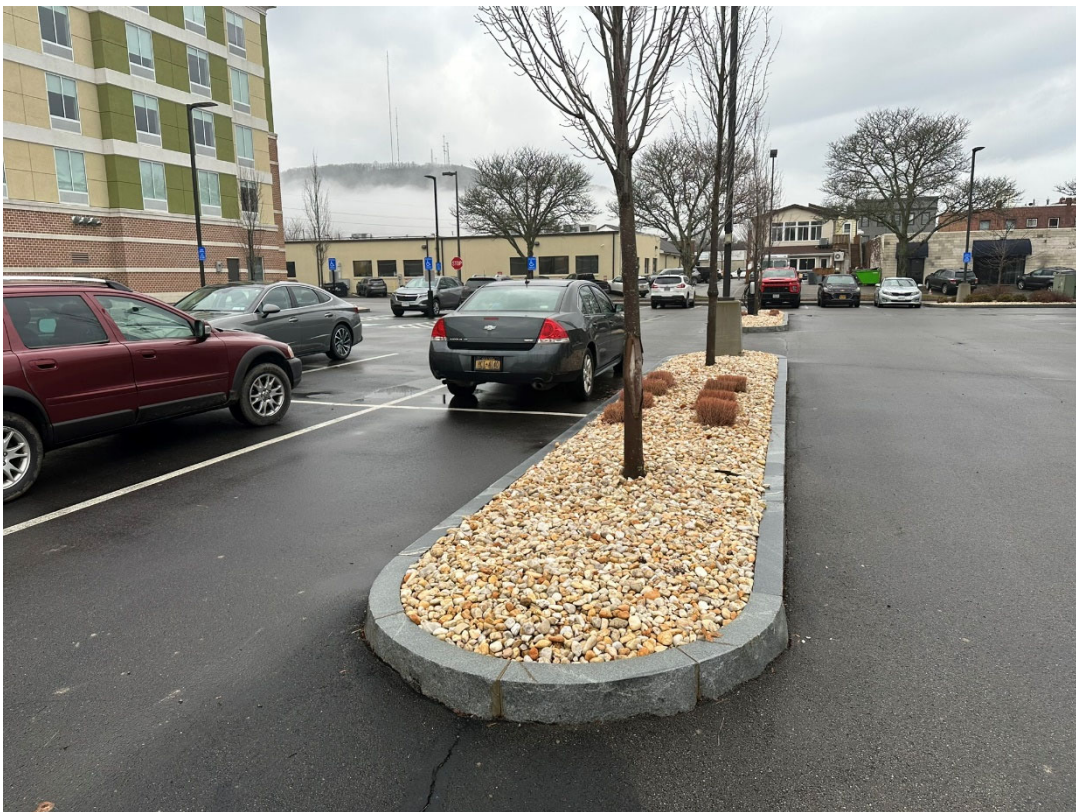
Photograph 14: Parking lot and landscaped island on north side of the building (looking east).
