# SHORT-TERM RESPONSE ACTION SUMMARY REPORT

River Road Site

Corning, Steuben County, New York

February 2025

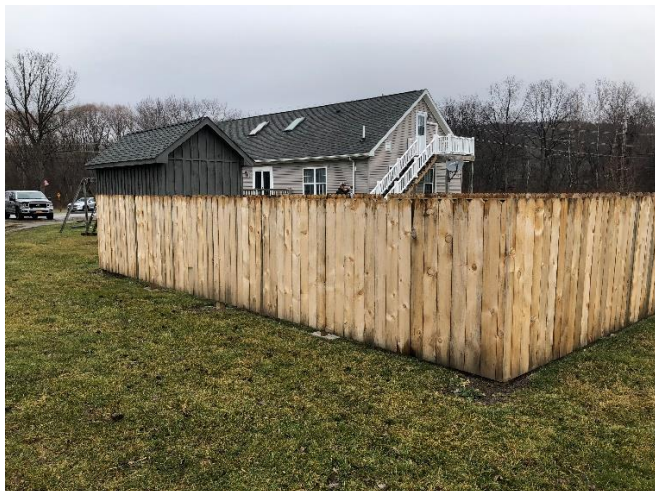
*Photo #1*

View Looking northeast: Fenced-in playground area exterior view. Residence is visible in the background.

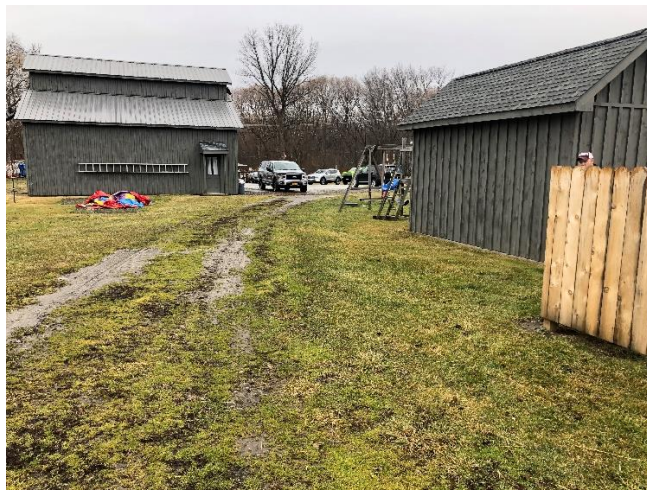
*Photo #2*

View Looking northeast: Fenced-in playground area visible on the right of the photo. Gravel access roadway runs to the southwest of the fenced enclosure.

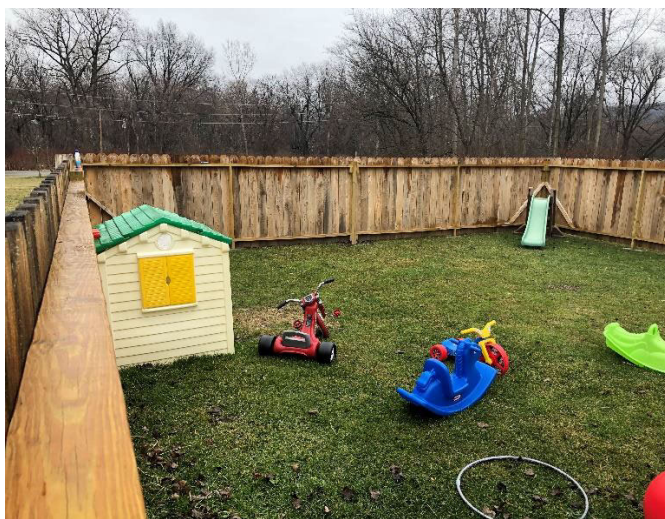
*Photo #3*

View Looking east: Interior view of the fenced enclosure containing multiple pieces of playground equipment including a small playhouse, toy chest (not visible) see-saw and tricycles. Fence posts are set in every corner and midway on the fence wall.

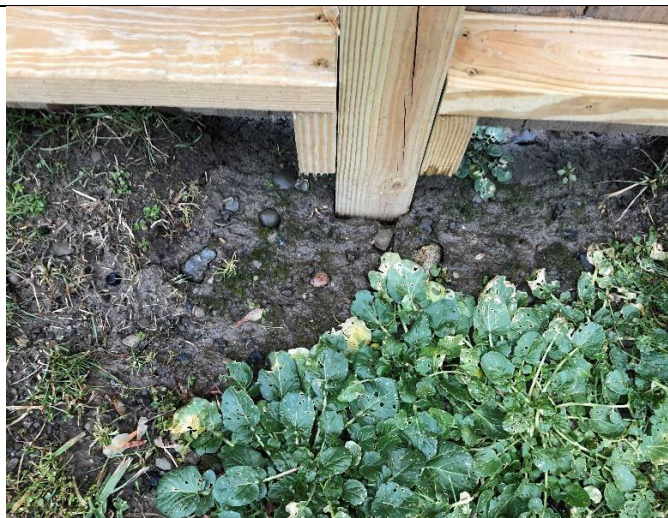
*Photo #4*

View Looking down: Typical fence post installation with excavated soils from the subsurface around the post. Glass is visible on the surface soils approximately 1.0 to 1.5 radius around the post.

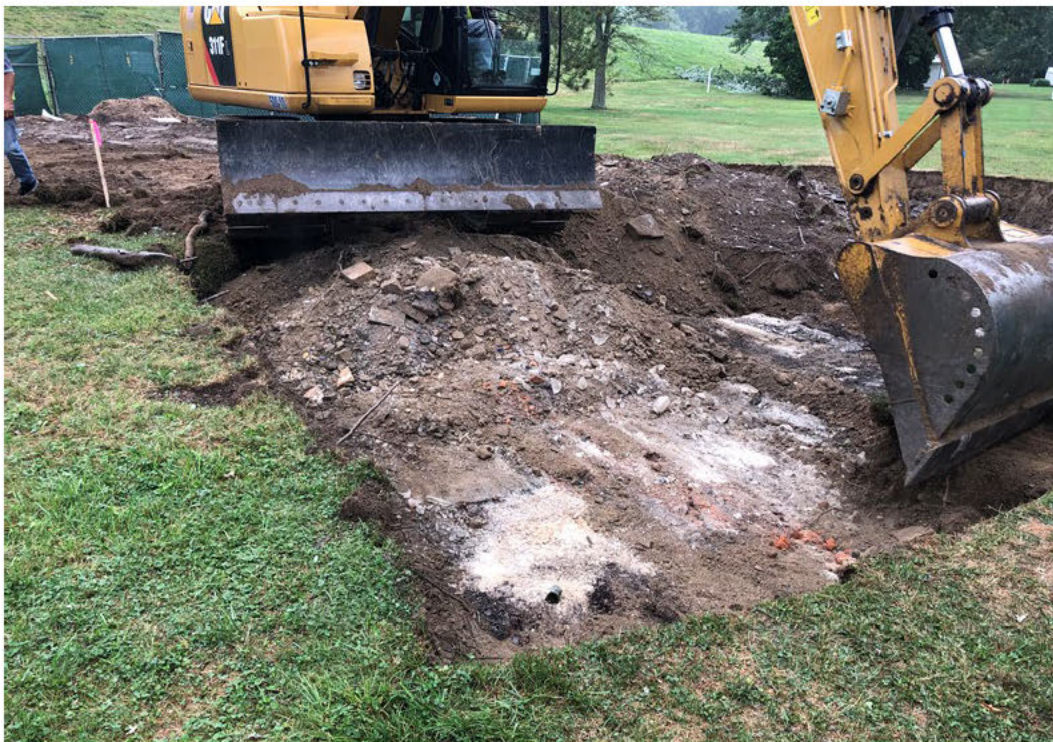
Picture 2: Excavation heavily impacted with ABG.

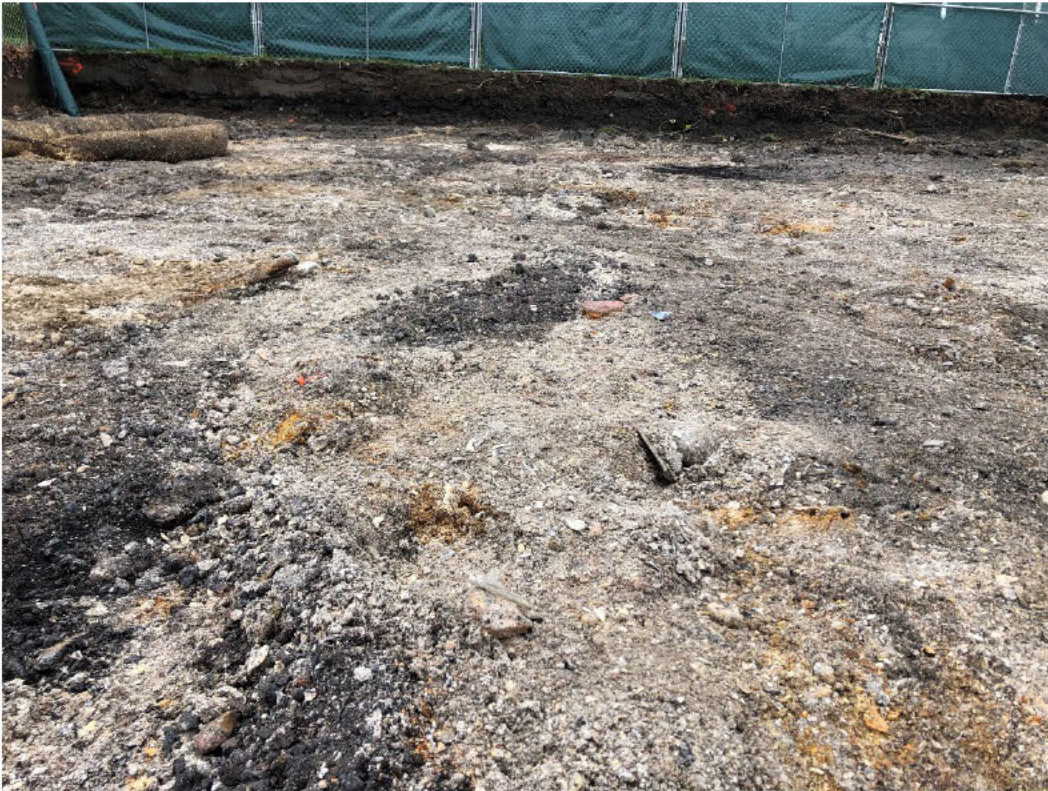
Picture 3: Excavation heavily impacted with ABG.

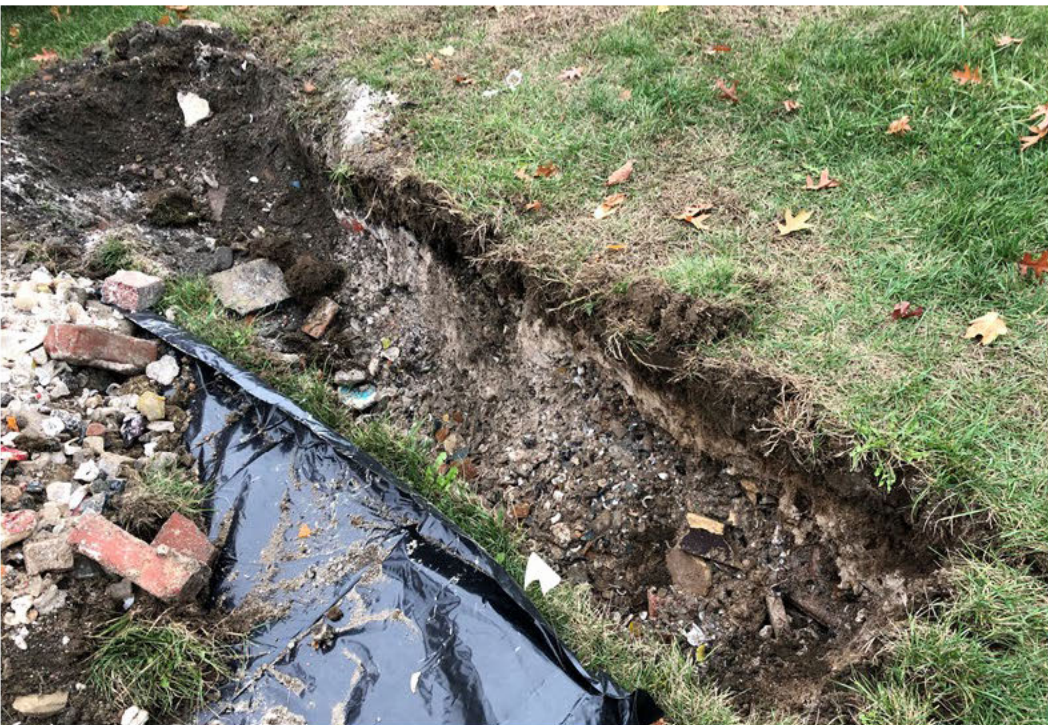
Picture 4: Test pit excavation heavily impacted with ABG.

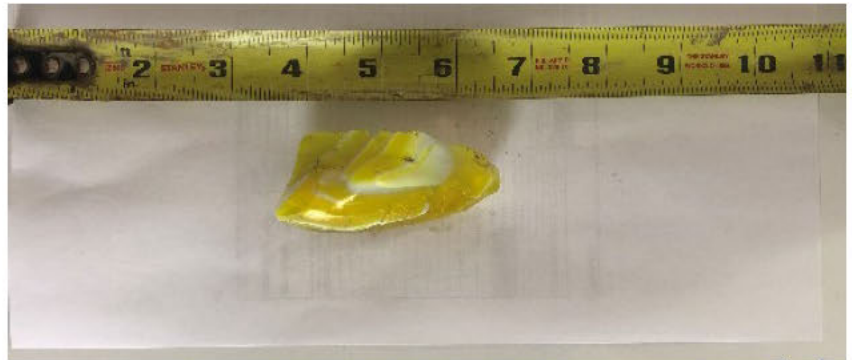
- Broken, fragmented, or discarded glass indiscernible from a final product.
- Sometimes air bubbles are trapped within glass media.
- Sometimes speckled or fused with other colored glass.

Picture 5: Cullet with layers of yellow and white.

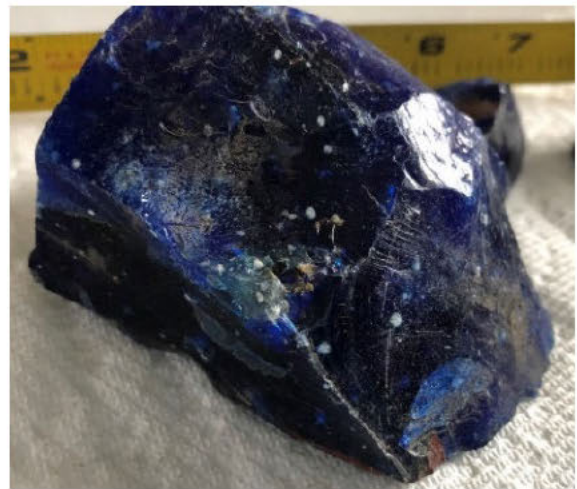
Picture 6: Blue cullet with white specks.

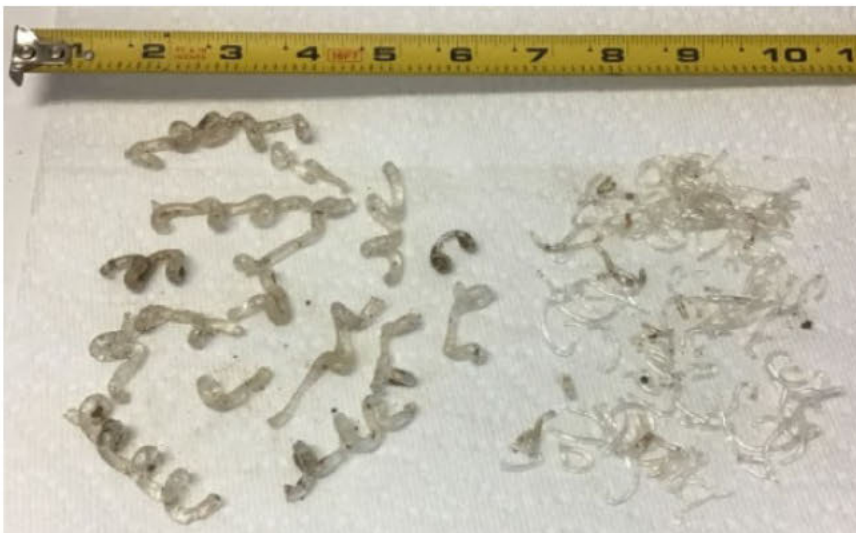
Picture 7: Clear spaghetti-shaped cullet.

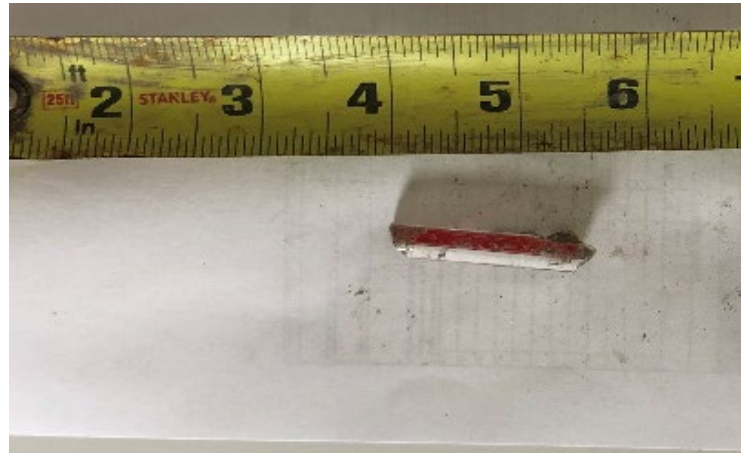
- Tubing is generally smaller than 1 inch diameter. Lengths of up to 1.5 feet have been observed.
- Clear glass makes up majority of the tubing; colored glass is encased within the clear glass and extends along the length of the piece.
- Most pieces have a hollow center (called a bore) extending the length of the tubing.
  - A visible bore is a manufacturing defect. The bore is not supposed to be visible to the naked eye.

Picture 8: Piece of thermometer tubing with red and white strips.

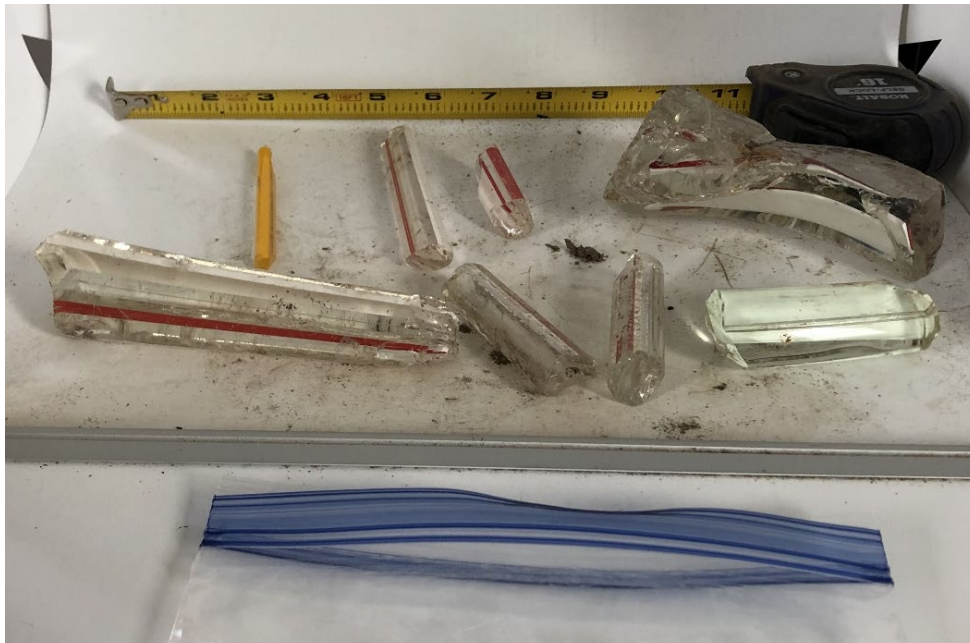
- Observed cross-section shapes include triangular, circular, and irregular.
- Encased colored glass is usually white, red, orange, and/or yellow but can be black, green, or blue.

Picture 9: Most thermometer tubing fragments have strips of white and red glass encased in clear glass. One piece has an orange strip (top left). One piece has only a white strip (bottom right).

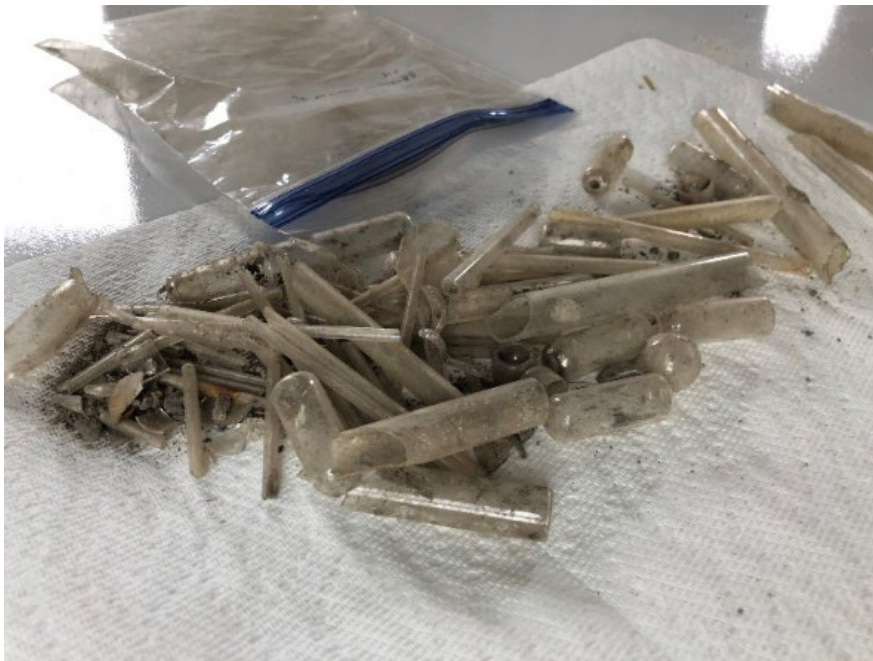
- Various inner and outer diameters, from less than 1 millimeter to greater than 1 inch.
- Diameter can vary for an individual piece.
- Primarily clear and transparent but can be blue, orange, yellow, green, and red. Opacity varies.

Picture 10: Collection of hollow tubing.

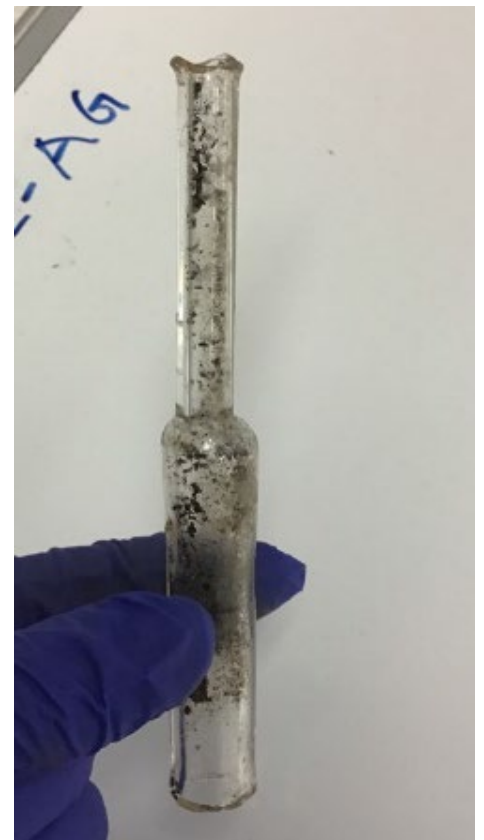
Picture 11: Hollow tubing fragment.

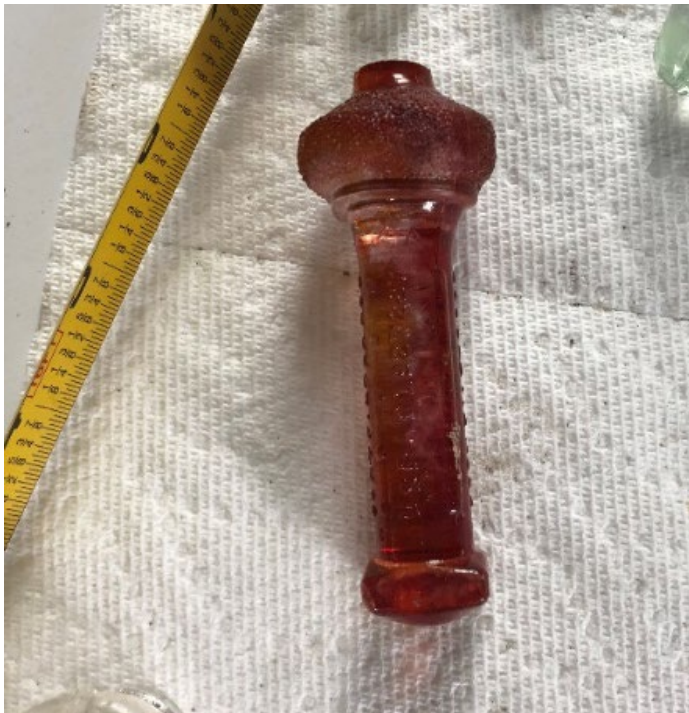
- Unique shape with embossing “Cory Filter Rod” or “New Cory Rod” and US Patent numbers.
- Pieces usually have one broken end (side with rounded bulb shape).
- Clear or reddish-brown color.
- The center cross section is circular and rounded-square.

Picture 12: Reddish-brown Cory Filter Rod fragment.

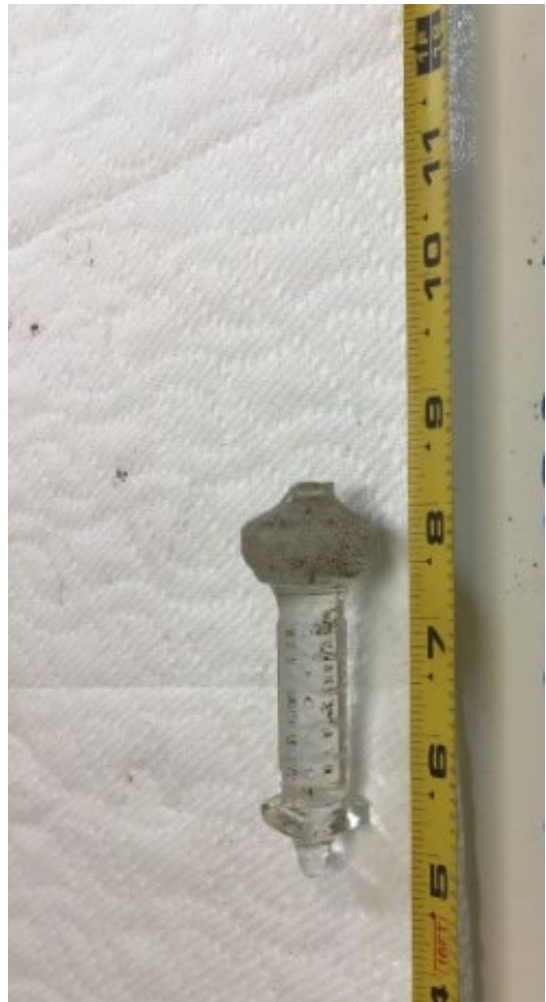
Picture 13: Clear Cory Filter Rod fragment.

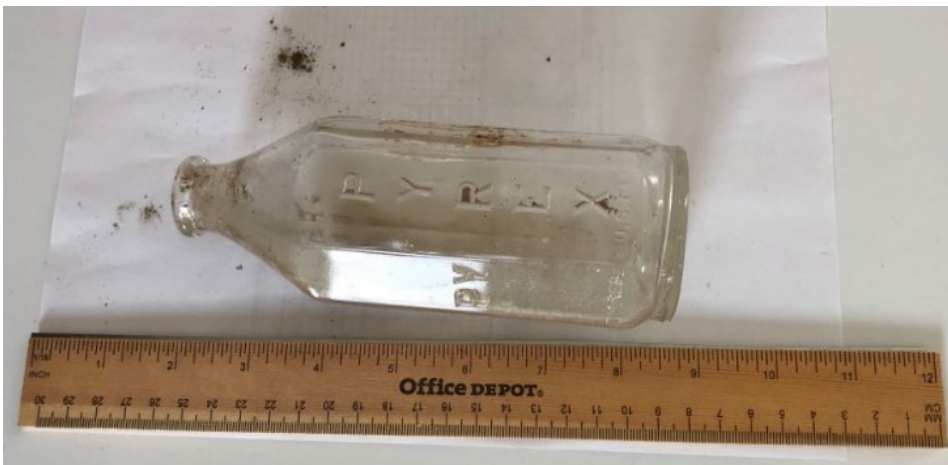
- Unique embossed or engraved logo.
  - Often just embossed as “PYREX.”
  - Embossing size varies.
- Some glass pieces have patent numbers embossed on them.
- Various manufactured glass products were branded PYREX.
- Other trademarked names include Corningware, Flameware, Nonex, Macor, Multiform, Vycor, Corelle, and Fota-Lite.

Picture 14: Pyrex baby bottle.

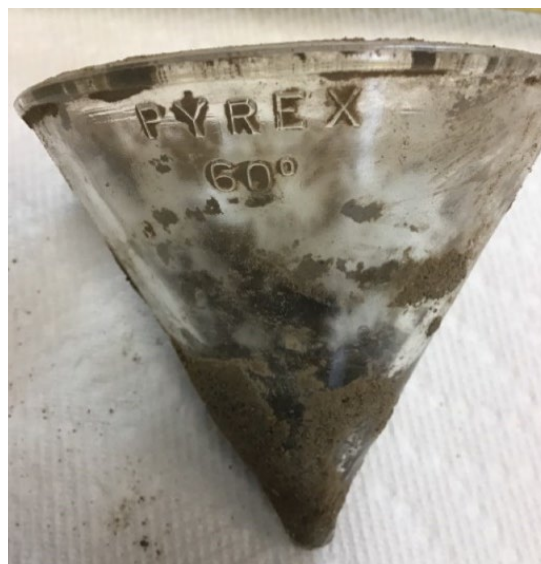
Picture 15: Pyrex glass cone.

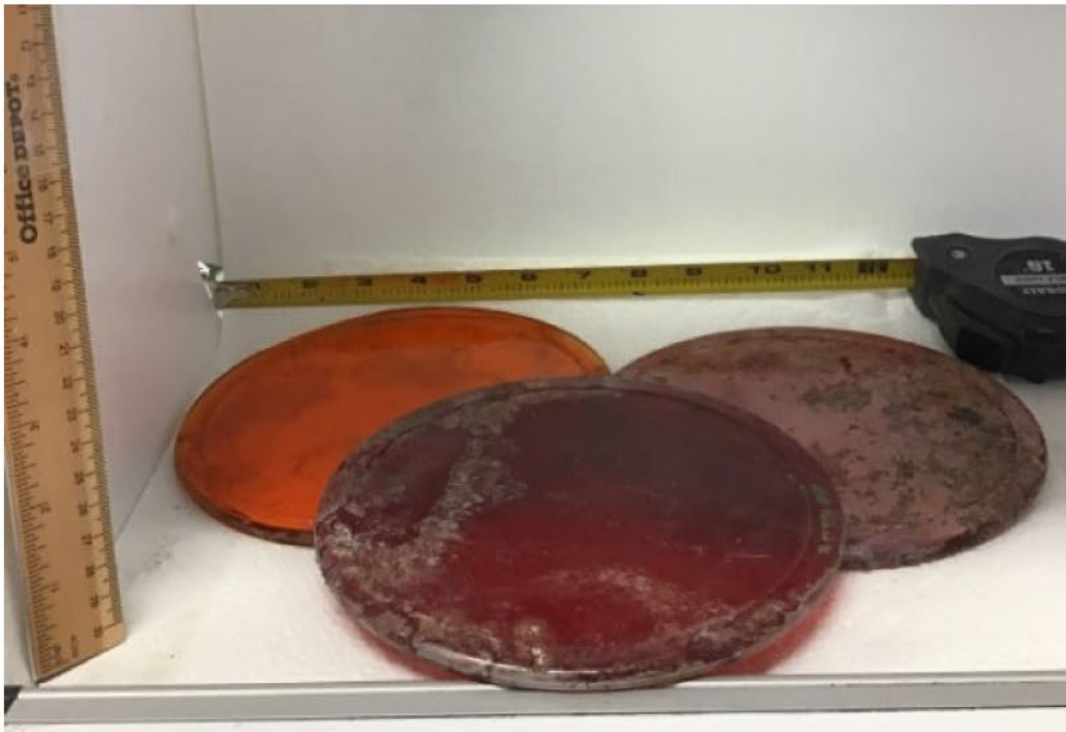
Picture 17: One orange and two red disk lenses. Each lens is embossed along the rim with "CORNING T. M. REG. U. S. PAT. OFF. MADE IN USA."

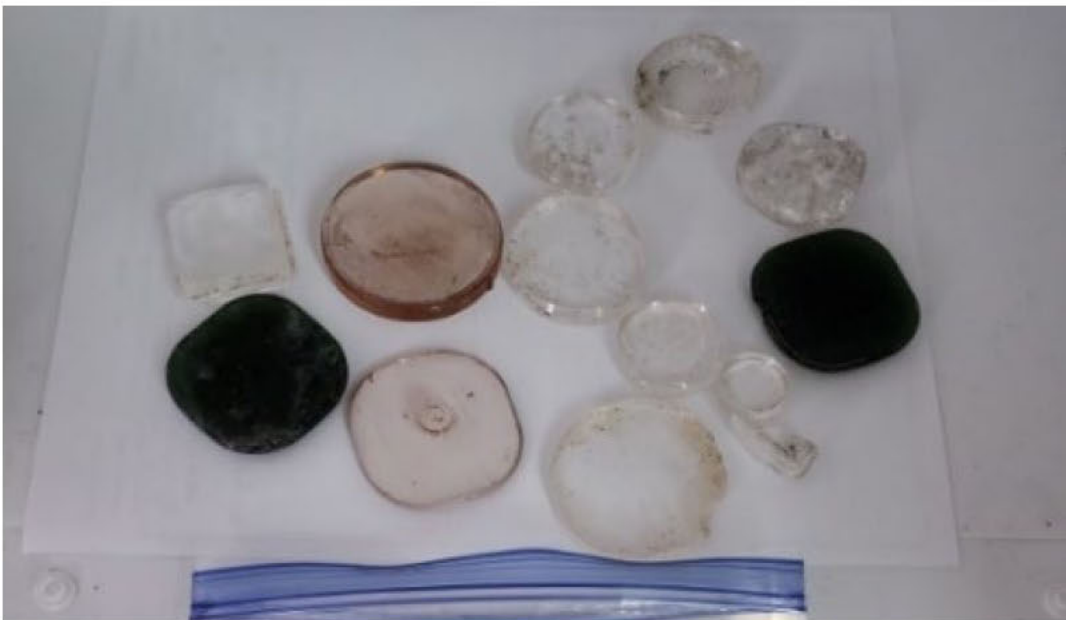
Picture 18: Green, light brown, and clear optical and ophthalmic lens blanks of various shapes.

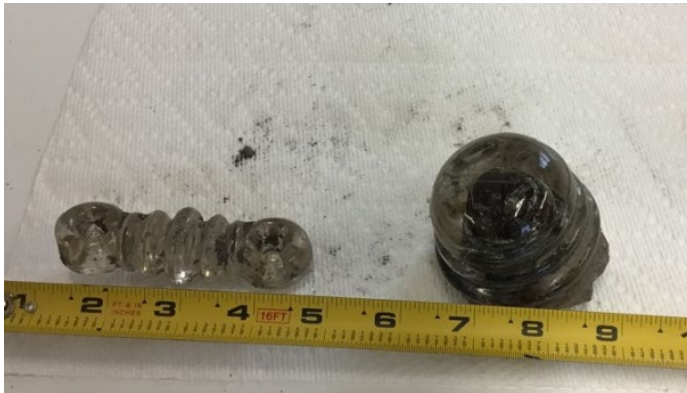
Picture 20: Glass radio antenna insulator (left) and insulator (right).

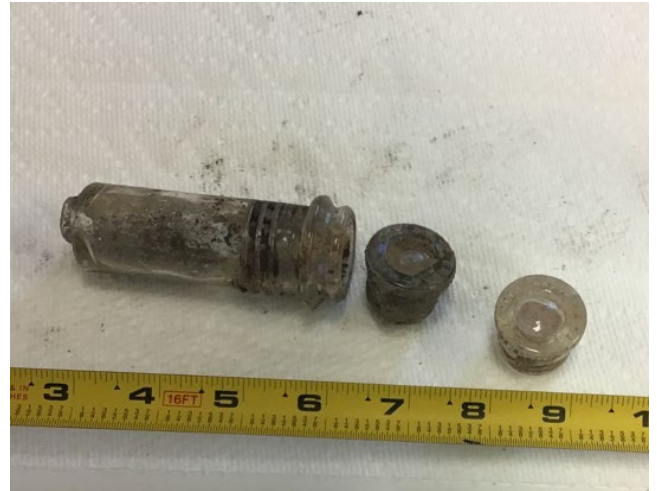
- Intact or recognizable pieces are usually embossed with “PYREX” and patent number.
- Generally clear glass but may be opaque and opalescent.

Picture 19: Insulator (left) and two glass fuses. “PYREX” is embossed on each piece.

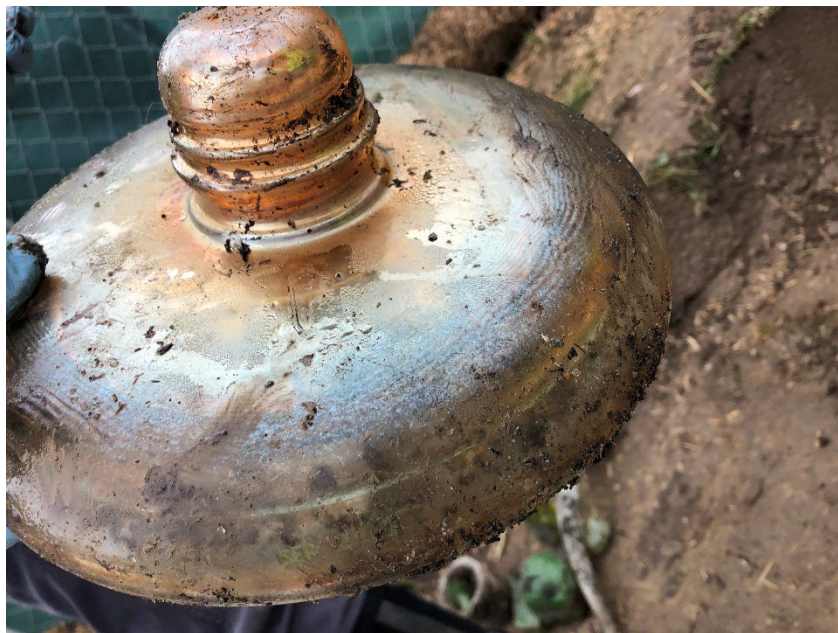
Picture 21: Opalescent insulator with approximately 1-ft diameter.

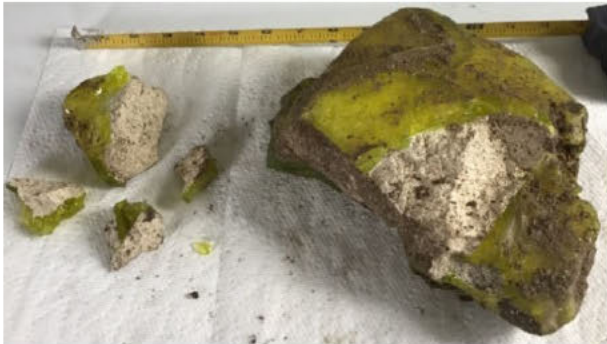
- Generally colored yellow, yellow-green, or green. Opacity varies.
- Fluoresces green under ultraviolet light.
- Generally observed as cullet (irregular pieces and chunks) but has been observed as hollow tubing.

Picture 23: Uranium glass fused to refractory brick.

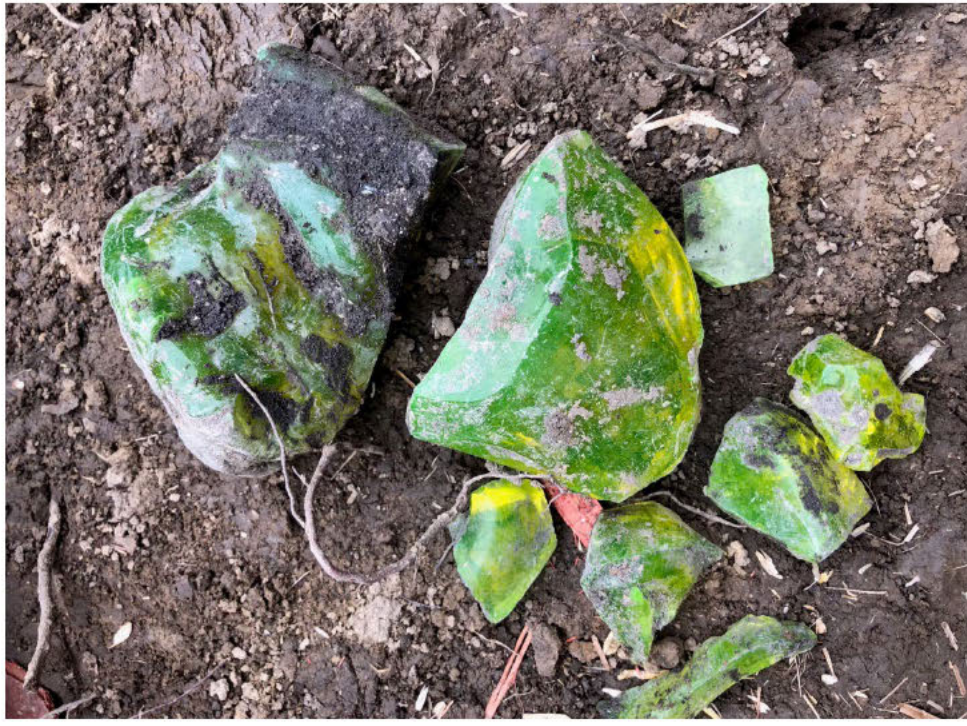
Picture 24: Translucent yellow-green uranium glass collected from an excavation.

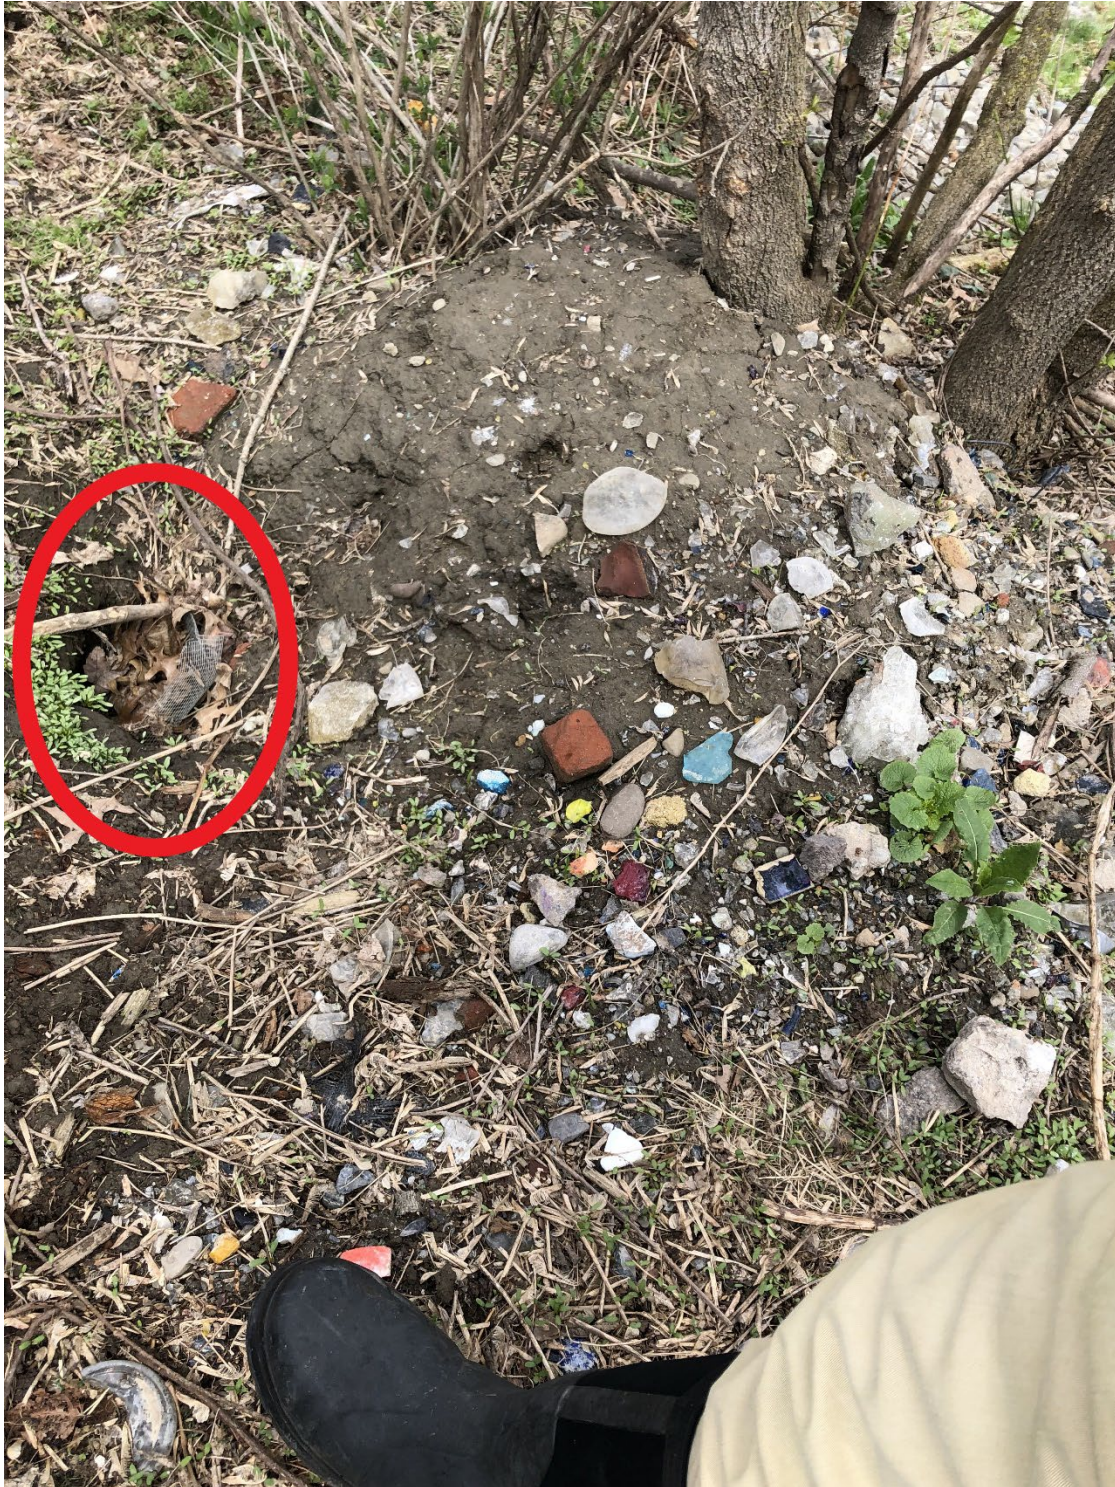
Picture 25: Comingled red brick, refractory chunks, and cullet. ABG ejected from animal burrow (circled red).

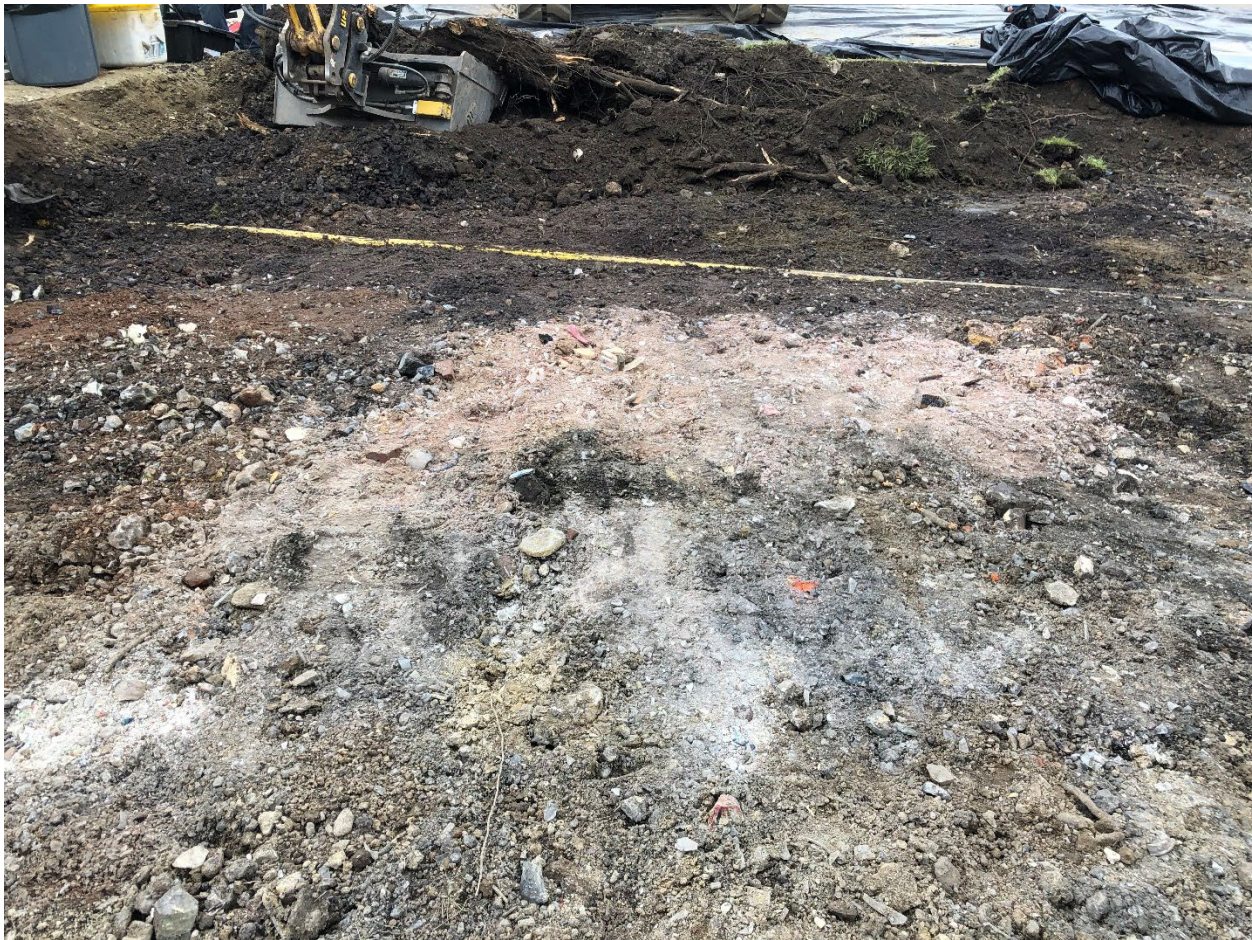
Picture 26: Comingled black ash and slag (top, along yellow gas line), cullet, refractory pieces, gray ash, and light orange ash.

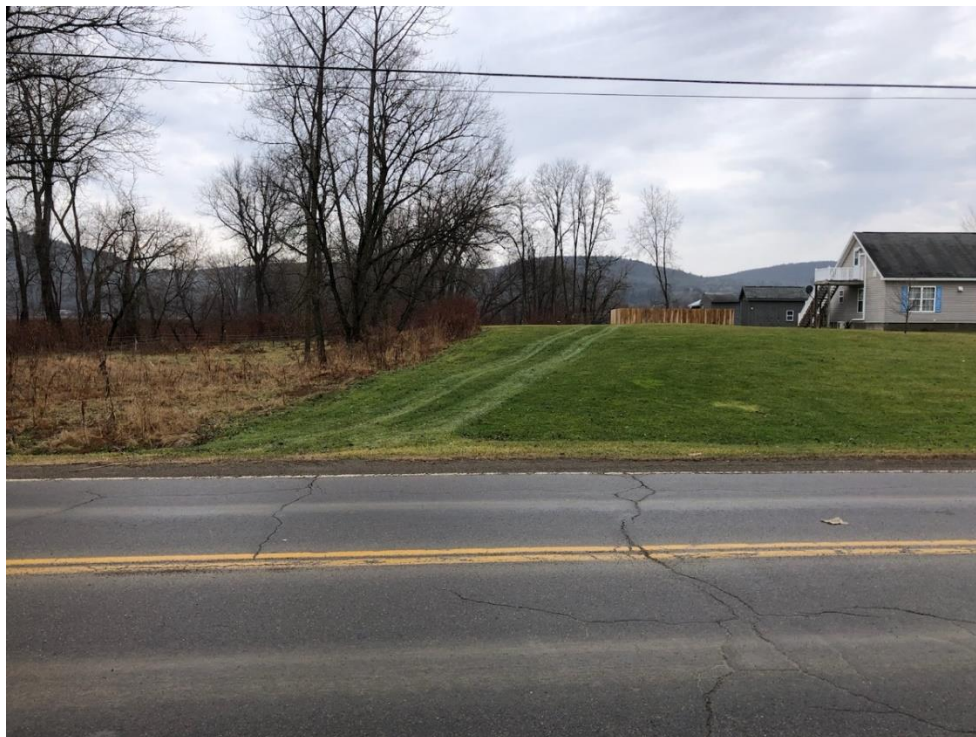
*Figure 1- View of site elevated approximately nine feet above natural grade (flood plain).*

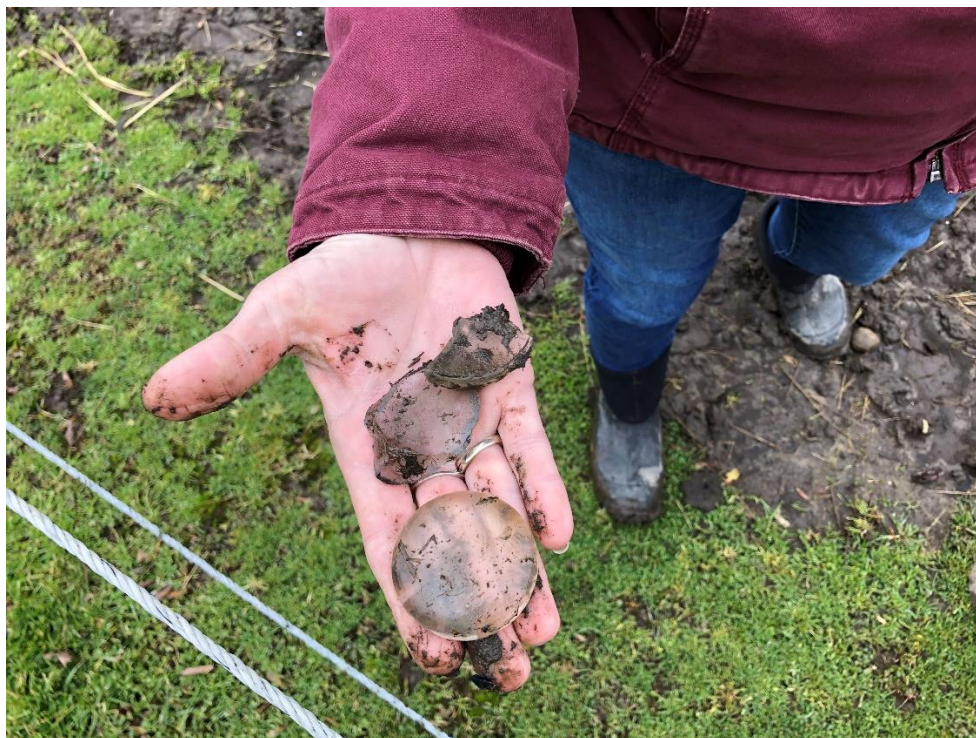
*Figure 2 - Glass lenses and fragments found on site.*

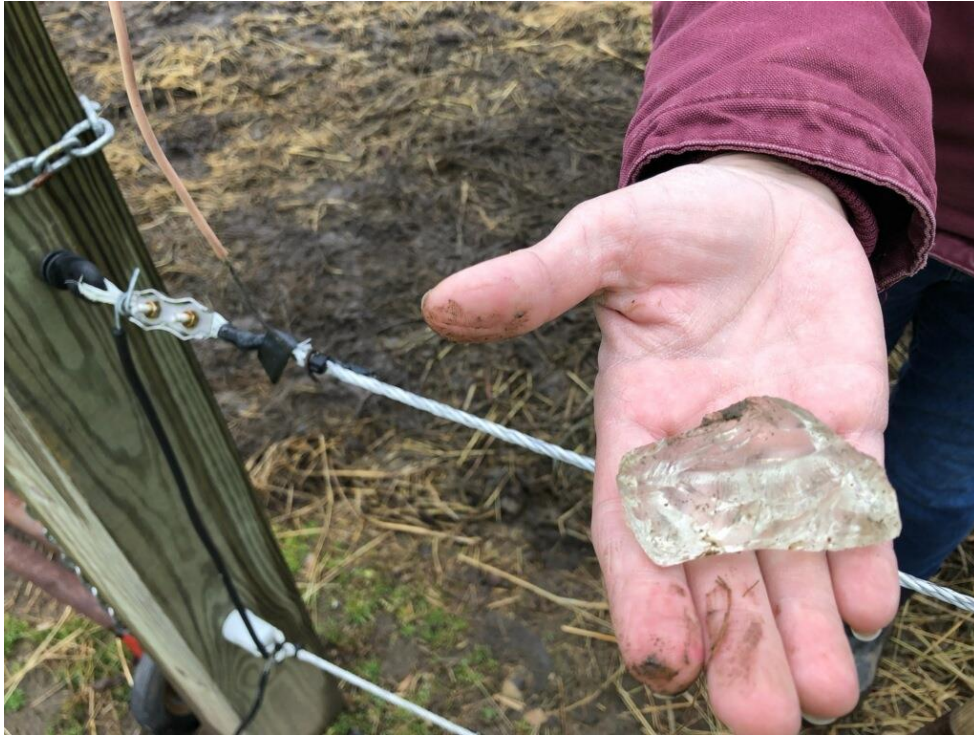
*Figure 3 – Glass cullet found on site.*

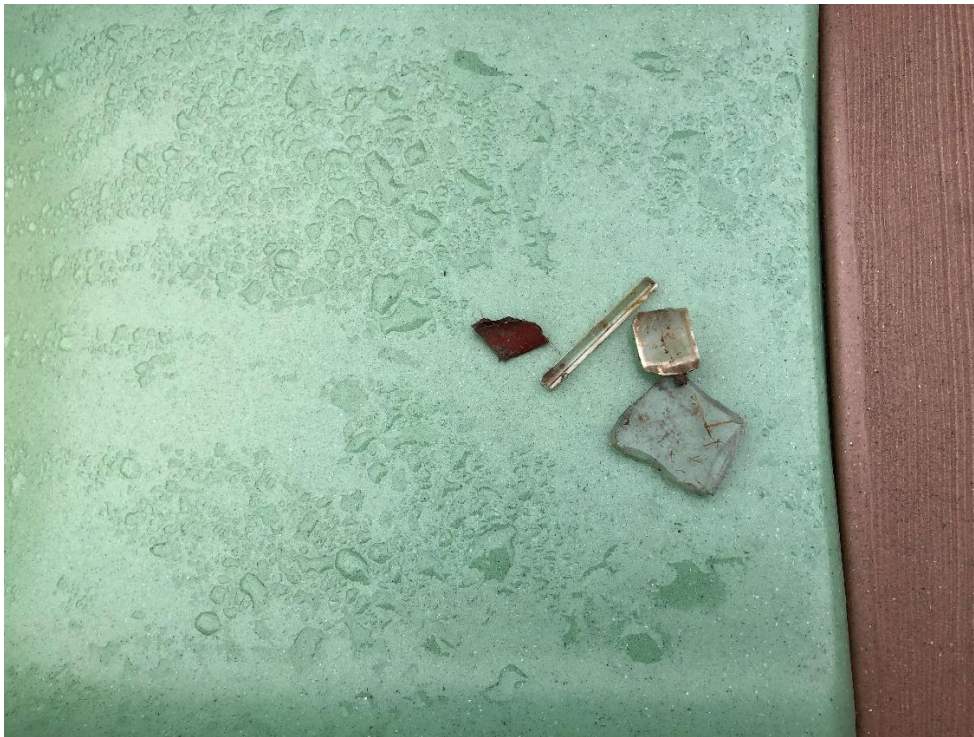
*Figure 4 - Fragments of thermometer glass and other ABG found on site.*

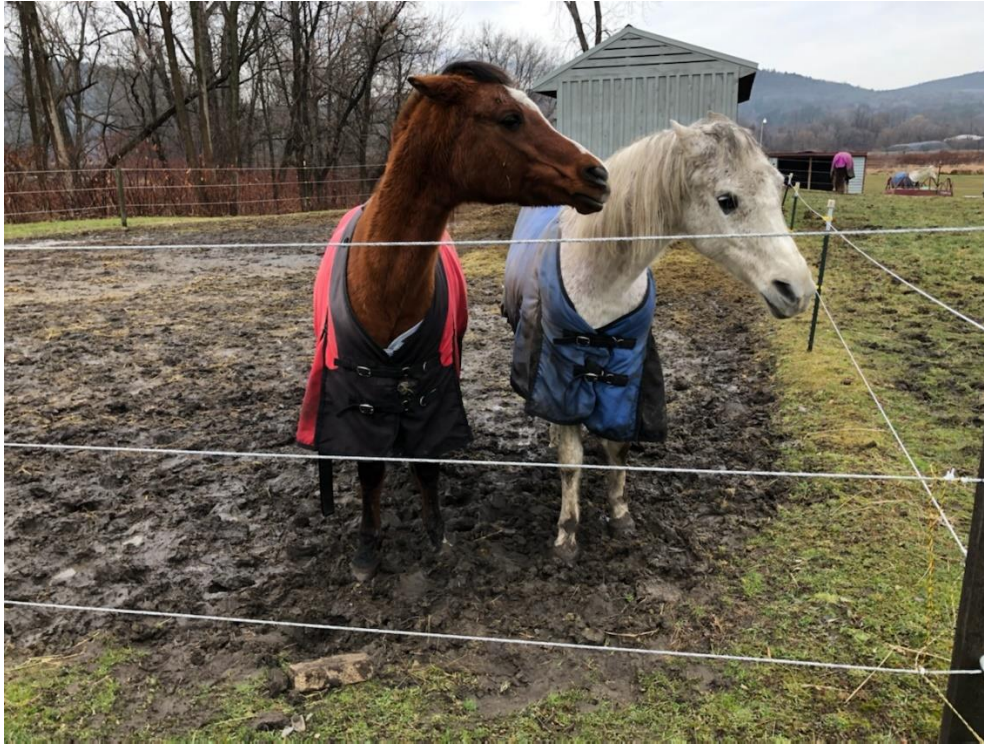
*Figure 5 - Furnace brick found on site near the edge of the horse paddock.*

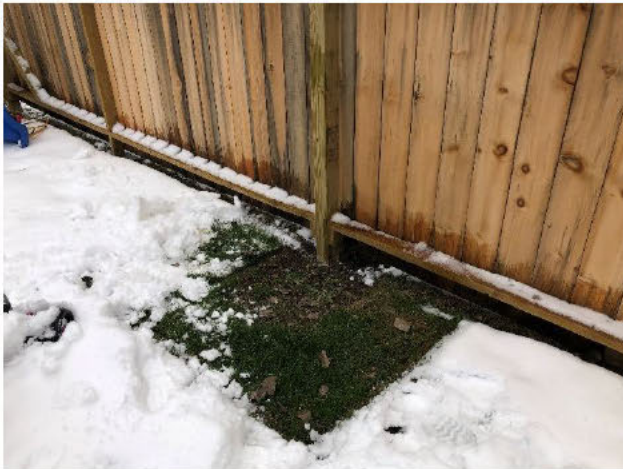
Picture 1

View facing north: Prior to excavation of soils around the fence post, snow was removed to allow visual observation and limit the area of disturbance.

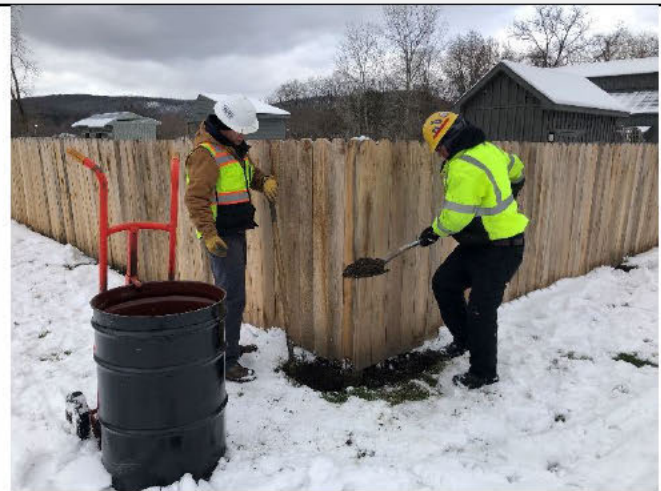
Picture 2

View facing northwest: Soil was excavated by hand and loaded directly into drums for transport to the staging area.

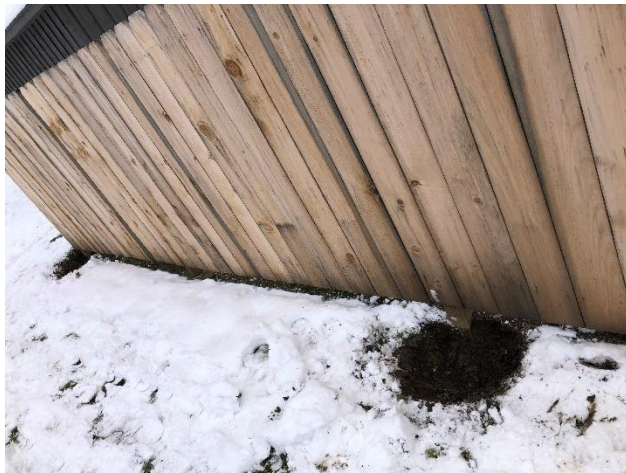
Picture 3

View facing southwest: Excavation activities were conducted along the exterior of the fence at multiple locations. Each excavation was associated with a fence post which supported the stockage fence.

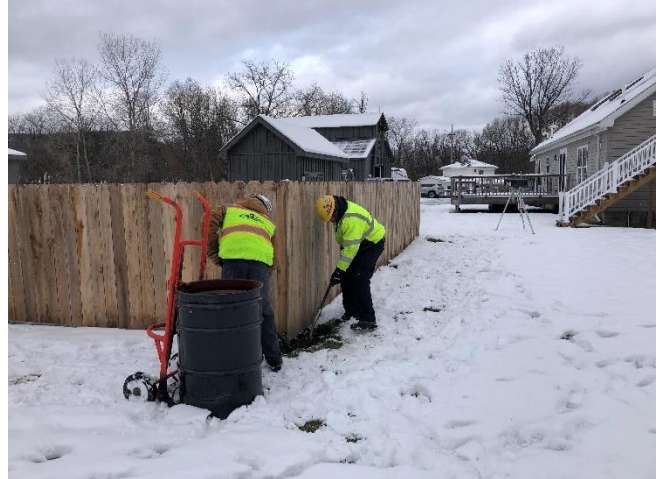
Picture 4

View facing north: Soil potentially impacted with ABG, was hand excavated from the southwestern corner of the fenced enclosure. The residence and back deck are visible in the background.

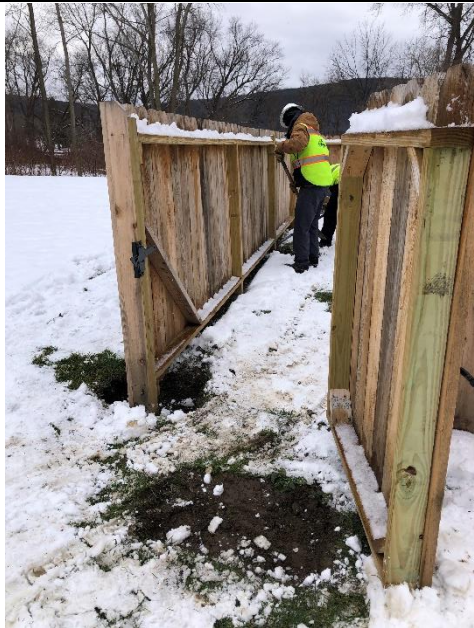
Picture 5

View facing south: Hand excavation continued within the interior of the fenced enclosure and within the gate swing radius where it dug into the ground surface.

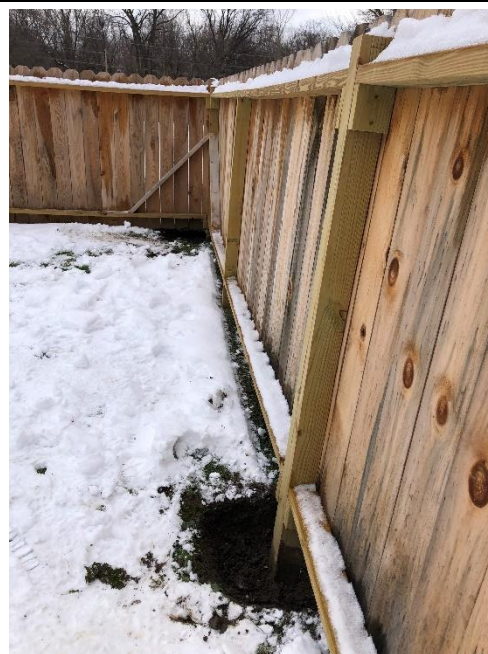
Picture 6

View facing south: Completed excavations around the fence post along the western side of the fenced enclosure.

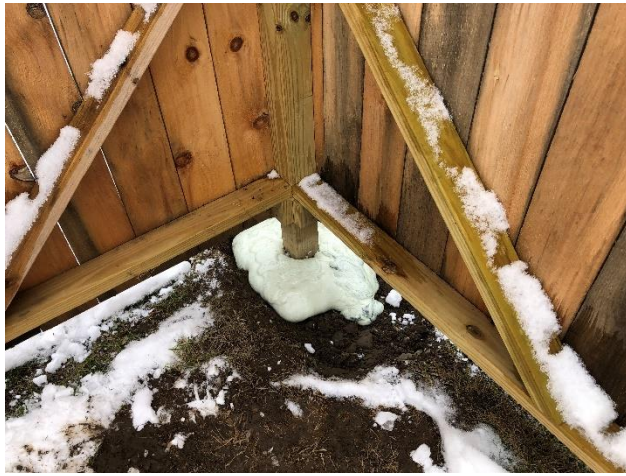
Picture 7

View facing down: The northwest fence post was backfilled with structural material (Sika™ foam) prior to backfilling with mulch.

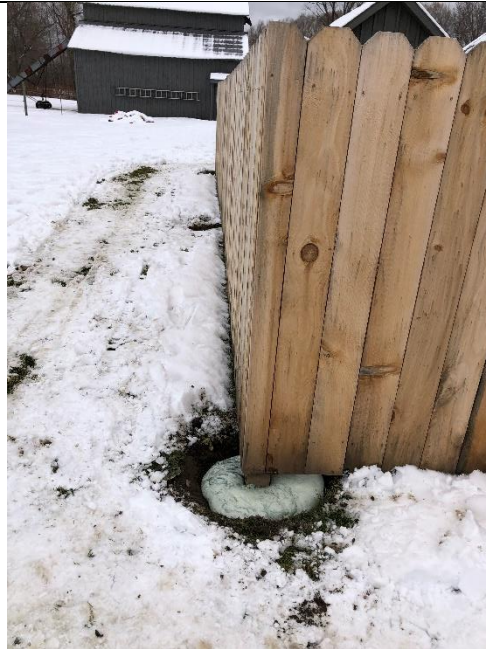
Picture 8

View facing north: Sika™ structural material was allowed to expand around each fence post for up to 30 minutes prior to backfilling with mulch.

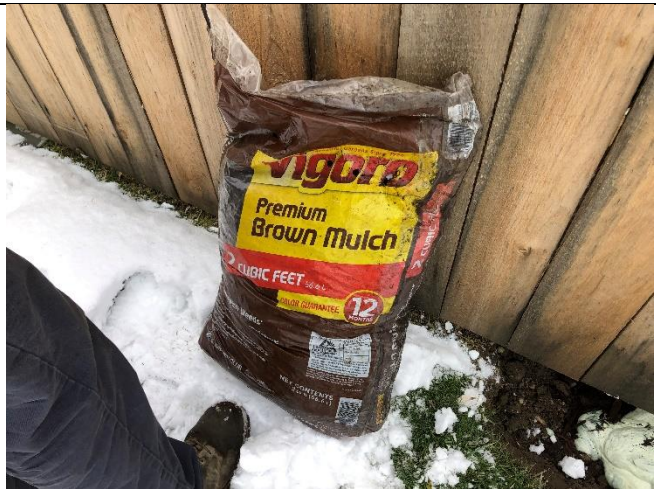
Picture 10

View facing down: Bagged mulch used as backfill around the fence posts.

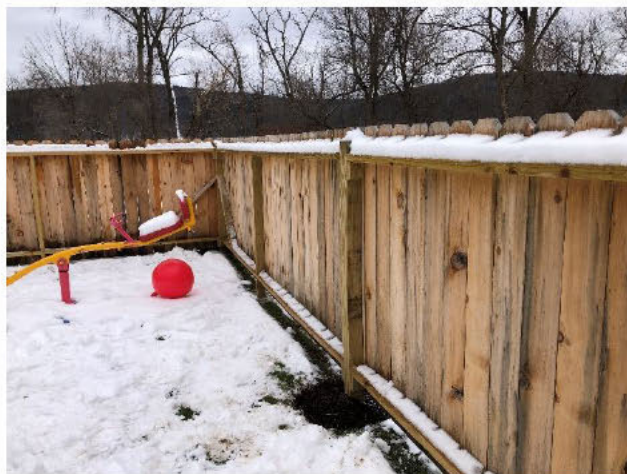
Picture 11

View facing southwest: Completed backfilling along the western fence line inside the fenced enclosure. All playground equipment within the fenced enclosure was returned to the original location prior to demobilization.
