# SHORT-TERM RESPONSE ACTION SUMMARY REPORT

River Road Site

Corning, Steuben County, New York

February 2025

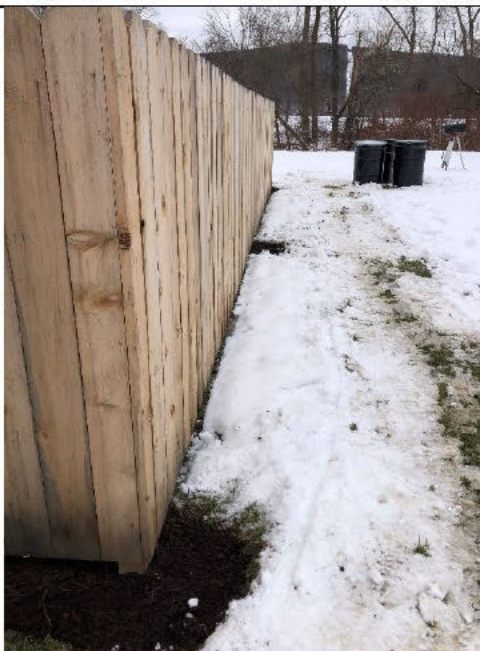
Picture 12

View facing north: Western fence enclosure exterior view of the completed short term response activities. Visible in the background is the drum staging area and CAMP station.
