### RANDO MACHINE CORP.

# 1071 NY-31, MACEDON, WAYNE COUNTY, NEW YORK

# **Site Management Plan**

**NYSDEC Site Number: 859014**

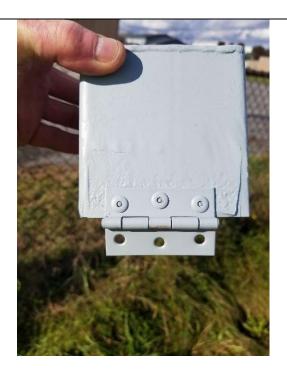
**Photo 5:** B103-OW-A's new cap and hinge; as fabricated by LaBella.

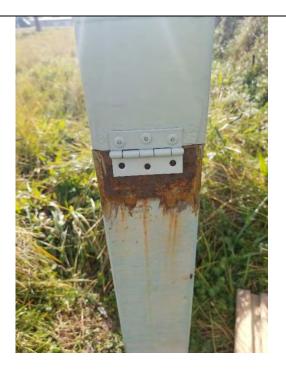
**Photo 6:** B103-OW-A's new cap and hinge; staged in the mount position.

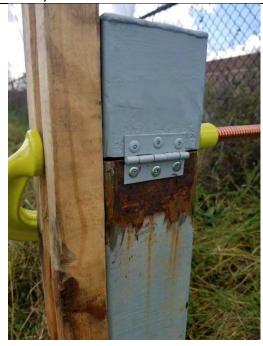
**Photo 7:** B103-OW-A's new cap and hinge; attached to the riser in the final position.

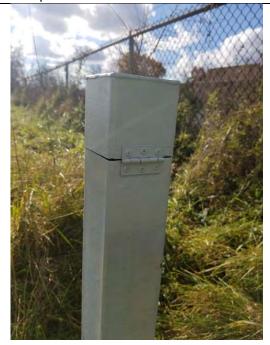
**Photo 8:** Final vicinity shot of B103-OW-A's new cap and hinge.
