**Re: Indoor Air Sampling Report
Former Rando Machine Corporation, 859014
Town of Macedon, Wayne County, New York**

**Indoor Air Sampling Report
1071 NY-31, Macedon, New York
(Former Rando Machine Corporation
Site)**

NYSDEC Site #859014
1071 NY-31

**Reference: Pre-Indoor Air Sampling Building Condition Inspection
1071 New York State Route 31 (Former Rando Machine Corporation Site)
NYSDEC Site #859014
Macedon, Wayne County, New York**

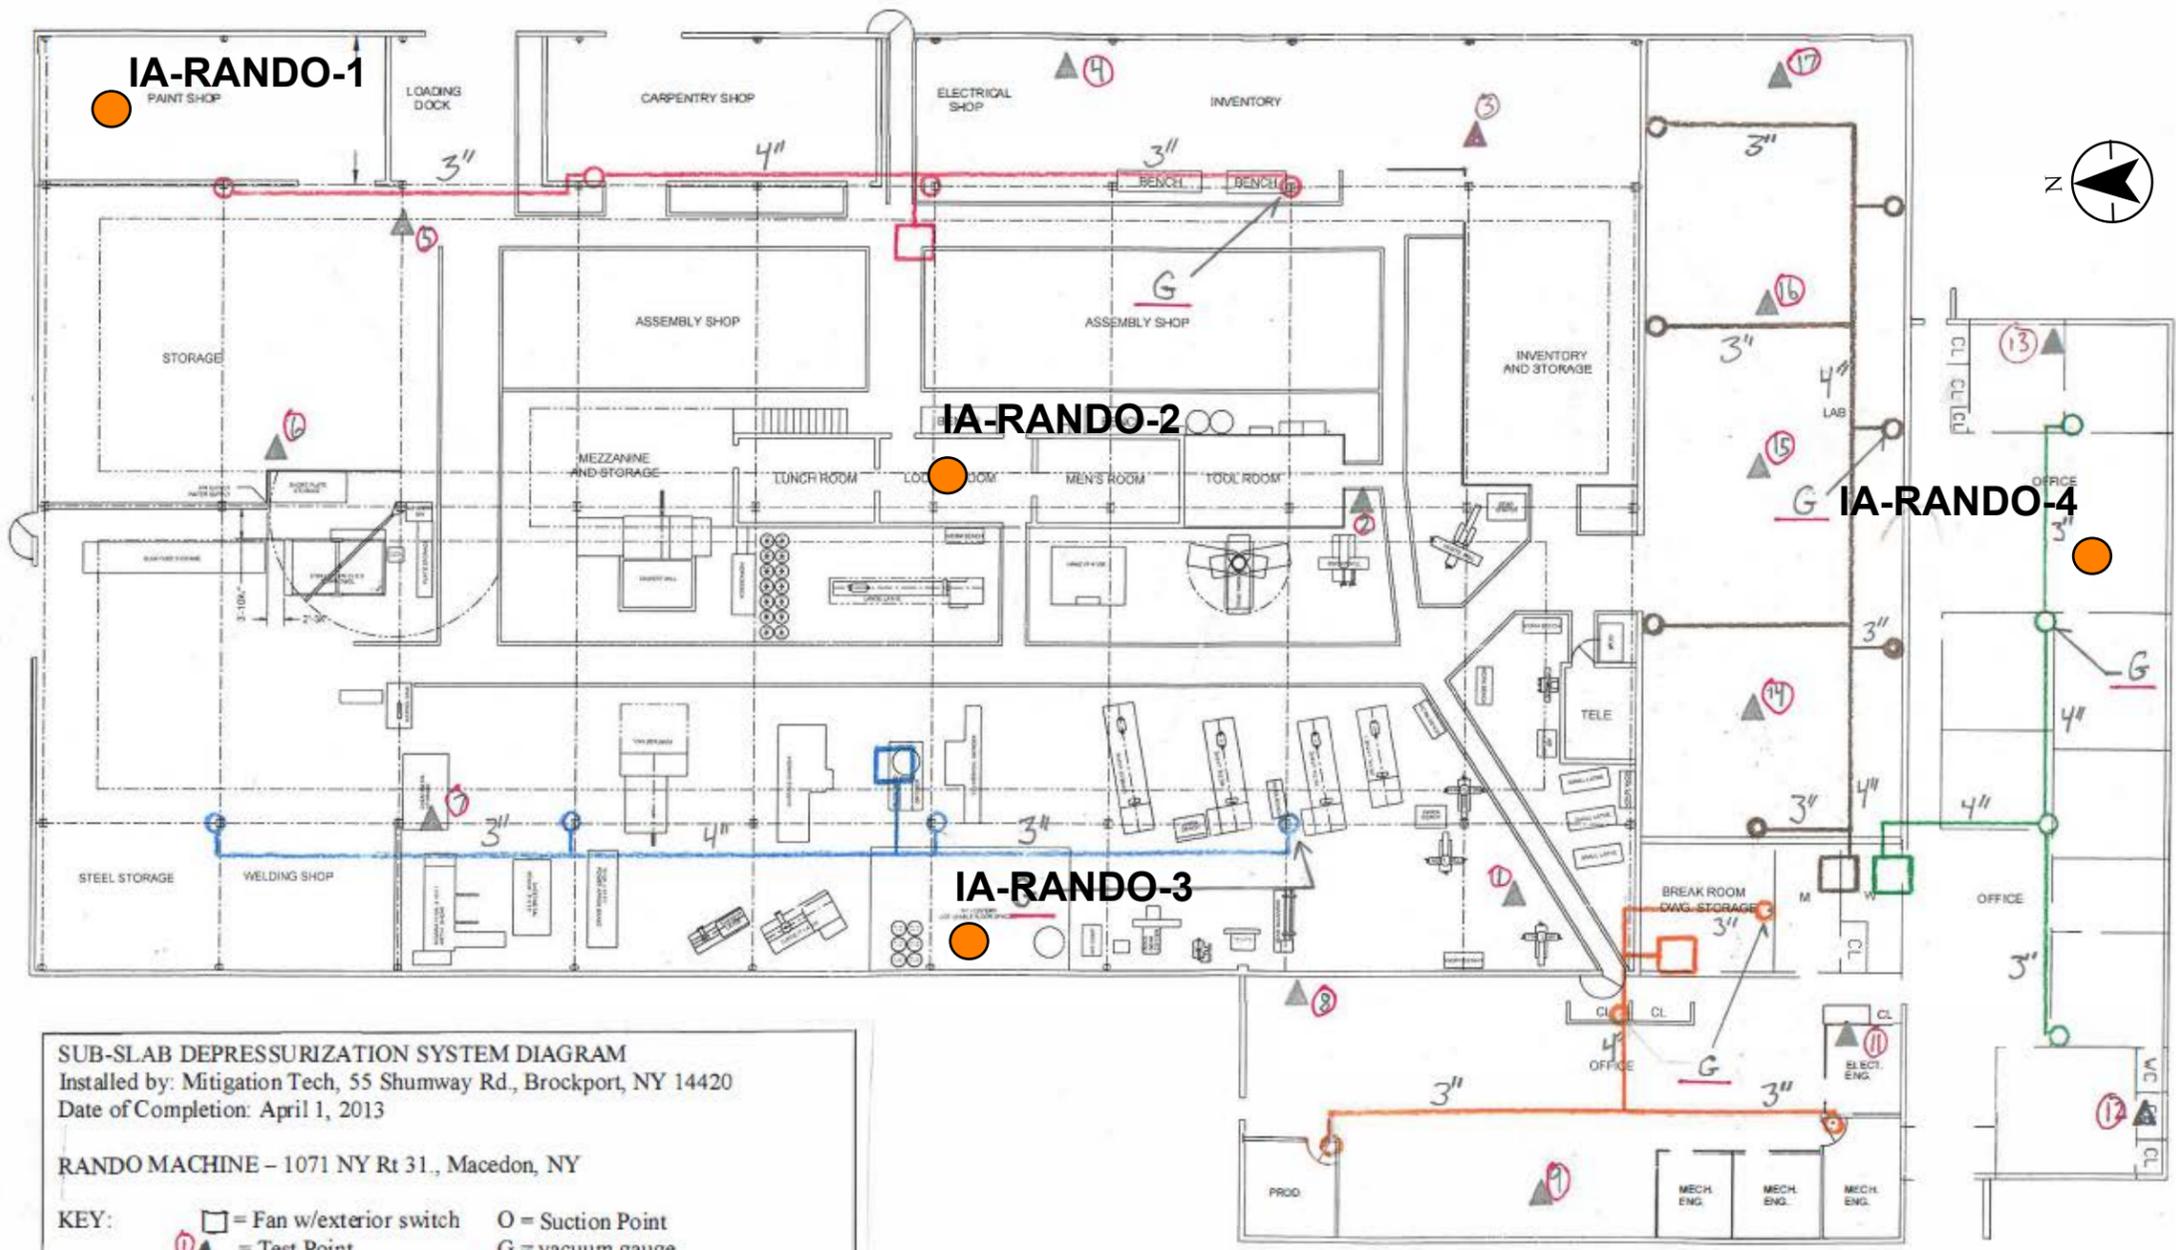
SUB-SLAB DEPRESSURIZATION SYSTEM DIAGRAM
Installed by: Mitigation Tech, 55 Shumway Rd., Brockport, NY 14420
Date of Completion: April 1, 2013

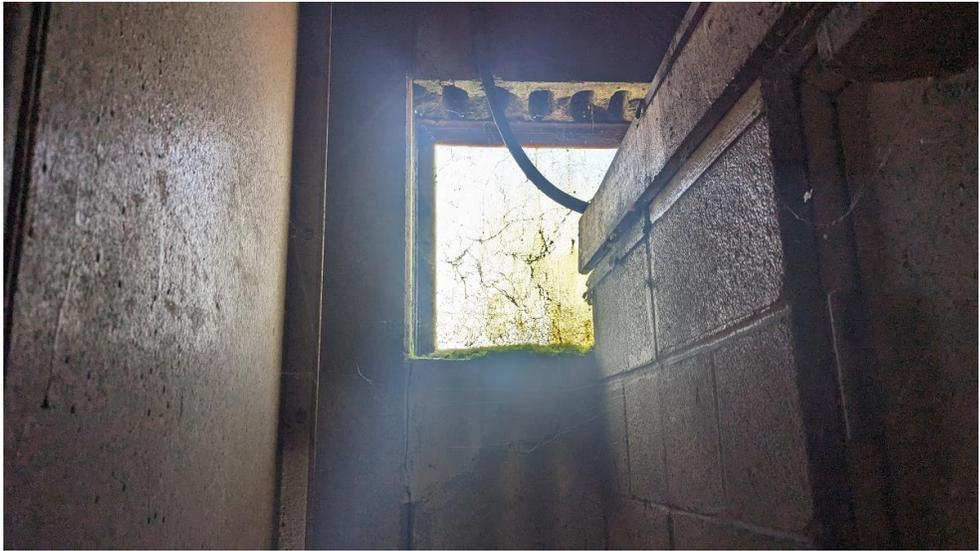
Photograph ID: 1

Photo Location: Paint Shop (Source Area)	
Direction: N	
Survey Date: 9/28/2023	
Comments: Minor outside air infiltration was observed from poorly sealed window in contaminant source area, near location of former dry crock.

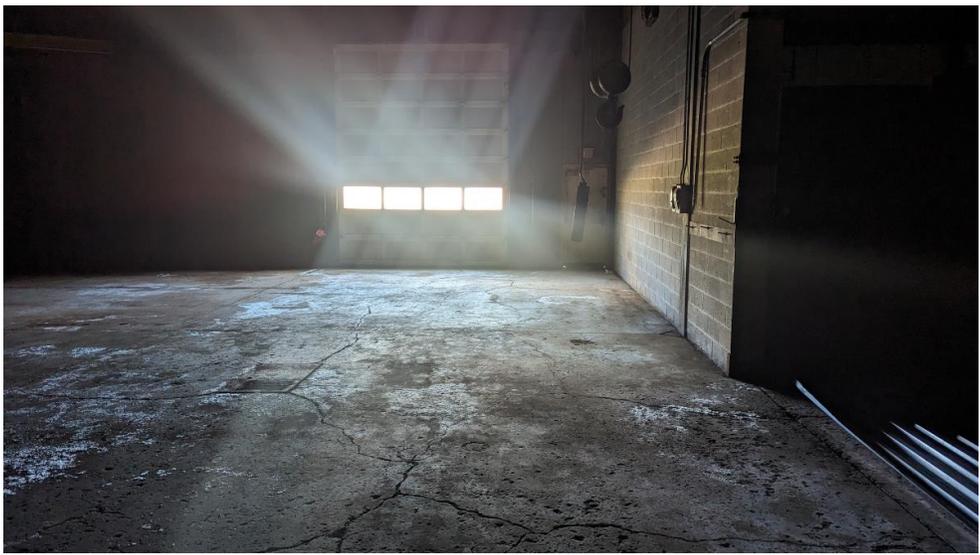
Photograph ID: 2

Photo Location: Main Floor - North	
Direction: N	
Survey Date: 9/28/2023	
Comments: Significant outdoor air infiltration from large, north-facing overhead door located in the north part of the main floor, designated as "Storage" on building layout map.

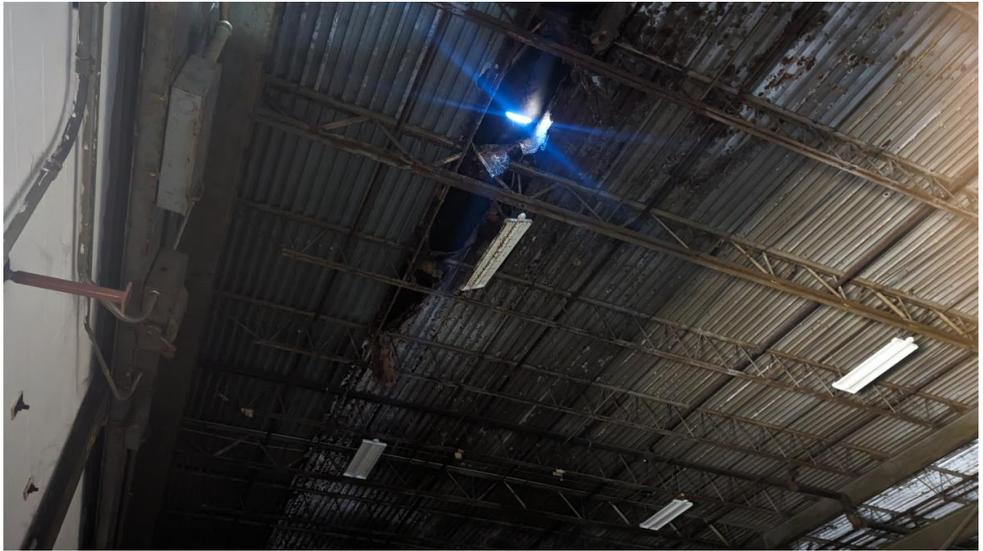
Photograph ID: 3

Photo Location: Main Floor - Northwest corner	
Direction: n/a	
Survey Date: 9/28/2023	
Comments: Sunlight shining through an approximately 2' opening in the roof above the the area designated "Welding Shop"

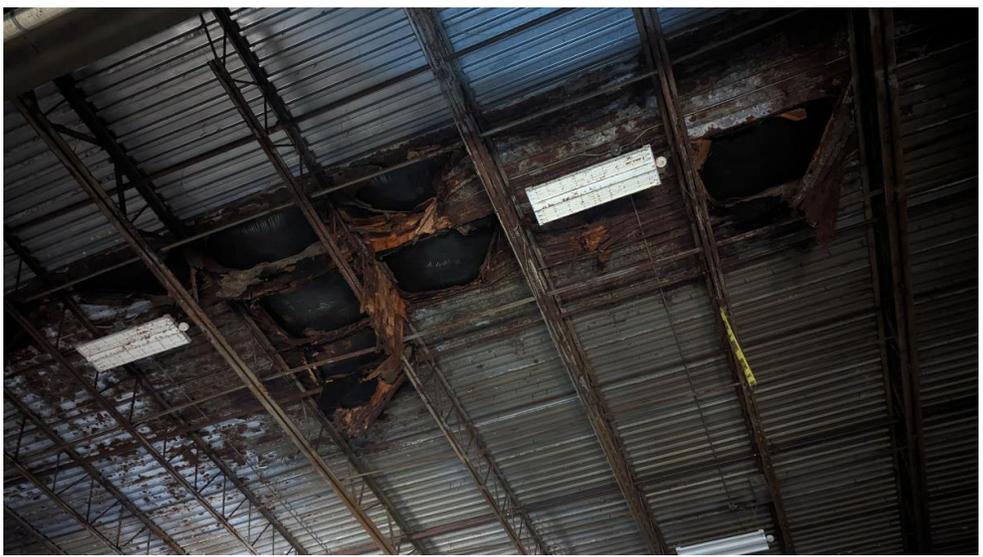
Photograph ID: 4

Photo Location: Main floor - Central	
Direction: n/a	
Survey Date: 9/28/2023	
Comments: An example of advanced stages of corrosion above "Assembly Shop" observed on numerous corrugated roof panels throughout the main product area.

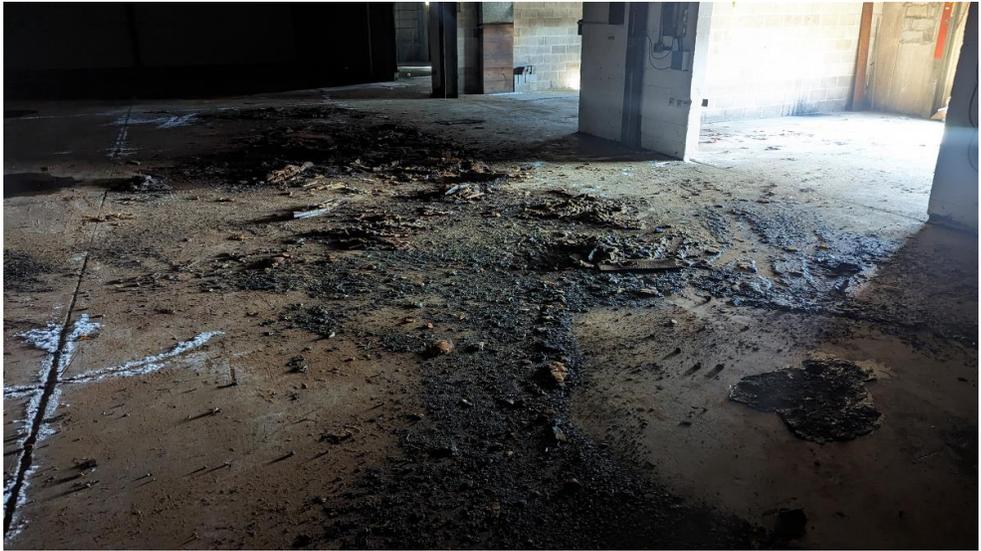
Photograph ID: 5

Photo Location: Main Floor - Central	
Direction: S	
Survey Date: 9/28/2023	
Comments: Piles of saturated, rusty metal from the roof were observed in several locations throughout the building, especially in the northeast portion of the main floor designated "Assembly Shop" where the water damage to the roof is most severe.	
Photograph ID: 6

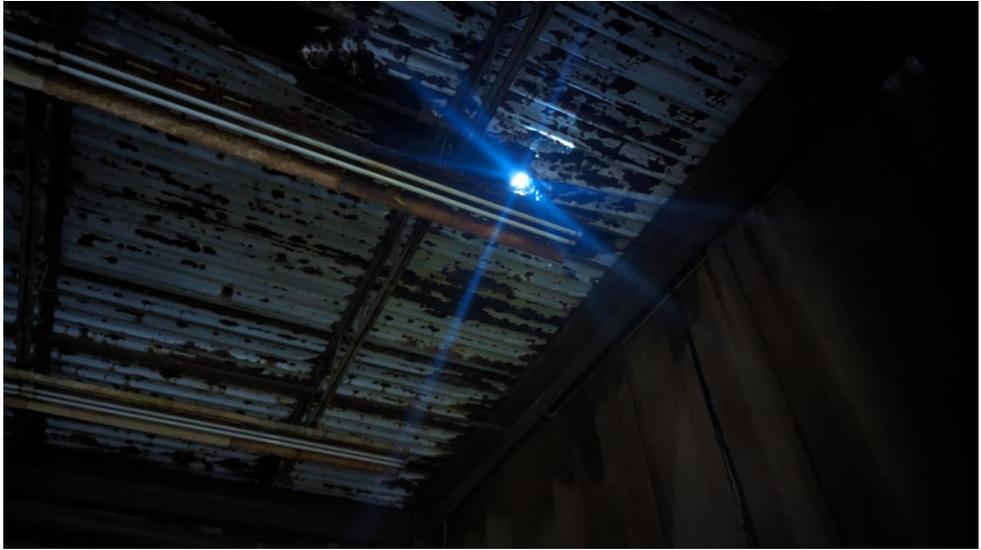
Photo Location: Main Floor - Central	
Direction: n/a	
Survey Date: 9/28/2023	
Comments: A 1 ft opening in the roof above the the area designated "Welding Shop."

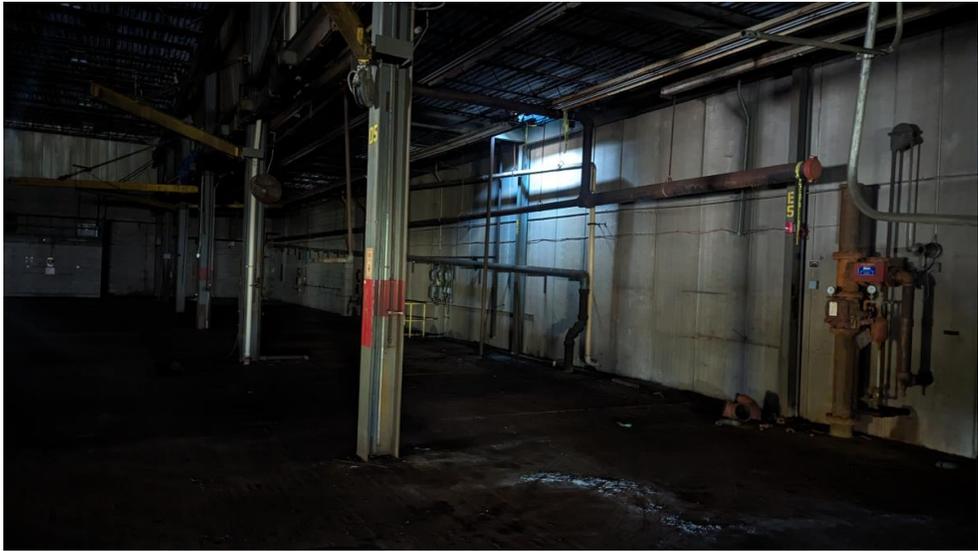
Photograph ID: 7

Photo Location: Main Floor -West	
Direction: SW	
Survey Date: 9/28/2023	
Comments: Sunlight shining through an opening in the roof illuminates the area above "Recessed sump area."

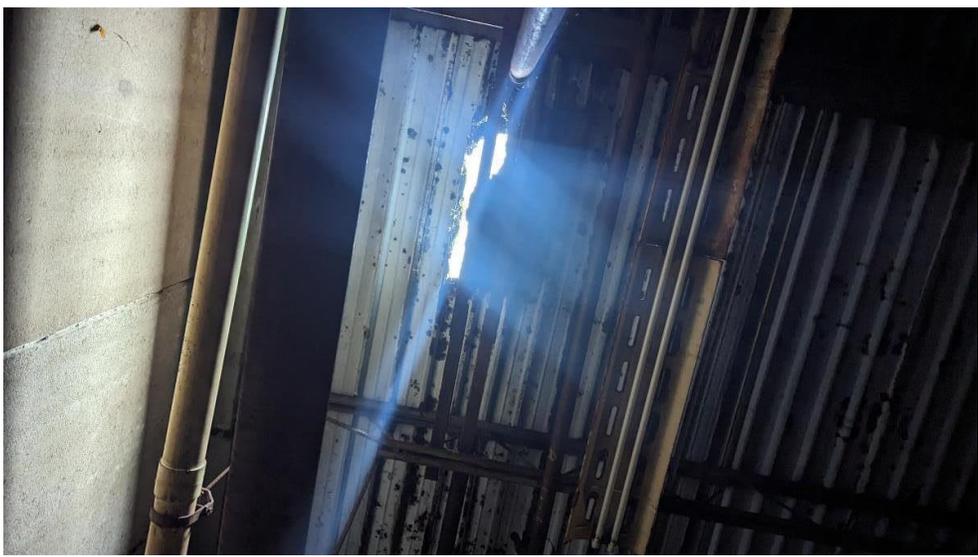
Photograph ID: 8

Photo Location: Main Floor - West	
Direction: n/a	
Survey Date: 9/28/2023	
Comments: An approximately 3.5 ft opening in the roof above the "Recessed Sump Area." Water and plant material was seen coming through the opening.

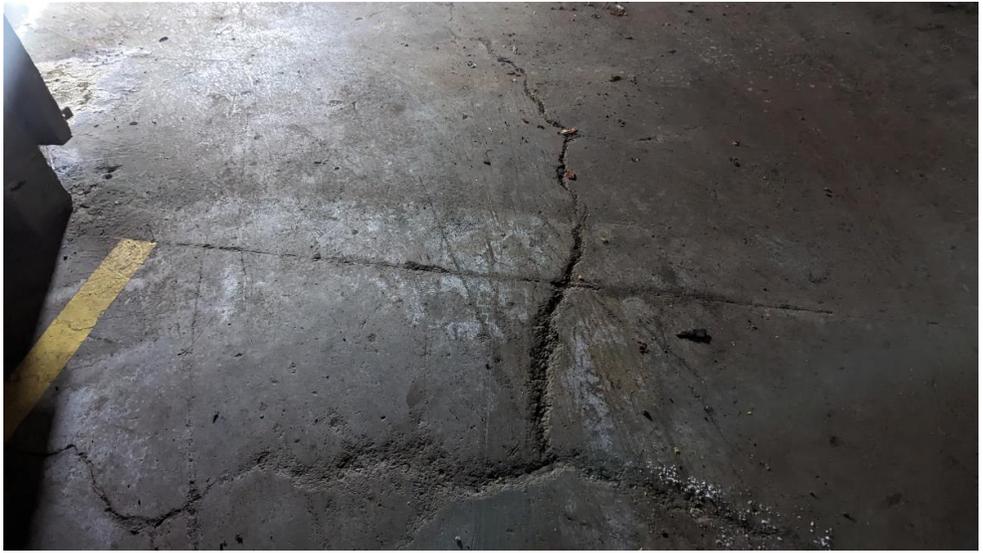
Photograph ID: 9

- Cracks in the slab up to 3" wide were observed throughout the main floor. The cracks are generally millimeters to 2 centimeters in depth (Photograph ID: **9**). 2x1 foot and 1x1 foot divots were observed in the center of main floor (Photograph ID: **11**). The slab is in fair condition otherwise. Surficial pits observed throughout (Photograph ID: **10**). SSDS system was active at the time of inspection and appears to be functioning properly.

Photo Location: Main Floor - North	
Direction: E	
Survey Date: 9/28/2023	
Comments: Cracks in slab up to 3-inch wide were observed throughout the main production area. The cracks are generally millimeters to up to 2 centimeters scale in depth. 2'x1'

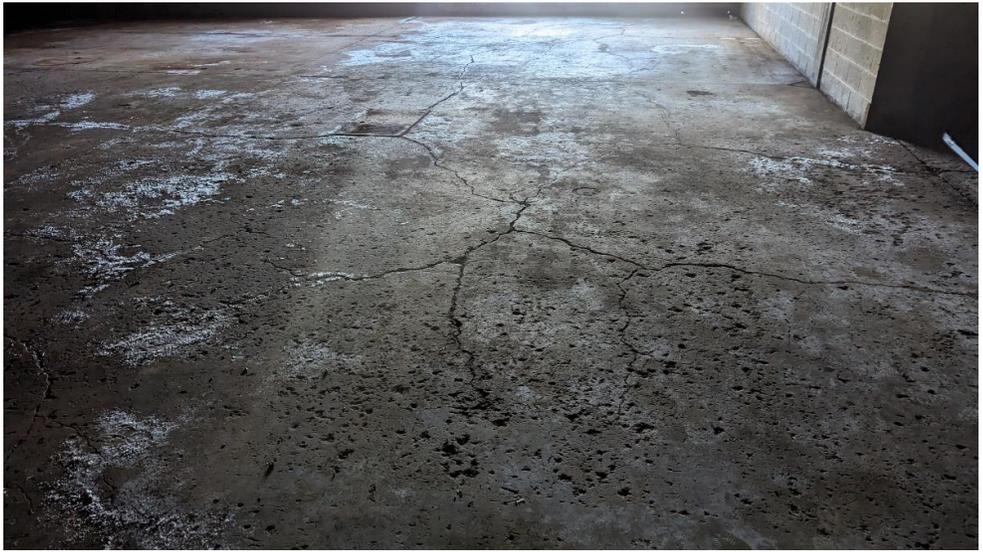
Photograph ID: 10

Photo Location: Main Floor - North	
Direction: N	
Survey Date: 9/28/2023	
Comments: Cracks and pitting were observed sporadically throughout the main floor, but diminish in severity as one moves south of the "Storage Area"

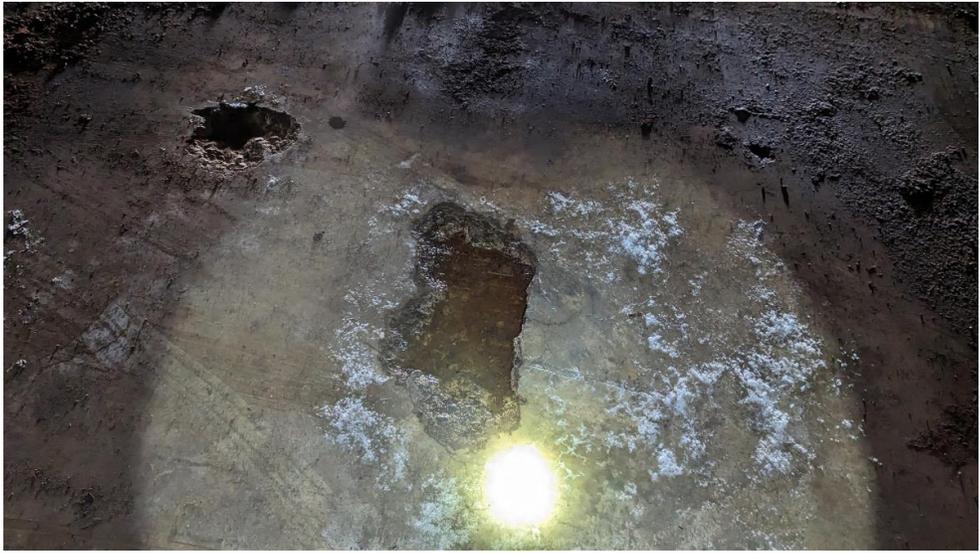
Photograph ID: 11

Photo Location: Main Floor - Central	
Direction: n/a	
Survey Date: 9/28/2023	
Comments: Divots up to 2-ft diameter and several inches deep were observed in the center of the main floor.

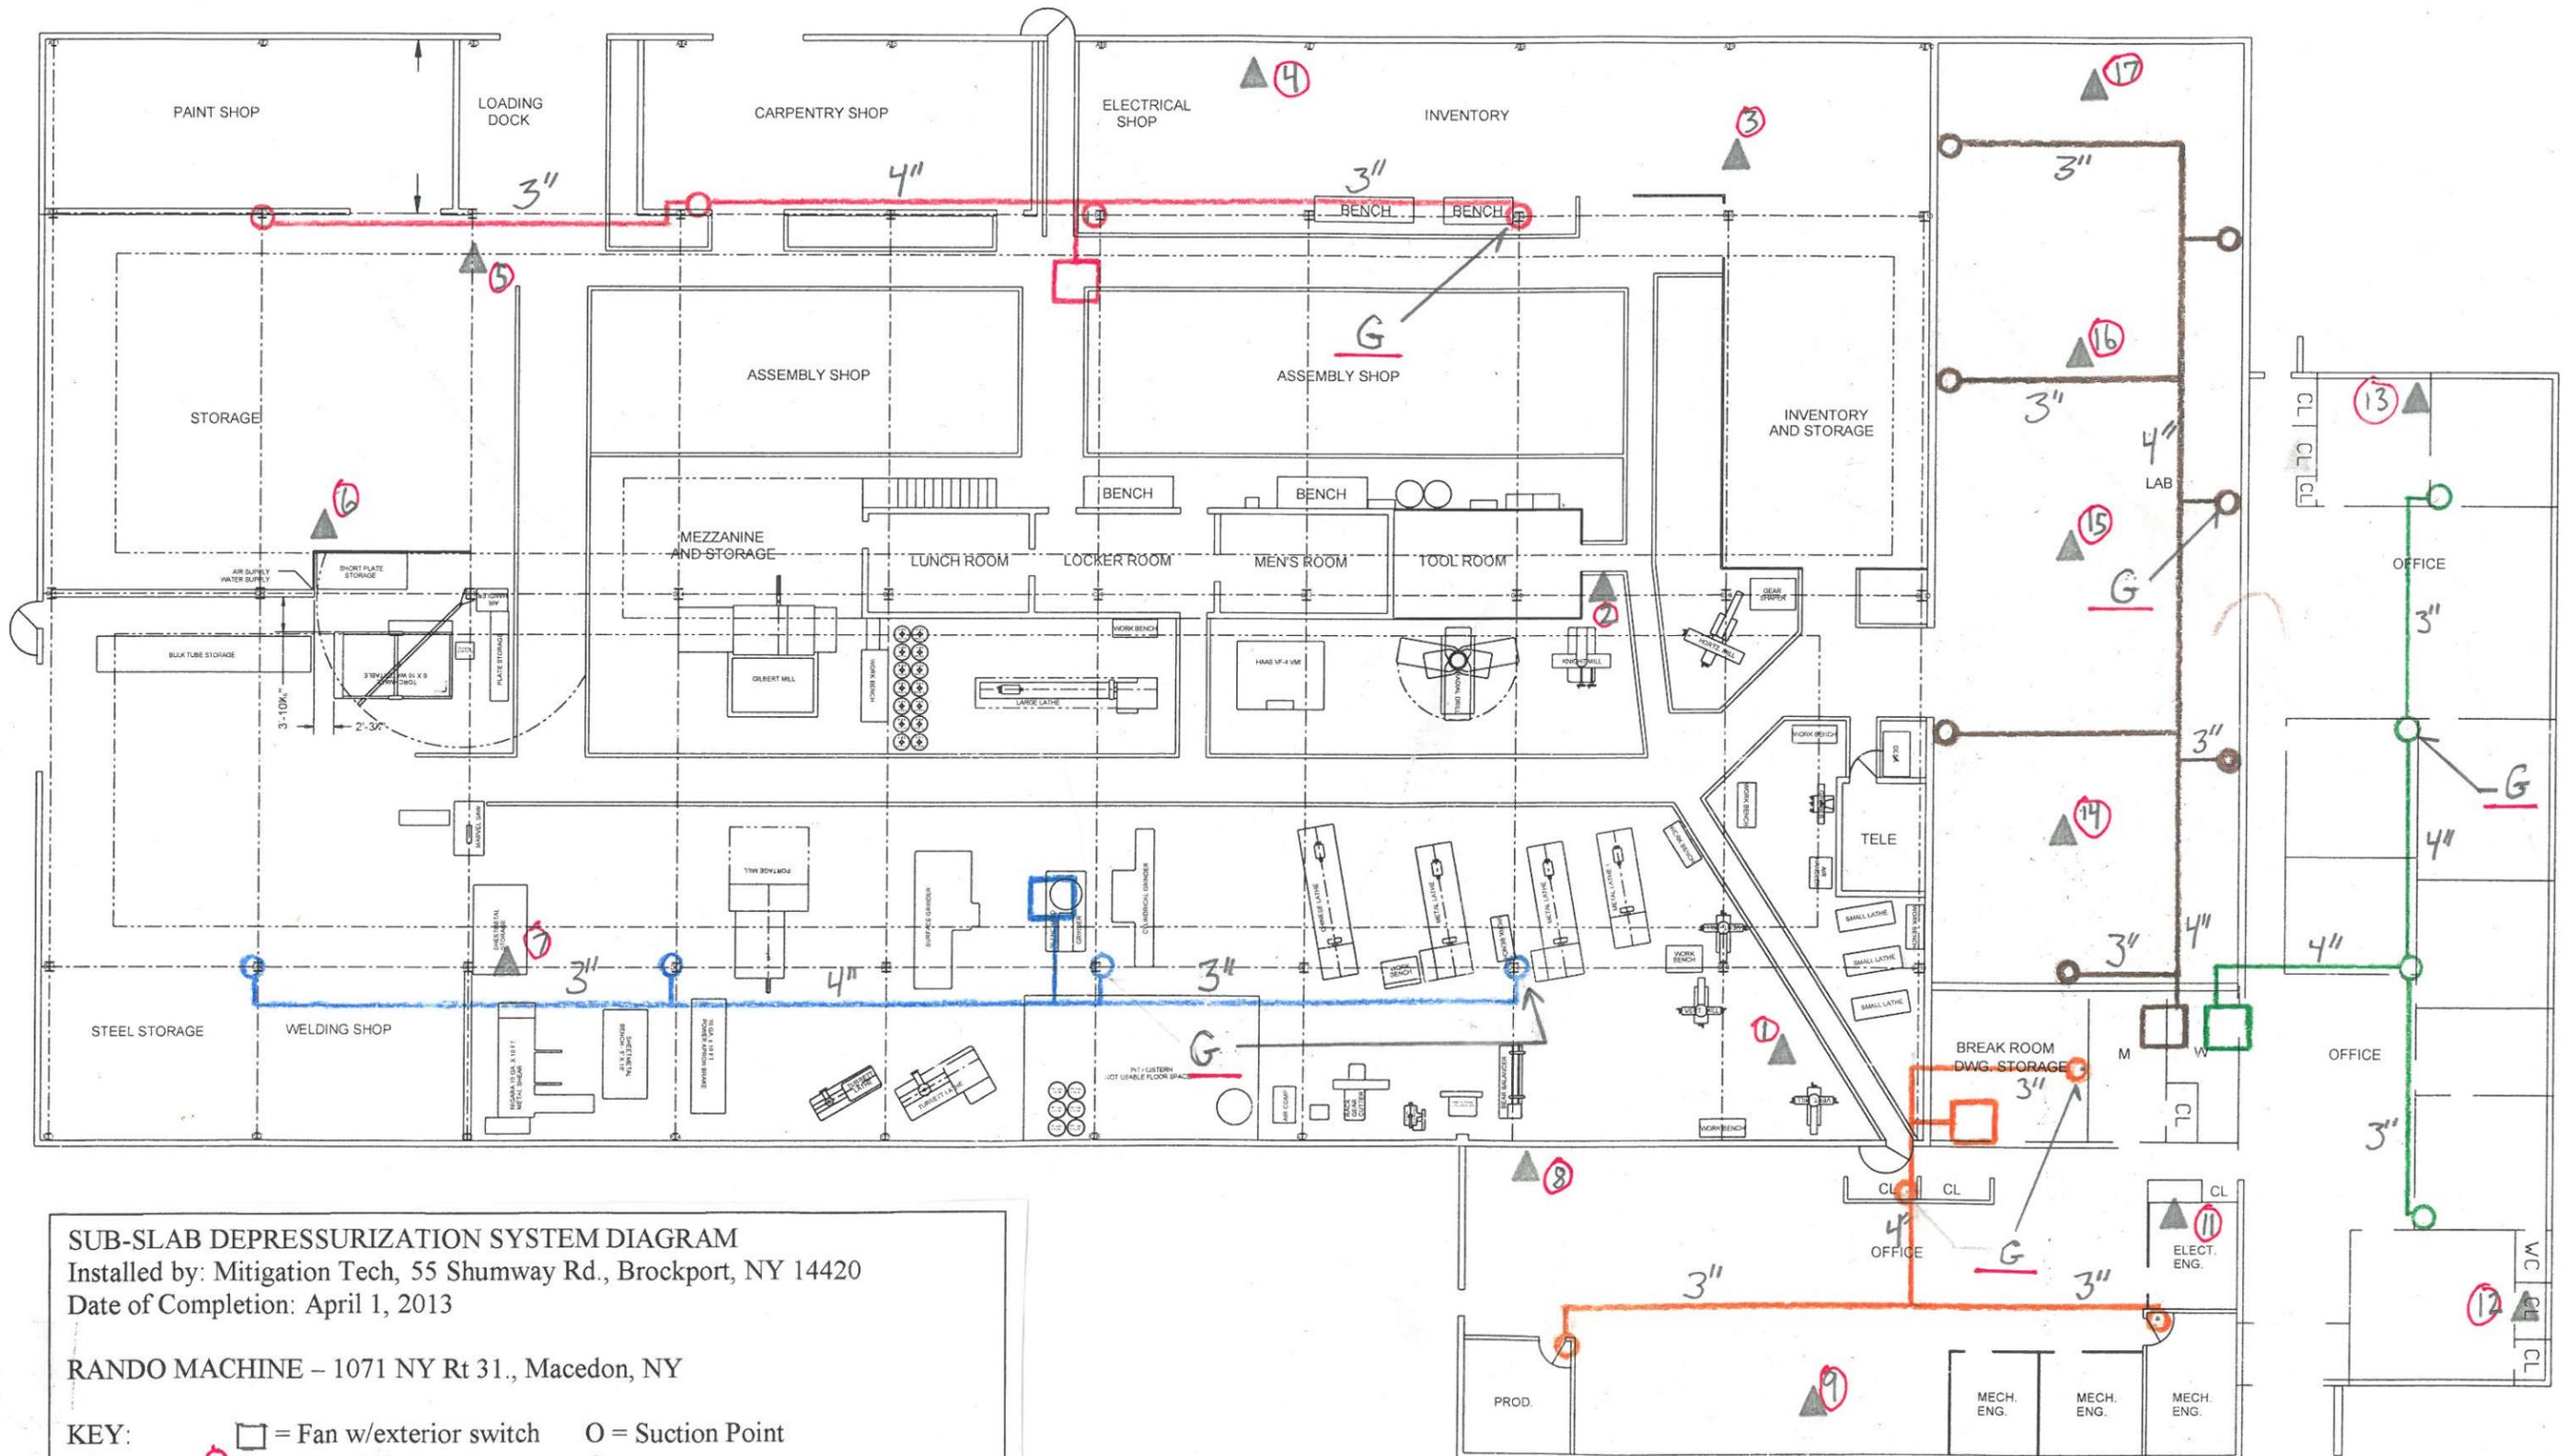
SUB-SLAB DEPRESSURIZATION SYSTEM DIAGRAM

Installed by: Mitigation Tech, 55 Shumway Rd., Brockport, NY 14420
