Mr. Michael Squire
NYSDEC
Remedial Bureau C
625 Broadway
Albany, New York 12233

Subject:
Soil Sampling Results
NYSEG/Clyde Former MGP
Clyde, New York
NYSDEC Site No. 859019

Date:
November 19, 2018

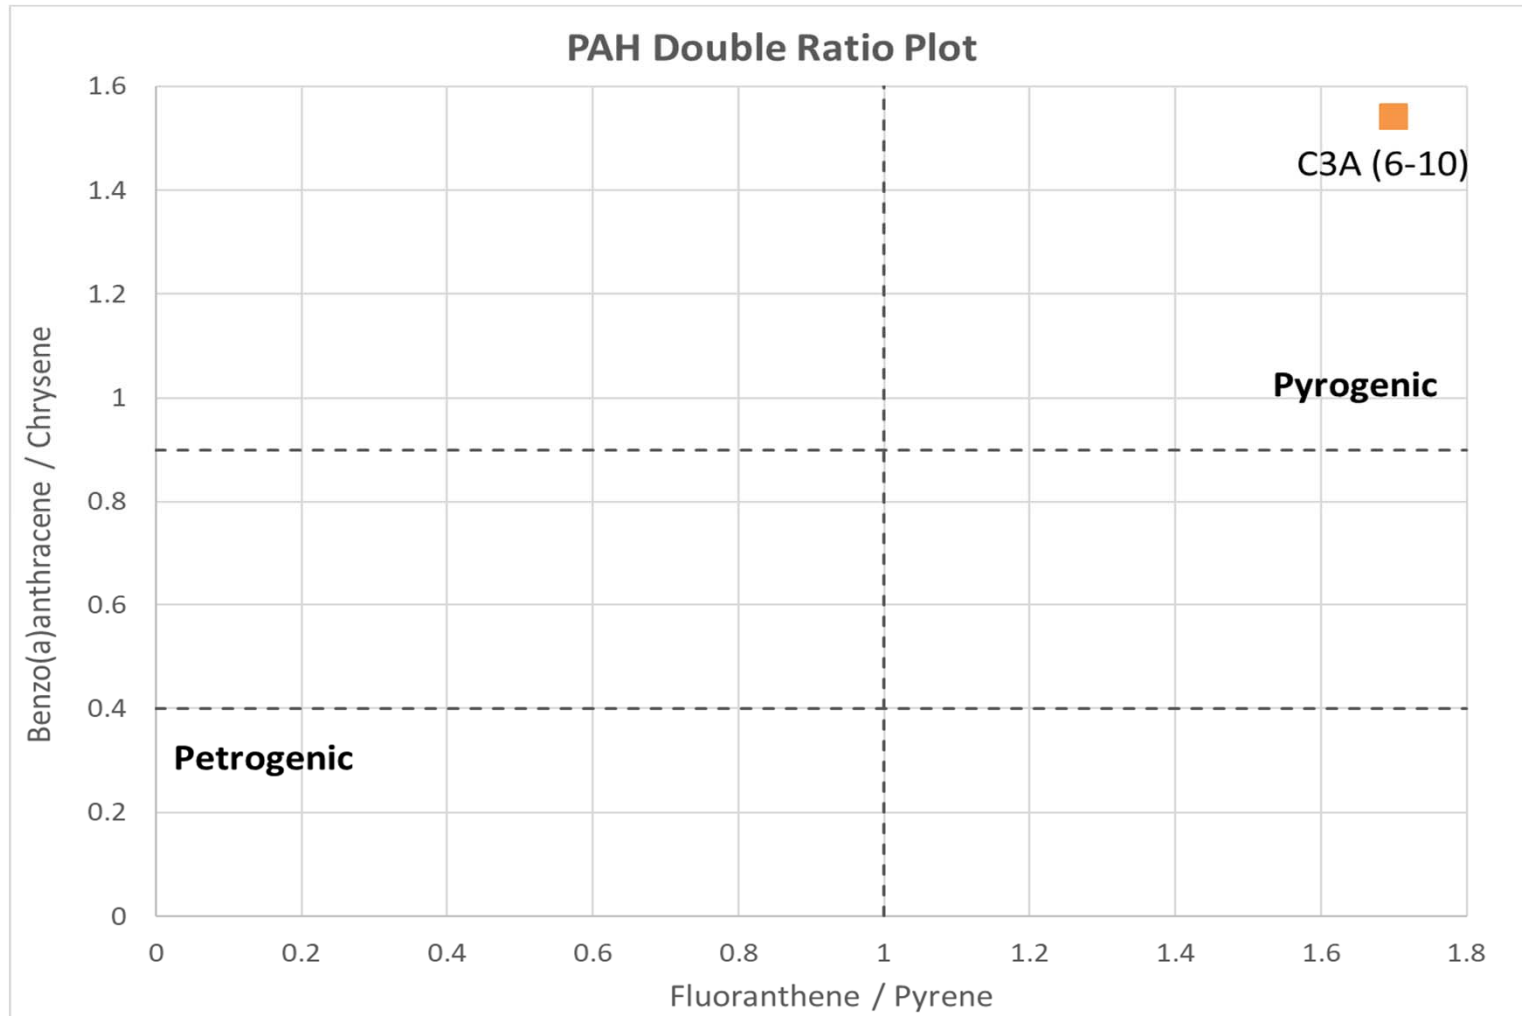
C3A (6-10) PAH Double Ratio Plot

Sample C3A (6-10) 4-ring PAH have a pyrogenic composition

- Forensic evaluation conducted for samples C3A (6-10) and C3A (8-10) based on NOAA 34 PAH analytical results (sample C3A (6-10) only) and TPH-DRO
- PAH double ratio plot of 4-ring PAH indicates presence of pyrogenic PAH
- PAH bar chart indicates petrogenic distributions for 2- and 3-ring PAH and pyrogenic distribution of 4- to 6-ring PAH
- PAH concentrations consistent with urban background
- Total NOAA 34 PAH 15.72 mg/kg, TPH-DRO 3,400 mg/kg – PAH/TPH is <0.5%, not consistent with MGP waste material which typically has PAH/TPH >>5%
- Chromatograms – TPH-DRO appears to be extremely weathered middle distillate petroleum hydrocarbon such as #2 fuel oil or diesel
- **Hydrocarbon material not associated with MGP waste**

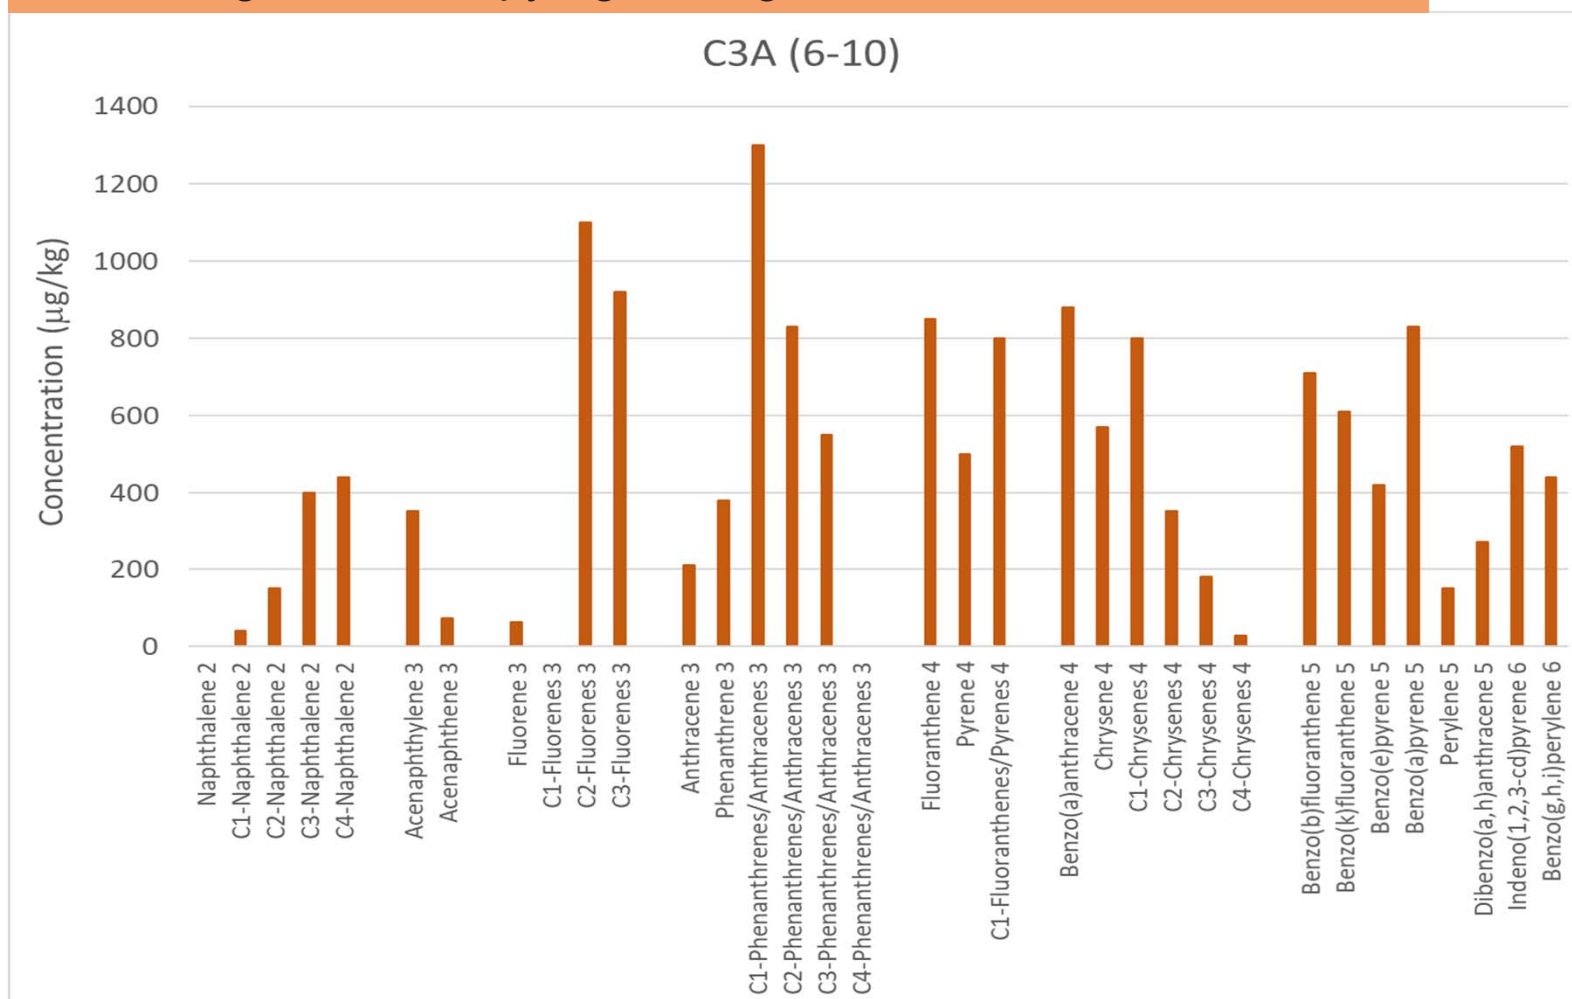
C3A (6-10) PAH Bar Chart

Sample C3A (6-10) 2- and 3-ring PAH have petrogenic signature, 4- to 6-ring PAH have pyrogenic signature

- A bar chart indicates a petrogenic distribution of 2- and 3-ring PAH and pyrogenic distribution of 4- to 6-ring PAH.
- The ratio of Total NOAA PAHs to TPH-DRO is less than 0.5%, which is not consistent with manufactured gas plant (MGP) material, which typically has ratio much greater than 5%.
- Chromatograms appear to indicate extremely weathered middle distillate petroleum hydrocarbon such as #2 fuel oil or diesel.
- PAH concentrations are consistent with urban background concentrations.
