NYSEG – Lyons Former MGP Site, Lyons, New York NYSDEC Site No. 859020 Supplemental Pre-Design Investigation Summary

This letter summarizes the supplemental pre-design investigation (PDI) activities completed at the New York State Electric and Gas (NYSEG) Lyons Former Manufactured Gas Plant (MGP) Site (the site) located in Lyons, New York (Figure 1). Arcadis of New York, Inc. (Arcadis) conducted the Supplemental PDI activities in accordance with the following.

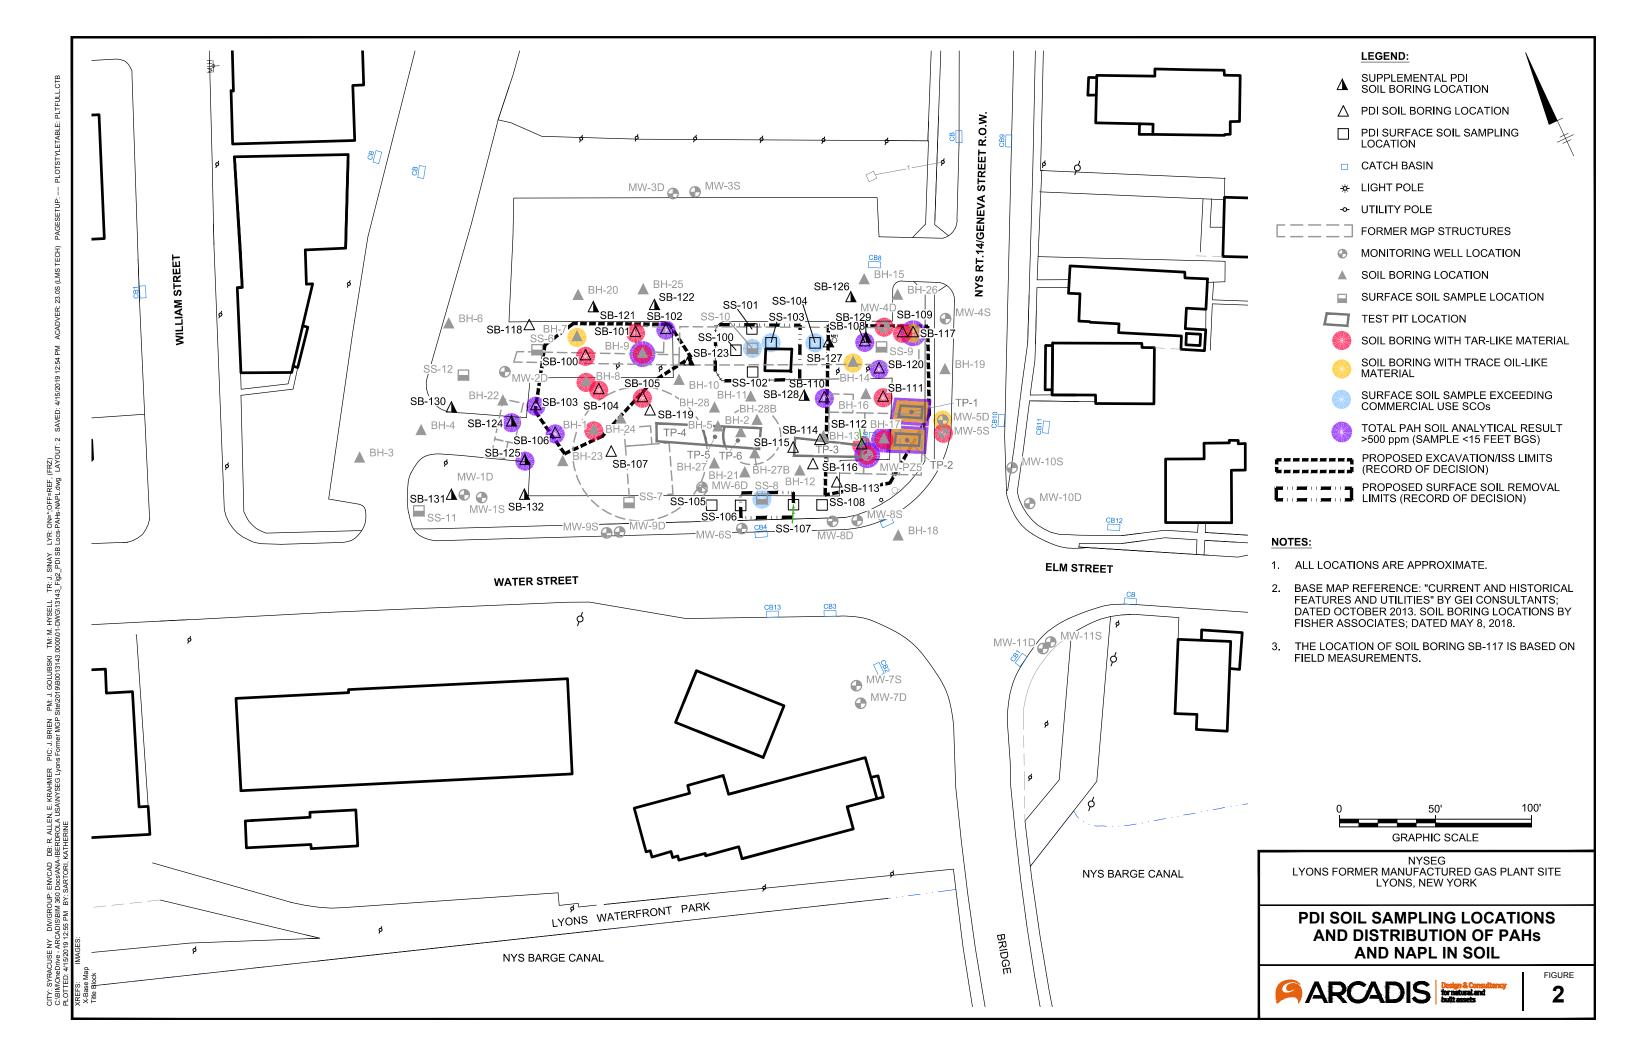
Arcadis completed soil borings at 12 locations (SB-121 through SB-132, as shown on Figure 2) from November 19 through 21, 2018 and on December 18 and 19, 2018 using direct push technology (DPT) drilling techniques.

Subsurface soil samples with total PAHs greater than 500 ppm were identified at two soil borings (SB-124 and SB-125) completed during November 2018, which required drilling three additional step-out soil borings (SB-130, SB-131, and SB-132) in December 2018 to further delineate PAHs. Total PAHs

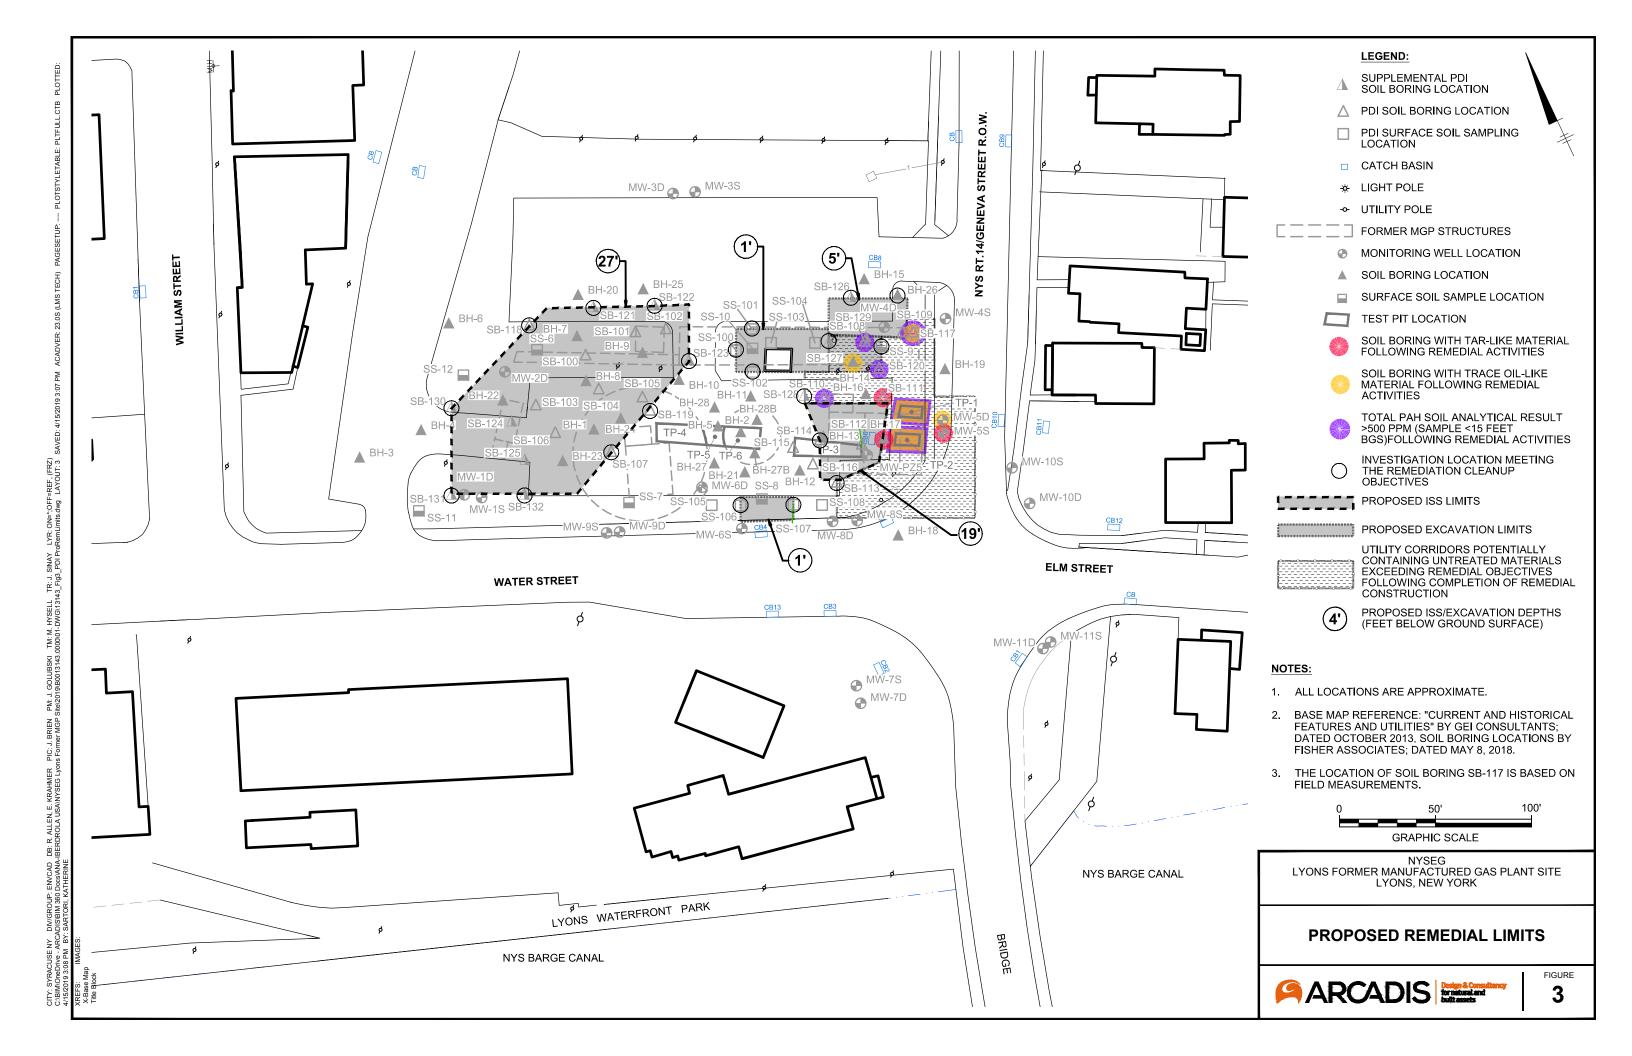
The revised remedial limits are shown on Figure 3 and include the following:

- A 10-foot offset distance from natural gas mains as required by NYSEG's gas department for subsurface construction activities. The required set-back distance and geotechnical monitoring (vibration and settlement monitoring) are necessary to prevent damage to the natural gas mains and onsite natural gas regulator station.
- A 10-foot offset distance from the overhead utilities along Geneva Street, in accordance with the
 minimum approach distance for "exposed energized circuits for unqualified persons" as set forth in
 Occupational Safety and Health Act (OSHA) 29 Code of Federal Regulations (CFR)
 1910.333(c)(3)(i)(A).

Onsite areas where impacts are anticipated to remain onsite following the remedial activities are shown on Figure 3.

- a narrow corridor beneath the natural gas mains aligned east-west from Geneva Street to the onsite natural gas regulator station;
- a small area along Geneva Street that is contiguous to Operable Unit 3 (i.e., which is located beneath Geneva Street and within the utility corridor).
