**FINAL COMPLETION REPORT**

**REMEDIAL ACTIVITIES FOR  
SEPARATOR AND POWERHOUSE**

**SINCLAIR REFINERY SITE  
WELLSVILLE, NEW YORK**

**VOLUME IV**

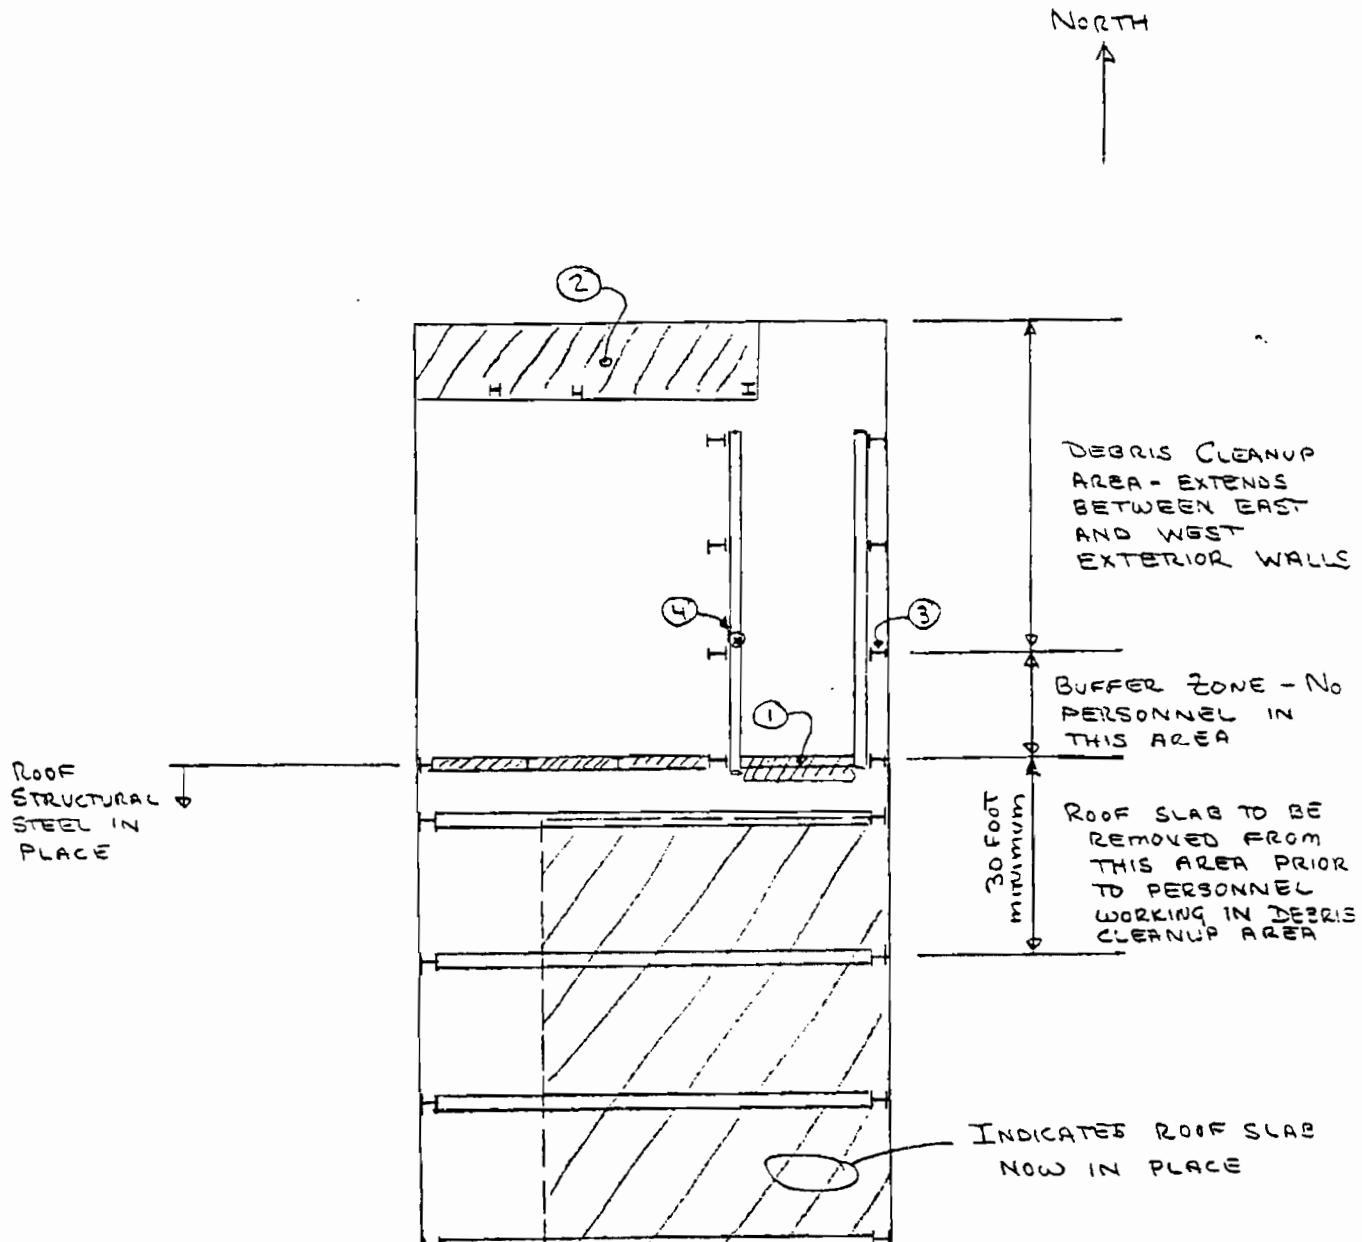
BY D.H. DATE 9/27/93 SUBJECT \_\_\_\_\_  
CHKD. BY \_\_\_\_\_ DATE \_\_\_\_\_SHT. NO. SP-1 OF 1  
JOB NO. 93-320

Based upon my observations, upon the performance of the floor during the load tests, and upon consultation with Mr. Mancini and Mr. Ivy, it is my opinion that debris can be removed from the cleanup area provided that certain precautions are observed. With reference to the enclosed schematic plan, the nine recommended precautions are:

- (1) loose bricks, mortar, etc., are to be removed from the overhead area labeled "1" on the plan;
- (2) loose bricks, mortar, etc., are to be removed from the overhead area labeled "2" on the plan;
- (3) the overhead cantilever column at location "3" is to be inspected to determine whether torch cutting has weakened it to the point that it might fall and, if so, it is to be removed;

SCHEMATIC PLAN OF POWER HOUSE DEMOLITION SITE  
(NO SCALE)

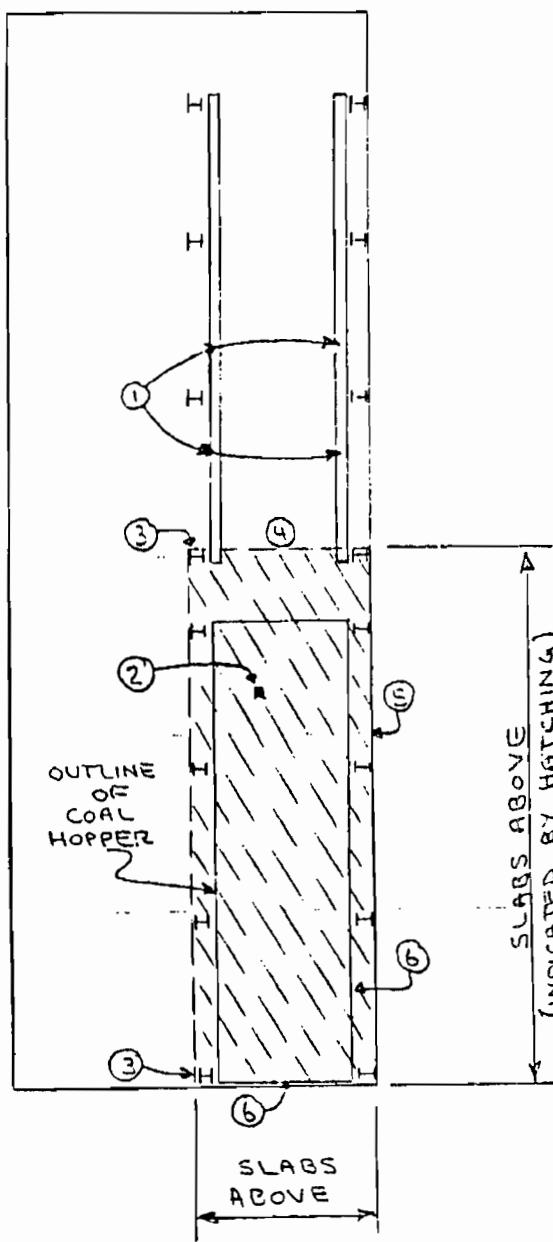
SHT. NO. EP-7JOB NO. P3-27SCHEMATIC PLAN OF Power House AT ARCO SITESITE VISIT October 9, 1923  
(No Scale)NORTH  
↑

- (A) the structural steel framing supporting the hopper, roof slab, walls, etc., appears sound, and work adjacent to it and within it is not believed to be hazardous relative to collapse of the structure,
- (B) the lower floor slab (located approximately 6 feet higher than the surrounding grade) and the steel framing supporting it appear to be sound, and the use of a small "Bobcat" loader on it is considered to be satisfactory,
- (C) several locations (listed below) exist where debris is potentially hazardous, as it may fall.

- (1) bricks and other small items of debris are situated on the girders,
- (2) a piece of concrete debris is situated on two parallel electrical conduits,
- (3) bricks located at the demolition faces at the north and south ends of the brick walls should be inspected, and loose bricks should be removed,
- (4) three separate pieces of concrete are hanging from the frame,
- (5) individual bricks and other debris are situated on the window sills of the east exterior wall,
- (6) debris is located on top of the roof slab along the north, south, and east edges,
- (7) debris is located on the north edge of the slab which is situated approximately 10 feet below the roof slab.

It is my opinion that cleanup of debris in the south portion of the building can proceed safely provided the debris items noted above are removed first. Additionally, the Bobcat loader can be used on the floor slab discussed in Item (B) above. This is conditional upon maintaining the protective equipment on the loader and also upon no further demolition of the structure above until the current debris cleanup is completed.

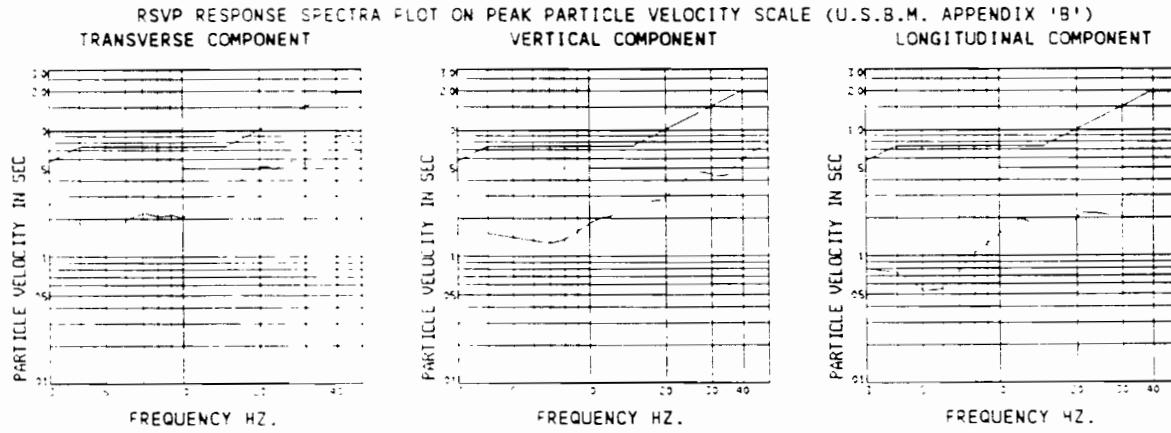
LONGITUDINAL = 0.79 in/sec

The vibrations satisfy the Variable Particle Velocity vs. Frequency Limits recommended by the U.S.B.M. Report RI-8507(Nov 1980)

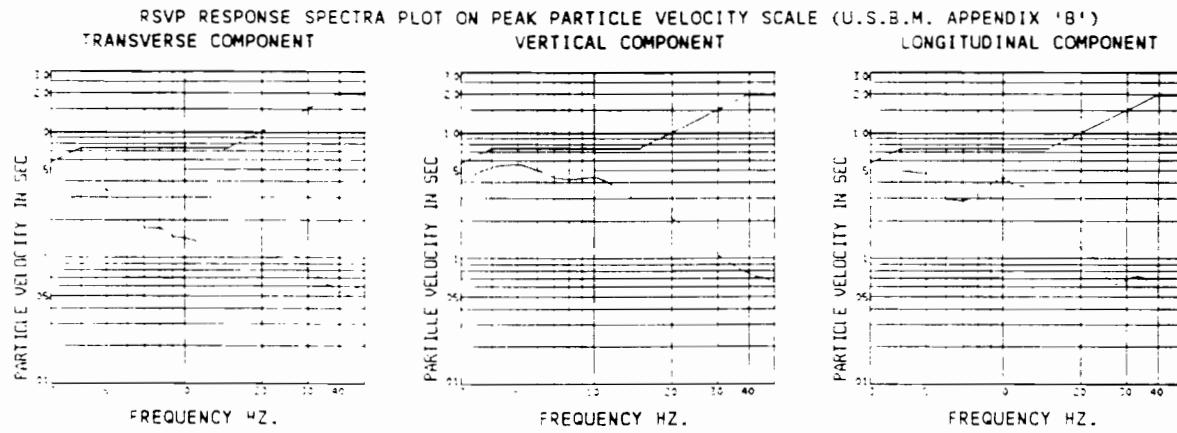
LONGITUDINAL = 0.49 in/sec

The NON-damage probability for this event was calculated as:

Type of Structure	1 STORY	1 1/2 STORY	2 STORY
NONDAMAGE Probability	100%	100%	100%
