# Village of Cuba Landfill Site

## Periodic Review Report (2019-2020)

**NYSDEC Site Number: 902012**

February 2020

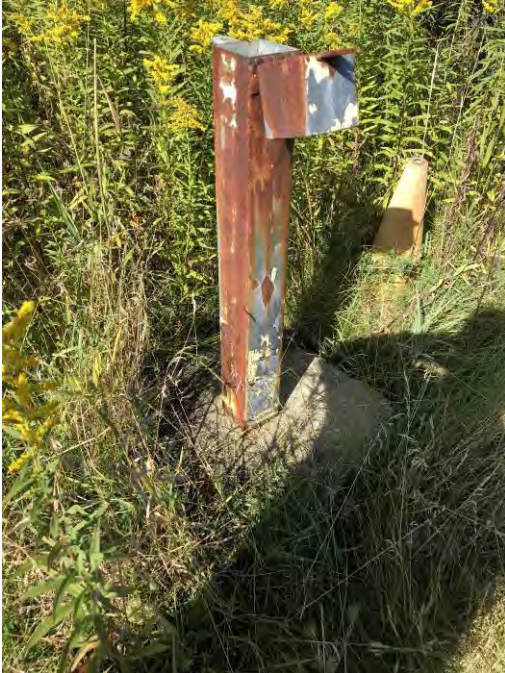
**Photo No. 1 MW-1S upheaved**

**EVIDENCE OF DAMAGE TO WELLS/VENTS:** MW-1S is upheaved approximately 1.0 feet (Refer to photographs). The protective caps from the landfill vents have fallen out (refer to photographs).

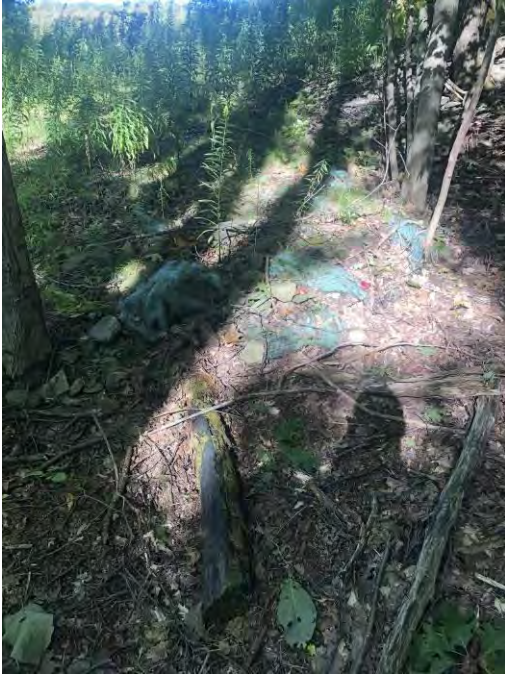
Photo No.5 Exposed geotextile

- Continue to monitor willow trees;
- If determined necessary, repair the exposed green geotextile on the Site cap;
- Replace landfill vent caps.

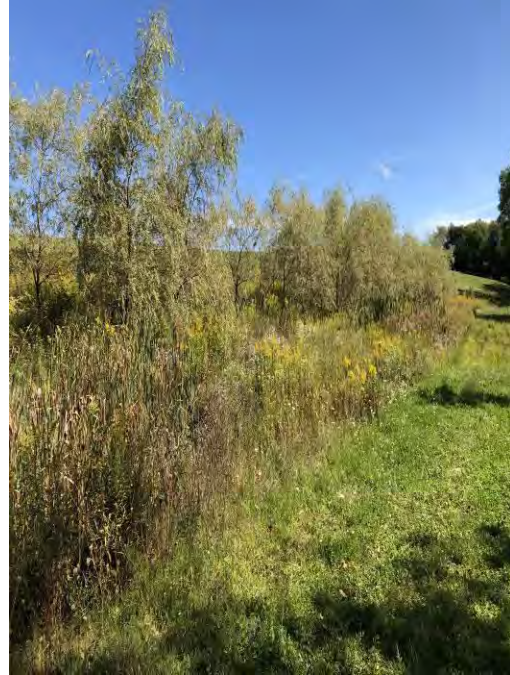
- Landfill cap drainage is largely effective and structures are in good working condition; however, minor ponding was observed at the base of the hill on the southern edge of Site (refer to Appendix B, Site Photographs).
- The placement of large tree stumps on either side of the western access road appears to be inhibiting vehicular trespassing.
- Minor erosion has been observed on the eastern and western access roads on the steepest portions. A small area of exposed geotextile was observed on the landfill cap (refer to Appendix B, Site Photographs).
- In the 2018 sampling event, approximately 30% (eastern-most) of the willow trees, a component of the phytoremediation effort at the Site, appeared to have died. In the September 2019 sampling event, the willow trees appeared to be partially recovered (refer to Appendix B, Site Photographs).

Photo No. 6 Recovering willow trees

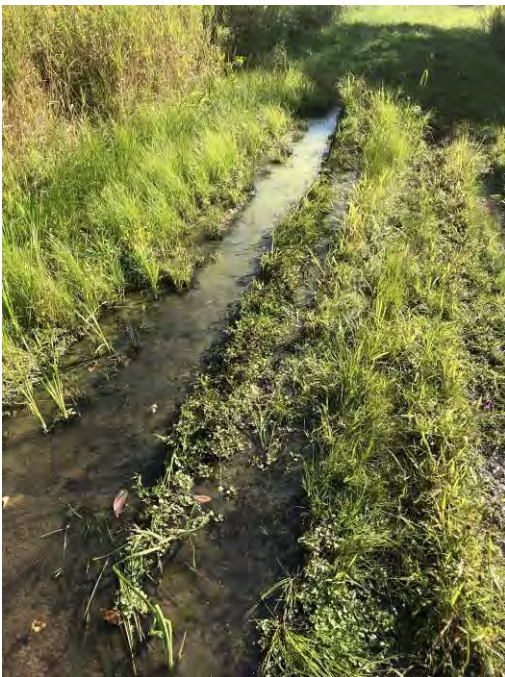
Photo No. 7 Ponding on south edge of Site

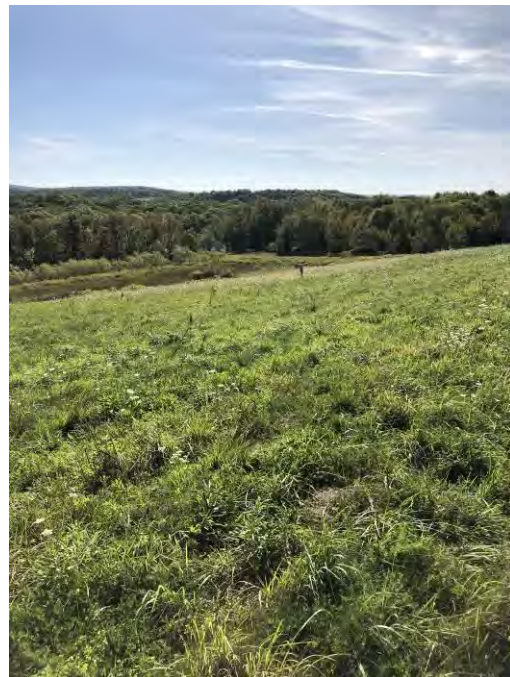
Photo No. 8 Landfill gas vent

**GAS VENTS: Unusual conditions- belching, whistling, excessive gas production:**  
None; protective vent caps have fallen out
