**SITE CHARACTERIZATION INVESTIGATION  
REED ROAD LANDFILL  
Friendship, New York  
Site No. 902018**

April 2007

Division of Environmental Remediation  
New York State Department of Environmental Conservation

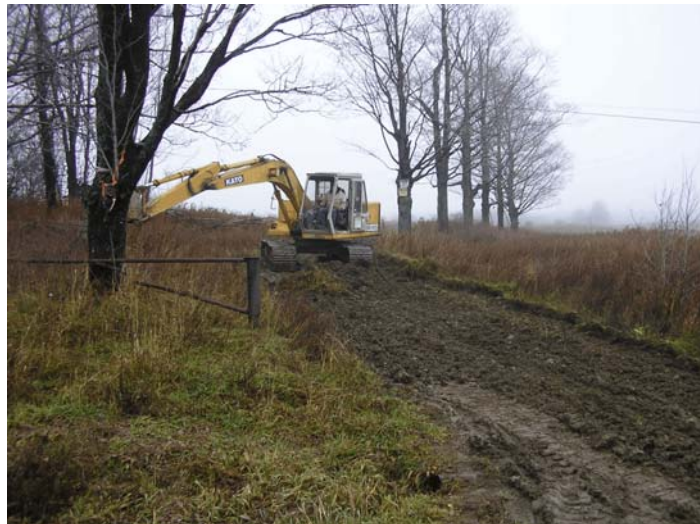
- Green had difficulty accessing the site with the vac truck due to soft access road conditions. The access road was rutted during Green's previous work at the site. The existing ruts and recent wet weather had softened the road. The vac truck got stuck and Green solicited local businesses for a tractor and excavator to free the vac truck and gain access to the site. The Department agreed to pay for the tractor/excavator (assumed cost approximately \$100.00).

Excavator Fixing Access Road

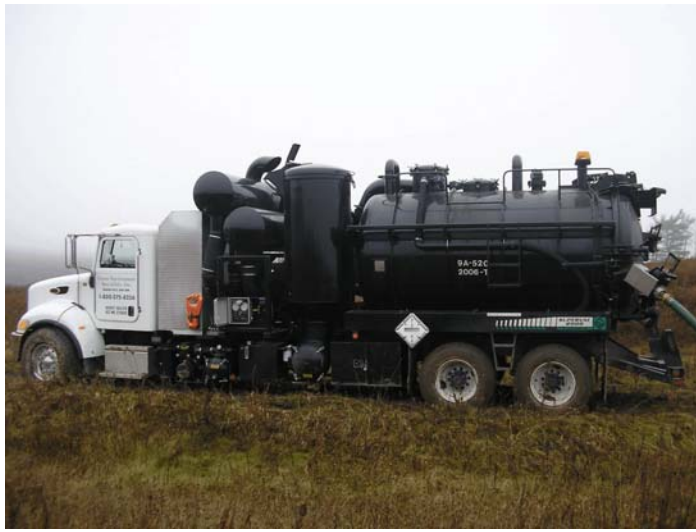
Green Environmental used a vacuum truck to removed approximately 7,500 gallons of leachate and sediment from the leachate collection tank on November 2, 2006. The inside of the tank was inspected and appeared to be in good condition. Green Environmental returned to the site on November 13, 2006 and remove approximately 2,300 gallons of leachate and sediment from the three manholes (some leachate was removed from the tank to access the header pipe and prevent tank overflow during flushing). Green Environmental flushed the leachate collection piping using potable water and a high pressure cleaning nozzle to power wash the inside of the collection pipes. The full length of the header pipe, between the leachate tank and each manhole, was successfully cleaned. Lateral pipe flushing was limited to down gradient sections due to limited potable water, limited flushing hose length and poor vehicle access due to wet/soft ground conditions. The lateral pipes from each disposal trench were flushed up gradient from their associated manhole. The lateral pipe from the northern trench was flushed approximately 25-feet from the northern manhole, the lateral pipe from the center trench was flushed approximately 75-feet from the center manhole and the southern trench was flushed approximately 100-feet from the south manhole.

High Suction Vacuum Truck

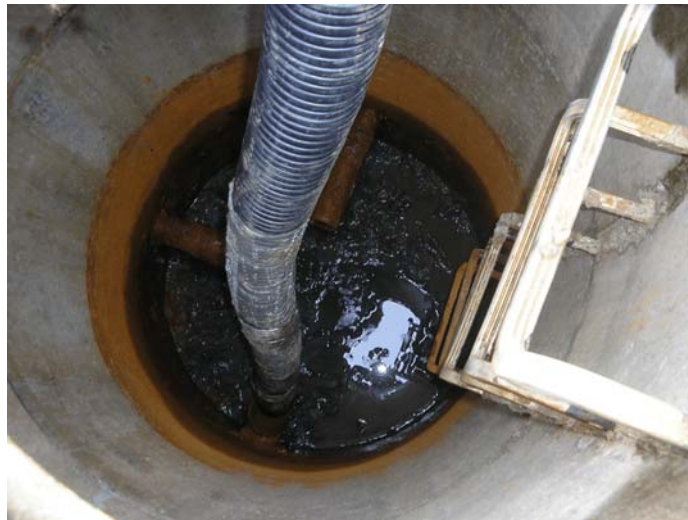
A significant amount of sediment was removed from the collection pipes, manholes and leachate tank. An increase in leachate flow was noted from each lateral pipe after flushing was completed, indicating leachate was backed up into the disposal trenches. The leachate tank and manholes appeared to be in good condition. No blockages in the piping were encountered. No leachate was discharged during the flushing and sediment removal activities.

Removing Sediment From Manhole

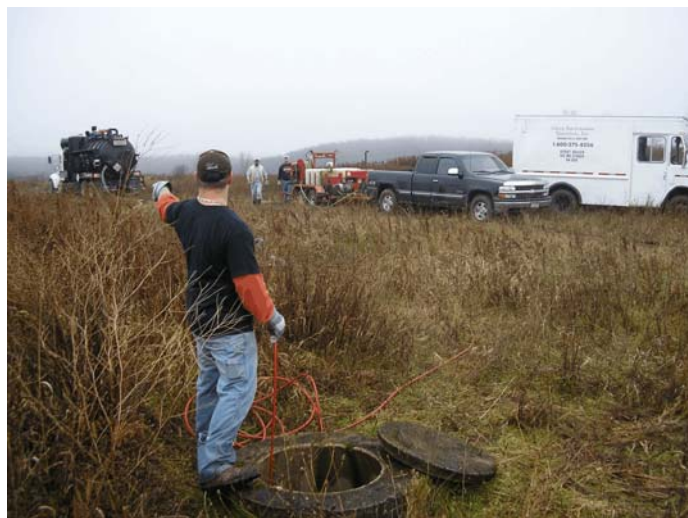
Flushing Leachate Pipes

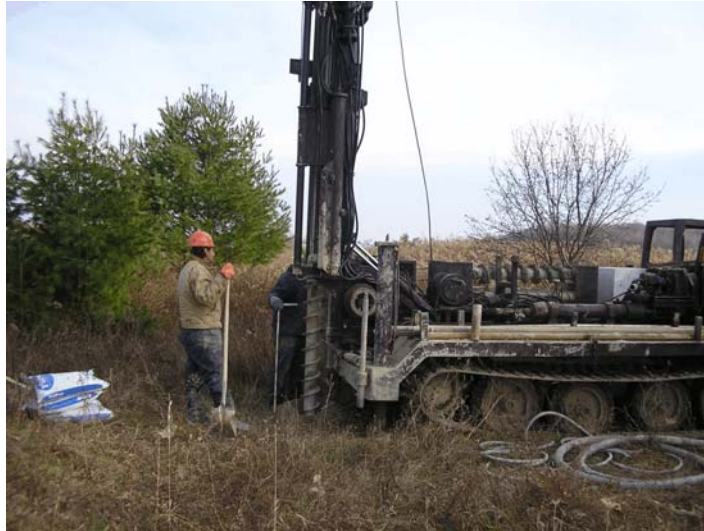
- Empire used a track mounted drill rig to installed (5) 2-inch PVC groundwater monitoring wells (MW-1 thru MW-5) surrounding the perimeter of the landfill. Wells were installed in the following general locations: MW-1 and MW-4 south of the landfill, MW-2 west of the landfill, MW-3 north of the landfill and MW-5 east of the landfill (east of manhole 2). The wells were installed to a depth of approximately 20 to 25 feet bgs. Split spoon sampling was attempted below a depth of 10 feet (soil conditions were previously documented above the 10 foot depth during the previous direct push probe investigation). In general, hard weathered shale was encountered below 10 feet and split spoon sample recovery was poor. Seams of moist wet soil/weathered shale were encountered in each boring. Boring logs and monitoring well installation logs are being prepared by Empire.

Drilling MW-2 (West Side of Landfill)

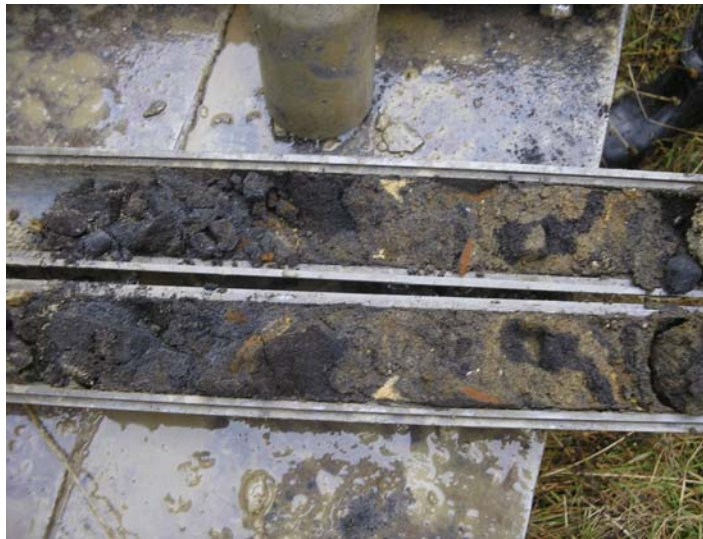
Foundry Sand Waste In Split Spoon Sample (Trench 3)

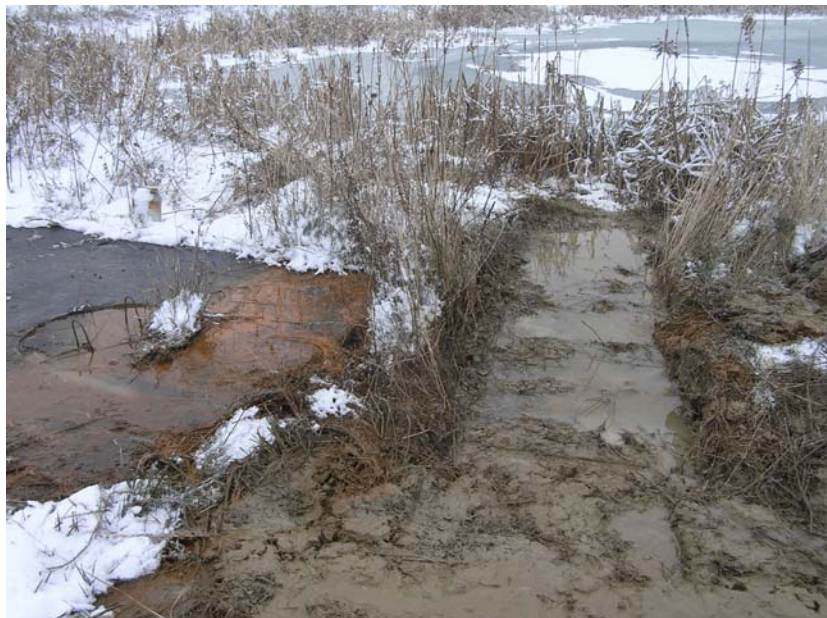
Ditch Excavated to Direct Tank Overflow to Pond

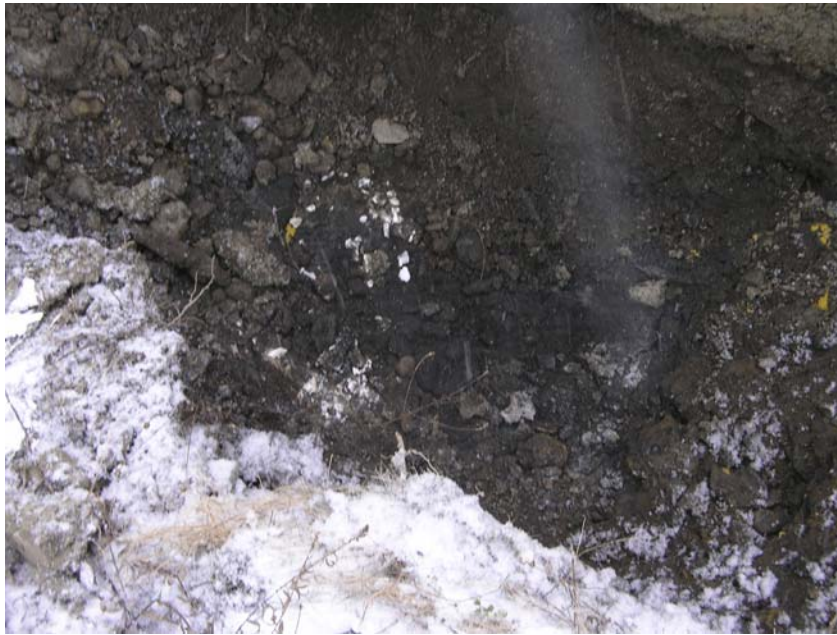
The test pit excavated in the area of anomaly A-4 located a layer of refractory brick and foundry sand approximately 2 to 5 feet bgs (See 'Field Inspection Report' dated December 7, 2006 included in Appendix A). One side of the refractory brick was covered in deposits of iron, which probably caused the EM response typical of metal debris. The Department collected a sample of the foundry sand. Native clay material was observed below the brick and sand. The excavated waste material was placed back in the test pit, covered with soil and tamped into place.

The geophysical survey located one area (anomaly A-4) of buried metal debris not positioned within, or immediately adjacent to, the disposal trenches. Anomaly A-4 is located near the south west corner of the southern disposal trench. A test pit excavated in this location confirmed the presence of foundry sand and refractory brick (w/ iron deposits) in the 2 to 5 foot bgs interval. This waste is consistent with the waste type approved for disposal in the landfill.

Geophysical Survey Anomaly A-4 Excavation  
(Refractory Brick/Foundry Sand)
