# Remedial Action Report

*Peter Cooper Markhams NPL Site  
Dayton, New York*

February 2009  
Revised June 26, 2009

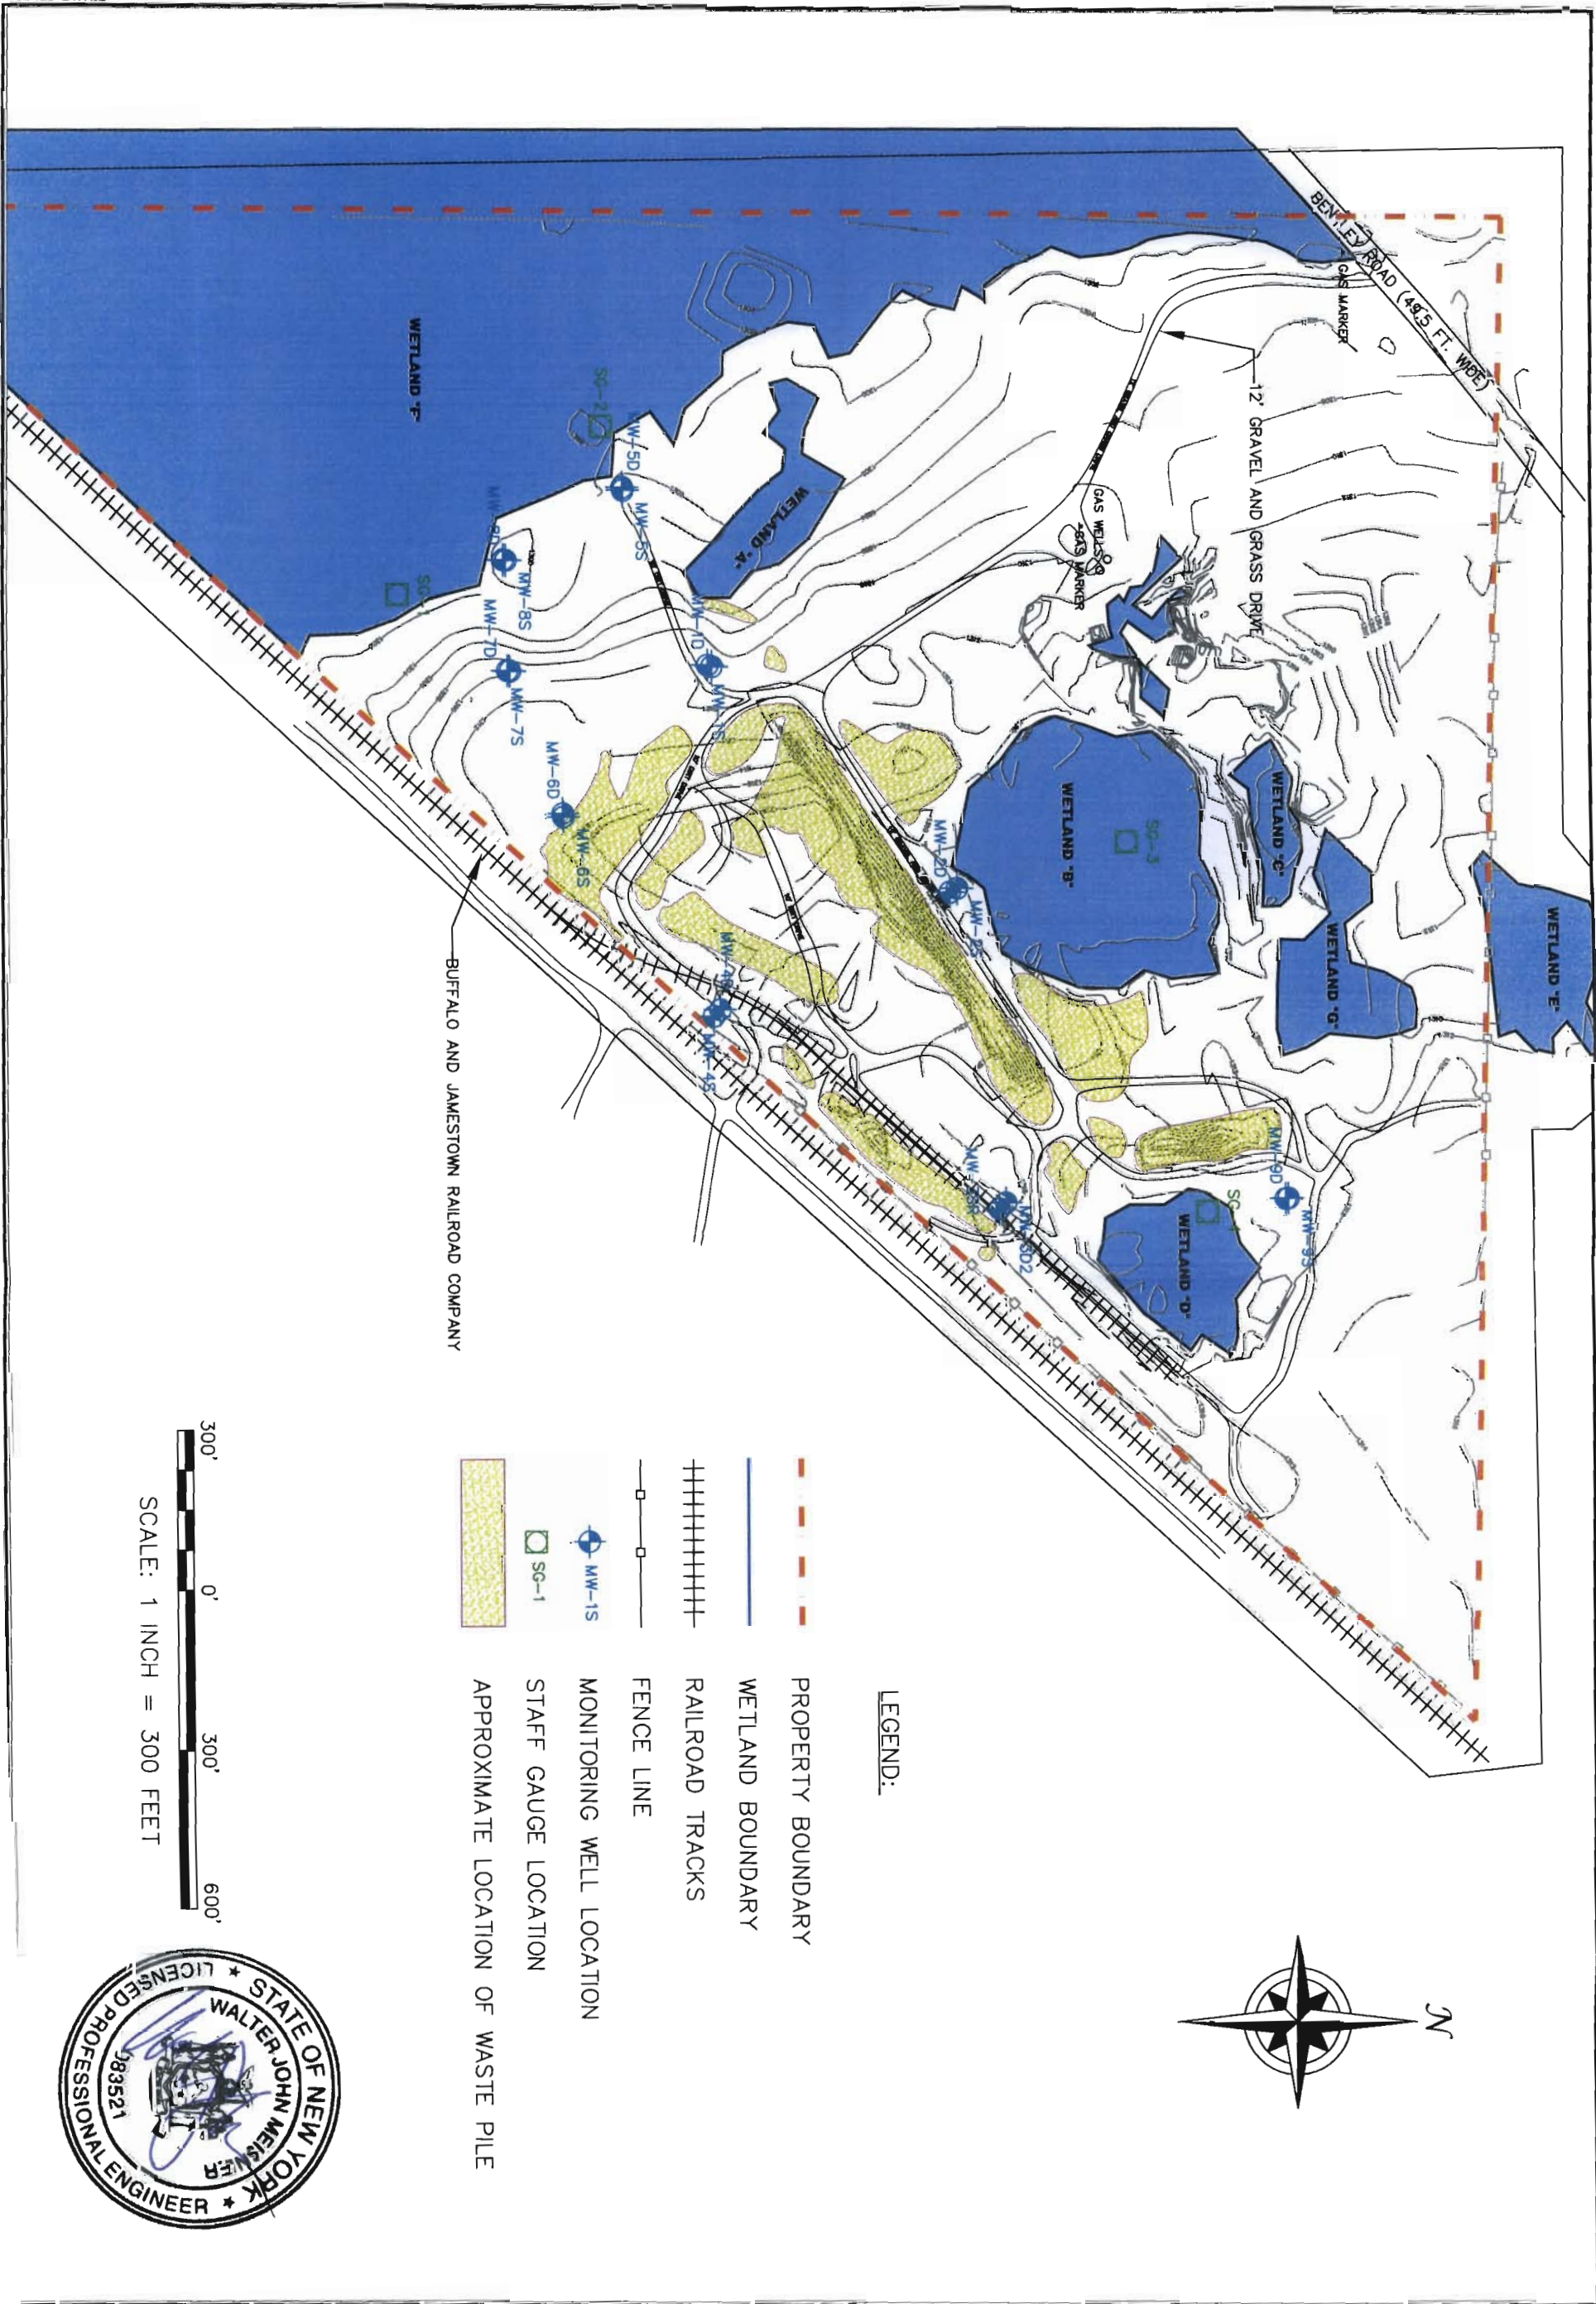
FIGURE 2

**PRE-REMEDIAL SITE PLAN**  
REMEDIAL ACTION REPORT  
PETER COOPER MARKHAMS NPL SITE  
BENTLEY ROAD, DAYTON, NEW YORK  
PREPARED FOR  
CPRPs FOR PETER COOPER MARKHAMS

A description of the remedial actions undertaken at the Site are presented below. Figure 2 presents a site plan showing pre-remedial conditions.

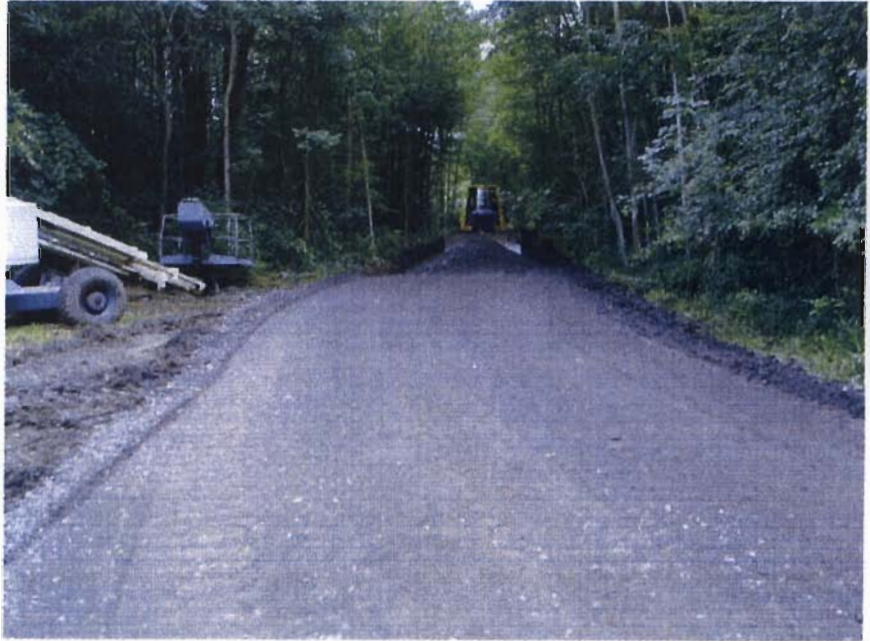
| <b>Photo No.</b><br>1A | <b>Date</b><br>Aug-08 | | |

| <b>Description:</b><br>Reestablish site access road. | | | |

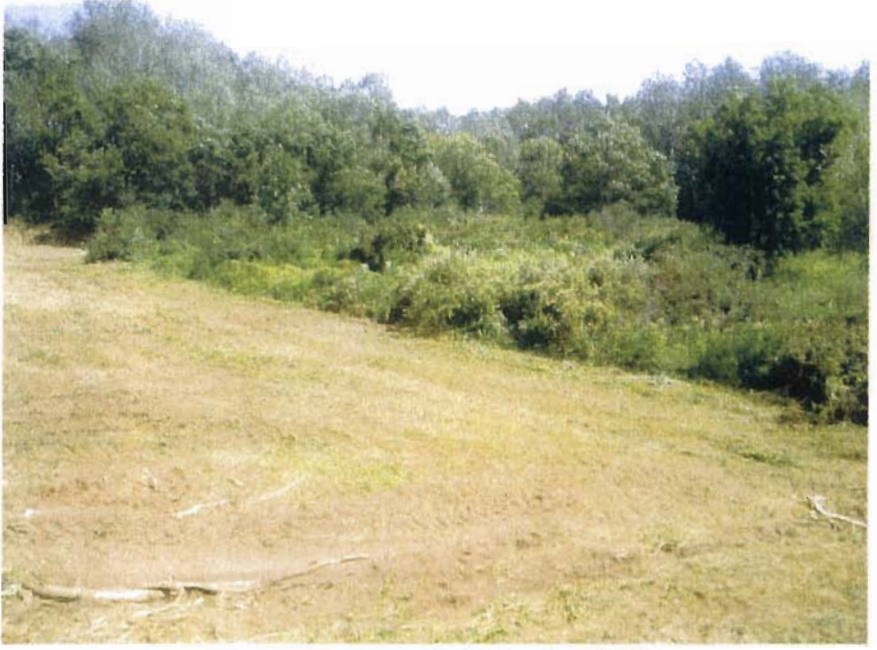
| <b>Photo No.</b><br>3 | <b>Date</b><br>Aug-08 | | |

| <b>Description:</b><br>Site prior to remedial activities | | | |

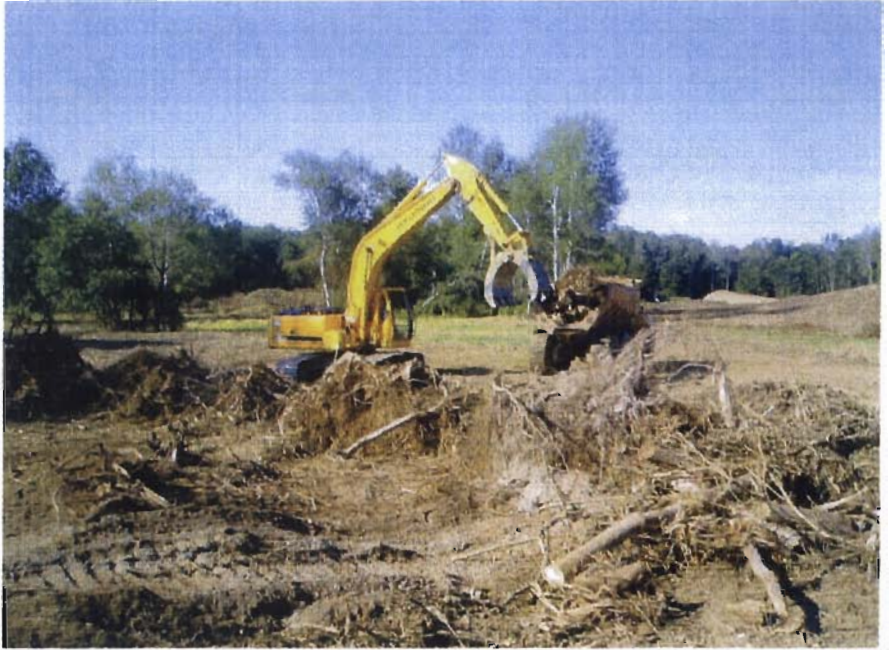
| <b>Photo No.</b><br>19A | <b>Date</b><br>Aug-08 | | |

| <b>Description:</b><br>Stump Removal | | | |

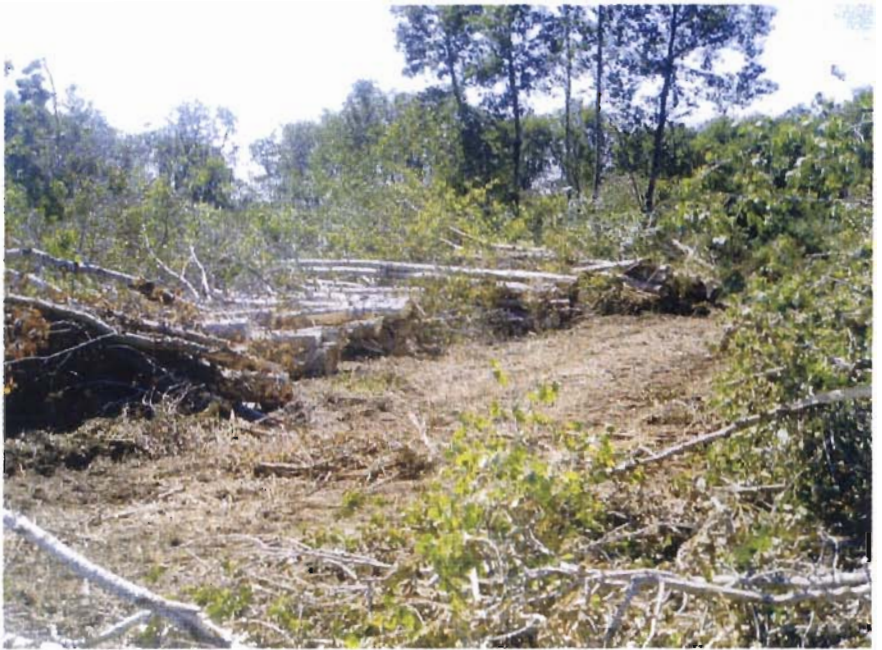
| <b>Photo No.</b><br>21 | <b>Date</b><br>Aug-08 | | |

| <b>Description:</b><br>Staging of cut trees prior to grinding. | | | |

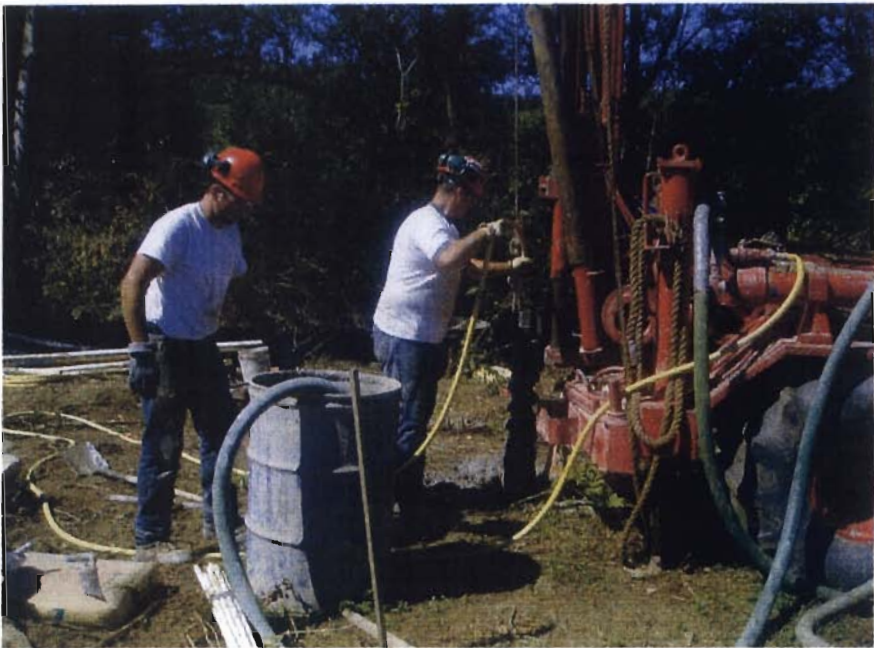
| <b>Photo No.</b><br>29 | <b>Date</b><br>Aug-08 | | |

| <b>Description:</b><br>Decommissioning damaged monitoring well MW-2S. | | | |

Per the design documents, several of the existing site monitoring wells were slated for decommissioning, with one well (MW-2S) slated for replacement due to suspect well integrity issues identified in the RI/FS. Monitoring wells to be retained in support of the post-remedial groundwater monitoring program for the Site (i.e. MW-4S through MW-9S) were protected during construction.

steel casing and screen, and was found to be visibly rusted/rotted upon removal. Earth Dimensions over-drilled the existing boring and installed a new 2-inch PVC replacement well (MW-2SR) to a depth of 10 feet with 5 feet of slotted PVC screen. Appendix G includes the borehole log for decommissioned well MW-2S and the monitoring well completion detail for replacement well MW-2SR. On October 11, 2008, MW-2SR was developed via removal of approximately 15 gallons (10 well volumes) of groundwater. MW-2SR will be sampled as part of the O&M activities at the site as outlined in Section 4.1. Remaining monitoring wells were decommissioned as listed below:

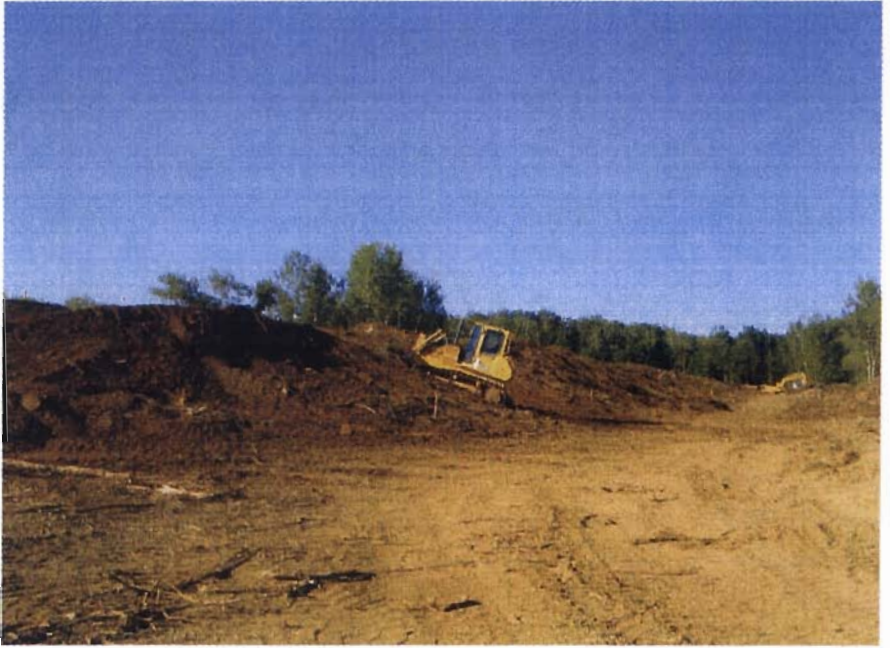
| <b>Photo No.</b><br>31 | <b>Date</b><br>Sep-08 | | |

| <b>Description:</b><br>Regrading waste material. | | | |

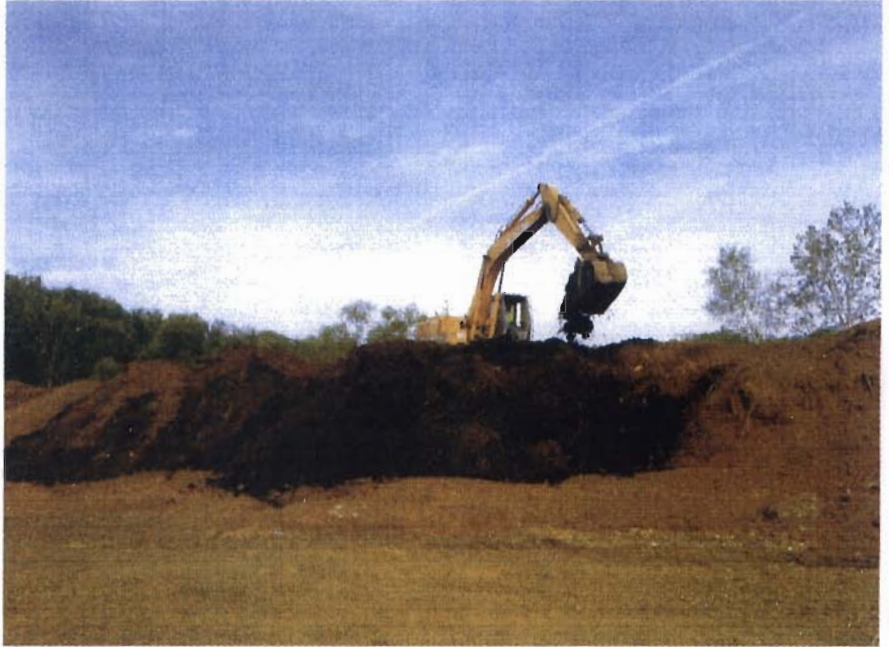
| <b>Photo No.</b><br>33 | <b>Date</b><br>Sep-08 | | |

| <b>Description:</b><br>Consolidating waste/fill material. | | | |

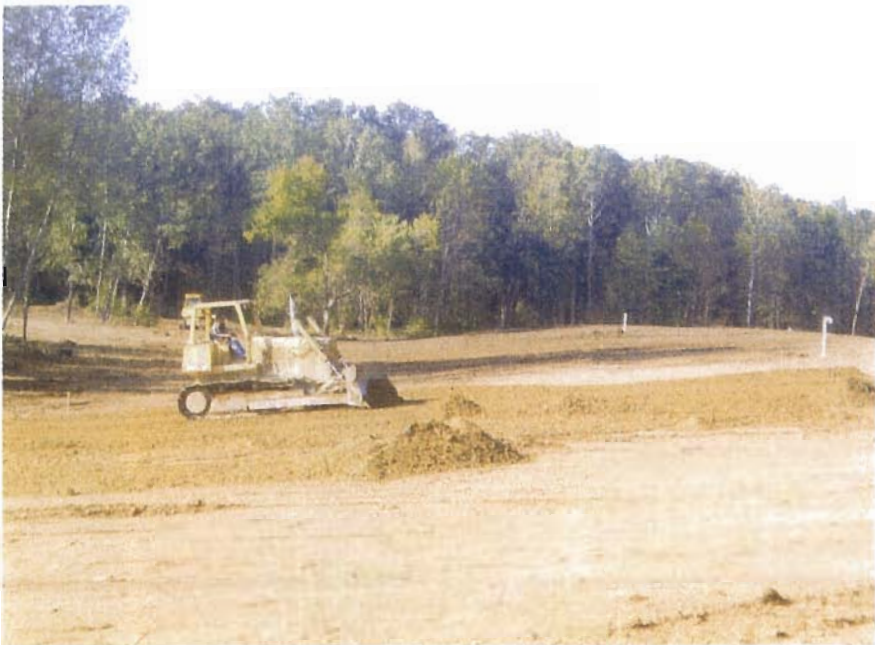
| <b>Photo No.</b><br>39 | <b>Date</b><br>Oct-08 | | |

| <b>Description:</b><br>Placement of barrier protection soils. | | | |

On September 24, 2008, barrier soils placement was initiated on the east end of the consolidation area. Barrier layer soils were placed in two, 10-inch loose lifts and compacted to 9-inch lifts with a pad foot roller. Compacted lift thickness was controlled through grade stakes and verified by Benchmark throughout placement.

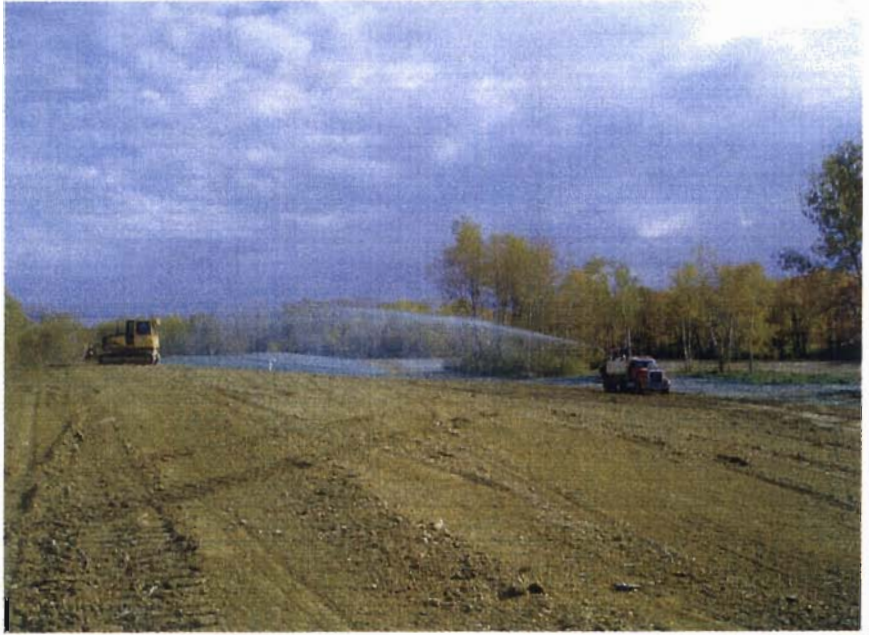
| <b>Photo No.</b><br>47 | <b>Date</b><br>Oct-08 | | |

| <b>Description:</b><br>Applying hydroseed vegetation on placed topsoil. | | | |

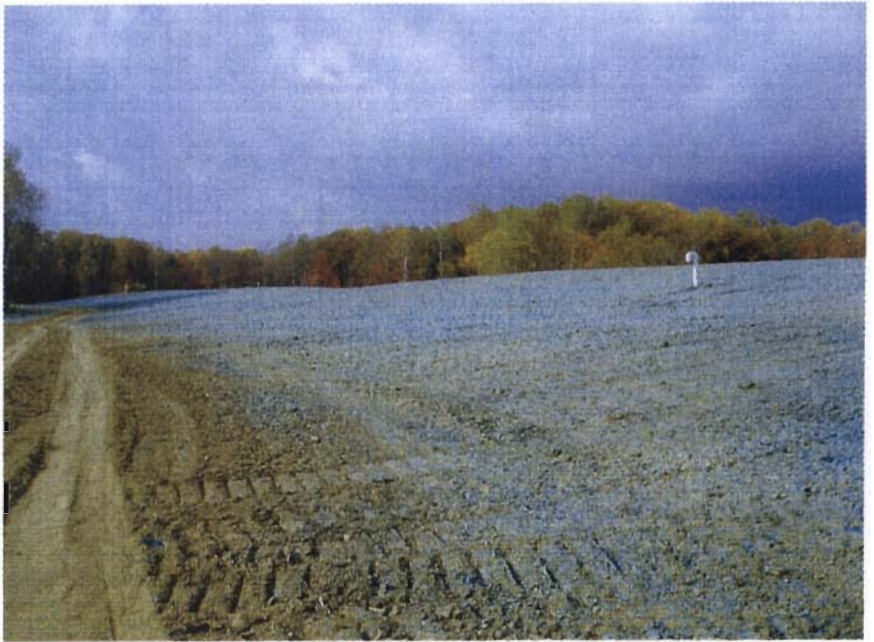
| <b>Photo No.</b><br>49 | <b>Date</b><br>Oct-08 | | |

| <b>Description:</b><br>Applied hydroseed vegetation. | | | |
