**Moench Tanning
Cattaraugus County
Gowanda, New York**

PERIODIC REVIEW REPORT

NYSDEC Site Number: 905004

January 2025

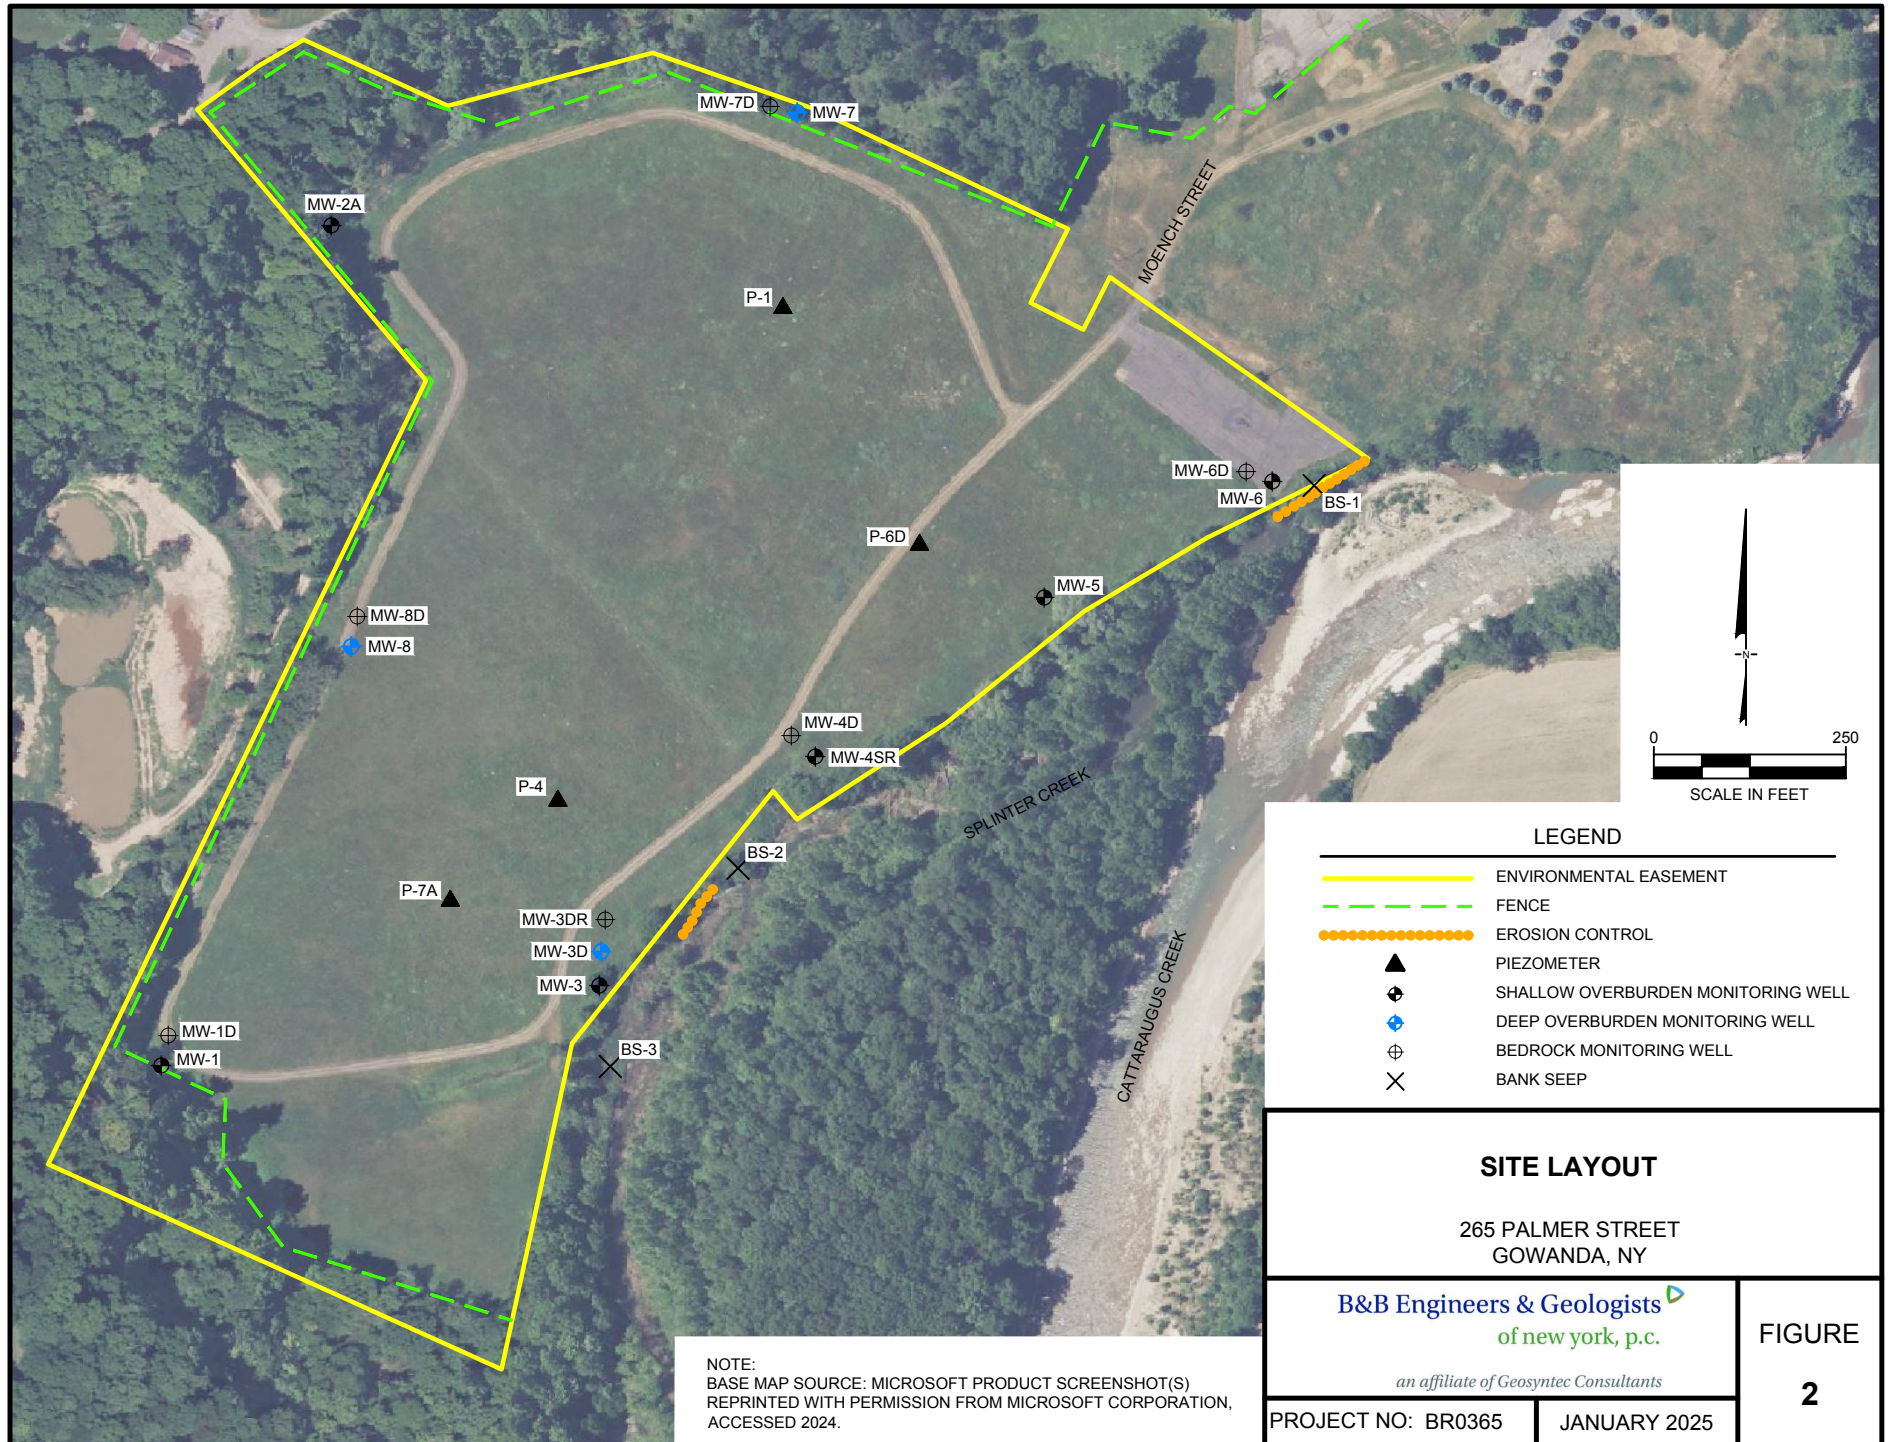
Figure 2 – Site Layout Map

The Site is located partly in the Village of Gowanda and the Town of Collins, Cattaraugus County, New York and is identified as Tax Map Numbers 17.029-1-4, 16.036-3-30, 16.036-3-41 and 16.002-4-31 (**Figure 1**). The Site is a 25.87-acre area, which includes the approved landfill cover system and surrounding support areas and is bounded by steeply sloped wooded areas to the west and south, a swampy area to the northwest, and Cattaraugus Creek and Splinter Creek to the east (**Figure 2**).

- a cover system placed over the Site; and
- preventative erosion control measures along the oxbow portion of Splinter Creek and along the northern bank of the landfill adjacent to Cattaraugus Creek near and over bank seeps 1, 2, and 3 and as such these bank seeps are no longer accessible (**Figure 2**).

Locations of these monitoring points are presented in **Figure 2**.

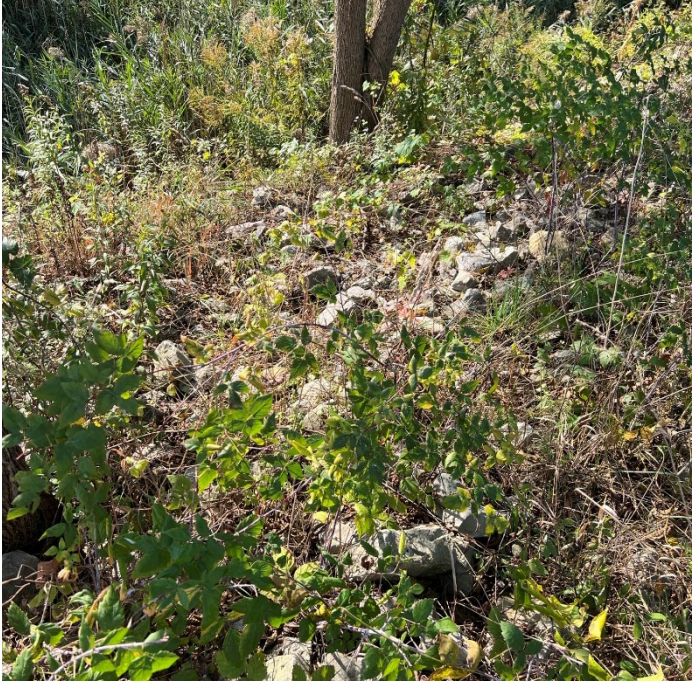
Photographic Record	
Client: Caleres, Inc.	Project Number: BR0365
Site Name: Palmer Landfill	Location: Gowanda, NY
Photograph 1: Date: 09/28/2024 Direction: East Comments: South (BS-2) erosion control measure

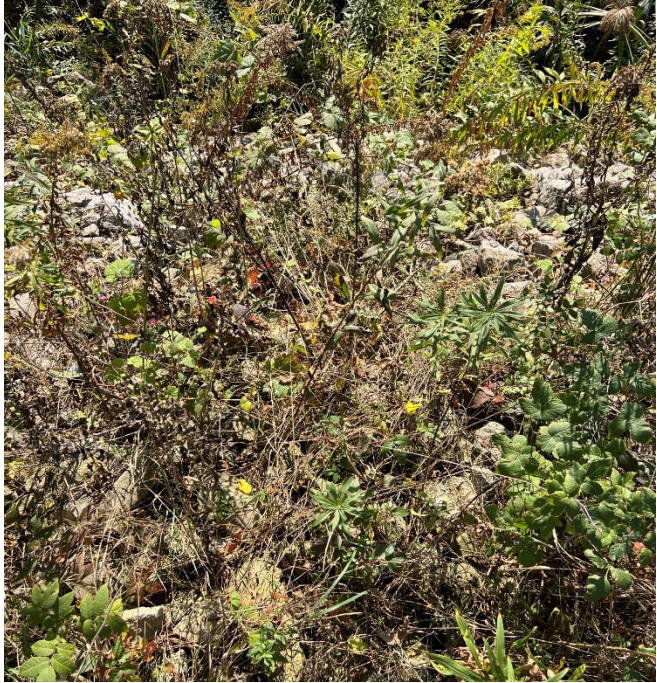
Photograph 2: Date: 09/28/2024 Direction: East Comments: South (BS-2) erosion control measure

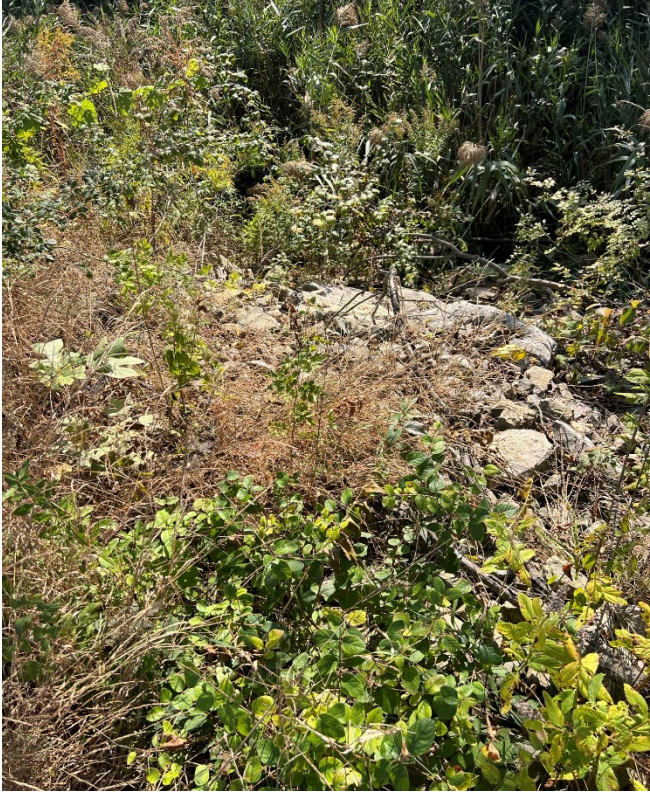
Photographic Record	
Client: Caleres, Inc.	Project Number: BR0365
Site Name: Palmer Landfill	Location: Gowanda, NY
Photograph 3: Date: 09/28/2024 Direction: East Comments: South (BS-2) erosion control measure

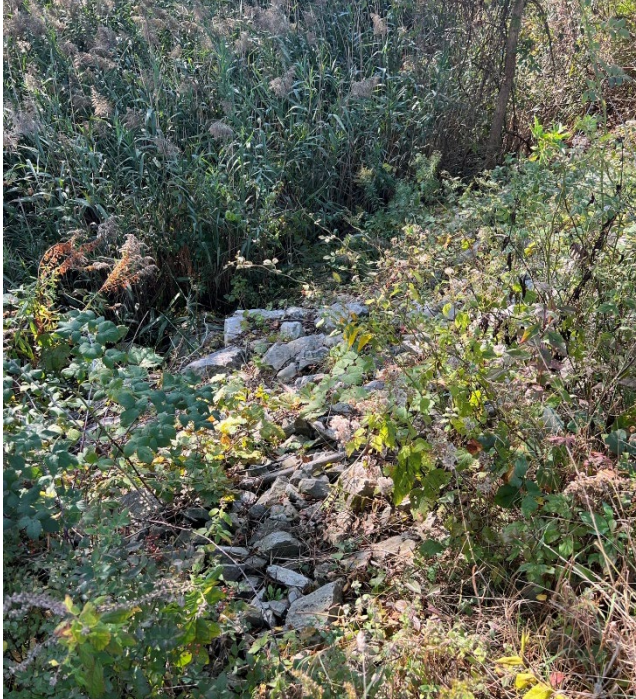
Photograph 4: Date: 09/28/2024 Direction: East Comments: South (BS-2) erosion control measure

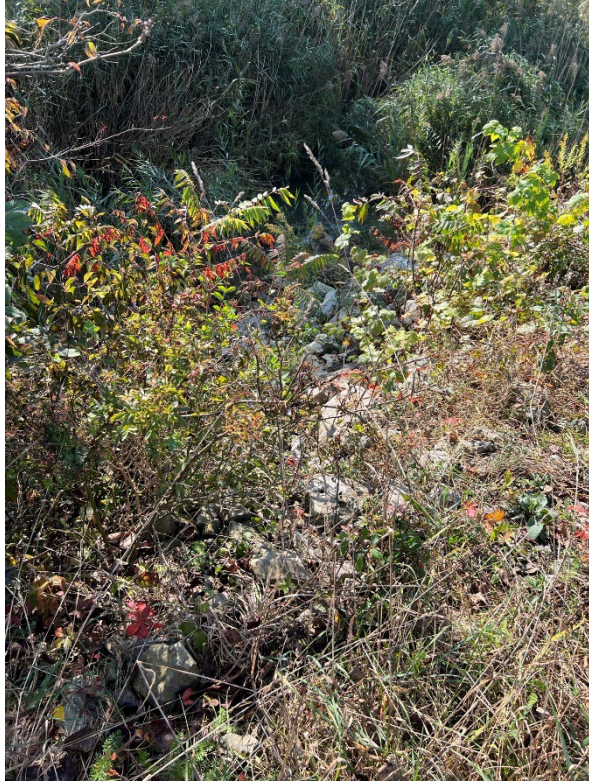
Photographic Record	
Client: Caleres, Inc.	Project Number: BR0365
Site Name: Palmer Landfill	Location: Gowanda, NY
Photograph 5: Date: 09/28/2024 Direction: Southeast Comments: North (BS-1) erosion control measure

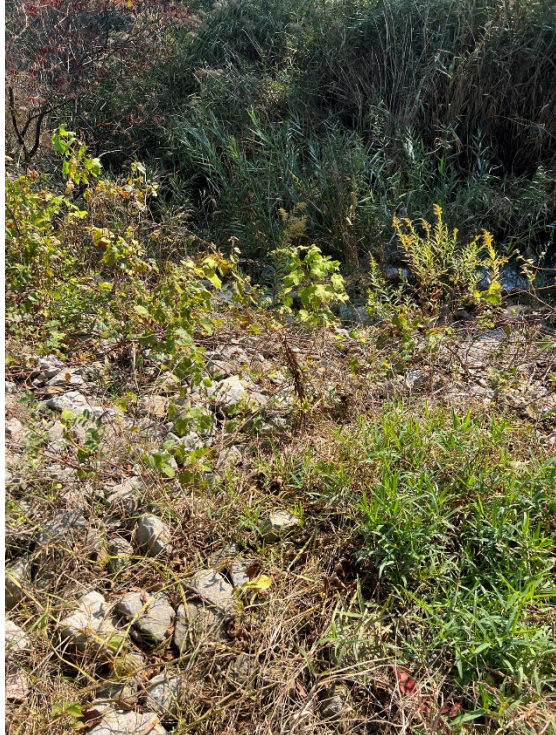
Photograph 6: Date: 09/28/2024 Direction: Southeast Comments: North (BS-1) erosion control measure

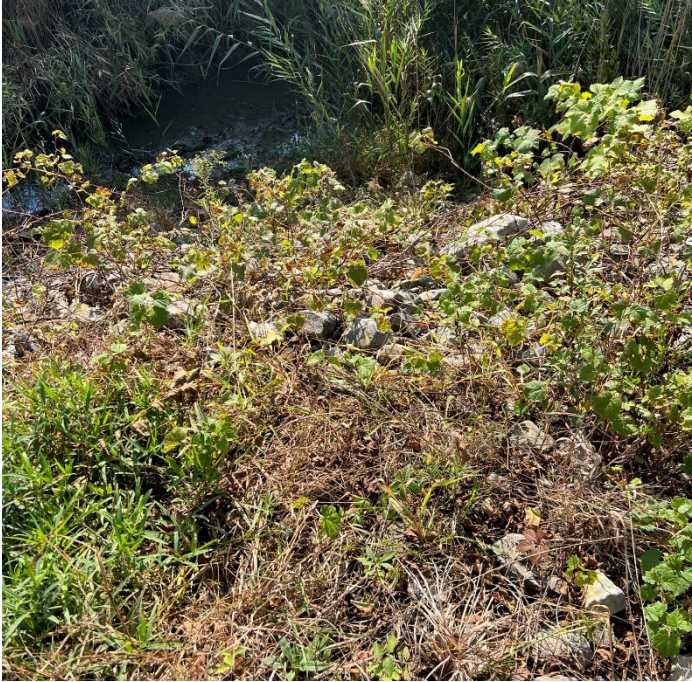
Photographic Record	
Client: Caleres, Inc.	Project Number: BR0365
Site Name: Palmer Landfill	Location: Gowanda, NY
Photograph 7: Date: 09/28/2024 Direction: Southeast Comments: North (BS-1) erosion control measure

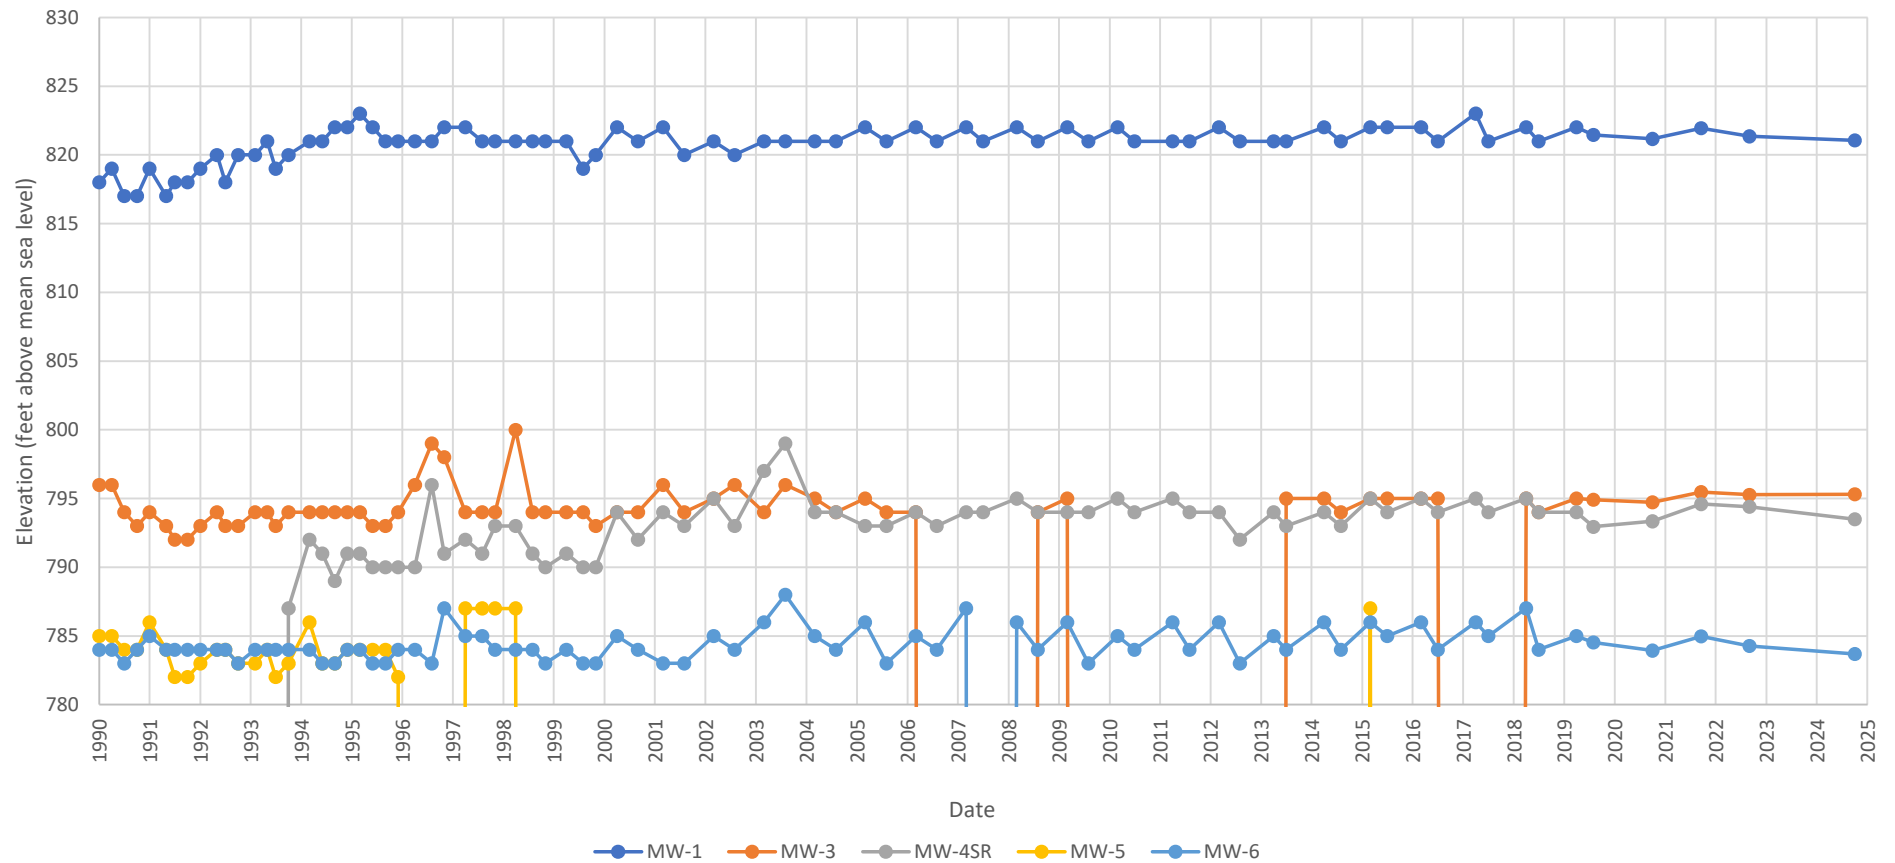
Appendix D-1
Trend in Groundwater Elevations
Shallow Overburden
Palmer Landfill
Gowanda, New York

A trend analysis of groundwater elevations is presented in **Appendix C**. As shown, the 2024 groundwater elevations were consistent with recent historical elevations.

Notes:
Time between vertical lines indicate when wells were dry or not able to be measured.

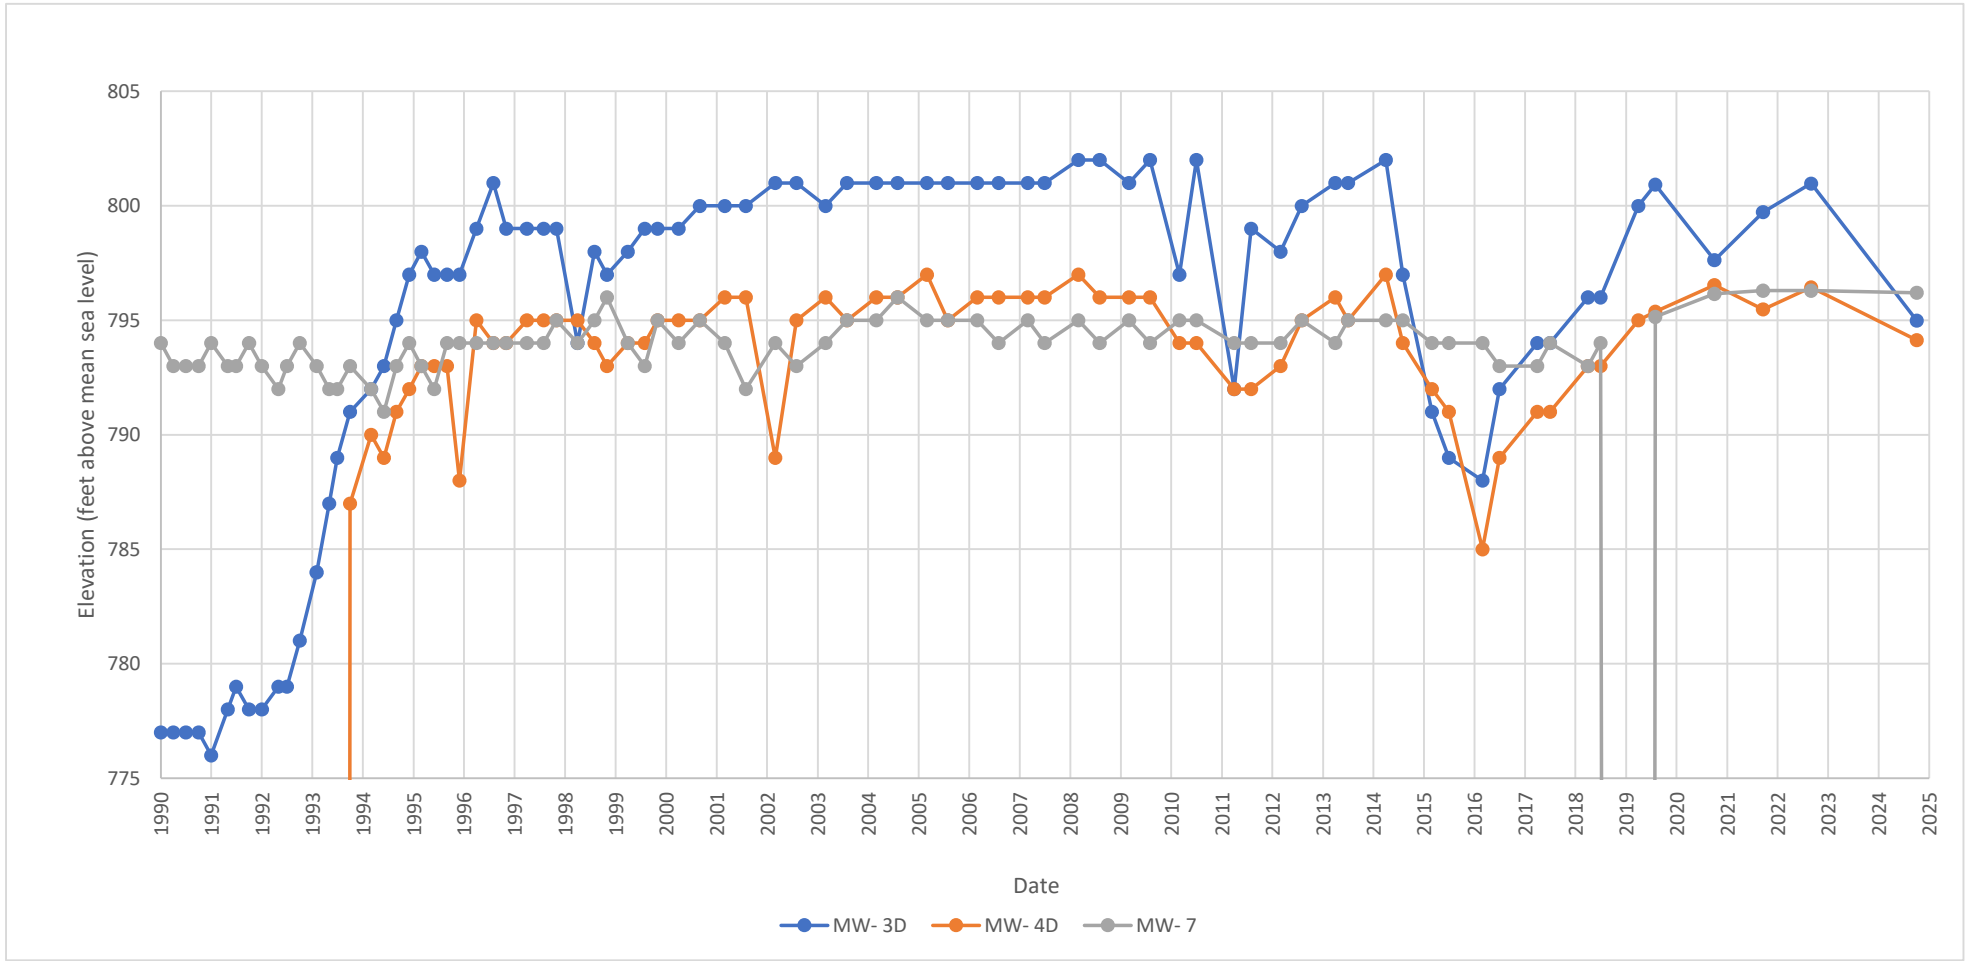
Appendix D-2
Trend in Groundwater Elevations
Deep Overburden
Palmer Landfill
Gowanda, New York

Notes:
Time between vertical lines indicate when wells were dry or not able to be measured.

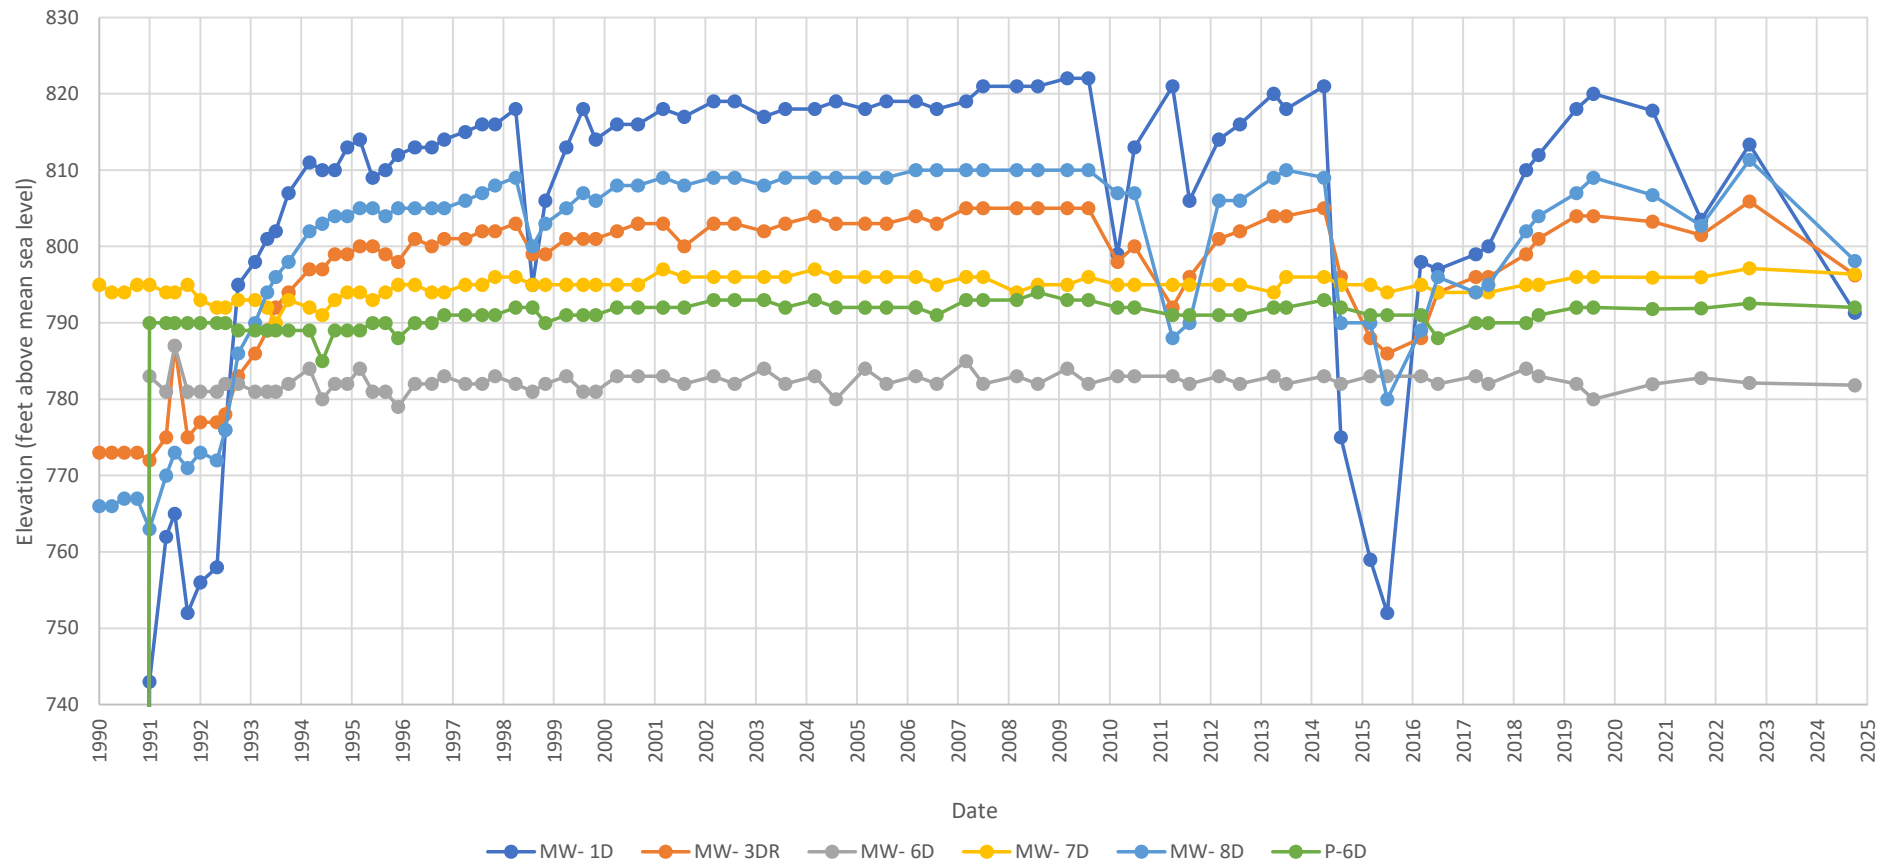
Appendix D-3
Trend in Groundwater Elevations
Bedrock
Palmer Landfill
Gowanda, New York

Time between vertical lines indicate when wells were dry or not able to be measured.
