REMEDIATION SUMMARY REPORT

SOIL EXCAVATION AND SITE RESTORATION PROJECT

VAN DER HORST PLANT NO. 1 SITE
CITY OF OLEAN, CATTARAUGUS COUNTY
CONTRACT NO. D003962
SITE NO. 9-05-008

April 2000

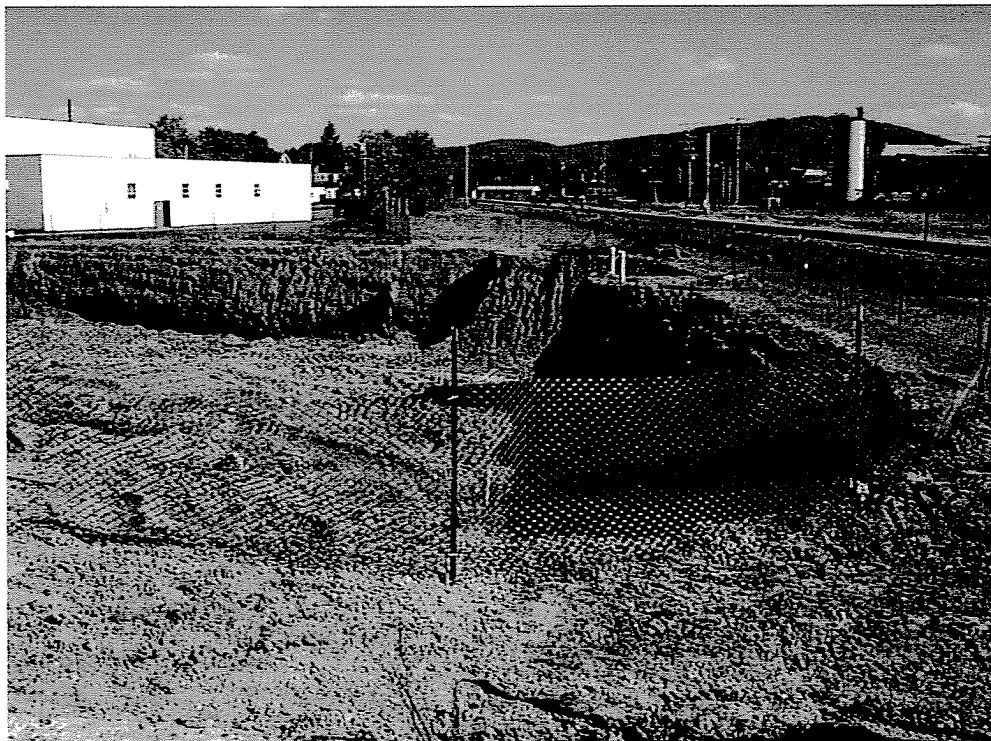
2. Non-Hazardous Soil Excavation: Initial 15 foot cut in area of shoring to remove uncontaminated soil from the work area.

After the driving of the sheet piling, CSC excavated the remaining non hazardous soils to be staged on site and used as backfill. The material from 10' to 16' was placed on two layers of 10 mil poly, but was segregated from the 0'-10' soils so it could be used as the initial backfill material after groundwater treatment.

It was anticipated that this portion of the excavation would continue to 18' below the ground surface, however the 40 mil HDPE material placed on top of the monolith during the previous contract was found at the approximately 16' bgs elevation. This increased the quantity of hazardous soil and proportionally decreased the amount of non-hazardous soil by 273 cubic yards. The higher encountered elevation of hazardous waste required CSC to pull back hazardous soils along the sheet piling to allow for the installation of the anchors and walers of the sheet piling system. These soils were staged in the center of the excavation until sheet piling was completed and until disposal arrangements could be made so as not to contaminate clean areas of the site and increase handling problems.

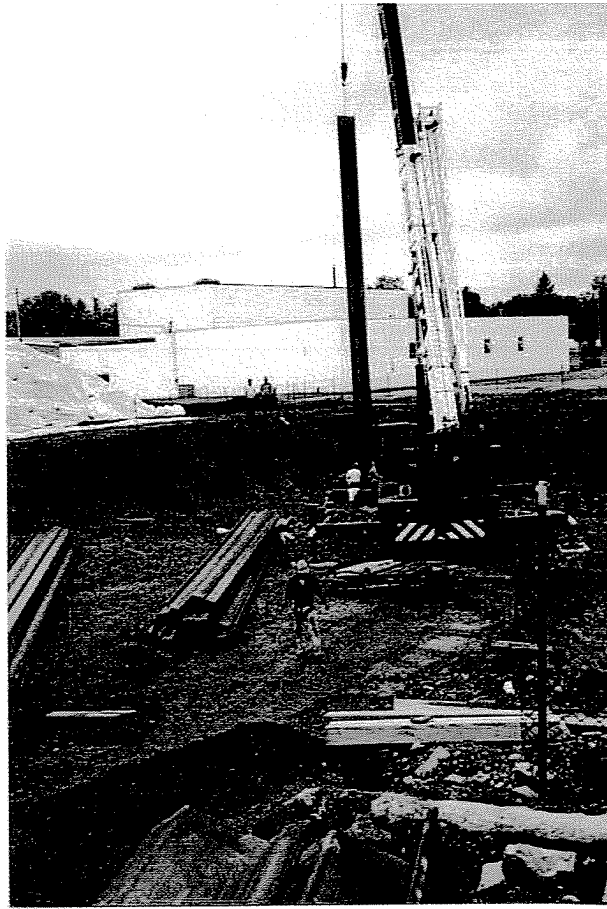
3. Shoring Installation: Setting sheets in place.

The work progressed in a clockwise direction with little difficulty with the installation of the piling until just south of corner #7. Piling pairs #33 and #34 were very difficult driving, hitting some obstruction at approximately 25' (35' bgs) from the final piling elevation. Several attempts were made to drive the piles through the obstruction resulting in damage to the top of the pile sections. Ultimately, all piles were driven to at least 48' below original ground level (12' short of the final

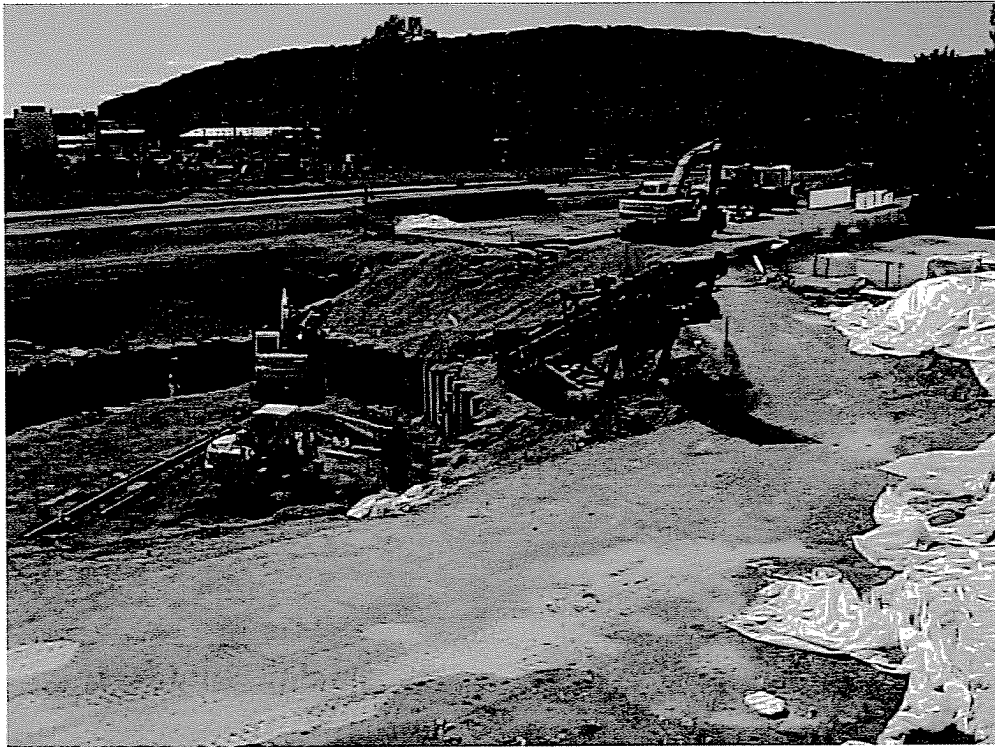
5. Shoring Installation: Overview of excavation and anchor installation.

For quality control purposes, 6 of the 54 (>10%) anchors were pull tested. The anchors tested were those chosen by Richter Corporation, CSC and DEC as most likely to fail the test due to wandering or shortness of anchor. All pull tests were taken to between 58,000 and 60,000 pounds, exceeding the required strength of 54,000 pounds.

Walers were installed spanning as many adjacent anchors as possible, typically 3 or 4, as many as 7, and as few as a single anchor. The walers were secured to the pilings using bolts installed in the end of the anchors and washer/nut combinations to secure to the pilings. After certification by the Design Engineer that the wall system was installed in accordance with the design, the Department provided permission to begin excavation of hazardous soils.

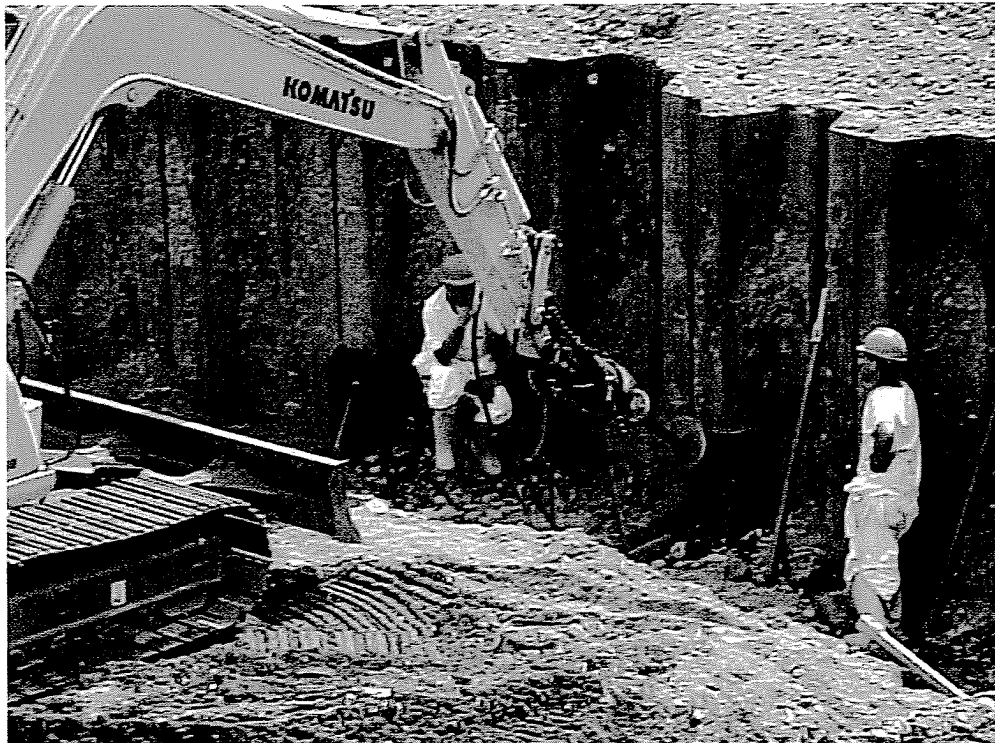
6. Shoring Installation: Installing anchors into shoring.

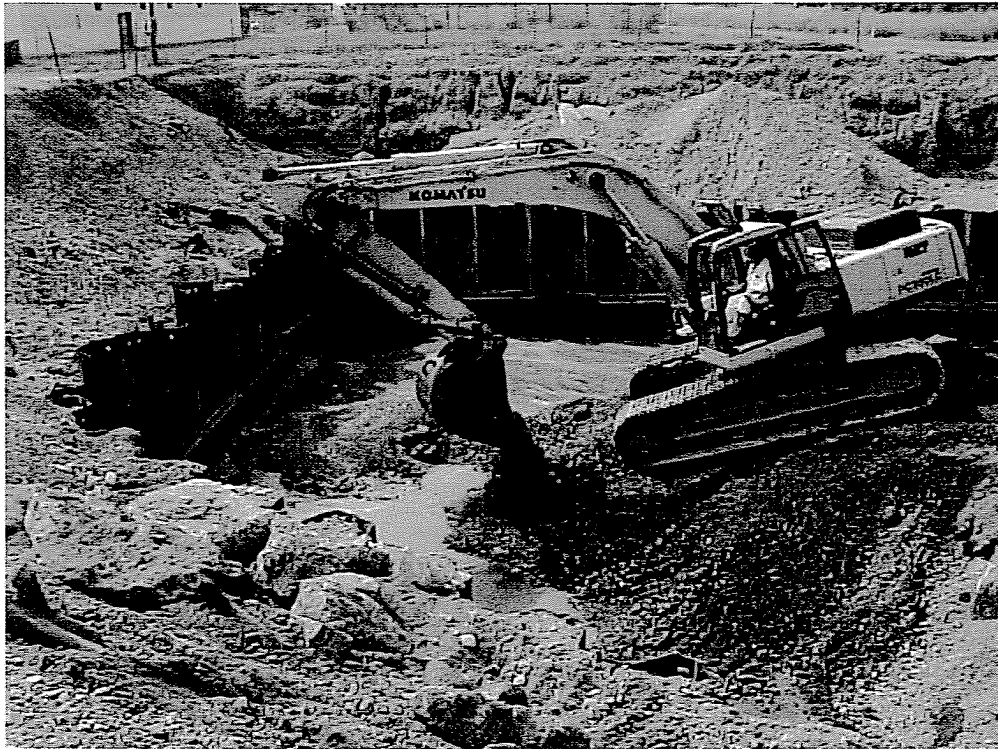
7. Hazardous Soil Excavation: Start of excavation of soil below 18' bgs.

The excavation of hazardous soil began on July 14, 1999. Prior to excavation of hazardous materials the dimensions of the surface inside the sheet piling was documented by a licenced surveyor per the contract specifications.

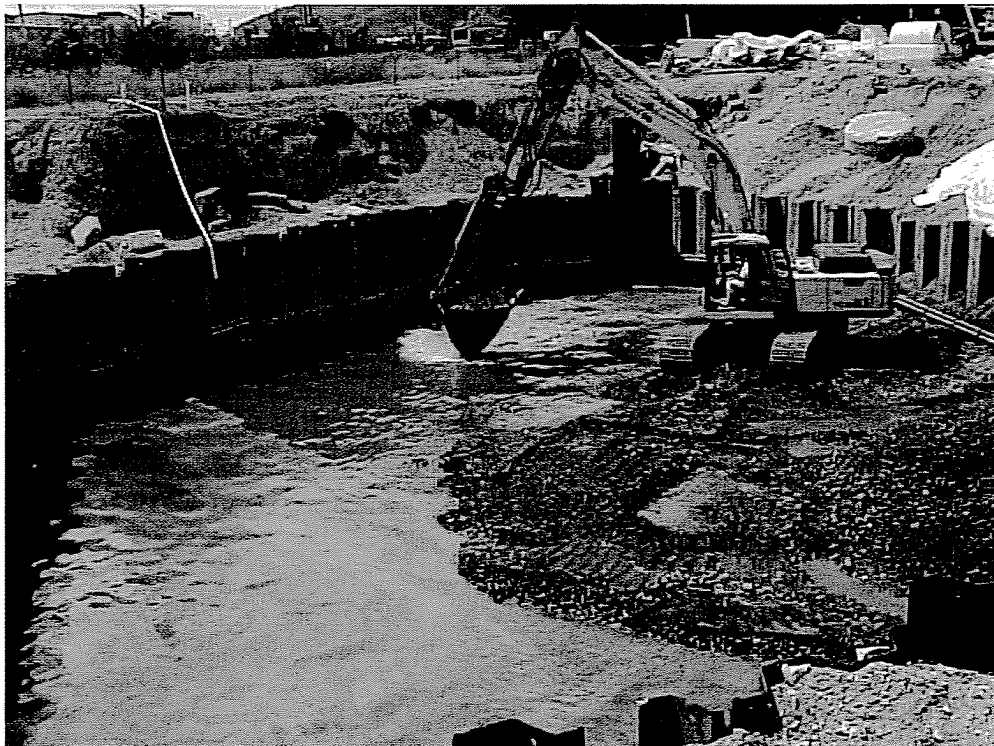
8. Hazardous Soil Excavation: Continuing excavation of soil below groundwater. (Note Yellow water)

Following the installation of the side wall support structure, excavation to the design depth began (18 feet to 42 feet bgs). This work occurred in wet conditions meaning that the soil was excavated through the water within the excavation. No attempt was made to dewater the excavation because of the highly permeable condition of the surrounding soils. Excavated soils which were deemed hazardous were placed on a conveyor system which partially dewatered the soil as it carried it up to grade. The contaminated soil was then temporarily placed on a staging pad until it could be loaded into trucks and transported off site for disposal. A total of 9732 tons of hazardous soil was excavated and disposed at the site. During excavation activities a petroleum material began to accumulate on the water surface within the excavation area. Complaints from local residents resulted in the Department implementing a Residential Relocation Plan and also taking steps to remove the material from the water surface as it accumulated. The odor also resulted in increase air monitoring on the site.

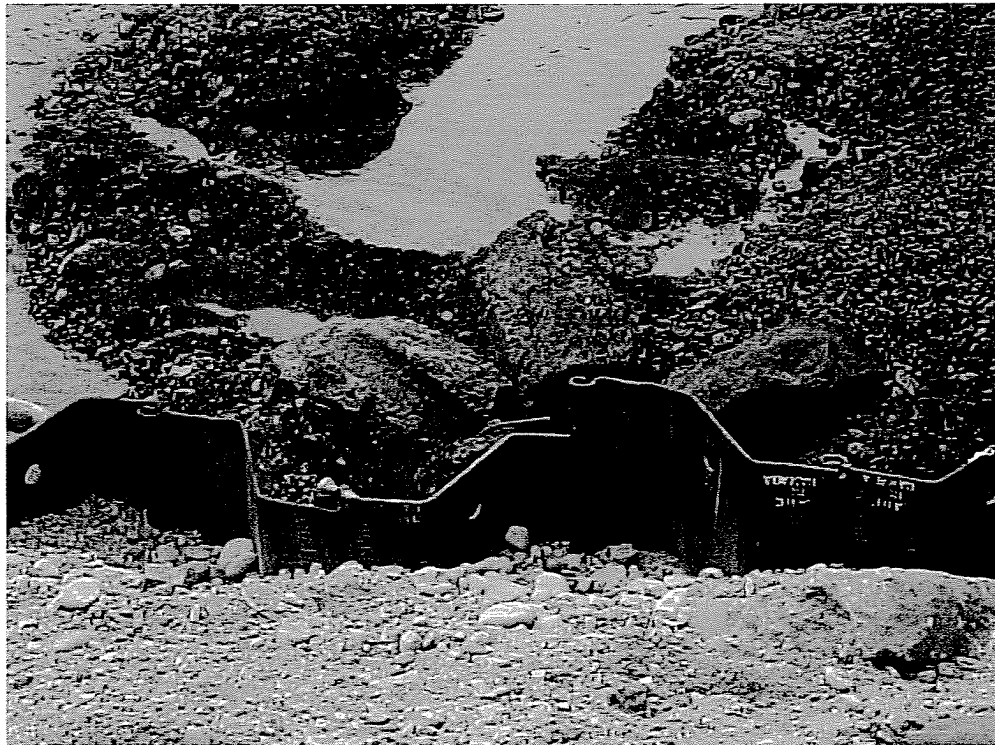
10. Hazardous Soil Excavation: Large chunks of solidified “monolith” soil.

CSC excavated the four feet of hazardous waste above the water table first to maximize the reach of the excavator trying to obtain the required depth of 42 feet below ground surface. As CSC progressed in the excavation, it became apparent that the PC 300 could not reach the construction depth (42' bgs). On July 22, 1999, CSC installed a 10' extension onto the arm of the PC 300 and resumed excavation. Again it was concluded that the PC 300, even with the extension, could not reach the required contractual depth for the entire excavation. On August 5, 1999, CSC cut a section out of the sheet pile wall between corners #2 and #3 at one foot above the waler to allow the removal of the PC 300 from the excavation. CSC brought on site a Komatsu 250 with a 54' reach to continue the excavation. It was quickly determined that this machine could not complete the excavation to the required grades,,and it was replaced on August 9, 1999, with a Komatsu 400 with a 64' reach. This machine was used to complete the excavation of hazardous waste to 42' below the ground surface +/- 6", confirmed by a licenced surveyor, as required by the contract. Excavation of hazardous soil was completed on August 26, 1999. The final survey of the bottom of the excavation was completed August 27, 1999. The last hazardous soil was shipped from the site on September 2, 1999.

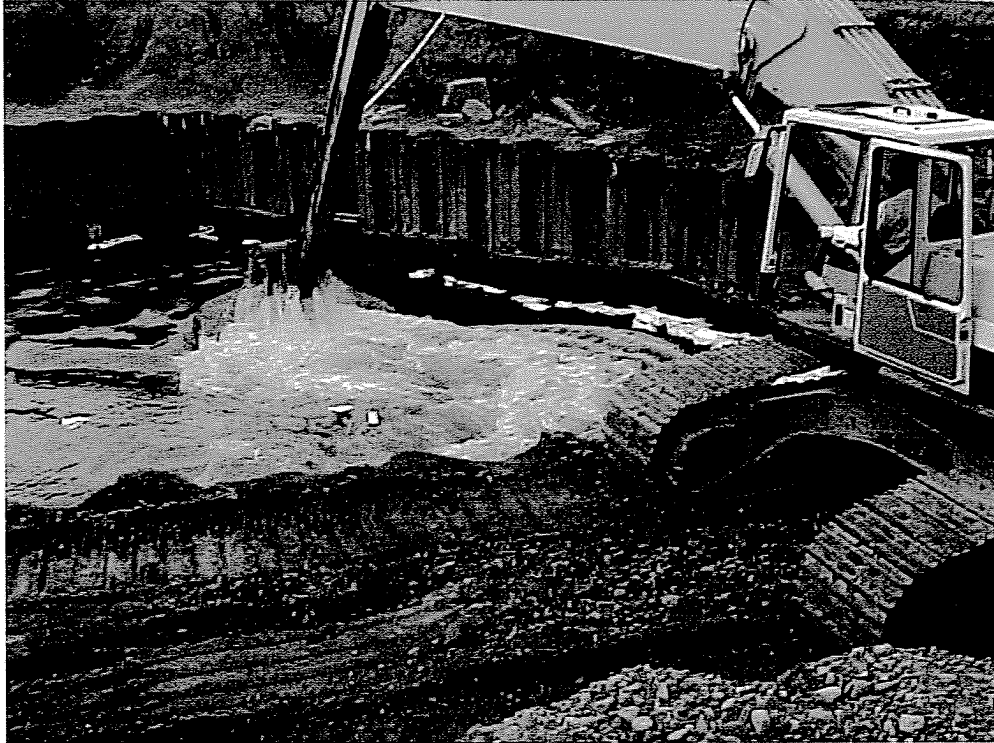
11. Hazardous Soil Excavation: Excavating through chromium contaminated groundwater.

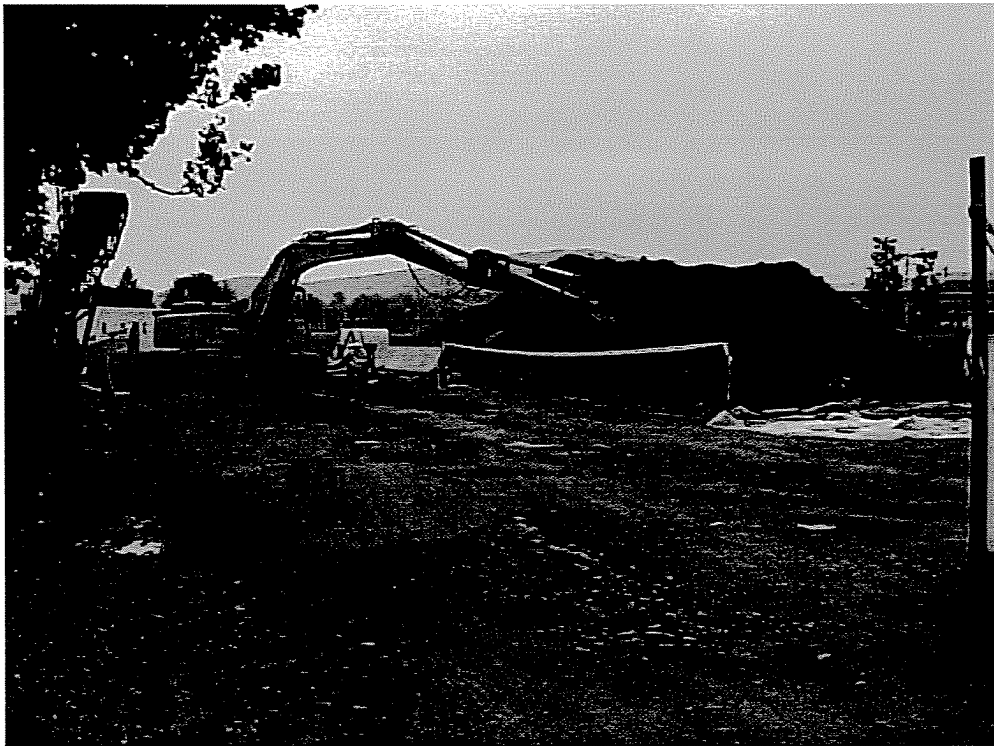
12. Hazardous Soil Excavation: Hazardous Soil staging pad.

CSC used the foundation and slab of building #24 as the base for the hazardous waste staging pad. CSC left approximately 6' high section of the west wall, and the SW corner of the building was used as a support for stockpiling waste, on the hazardous waste staging pad. At the conclusion of the handling of the hazardous waste the material was power washed to the satisfaction of the Department representative and the remaining building foundation, including the asphalt cover used for the storage pad was excavated and disposed off site at the Southern Tier Kleenfill C&D Landfill in Wellsville, NY.

Prior to the start of the excavation of hazardous soils, a staging pad for the stockpiling and dewatering of hazardous soils was constructed adjacent to the excavation area. The 60' x 100' pad was partially constructed on top of the existing concrete floor slab of Building #24 and extended an additional 40 feet north. The entire pad area was covered with 2 inches of blacktop on top of the concrete slab and 6 inches of blacktop over a 6 inch packed gravel base in the area north beyond the floor slab of building #24 . In order to prevent drainage of contaminated water that drained from the soil or contaminated precipitation that collects on the pad, a 6 inch high asphalt berm was installed along the pads edges. A collection sump was also installed in the north west corner of the pad for the collections of any contaminated waters that were generated. Collected waters were pumped into a 1000 gallon poly tank and the quantities recorded prior to returning to the excavation. CSC requested and was granted by the Department permission to discharge collected pad run-off back into the excavation during soil removal activities. At the conclusion of the excavation work, the discharge was stopped and the remaining waters were taken off site for disposal. As part of the agreement, CSC agreed to treat three times the volume of water that they discharge to the excavation.

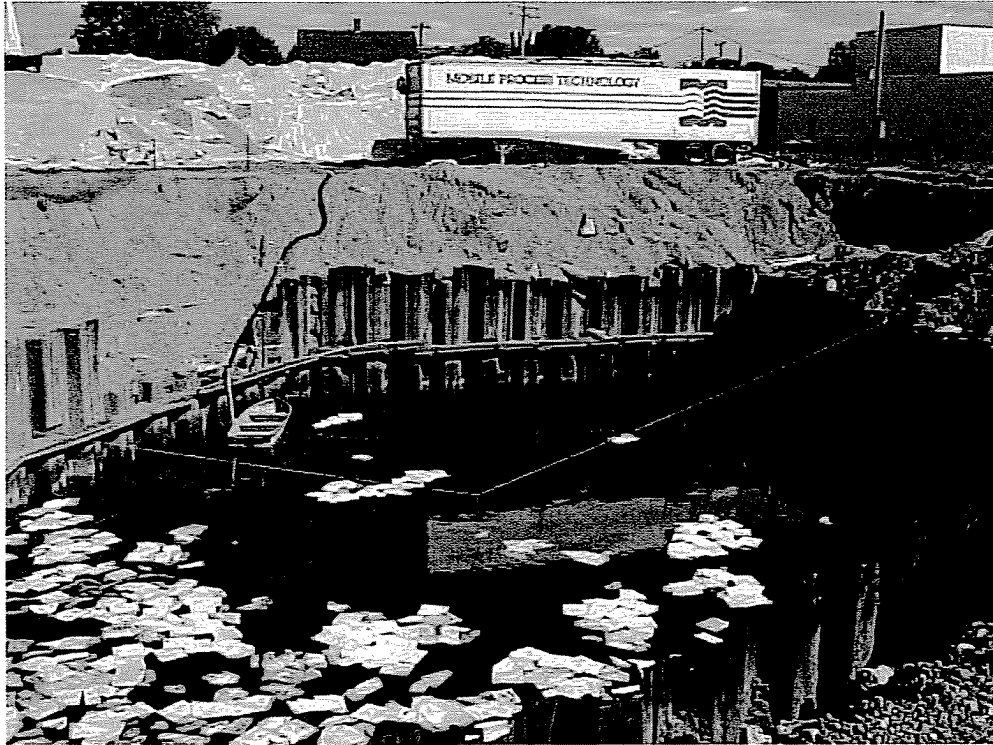
13. Groundwater Treatment: Groundwater Treatment Unit Trailer w/ submersible pump suspended in center of excavation.

Groundwater treatment began on September 1, 1999. The chromium concentration of initial influent was 124 ppm and deep yellow in color. The first 12,000 gallons treated were recirculated to the frac tank pending field verification that the discharge met the required discharge limits for the City of Olean. Field analysis found the effluent concentration to be <0.1 ppm of both total and hexavalent chromium, meeting the permitted discharge limits of 10 ppm total chromium and 5 ppm hexavalent chromium (>99% removal efficiency). With this confirmation, treatment of water began with a continuous discharge to the City of Olean waste water treatment facility via the sanitary sewer system.

MPT had anticipated running the system 24 hours per day, but found the capacity of their treatment unit insufficient to achieve this level of treatment. The first semi trailer unit had been exhausted after 435,000 gallons in a 3 day period. Because MPT could not continuously keep a sufficient supply of undepleted treatment units on site, MPT went to treating water 12 hours per day and having down time between the depletion of one unit and the arrival of the next. Spent absorption units were returned to Mobile Process facility in Tennessee for reclamation of the chromium from the exchange media.

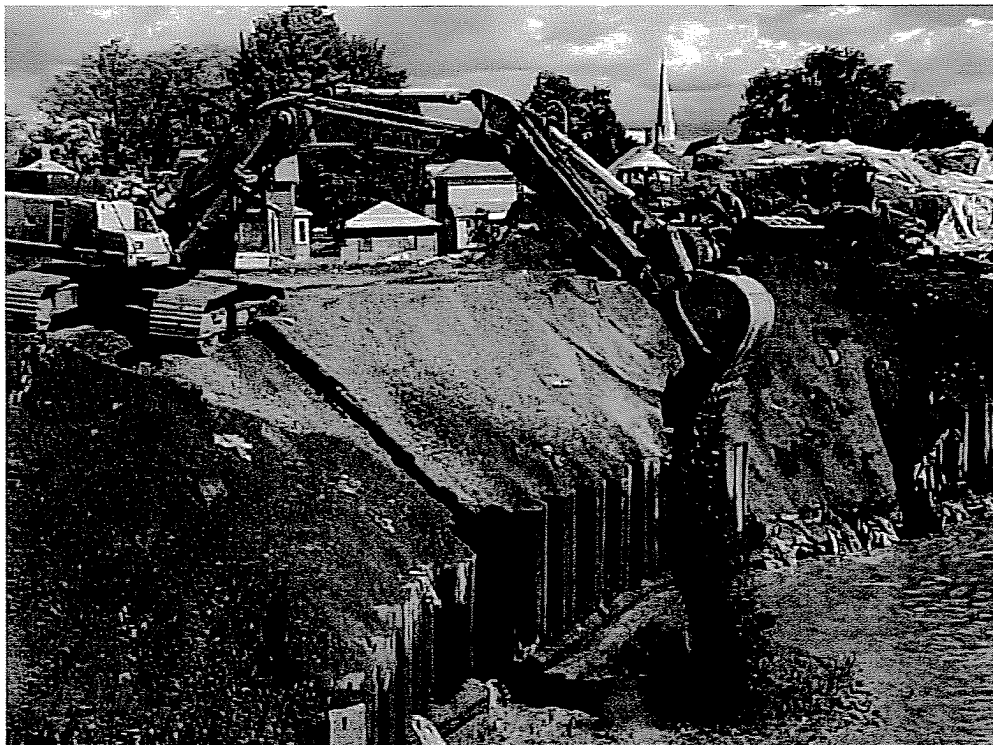
14. Backfilling: Groundwater treatment of 3,056,000 gallons was completed and backfilling was begun.

CSC obtained this material from the Work and Silvas Gravel Pit in the Town of Allegany, NY. Sieve analysis of the fill indicated that the material met the requirements of the specifications. A site visit to the gravel pit found that some oversized rocks would be encountered during the excavation of the bankrun material and advise CSC that any oversize materials would have to be picked out by the contractor at the site when encountered. A sample of the fill was submitted for a proctor analysis to determine maximum compaction densities; however, it was determined that the quantity of large stones in the material prevented the material from being analyzed under standard ASTM guidelines. Based on the determination that density testing could not be performed in accordance with ASTM procedures, the testing for compaction of the fill was waived by the Department. In lieu of testing compaction, above the water table was still completed through the use of a minimum of 4 passes with a vibratory drum roller.

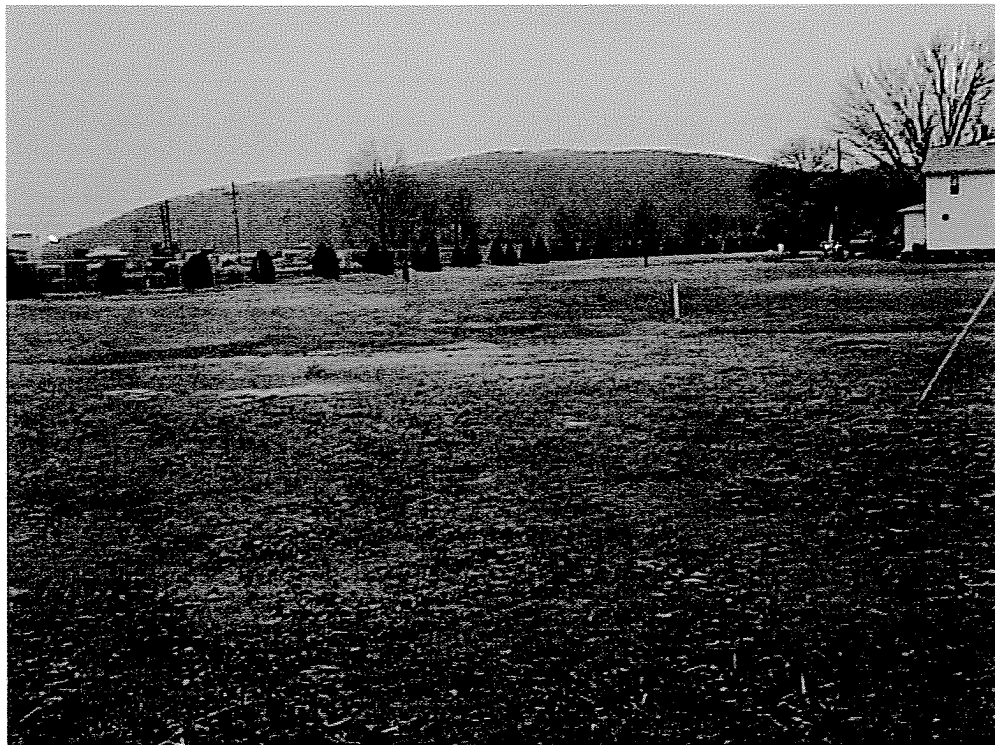
16. Restoration: Completed site showing signs of grass already growing.

October 26, 1999. It should be noted that even though seeding occurred late in the growing season, a healthy stand of grass covered the site by December 1, 1999.
