# ENGINEERING INVESTIGATIONS AT INACTIVE HAZARDOUS WASTE SITES

## PHASE II INVESTIGATION

Machias Gravel Pit Site No. 905013  
Town of Machias Cattaraugus County

DATE: February 1990

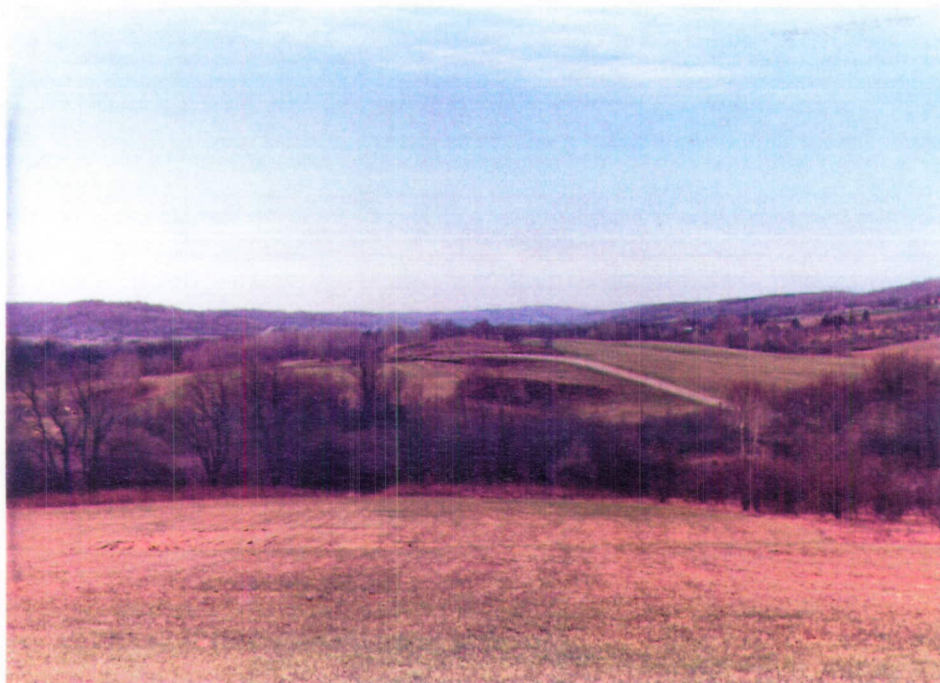
**Photo 1-1.** View south from Felton Hill Road. Machias Gravel Pit appears as a road cut on Very Road.

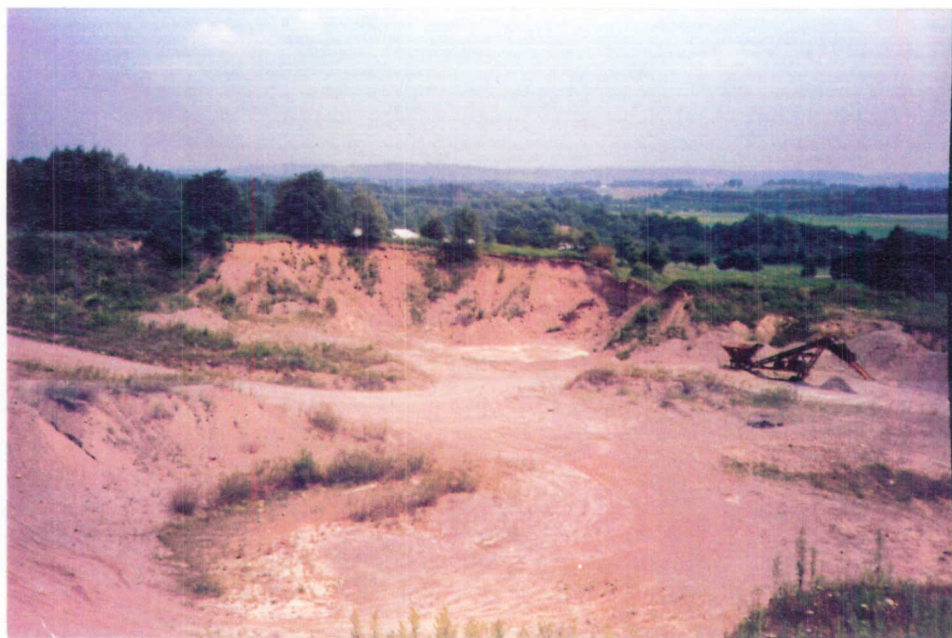
**Photo 1-2.** View east from western edge of Machias Gravel Pit. Cole residence is visible in background.

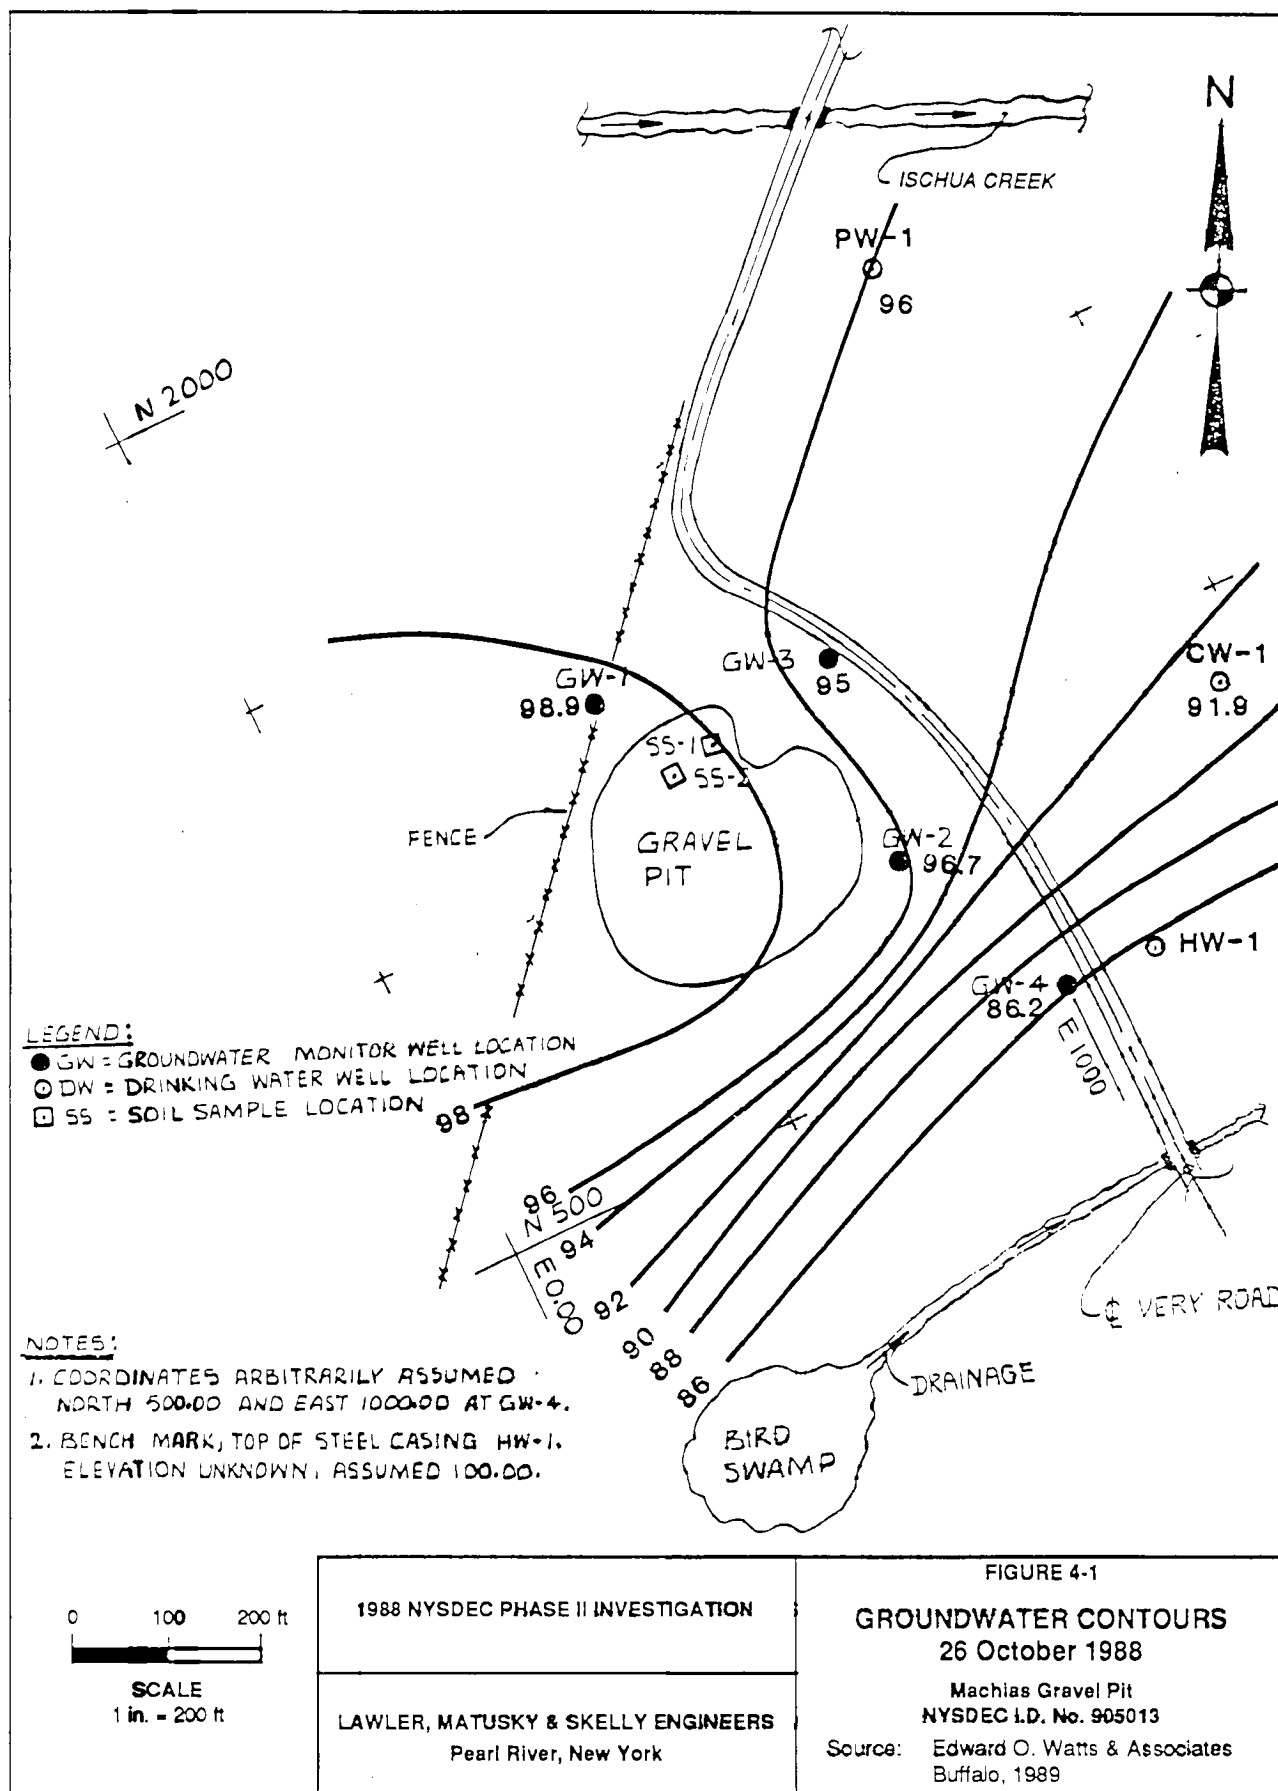
The limited number of water table reference points we have support this assumption. GW-1, located near the topographic high, had the highest water table elevation, with elevations decreasing with distance to the northeast (PW-1), east (CW-1), and southeast (GW-4) (see Figure 4-1). The gravel pit enhances the radial drainage by providing a recharge point and possible mounding of water under the pit. In fact, the highest groundwater level may be centered over

the pit and radial flow could go north (to GW-1), northeast (to GW-3), east (to GW-2), southeast (to GW-4), and south.

Although the flow from the pit or spur is probably radial, the contour lines suggest that the groundwater after the pit should be turning southeast toward the creek draining Bird Swamp.

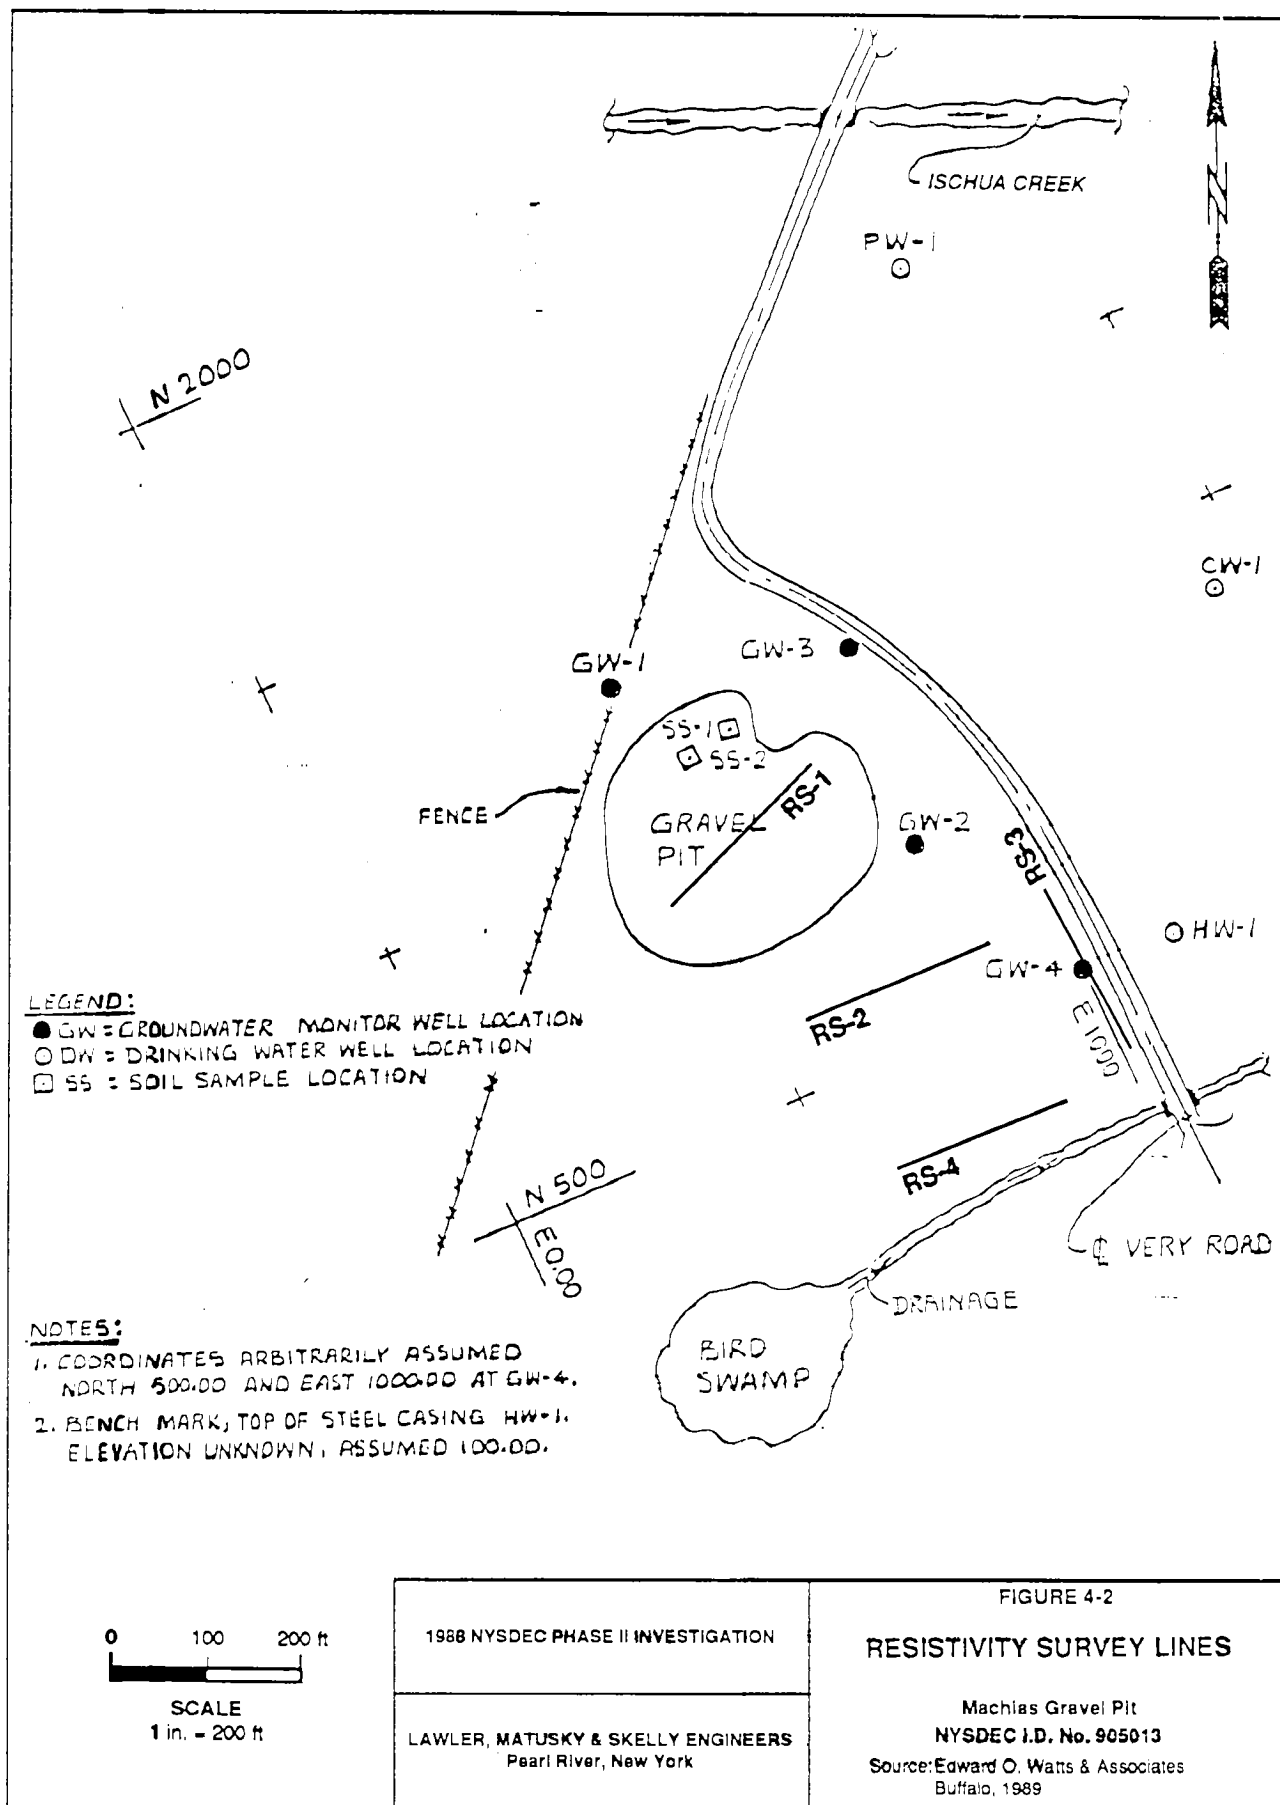
Qualitatively, according to Dunn, initial observations revealed that resistivity soundings RS-1 and RS-3 (see Figure 4-2) represent three cases where the first and third layers are less resistive than the second layers. Resistivity soundings RS-2 and RS-4 probably represent two-layer cases with a resistive layer above a less resistive layer.

In order to get a more quantitative interpretation, Dunn graphed the data ("A" spacings vs apparent resistivity). The resultant curve was then matched to theoretical curves representing two- and three-layer cases.

The following geoelectric section was compiled by Dunn based on interpretation of the four resistivity soundings:

LAYER	DEPTH (ft)	AVERAGE RESISTIVITY (ohm-ft)
1	0-2	645
2	0-7	1050
3	Greater than 7	185

The resistivity survey conducted by Dunn along four traverses revealed a multiple-layer case. These layers are said to represent zones of varying resistivity. Dunn attributes the changes in resistivity to geologic or hydrologic layers. The interpretation of the resistivity findings, as discussed in Section 4.5.2, does not directly correlate with conditions encountered during the subsurface investigation and therefore no supported conclusions can be made.
