# 2017 Annual Periodic Review Report Essex-Hope Site, Jamestown, New York

*Prepared for*

Essex Specialty Products, Inc.

March 2018

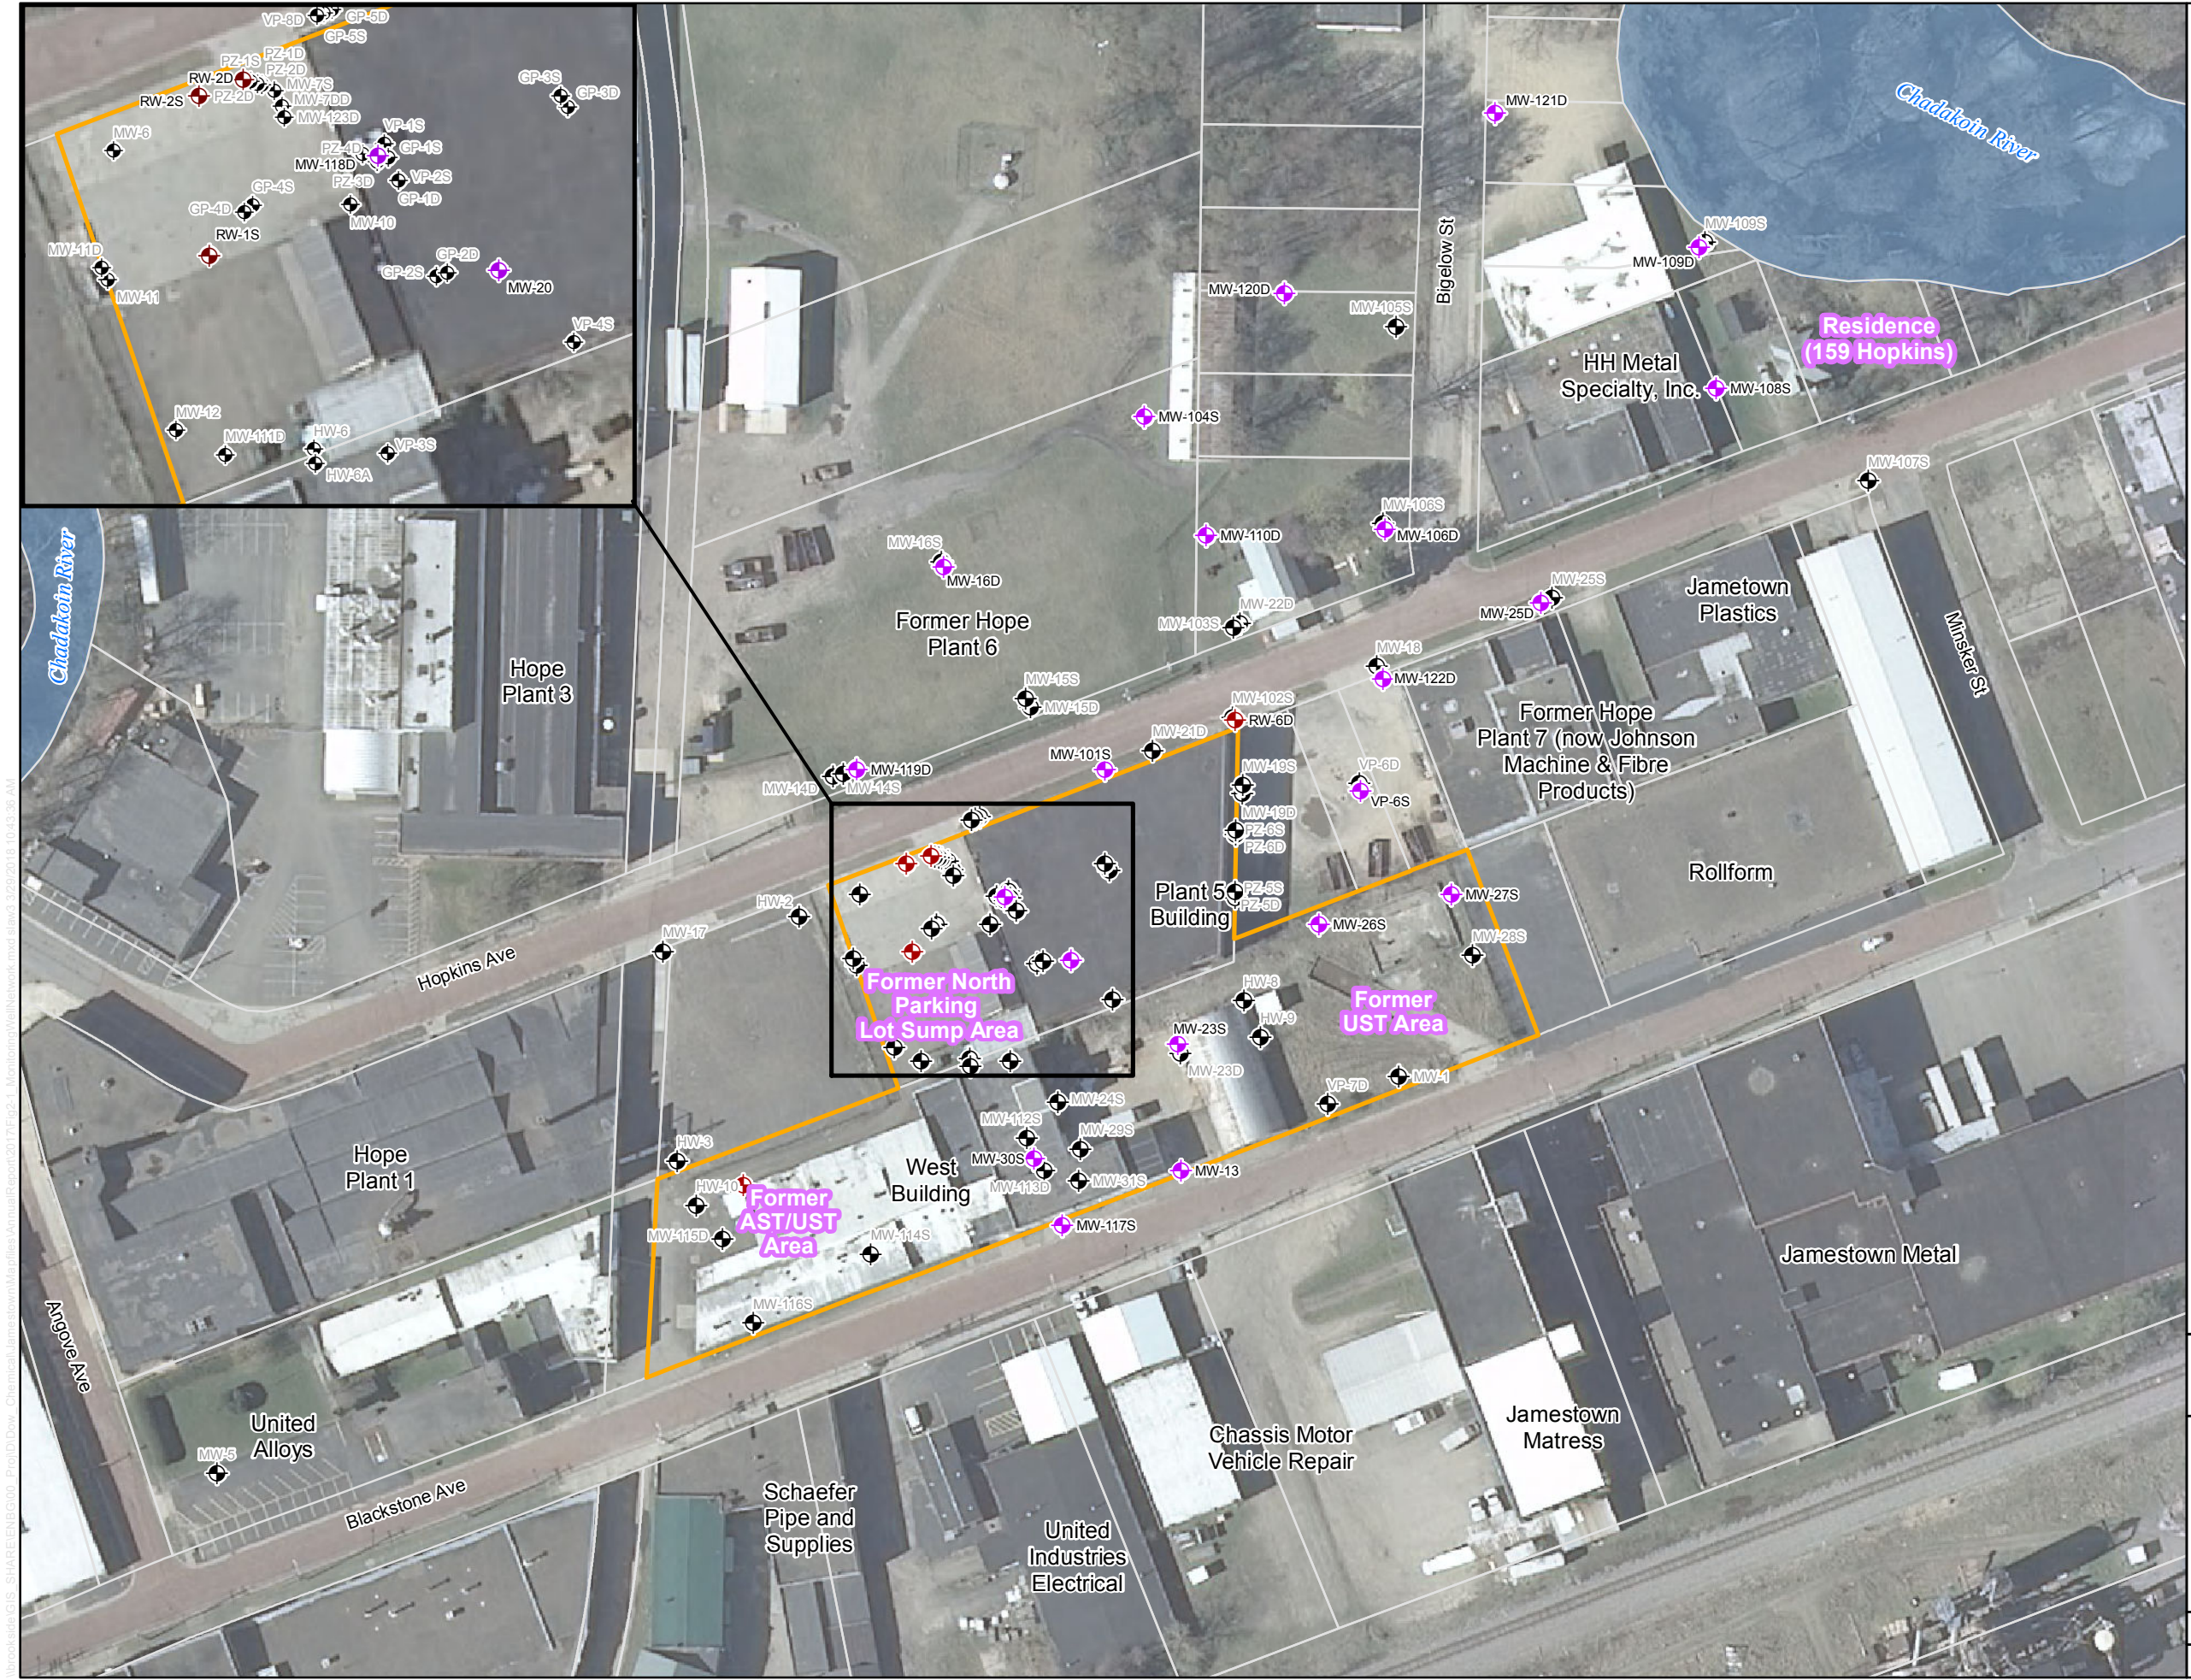
Monitoring Well - Annual Sampling Program

Recovery Well - Semiannual Sampling (Alternating Seasons)

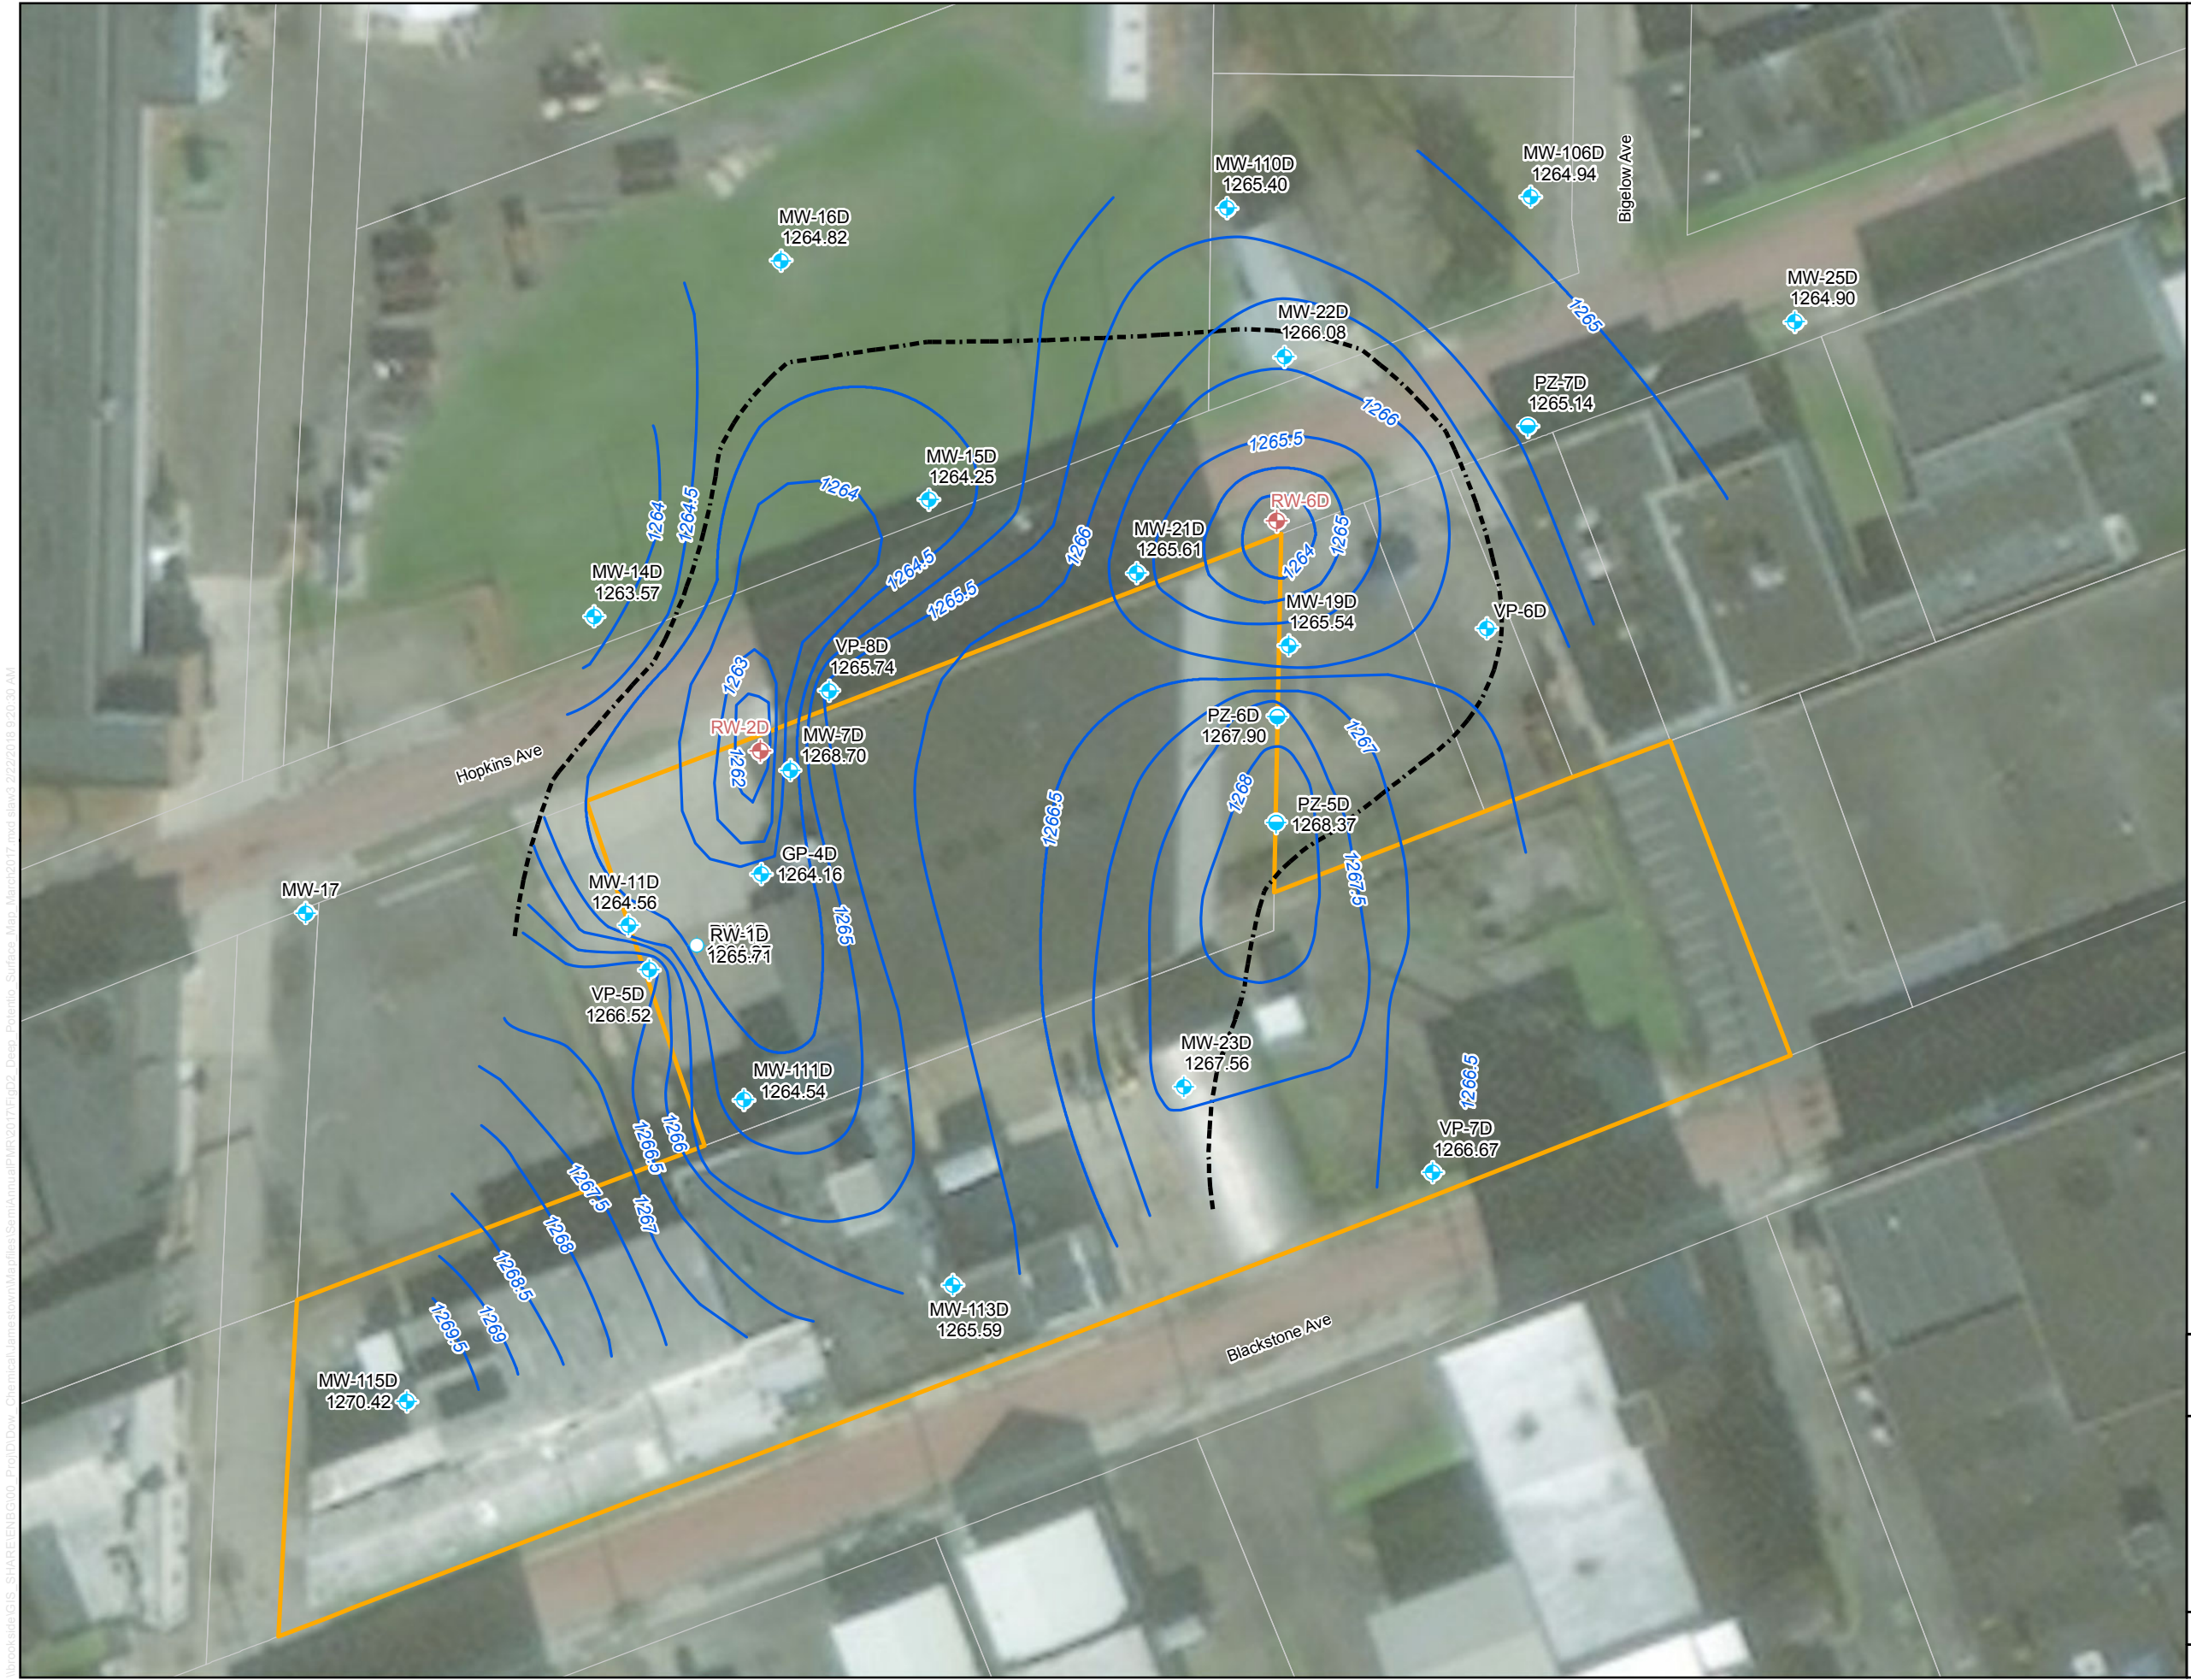
\\brooksides\GIS\_SHARE\ENBG000\_Proj\DI\Dow\_Chemical\Jamestown\Mapfiles\Serial\Annual\PMR\2017\FigD1\_Shallow\_Potential\_Surface\_Map\_March2017.mxd slaw3 2/22/2018 9:10:52 AM

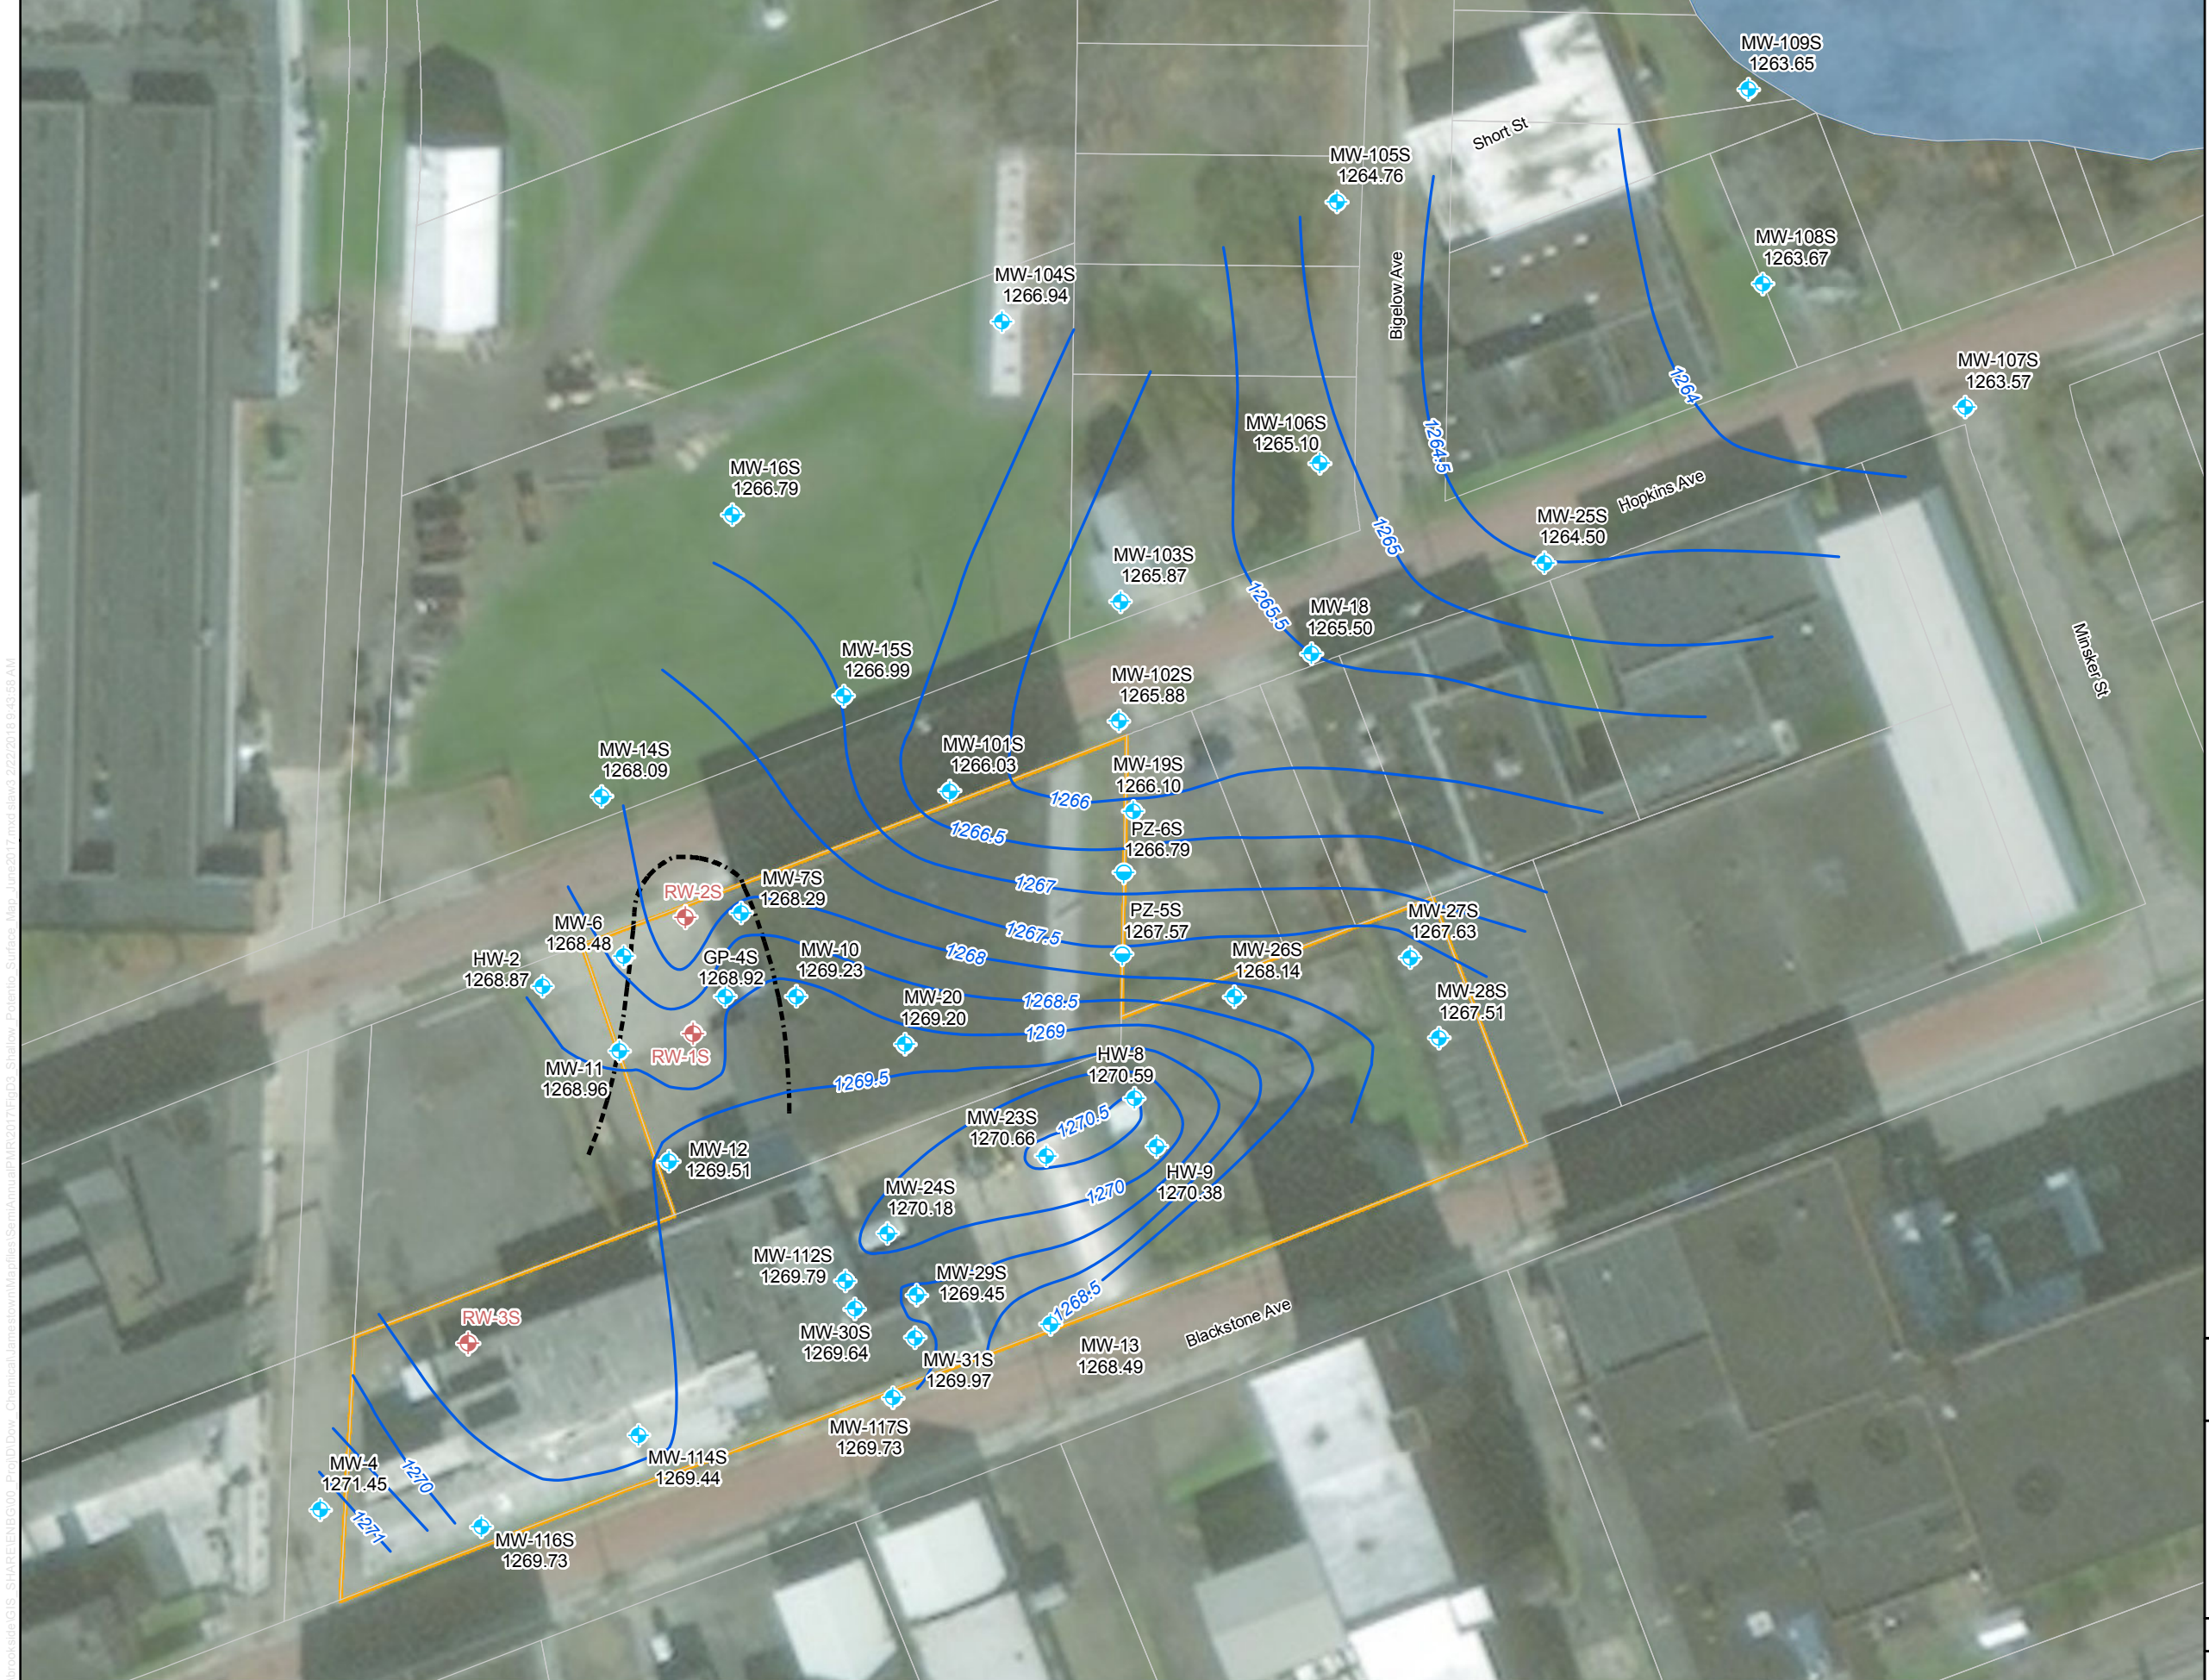
\\brooksides\GIS\_SHARE\ENBG000\_Proj\DI\Dow\_Chemical\Jamestown\Mapfiles\Serial\Annual\PMR\2017\FigD2\_Deep\_Potential\_Surface\_Map\_March2017.mxd slaw3 2/22/2018 9:20:30 AM

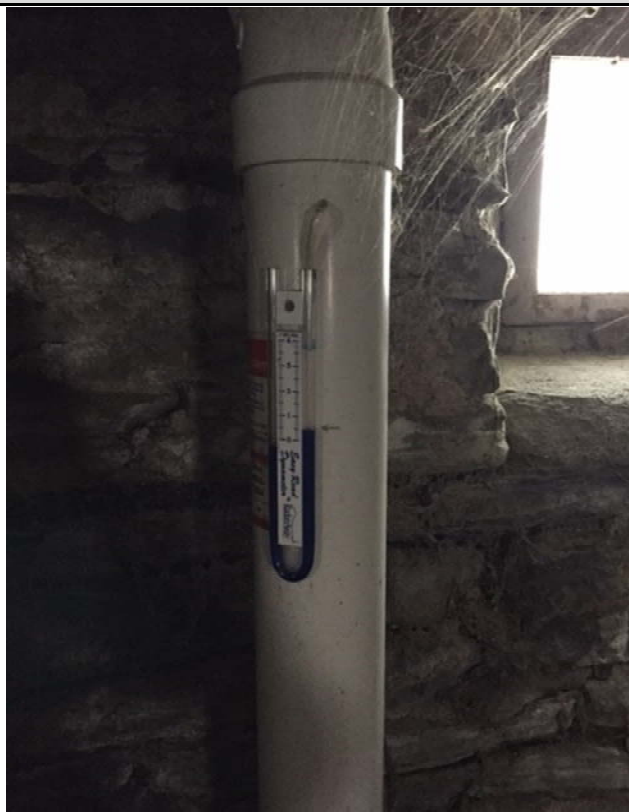
Piping and sytem in OK condition; blower is operating.
