# ENVIRONMENTAL INVESTIGATION ELLISON BRONZE COMPANY FALCONER, NEW YORK Phone J 5 7

Dowcraft Corporation 65 South Dow Street Falconer, New York 14733

Empire Soils Investigations, Inc. S-5167 South Park Avenue Hamburg, New York 14075

> BTA-90-179D August, 1991

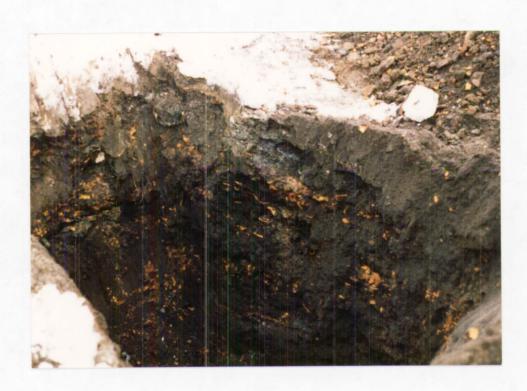
PHOTOGRAPHED BY: K. Shanahan PHOTOGRAPH 1 OF 2

DESCRIPTION: This photograph was taken of test pit TP-8 after excavation was completed.

The foundry material consists primarily of black and brown fine to coarse sand. Sand and gravel

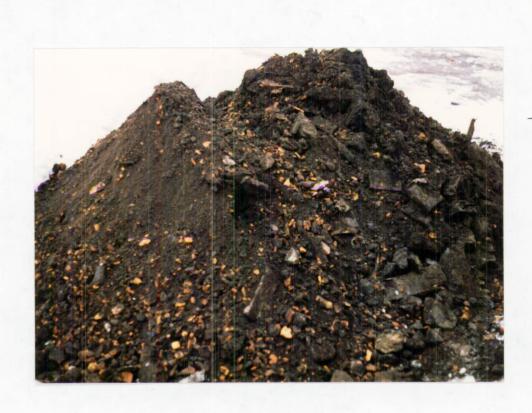
DESCRIPTION: This photograph illustrates the spoil pile generated during the excavation of test pit TP-8.
