**AL-Tech Specialty Steel  
Lucas Avenue Plant (OU-1)  
Chautauqua County  
Dunkirk, New York**

**FINAL ENGINEERING REPORT  
Site Number: 907022**

**AUGUST 2019**

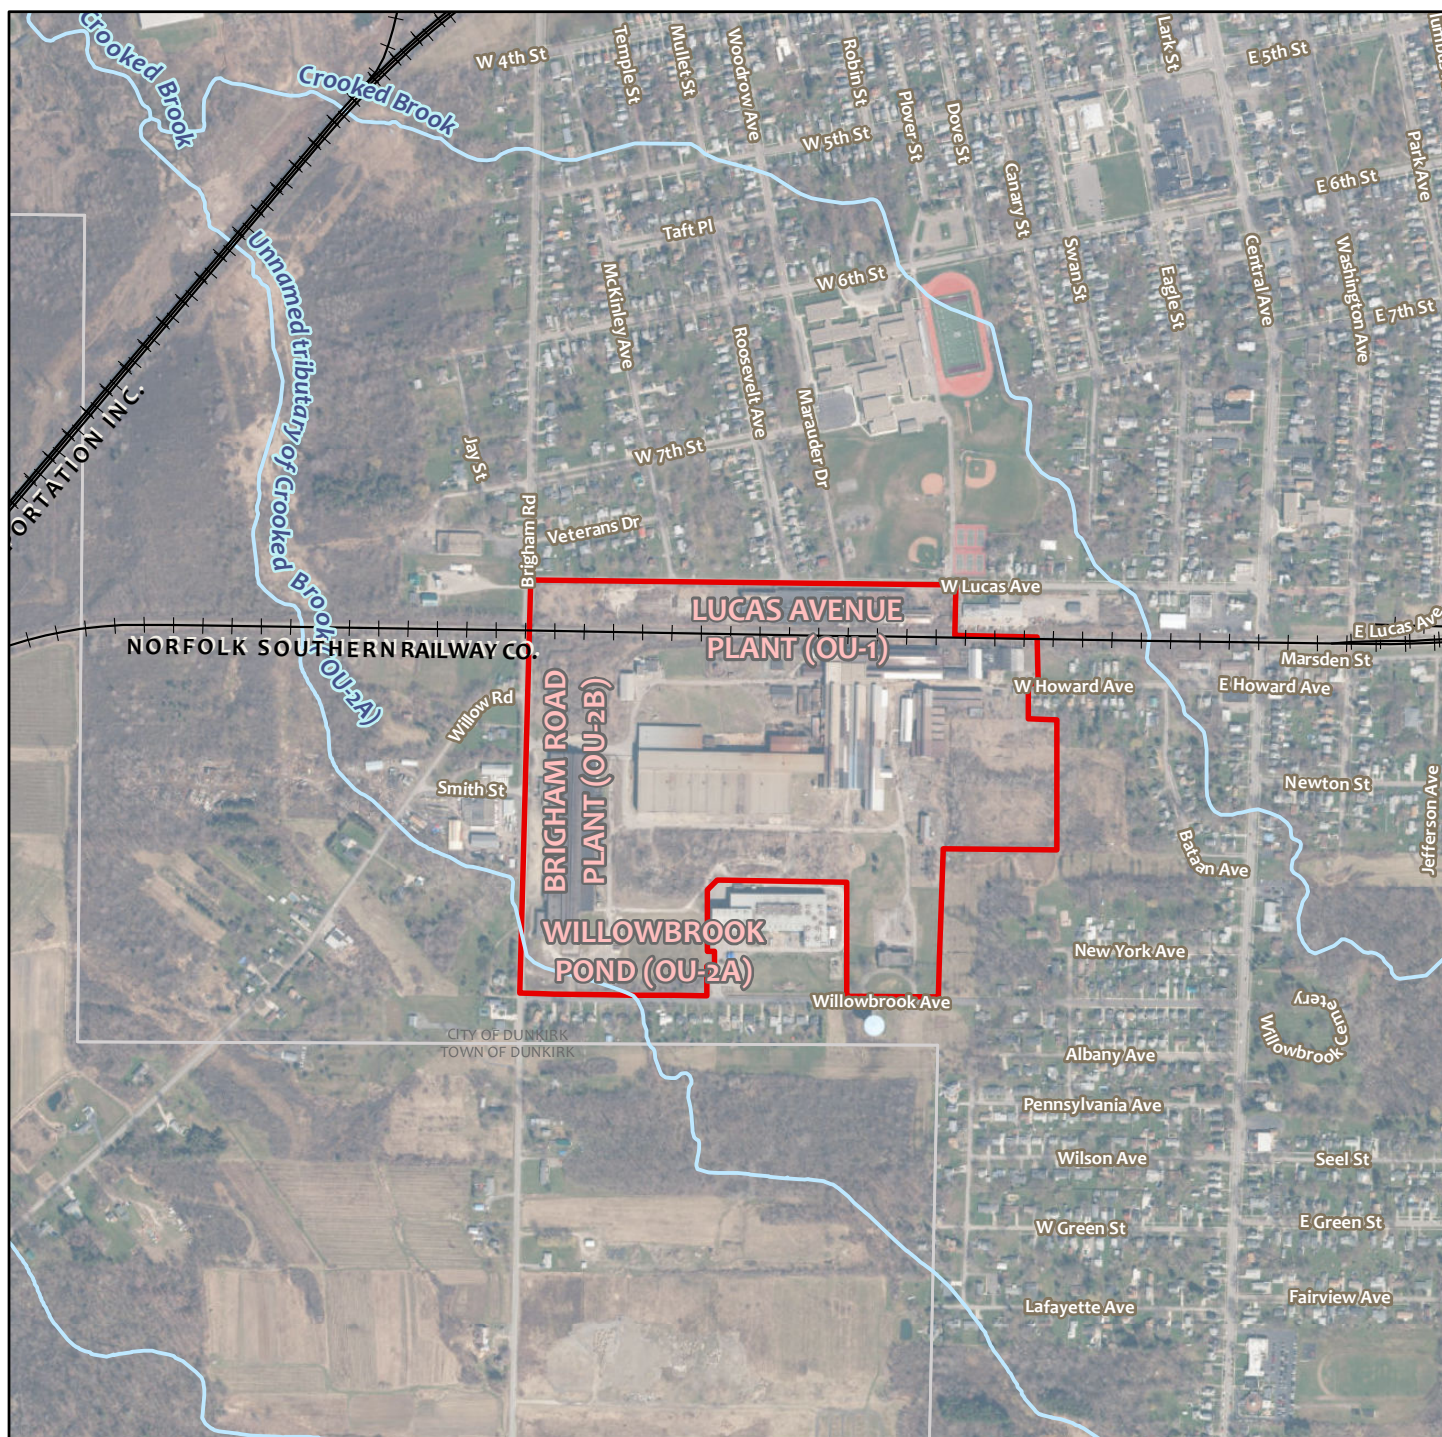
Figure 3-1

# Site Location Map with Operable Units OU-1, OU-2A, OU-2B, and OU-3

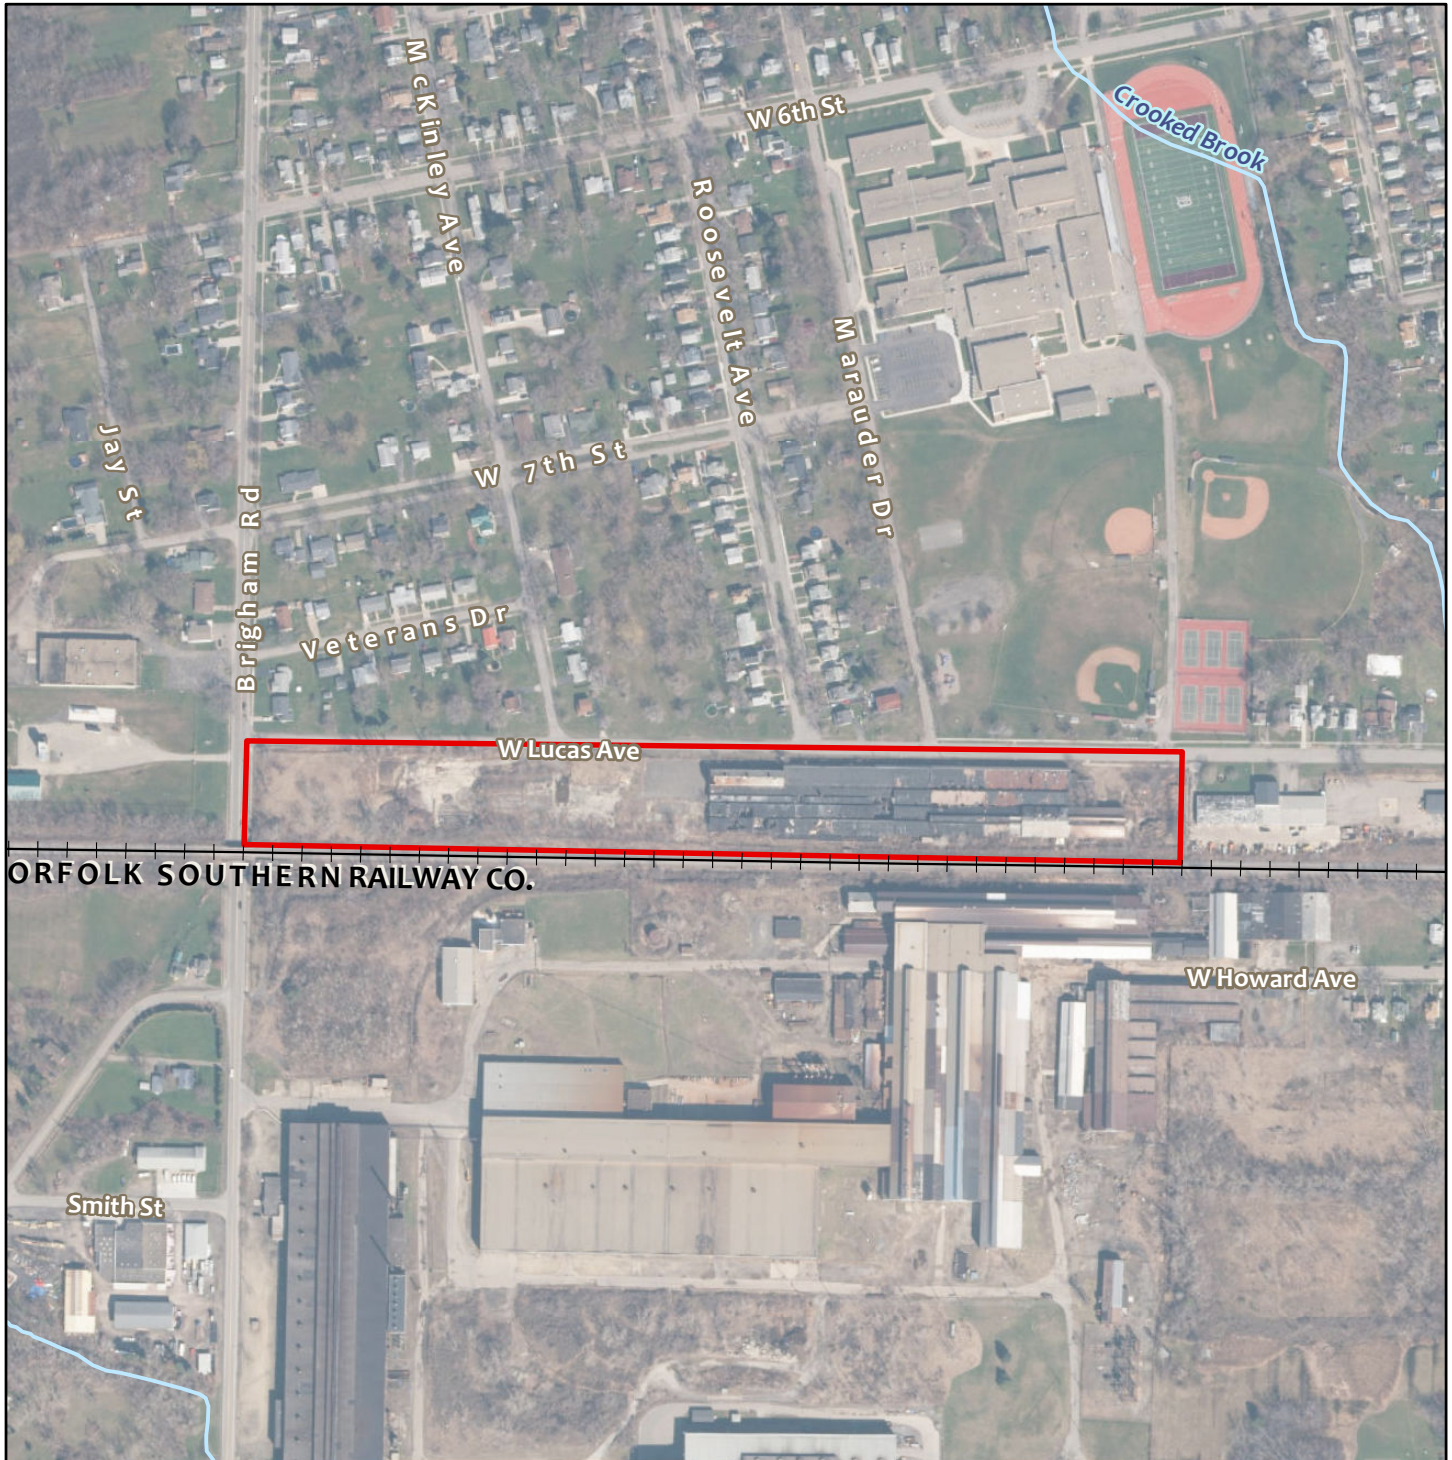
Figure 3-2

# Site Map

The remedial activities detailed in this report pertain only to OU-1 (see Figure 3-2), unless otherwise noted.
