2019 PERIODIC REVIEW REPORT SPECIAL METALS CORPORATION DUNKIRK, NEW YORK NYSDEC Site Number 907031

March 11, 2019

Re: 2019 Periodic Review Report (NYSDEC Site No. 907031)
Special Metals Corporation
100 Willowbrook Avenue
Dunkirk, New York

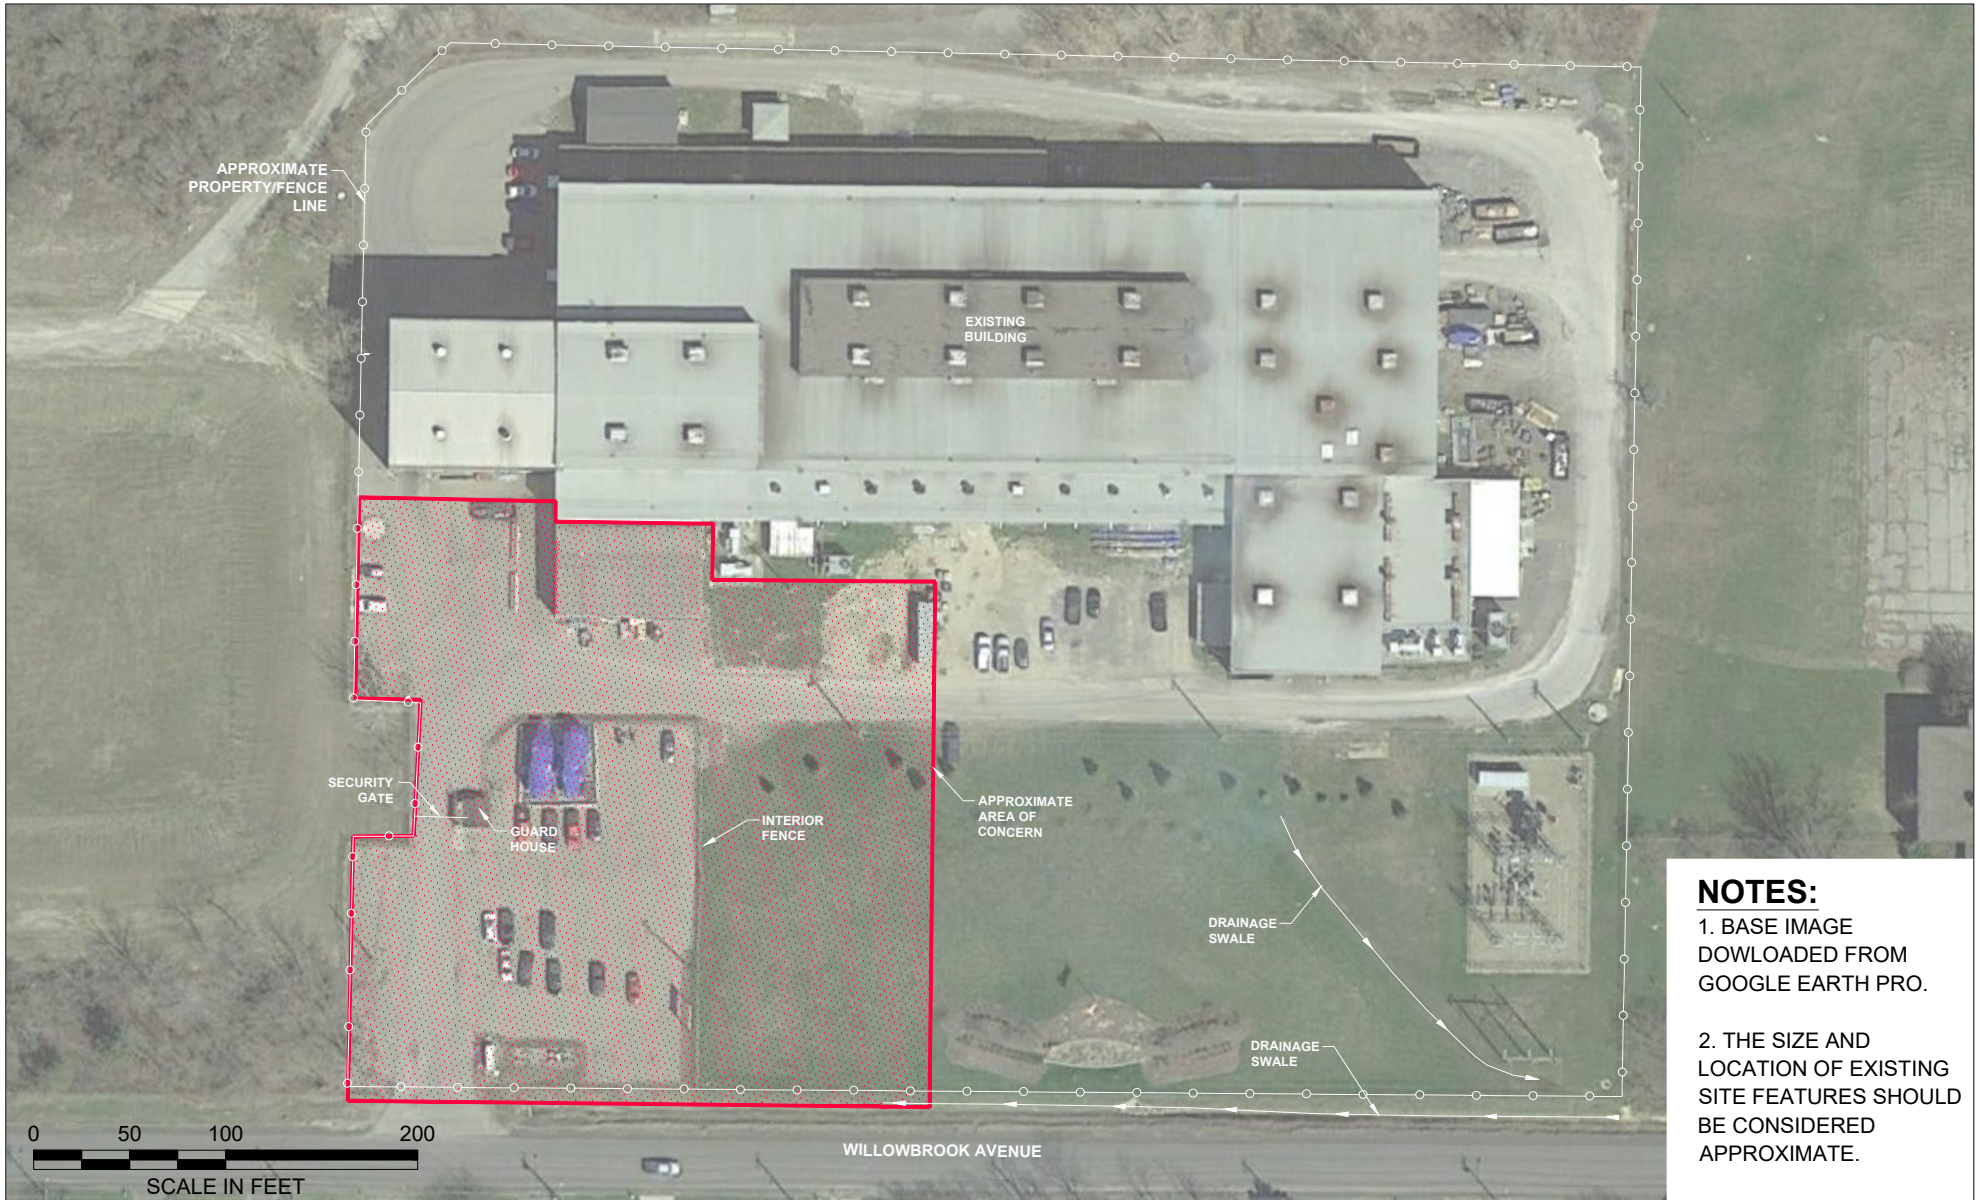
GZA GeoEnvironmental of NY Engineers and Scientists www.gza.com		PREPARED FOR: SPECIAL METALS CORPORATION	
SMC FACILITY PLAN AND AREA OF CONCERN		PROJ MGR: TB	REVIEWED BY: BAK	CHECKED BY:	FIGURE 2
		DESIGNED BY: JR	DRAWN BY: MDK	SCALE: AS SHOWN	
		DATE: FEBRUARY, 2018	PROJECT NO. 21.0056196.50	REVISION NO.

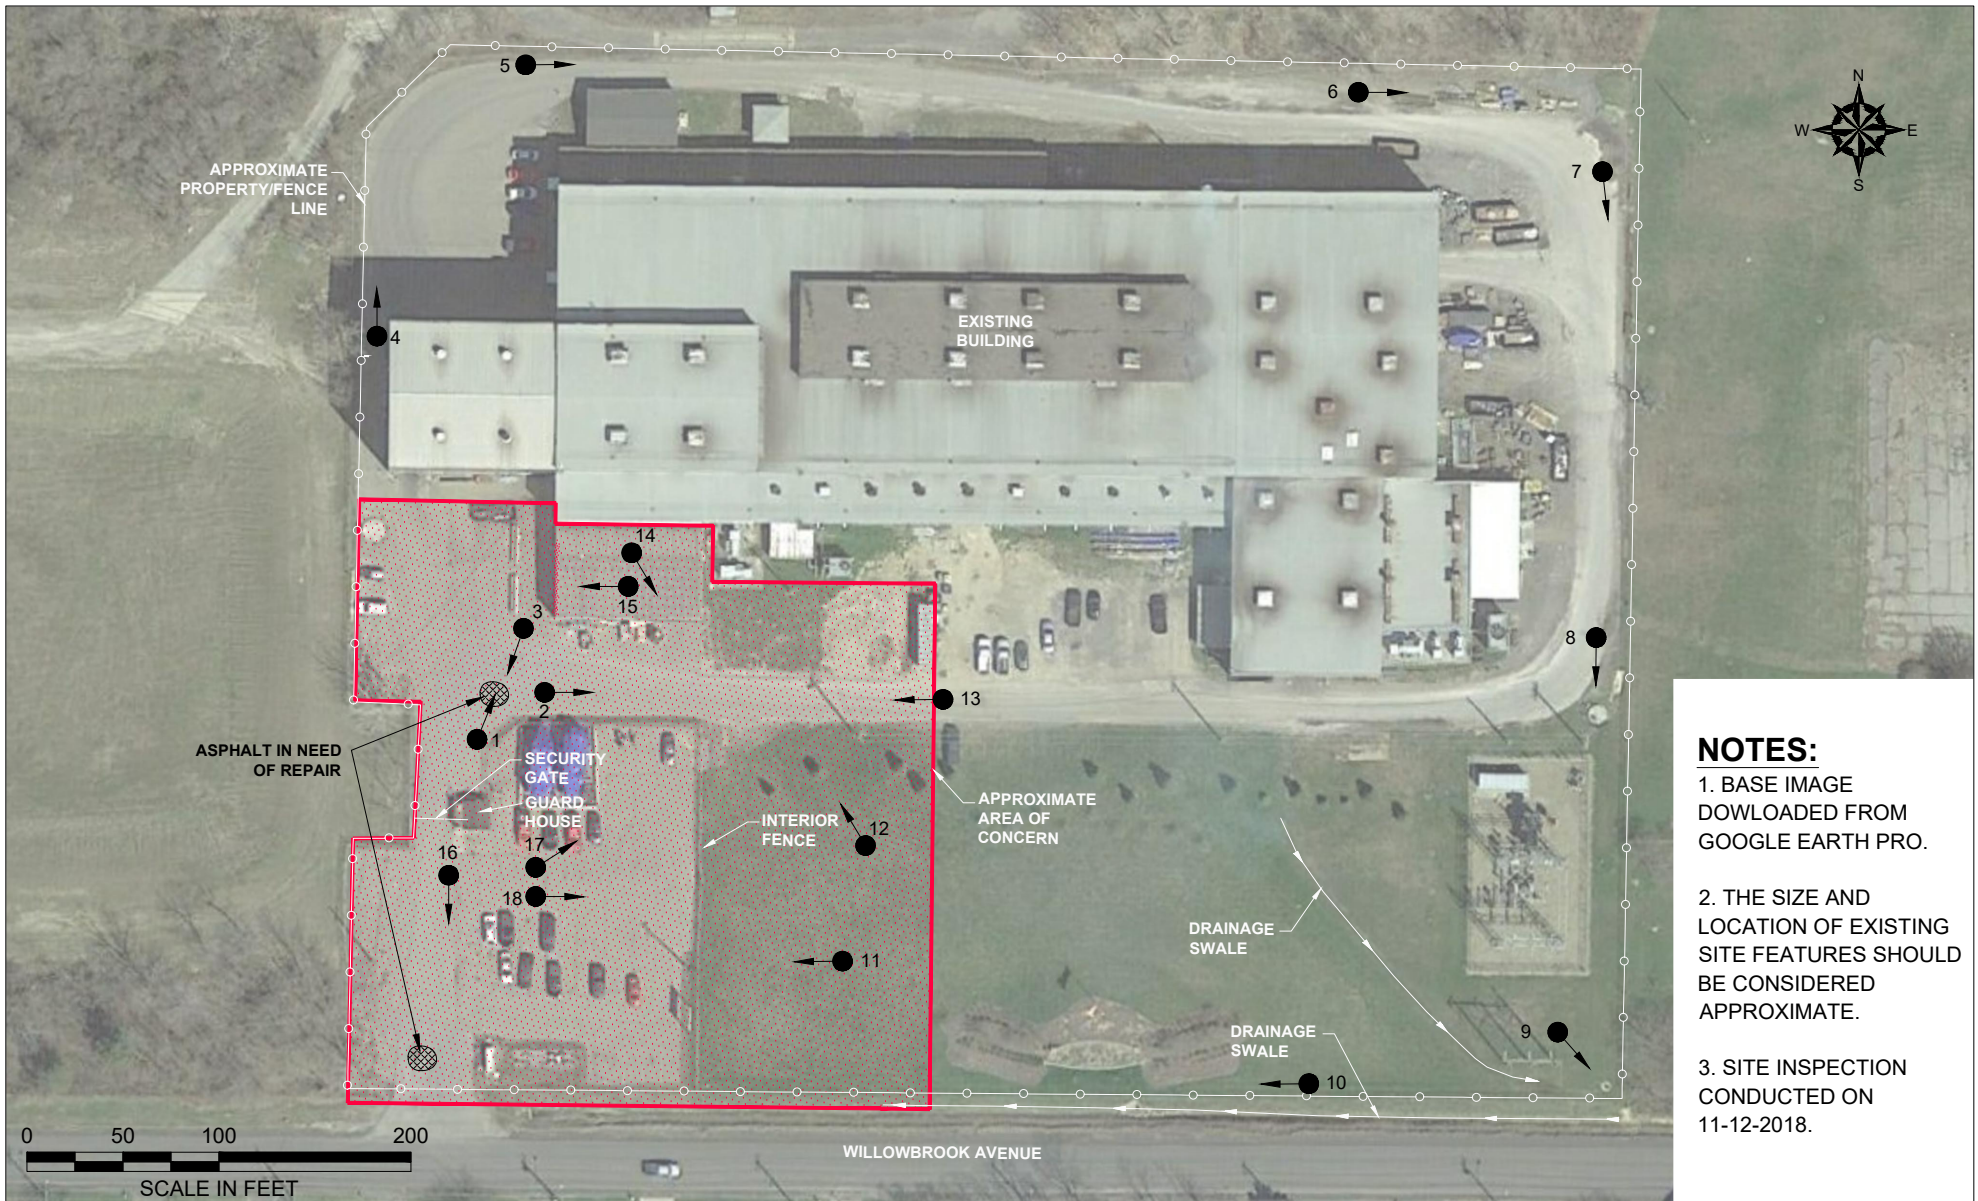
<p>PREPARED FOR: SPECIAL METALS CORPORATION</p>	<p>CHECKED BY: SCALE: AS SHOWN REVISION NO.</p>	<p>FIGURE 3B</p>
---	---	-----------------------------

<p>SPECIAL METALS CORPORATION 100 WILLOWBROOK AVENUE DUNKIRK, NEW YORK</p>	<p>NOV 12, 2018 SITE INSPECTION PHOTO LOCATIONS</p>
--	--

* Minor pavement repairs are warranted at two locations in particular. See Figure 3B.	
** Snow cover on grassy areas only limited view of soil cover but no evidence of soil disturbance noted.	
INTRUSIVE ACTIVITIES PLANNED FOR AREA OF CONCERN	DATE
LOCATION	
N/A	
ADDITIONAL NOTES & COMMENTS	
Site cover system is in overall good condition and performing as intended.	
SMC stated that they intend to perform pavement repairs in spring of 2019.

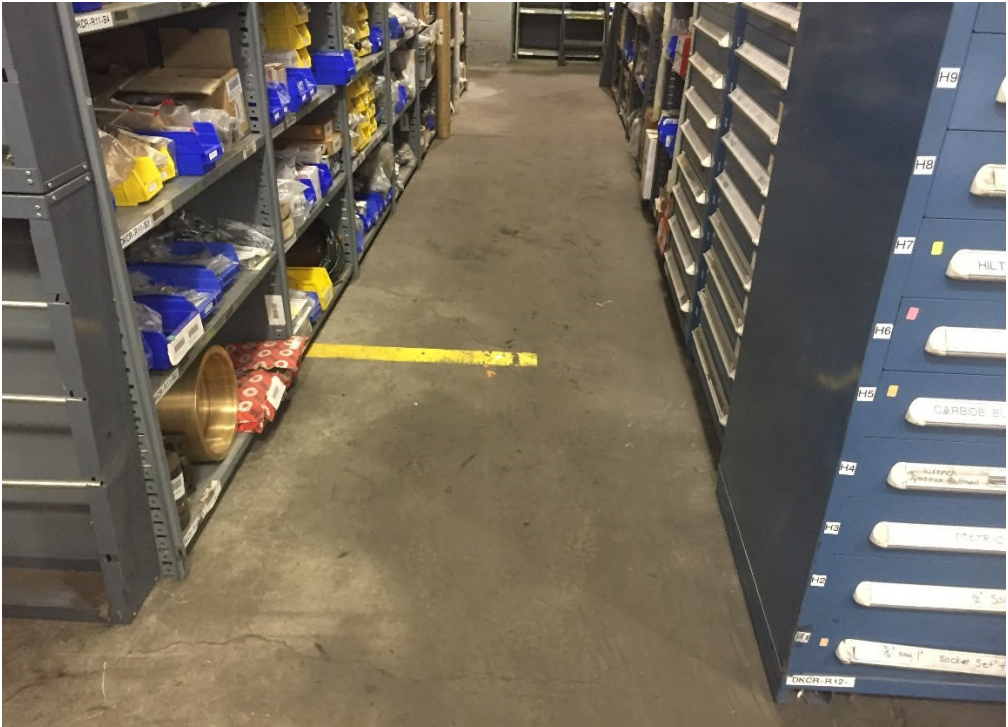
Photo No. 2	Date: 5-18-18

Direction Photo Taken: West		
Description: Typical good condition of concrete floor in maintenance building.

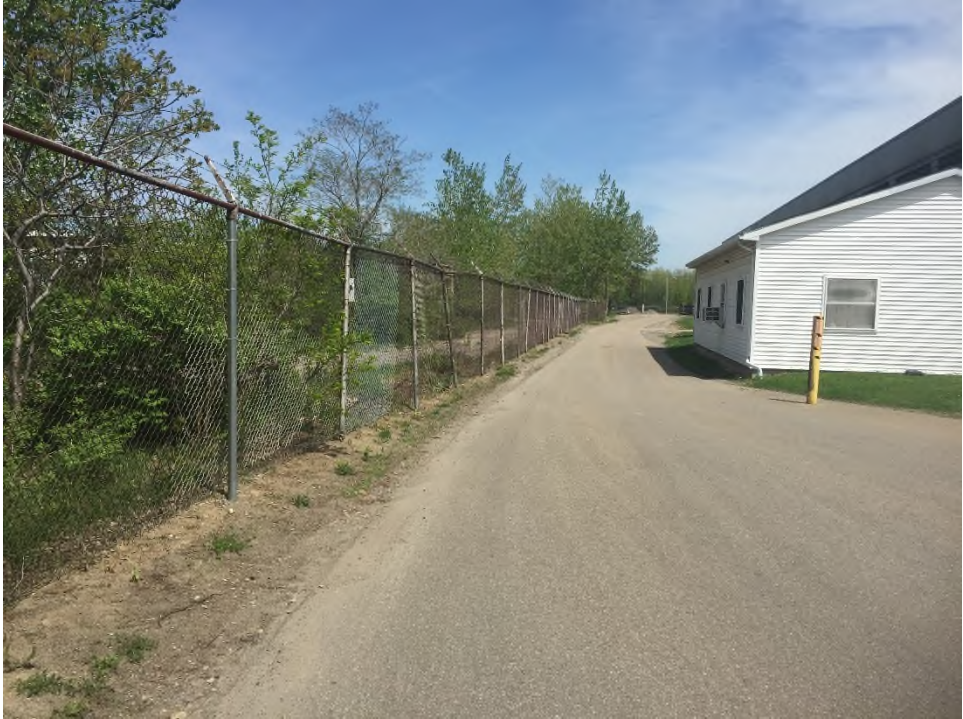
Client Name: Special Metals Corp.		Site Location: SMC Facility, Dunkirk, NY	Project No. 21.0056196.50
Photo No. 7	Date: 5-18-18

Direction Photo Taken: East			
Description: Northern Site perimeter fence.

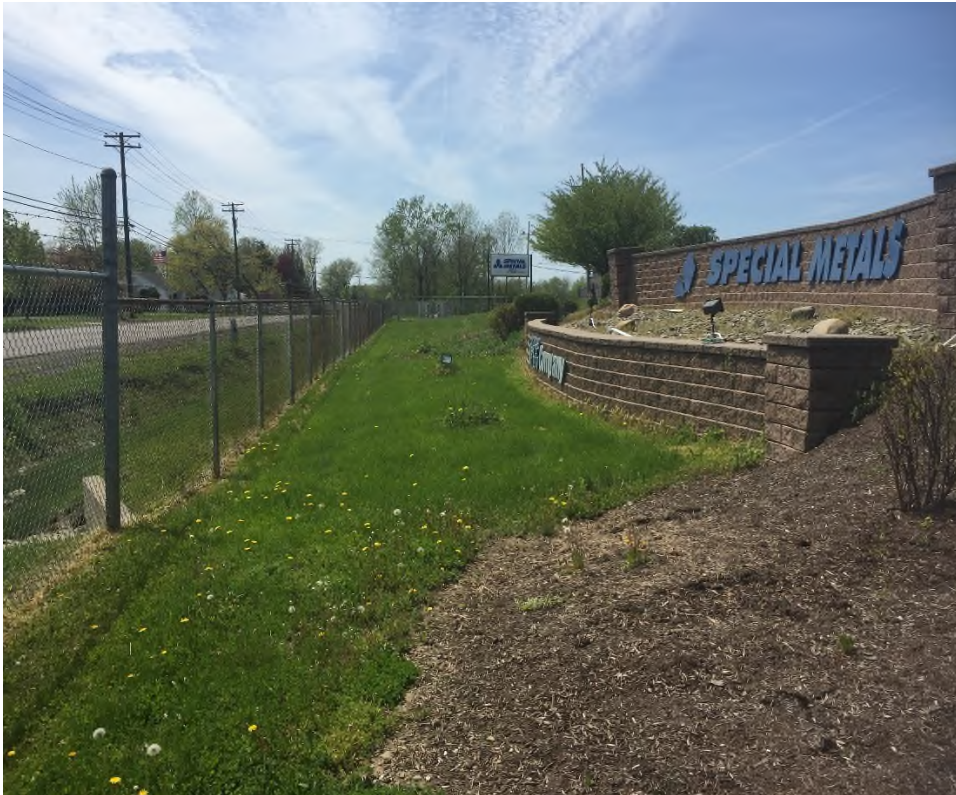
Photo No. 12	Date: 5-18-18

Direction Photo Taken: West			
Description: Central portion of the southern site perimeter fence.

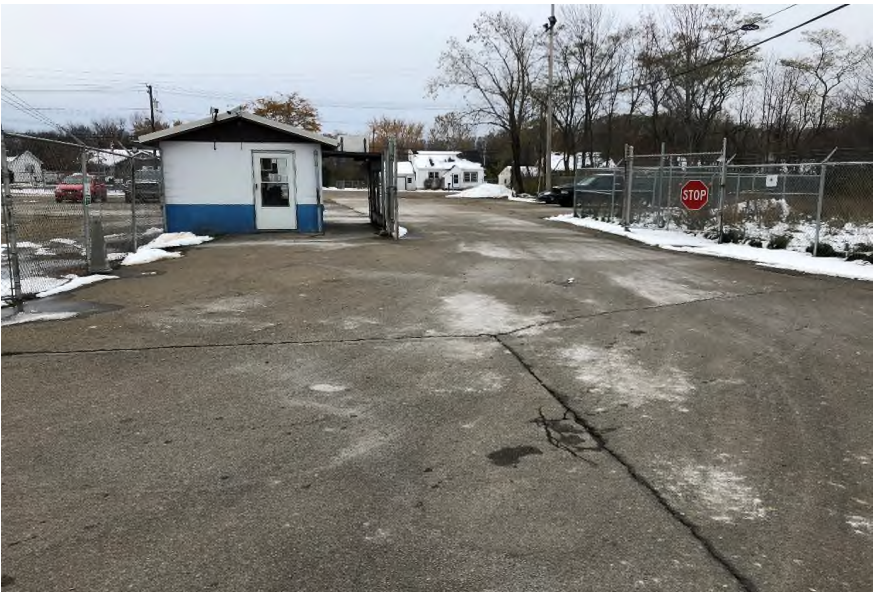
Client Name: Special Metals Corp.		Site Location: SMC Facility, Dunkirk, NY	Project No. 21.0056196.50
Photo No. 3	Date: 11-12-18

Direction Photo Taken: South			
Description: Entrance road and security building.

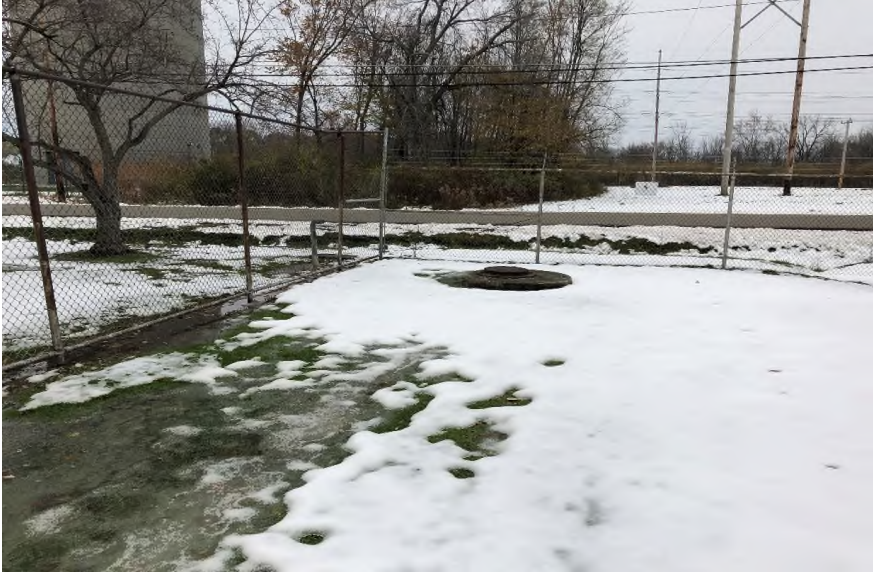
Client Name: Special Metals Corp.		Site Location: SMC Facility, Dunkirk, NY	Project No. 21.0056196.50
Photo No. 9	Date: 11-12-18

Direction Photo Taken: Southeast			
Description: Southeastern corner of the perimeter fence.

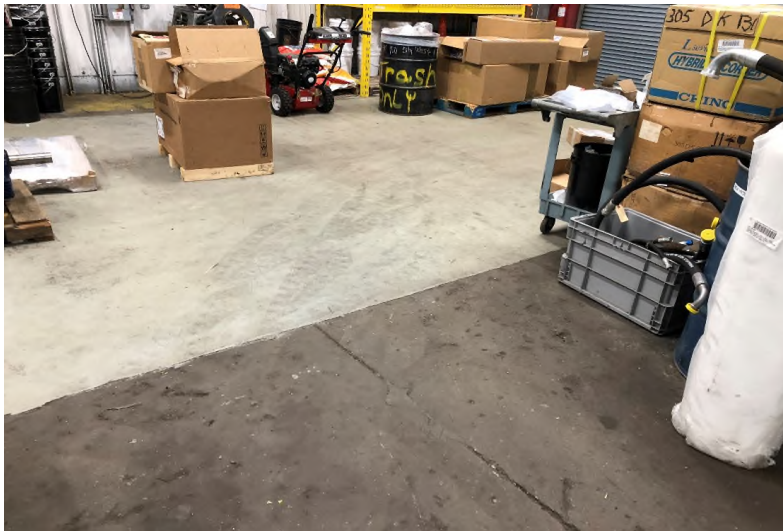
Photo No. 14	Date: 11-12-18

Direction Photo Taken Southeast		
Description: Concrete floor of crib building.

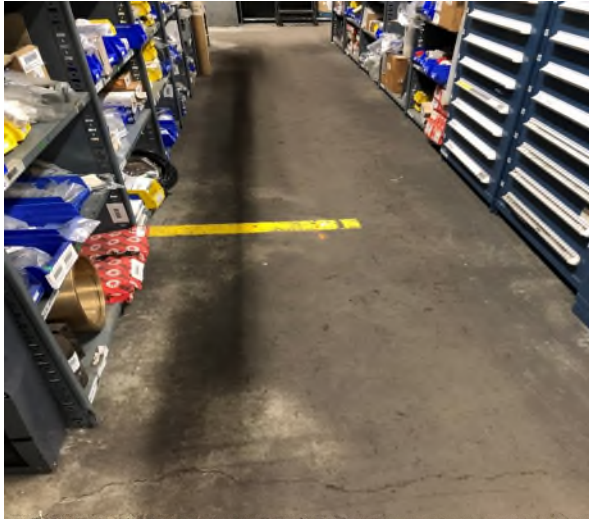
Client Name: Special Metals Corp.		Site Location: SMC Facility, Dunkirk, NY	Project No. 21.0056190.50
Photo No. 15	Date: 11-12-18

Direction Photo Taken: West			
Description: Another view of concrete floor of crib building.

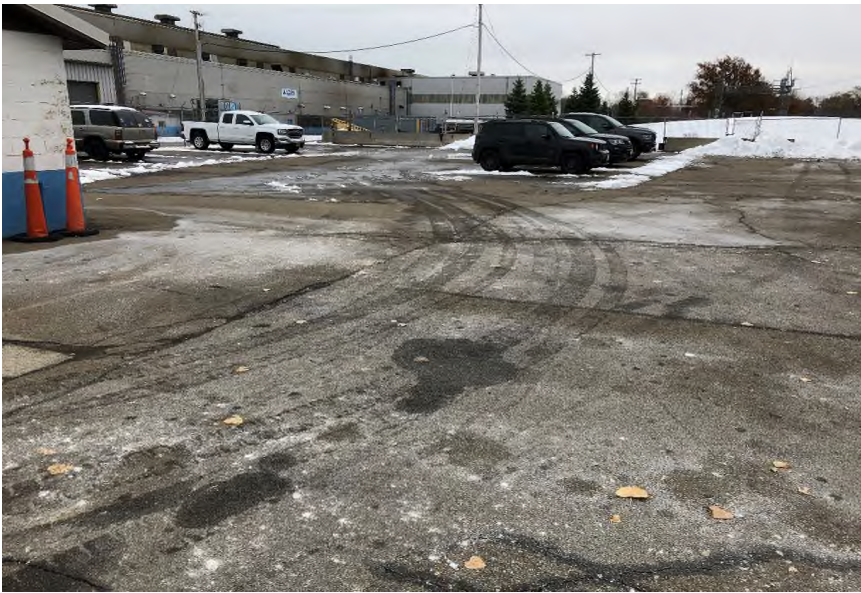
Client Name: Special Metals Corp.		Site Location: SMC Facility, Dunkirk, NY	Project No. 21.0056190.50
Photo No. 17	Date: 11-12-18

Direction Photo Taken: ENE			
Description: Parking lot.
