**Tonawanda Plastics**  
**3821 River Road, Tonawanda New York**  
**NYSDEC Site No. 915003**

**INVESTIGATION  
SUMMARY REPORT  
TONAWANDA PLASTICS  
EPA ID NYD051816262**

December 2015

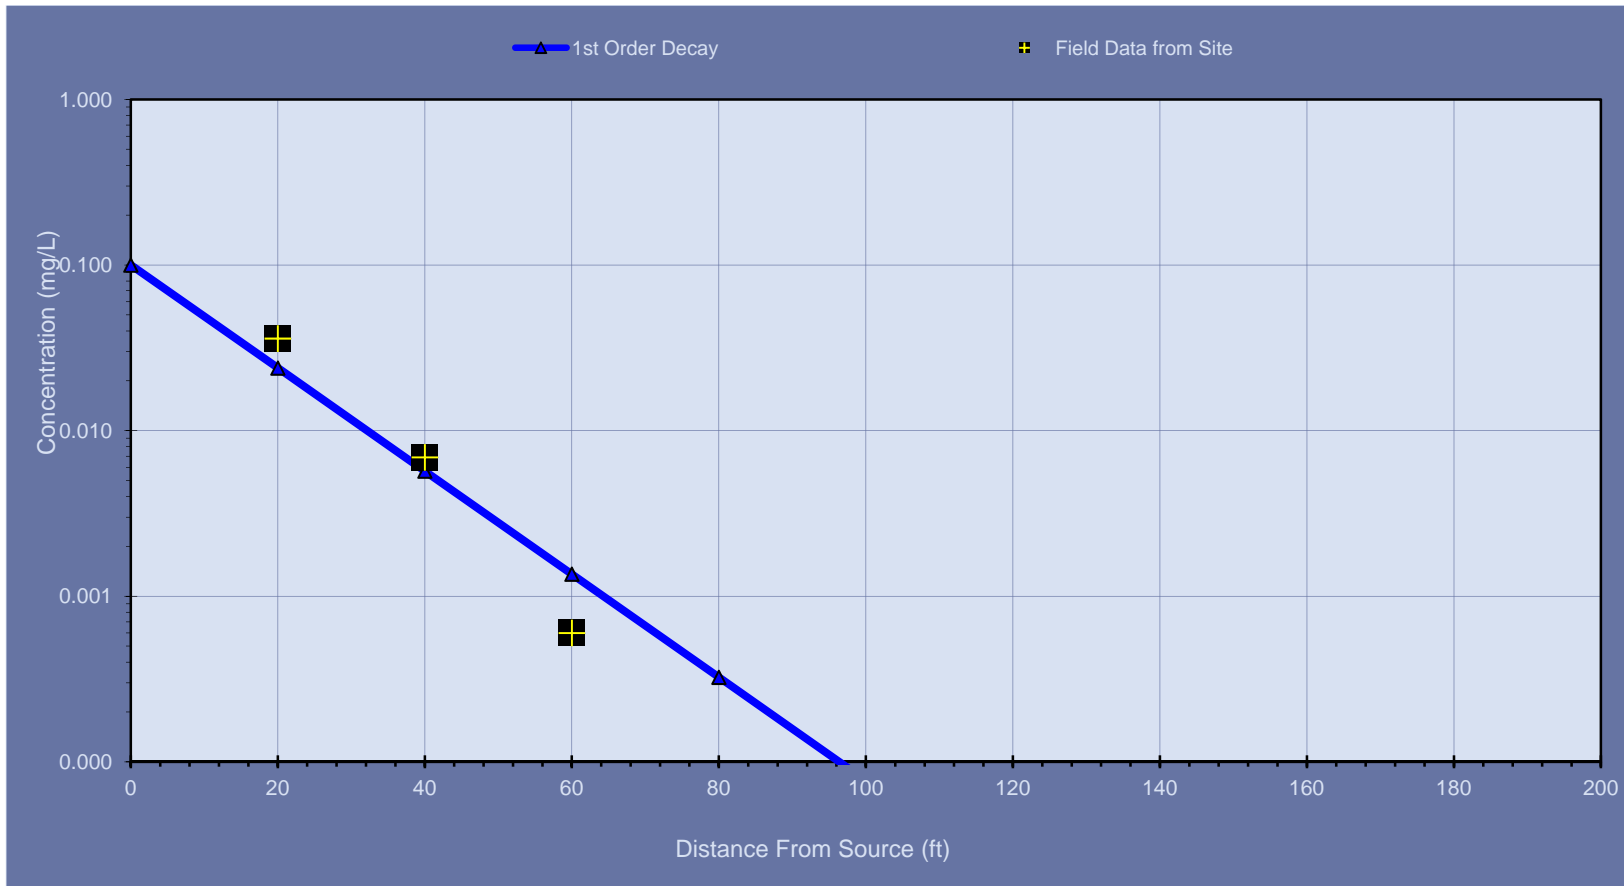
Figure 2 BIOSCREEN-AT results and site concentration data showing actual and simulated benzene concentrations

- Comparison between three measured concentrations (projected to centerline) and simulated concentrations indicates the model effectively simulates observed conditions (see Figure 2),
- Conservative benzene transport rates suggest that concentrations above 1 µg/l extend approximately a maximum of 100 feet downgradient of the source area, and
- Provided the degradation rate and time from release, the model suggests that the plume has reached steady-state conditions; therefore no further migration of the COCs is expected.
