# ENGINEERING INVESTIGATIONS AT INACTIVE HAZARDOUS WASTE SITES

## PRELIMINARY SITE ASSESSMENT

Aluminum Match Plate Corporation Site No. 915005

Town of Tonawanda Erie County

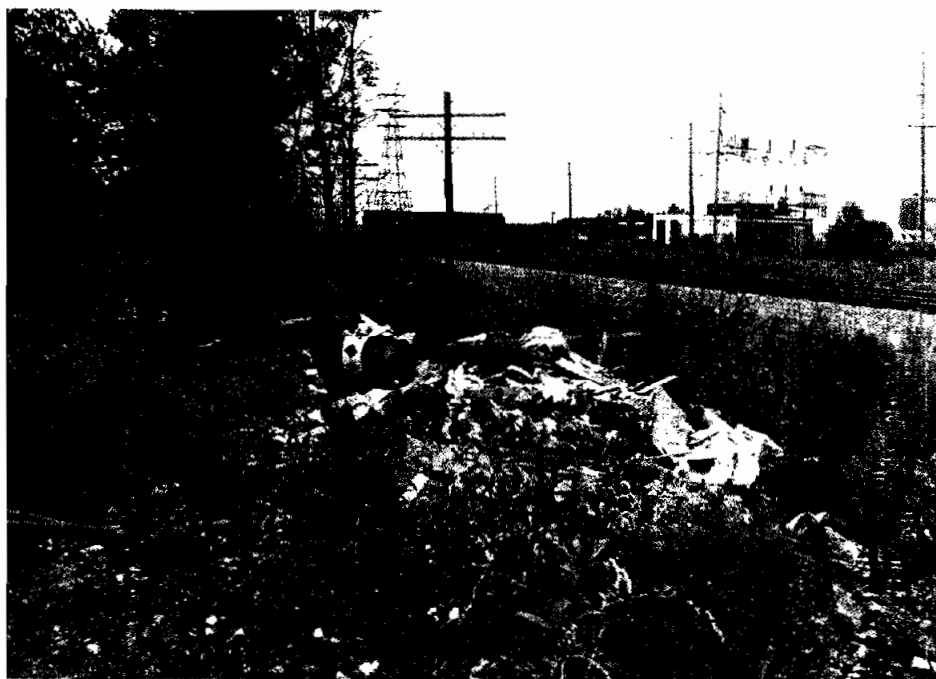
Photo No. 16

- 16) Disposal materials in the southeastern section of the site.
