# Existing Conditions Report

## BUFFALO COLOR PENINSULA

*Buffalo, NY*

AUGUST 2016

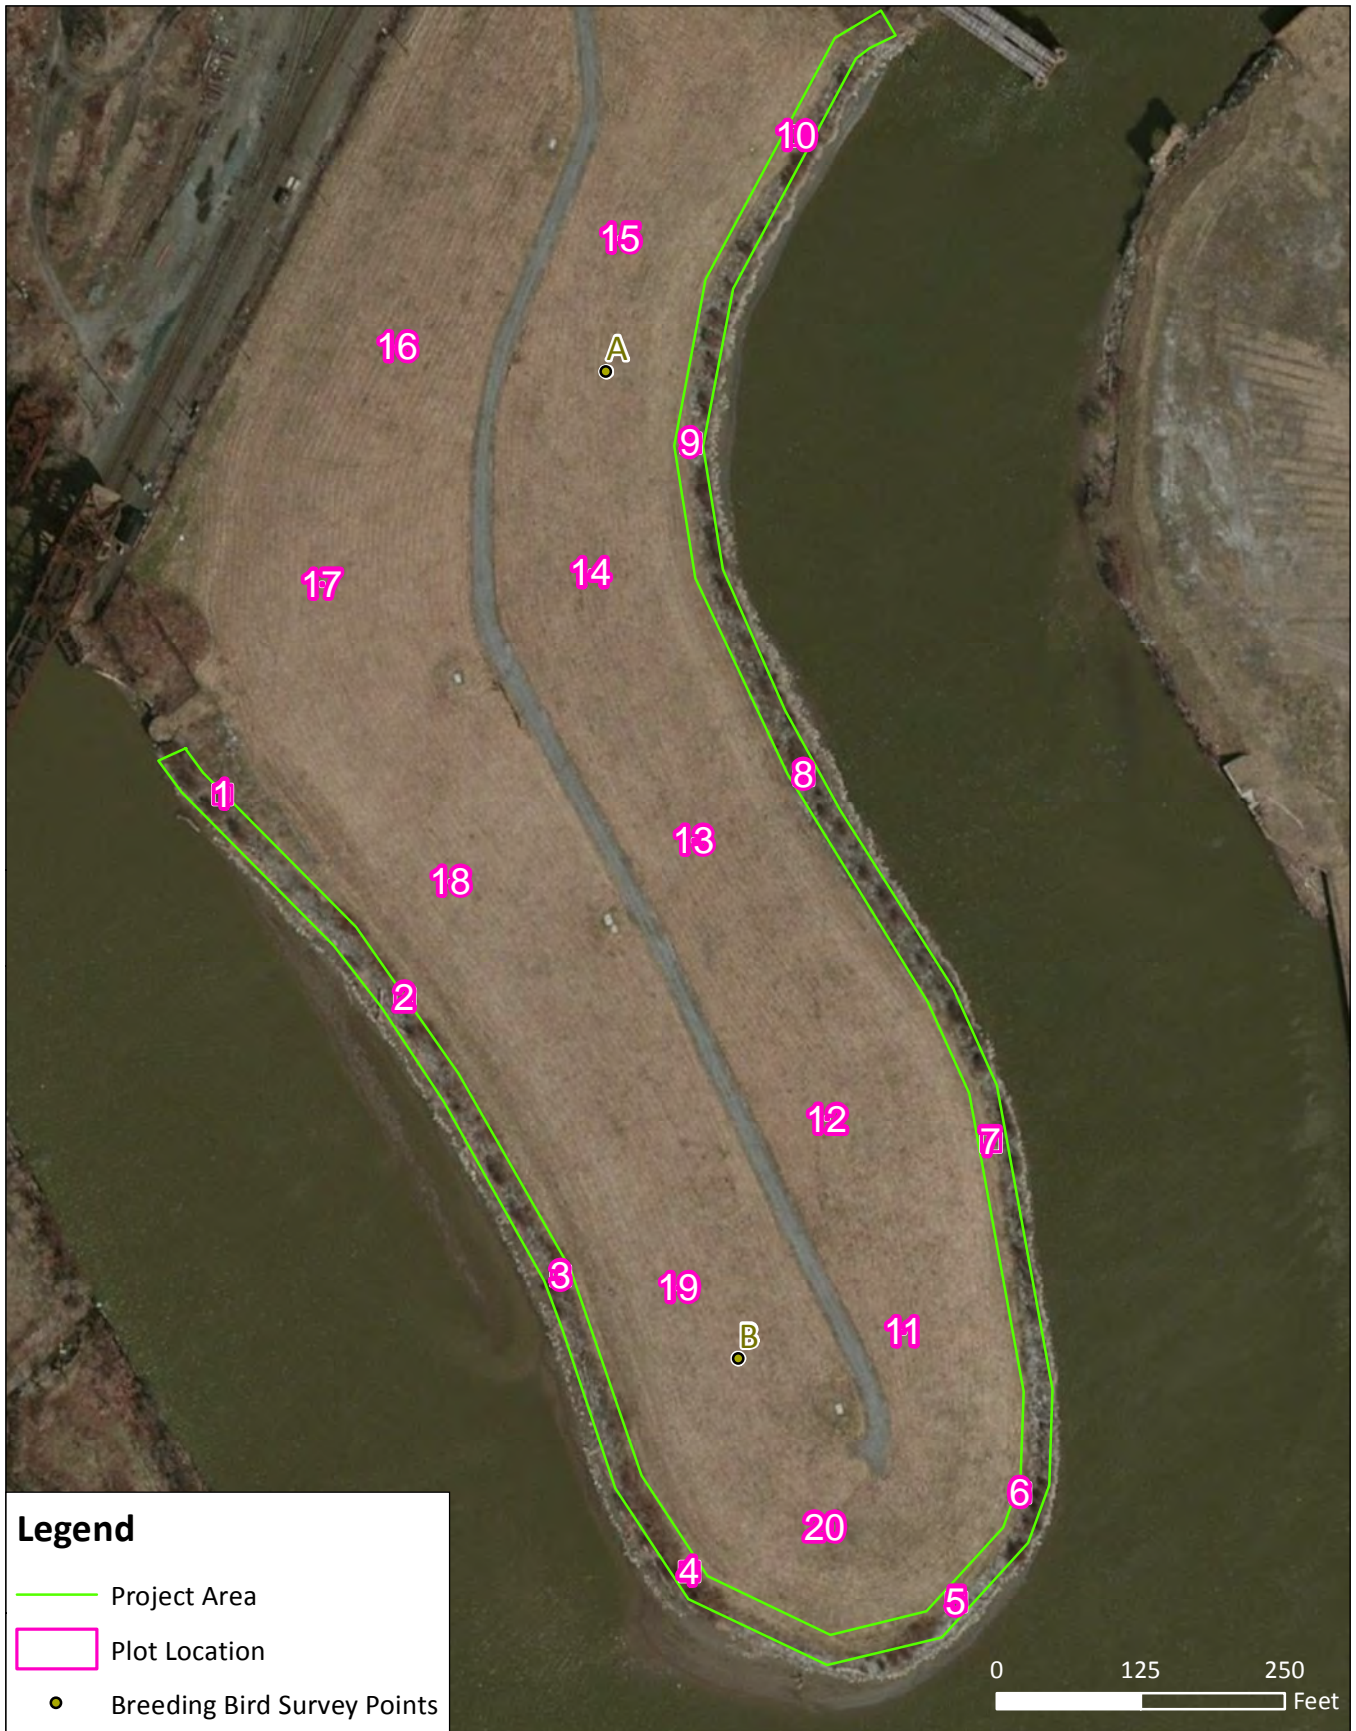
**Figure 3.1.1-1. Buffalo Color Peninsula  
Sampling Plot Locations**

Gomez and Sullivan and RIVERKEEPER staff visited the project area on July 22 and 26, 2016. The location of ten 5-meter by 5-meter plots along the 25-foot wide project area were recorded using a GPS unit (Table 3.1.1-1 and Figure 3.1.1-1, Plots 1-10). Table 3.1.1-2 shows a summary of the data collected at all of the plots. The plant species identified in each plot are shown in Table 3.1.1-3 and photos taken on the south side of each plot are shown as photo monitoring photographs in Appendix C.

Ten one-meter by one-meter plots were also established in the upland meadow area (Figure 3.1.1-1, Plots 11-20). Twelve plant species were present within these sampling plots (Table 3.1.1-4). The only native species was common milkweed (*Asclepias syriaca*). There were only three milkweed plants present within meadow plots. Both were exceptionally small for the species and neither had flowered in 2016. Photos from the meadow sampling plots are shown in Appendix D.

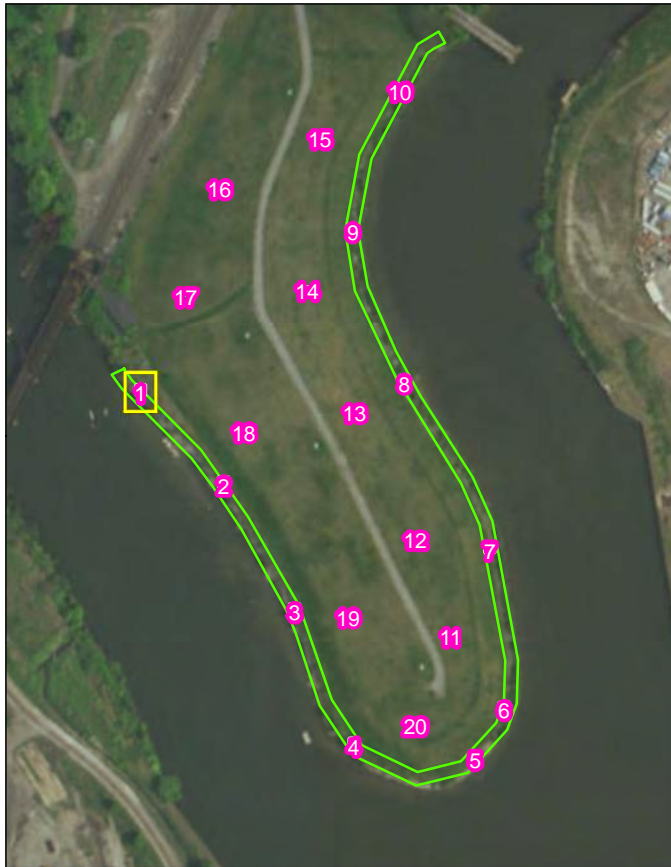
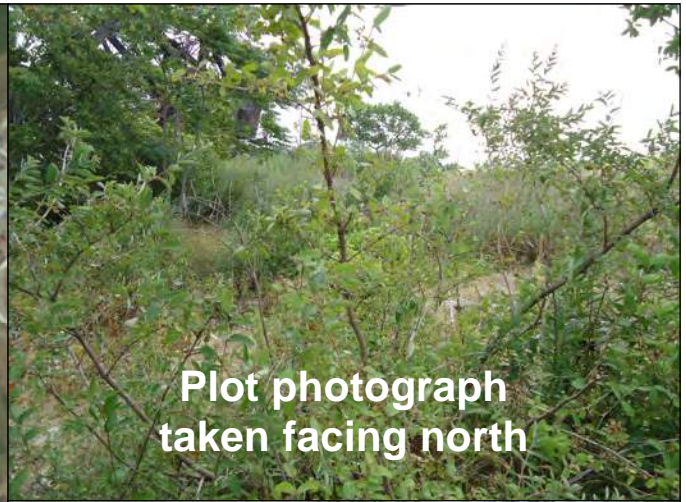
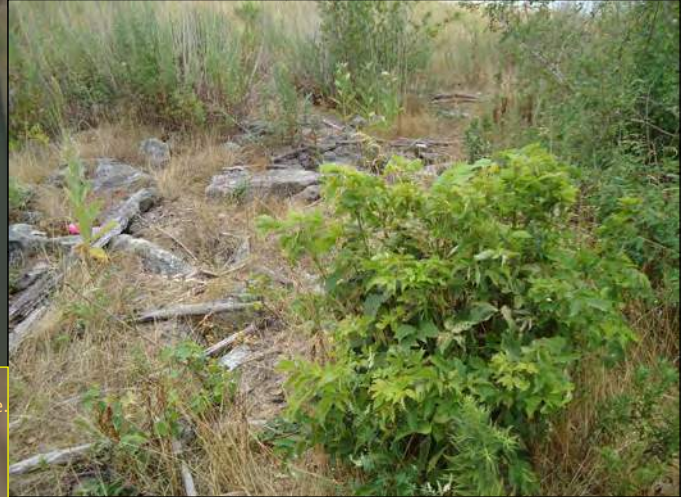
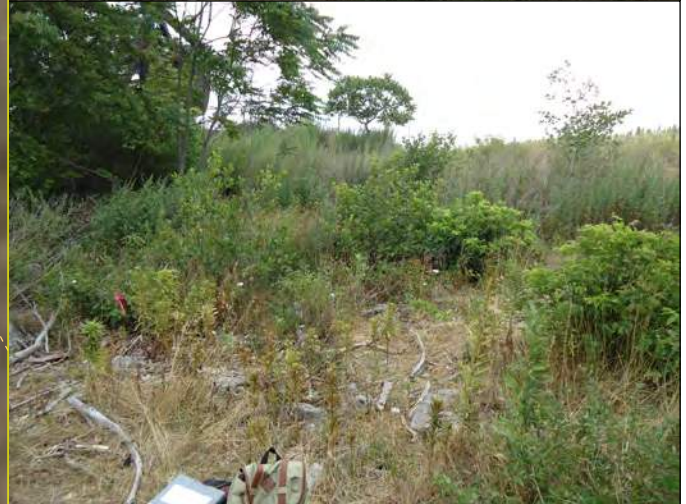
Elevation is presented in North American Vertical Datum 88.  
Plots locations are presented in North American Datum 83, New York West Zone.

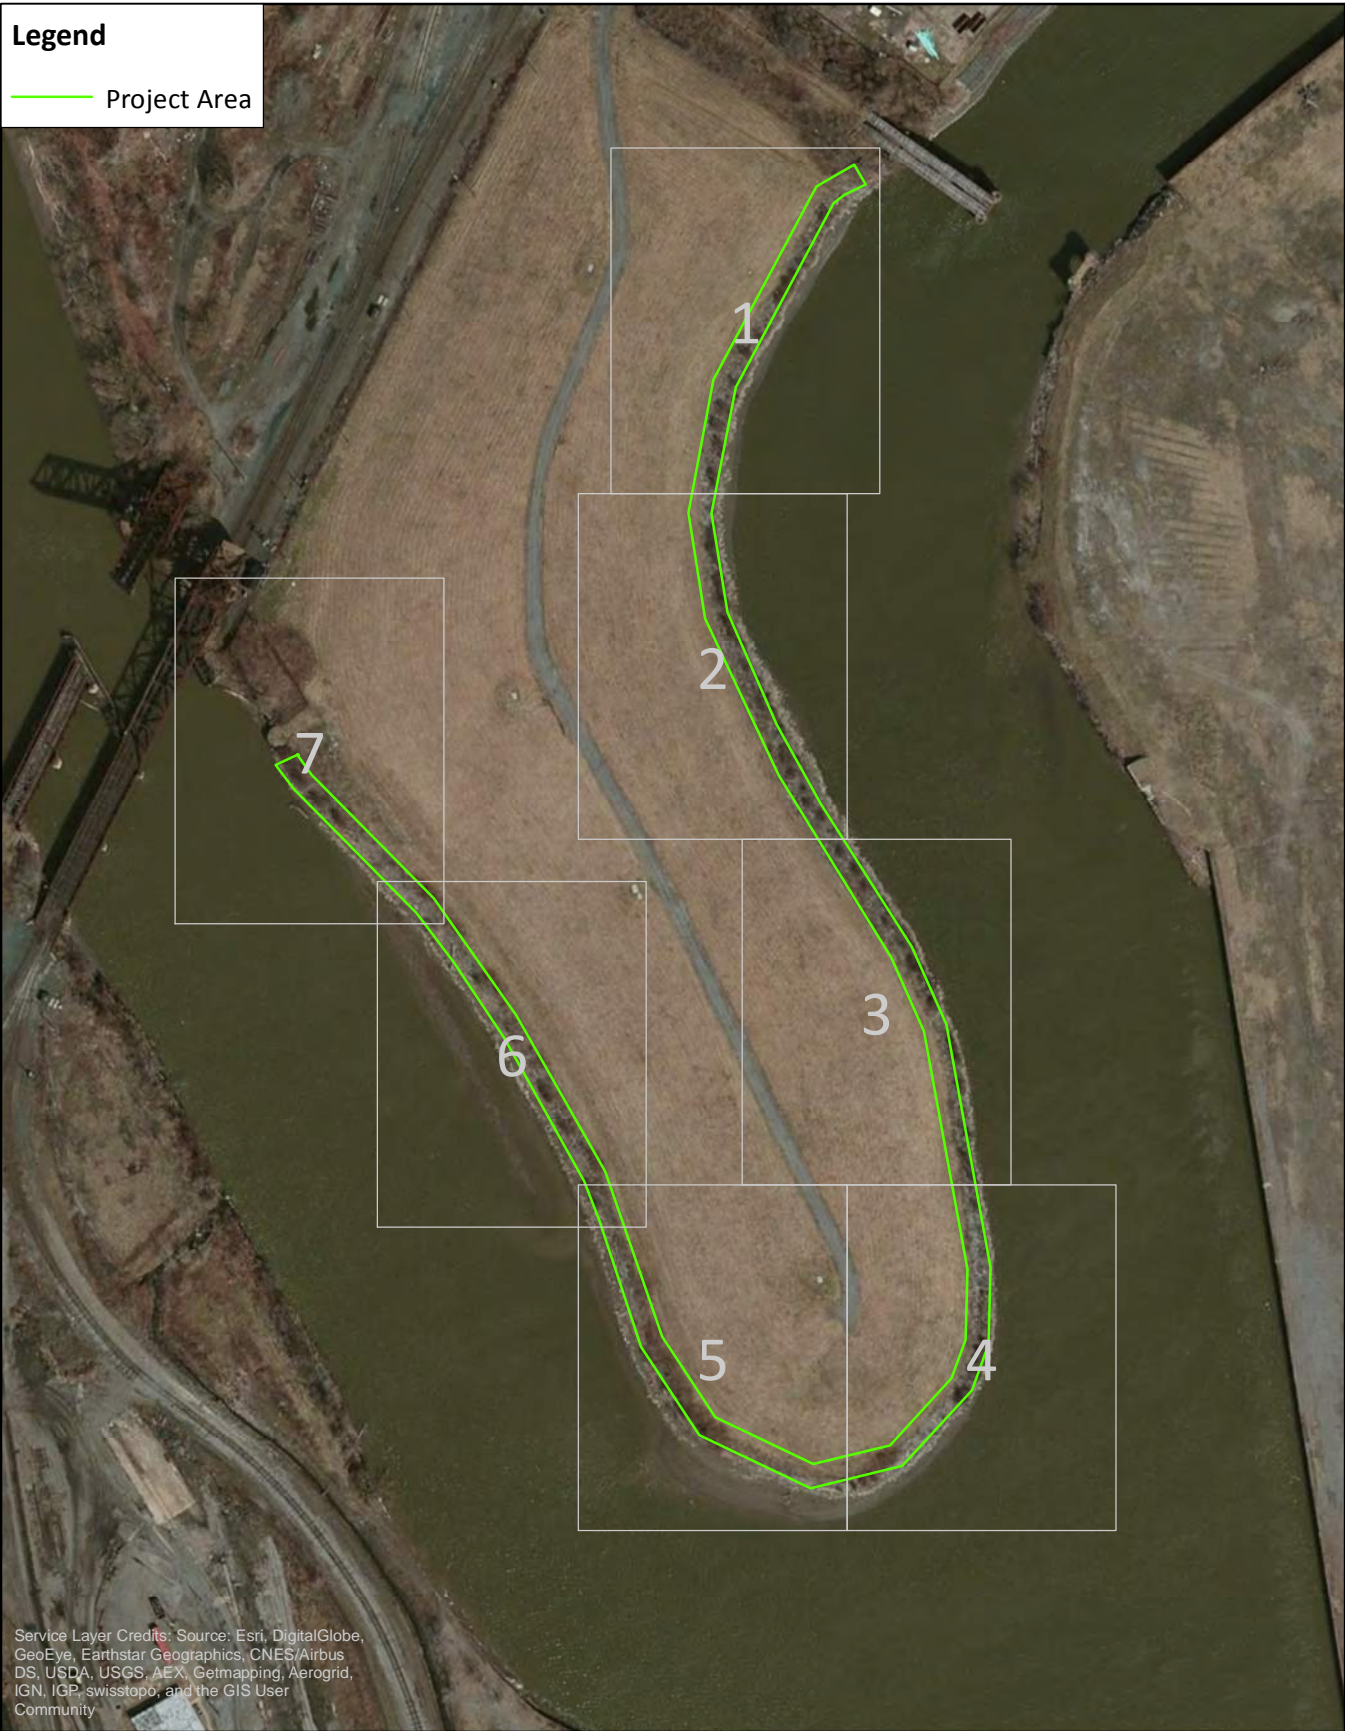
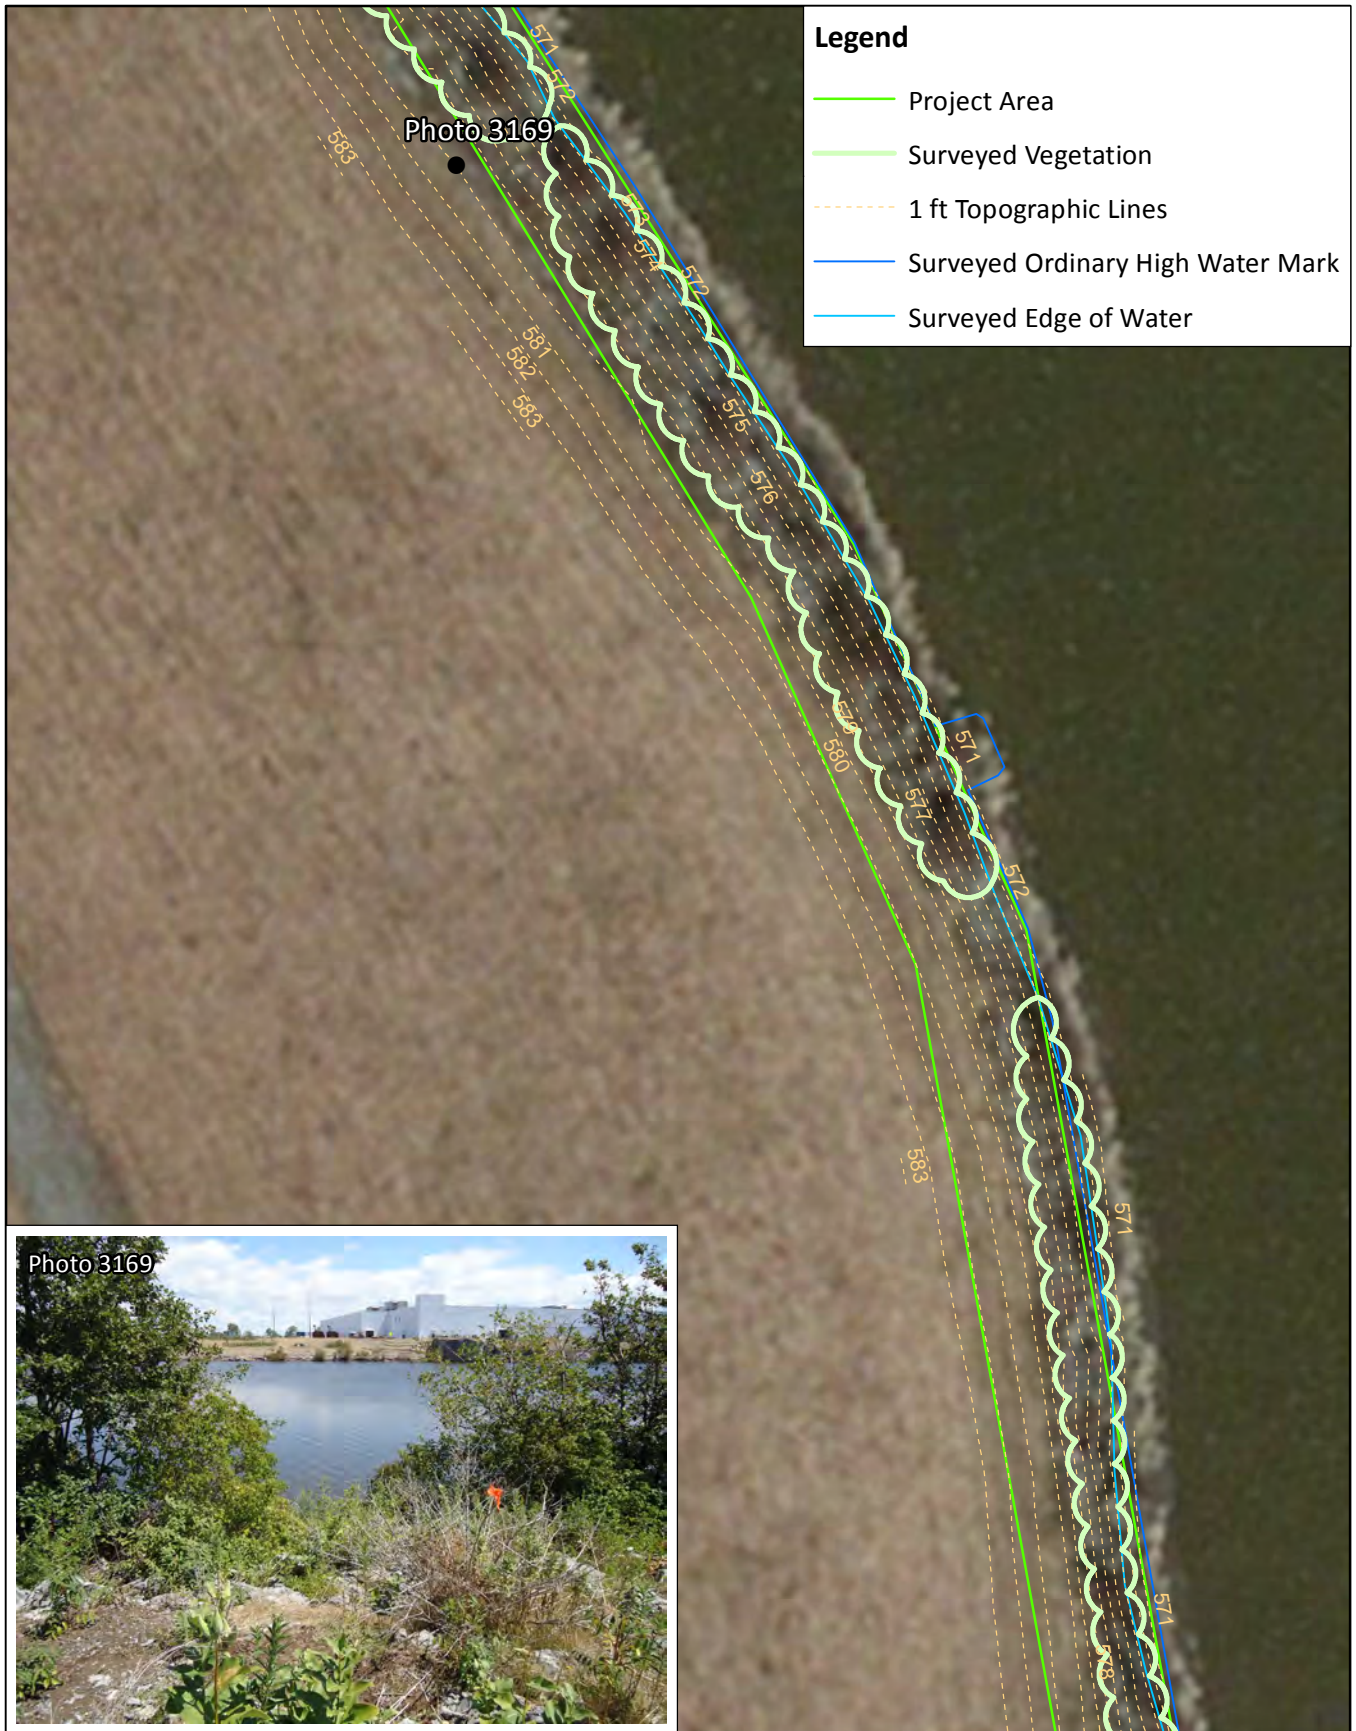
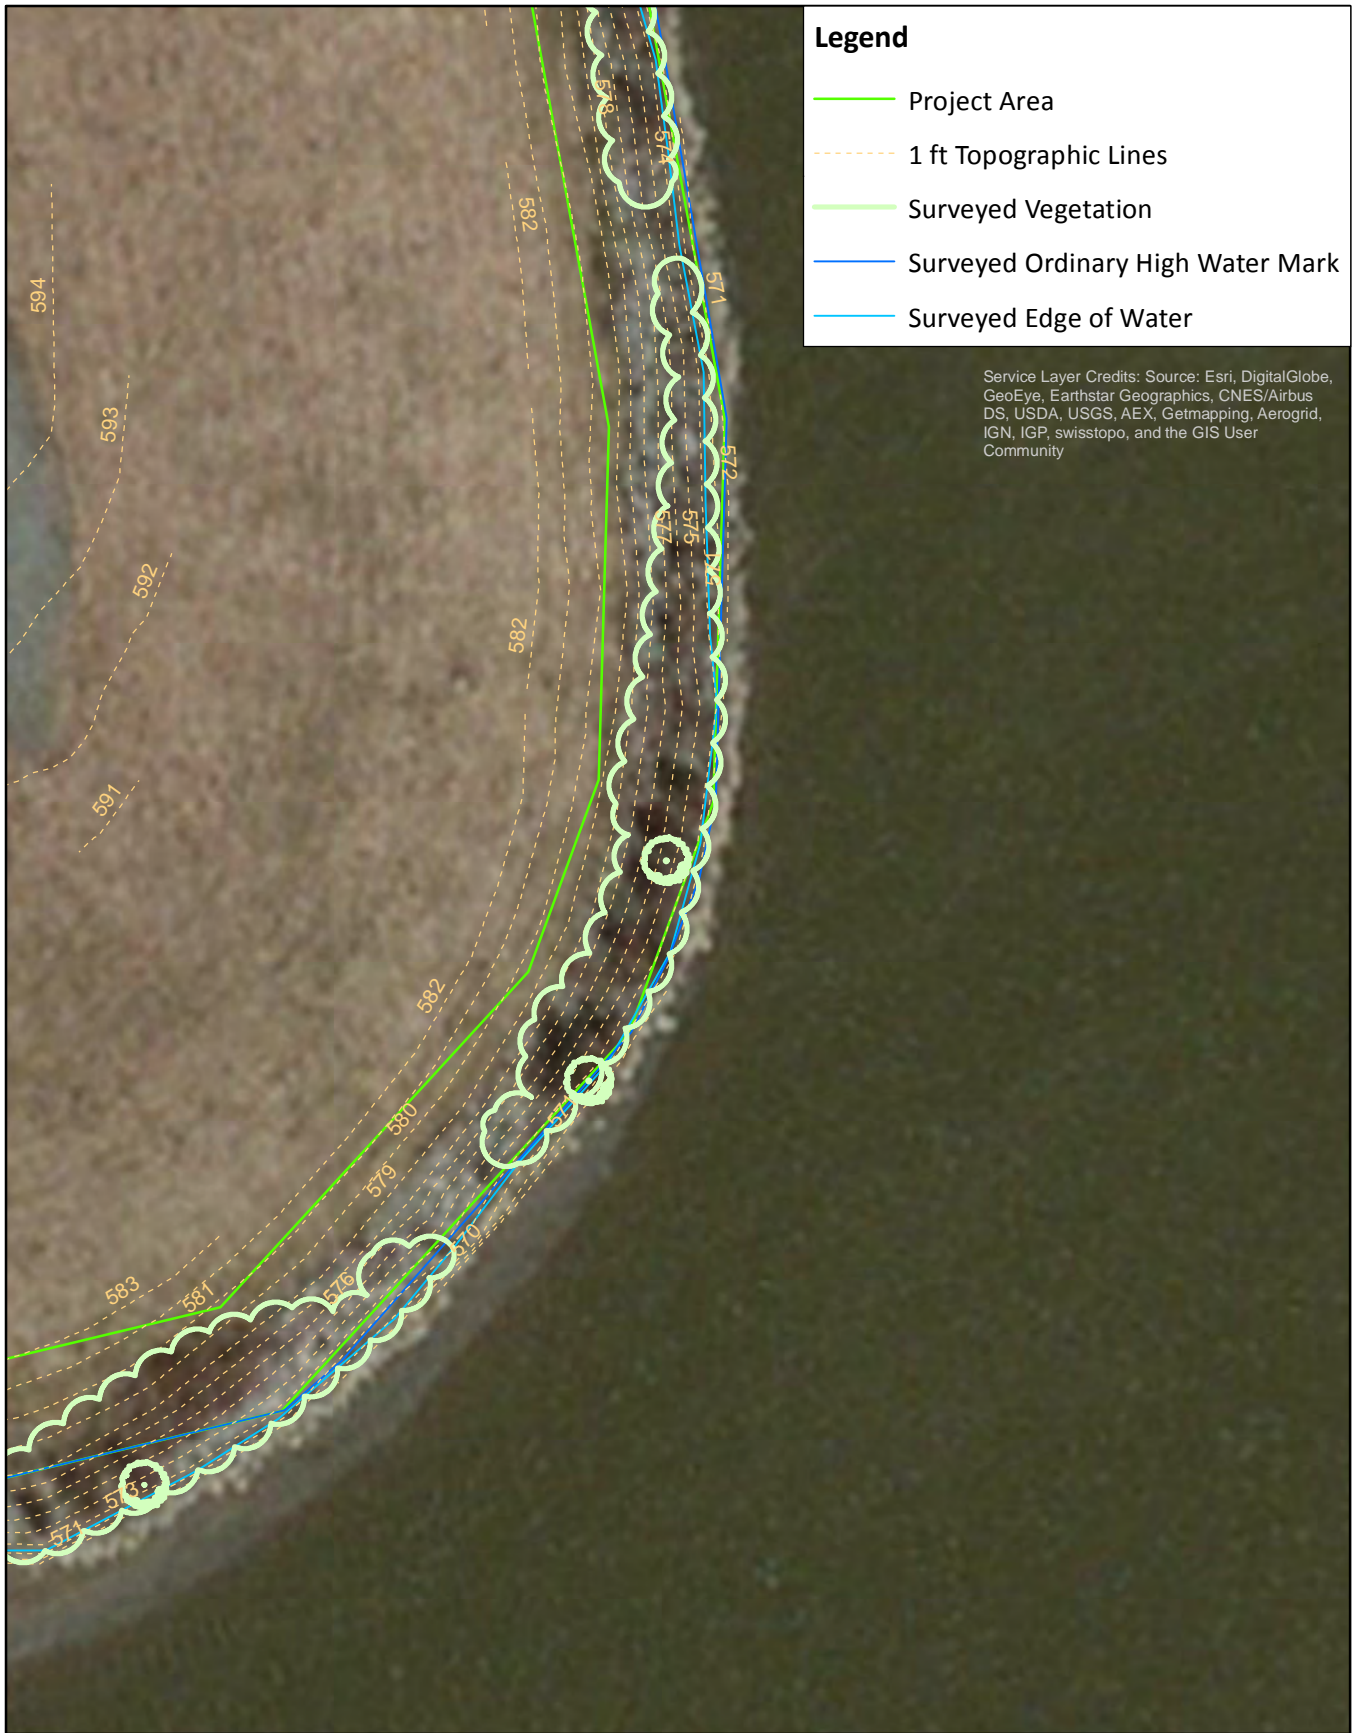
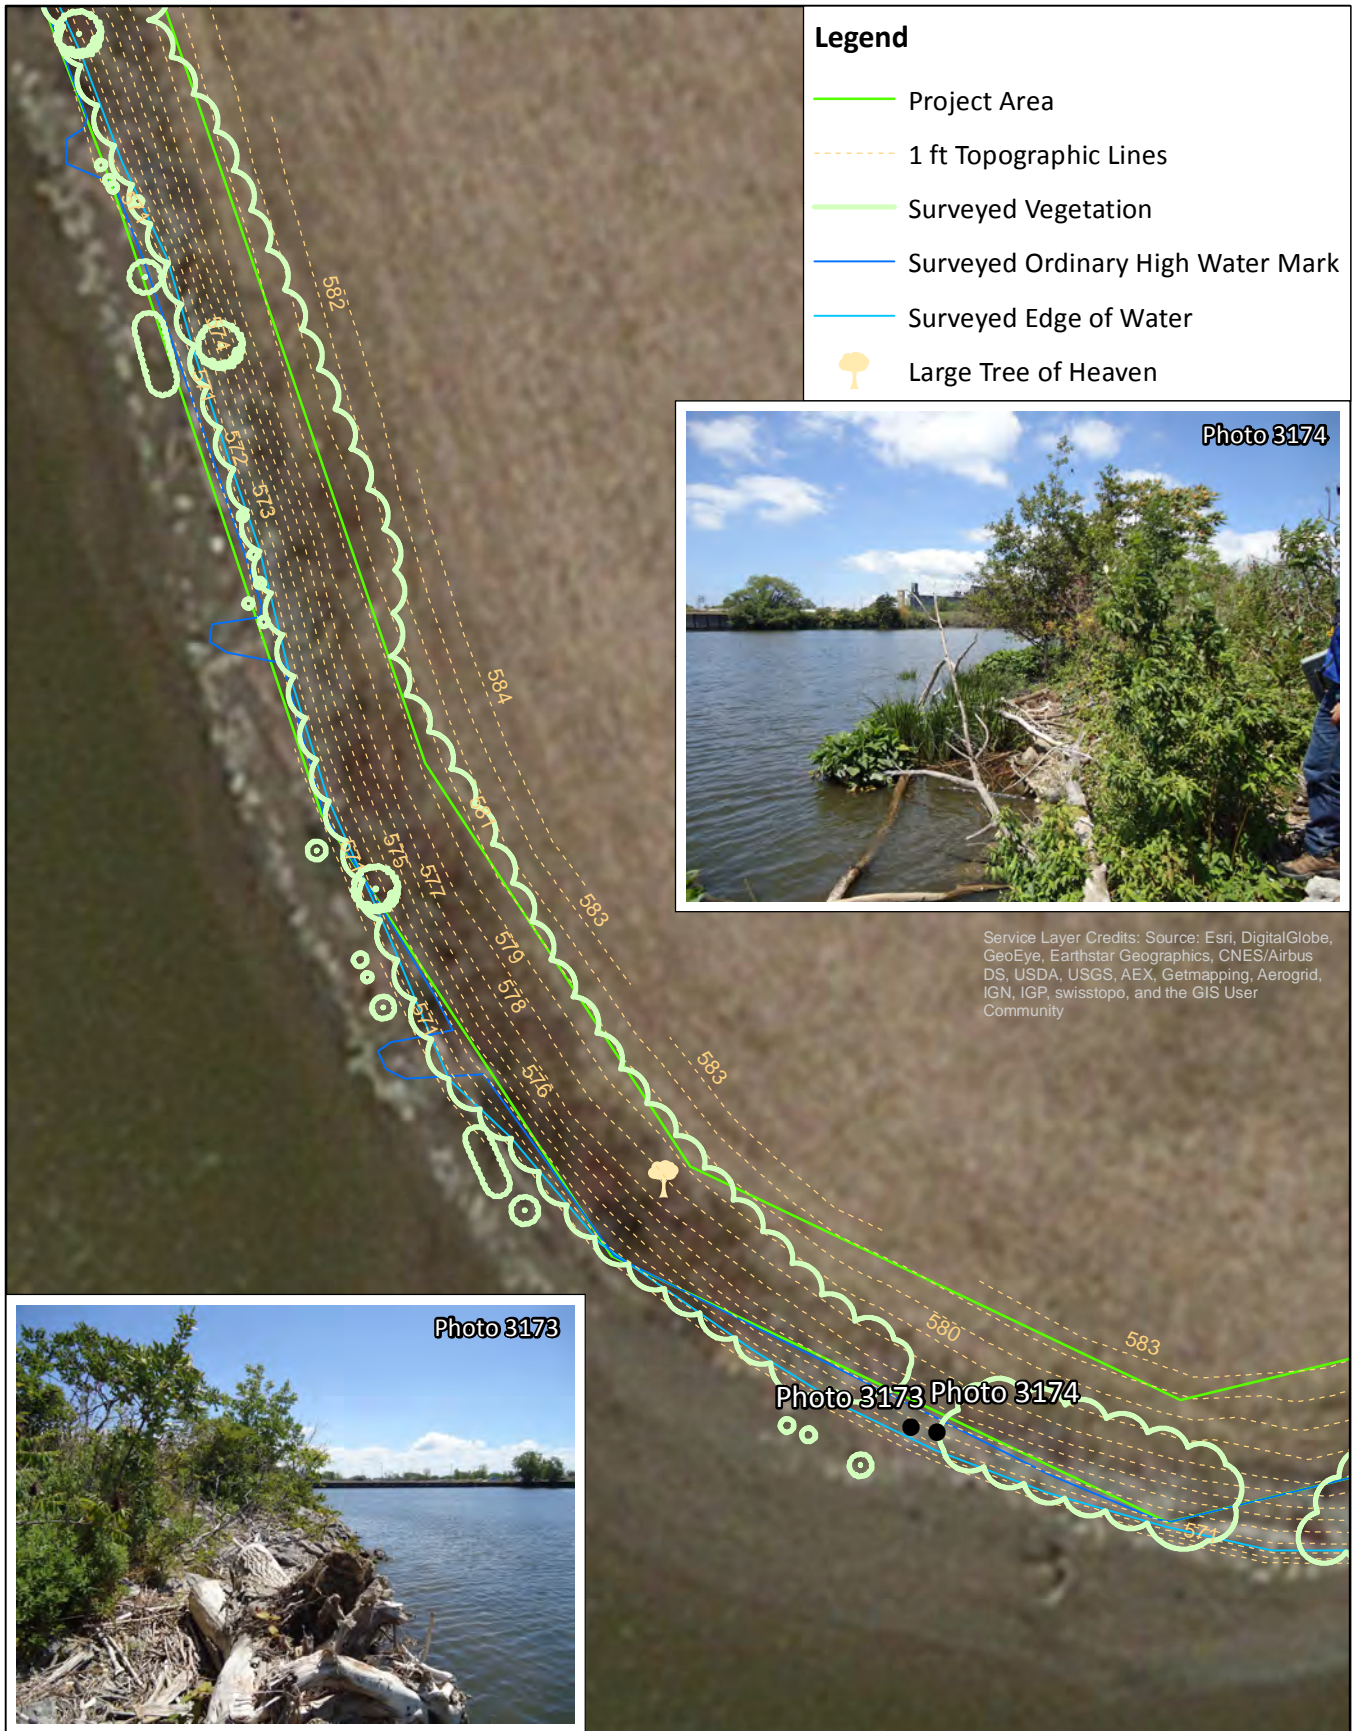
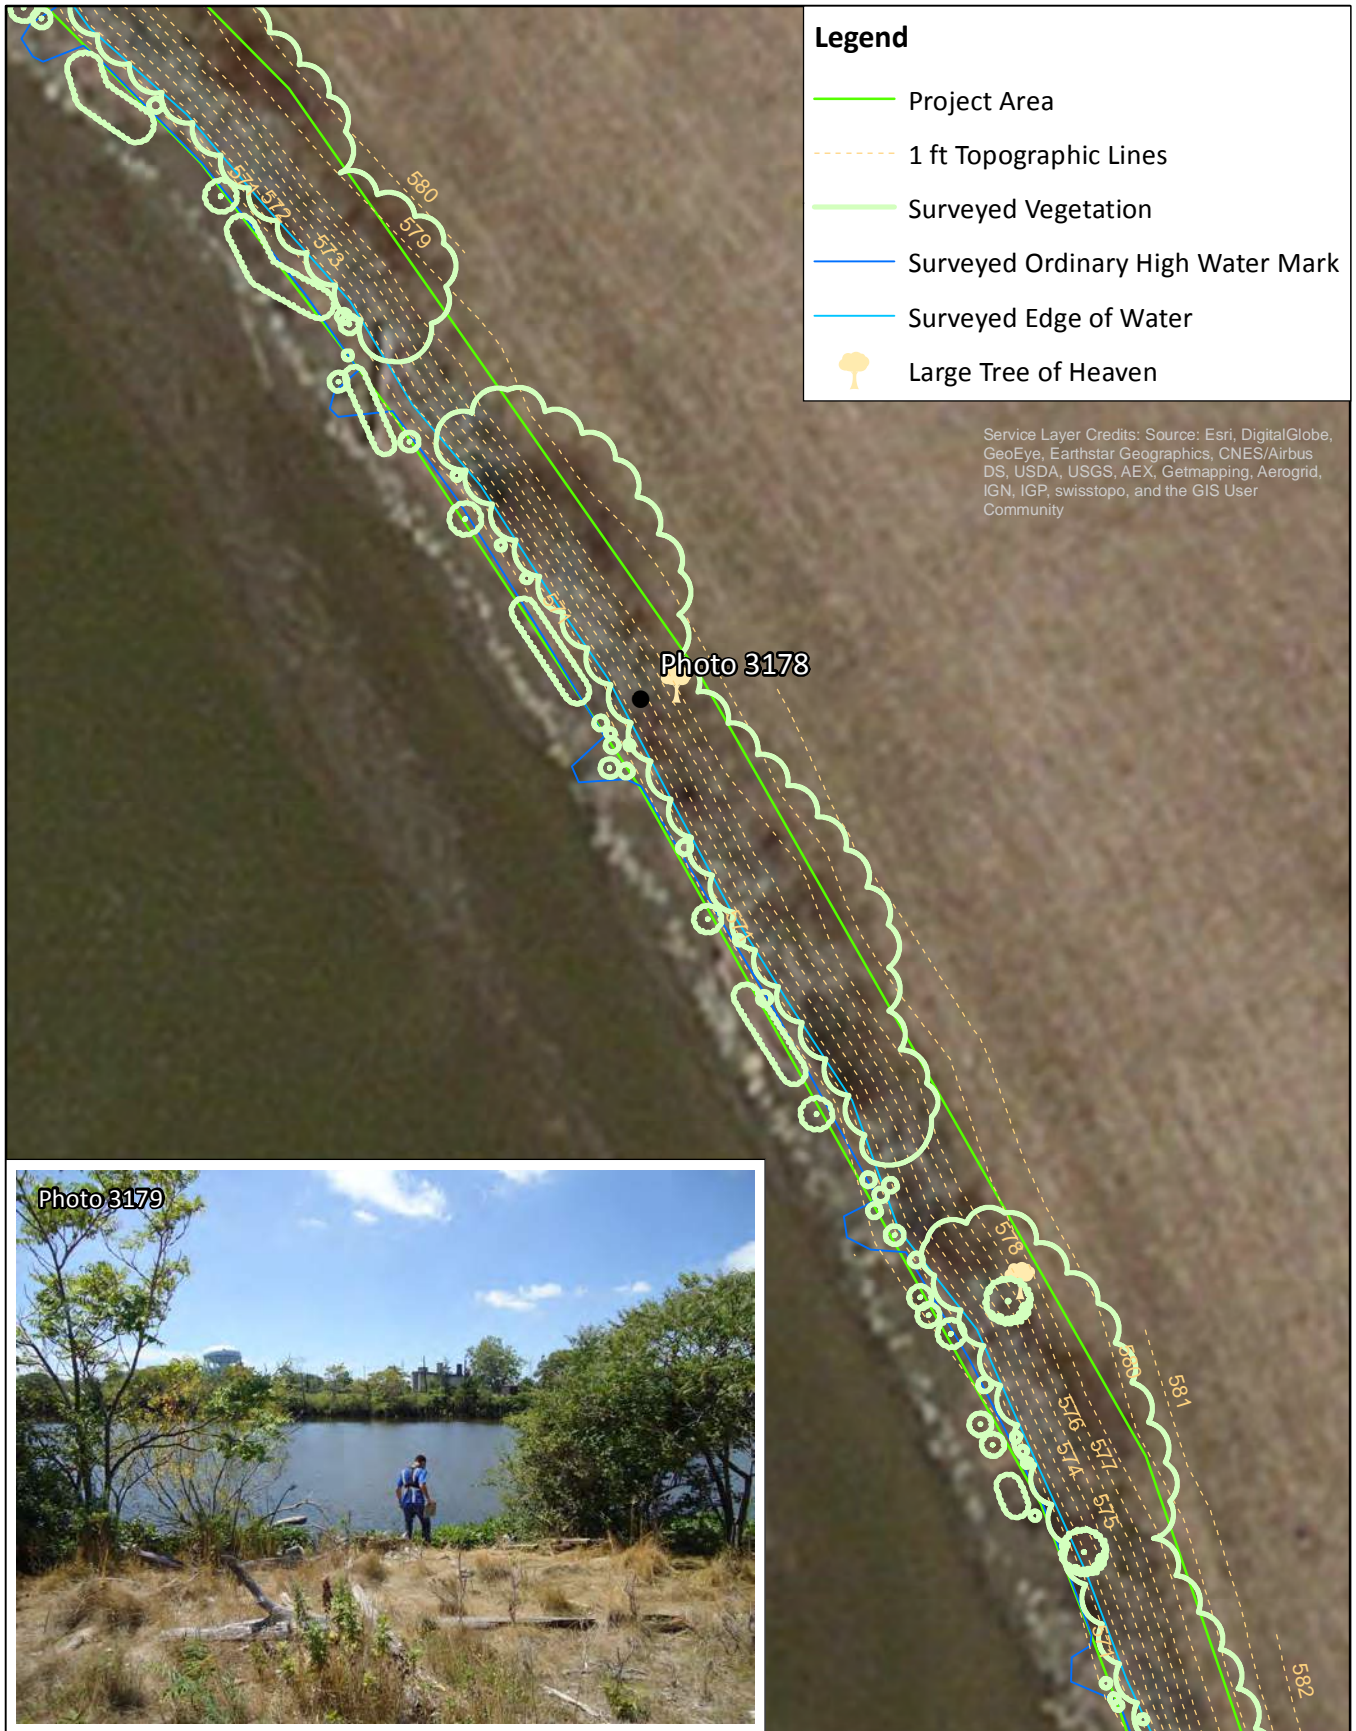
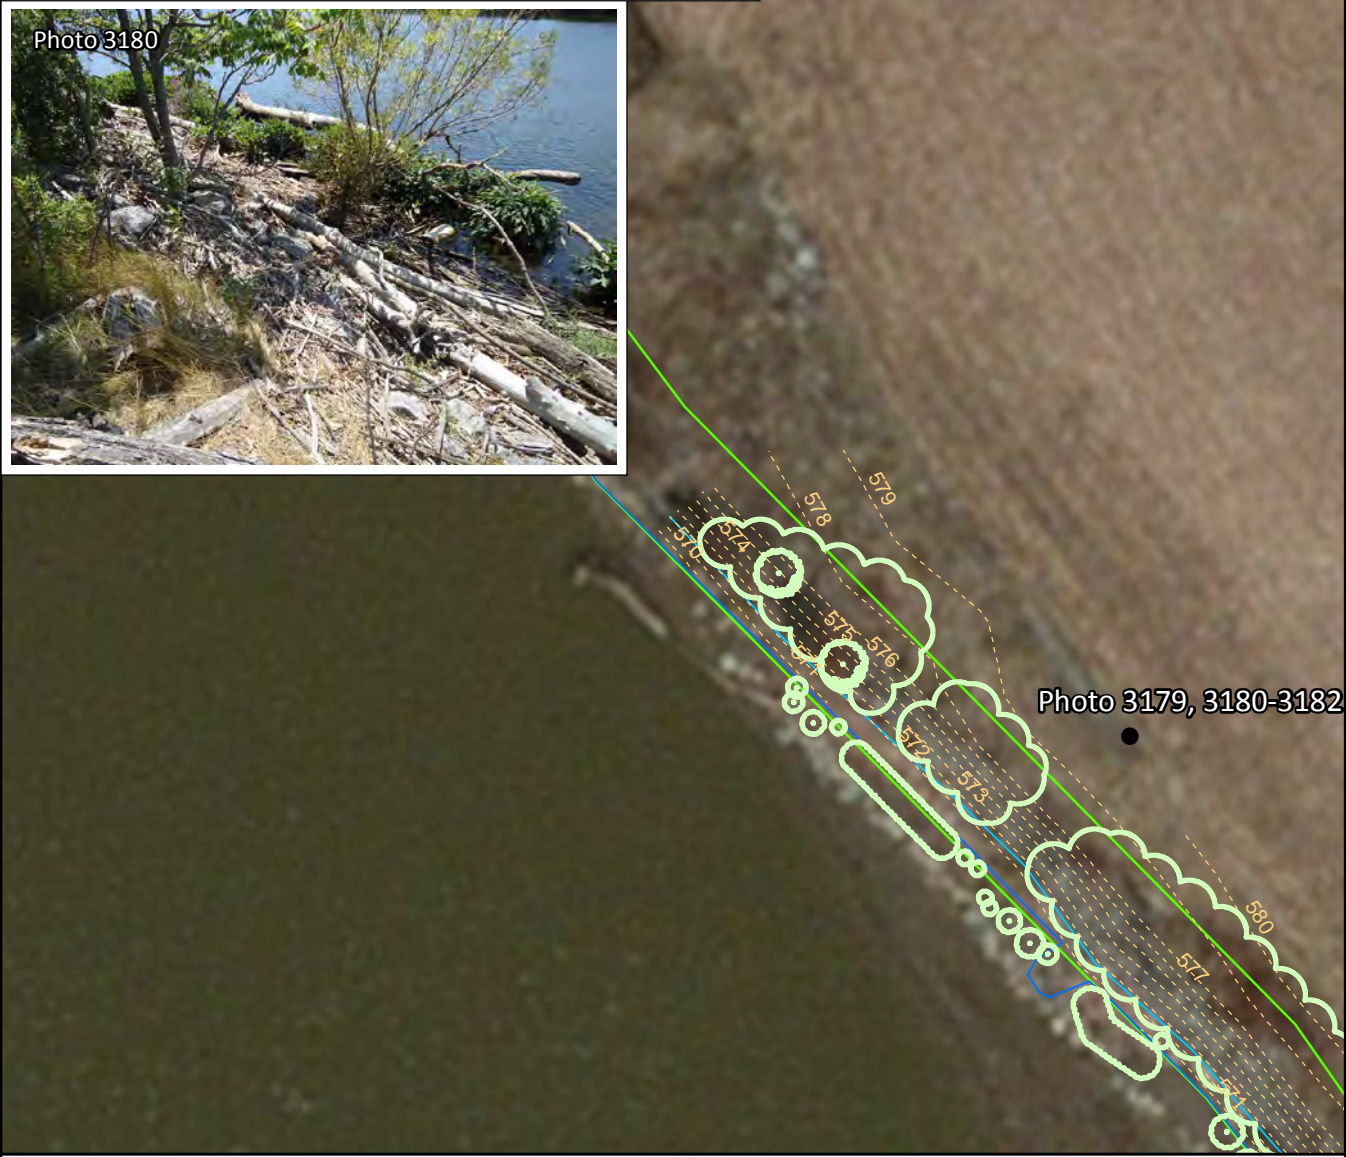
**Figure 3.1.1-3. Buffalo Color Peninsula Existing Conditions**

Field ecologists also took notes on areas outside of sampling plots with potential for restoration. Figure 3.1.1-3 shows areas along the shoreline where black alder are less abundant.

The primary issue at the Buffalo Color Peninsula is the lack of native plant richness and plant cover, particularly at the higher elevations in the rip-rap perimeter. Exposed rip-rap is lacking the soil necessary for abundant plant growth.

Additionally, the majority of European black alders will not be removed from the site during restoration, therefore restoration activities will need to focus on areas where native plants will not be out-competed by the mature alder trees. Alder trees may be removed if they are growing in areas with sufficient existing soil matrix to support native plant growth.

There are several areas along the perimeter of Buffalo Color Peninsula with potential for habitat enhancements. Due to the restrictions on moving existing rip-rap, an appropriate soil mixture will need to be brought in to fill the voids between rip-rap stones as well as create a layer of soil above some of the rip-rap. Additional tools such as Bio-D blocks made of coir fiber blocks and natural fabric or jute matting will also be used. Native shrubs, vines, and herbaceous plants can be planted in areas of the shoreline where vegetation is currently sparse. This vegetation will eventually grow to shade the rocks and the water, providing habitat for fish as well as migratory and resident birds. At elevations closer to the top of the rip-rap at the upland edge of the project area, restoration efforts can focus on perennial herbaceous plant species such as milkweeds, bee balm, and asters, which are beneficial to native insects.
