PRELIMINARY ASSESSMENT
DUNLOP SITE 2

**POTENTIAL HAZARDOUS WASTE SITE
PRELIMINARY ASSESSMENT**

Dunlop Site 2
Site Name

Sheridan Drive and River Road
Tonawanda, New York
Address

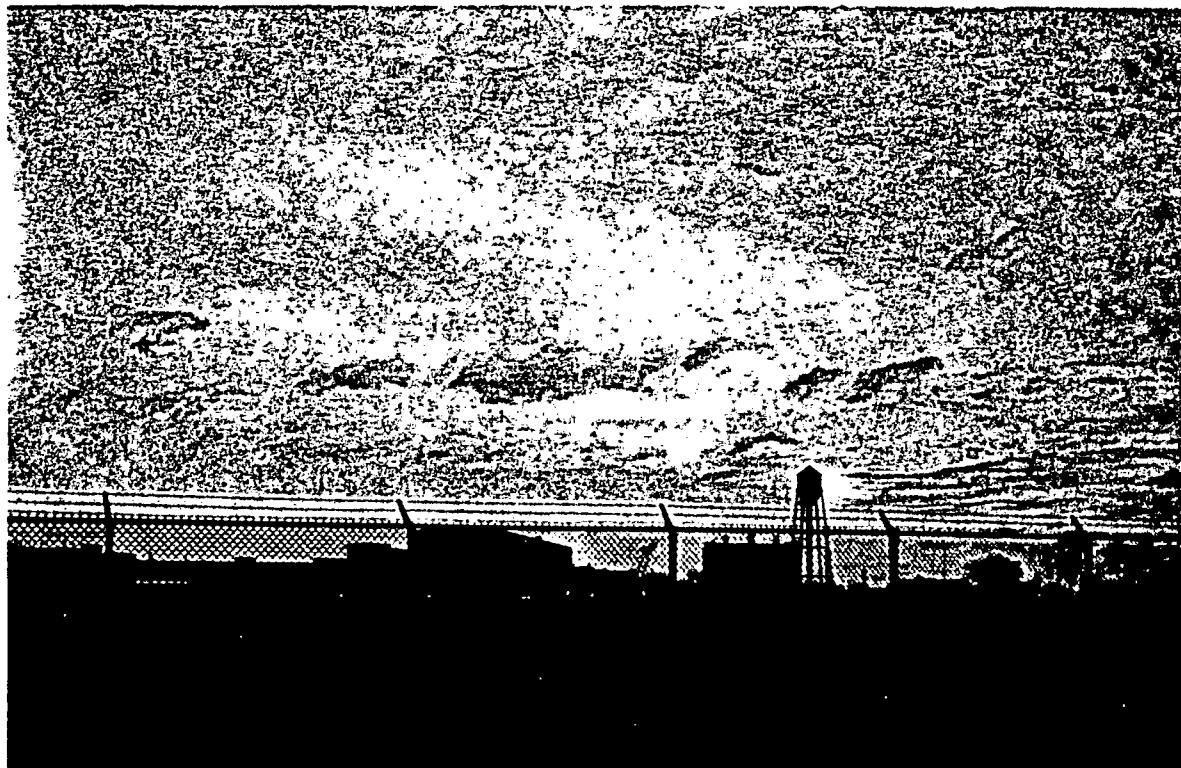
1P-9

View off River Road looking east at the Dunlop property.
Photographer: Donna Restivo.

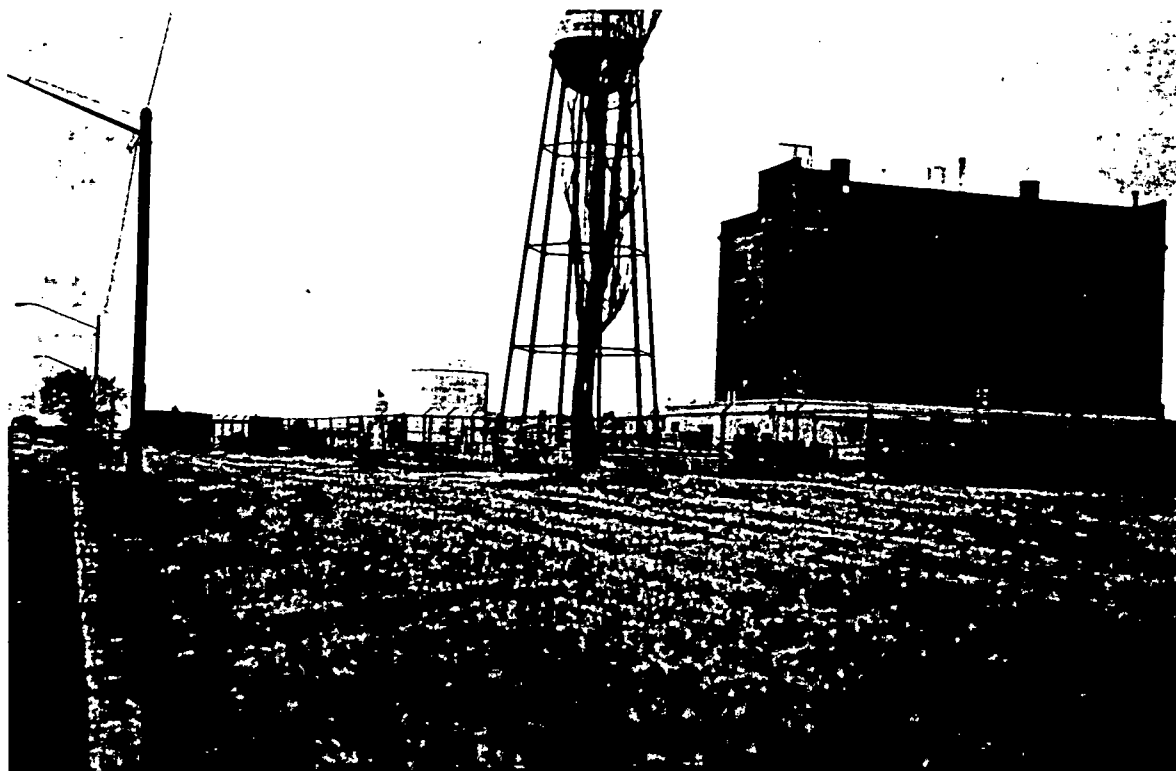
1P-10

View off Sheridan Drive looking northwest at the
Dunlop facility.
Photographer: Robert Nies.
