Revised Periodic Review Report and Institutional Controls Certification - Site No. 915018

Site Name Dunlop Tire and Rubber

Site Address: 3333 River Road Zip Code: 14150
City/Town: Tonawanda
County: Erie
Site Acreage: 25.000

SUMITOMO RUBBER USA, LLC
TONAWANDA, NEW YORK
LANDFILL CAP MANAGEMENT
SITE MANAGEMENT PERIODIC REVIEW REPORT (PRR)

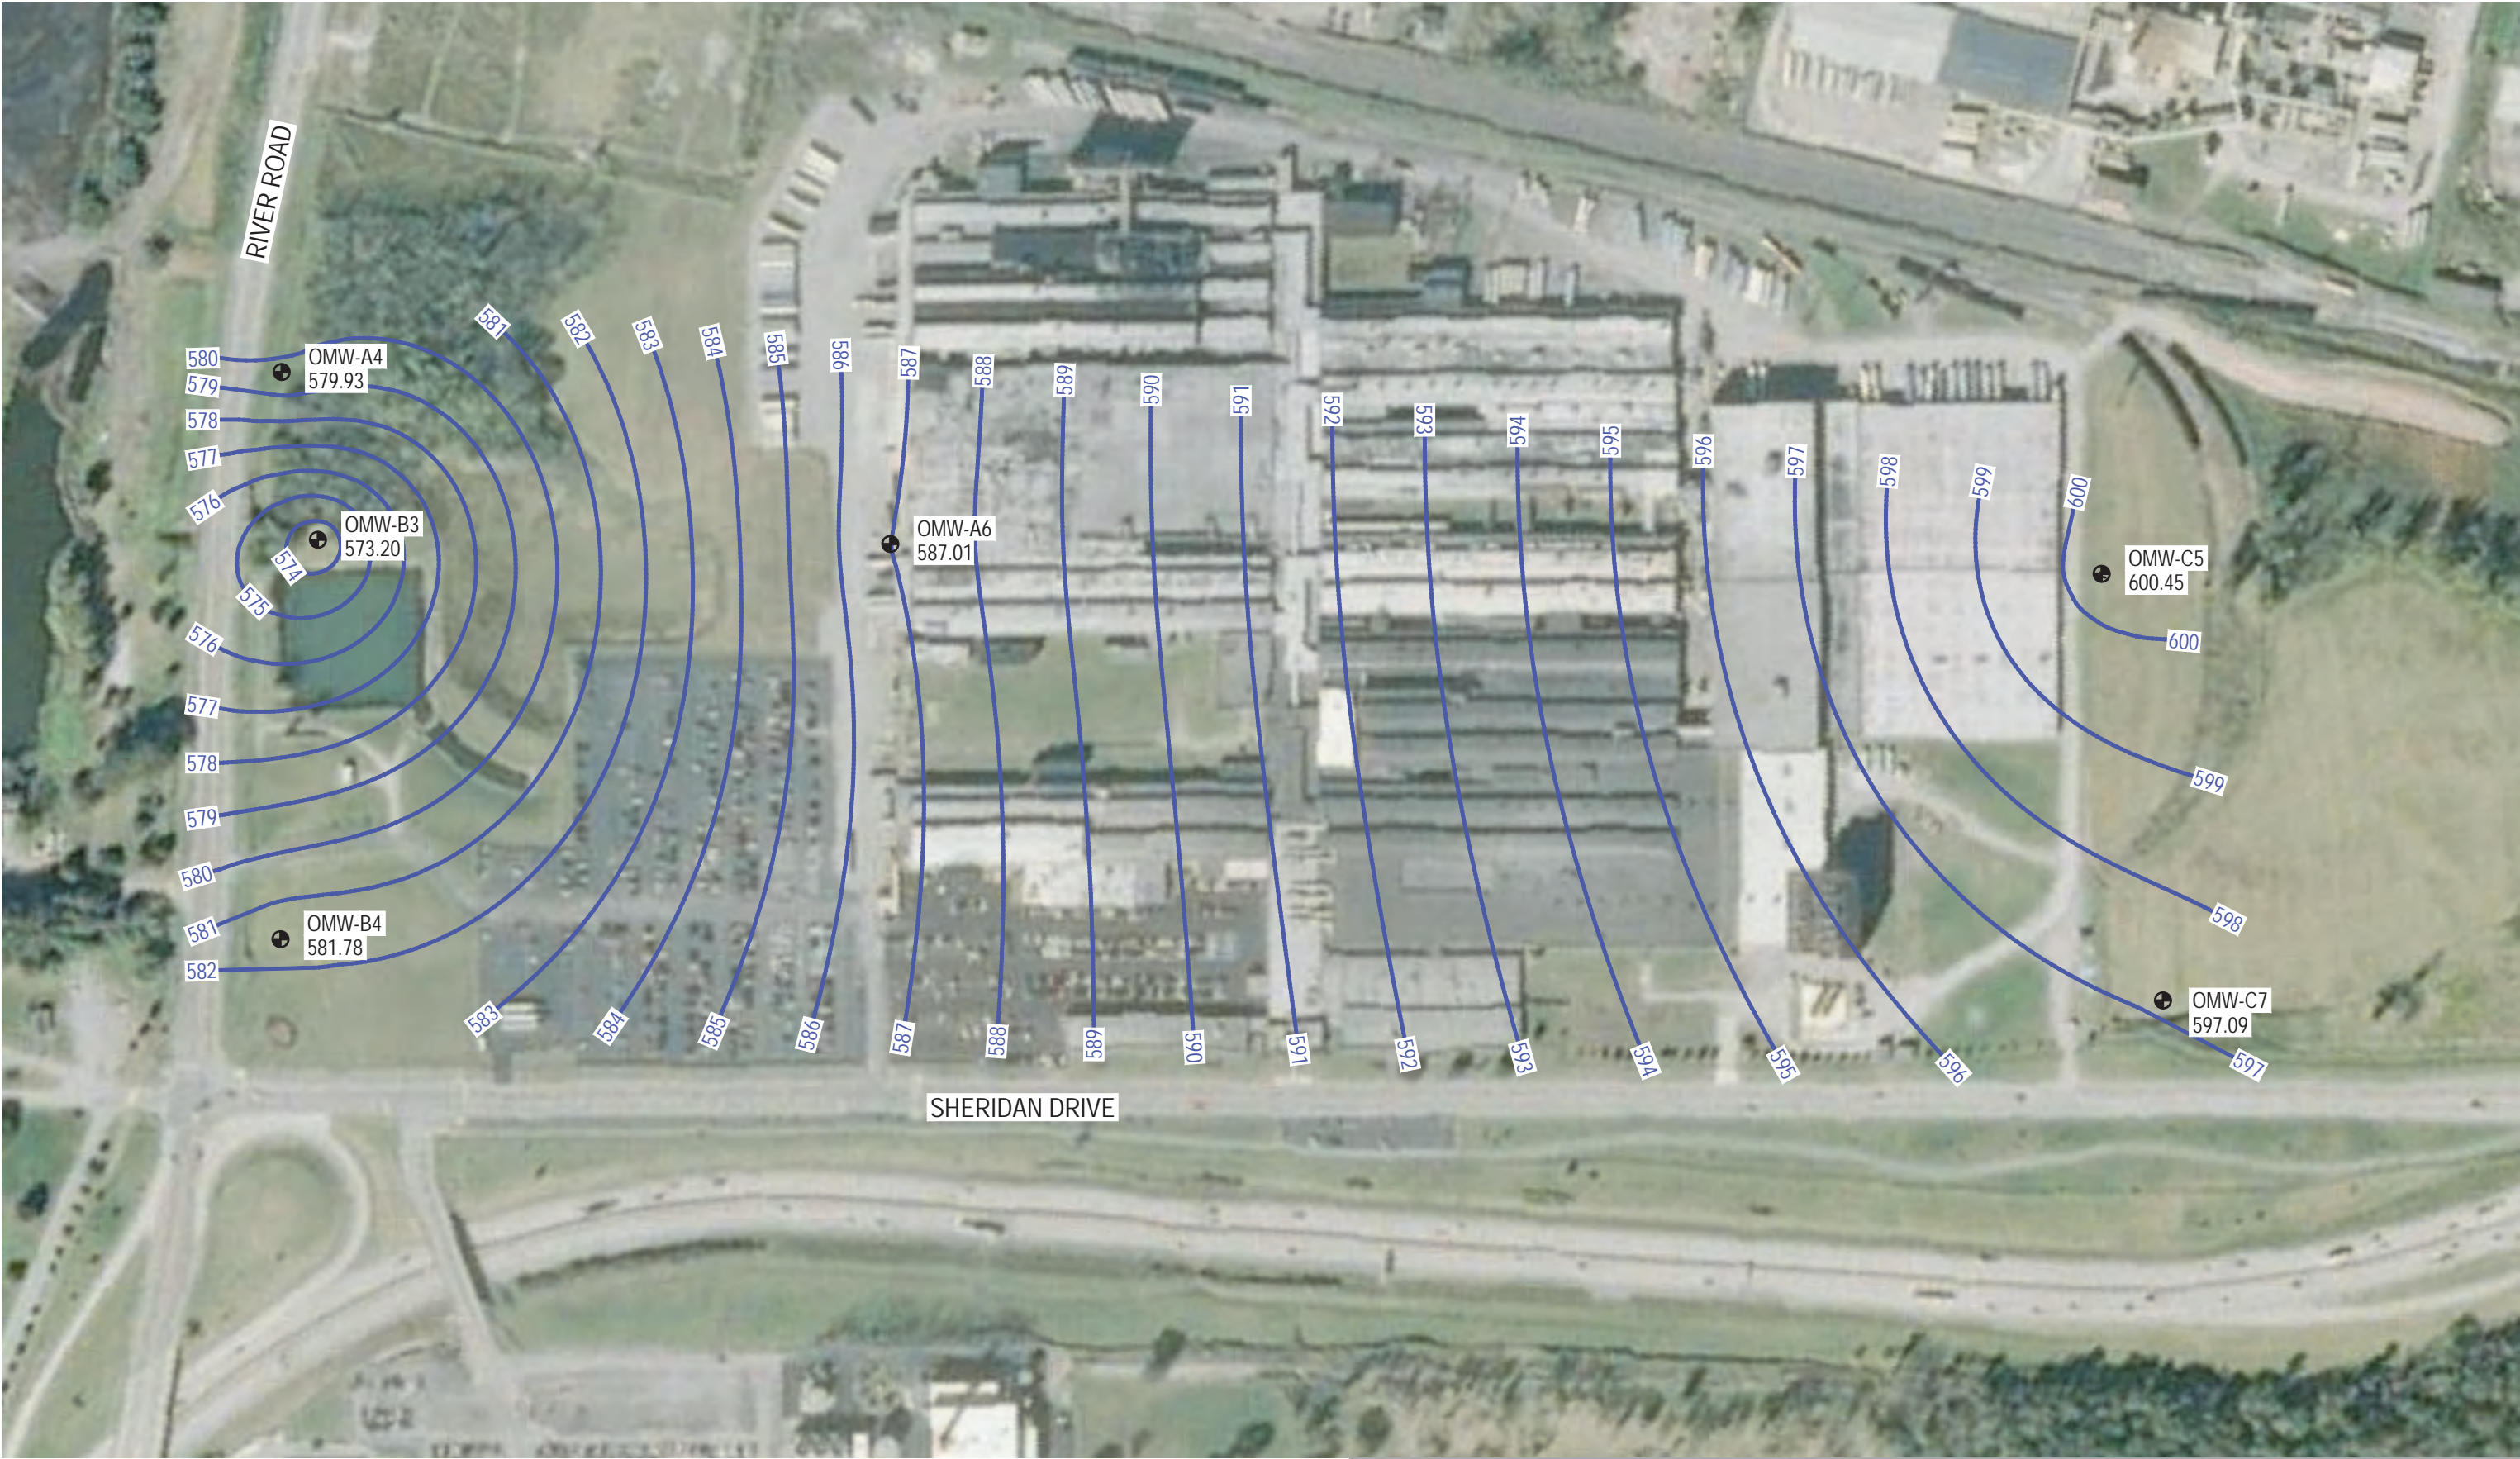
Groundwater measurements were taken to assess groundwater flow conditions. Table 4 summarizes the water level measurements taken May 18, 2023. Figure 4 shows the updated groundwater contour map with groundwater flow direction.
