Site Management Plan

Dunlop Tire and Rubber Site
(Currently owned by
Sumitomo Rubber USA, LLC)
Tonawanda, Erie County, New York

NYSDEC Site Number 915018

Revision 3: July 8, 2025

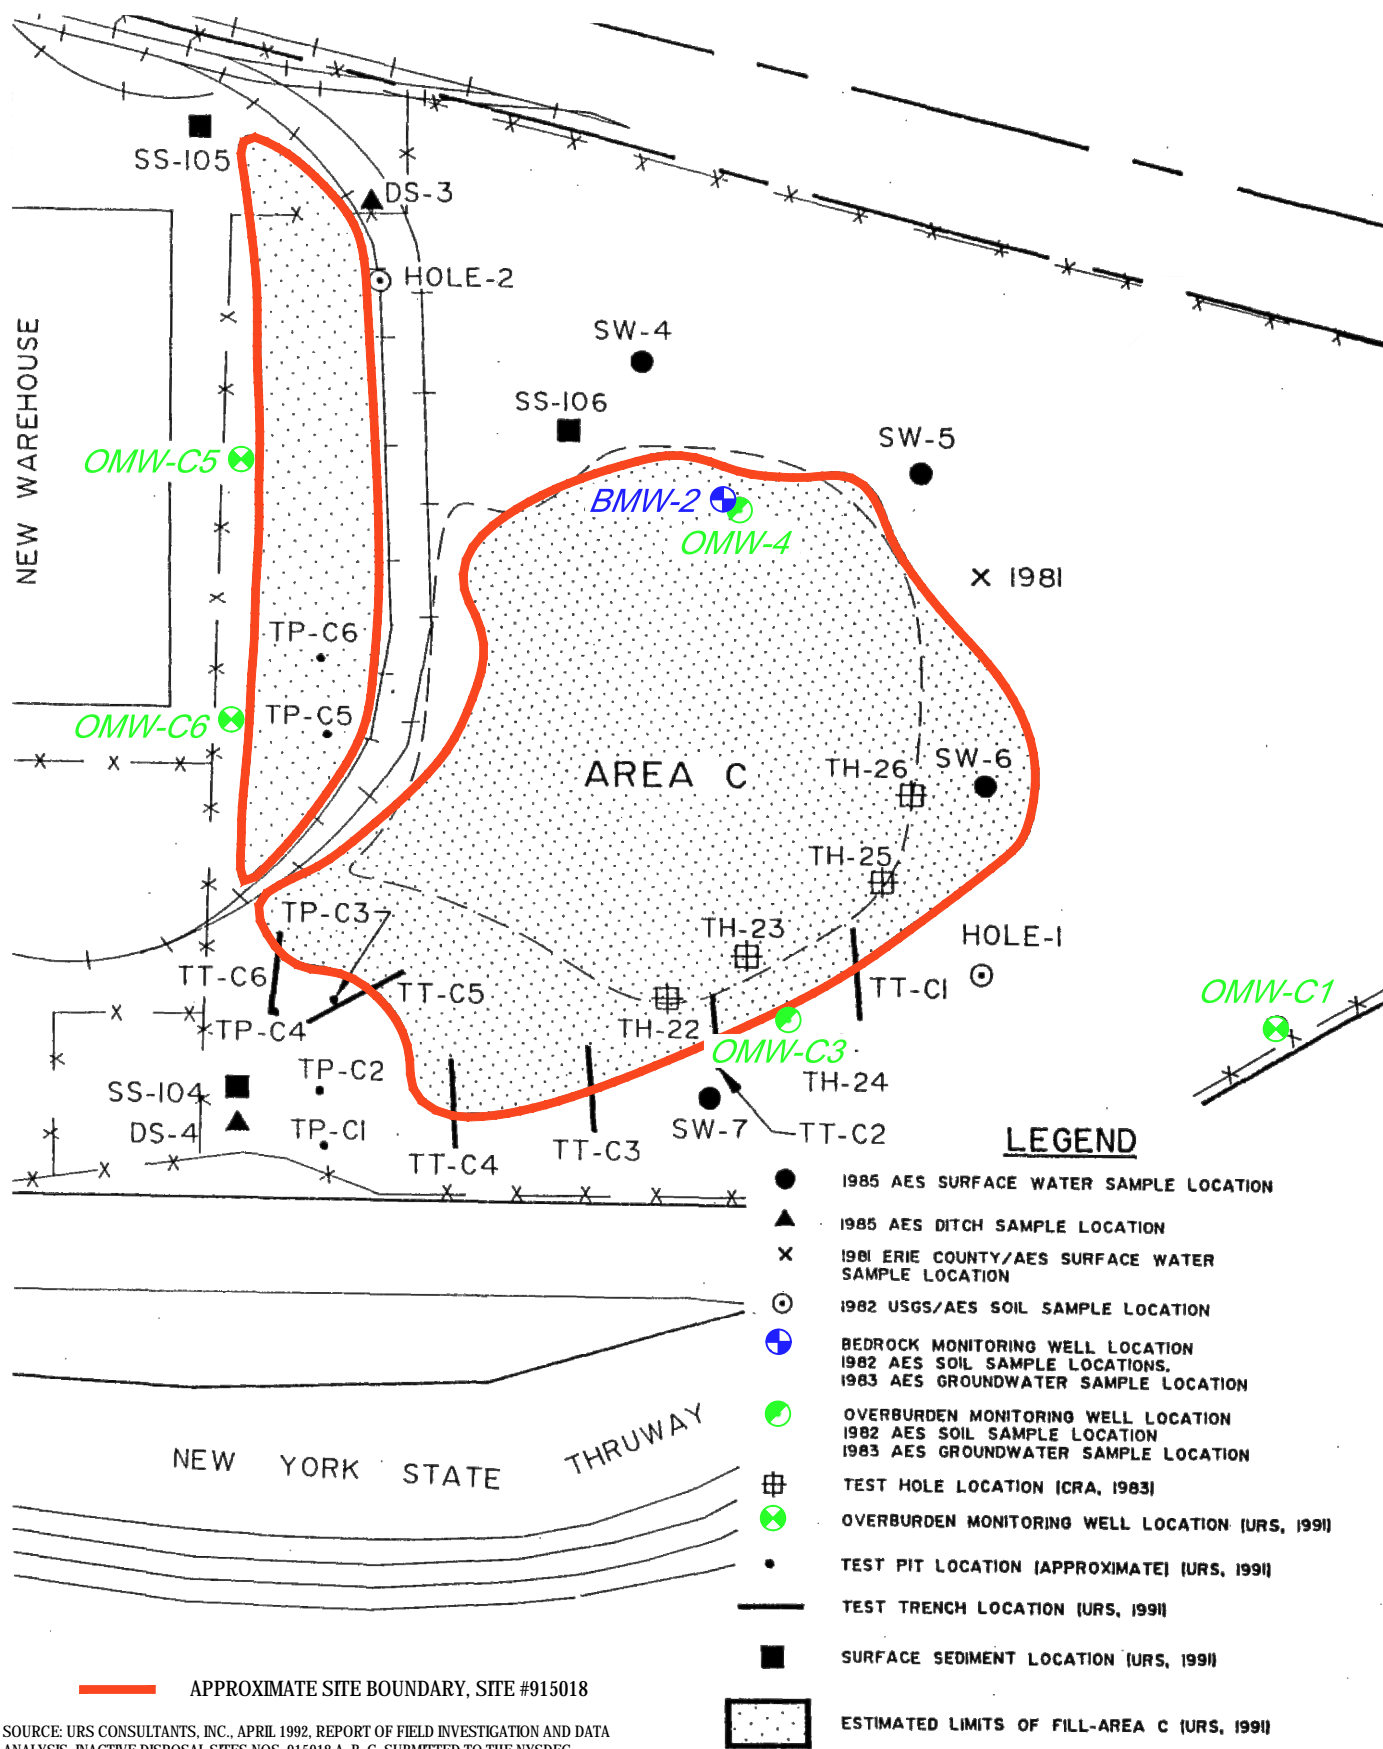
FIGURE 5

- Completion of 26 test holes (TH-1 through TH-26) throughout the 3 disposal sites (Figures 4 and 5). The maximum fill thickness encountered was reportedly 10 feet. Fill materials observed included ash, cinders, slag, gravel, rubber, wood, brick, and metal fragments in a clay, sand, or silt matrix. Test hole logs are included in Appendix C.

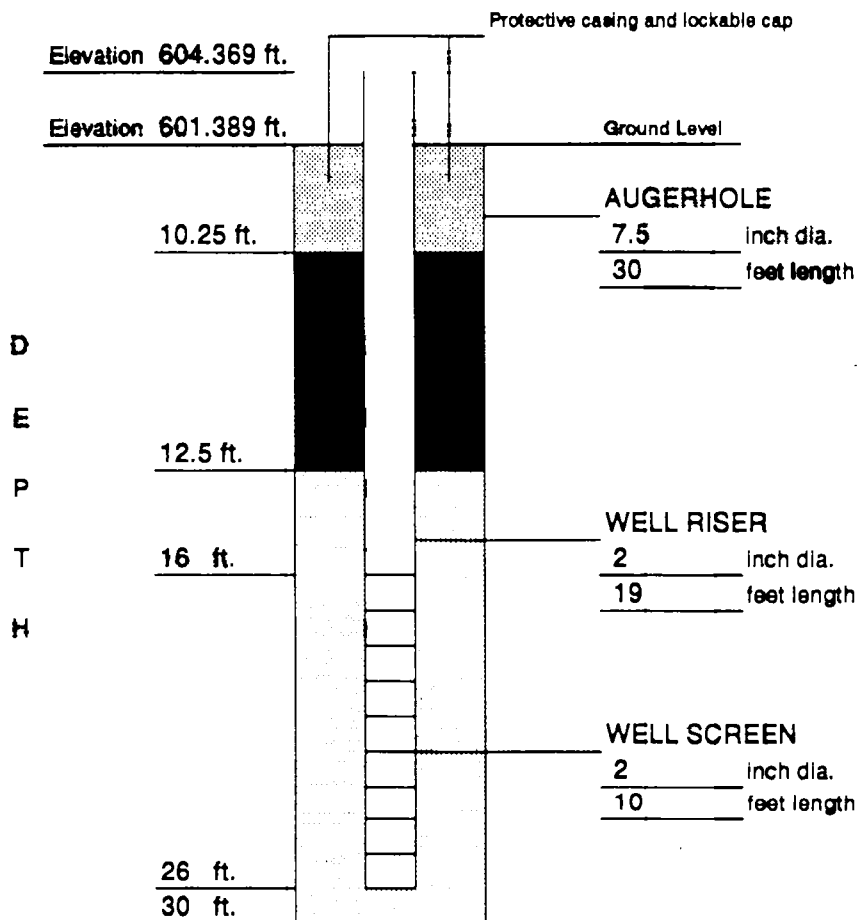
URS URS Consultants, Inc.
CONSULTING ENGINEERS
BUFFALO NEW YORK
JOB No. 35246

depth(ft.)	lithology
0-2'	Fill
2-16'	Dessicated Silty Clay
16-30'	Very Stiff Silty Clay
30-32'	Soft Silty Clay

CASING MATERIAL		SCREEN MATERIAL		SEAL MATERIAL	
Surface: Steel		Type: Stainless Steel Type 304		Seal #1 Type: Bentonite Pellets Setting: 10.25 - 12.5 ft.	
Monitor: Stainless Steel		Slot Size: .010 in.		Seal #2 Type: None Setting:	
FILTER MATERIAL		ROCK CORING		LEGEND	
Type: #2 Q Rok		Cored Interval: None

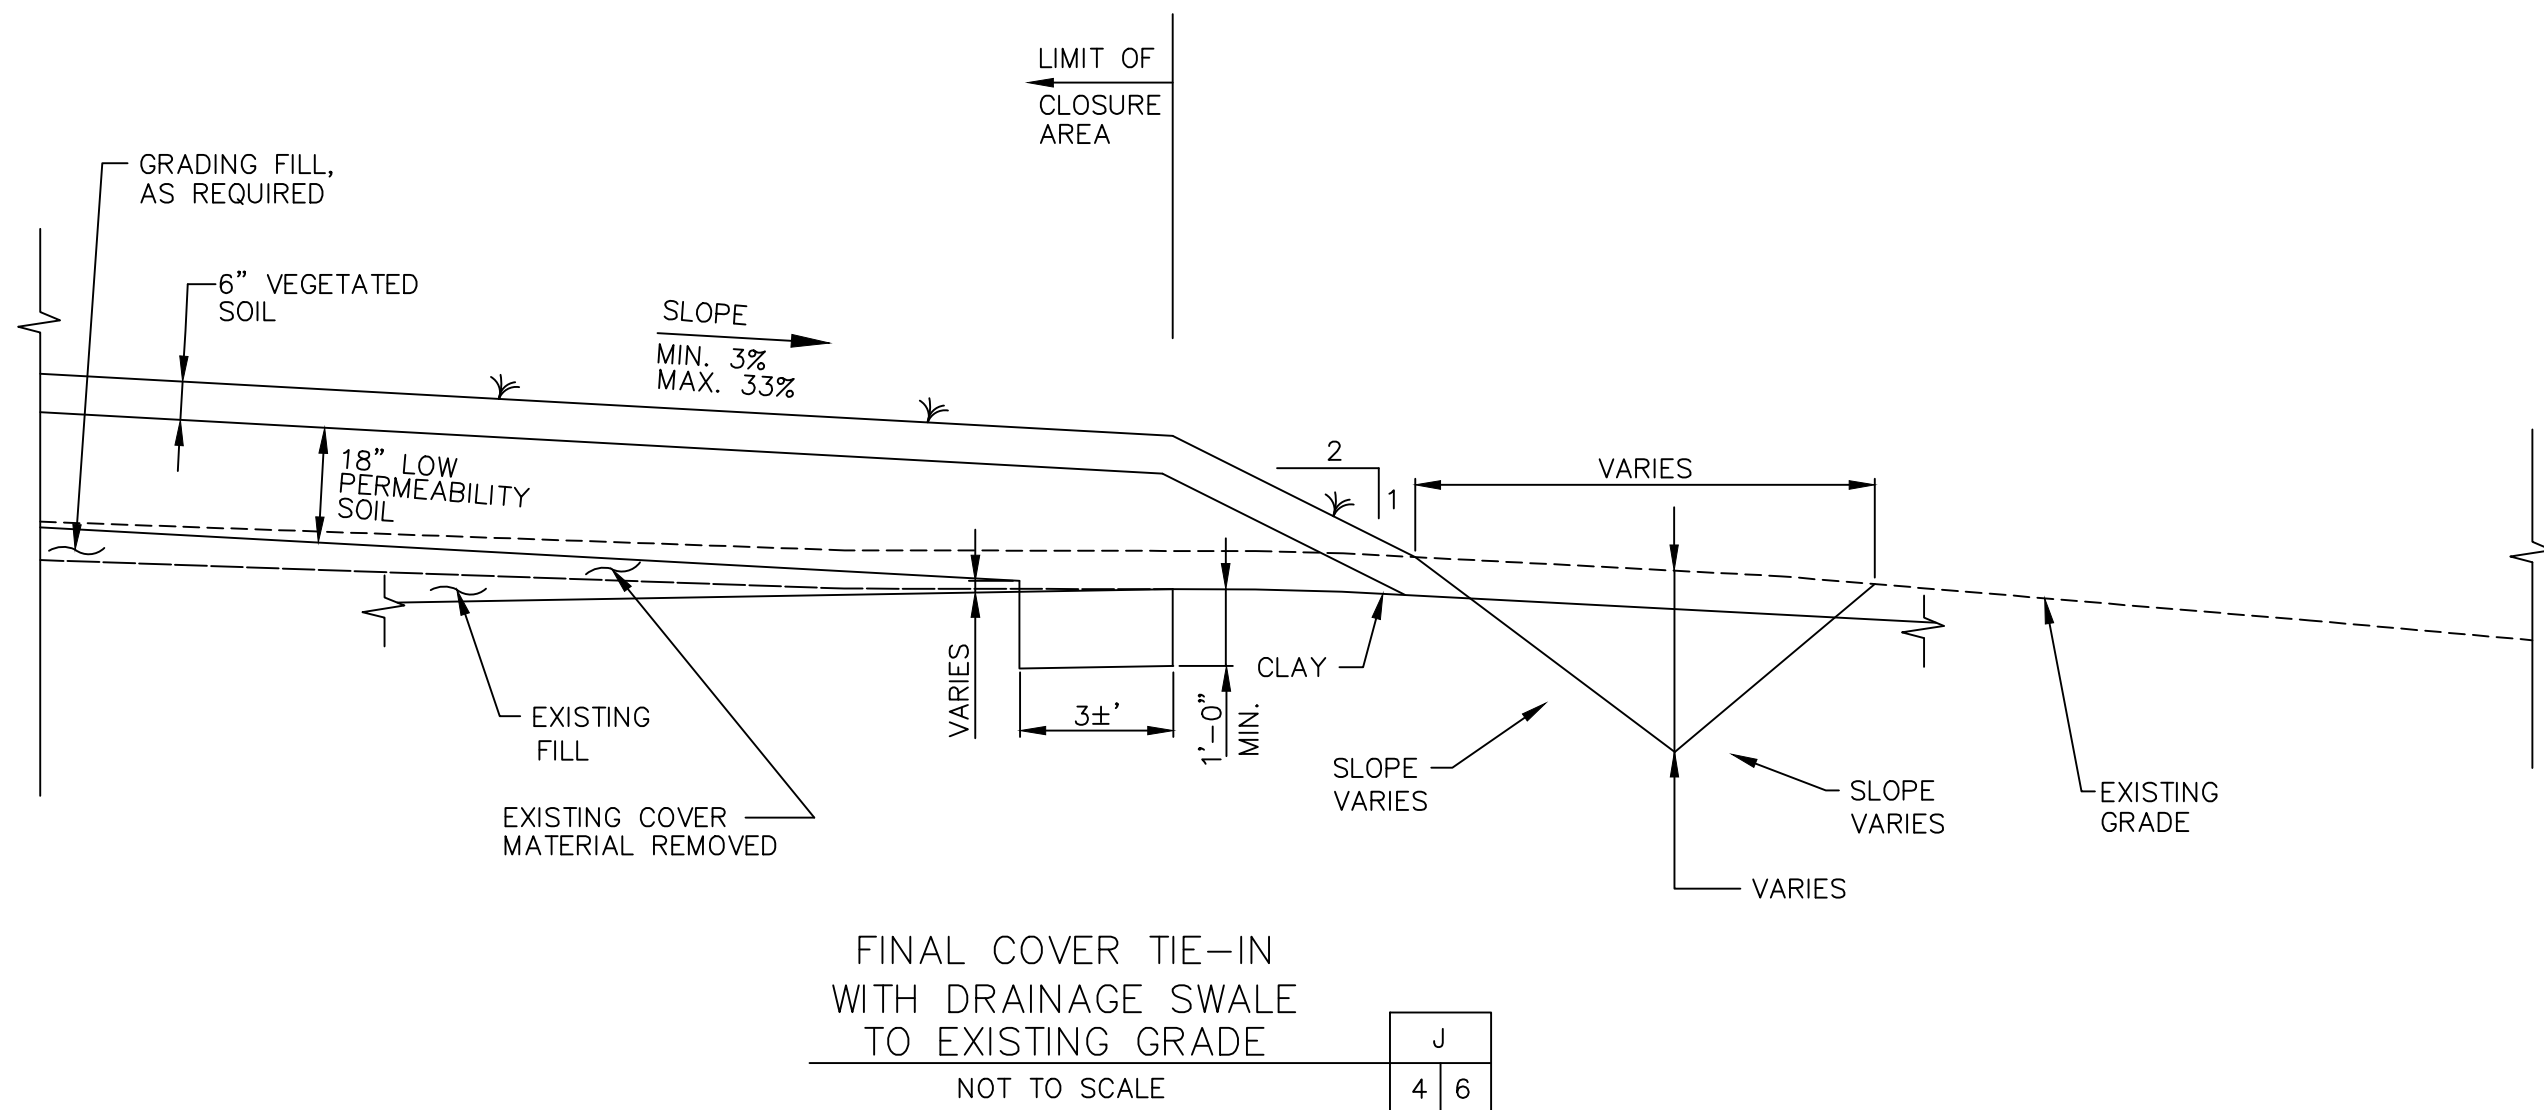
J
4 6

FINAL COVER TIE-IN
WITH DRAINAGE SWALE
TO EXISTING GRADE
NOT TO SCALE

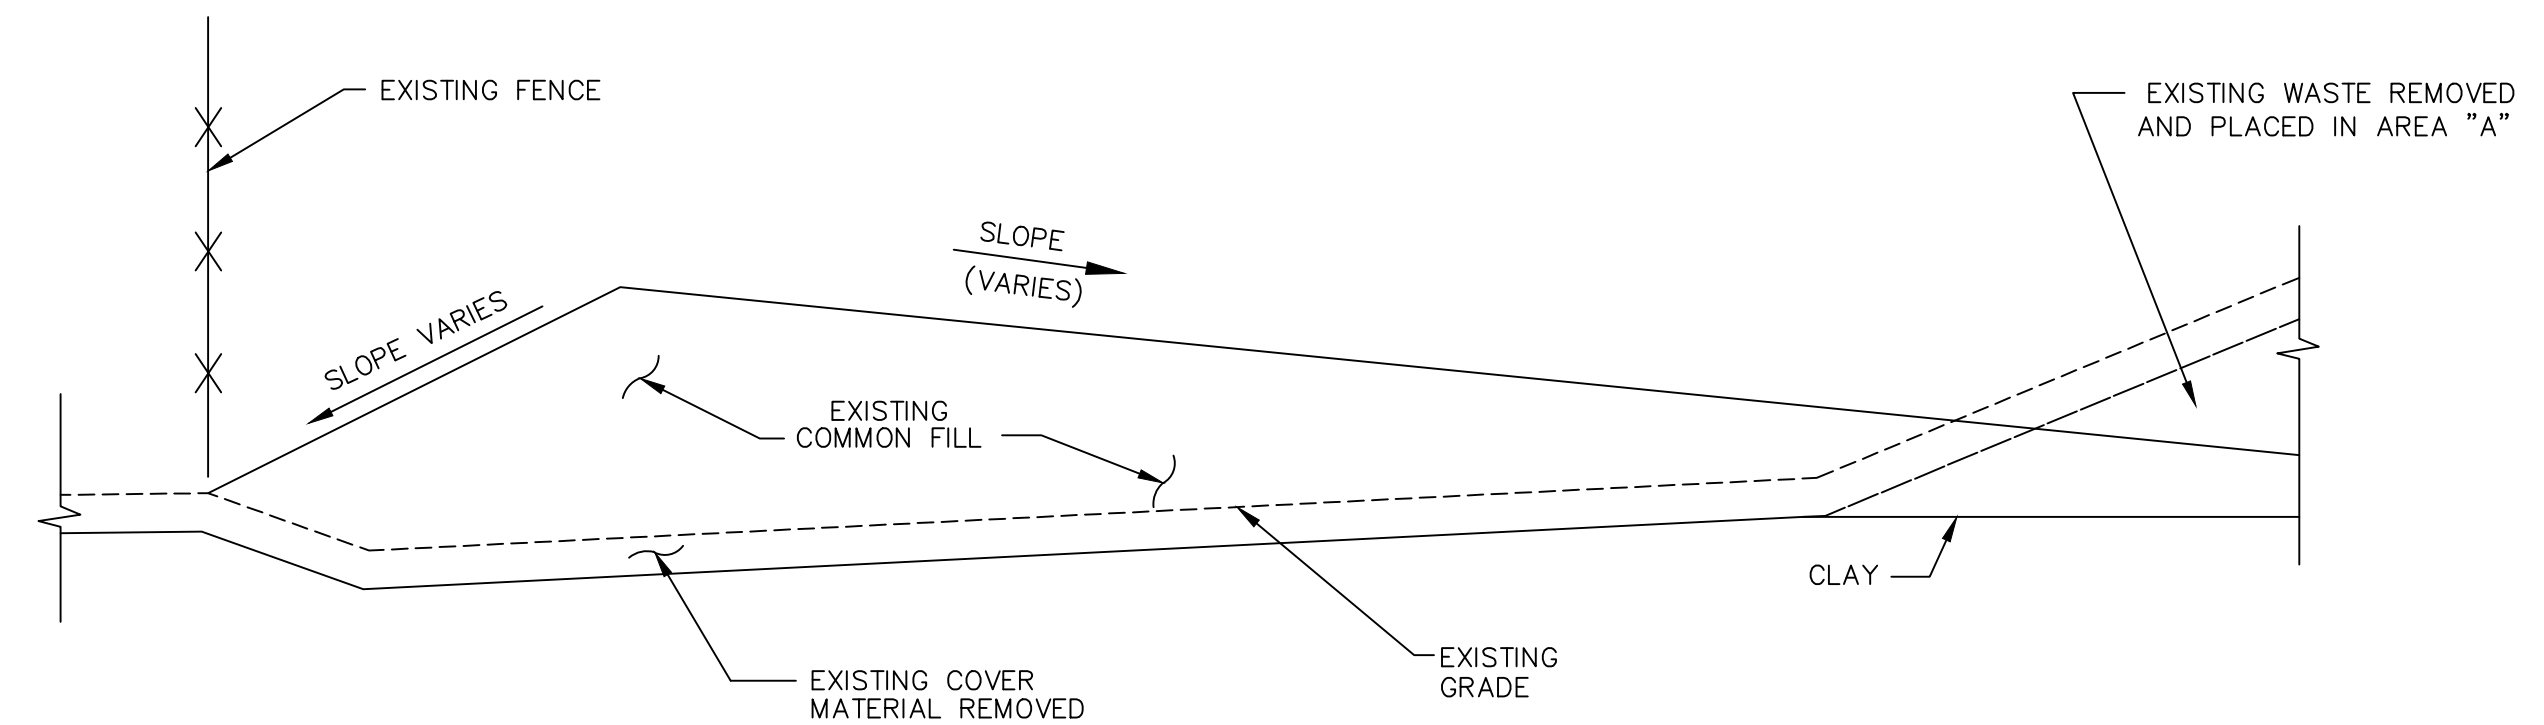
M
3 6

BERM, NORTHERN AREA "A"
ALONG EXISTING FENCE
SCALE: 1/2"=1'-0"

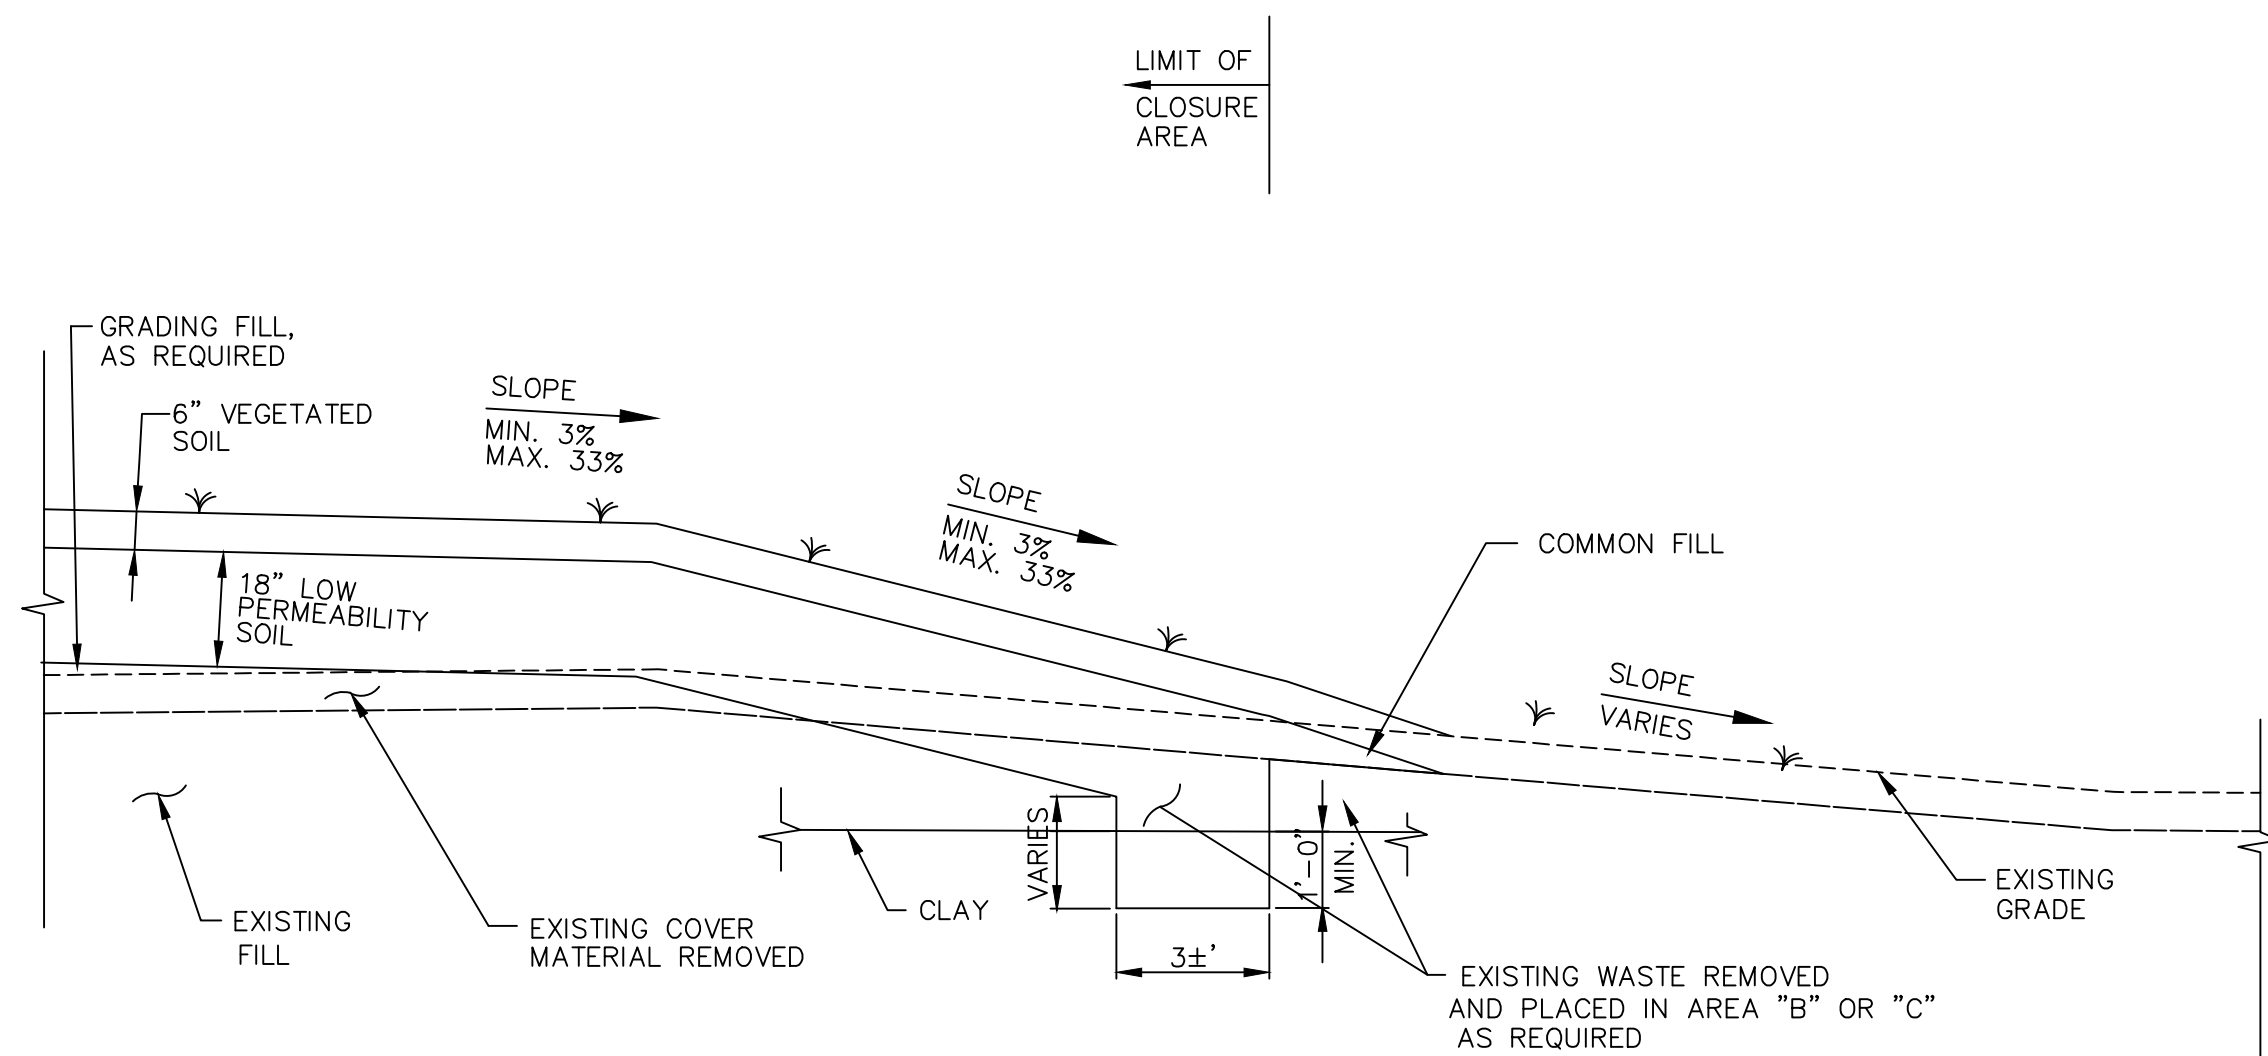
K
3 6

FINAL COVER TIE-IN
AREA "B" AND "C" AT FENCE
TO EXISTING GRADE
NOT TO SCALE

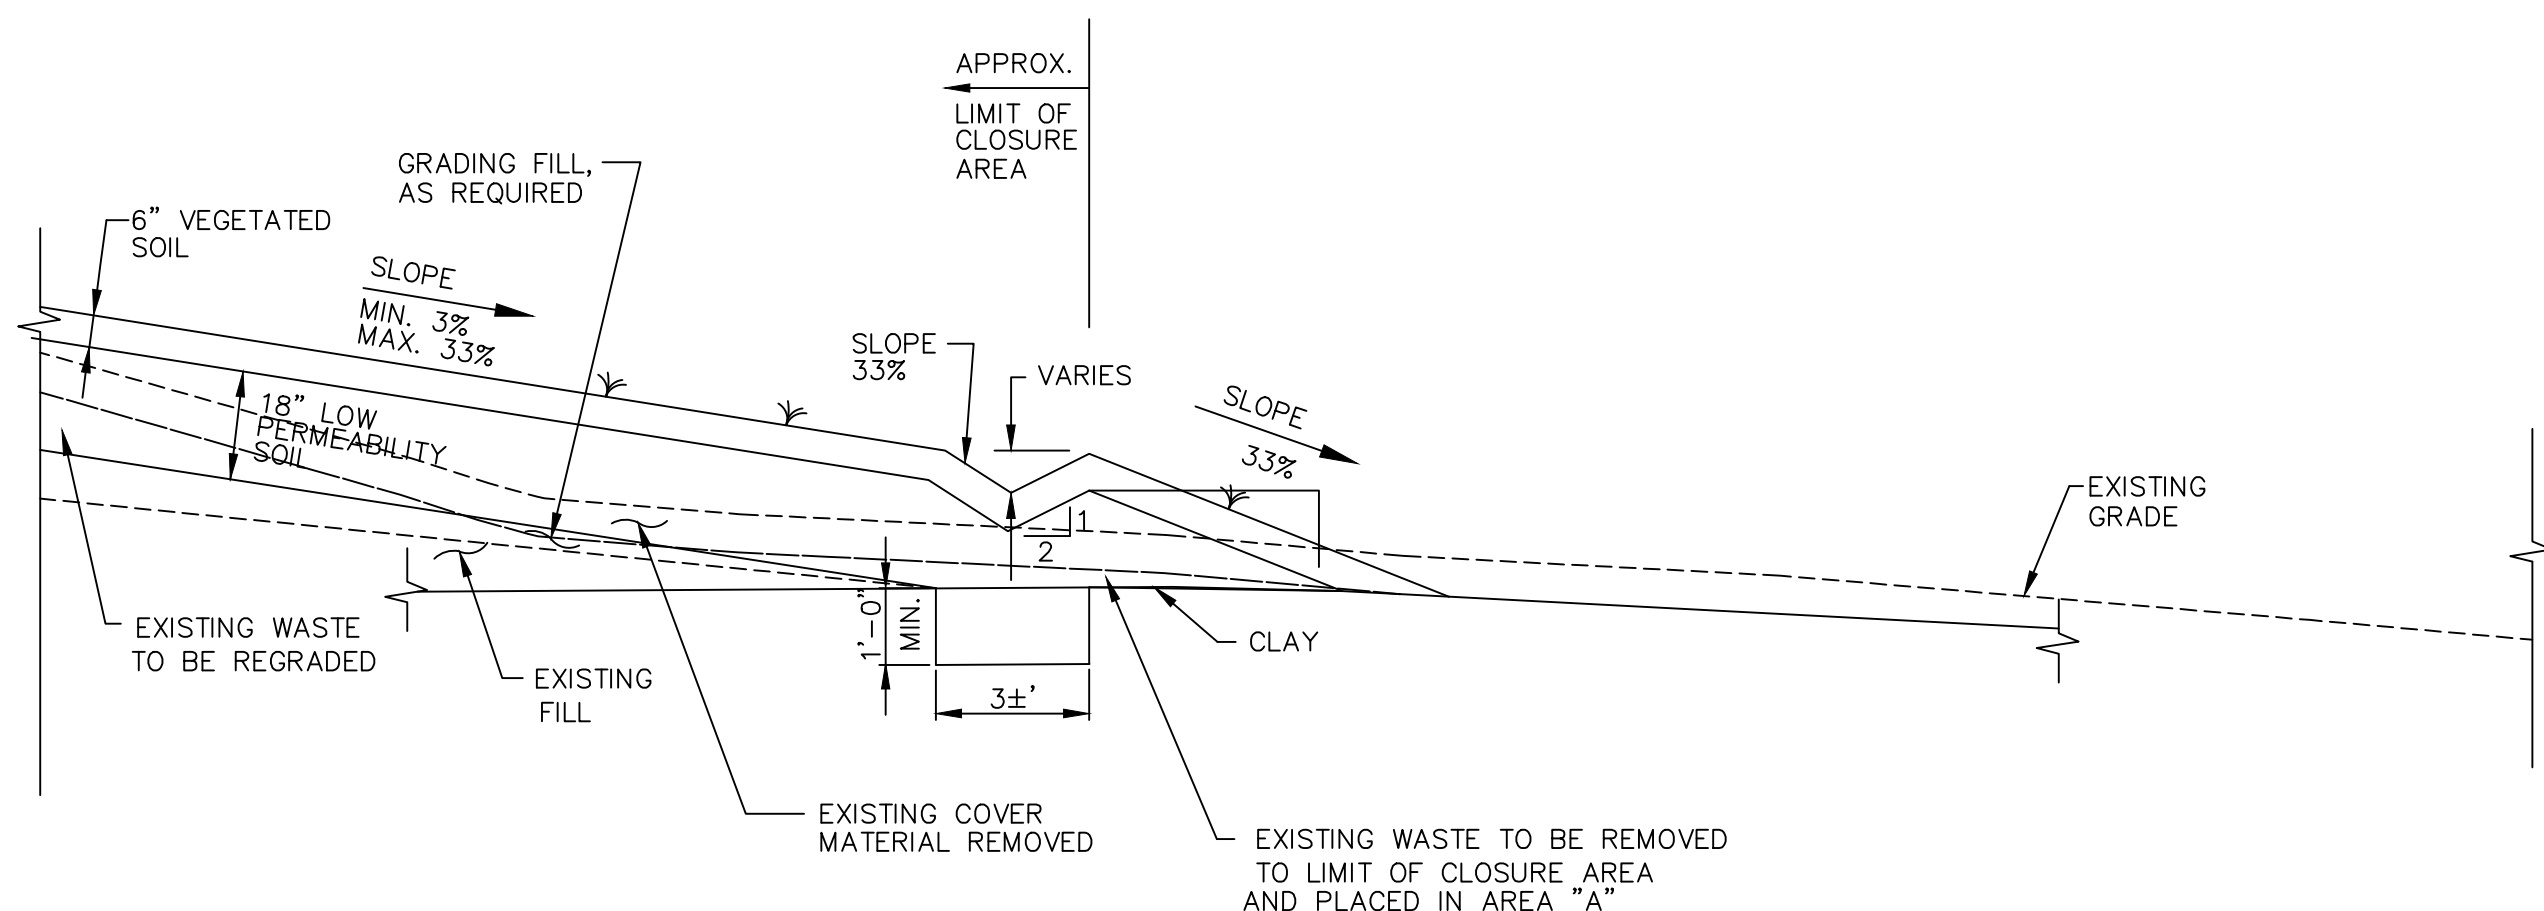
L
3 6

FINAL COVER TIE-IN
WITH DRAINAGE SWALE
NOT TO SCALE

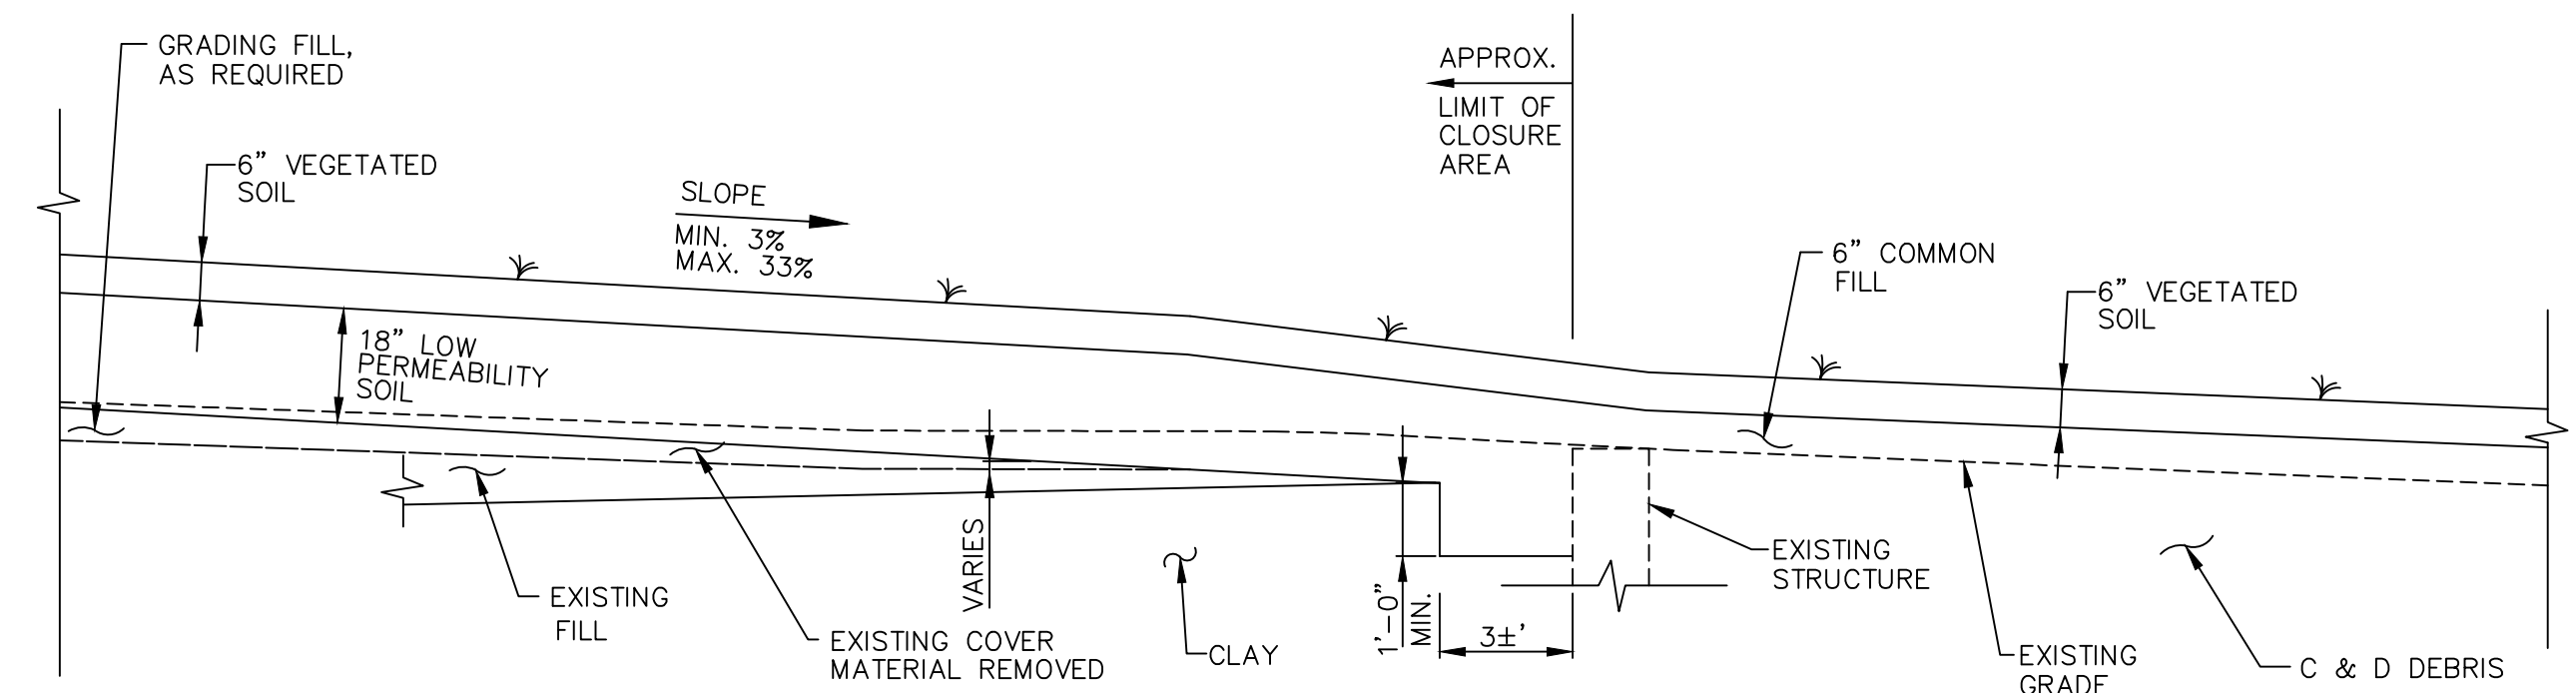
P
3 6

FINAL COVER TIE-IN
TO C & D AREA
NOT TO SCALE

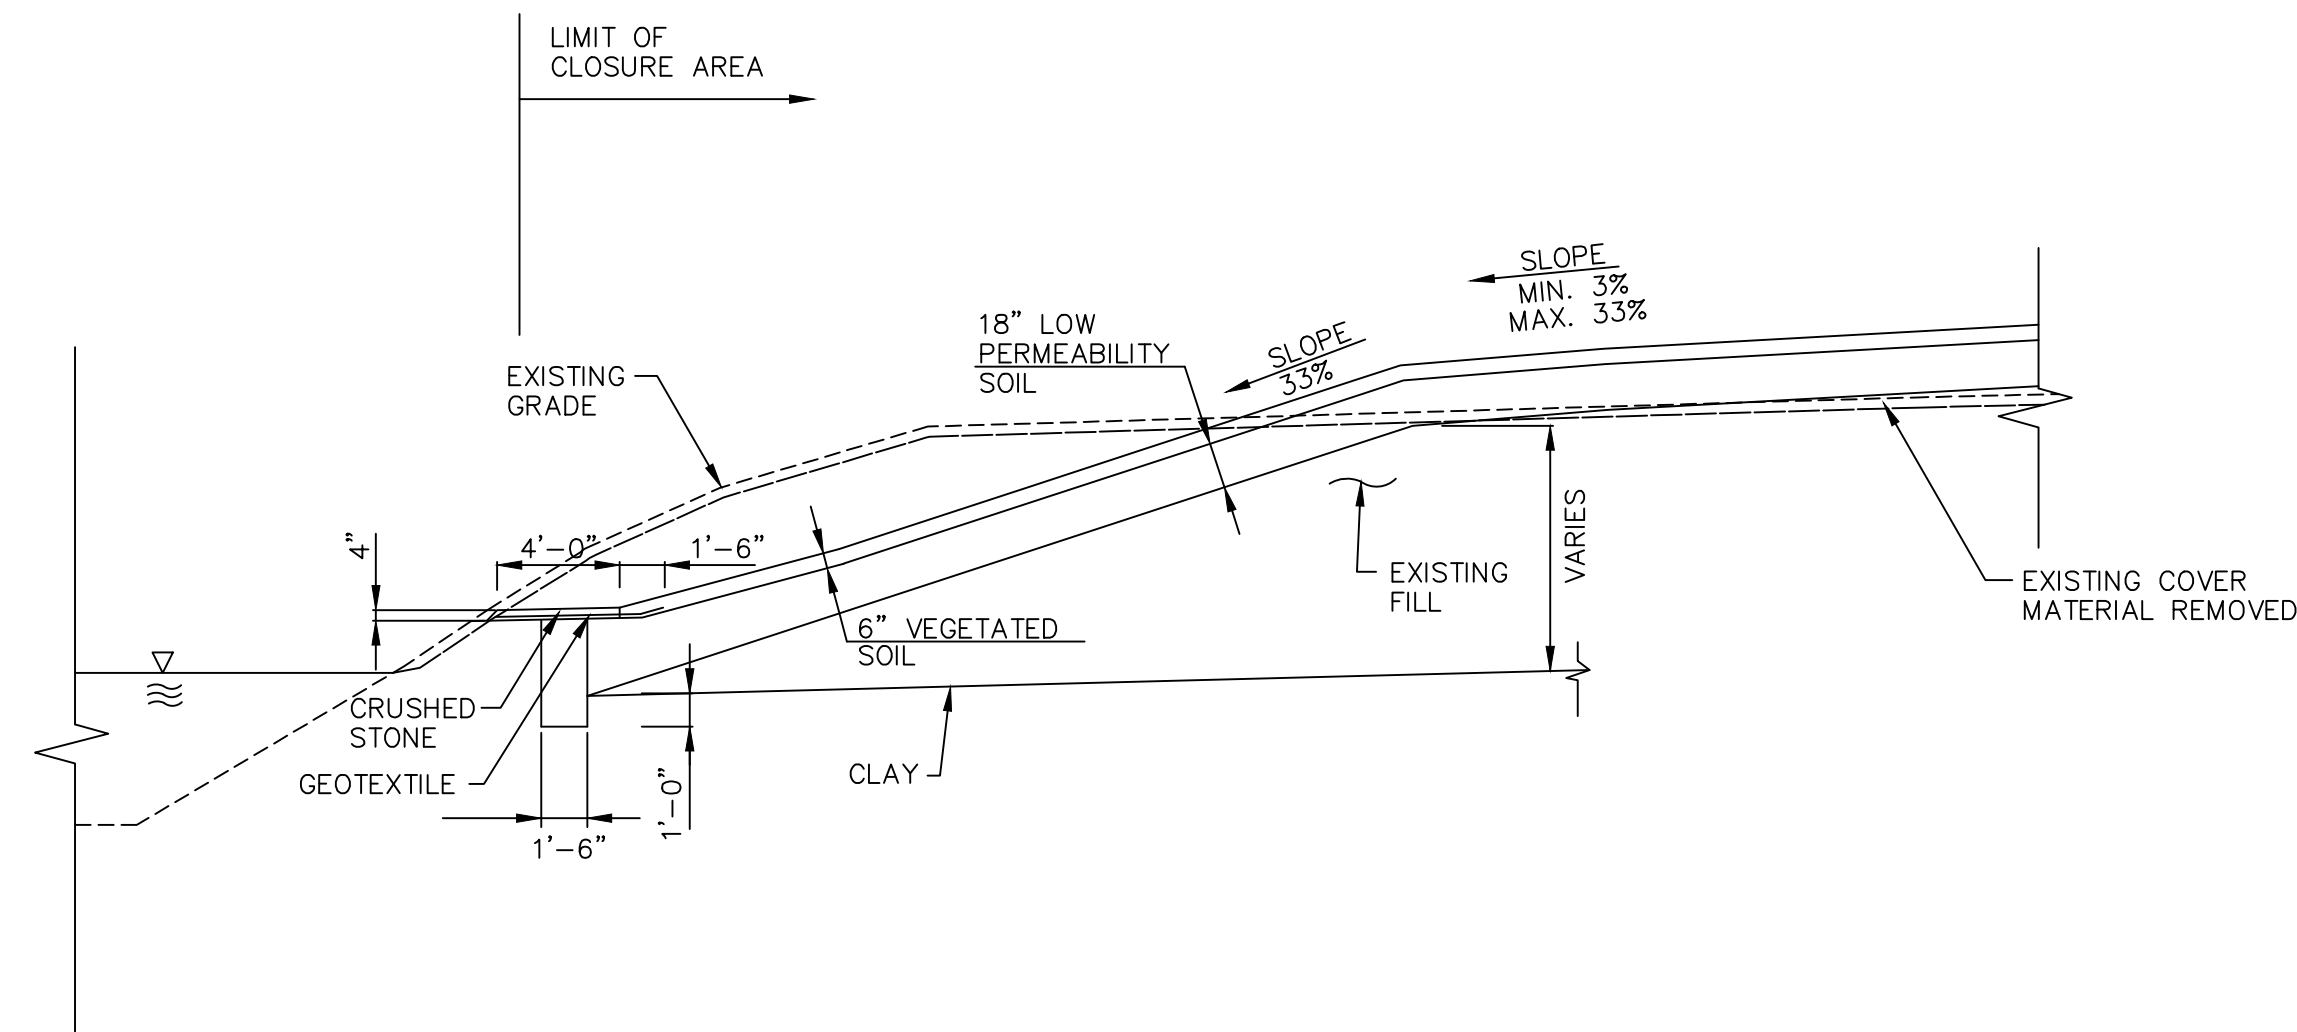
Q
3 7

FINAL COVER TIE-IN
AT CREEK

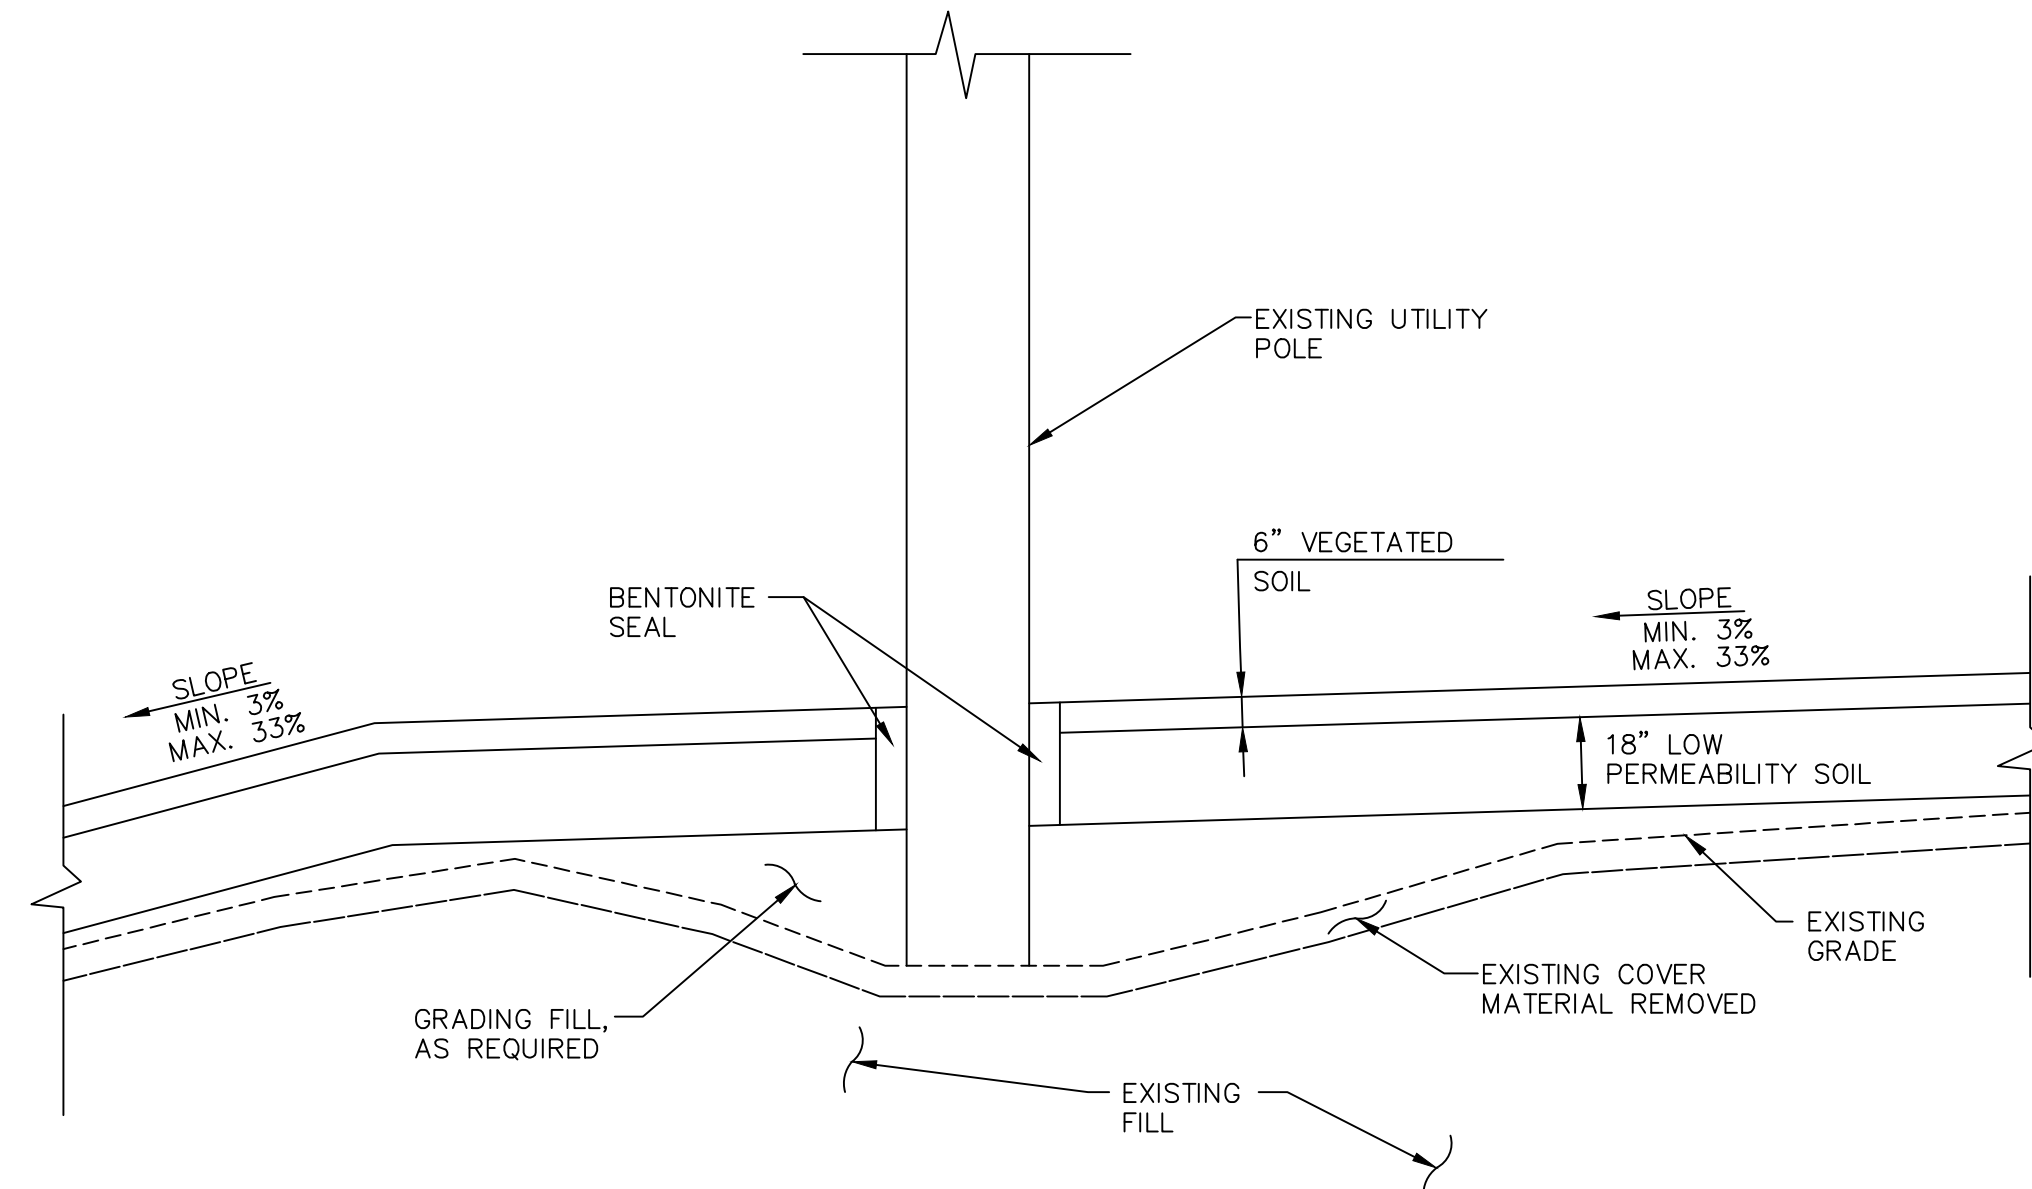
R
4 7

FINAL COVER TIE-IN
AT UTILITY POLE
(TYPICAL AT 4 POLES)

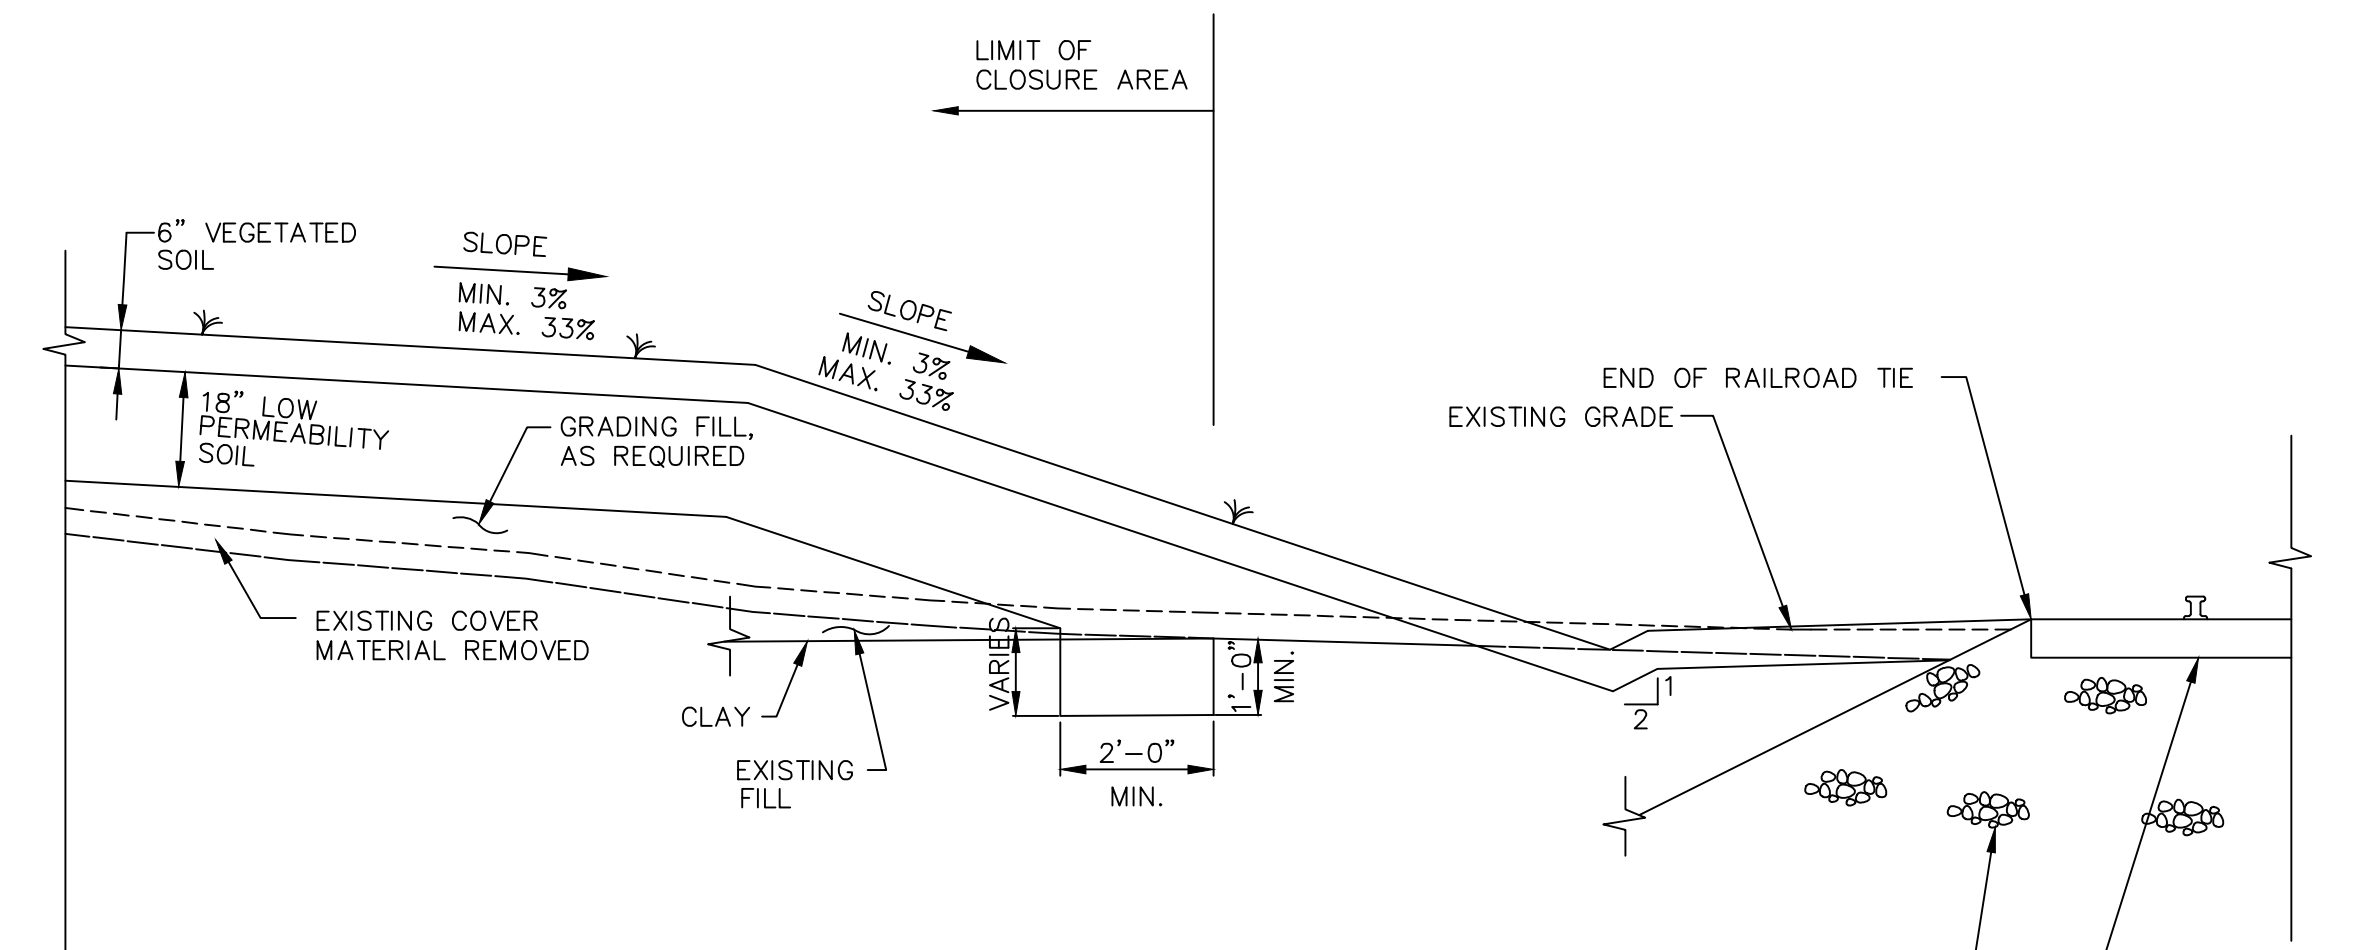
T
4 7

FINAL COVER TIE-IN
TO AREAS ADJACENT TO
RAILROAD TRACKS WITH
DRAINAGE SWALE OUTSIDE
LIMIT OF CLOSURE
