Site Management Plan

Dunlop Tire and Rubber Site
(Currently owned by
Sumitomo Rubber USA, LLC)
Tonawanda, Erie County, New York

NYSDEC Site Number 915018

Revision 3: July 8, 2025

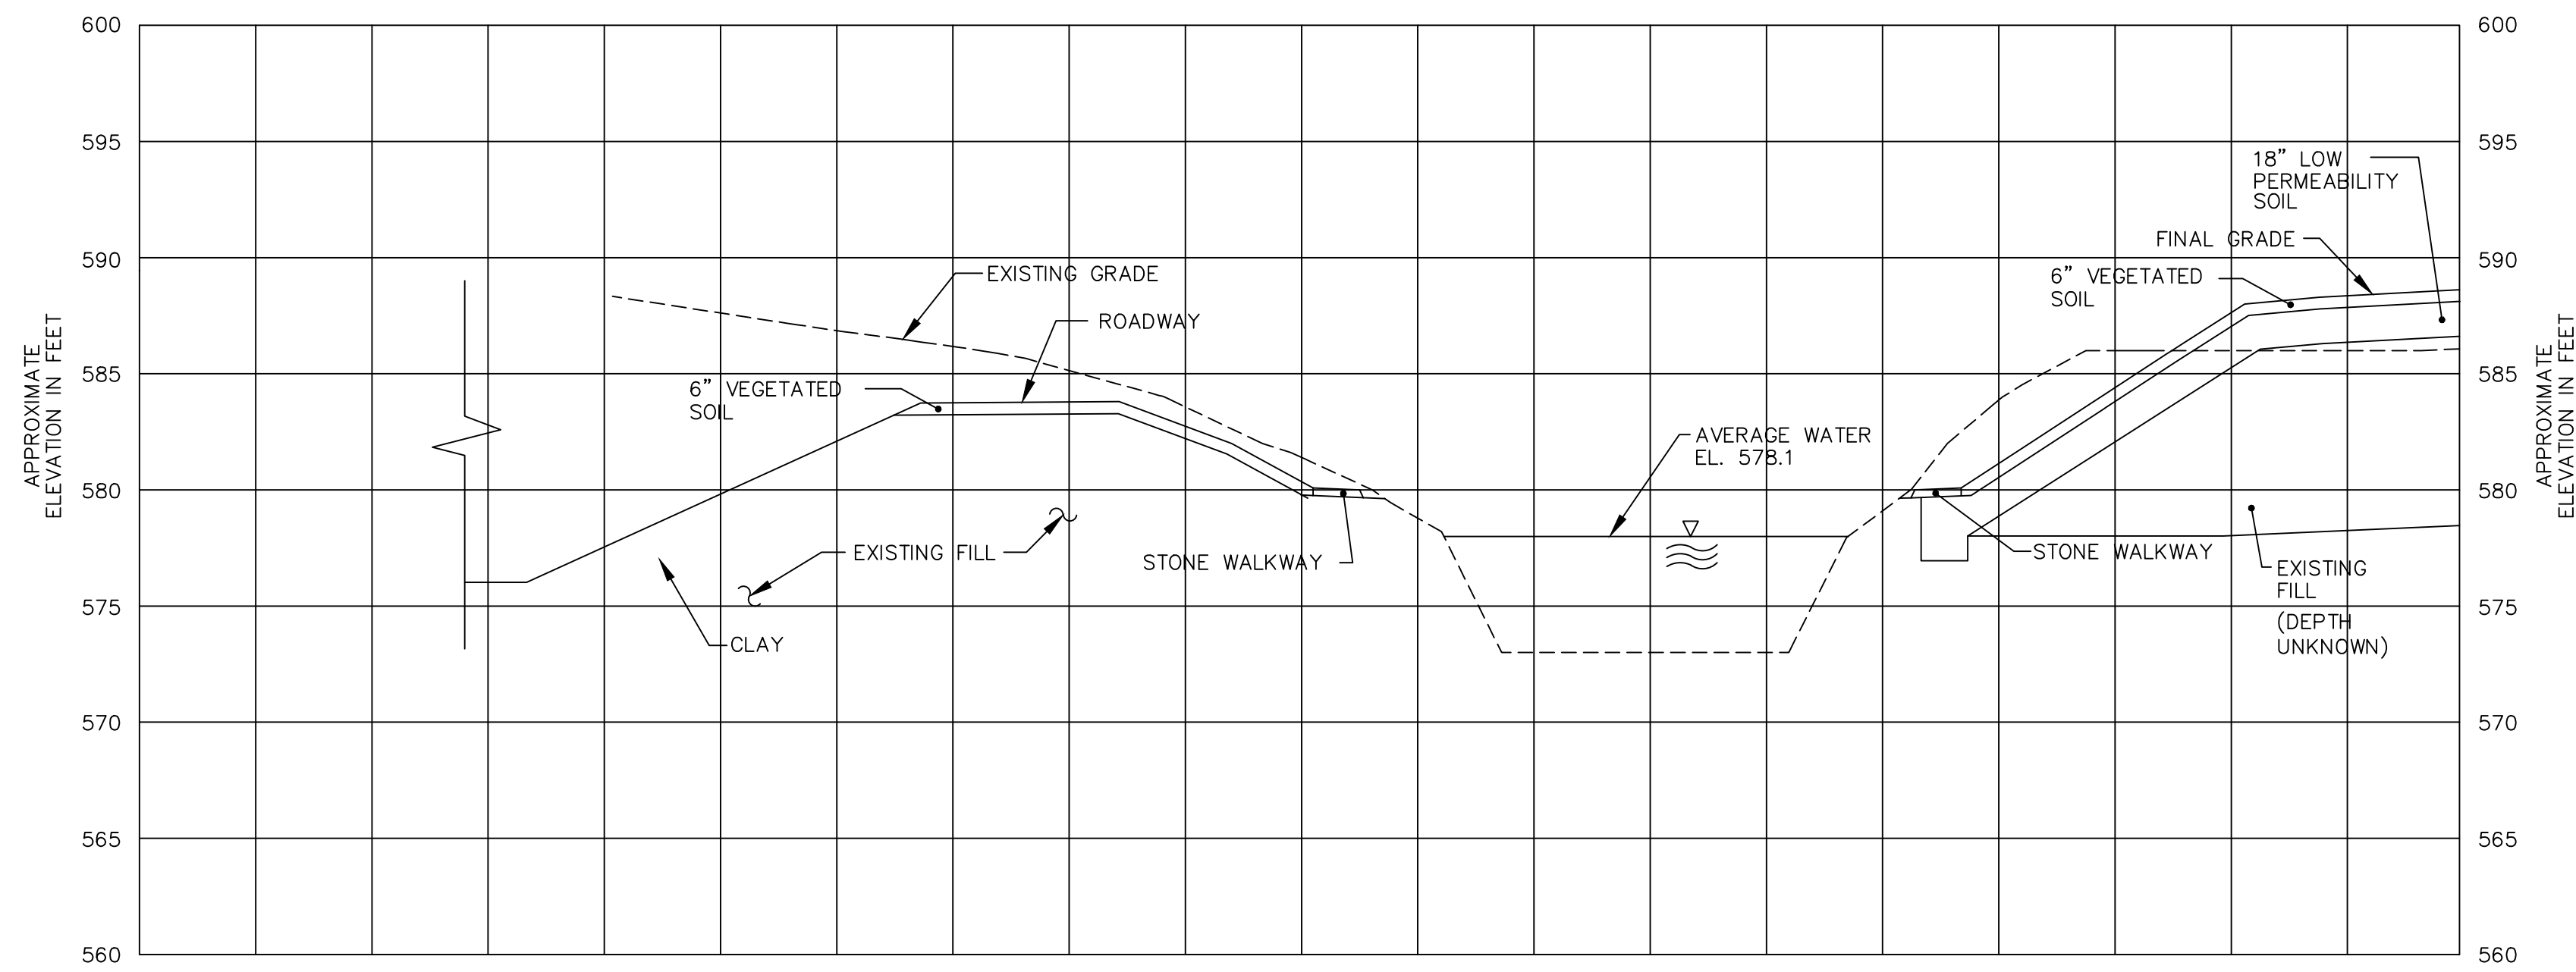
SECTION A-A
NOT TO SCALE

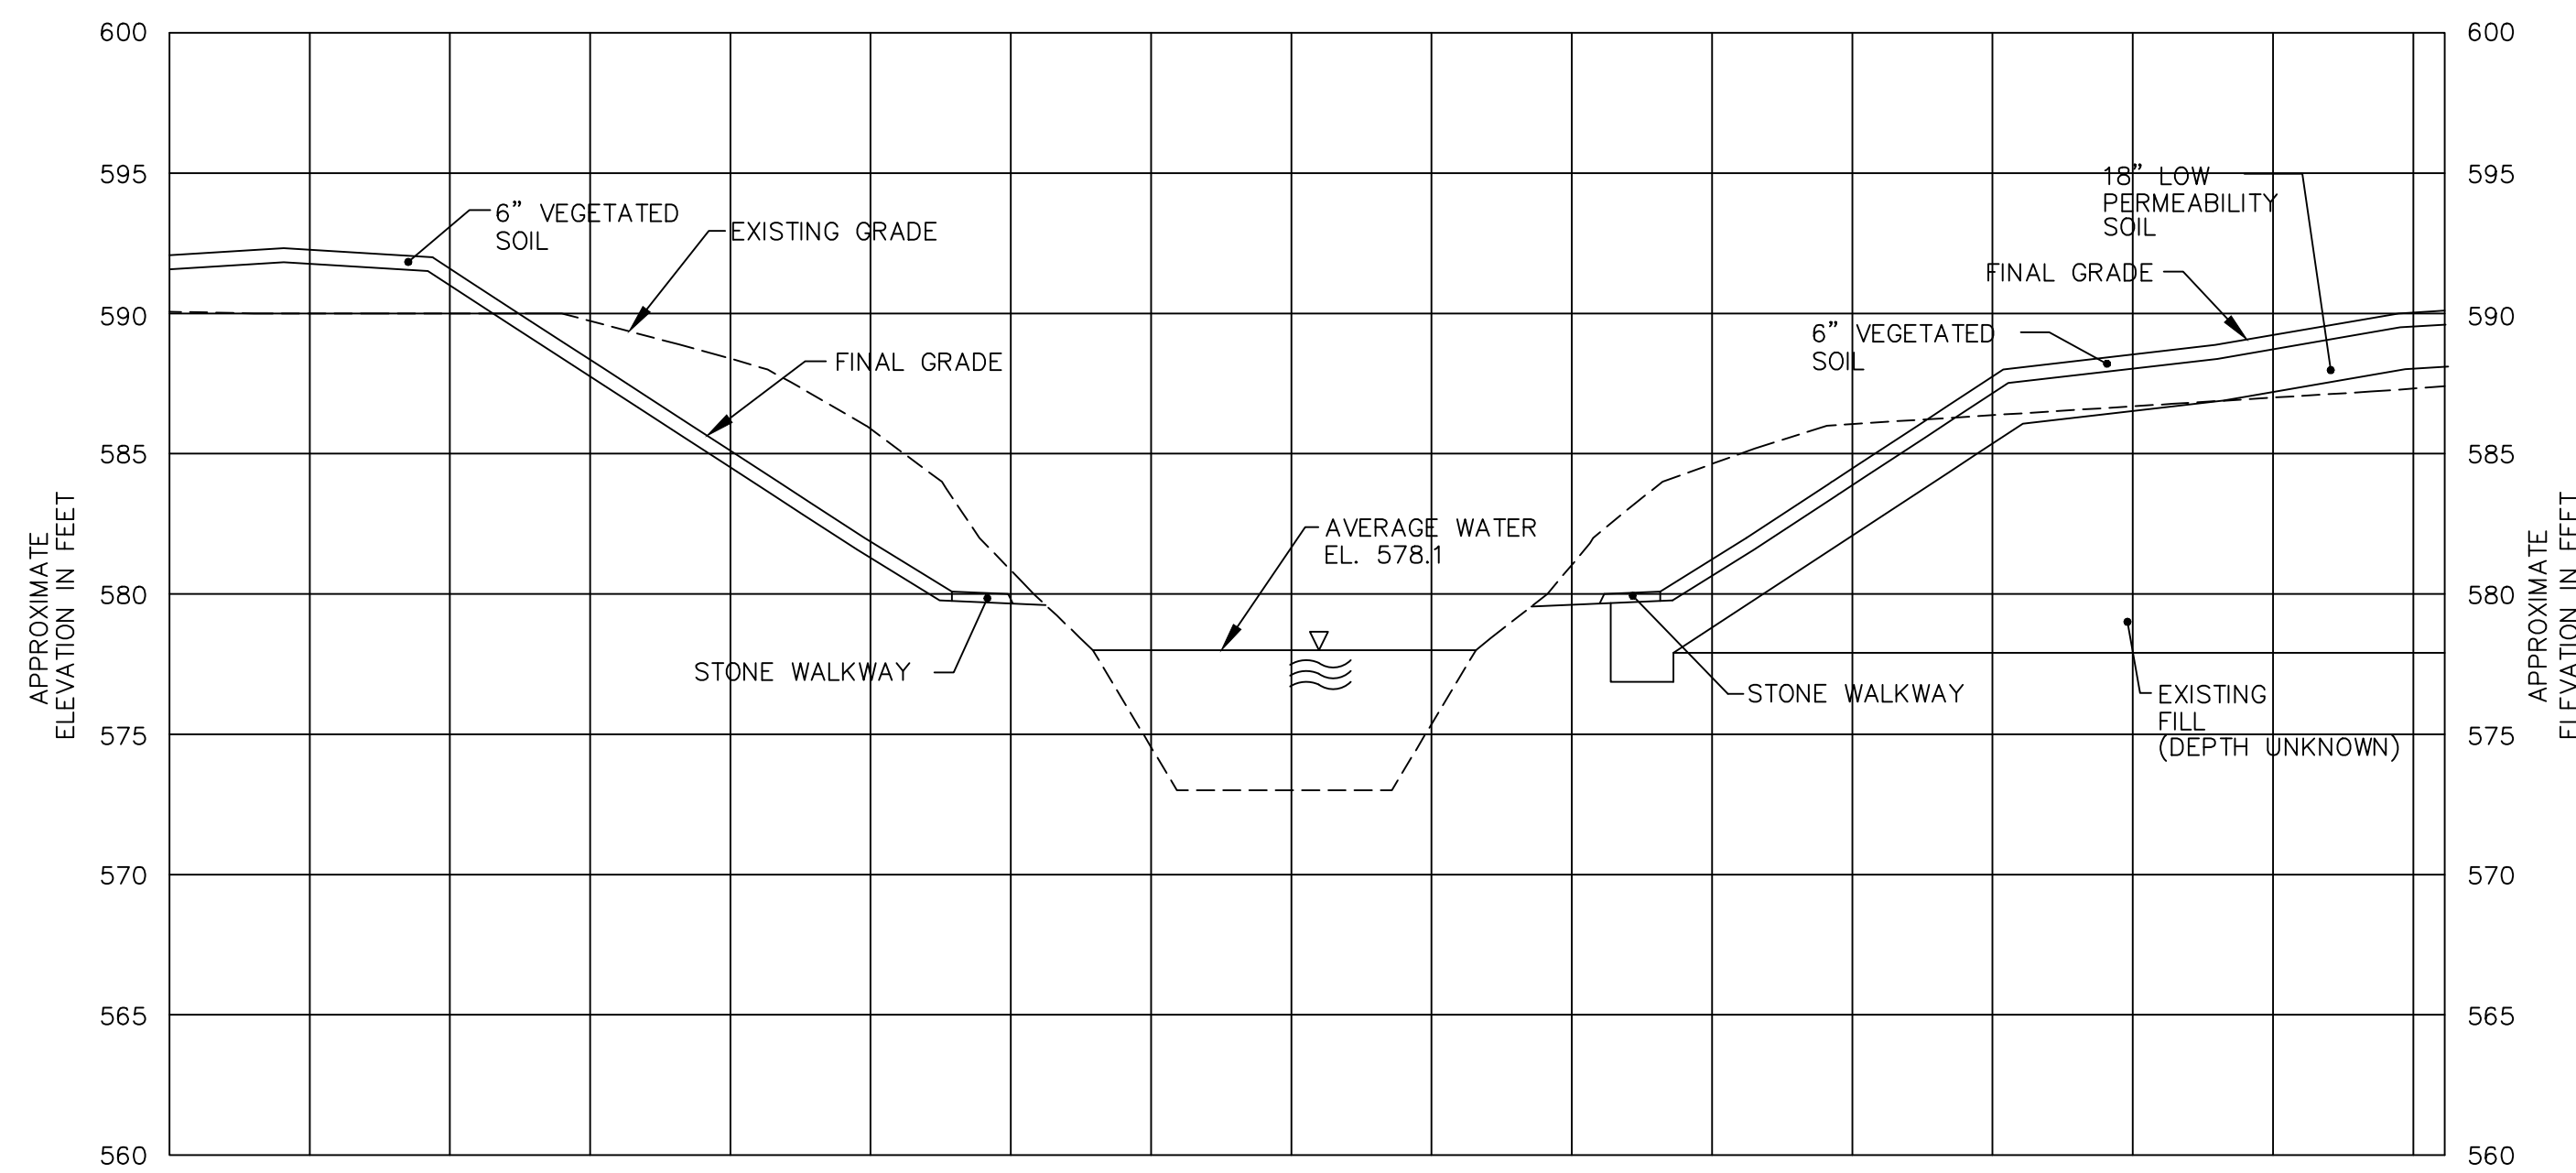
SECTION B-B
NOT TO SCALE

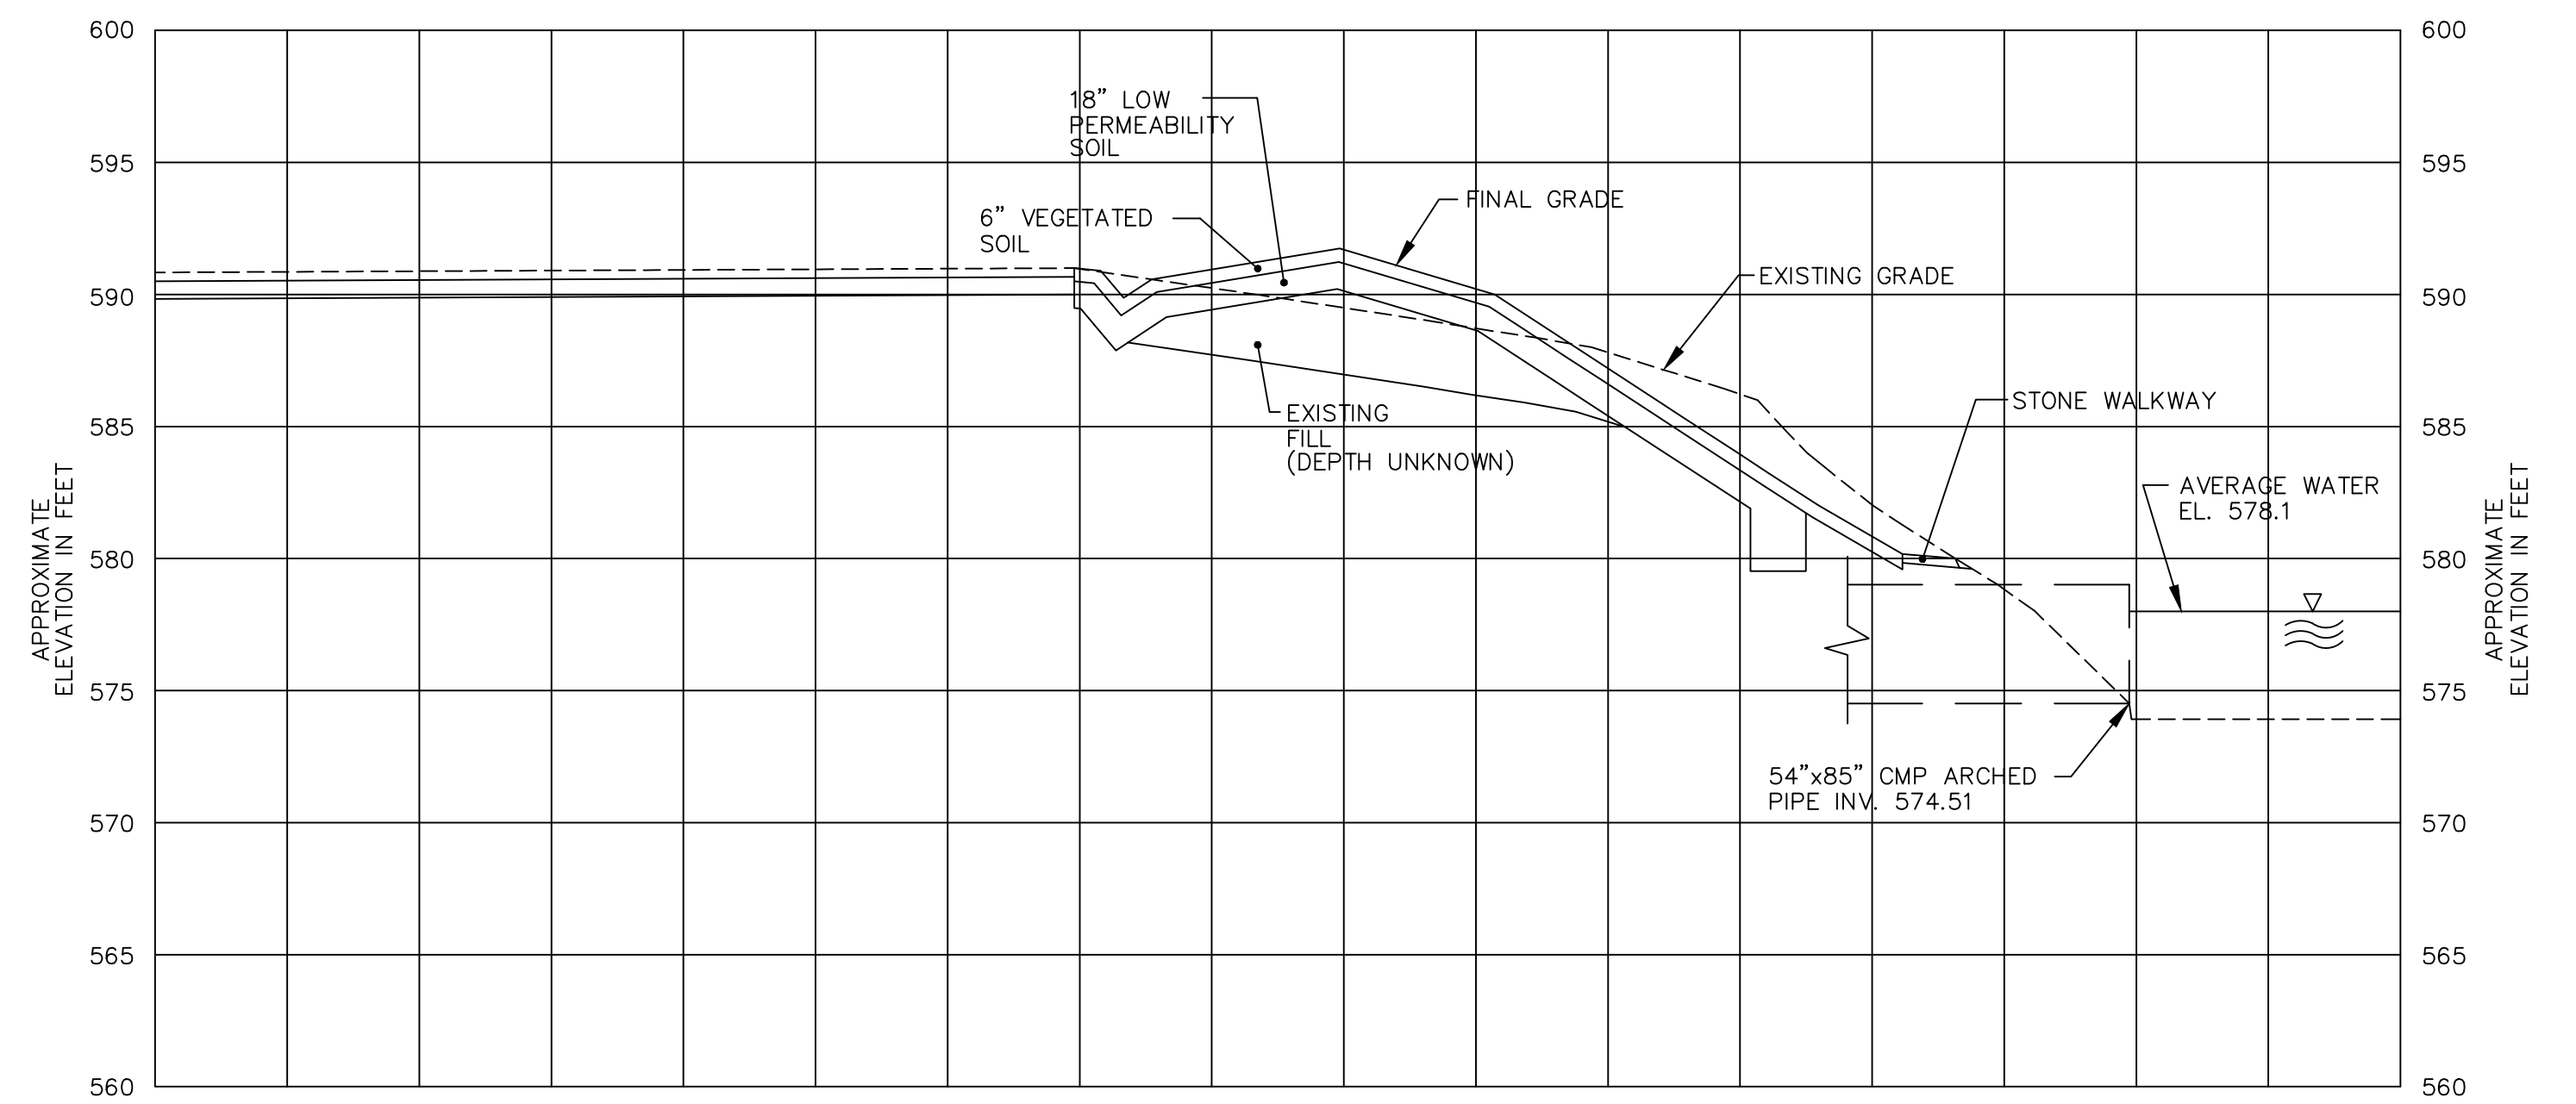
SECTION C-C
NOT TO SCALE

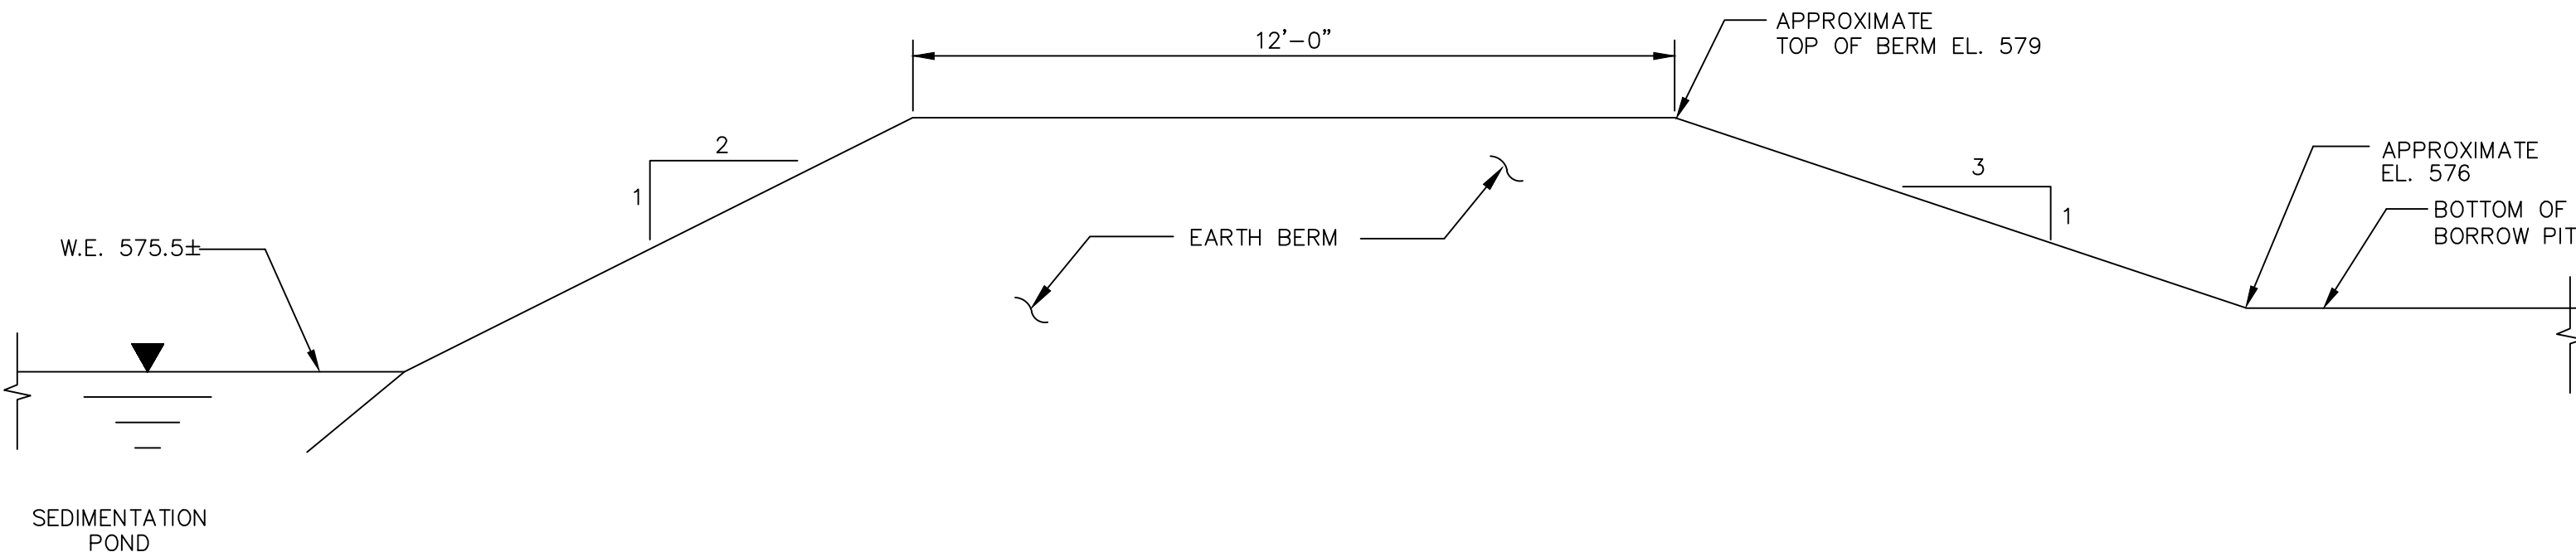
SECTION F-F
SCALE: 1/2"=1'-0"
F-F
12/12

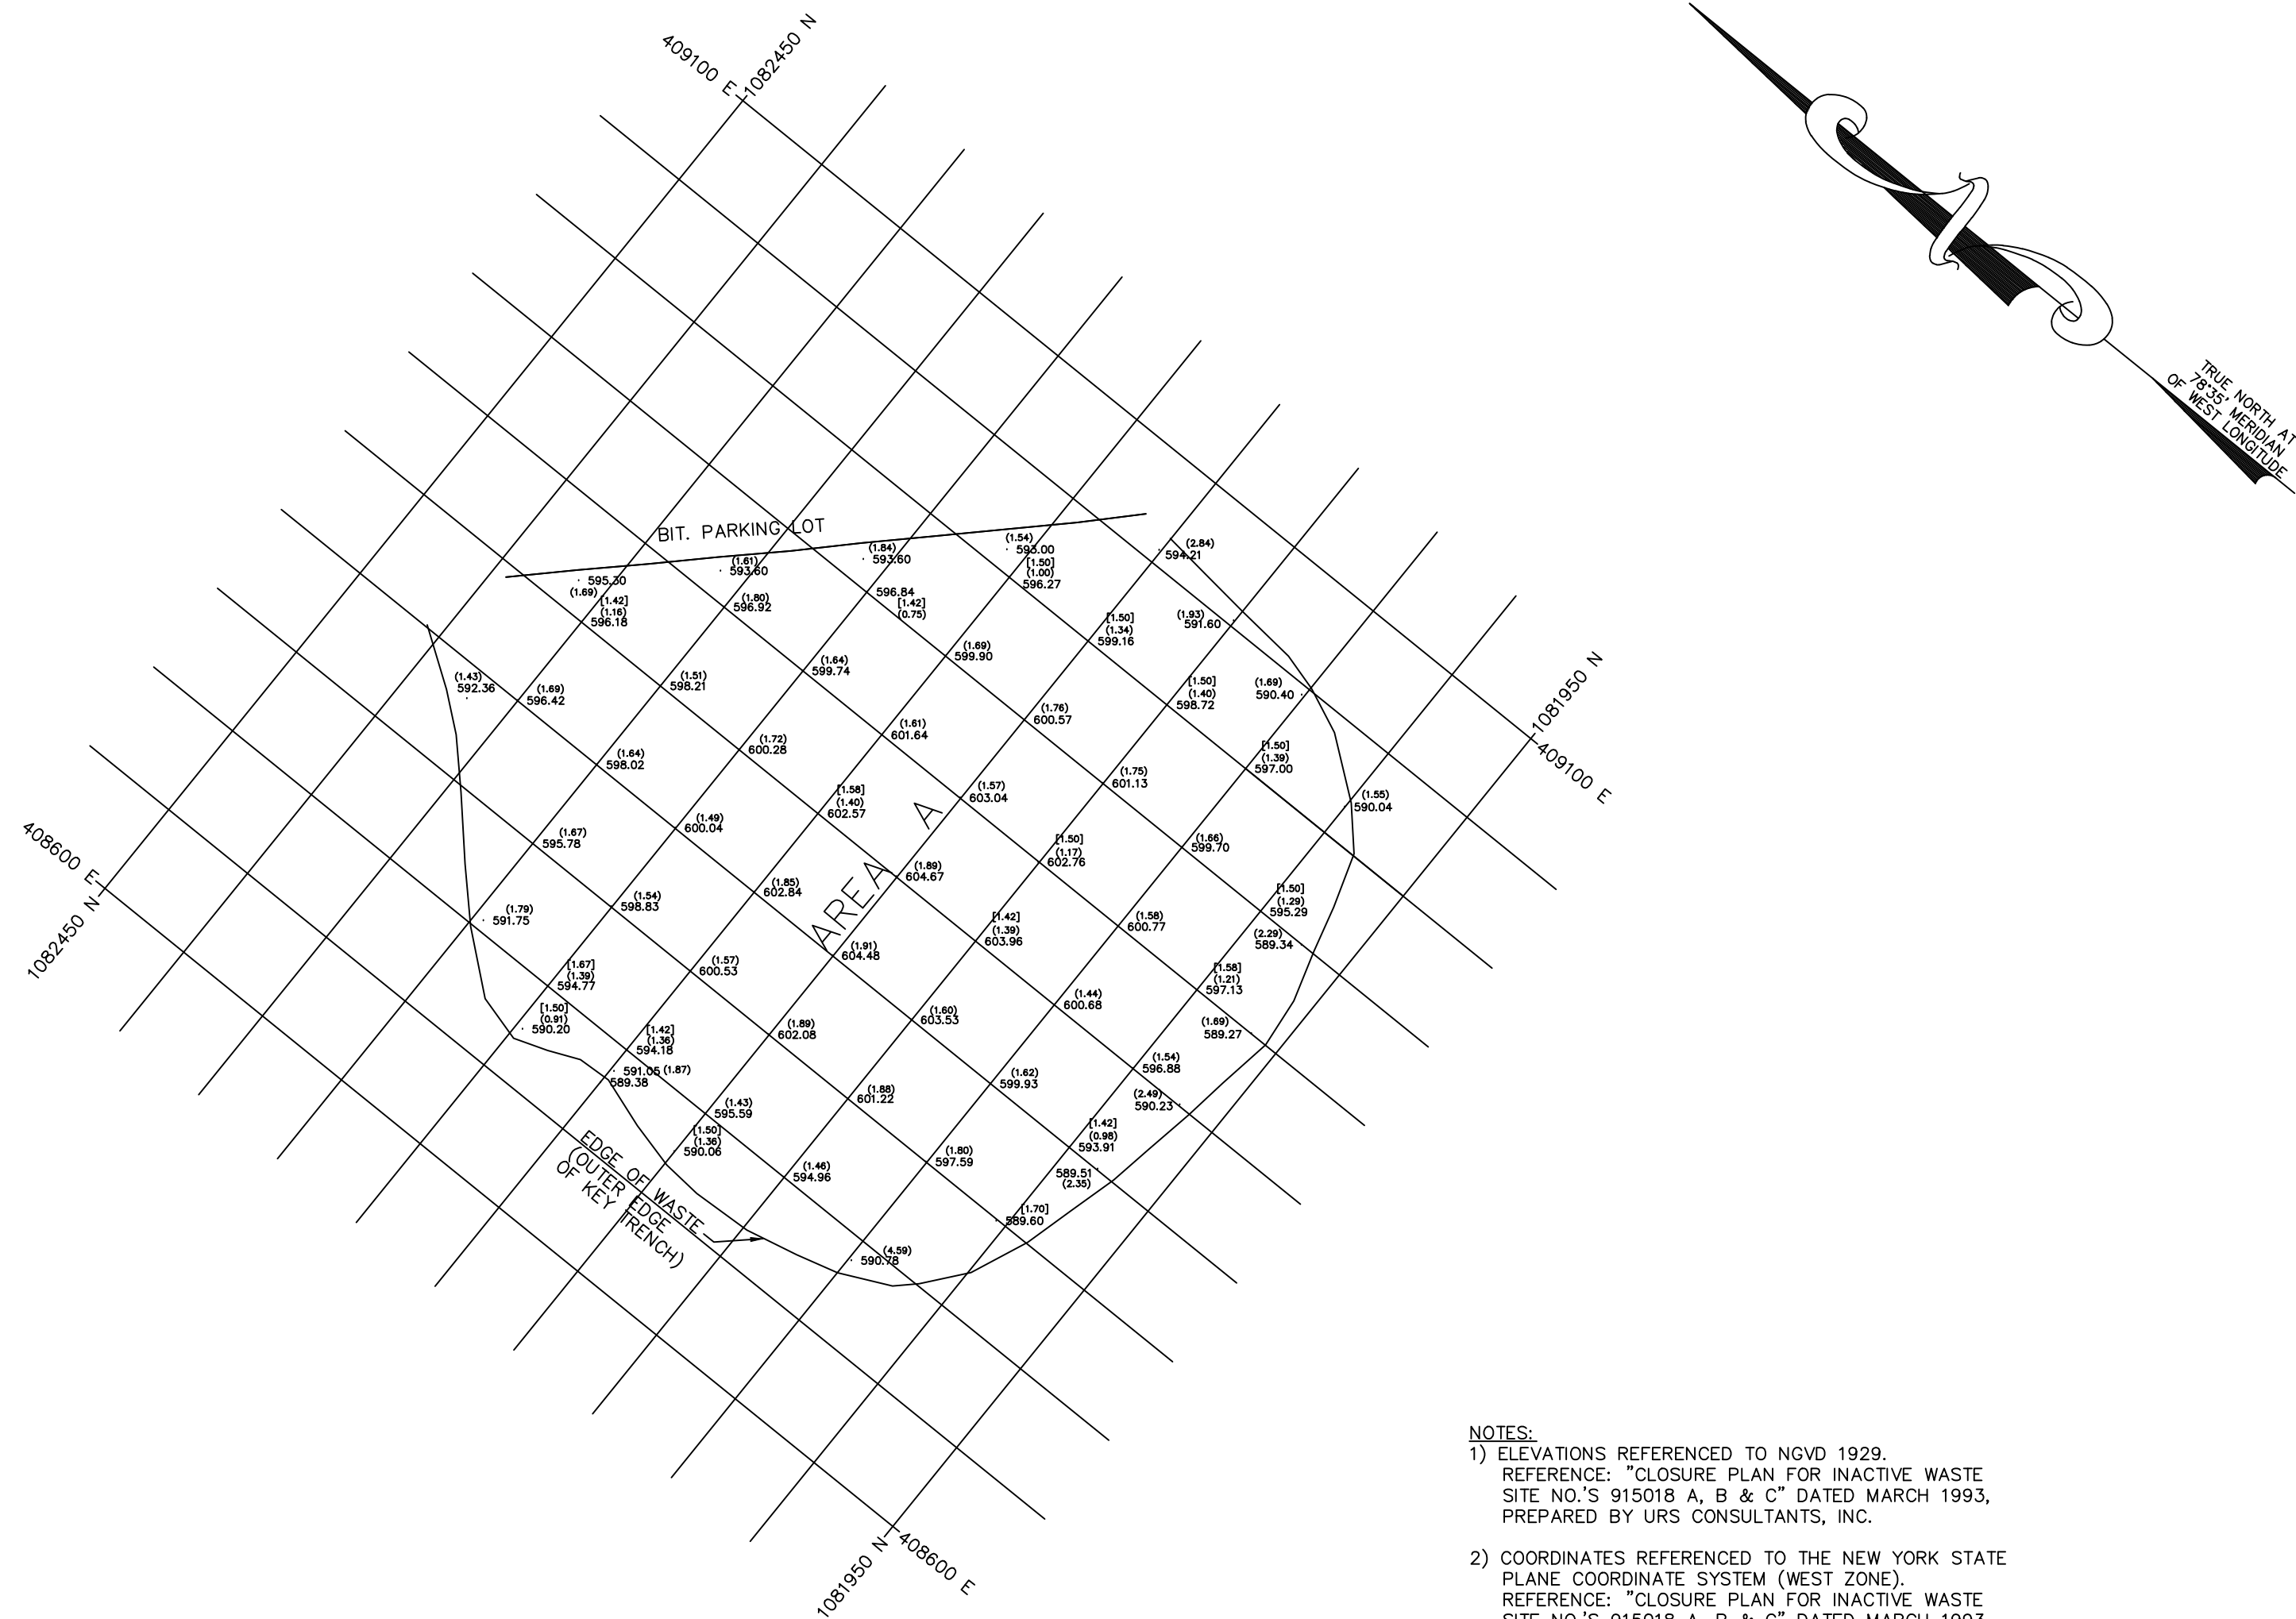
- NOTES:
- ELEVATIONS REFERENCED TO NGVD 1929.
REFERENCE: "CLOSURE PLAN FOR INACTIVE WASTE SITE NO. 915018 A, B & C" DATED MARCH 1993, PREPARED BY URS CONSULTANTS, INC.
 - COORDINATES REFERENCED TO THE NEW YORK STATE PLANE COORDINATE SYSTEM (WEST ZONE).
REFERENCE: "CLOSURE PLAN FOR INACTIVE WASTE SITE NO. 915018 A, B & C" DATED MARCH 1993, PREPARED BY URS CONSULTANTS, INC.
 - DATES OF SURVEY:
9/02/93
9/08/93
 - AUGER DATES:
9/12/93
9/13/93
9/22/93
10/13/93

- LEGEND:
- [] - CONFIRMED LPS LAYER THICKNESS. DAMES & MOORE AND URS VERIFIED LPS LAYER BY DRILLING A HAND AUGERED CORE IN THE AREA IN QUESTION (SEE FIELD VERIFICATION DATA SHEETS).
 - () - LAYER THICKNESS DERIVED FROM SURVEY DATA POINTS.

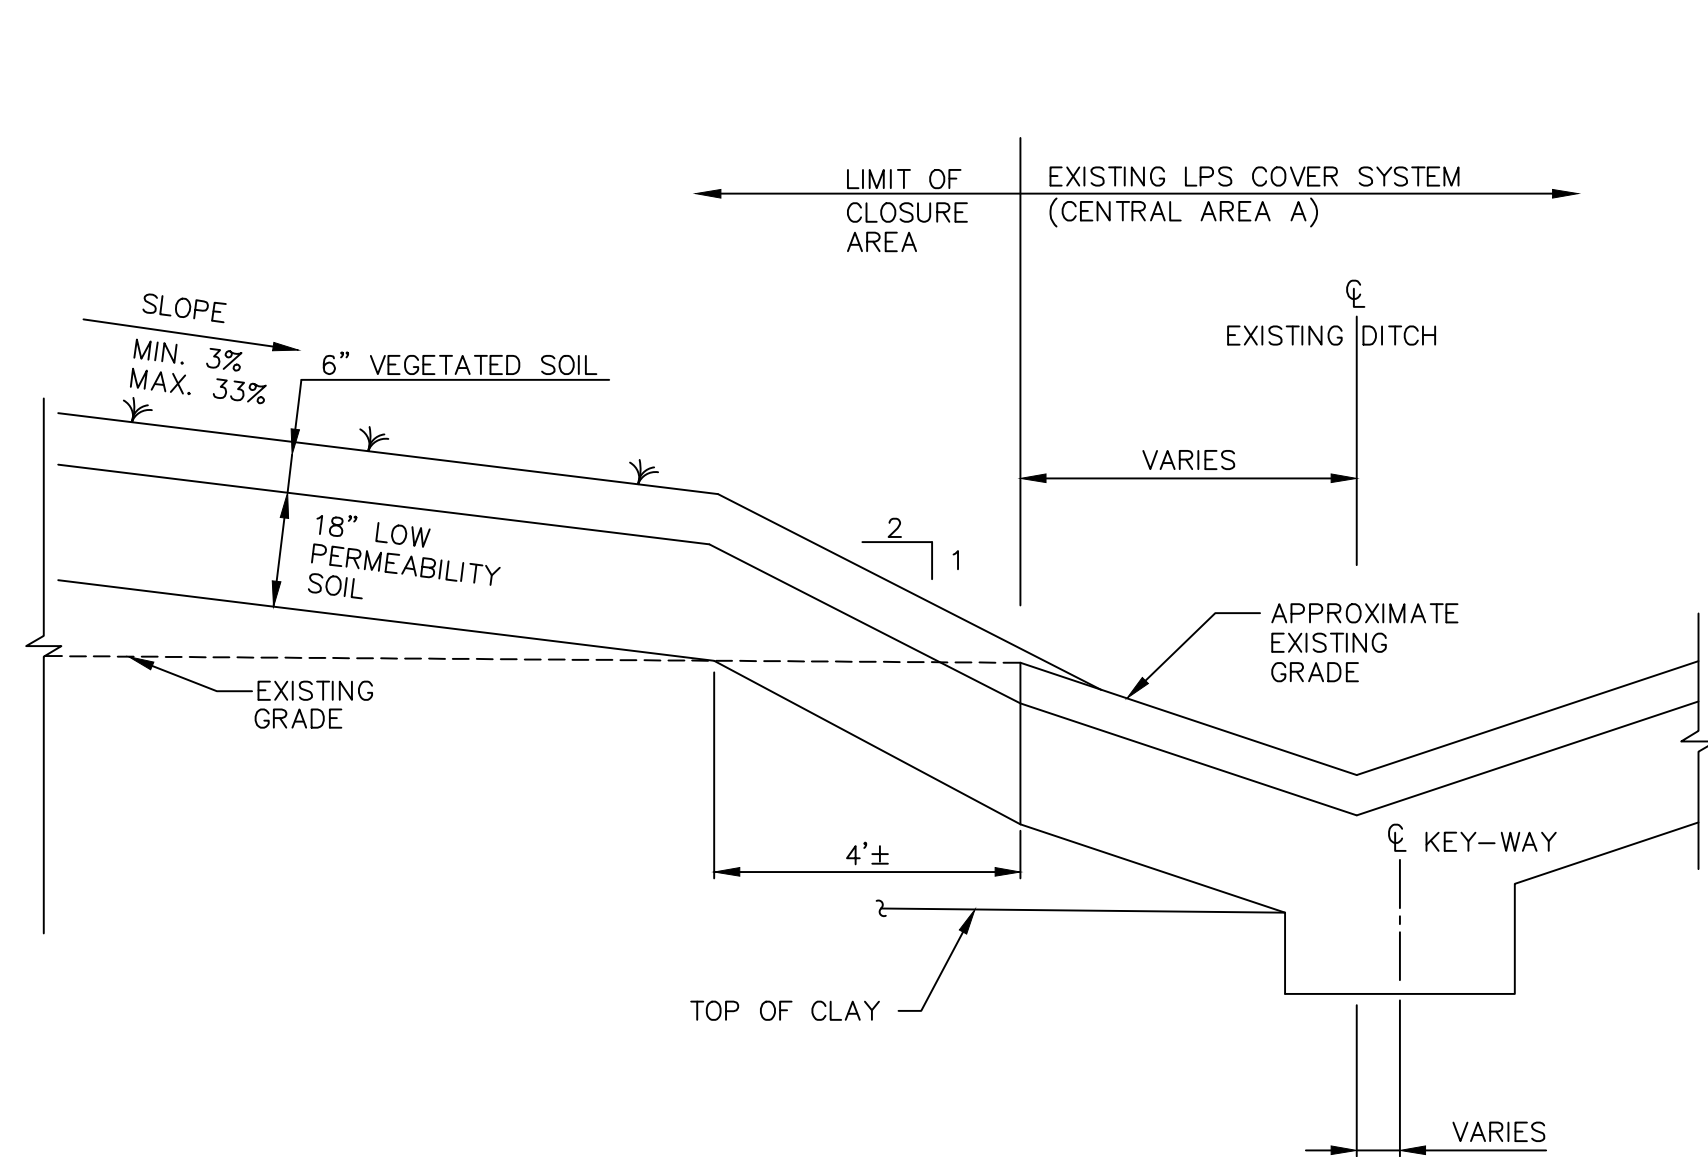
A	2	3
---	---	---

FINAL COVER TIE-IN
WITH EXISTING DRAINAGE DITCH

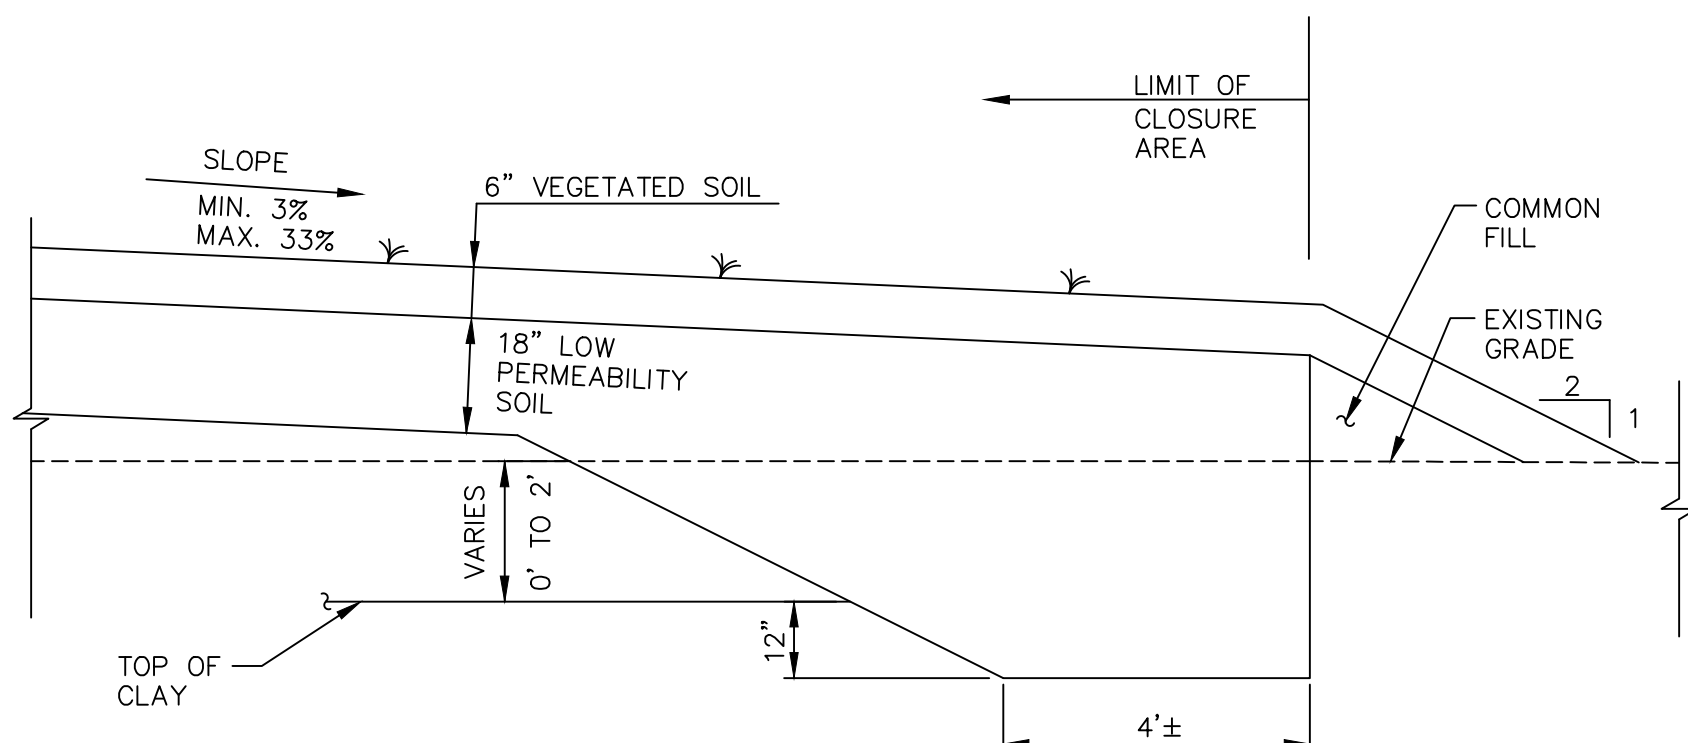
C	2	3
---	---	---

FINAL COVER TIE-IN
WITH EXISTING GRADE

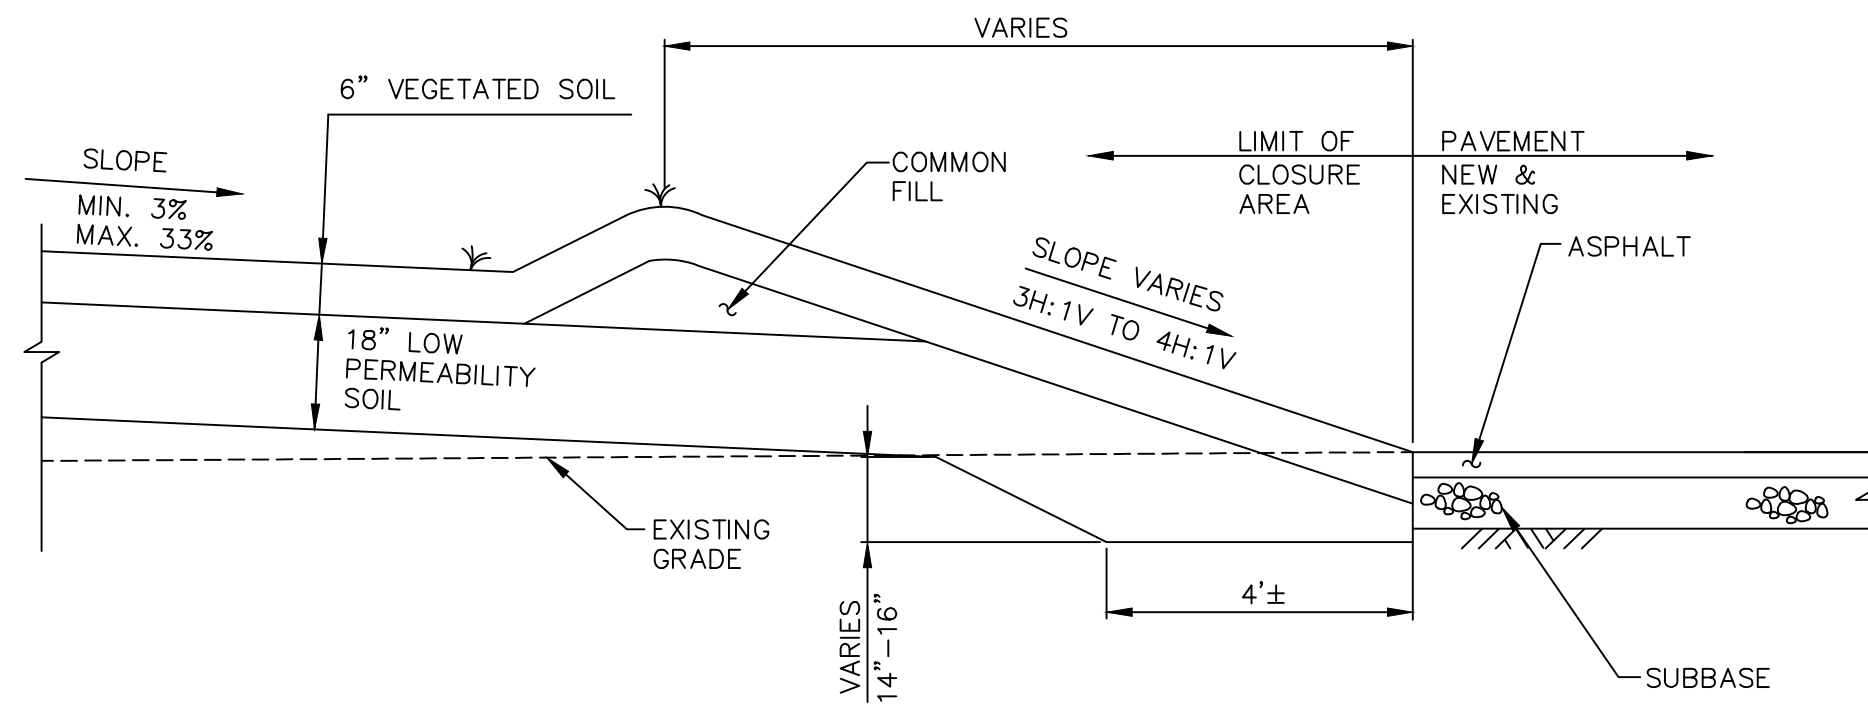
D	2	3
---	---	---

FINAL COVER TIE-IN
WITH NEW AND
EXISTING PAVEMENT

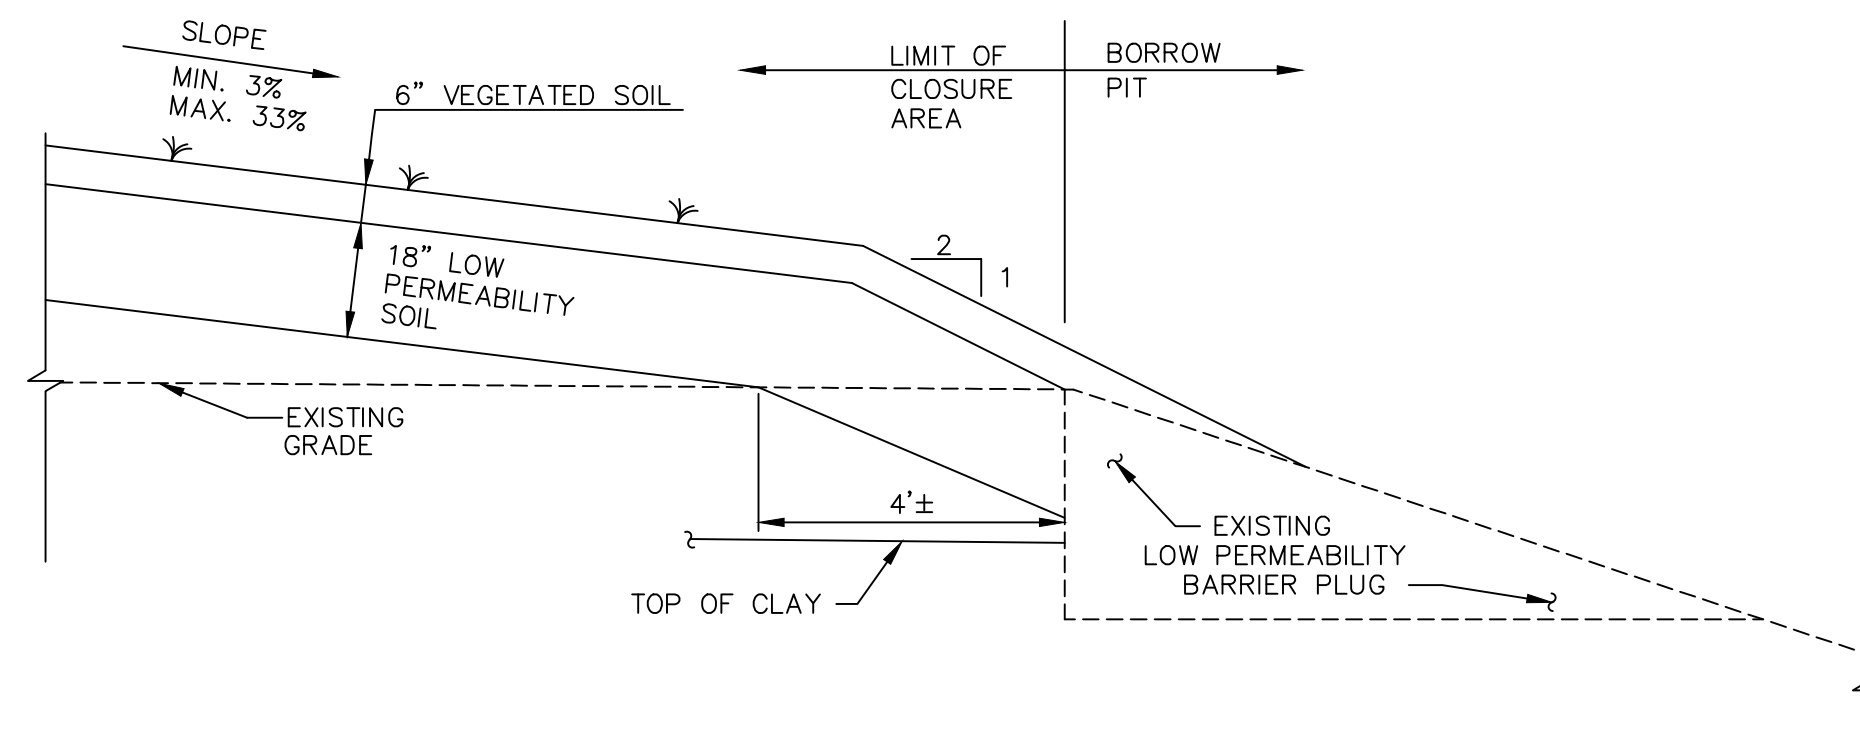
E	2	3
---	---	---

FINAL COVER TIE-IN
BORROW PIT BARRIER PLUG
