FINAL DRAFT
SITE INSPECTION REPORT
Ernst Steel
Cheektowaga, Erie County
New York

EPA ID# NYD980508246

SITE NAME: Ernst Steel
EPA ID NO.: NYD980508246
ADDRESS: 1746 Walden Avenue, Cheektowaga
Erie County, New York 14240
LATITUDE: 42° 54' 37" N.
LONGITUDE: 078° 46' 18" W.

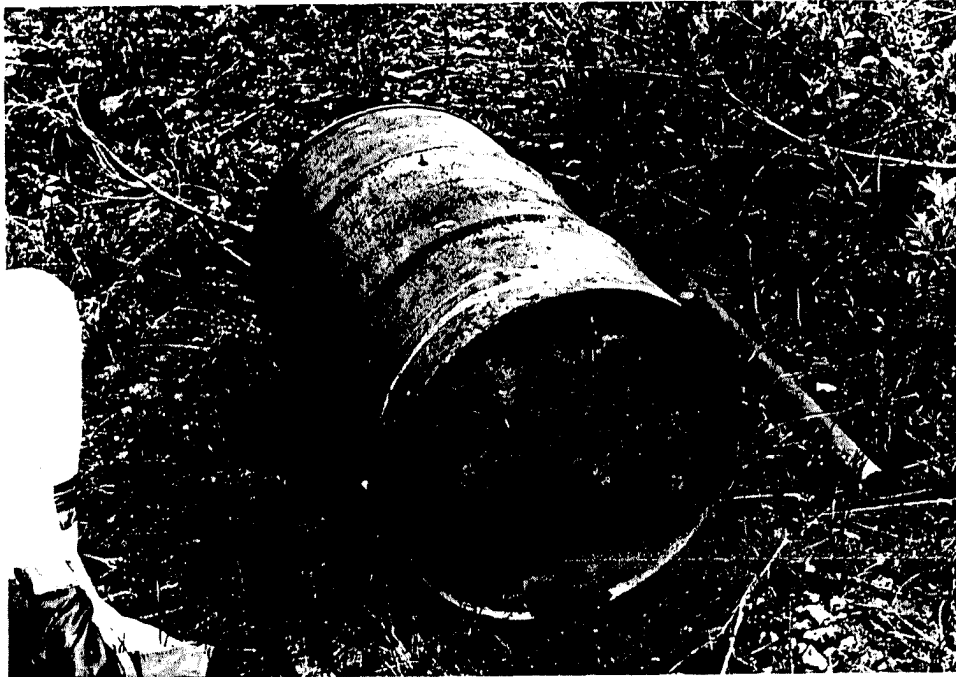
1P-7

Picture of drum located near NYFH-S5.
