# **ENGINEERING INVESTIGATIONS AT INACTIVE HAZARDOUS WASTE SITES**

## **PHASE I INVESTIGATIONS**

**WHITING DEVELOPMENT, SITE NUMBER 915027  
TOWN OF NEWSTEAD, ERIE COUNTY**

**February 1990**

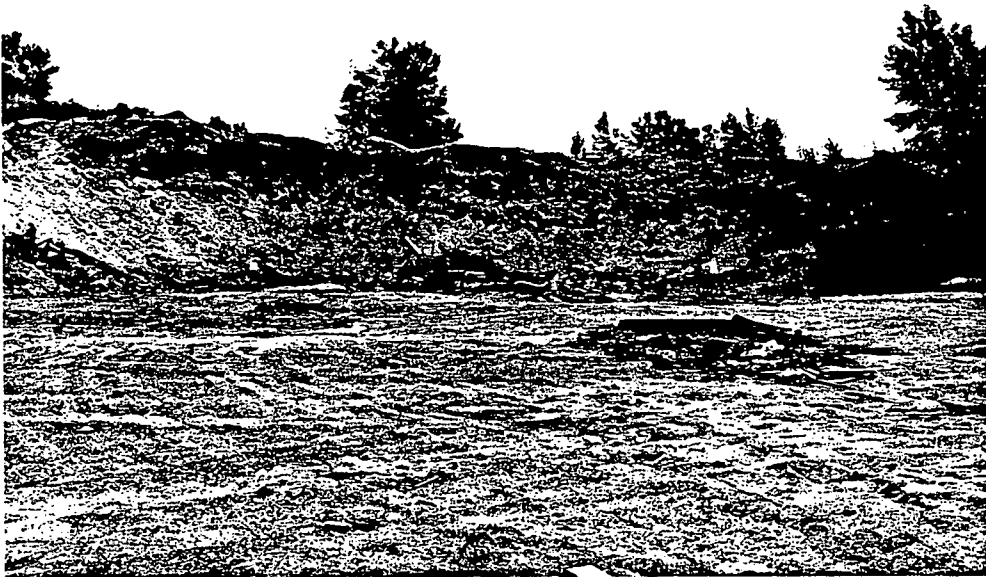
Photographer: A.M. Sienkiewicz  
Date/Time: 7/16/87 10:30  
Lens: Type: 35-70 mm  
SN: 301285  
Frame No.: 14  
Comments\*: Excavated  
gypsum material and area  
where scrap wood is being  
burned.

The site appears to be completely abandoned. At the northwest corner, waste material has been removed and scrap wood was burned. The vegetation is very thick in some areas, and no vegetative stress was observed. Surface water was noted in the ditch along the north and east borders; there is no evidence of leachate in the surface water.
