Historical Summary and Archival Photographs

**The Hanna Furnace Corporation
and
the Union Ship Canal**

**Buffalo, Erie County, New York
(01PR0610)**

This photographic record of the ruins of the Hanna Furnace Corporation was compiled by Christine Longiaru, Mark Drumlevitch (PCI), and Leonid I. Shmookler (E & E) on 9-11-01.

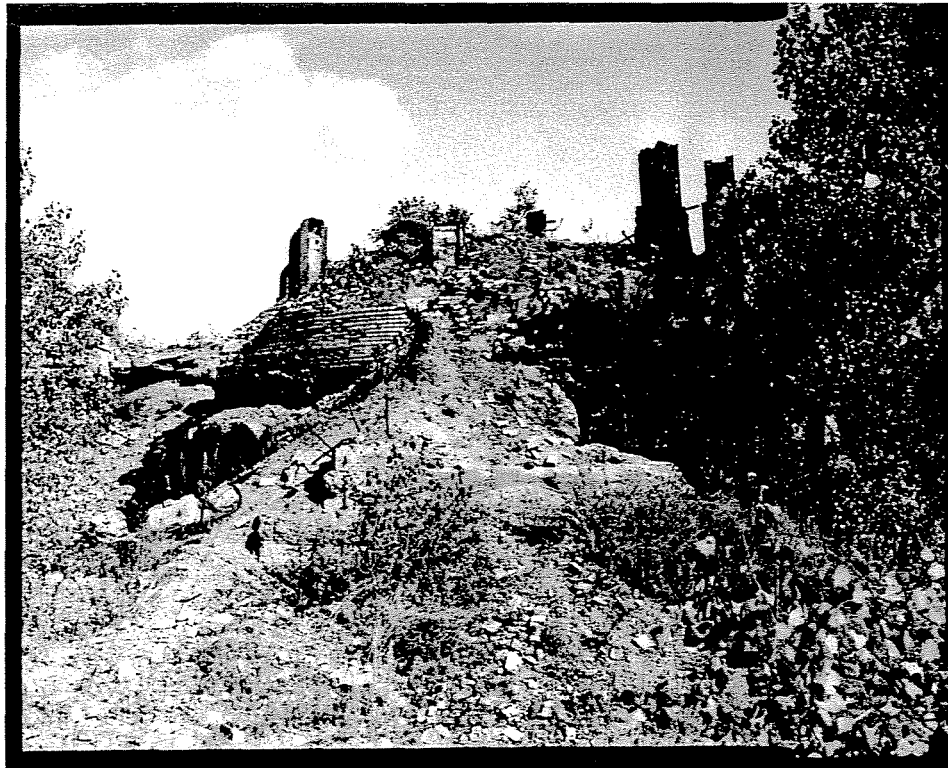
Photograph 1. Southwest section of Hanna Furnace No. 4, facing north. Hanna Furnace Redevelopment Project, Buffalo, Erie County, New York (PCI 2001).

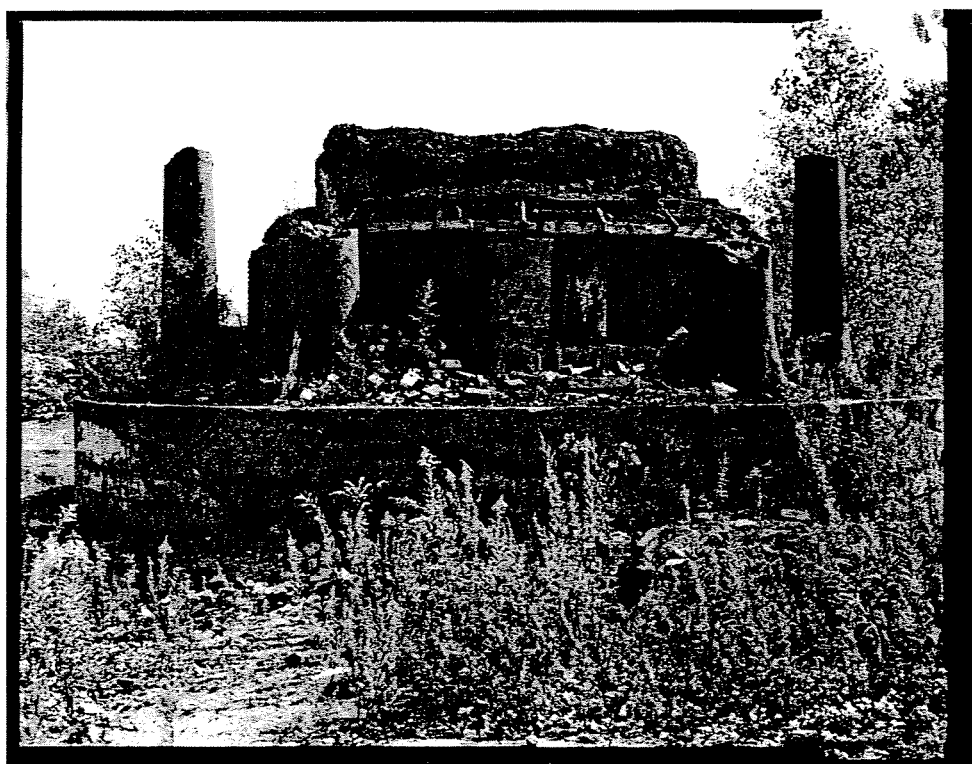
Photograph 4. West elevation of Hanna Furnace No. 3, facing east. Hanna Furnace Redevelopment Project, Buffalo, Erie County, New York (PCI 2001).

At the heart of the Hanna Furnace plant were four relatively large blast **furnaces** that were approximately 100 feet high and 25 feet in diameter (NSC nd: 22). Blast furnaces were cylindrical steel shells lined with fire resistant bricks (Photograph 5). These furnaces were erected on very strong concrete foundations that would support the enormous weight of the furnace and its charge and could also withstand side forces exerted by **skip bridges** and **downcomers** (Photograph 4)(See below).

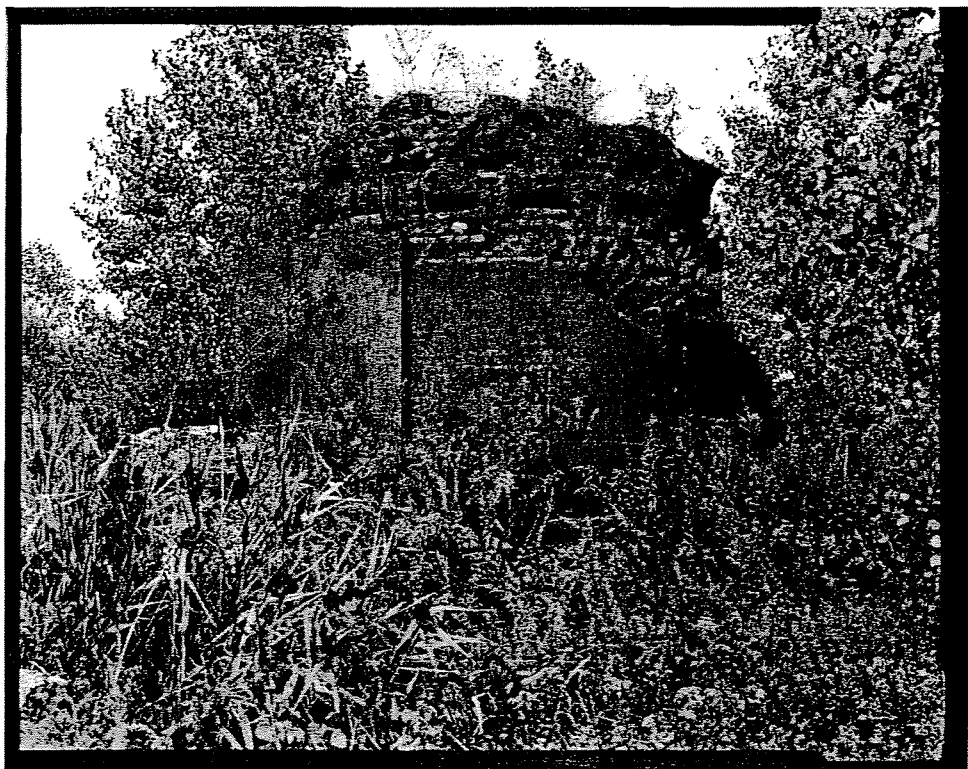
Photograph 5. Southeast section of Hanna Furnace No. 2, facing northwest. Hanna Furnace Redevelopment Project, Buffalo, Erie County, New York (PCI 2001).

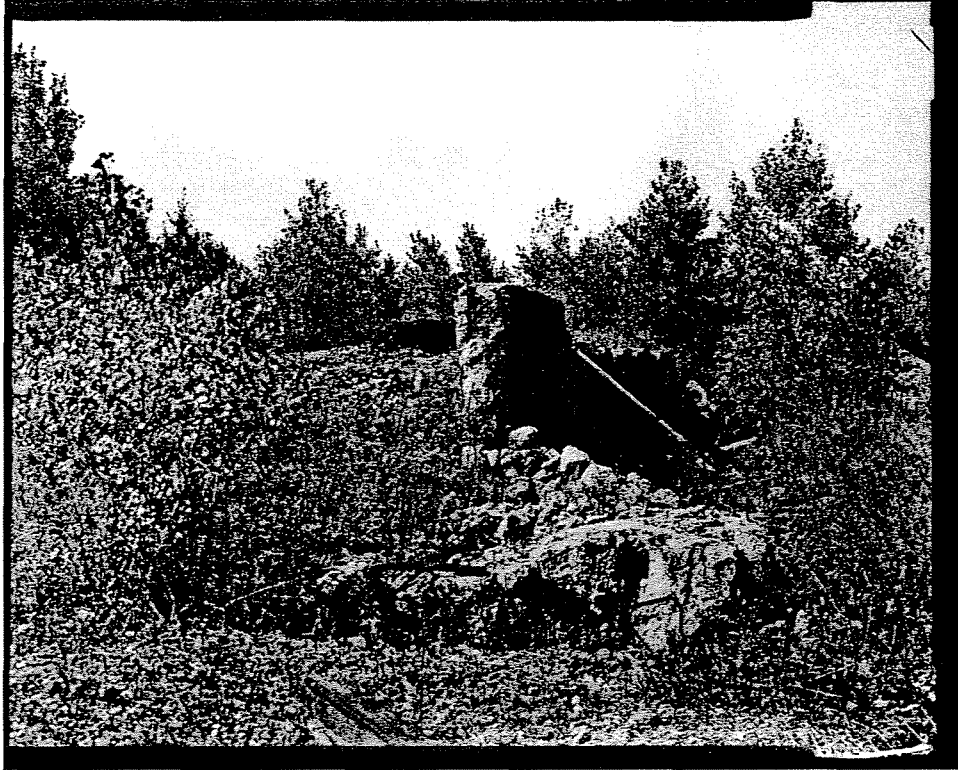
Photograph 6. Hanna Furnace No. 1 with slag dump and drain, facing southwest. Hanna Furnace Redevelopment Project, Buffalo, Erie County, New York (PCI 2001).

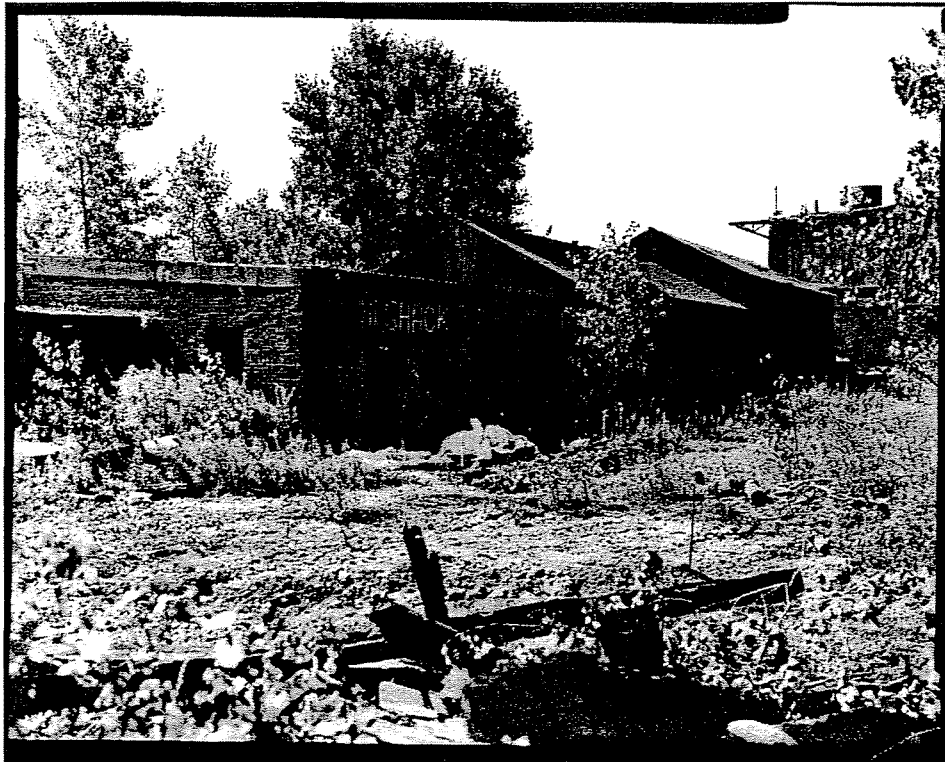
Photograph 9. South elevations of Hanna Furnace Oil Shack and Coal Storage Building, facing south. Hanna Furnace Redevelopment Project, Buffalo, Erie County, New York (PCI 2001).

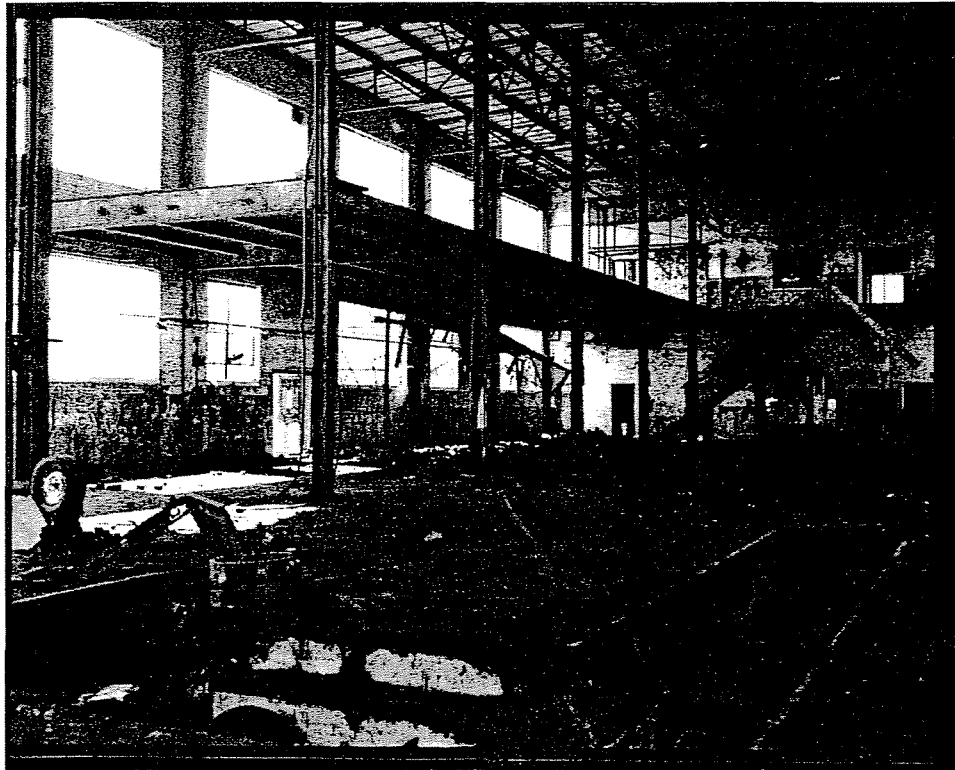
Photograph 10. Interior of Hanna Furnace Machine Shop from northeast corner of the building, facing southwest. Hanna Furnace Redevelopment Project, Buffalo, Erie County, New York (PCI 2001).

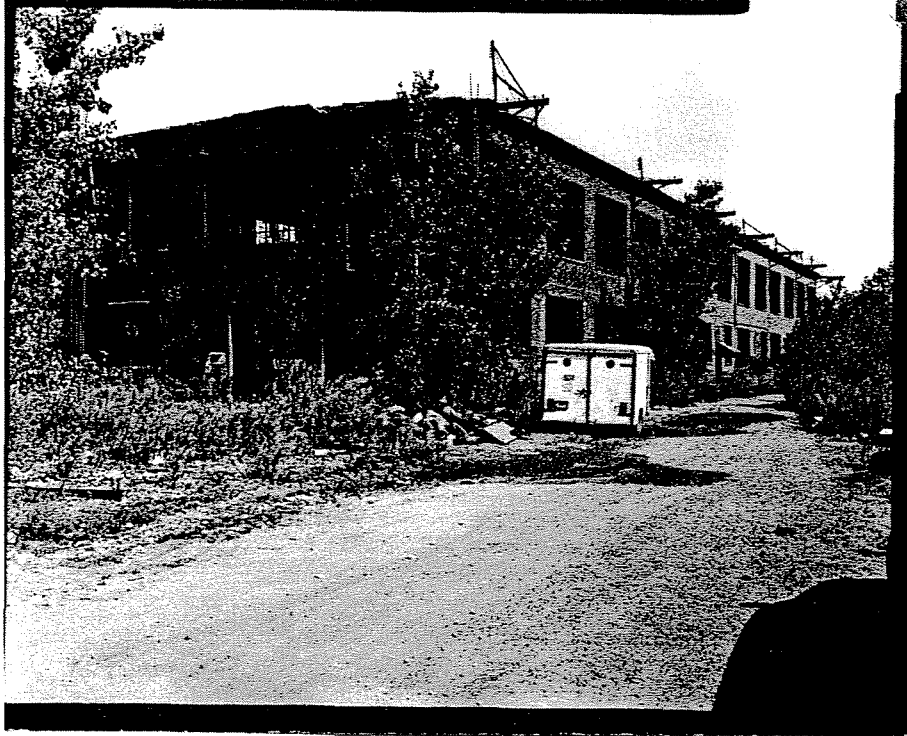
Photograph 11. West and south elevations of Hanna Furnace Machine Shop, facing northeast. Hanna Furnace Redevelopment Project, Buffalo, Erie County, New York (PCI 2001).

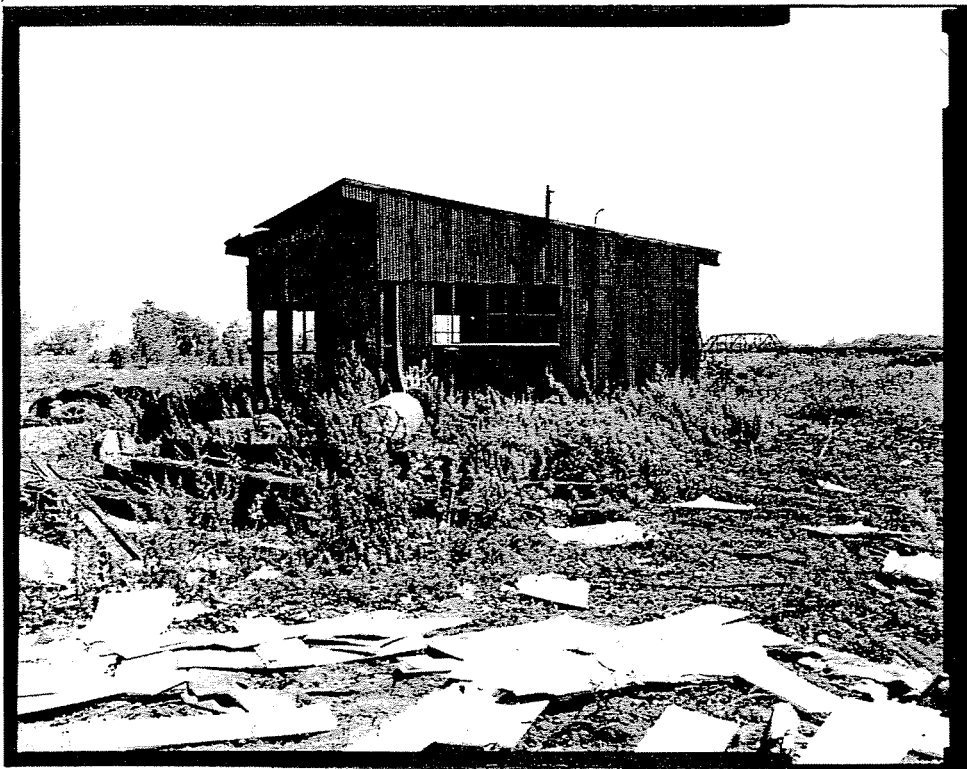
Photograph 12. North and west elevations of Hanna Furnace Filter House, facing east. Hanna Furnace Redevelopment Project, Buffalo, Erie County, New York (*PCI 2001*).
