PHASE I REPORT
ENGINEERING INVESTIGATIONS
AND EVALUATIONS AT INACTIVE
HAZARDOUS WASTE DISPOSAL SITES

INS Equipment
Erie County, NY

Prepared for
New York State
Department of
Environmental Conservation

SEPTEMBER 1984

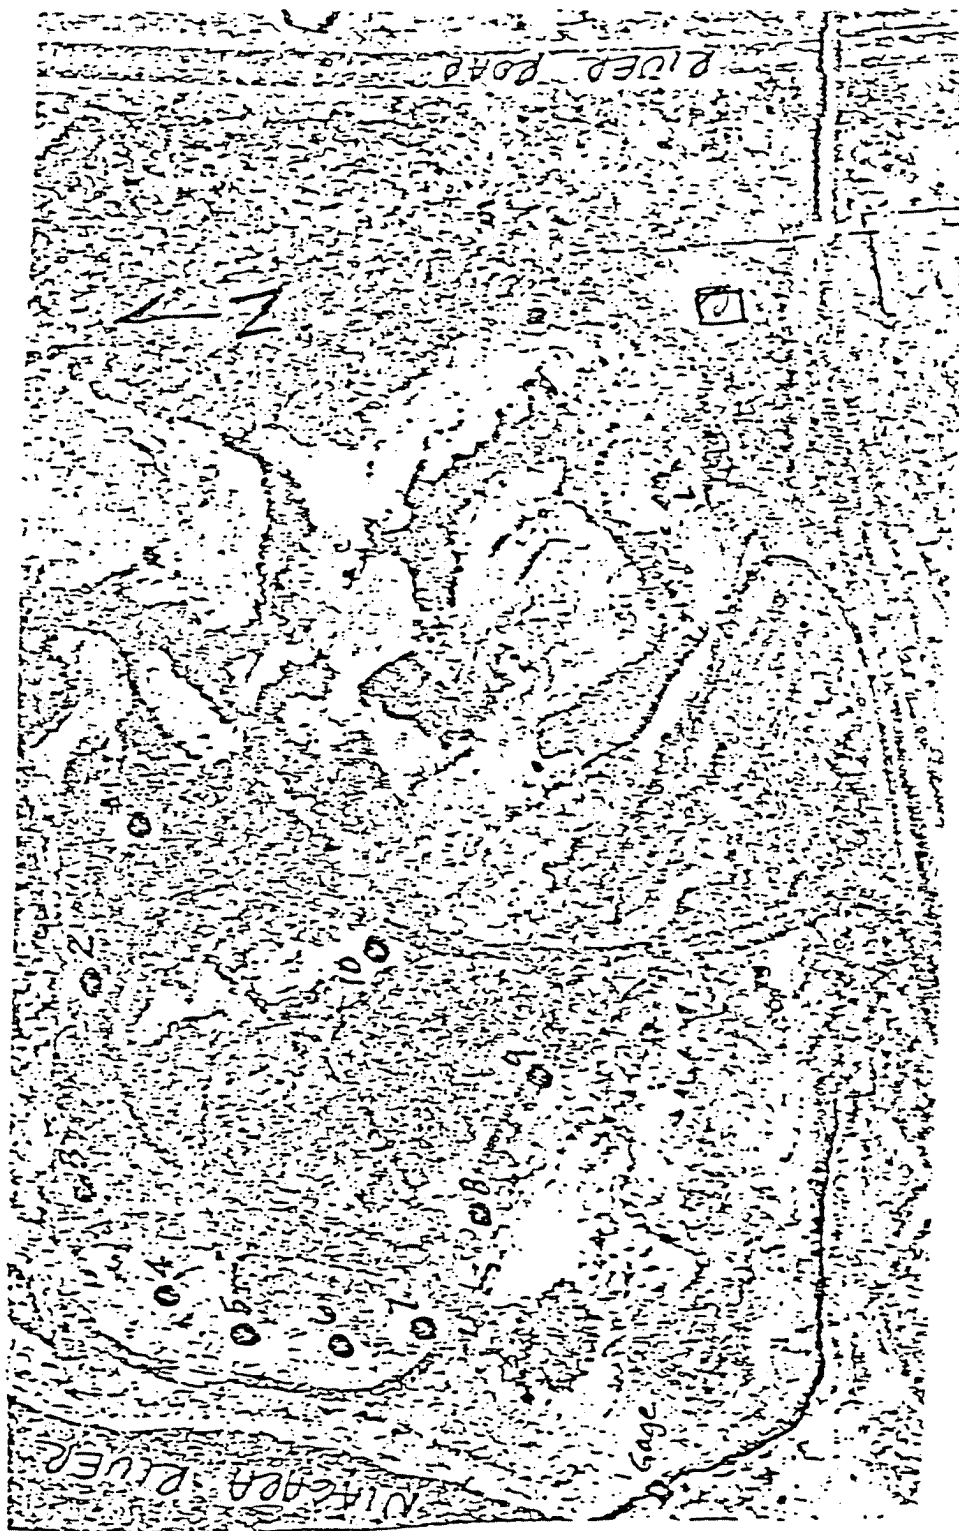
FIGURE V-1. LOCATION OF SAMPLING - INS EQUIPMENT SITE (USGS, 1982)

The only available analytical data for the INS site are analyses of substrate samples performed by the USGS (USGS, 1982). Figure V-1 shows the sample locations and Table V-1 summarizes the results. Complete analytical results are included in Appendix A.

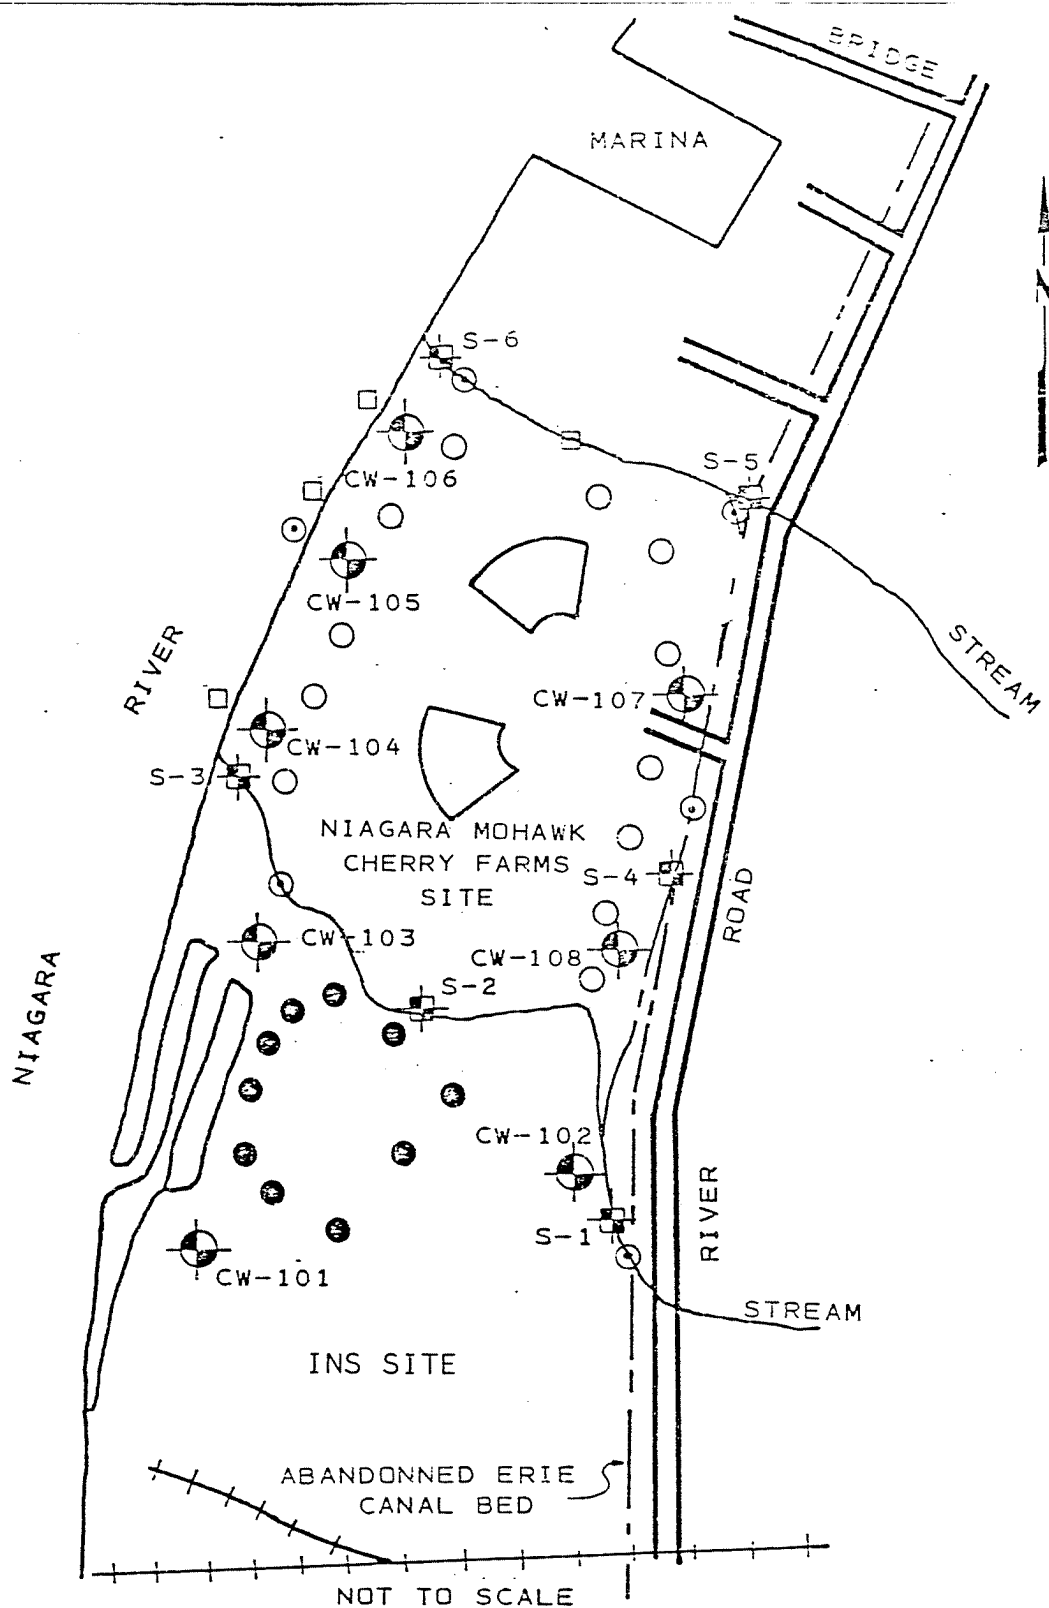
EXPLANATION:

PREVIOUS BORINGS (APPROXIMATE LOCATION)

Geophysical Survey - A geophysical study consisting of electrical resistivity and magnetometry surveys is recommended. The electrical resistivity survey will be performed at various locations within and beyond the perimeter of the site to determine the continuity of site geologic conditions, delineate significant discontinuities and define the horizontal and vertical extent of contaminant plumes. A magnetometry survey will be conducted on a grid system to aid in delineating the limits of the site.

Ground Water - A ground water monitoring system consisting of 3 wells is recommended. The wells are to be approximately 30 feet

Surface Water - A surface water monitoring system consisting of two monitoring stations is recommended. The surface water and sediment samples will be analyzed for phenol, Hg, Cd, Cr, Pb and organics using a GC/MS scan.
