**FIFTH FIVE-YEAR REVIEW REPORT FOR
PFOHL BROTHERS LANDFILL SUPERFUND SITE
CHEEKTOWAGA COUNTY, NEW YORK STATE**

**U.S. Environmental Protection Agency
Region 2
New York, New York**

November 13, 2025

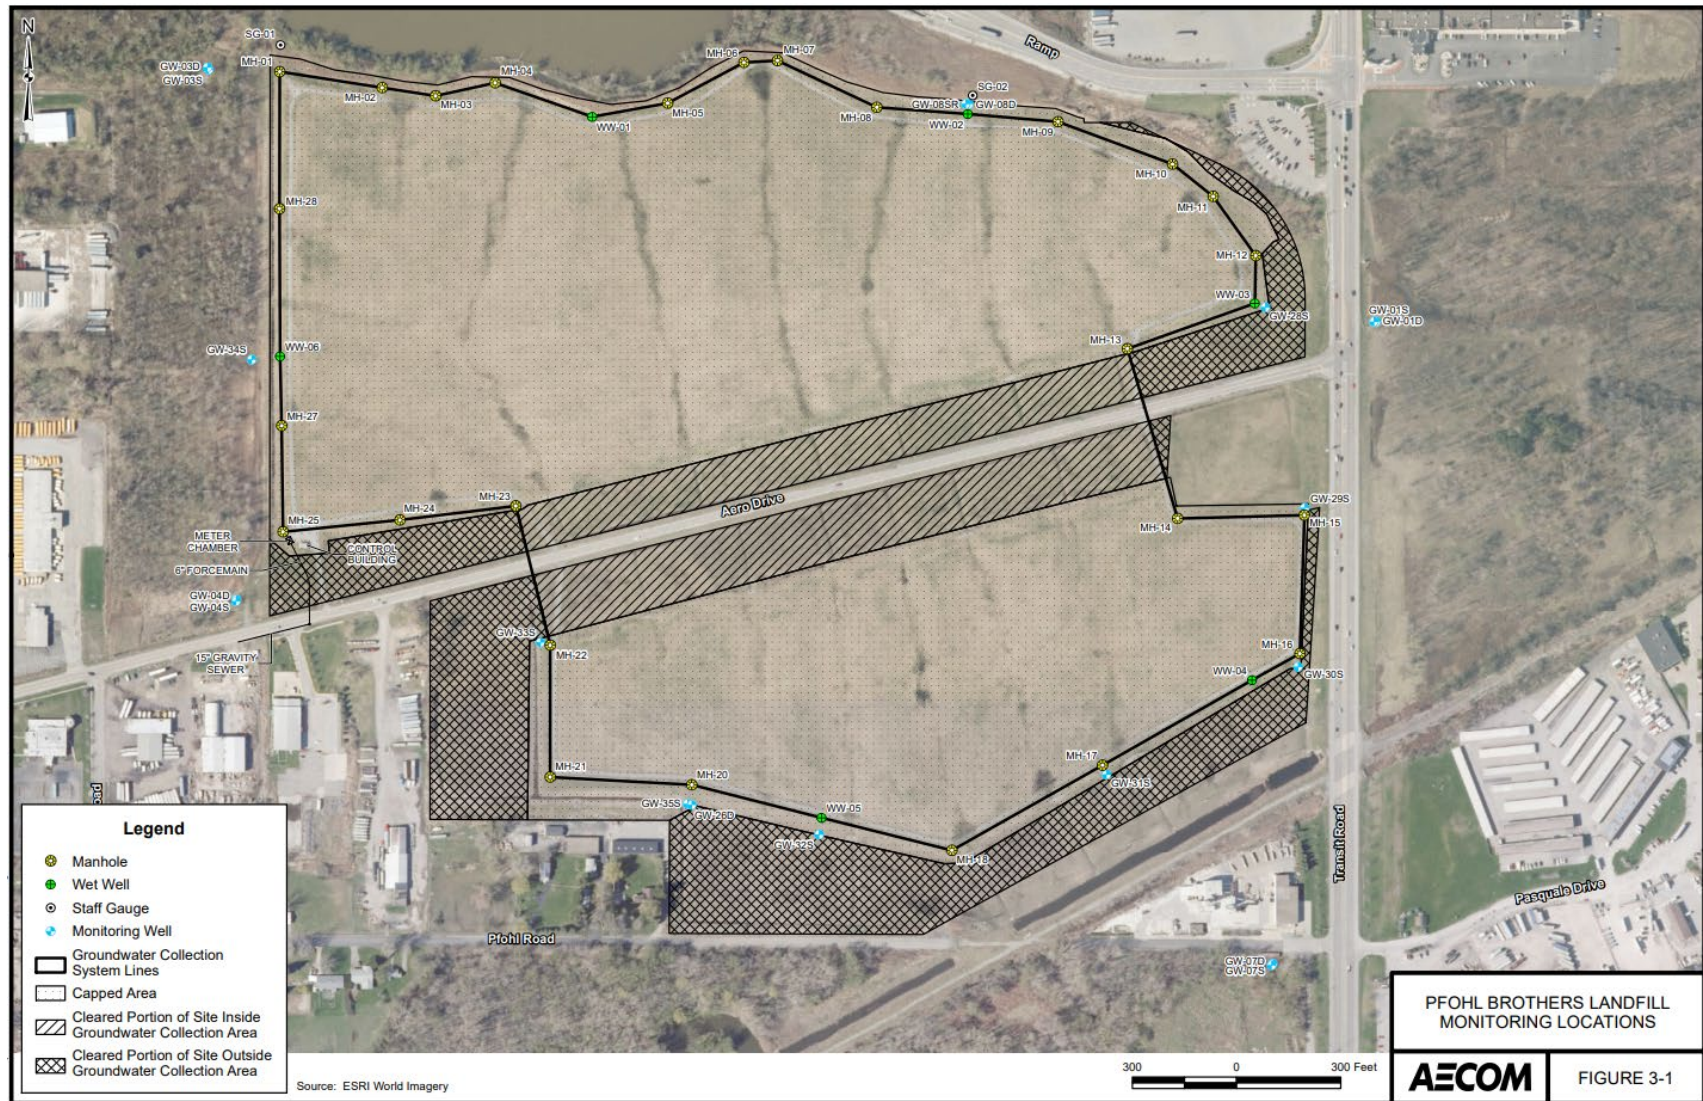
Figure 3 — Monitoring Well Locations

Groundwater sampling was conducted during this FYR period using overburden and bedrock monitoring wells GW-01D, GW-01S, GW-03D, GW-03S, GW-04D, GW-04S, GW-07D, GW-07S, GW-08D, GW-08SR, GW-26D, GW-28S, GW-29S, GW-30S, GW-31S, GW-32S, GW-33S, GW-34S, and GW-35S (see Appendix A, Figure 3). Semi-annual groundwater sampling was conducted until 2023, at which time the sampling frequency was reduced to an annual basis with sampling events alternating between May and November to capture any seasonality in groundwater concentrations.

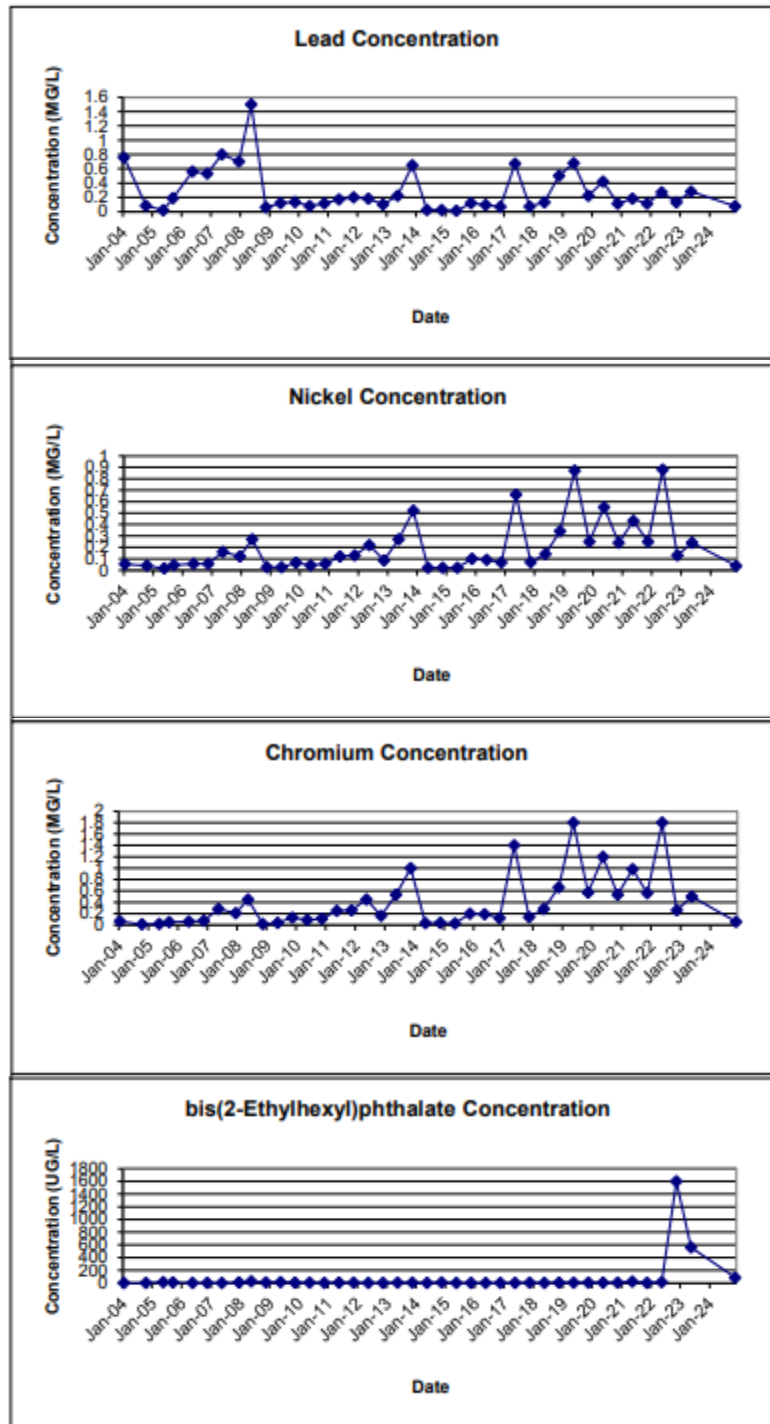
Figure 4 — Monitoring Well GW-07D Concentration Trends

During the review period, there were sporadic exceedances of additional metals in monitoring well GW-07D, including lead, nickel, and chromium above their respective AWQS of 0.025 mg/L, 0.1 mg/L, and 0.05 mg/L. The maximum concentration of lead in GW-07D was 0.042 mg/L in May 2020. The maximum concentration of nickel in GW-07D was 0.88 mg/L in May 2022. The maximum chromium concentration in GW-07D was 1.8 mg/L in May 2022. The trends of these metals, including the naturally occurring metals identified above, mirror each other. They have fluctuated significantly between sampling events, typically higher in May than November, with an overall increasing trend since the previous review period. During the November 2024 sampling event, both filtered and unfiltered samples were analyzed for metals at GW-07D. The filtered results for lead and chromium were substantially lower than the unfiltered results, suggesting the metals are related to sample turbidity. Concentrations of lead, nickel, and chromium in landfill leachate are either not detected or are significantly lower than those observed in groundwater at GW-07D, and groundwater concentrations of lead, nickel, chromium, and bis(2-ethylhexyl) phthalate in upgradient monitoring wells GW-30S and GW-31S are also not detected.

or are below AWQS. Trend charts for lead, nickel, chromium, and bis(2-ethylhexyl) phthalate in GW-07D are presented in Appendix A Figure 4.

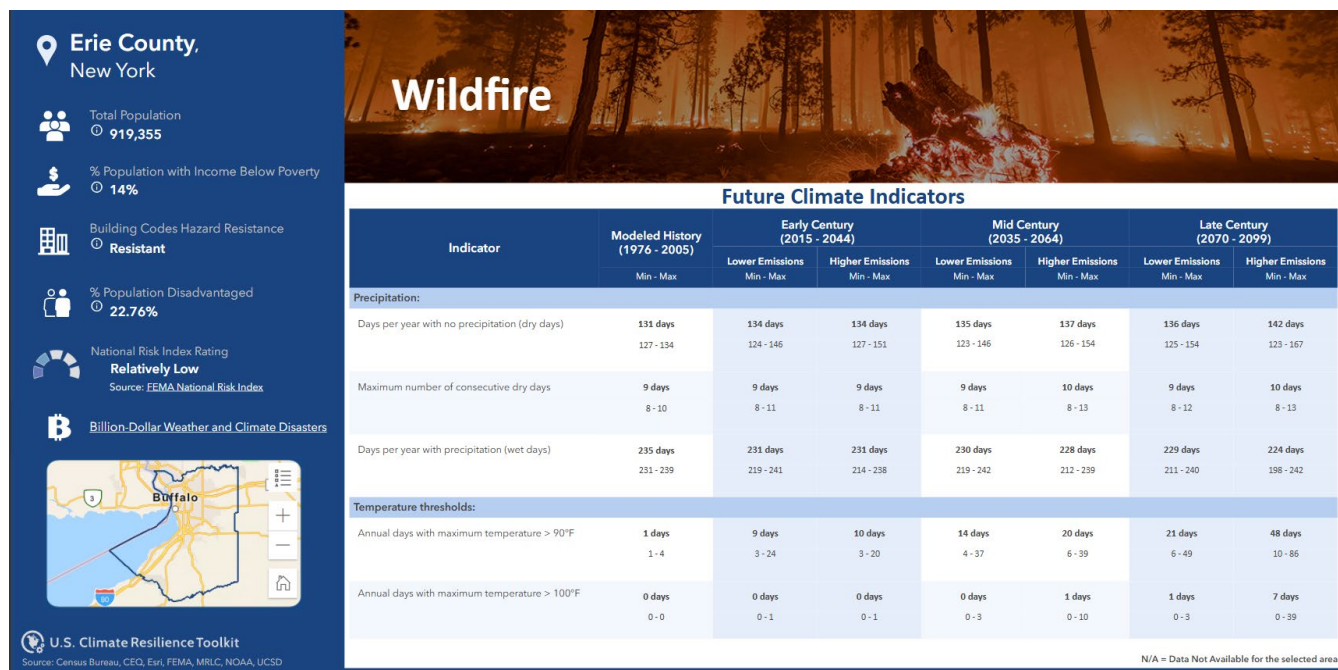
The first tool, the CMRA (see [CMRA](#)), examined five hazards (extreme heat, drought, wildfire, flooding, and coastal inundation) for Erie County, the county in which the Site is located. According to the CMRA tool the National Risk Index Ratings for extreme heat and flooding are “Relatively Moderate” (see figure D1 and figure D4). However, no impacts from these hazards to the Site area or to the implementation of the remedy have been observed. The CMRA tool reported the risk for drought, wildfire and coastal inundation as “Very Low” or “Relatively Low”, as shown in Figure D2, Figure D3 and Figure D5.

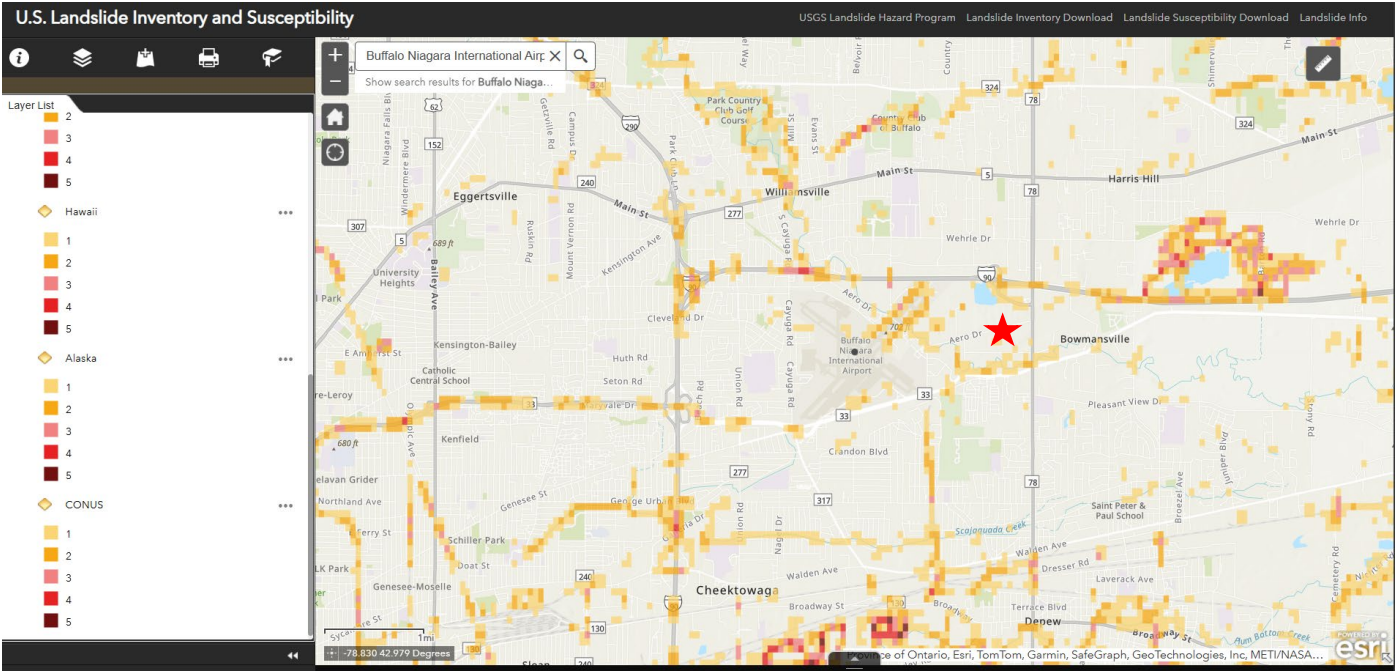
Figure D7

The final tool is called the USGS U.S Landslide Inventory (see <https://www.usgs.gov/tools/us-landslide-inventory-and-susceptibility-map>). As shown by figure D7, there is a low to moderate vulnerability of landslides around the perimeter of the Site and no landslides have been observed in the Site vicinity in the past. Note the red star on Figures D6 and D7 designate the site’s approximate location.
