ENGINEERING INVESTIGATIONS AT INACTIVE HAZARDOUS WASTE SITES

PHASE II INVESTIGATION

Pratt and Letchworth

Site No. 915045

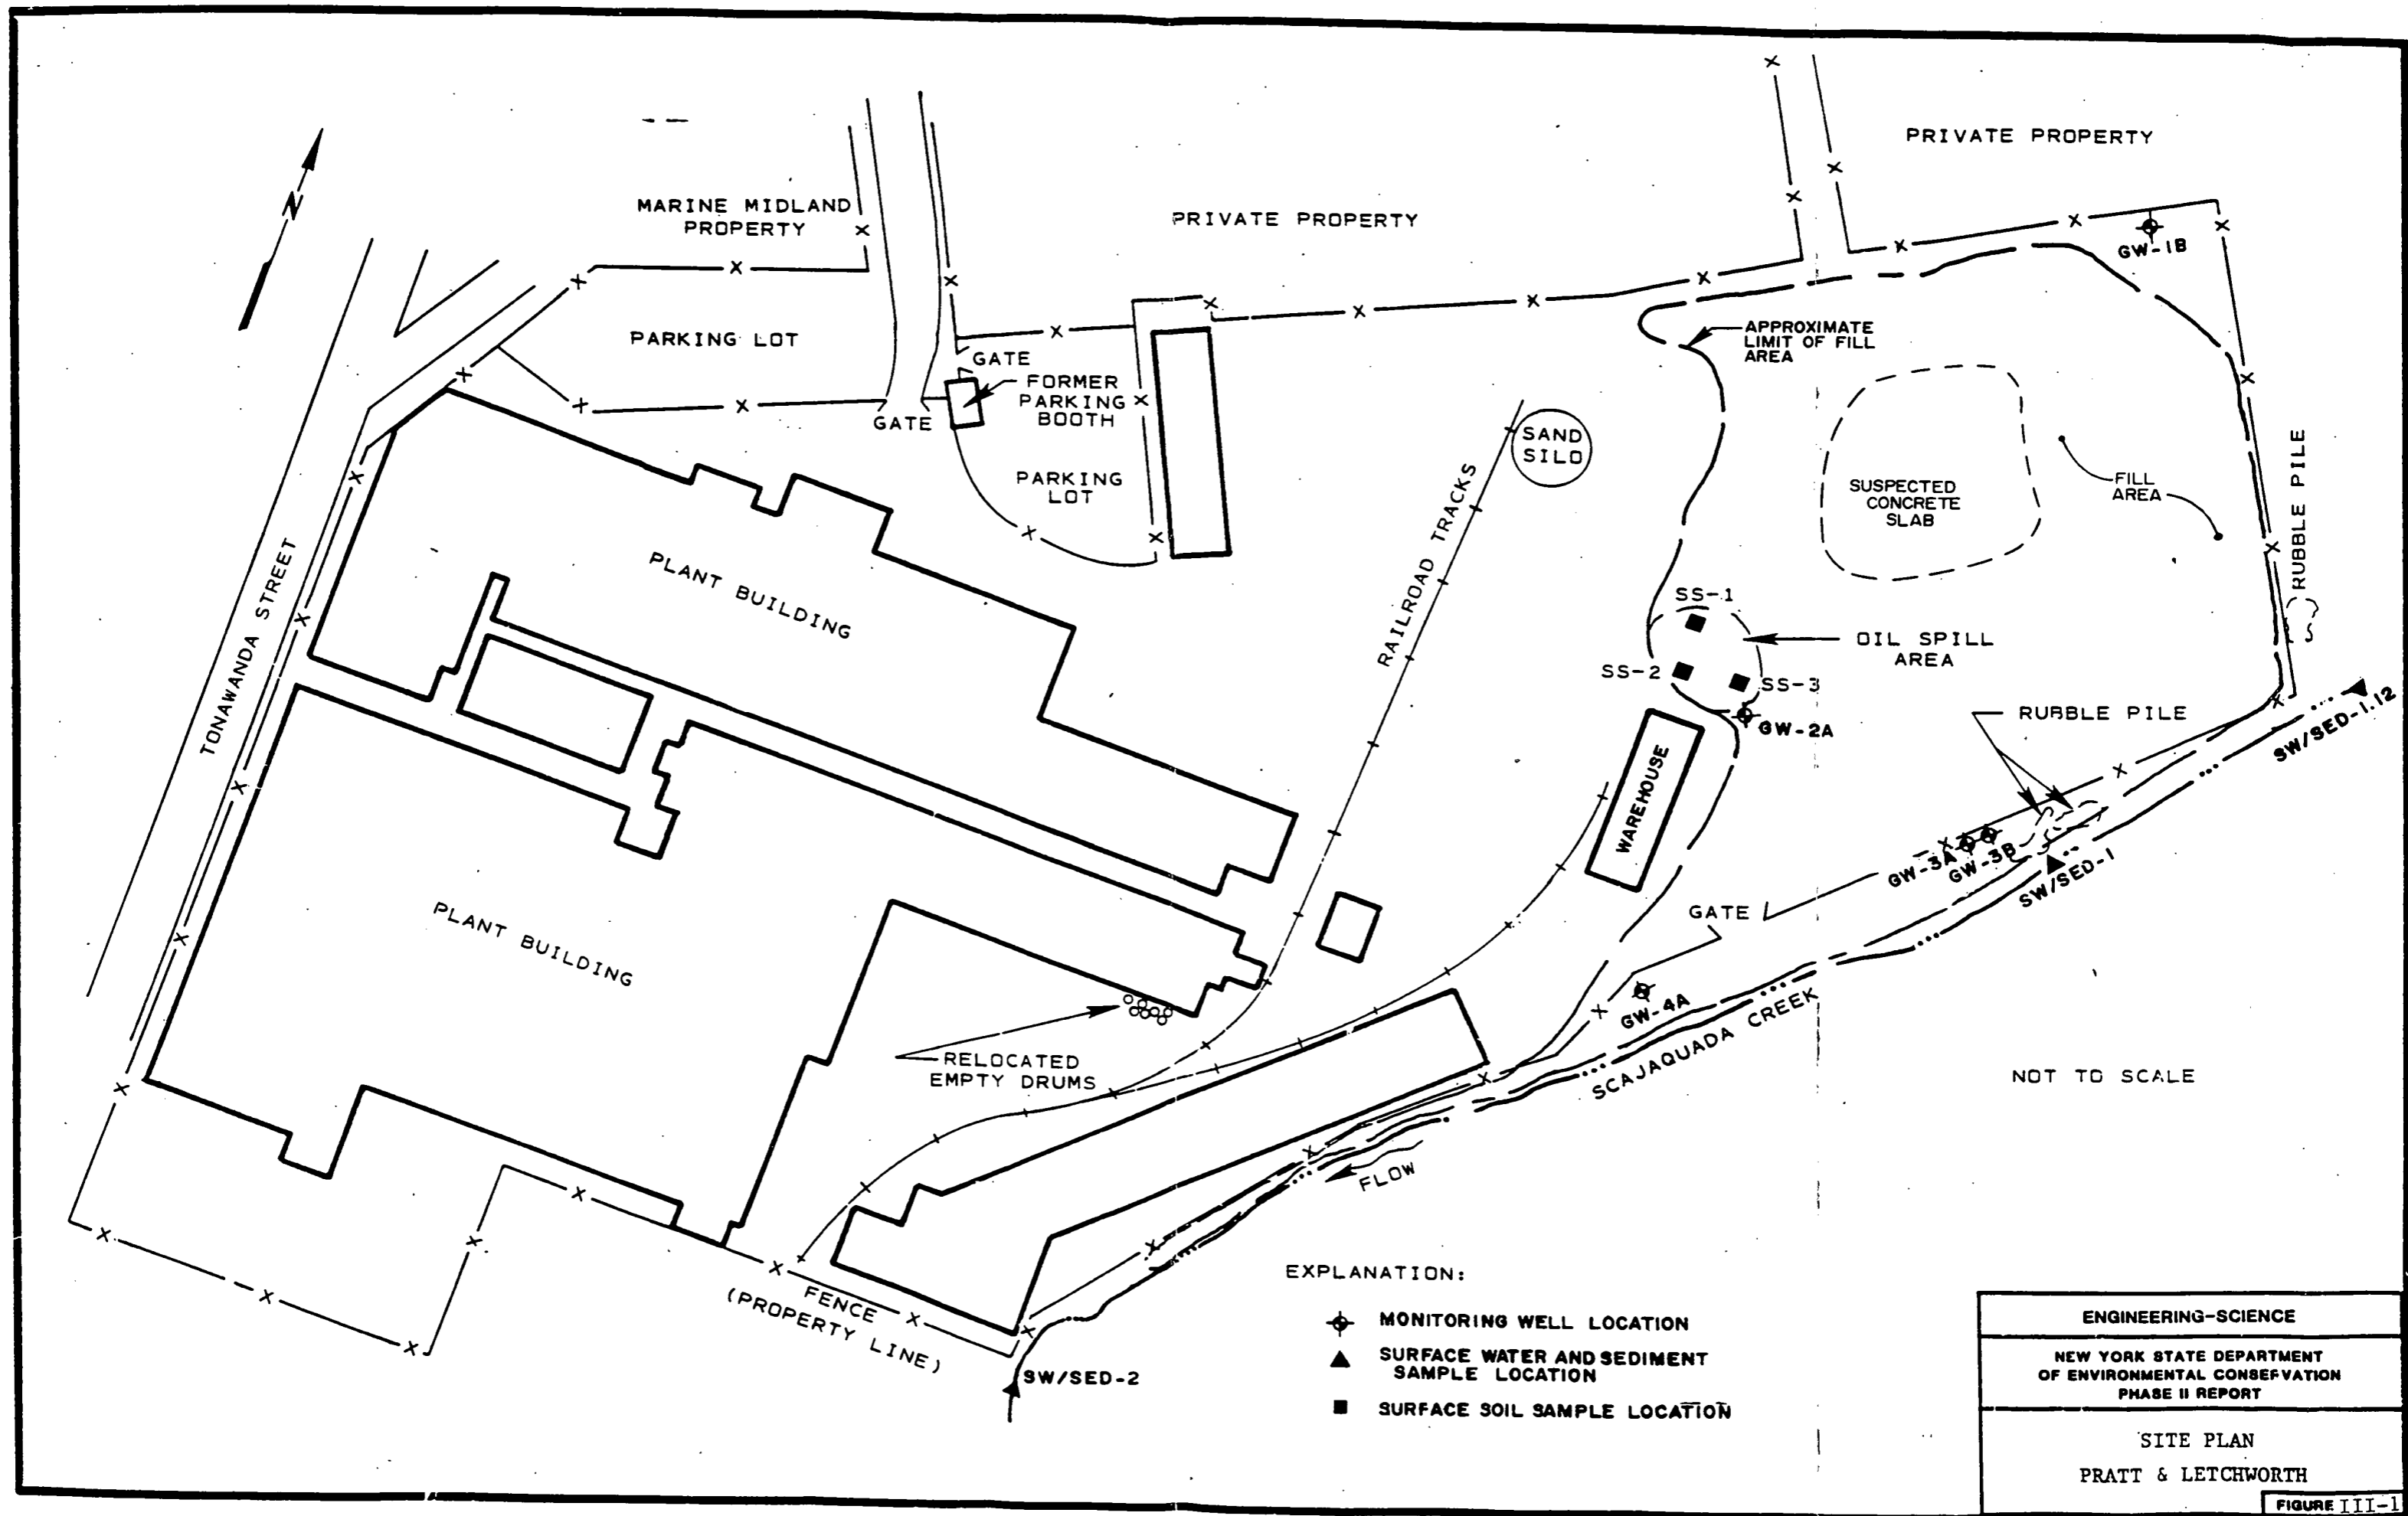
- ⊕ MONITORING WELL LOCATION
- ▲ SURFACE WATER AND SEDIMENT SAMPLE LOCATION
- SURFACE SOIL SAMPLE LOCATION

Three fill/clay interface and two bedrock monitoring wells were installed around the perimeter of the site between October 26 and November 4, 1987 by Rochester Drilling Co., Inc. (Figure III-1). Wells were installed upgradient and downgradient of the oil spill area where leaking drums were previously found, and the foundry sand landfill areas as shown on Table III-2. The upgradient well for the fill area, GW-1B, monitors the upper portion of the bedrock. Downgradient

All surface water and sediment samples were collected along the north bank of Scajaquada Creek. Samples SW/SED-1 and SW/SED-2 were collected adjacent to the fill area and downstream of the site, respectively (Figure III-1). Samples SW-1.12 and SED-1.12 were collected upstream of the site. Surface water samples were collected with decontaminated stainless steel beakers. Sediment samples were collected with decontaminated stainless steel spoons. The field procedures utilized are presented in Appendix A, and the analytical results are discussed in Section IV and listed in Appendix D.

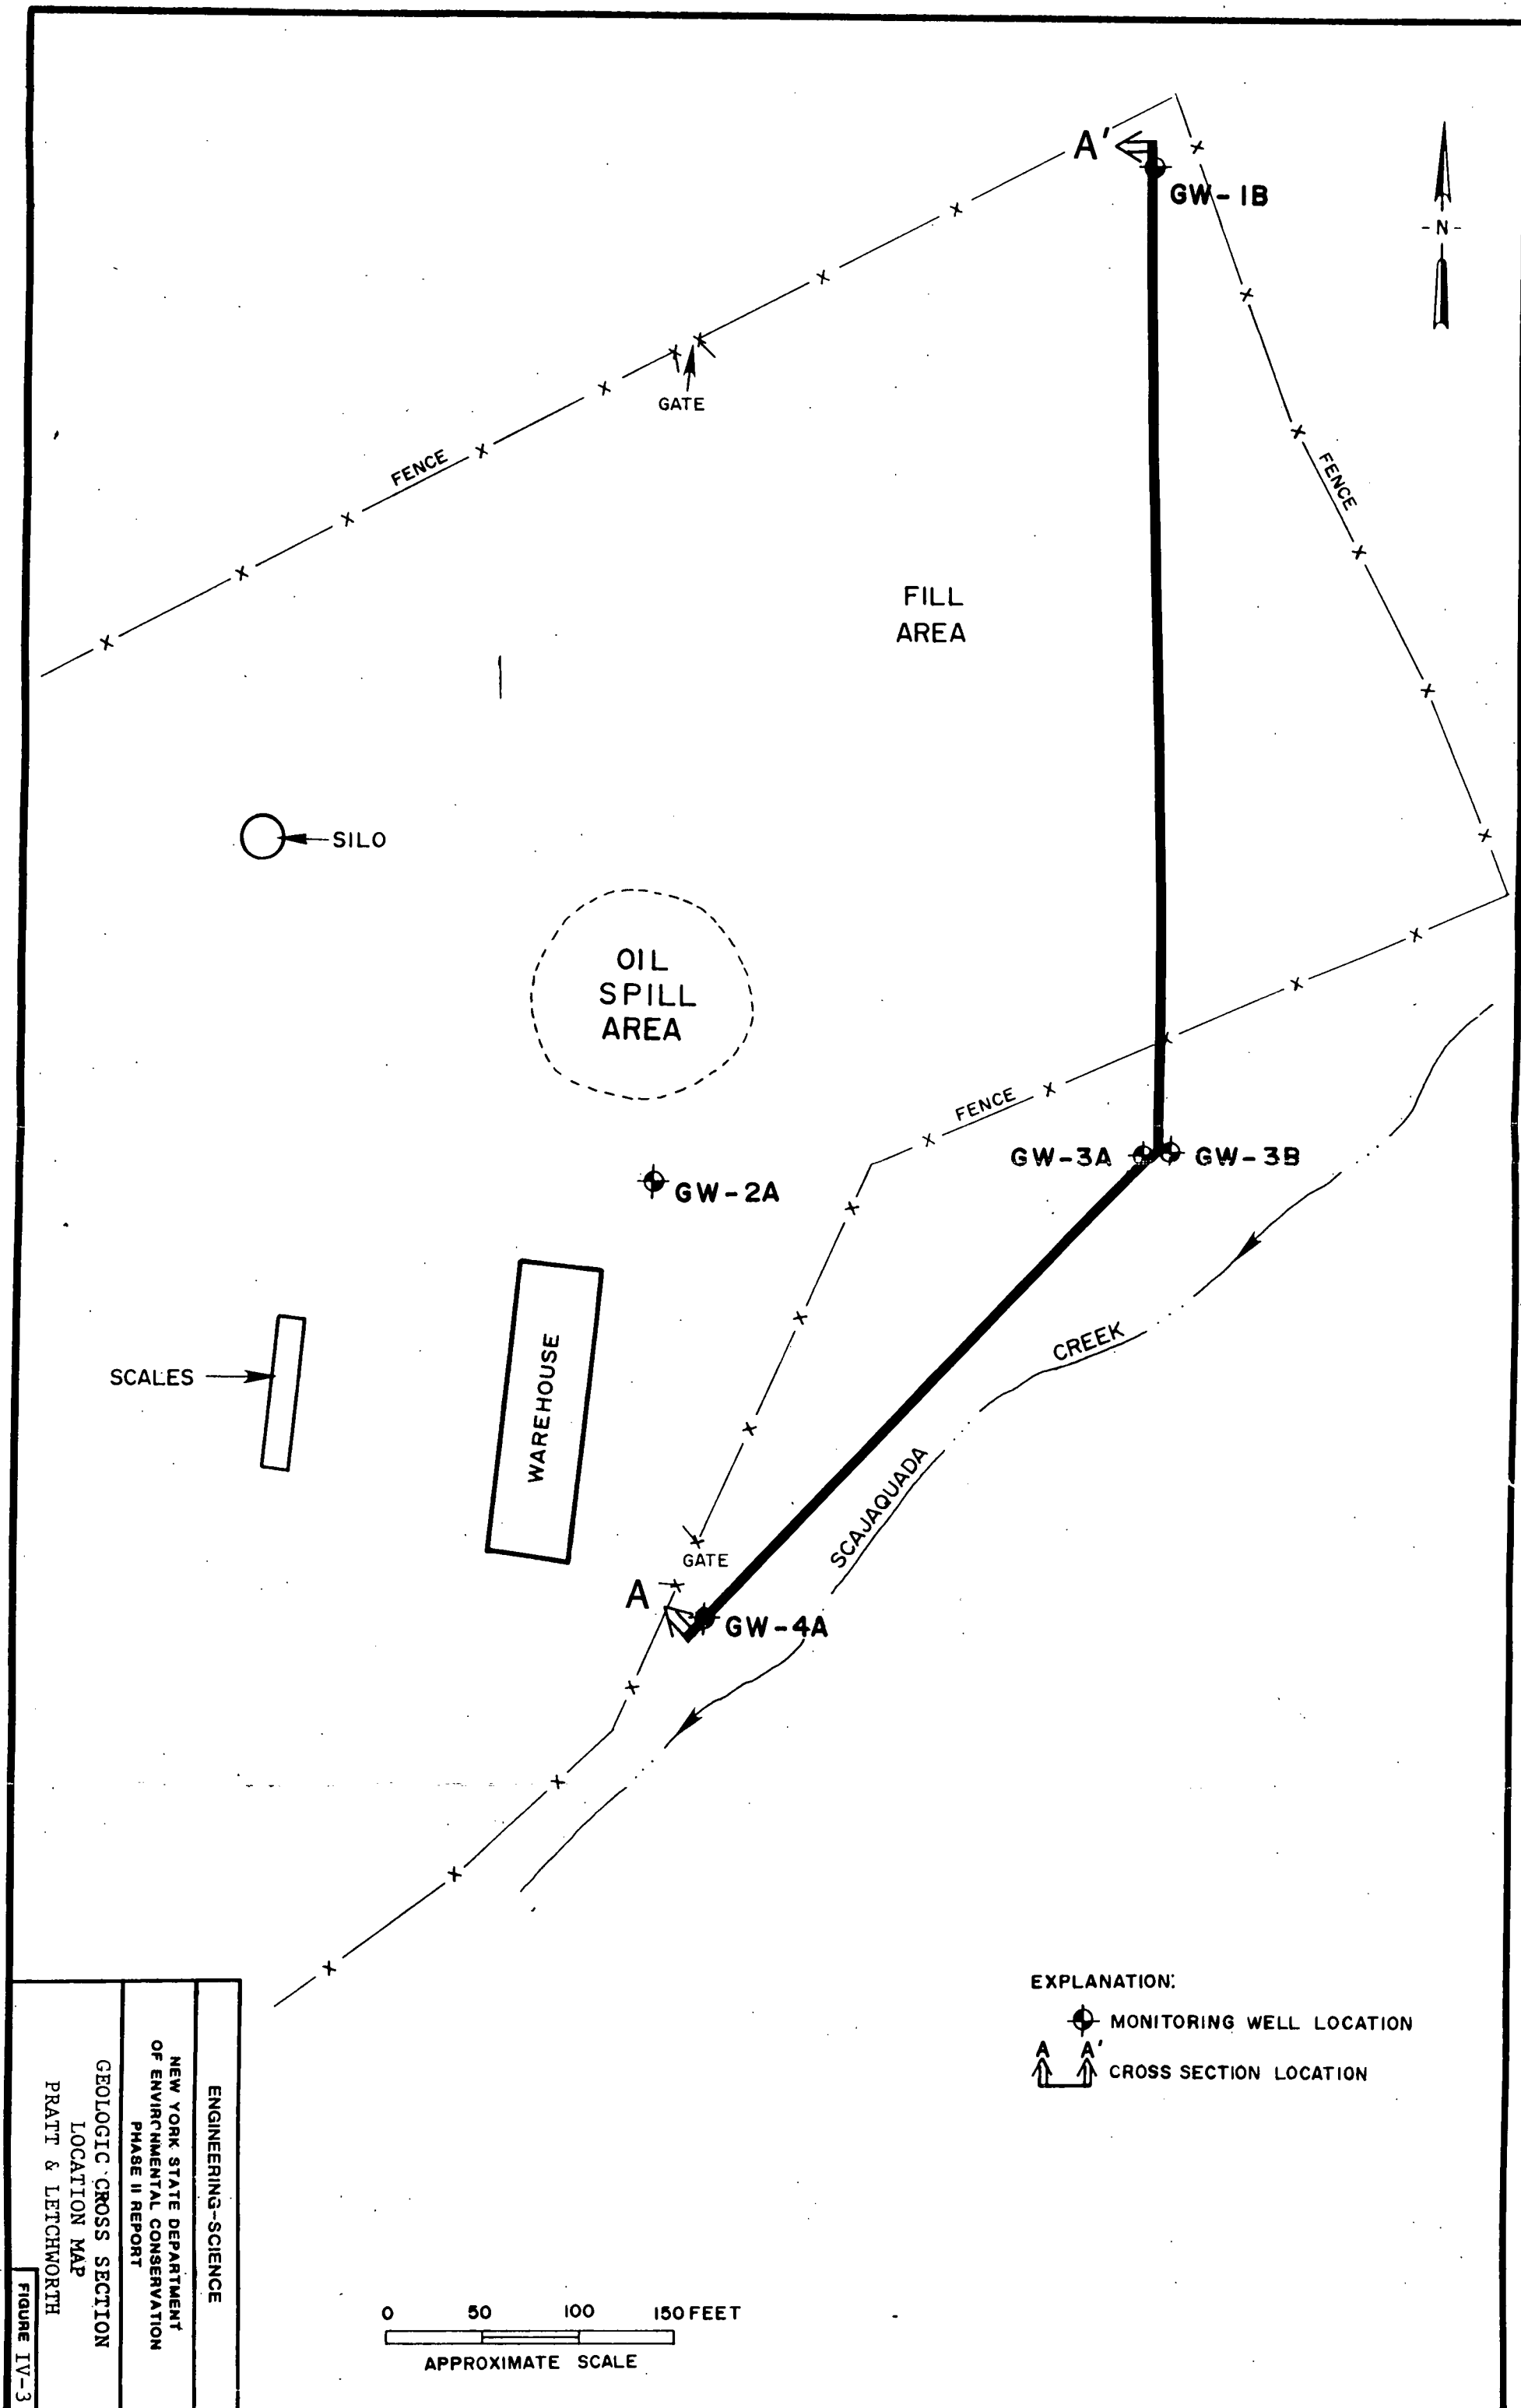
FIGURE IV-3

ENGINEERING-SCIENCE
 NEW YORK STATE DEPARTMENT
 OF ENVIRONMENTAL CONSERVATION
 PHASE II REPORT
 GEOLOGIC CROSS SECTION
 LOCATION MAP
 PRAIT & LETCHWORTH

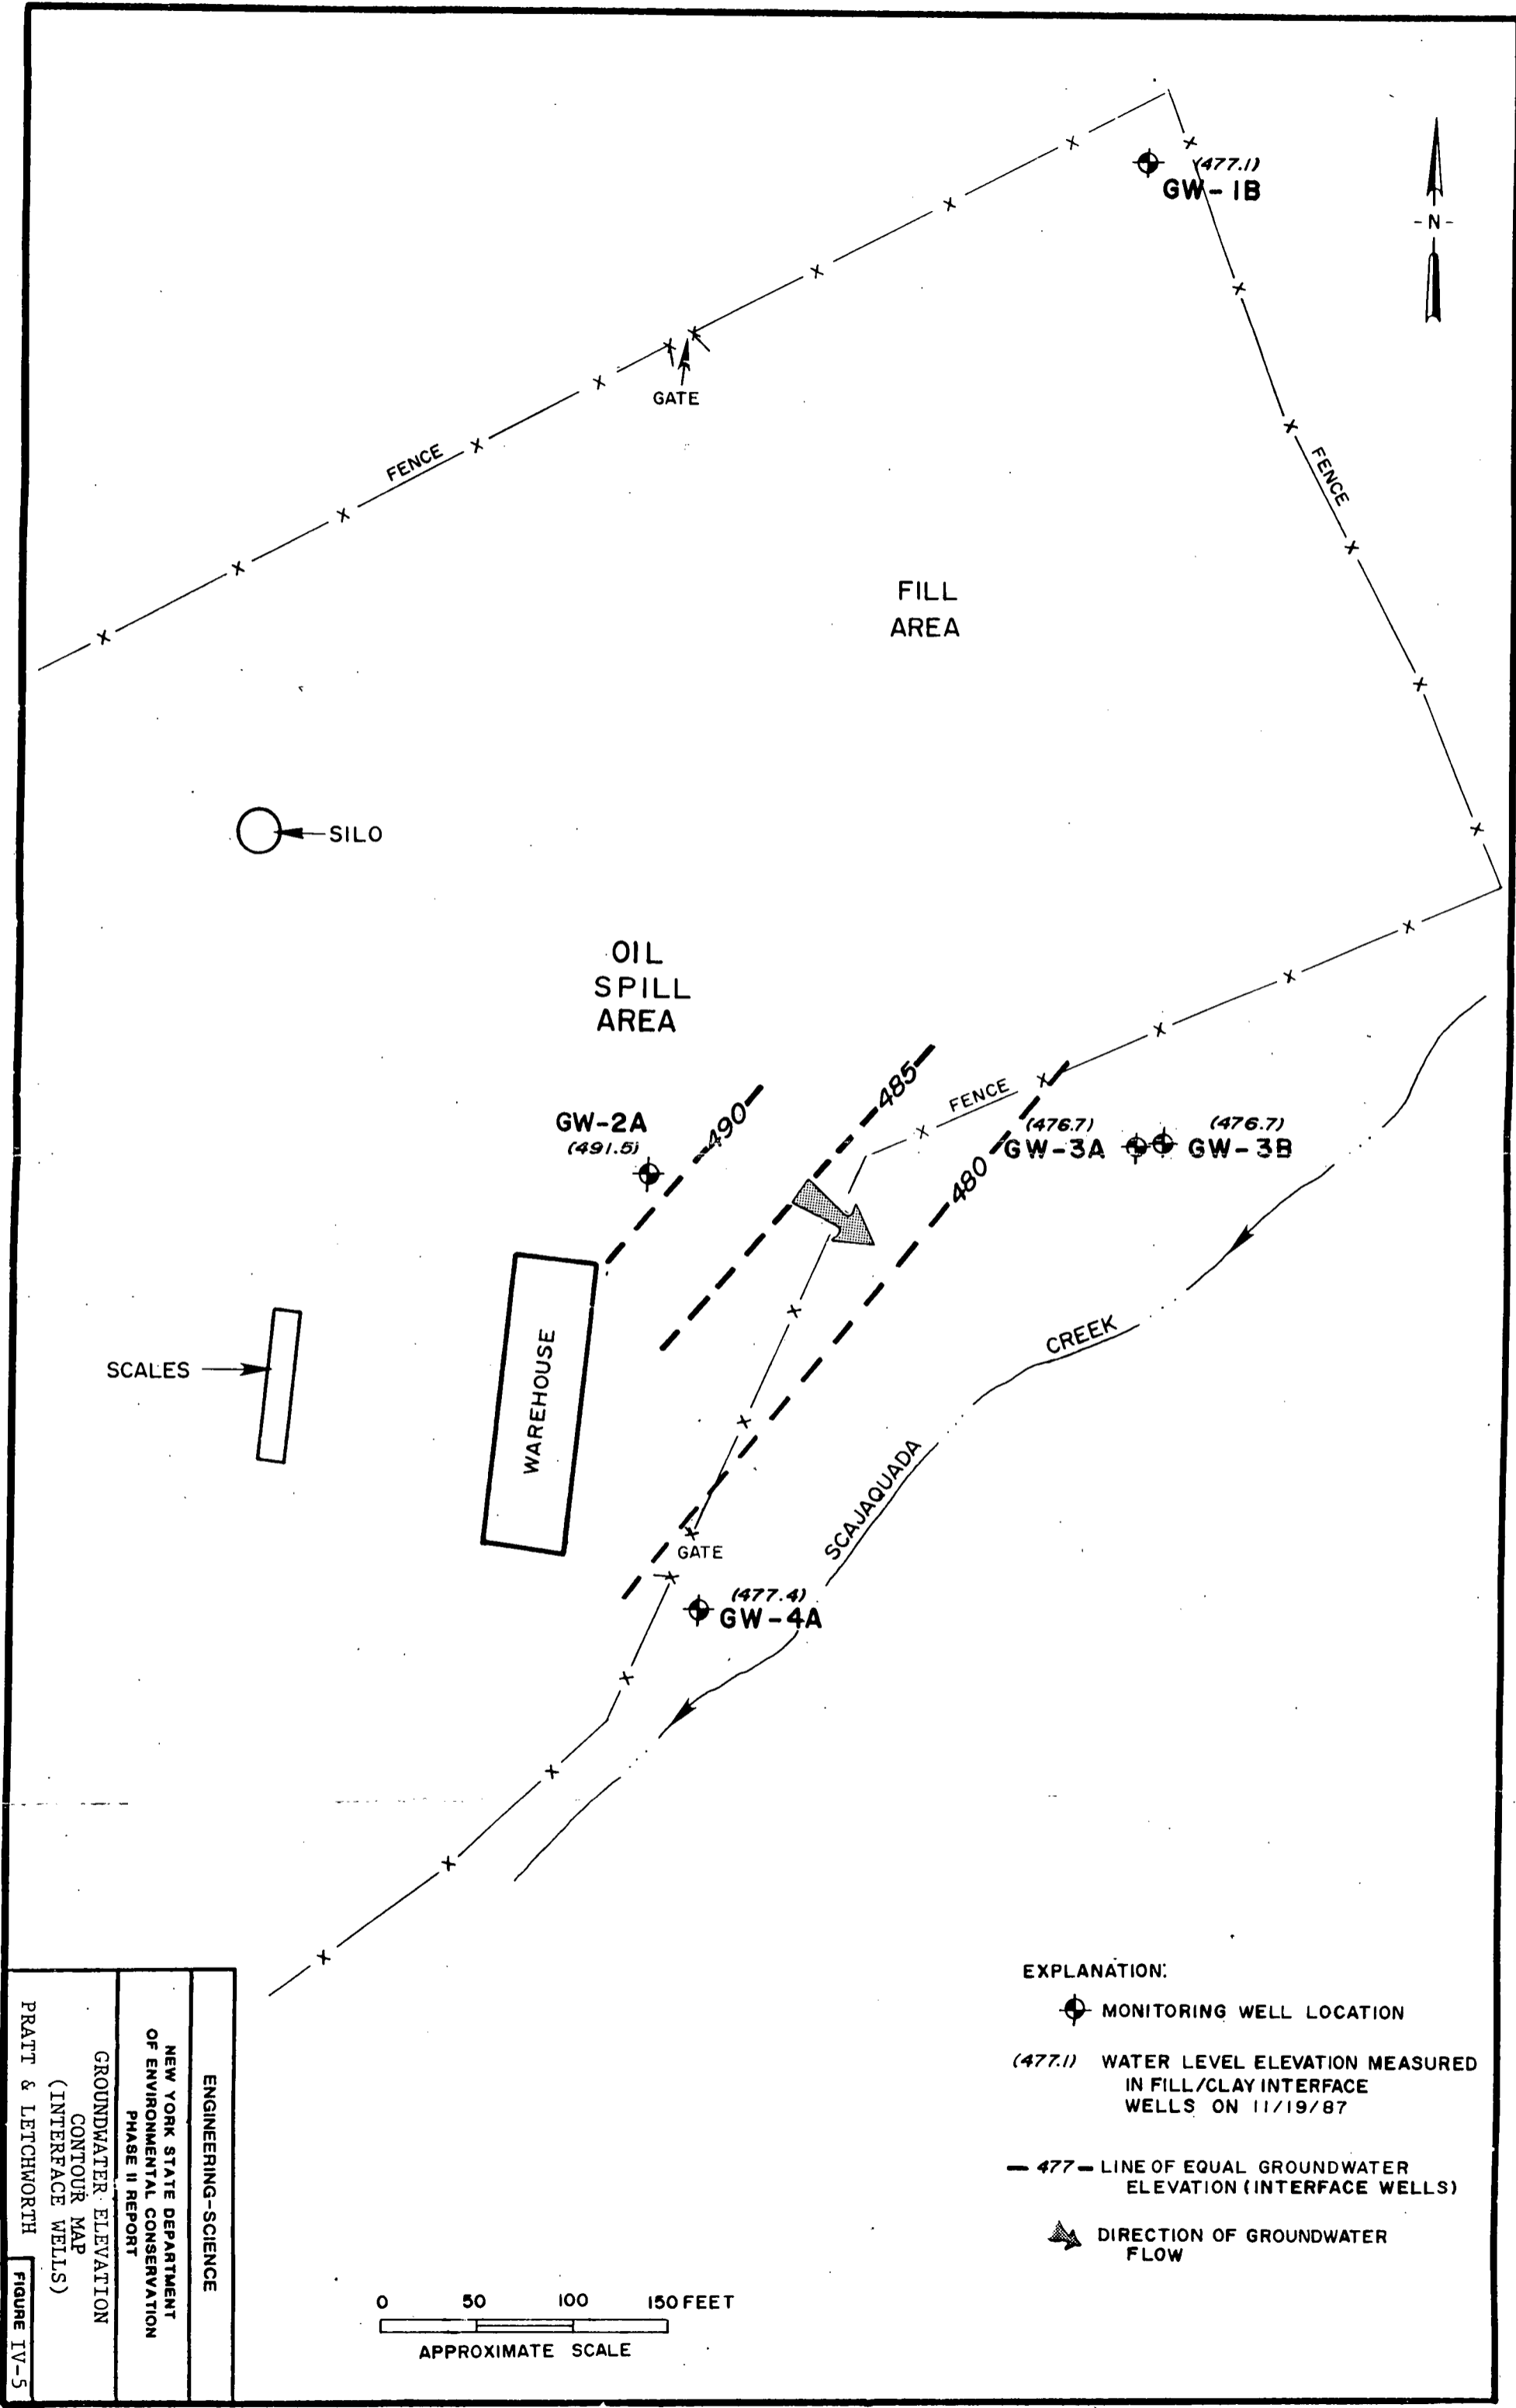
ENGINEERING-SCIENCE NEW YORK STATE DEPARTMENT OF ENVIRONMENTAL CONSERVATION PHASE II REPORT GROUNDWATER ELEVATION CONTOUR MAP (INTERFACE WELLS) PRAIT & LETCHWORTH	
	FIGURE IV-5

Groundwater within the fill/clay interface zone occurs under water table conditions. The depth to groundwater in this zone ranged from about 6 to 17 feet on November 19, 1987 (Table IV-4).

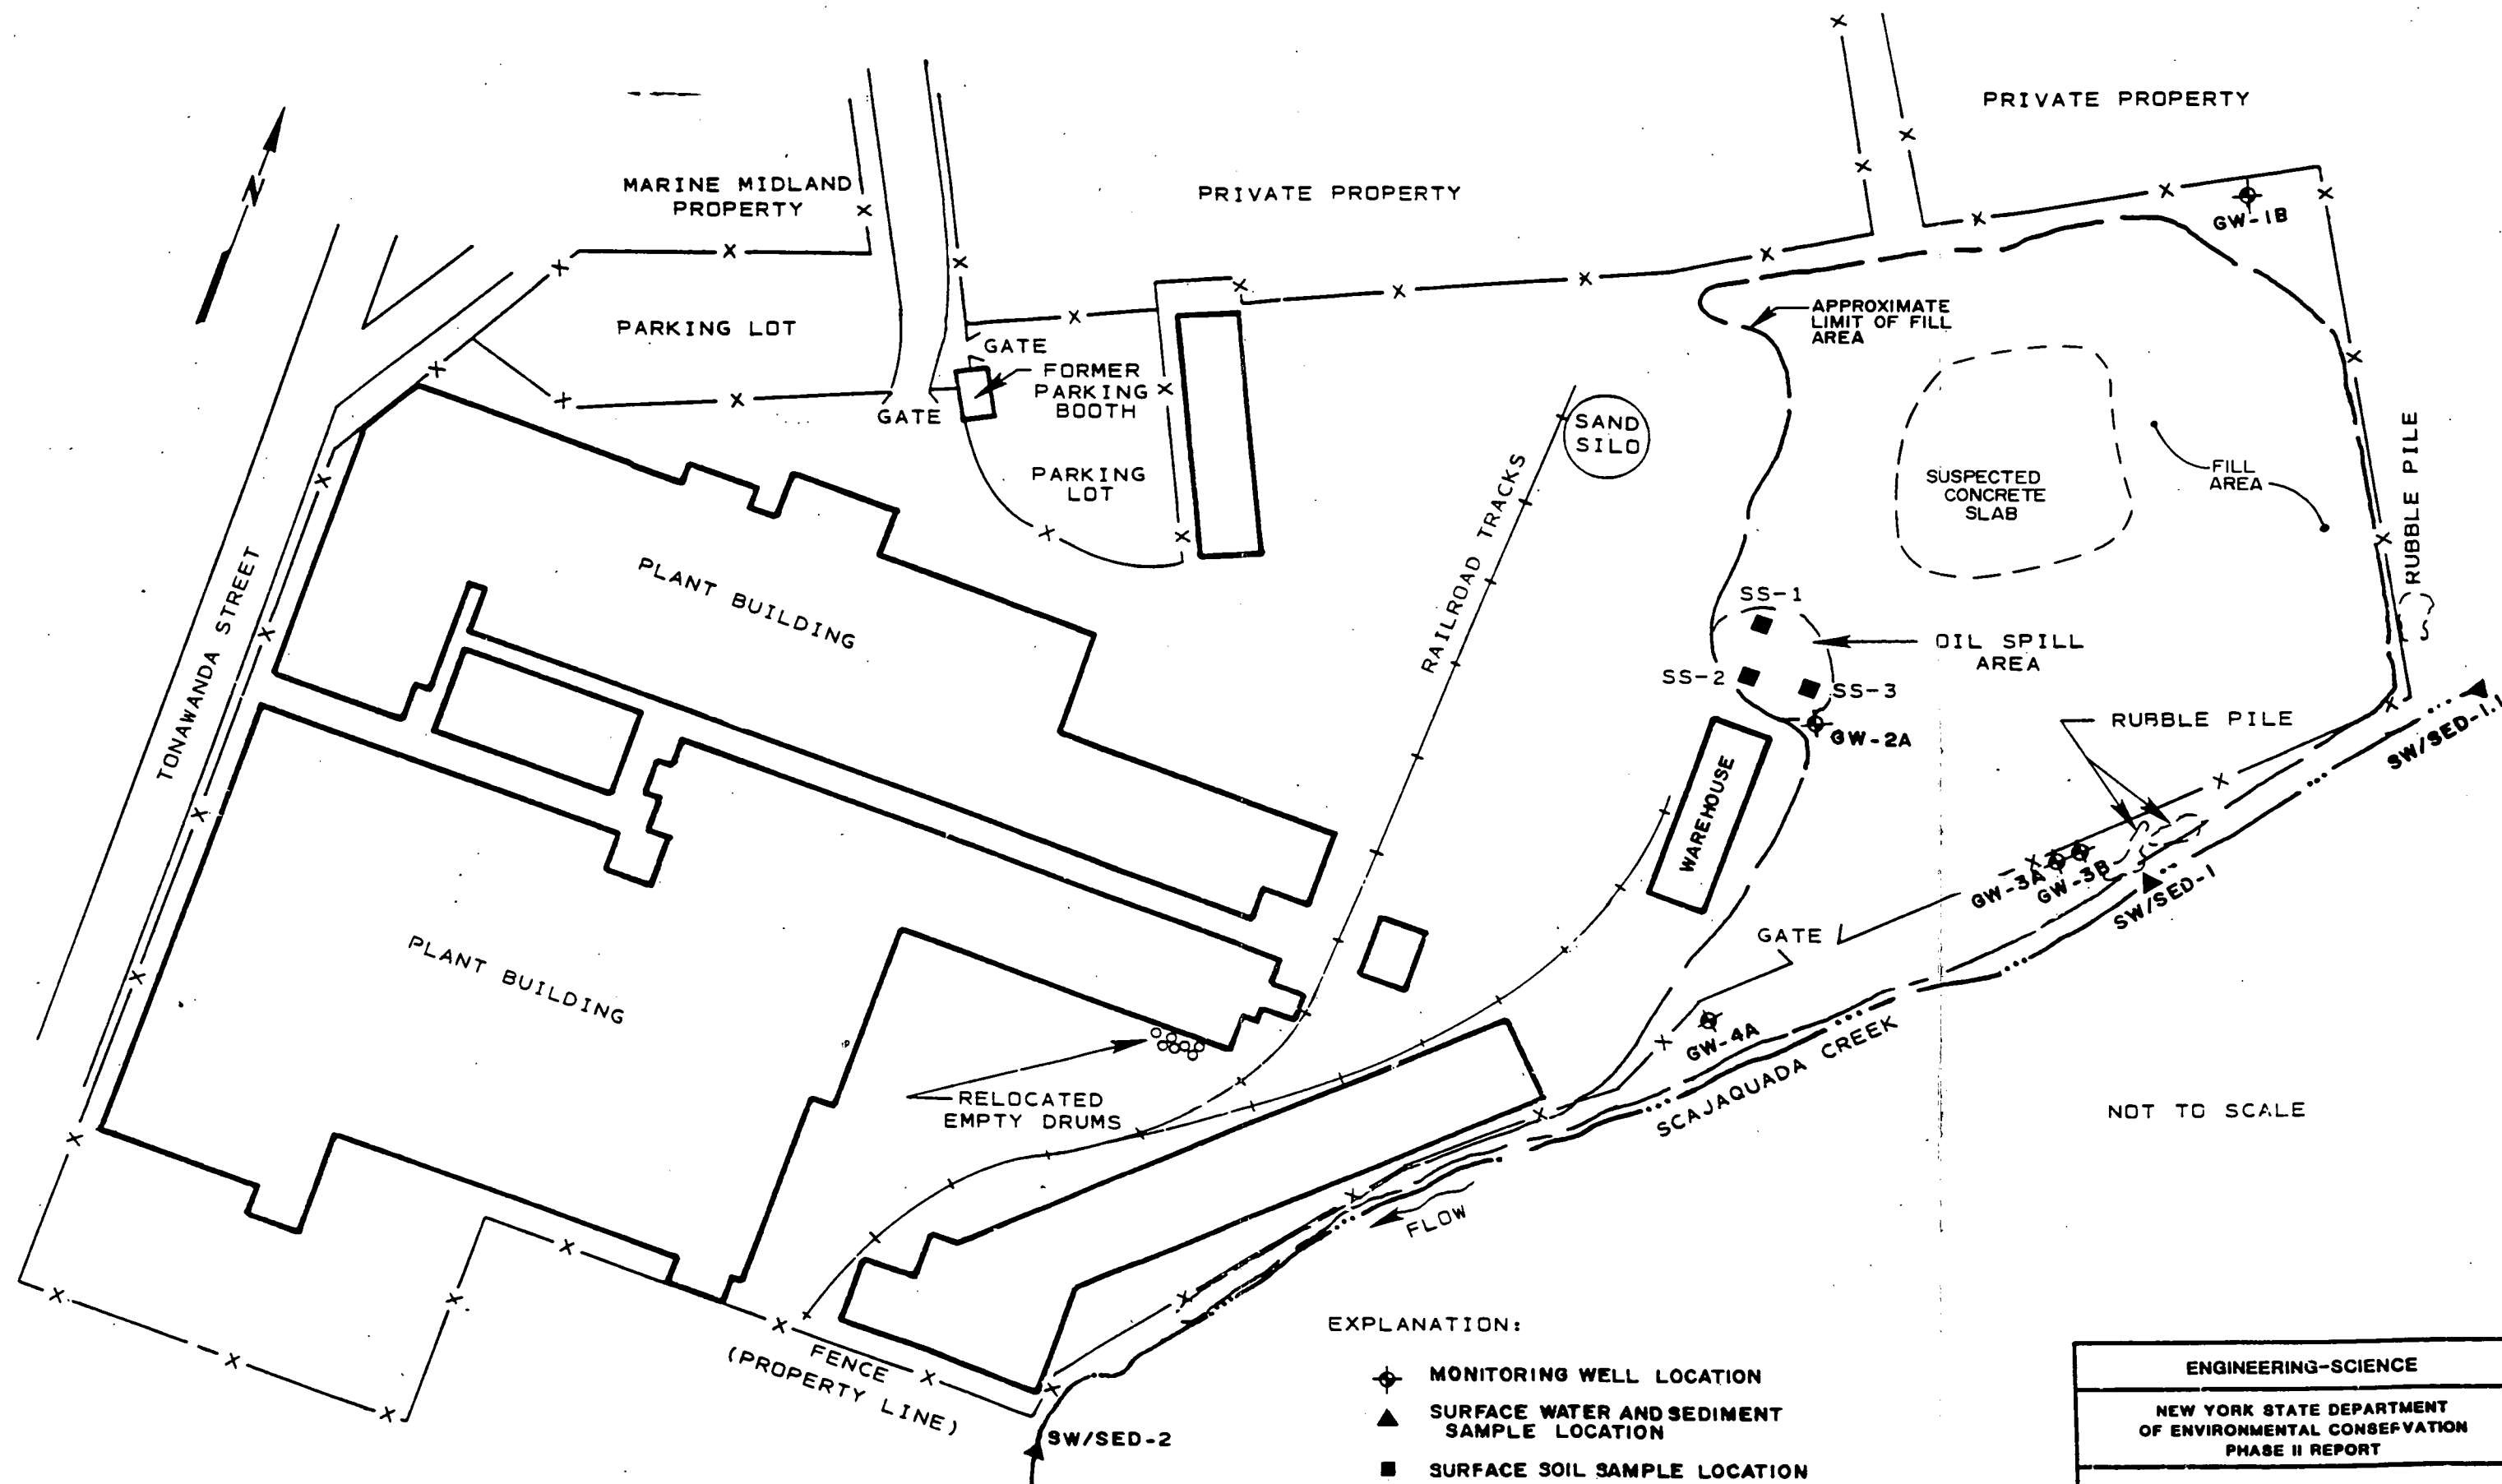
ENGINEERING-SCIENCE
NEW YORK STATE DEPARTMENT OF ENVIRONMENTAL CONSERVATION PHASE II REPORT
SITE PLAN PRATT & LETCHWORTH
FIGURE V-2

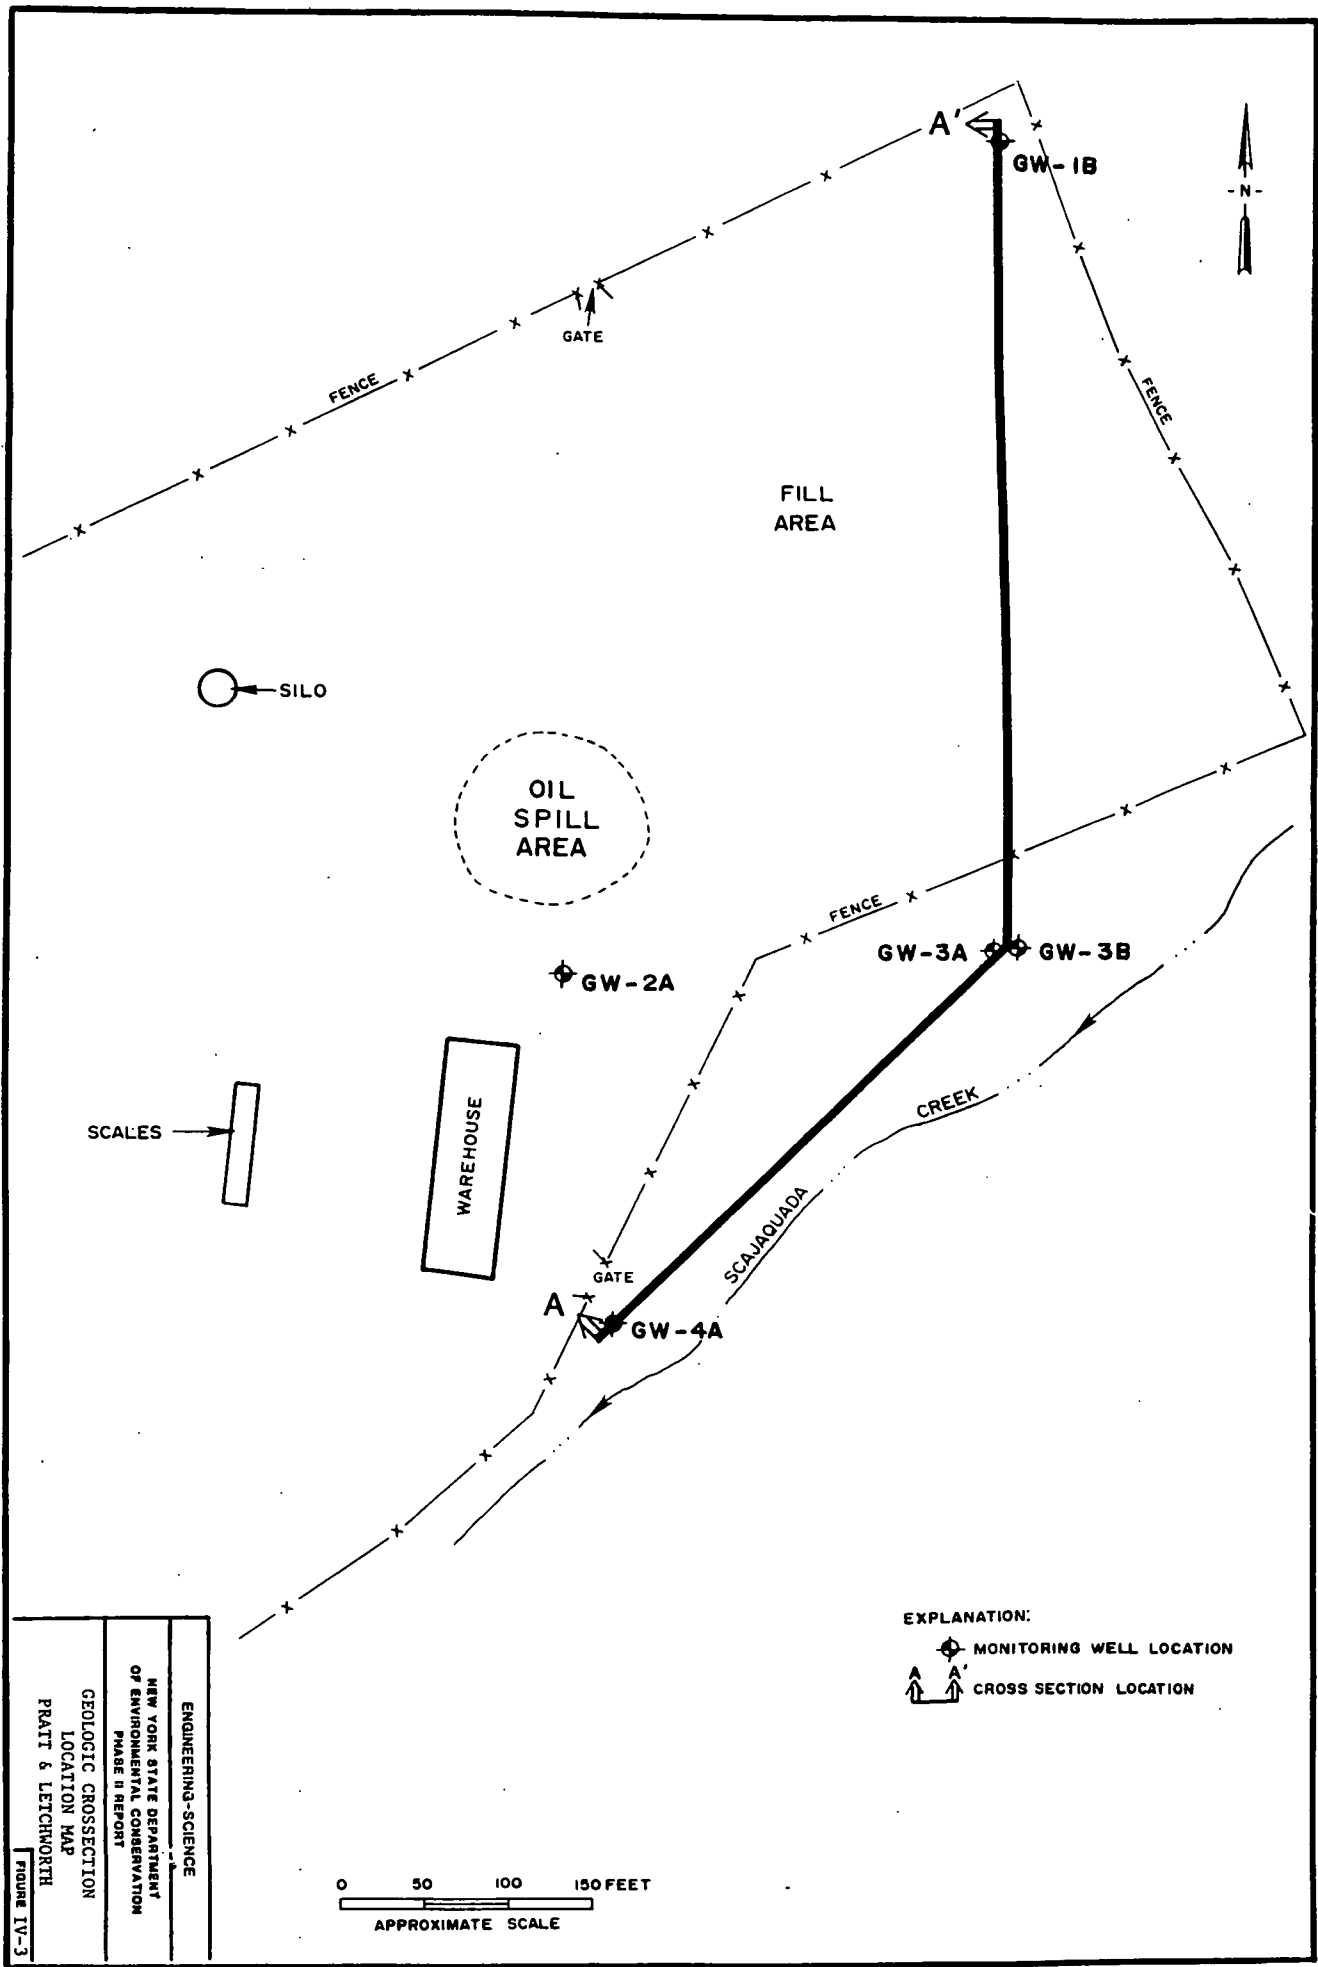
ENGINEERING-SCIENCE
NEW YORK STATE DEPARTMENT
OF ENVIRONMENTAL CONSERVATION
PHASE II REPORT
GEOLOGIC CROSSSECTION
LOCATION MAP
PRAIT & LETCHWORTH
FIGURE IV-3
