ENGINEERING INVESTIGATIONS AT INACTIVE HAZARDOUS WASTE SITES

PHASE I INVESTIGATION

REPUBLIC STEEL, SITE NUMBER: 915047
CITY OF BUFFALO, ERIE COUNTY

June 1989

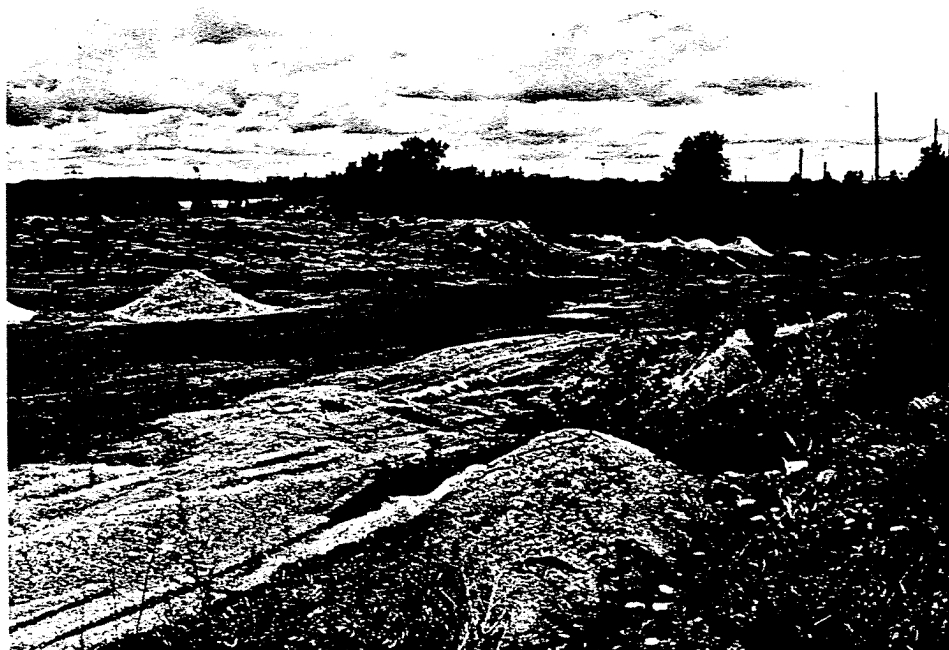
Photographer: A.M. Sienkiewicz
Date/Time: 7/15/87; 10:10
Lens: Type: 35-70 mm
SN: 301285
Frame No.: 22
Comments*: BOF dust from
south.

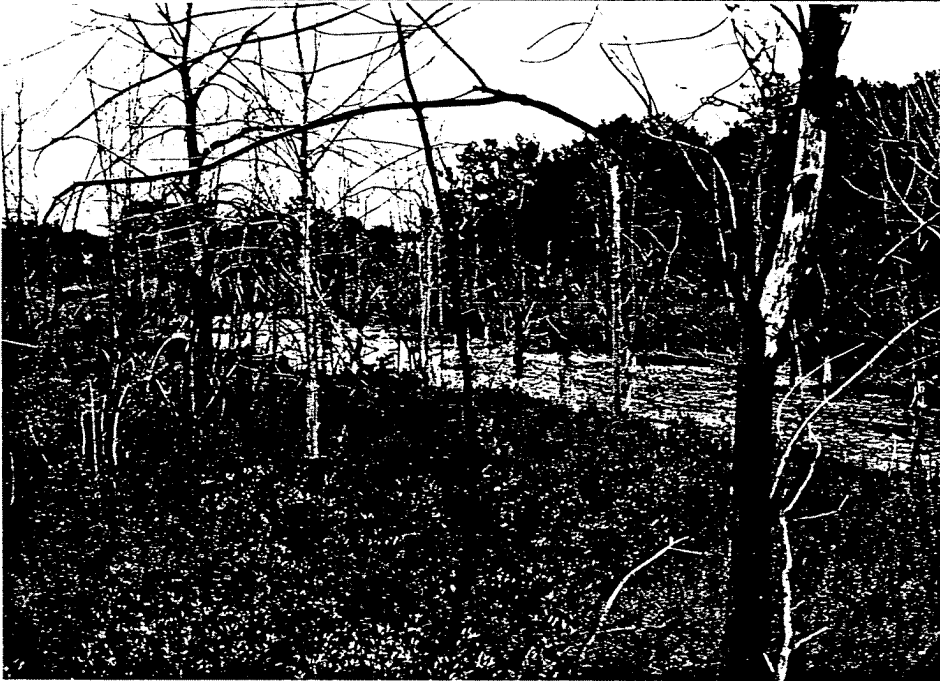
Photographer: A.M. Sienkiewicz
Date/Time: 7/15/87; 10:00
Lens: Type: 35-70 mm
SN: 301285
Frame No.: 23
Comments*: State wetland,
west border, from bridge
looking north.

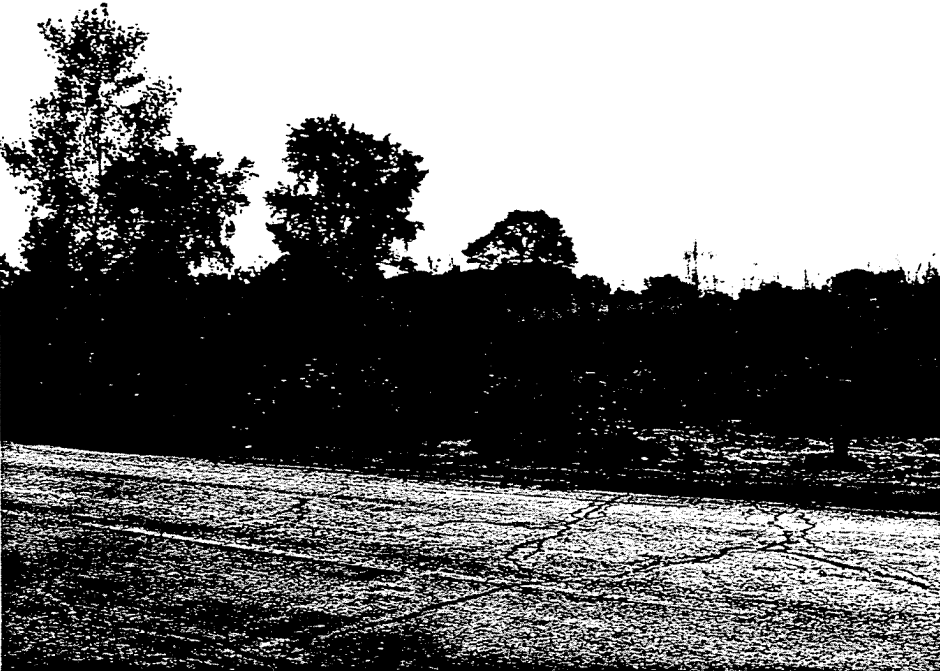
Frame No.: 20

Comments*: State wetland,
looking from west on site.

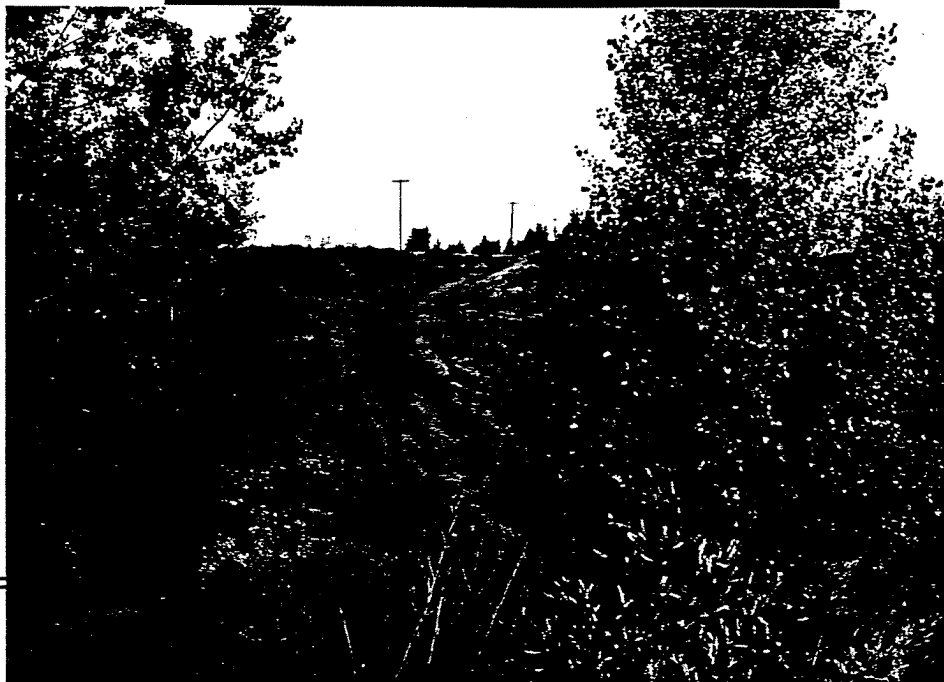
Photographer: A.M. Sienkiewicz
Date/Time: 7/15/87; 10:15
Lens: Type: 35-70 mm
SN: 301285
Frame No.: 24
Comments*: State wetland,
west border, from bridge
looking south.

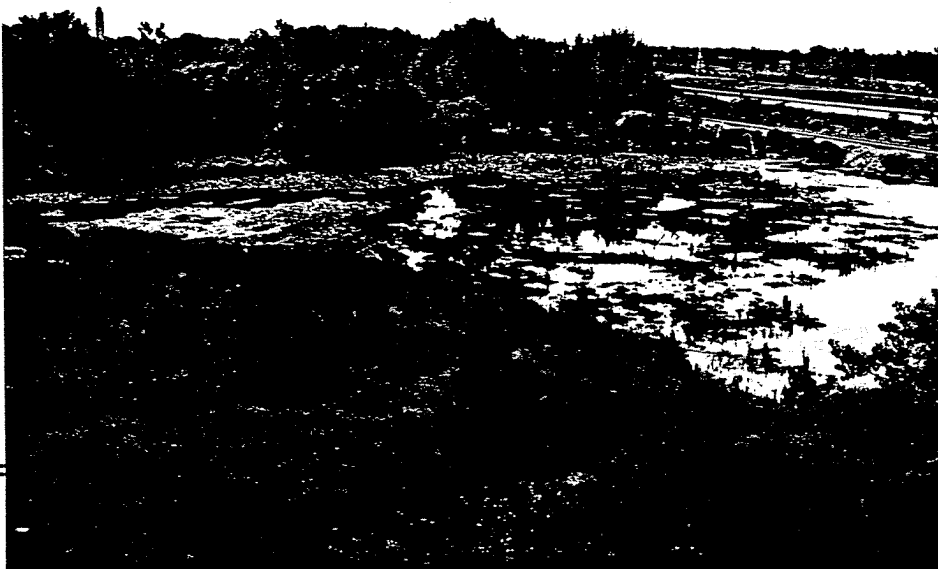
Frame No.: 27

Comments*: State wetland and
swamp at south end of site.

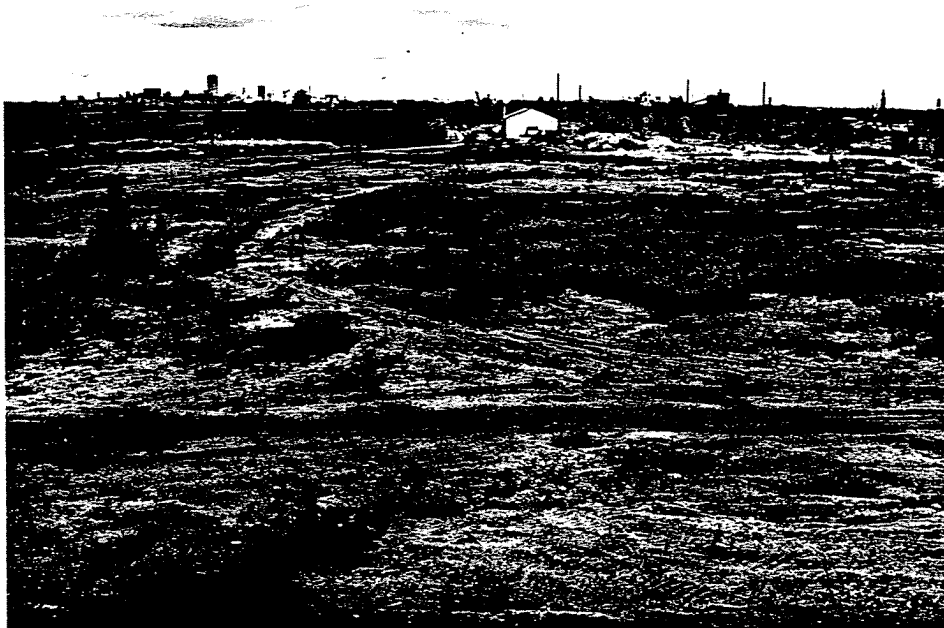
Photographer: A.M. Sienkiewicz
Date/Time: 7/15/87; 10:53
Lens: Type: 35-70 mm
SN: 301285
Frame No.: 29
Comments*: Site from south
high point slag pile.

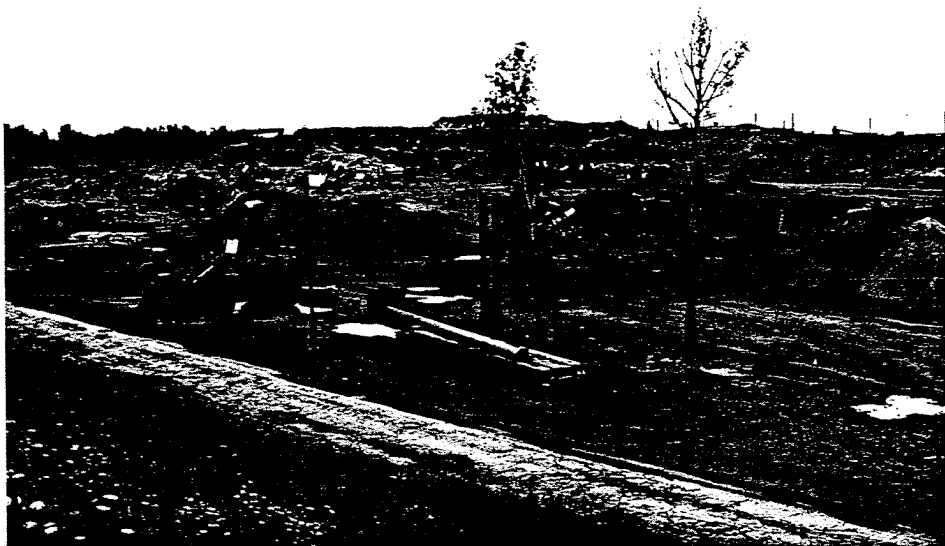
Photographer: A.M. Sienkiewicz
Date/Time: 7/15/87; 10:55
Lens: Type: 35-70 mm
SN: 301285
Frame No.: 30
Comments*: 1 of 5 panoramic
view of excavated vacated area
from Hopkins Street.

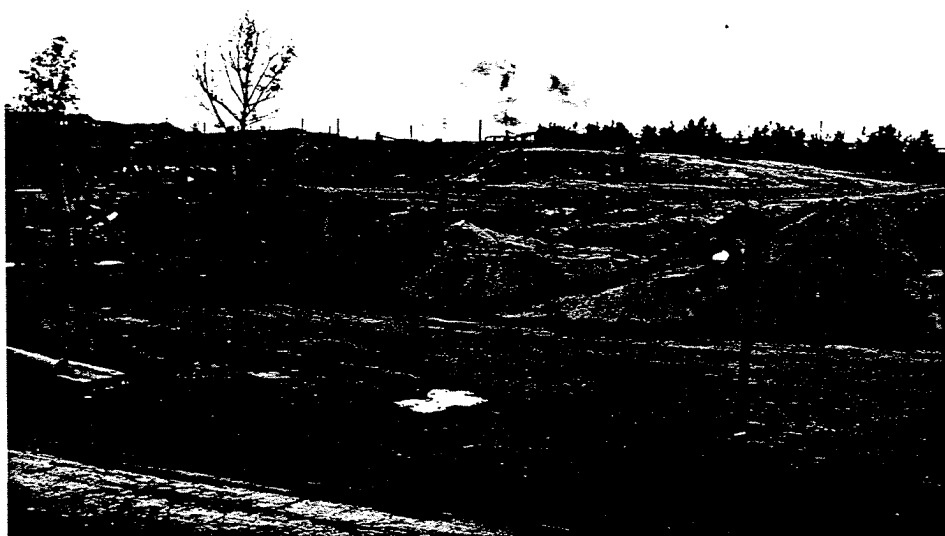
Photographer: A.M. Sienkiewicz
Date/Time: 7/15/87
Lens: Type: 35-70 mm
SN: 301285
Frame No.: 31
Comments*: 2 of 5 panoramic
view of excavated vacated area
from Hopkins Street.

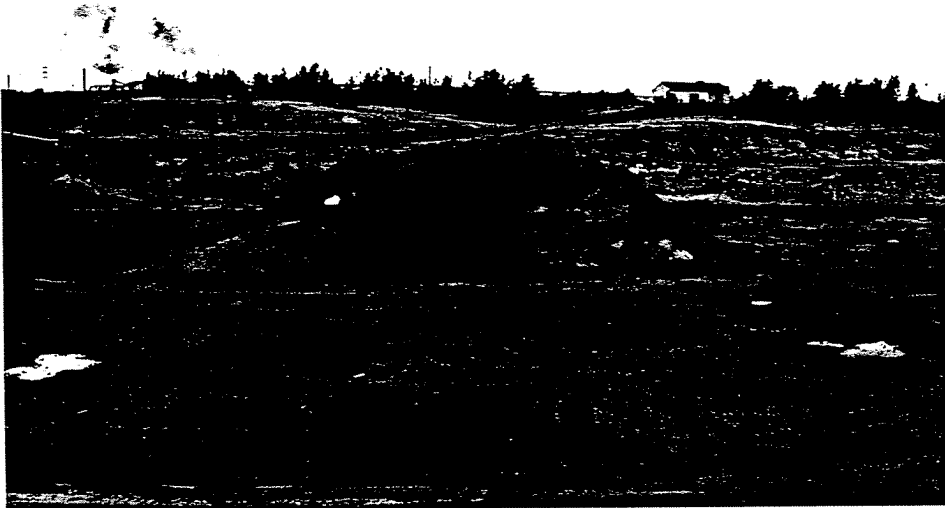
Photographer: A.M. Sienkiewicz
Date/Time: 7/15/87; 10:55
Lens: Type: 35-70 mm
SN: 301285
Frame No.: 32
Comments*: 3 of 5 panoramic
view of excavated vacated area
from Hopkins Street.

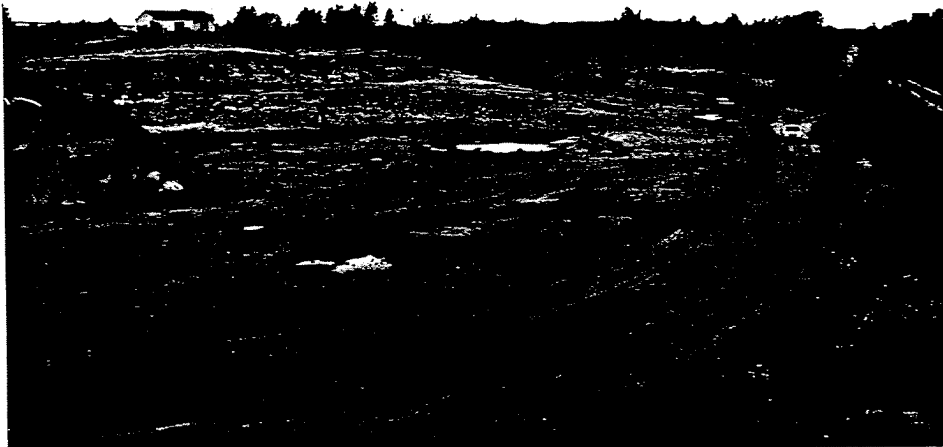
Photographer: A.M. Sienkiewicz
Date/Time: 7/15/87
Lens: Type: 35-70 mm
SN: 301285
Frame No.: 33
Comments*: 4 of 5 panoramic
view of excavated vacated area
from Hopkins Street.

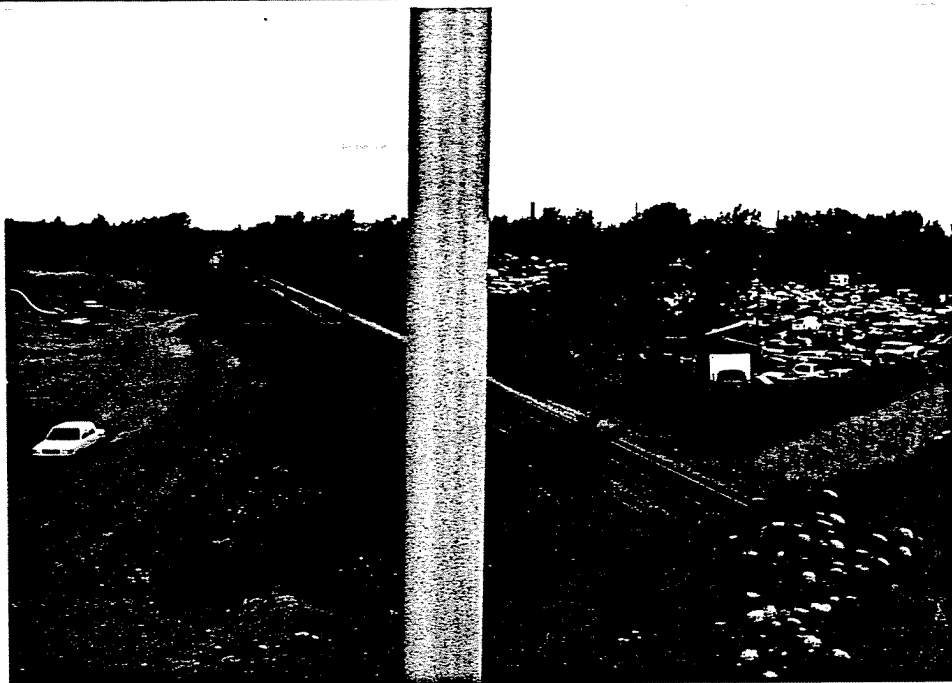
Photographer: A.M. Sienkiewicz
Date/Time: 7/15/87; 10:55
Lens: Type: 35-70 mm
SN: 301285
Frame No.: 34
Comments*: 5 of 5 panoramic
view of excavated vacated area
from Hopkins Street.
