**FOCUSED FEASIBILITY STUDY  
FOR THE MARILLA STREET LANDFILL WETLANDS**

**LTV STEEL COMPANY  
CLEVELAND, OHIO**

**FEBRUARY 1996**

**MALCOLM PIRNIE, INC.**

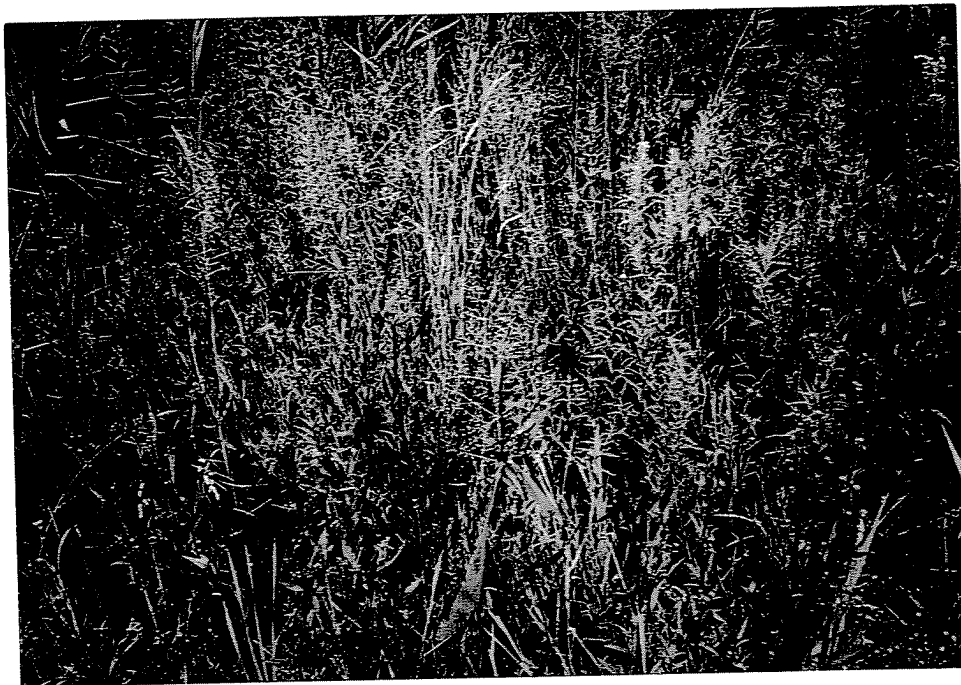
PHOTO #1  
Wetland delineation flag A-1.  
View is from Marilla Street looking east into North Ditch.

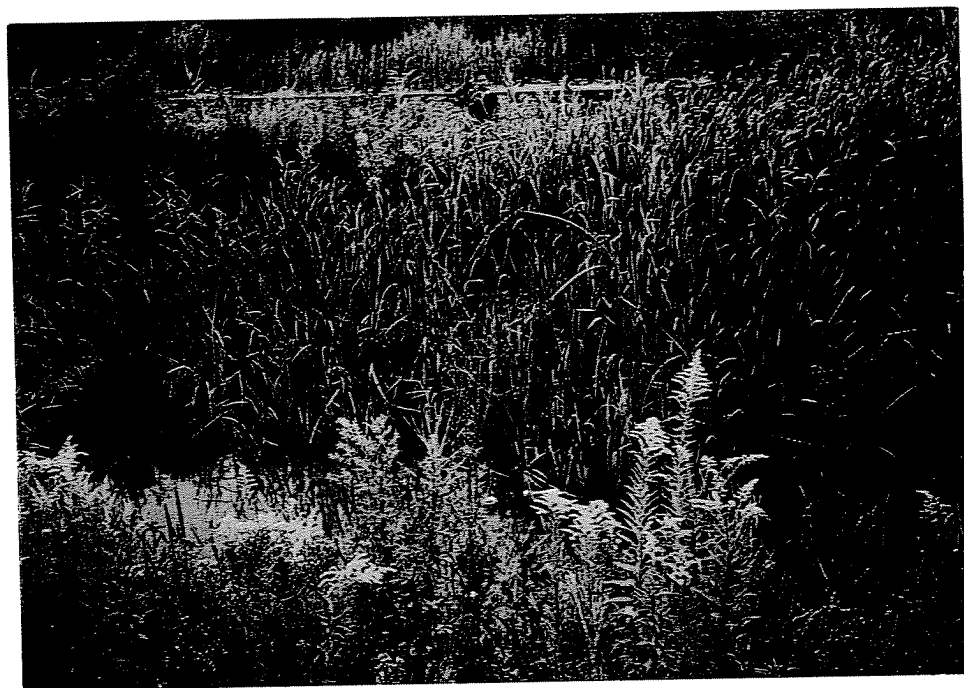
PHOTO #2  
Both A-5 wetland delineation flags.  
View is to the northeast from the landfill toe-of-slope into North Ditch.

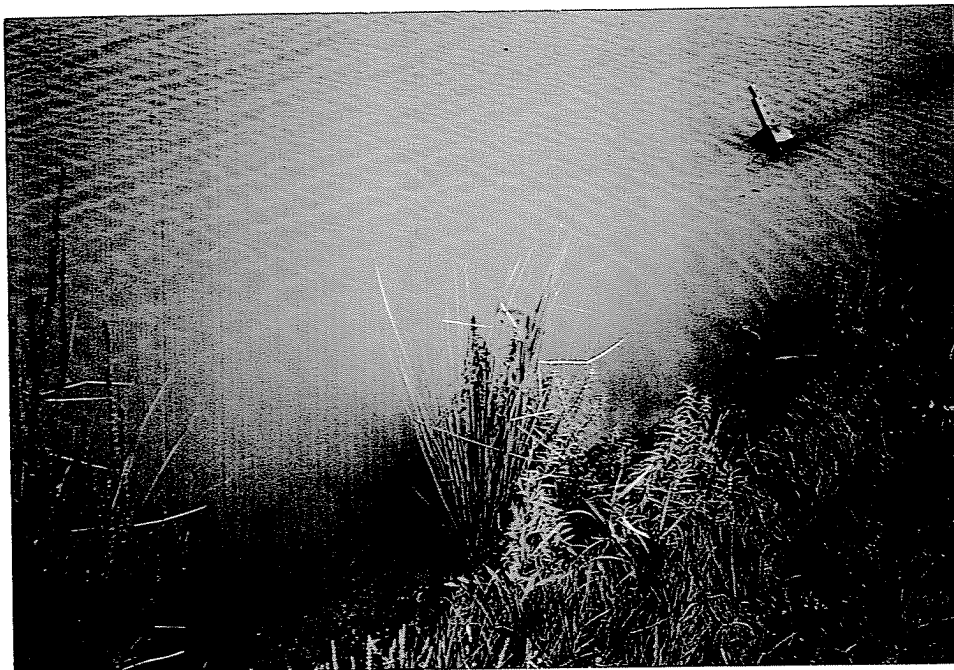
PHOTO #3  
Wetland delineation flag B-1.  
View is from the landfill toe-of-slope looking into North Pond West.

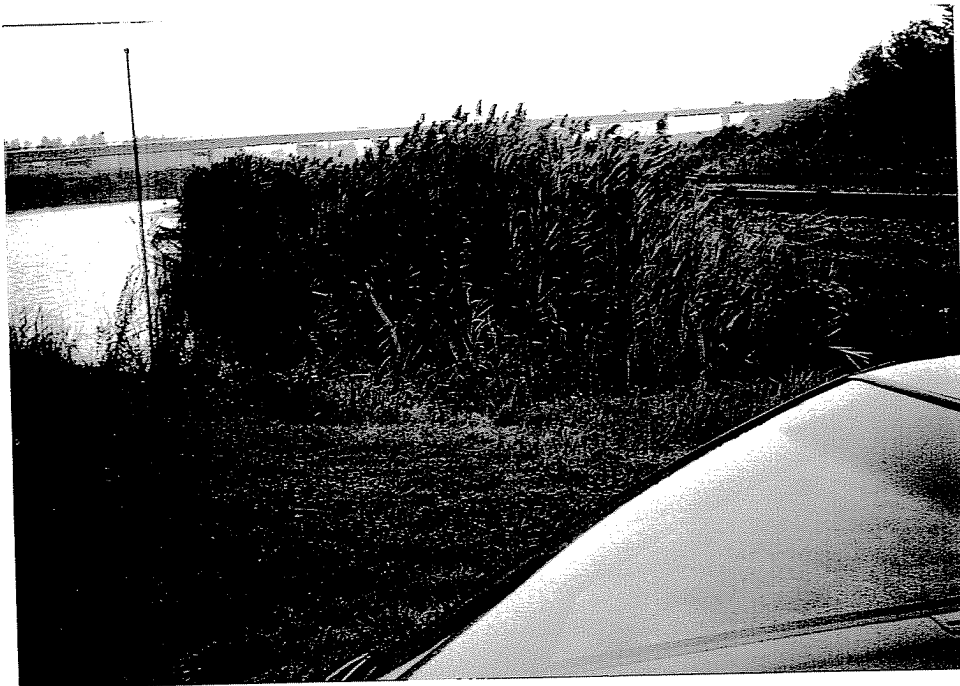
PHOTO #5  
Wetland delineation flags B-4 and C-1.  
View is from the landfill toe-of-slope looking north at  
wetland C adjacent to North Pond West.

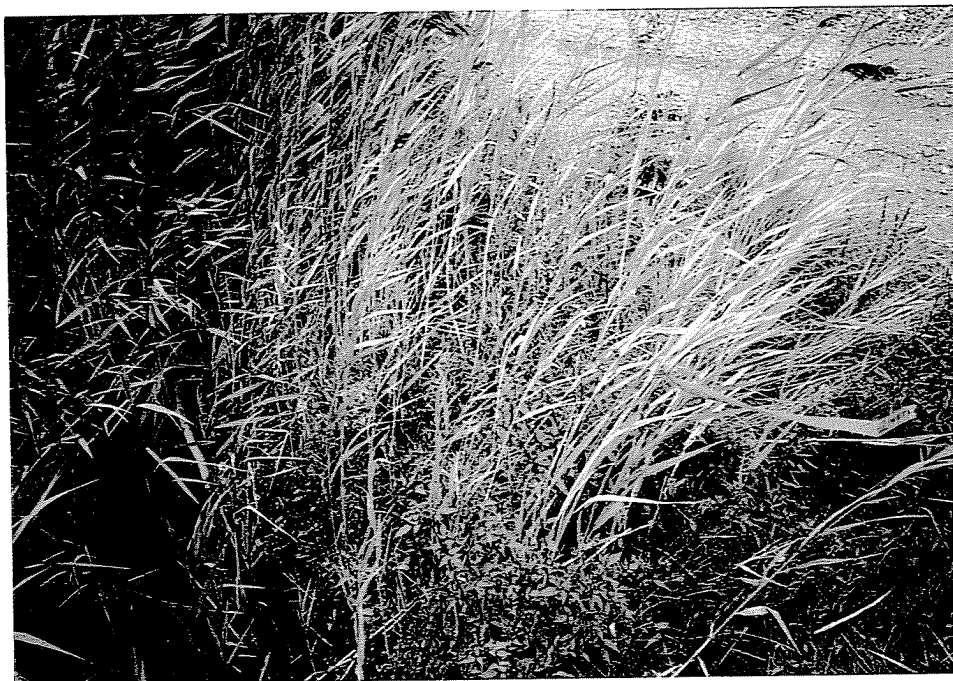
PHOTO #6  
Wetland delineation flag C-1.  
View is from the landfill toe-of-slope looking north into wetland.

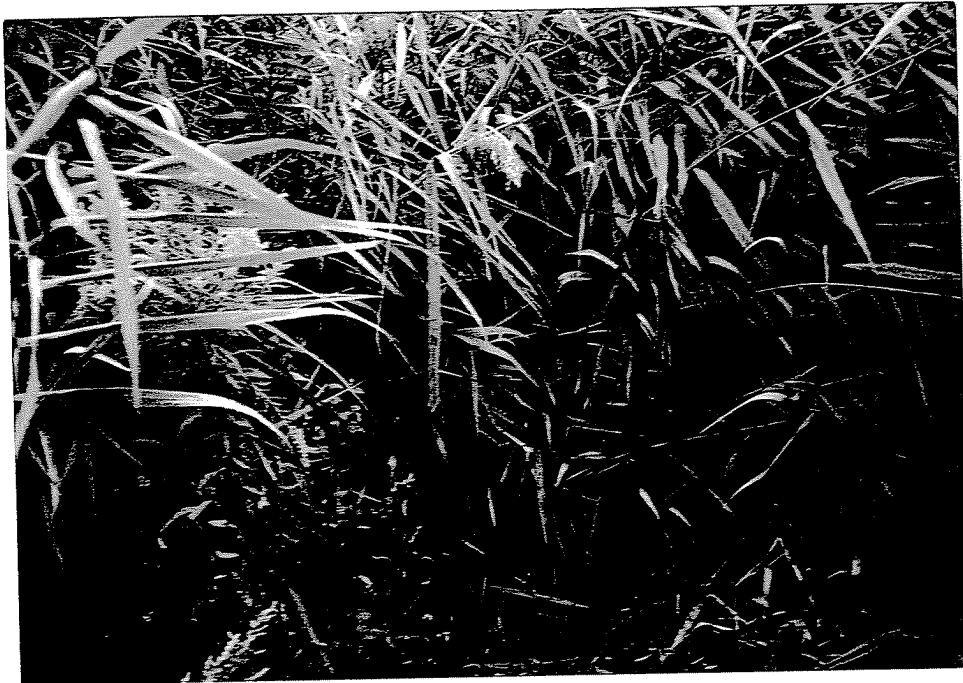
PHOTO #8  
Wetland delineation flag E-1.  
View is from the landfill toe-of-slope looking west into West Ditch.

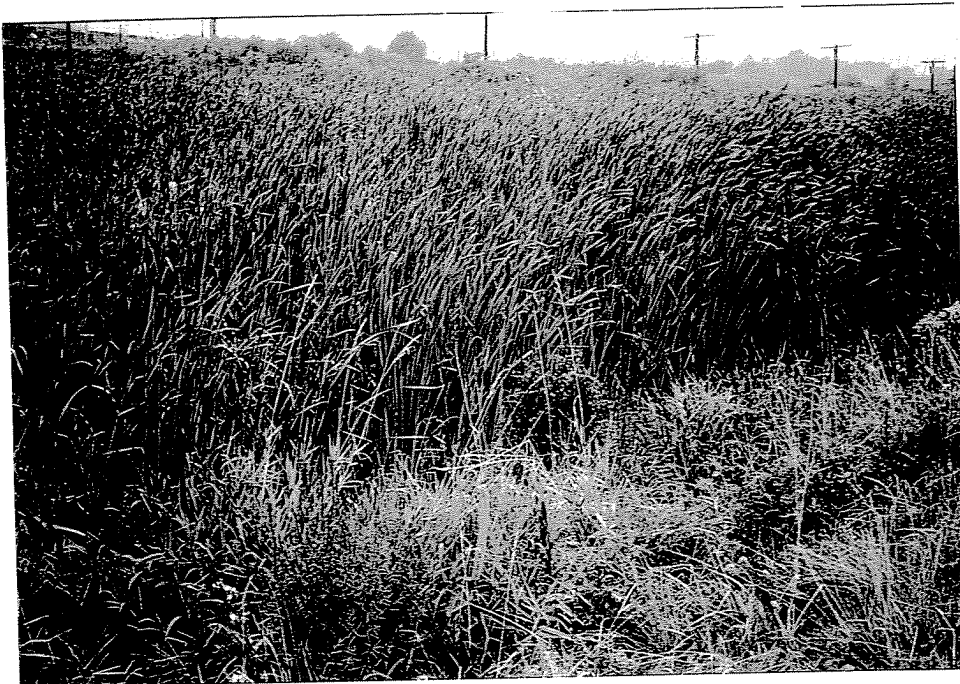
PHOTO #9

Wetland delineation flag E-7.

View is from the landfill toe-of-slope looking west into West Ditch.

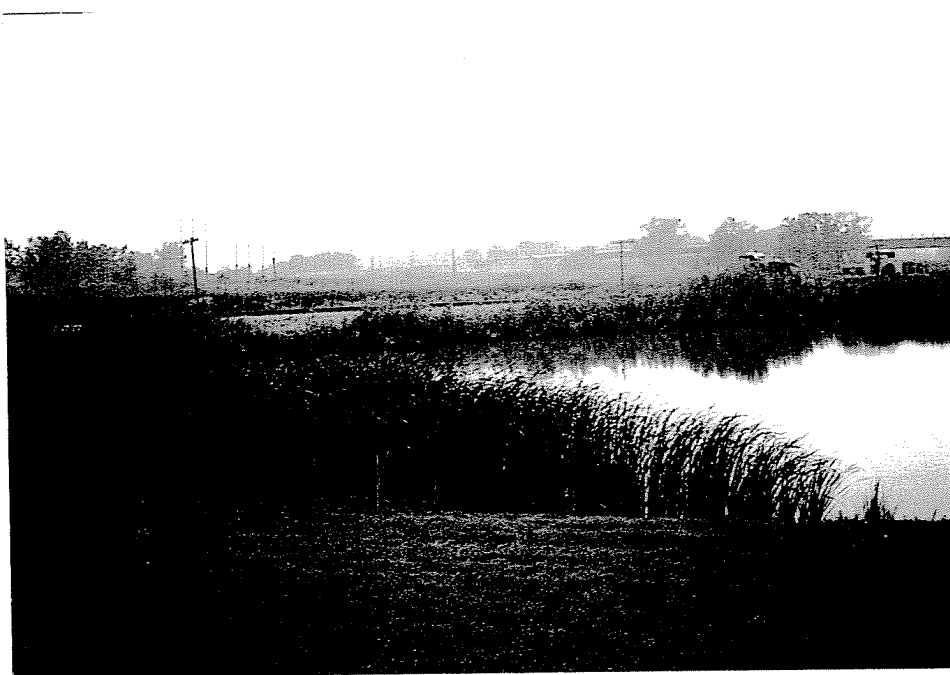
PHOTO #10

Wetland delineation flags E-13 and B-2.

View is from the landfill toe-of-slope looking northwest into North Pond West.

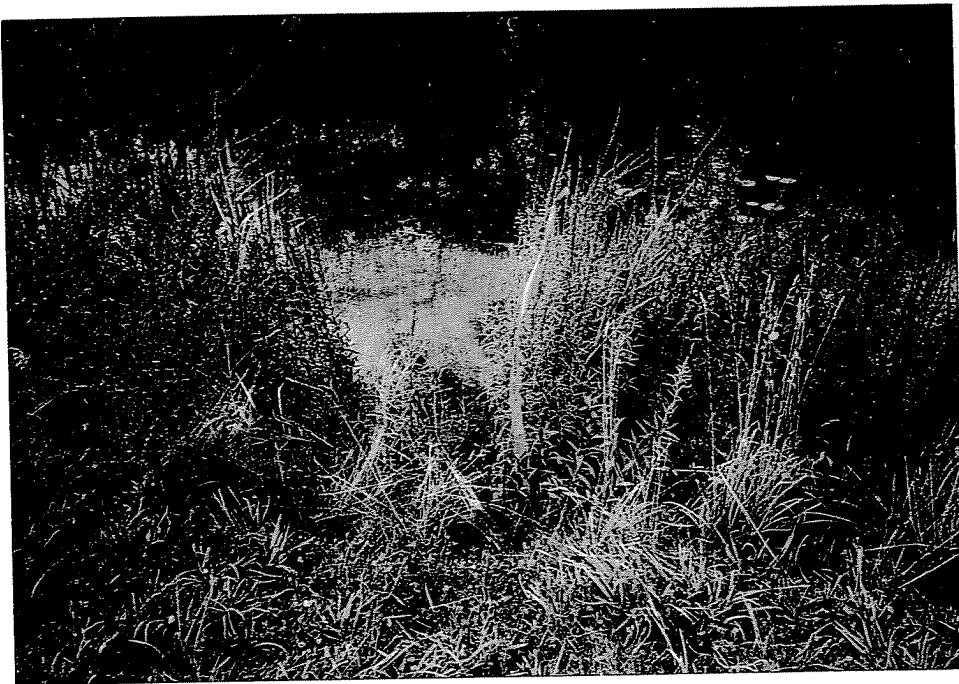
PHOTO #11  
Wetland delineation flag F-1.  
View is from the landfill toe-of-slope looking west into West Ditch.

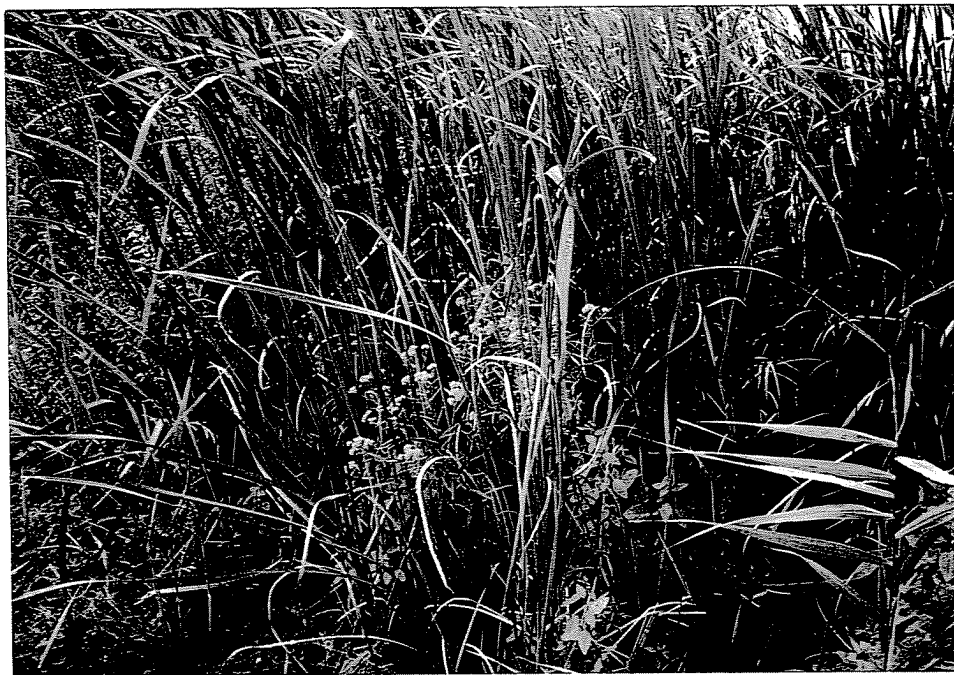
PHOTO #12  
Wetland delineation flag G-1.  
View is from the landfill toe-of-slope looking southwest into South Pond.

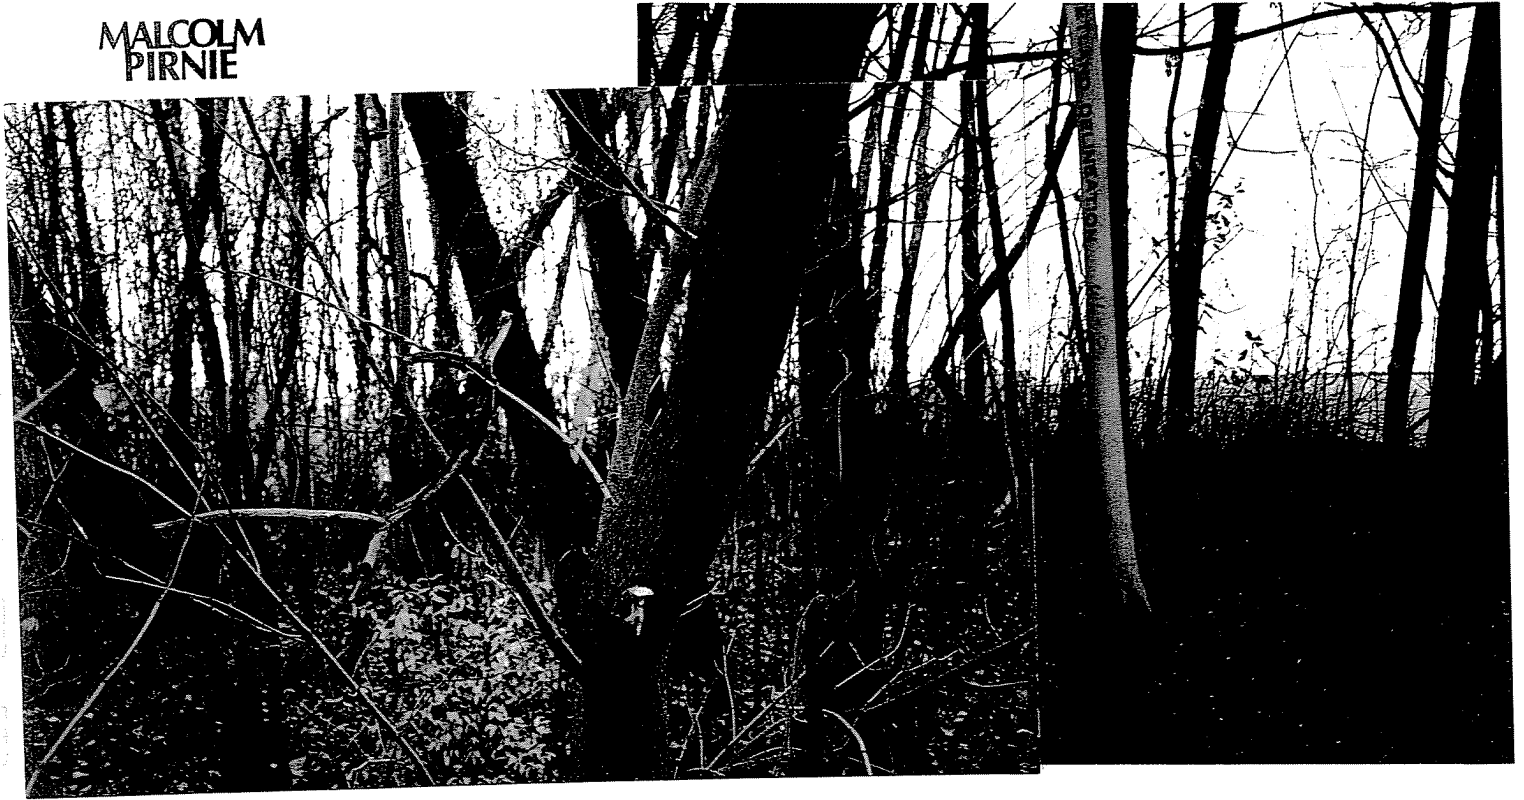
**Photo #1 - Site west of Hopkins Street**

**Description:** Looking north at floodplain wetland near flag #3. The West Ditch and closed

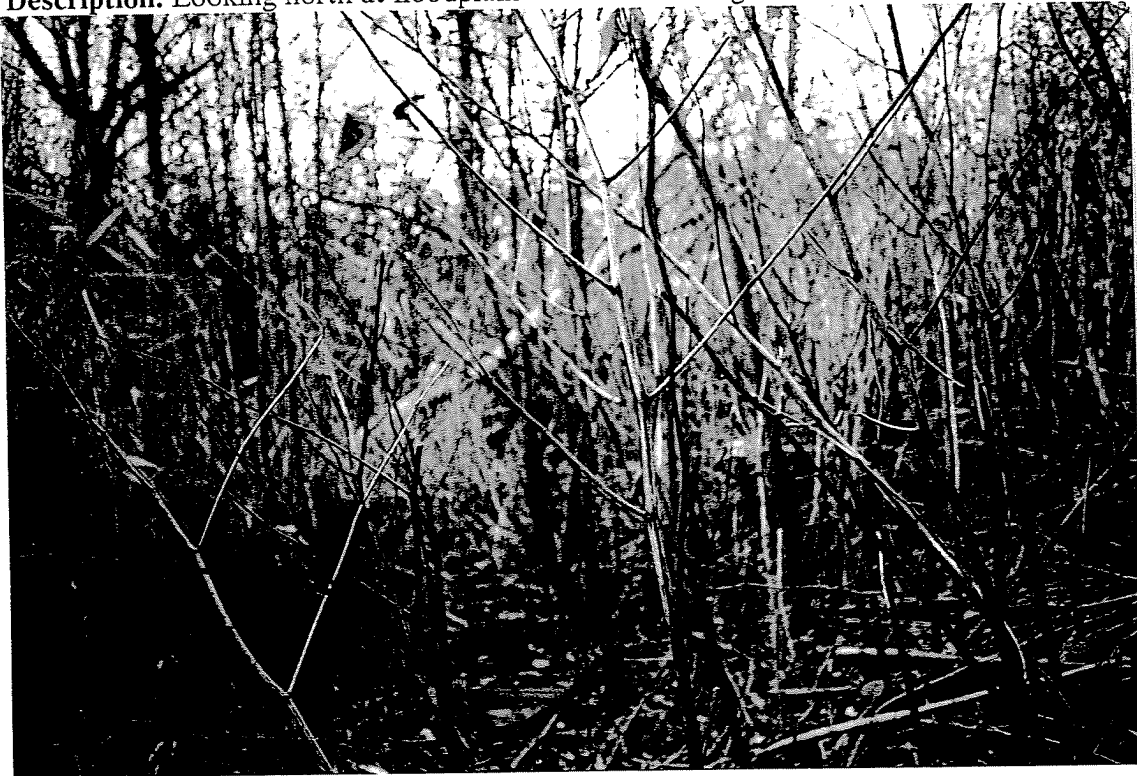
**Photo #2 - Site west of Hopkins Street**

**Description:** Looking east at upland dominated by Japanese knotweed in area near flag #3.

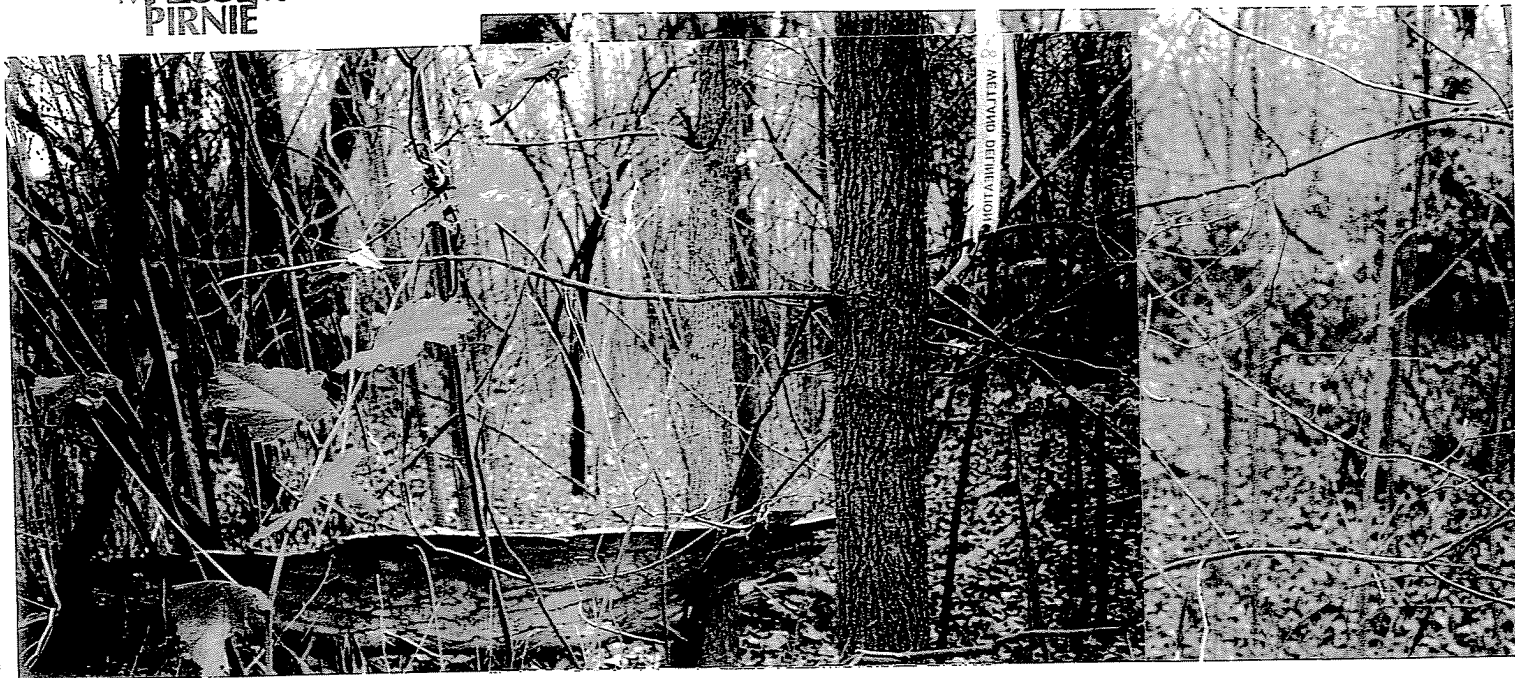
**Photo #3 - Site West of Hopkins Street**

**Description:** Looking north at upland/wetland interface near flag #8. The area is typical of the floodplain wetlands located between Hopkins Street and the West Ditch.

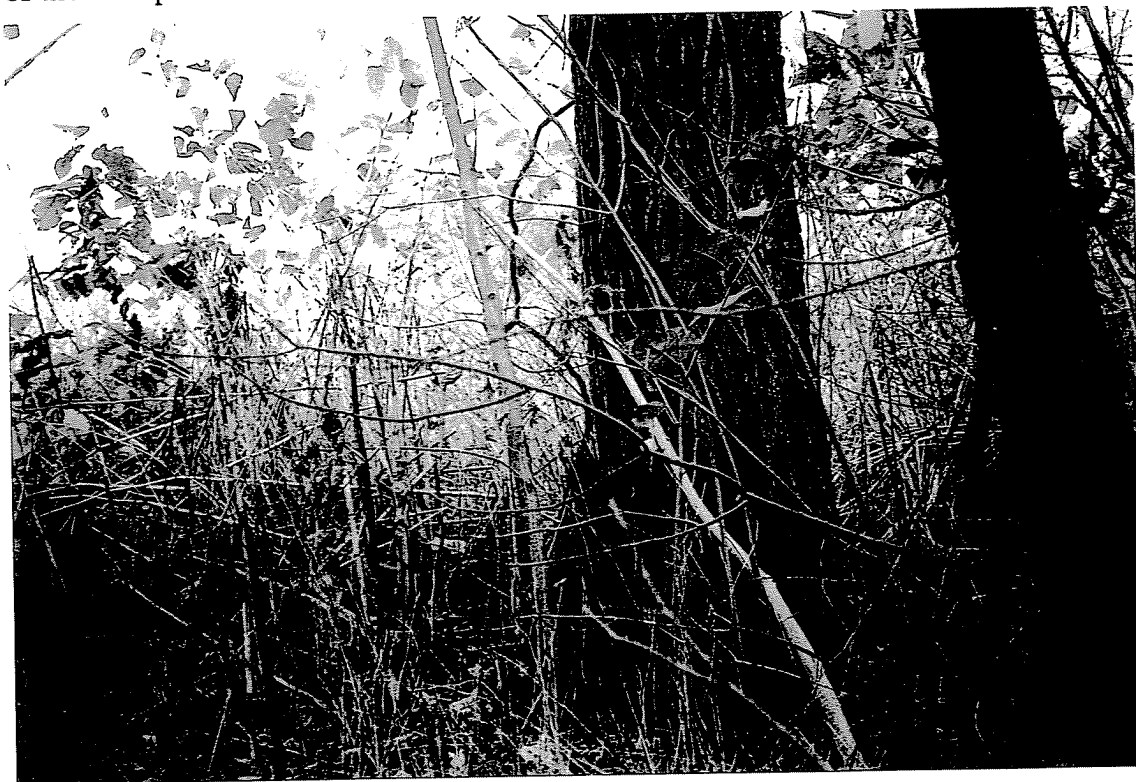
**Photo #4 - Site west of Hopkins Street**

**Description:** Looking east near flag #8 at upland dominated by Japanese knotweed.

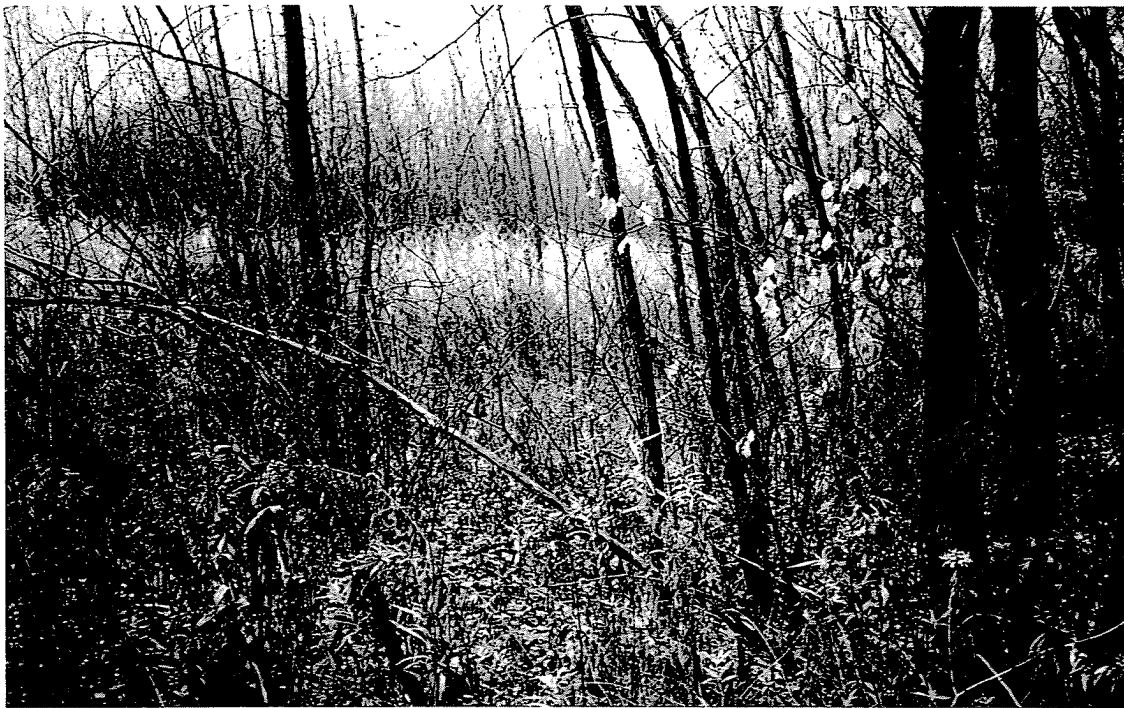
**Photo #5 - Site west of Hopkins Street**

**Description:** Typical upland/wetland interface in the mid-section of the site. *Phragmites* dominate the wetland area and red-osier dogwood is common in the transition area between upland and wetland.

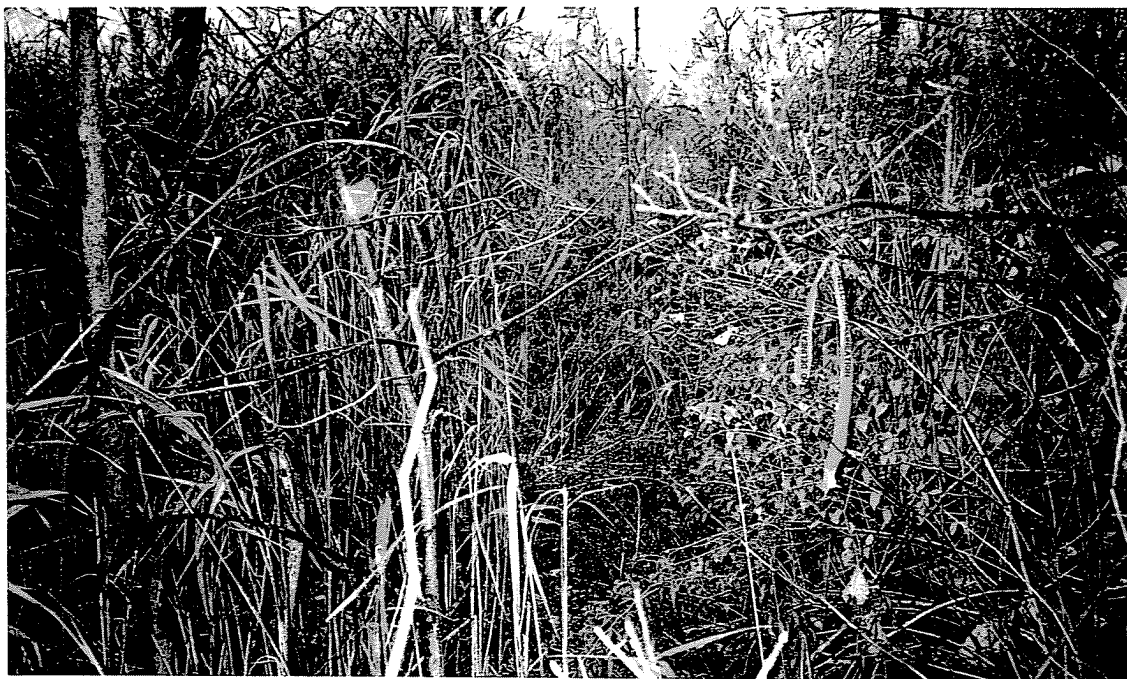
**Photo #6 - Site west of Hopkins Street**

**Description:** Upland/wetland interface in area near South Pond. *Phragmites* dominates the wetland, Japanese knotweed dominates the upland.

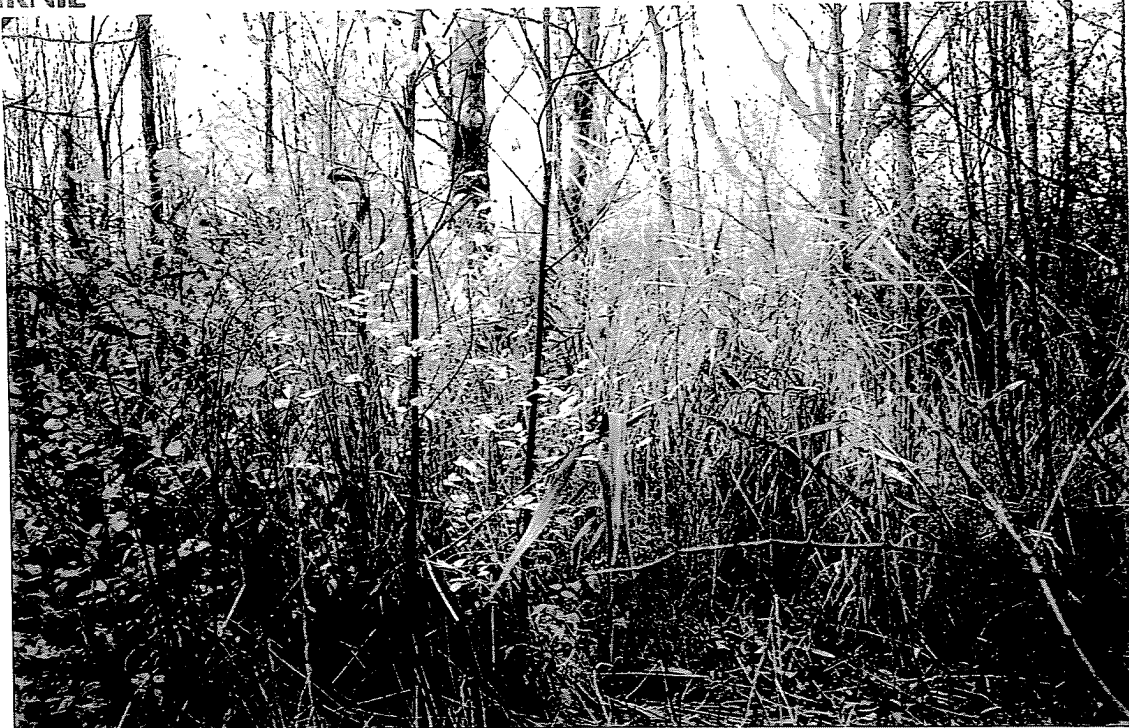
**Photo #7 - Site west of Hopkins Street**

**Description:** Looking northwest in the area near South Pond. Wetlands dominated by *Phragmites*, Tartarian honeysuckle and eastern cottonwood are common in the transition area between upland and wetland.

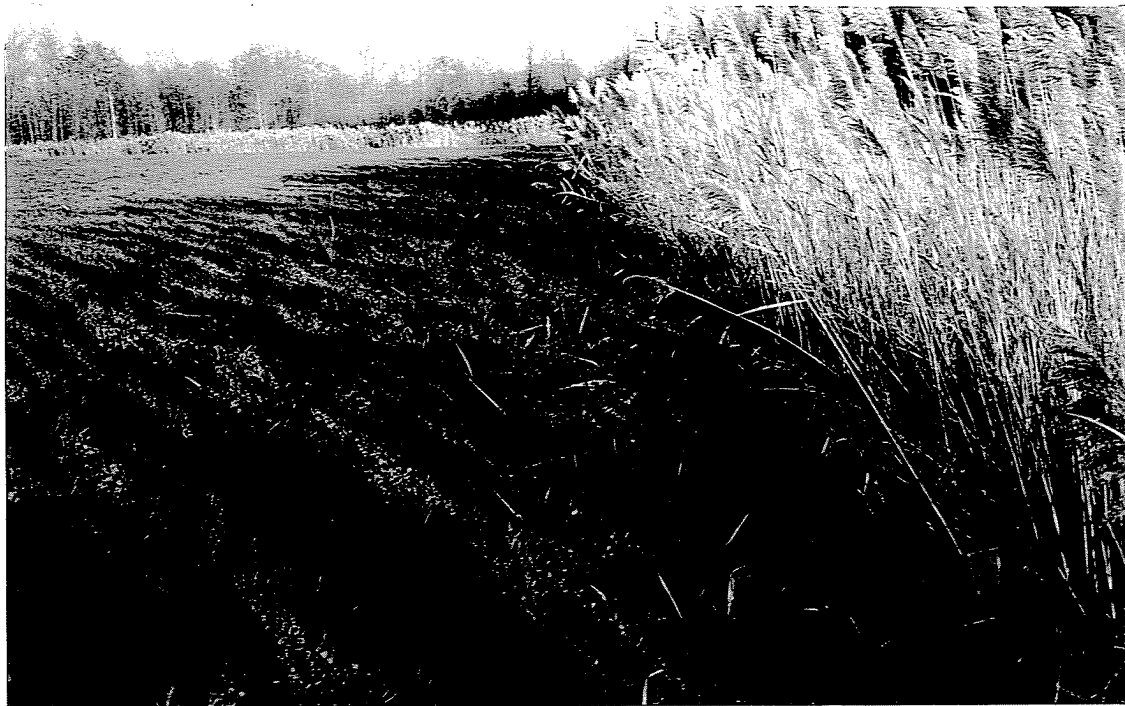
**Photo #8 - Site west of Hopkins Street**

**Description:** Looking east along boundary of the West Ditch and closed landfill.

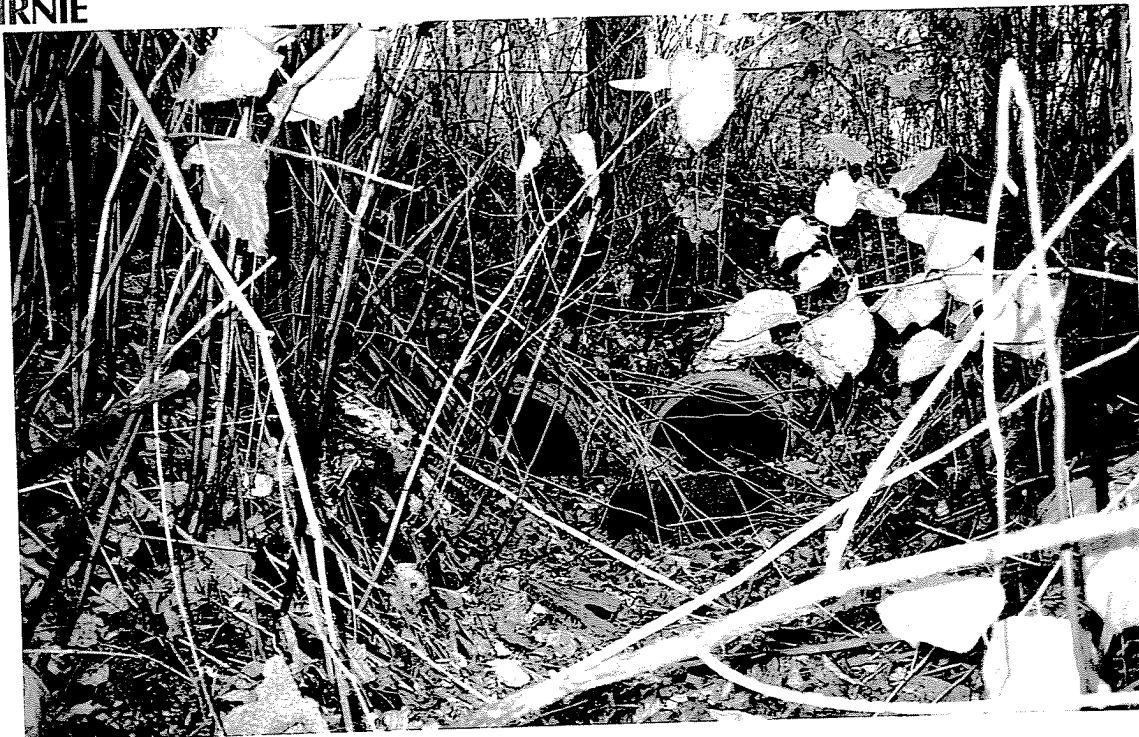
**Photo #9 - Site west of Hopkins Street**

**Description:** Twin culvert provide the hydrologic connection between the wetland east of Hopkins Street and the South Pond.

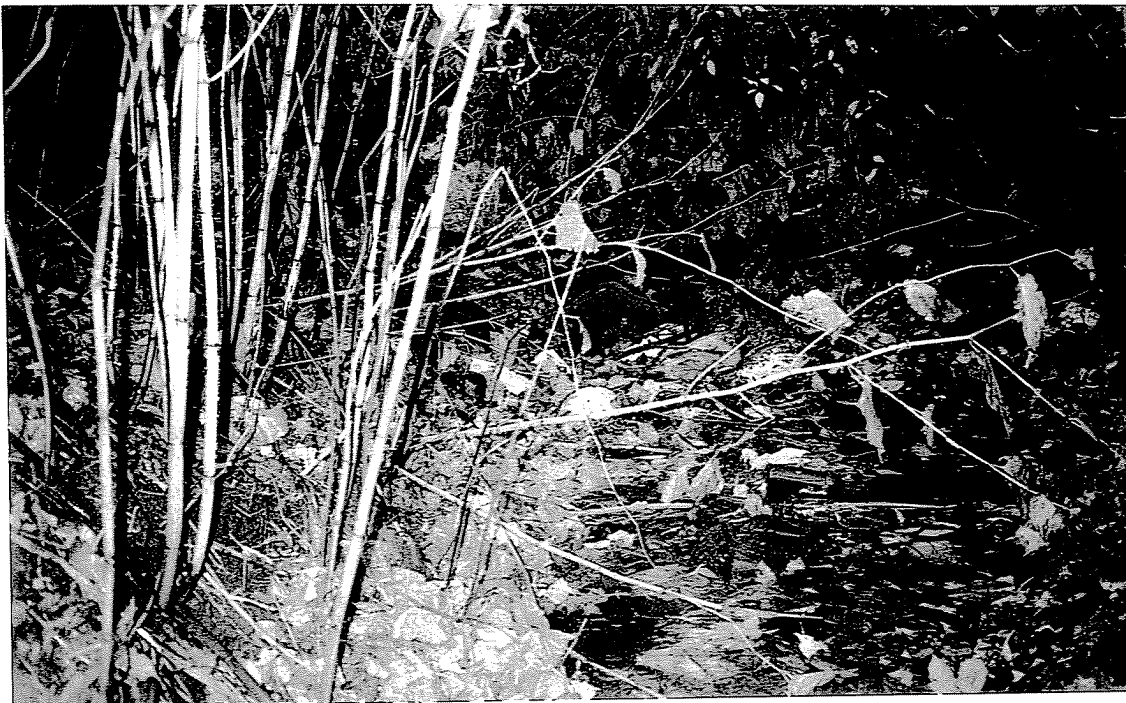
**Photo #11 - Site east of Hopkins Street**

**Description:** One of the culverts forming the hydrologic link between wetlands east of Hopkins Street and the West Ditch and South Pond.

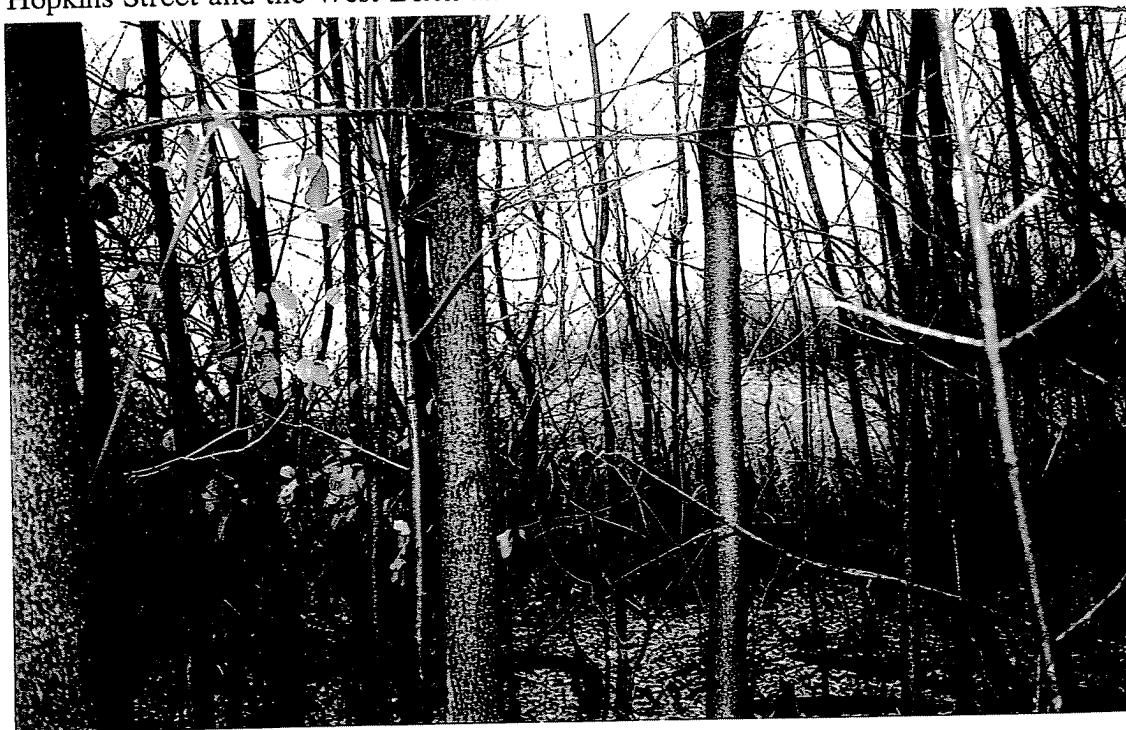
**Photo #12 - Site east of Hopkins Street**

**Description:** Photo shows a portion of a small circular upland inclusion in the emergent area bordering the adjoining junk yard north of the site.
