PRELIMINARY SITE ASSESSMENT

Shanco Plastics and Chemicals Site No. 915048

Town of Tonawanda Erie County

March 1993

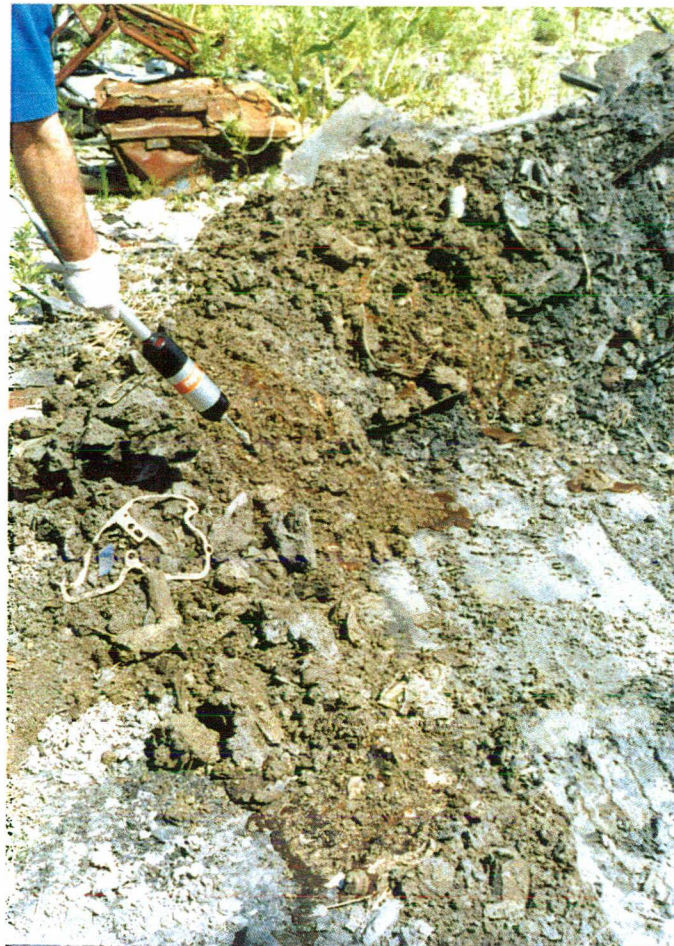
Photo No. 7

- 7) Resin material in a debris pile located in the western section of the site.
Direction: West
- 8) The front side of the former Shanco plant.
Direction: West

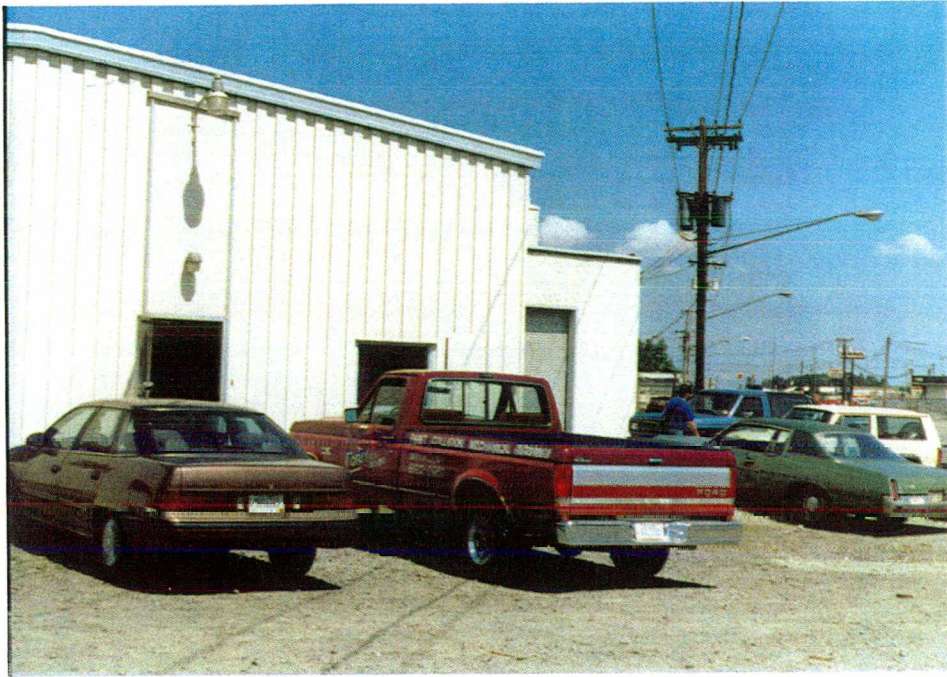
Photo No. 9

- 9) The front side of the former Shanco plant.
Direction: Northwest
